## Ground Floor

As at December 2021, during strip out works, this floor comprises:

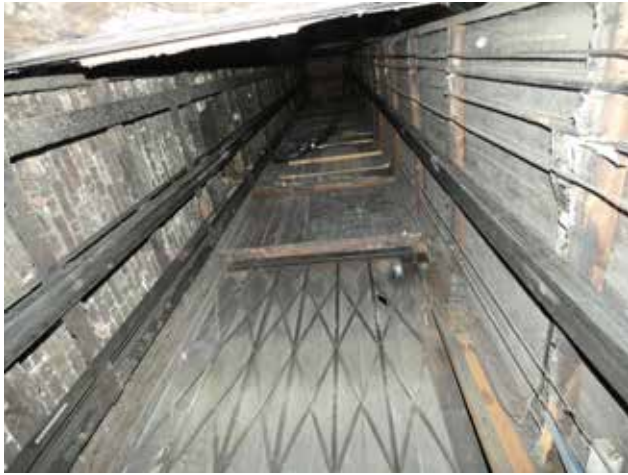
**3.24** B017 and B017a (Insall)

**B017** is the lift shaft. It contains metal concertina doors, probably from the 1960 refurbishment. The shaft is red brick lined and a double opening with concertina door is visible at ground level – parallel with the Newton Street elevation [Plates 3.23-3.24]. **B017a** is a small lift lobby, it is finished much the same as the main corridor, with screed floors, painted walls and a boarded ceiling [Plate 3.25].

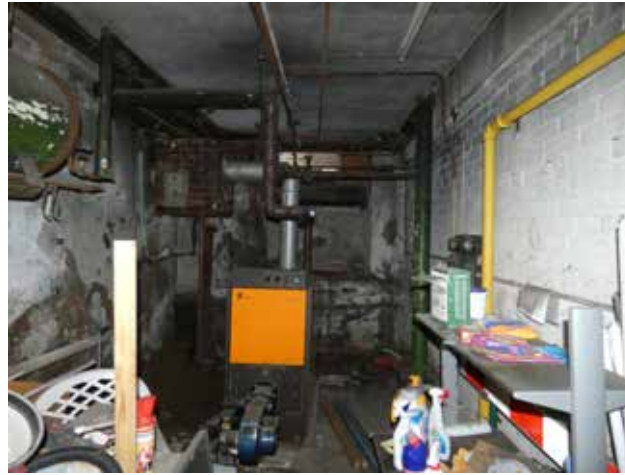
**3.26** B018 (Insall)

**B018** is the plant room at the NE end of the building. Its walls appear to be original brick, painted or plastered, except the wall to B019 which is brick, probably from 1960. One bricked / concreted and vented window opening with arched lintel in the SE wall. There is an RSJ running NE-SW above the door, with breezeblock infill above it. Angled bulkhead in N angle. Ceiling is plastered, the floor is screed. There is a late-20<sup>th</sup> century wall-mounted boiler against the NE wall, further floor-mounted kit and a series of ceiling-mounted pipes. Modern brick enclosure high on the NW wall, part of boiler system [Plate 3.26].

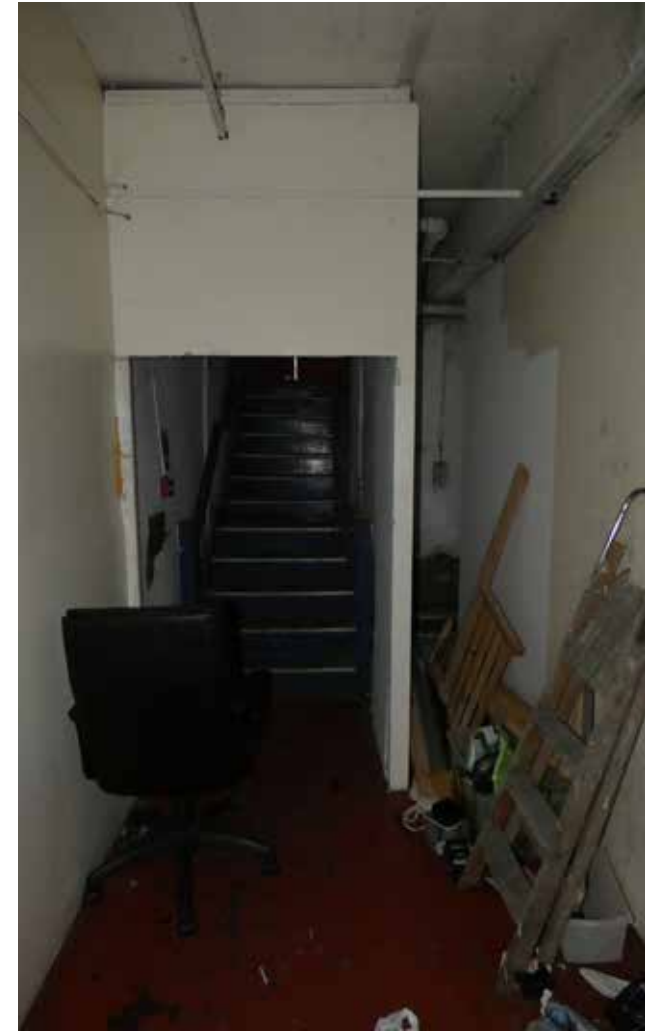
**3.27** B022 (Insall)

**B022** is a lobby and staircase set between B020 and B023, the latter leading up to the rear yard. The stair appears to be 1960s, timber treads and risers with lino and metal tread ends, simple timber newels and a timber handrail. Plasterboard and brick walls flank the stair, which rises into a small single storey extension. The fire doors are modern. The staircase enters the building via a blocked original basement window, under segmental arch brick lintel [Plates 3.27-3.29]. The lobby is much the same as the remainder of the corridor – screed floors, plasterboard walls, veneered doors in varnished frames, encased original timber beams, partially expressed cast iron columns.

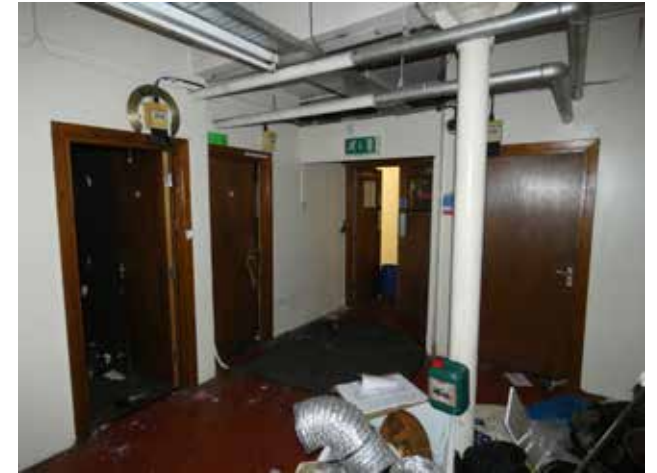
**3.30** B028, looking south (Insall)

**B028** is the main spine corridor – which is an early-21<sup>st</sup> century addition. In the main portion of the corridor there is a row of 12 original painted cast iron columns with capitals and flanges; they are thicker at this level than on the upper floors and are at the centre of the plan, semi-submerged within the modern partitions which form one side of the corridor. The floor is screeded, ceilings are painted board or plaster, the walls are painted plasterboard, there are a few off the peg timber skirtings. All doors are cheap veneer. The columns support the original timber beams, which are encased / overboarded. The corridor ceiling is filled with service runs - exposed pipework, including sprinkler system, metal trunking and fluorescent lighting. Each room has a fuse isolator above its door. There are two sets of double doors enclosing the lobby which leads to the external staircase to the rear yard (B022).

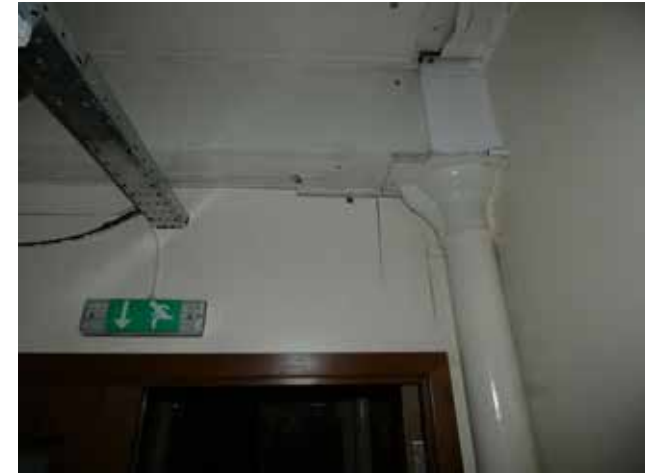
**3.33** B028 Typical cast iron column and overlaid beam (Insall)

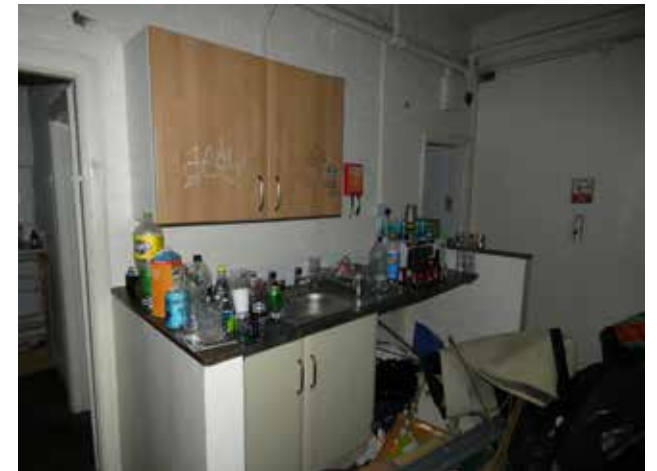
**3.34** B029 (Insall)

**B029** is a squarish space, off the southern end of the main corridor (B028) and contains a modern kitchenette with a few fixed cabinets and a base unit set against the wall with B008-B009 [Plate 3.34].

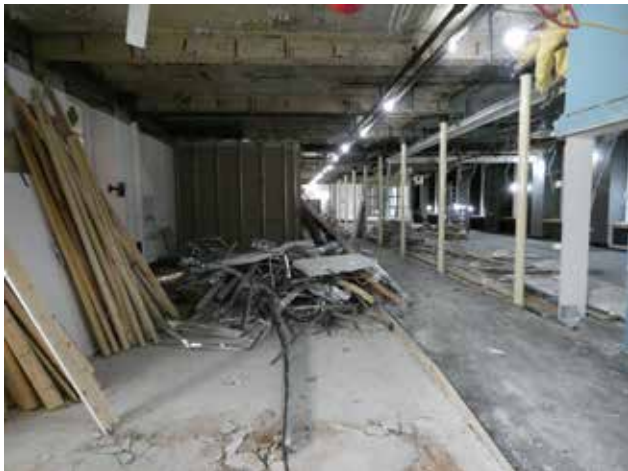
**3.38** G001, Ground Floor

- The original ceiling structure is visible following the strip out of the suspended ceilings, this comprises deep principal beams running NW-SE. They are supported on the external brick walls and a series of cast iron columns – placed centrally within the floorplan **[Plate 3.38]**.

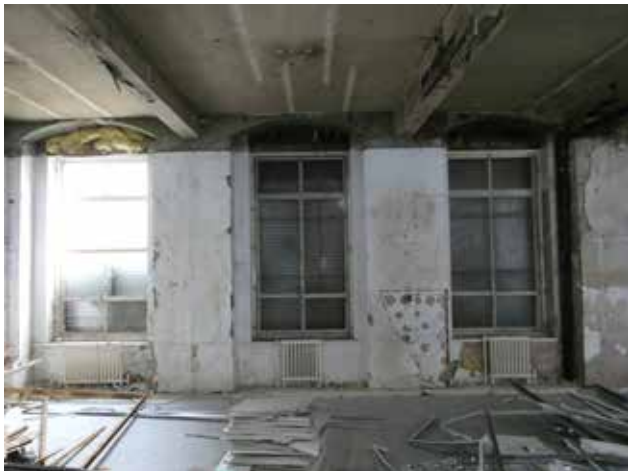
- The ceiling is finished in thin tin sheets in some locations **[Plate 3.39]**.
- The suspended ceiling has revealed arch-headed lintels to the rear windows **[Plate 3.40]** and the arched opening to Newton Street **[Plate 3.41]**.

**3.40** Arched lintels in rear wall, Ground Floor

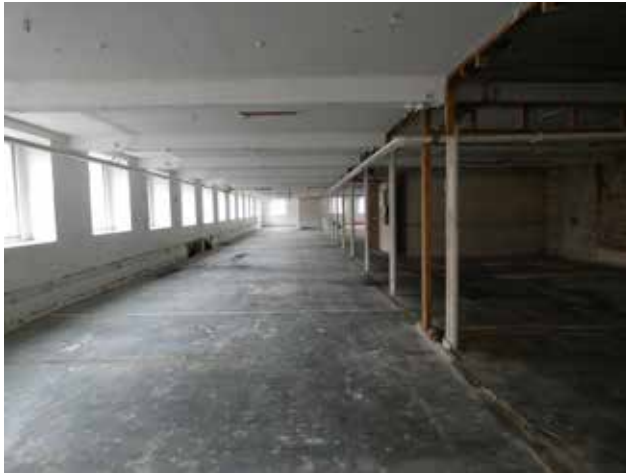
**3.43** *First Floor*

- 1960 lift and staircore, with plastered walls, lino floor and boarded ceiling (F001).
- A largely open-plan space (F002), with a series of cast iron columns – placed centrally within the floorplan **[Plate 3.43]**.
- The floors are screed. No historic floor finishes are visible at present.
- Some late-20<sup>th</sup> century partitions and a historic timber screen remain at the centre of the building (timber stud and plasterboard) – in F003 **[Plates 3.44 and 3.45]**.
- Painted brick walls.
- The removal of partitions has revealed the top of the arched opening to Newton Street **[Plates 3.46 and 3.47]**.
- Bricked and breeze-blocked windows in the rear wall **[Plate 3.48]**.
- The lift shaft at the north end of the building remains – now isolated, clad in plasterboard and with concertina doors exposed.
- Asbestos-clad ceiling and beams remain.

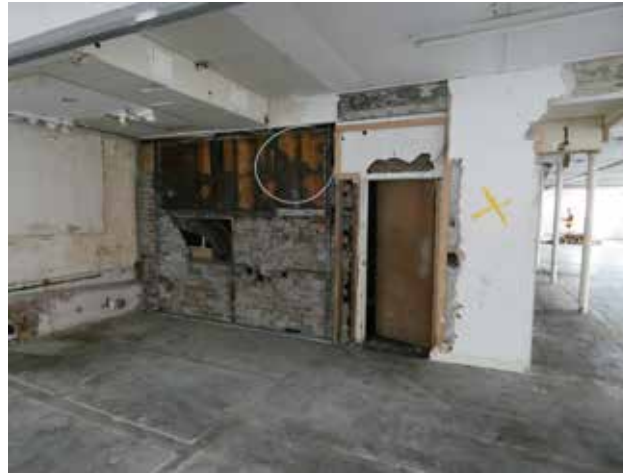
**3.45** *Partitions and screen around timber staircase, First Floor*

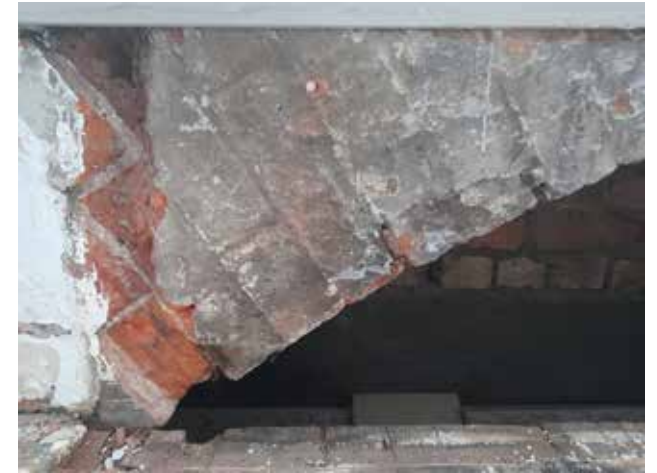
**3.47** *Arch revealed in front wall to Newton Street, First Floor*

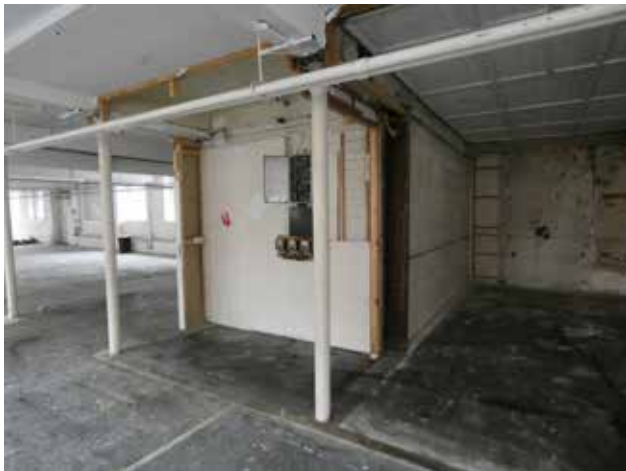
**3.44** *Partitions around timber staircase, First Floor*

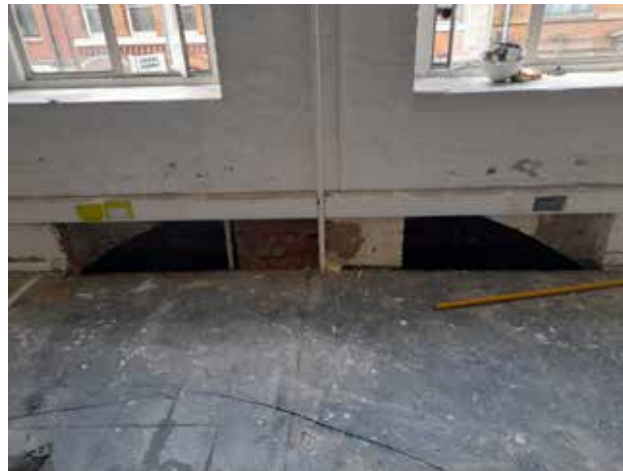
**3.46** *Arch revealed in front wall to Newton Street, First Floor*

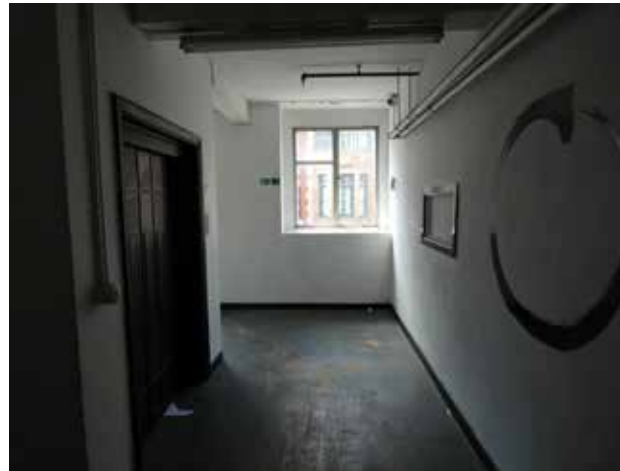
3.49 S001, Second Floor

- 1960 lift and staircore, with plastered walls, lino floor and boarded ceiling (S001) **[Plate 3.49]**.
- A largely open-plan space (S002) - with a series of cast iron columns – placed centrally within the floorplan **[Plate 3.50]**.

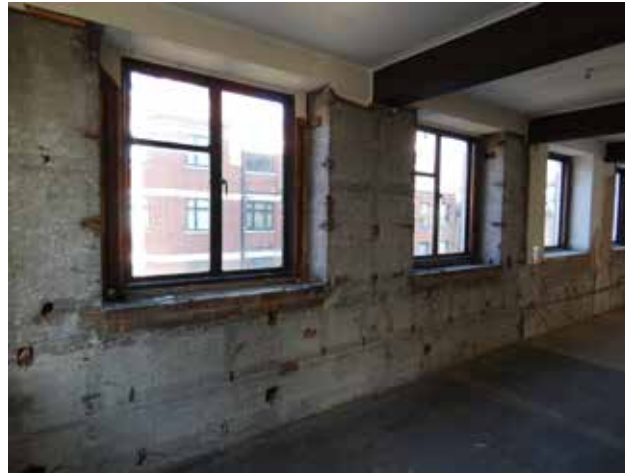
**3.53** *Part-plastered walls, S002, Second Floor*

- Painted brick, limewashed and plastered walls (of a variety of ages). Some cills have a slight bullnose, many have been replaced with modern brickwork **[Plate 3.53]**.

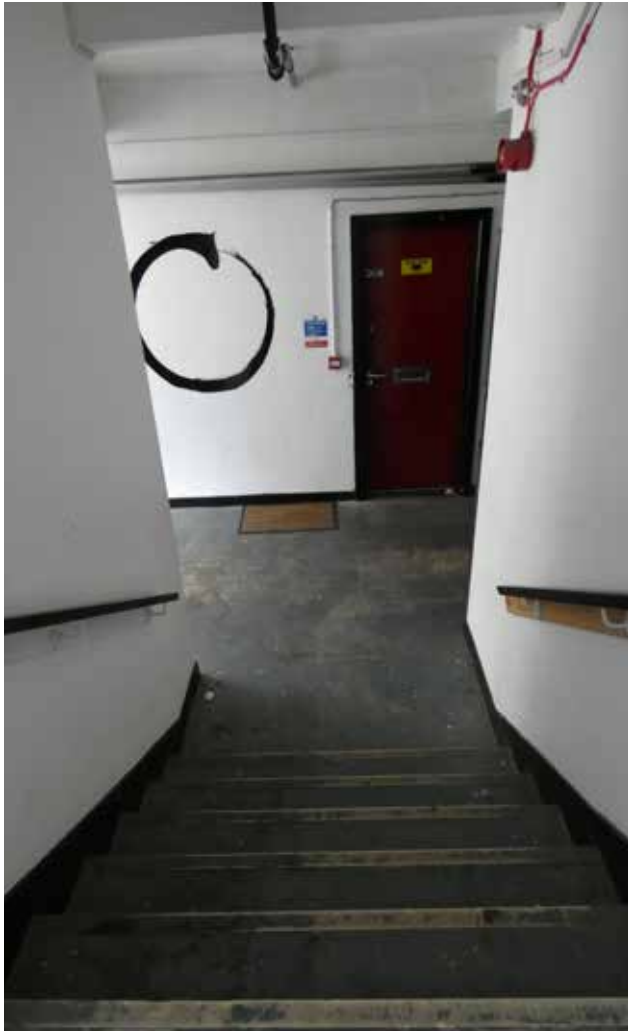
3.55 T001

**T001 / T002** is a 1960 lift and wrap around staircore and lobby at the southern angle of the building. Concrete stairs, with terrazzo (unconfirmed) covered with vinyl. Plain plaster walls and boarded ceilings, timber skirtings, metal concertina door to the lift, cheap timber veneer doors with vision panels to T003 and solid door to the continuation of the stair leading to the fourth floor. One metal casement in the SW wall. Sprinkler system, services and fluorescent lighting fixed to the ceiling. All 1960s and later finishes **[Plates 3.55-3.57]**.

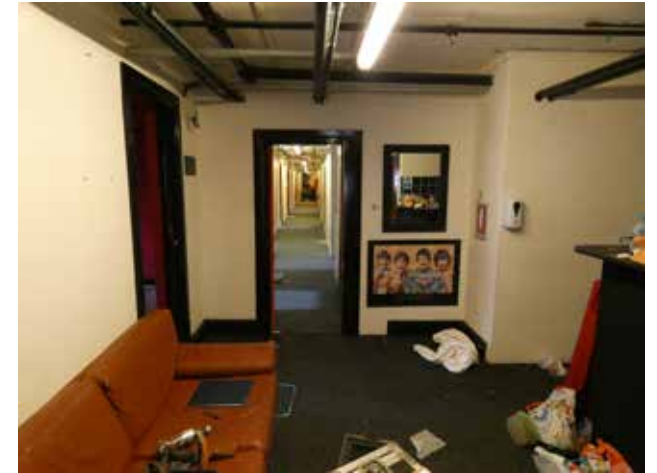
3.58 T003

**T003** is a lobby / waiting area / kitchenette with screeded floors with carpet over, plaster walls, part-tiled walls around the kitchenette, plasterboard / sheet asbestos ceilings and late-20<sup>th</sup> century painted doors to T004, T006 and T016. Multiple ceiling-mounted services including sprinkler system pipes, conduit trays and fluorescent lighting **[Plate 3.58]**.

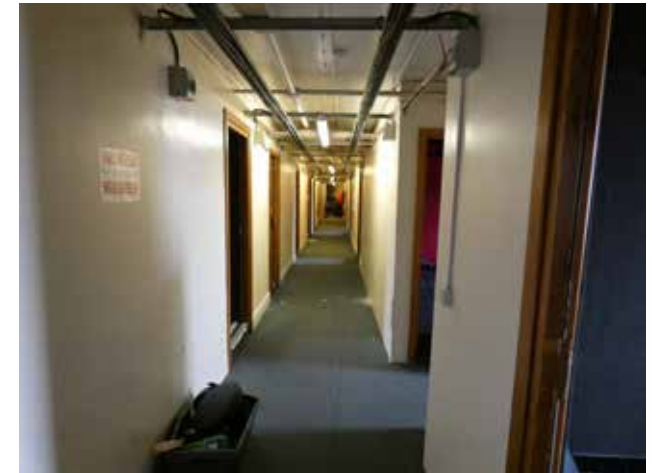
**3.76** T016 looking NE

**T016** is the main spine corridor. Again, there is a row of 12 painted cast iron columns with capitals and flanges at the centre of the plan, semi-submerged within modern partitions which form one side of the corridor. The floor is screeded, ceilings are painted board, the walls are painted plasterboard, there are a few off the peg timber skirtings. All doors are cheap veneer. The columns support the original timber beams, which are hidden by a lowered ceiling. The ceiling is filled with service runs - exposed pipework, including a sprinkler system, metal trunking and fluorescent lighting [Plates 3.76-3.77].

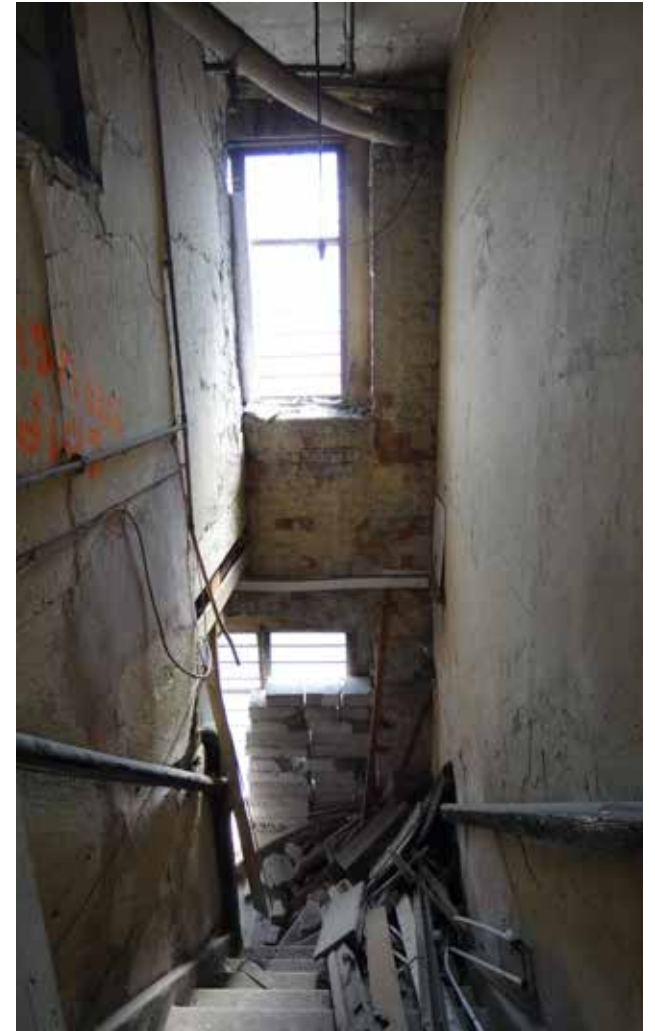
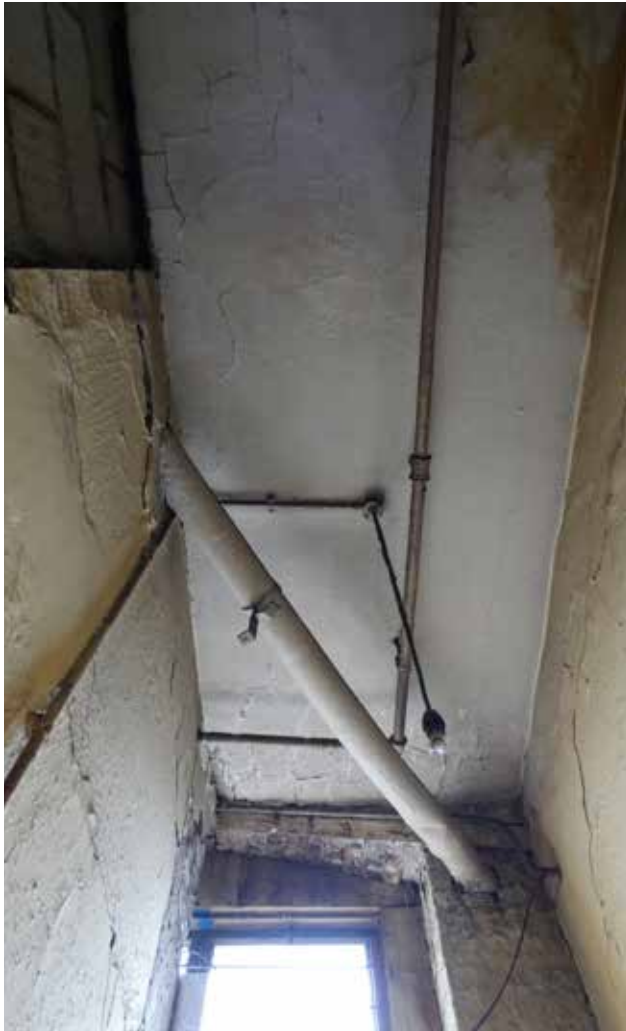
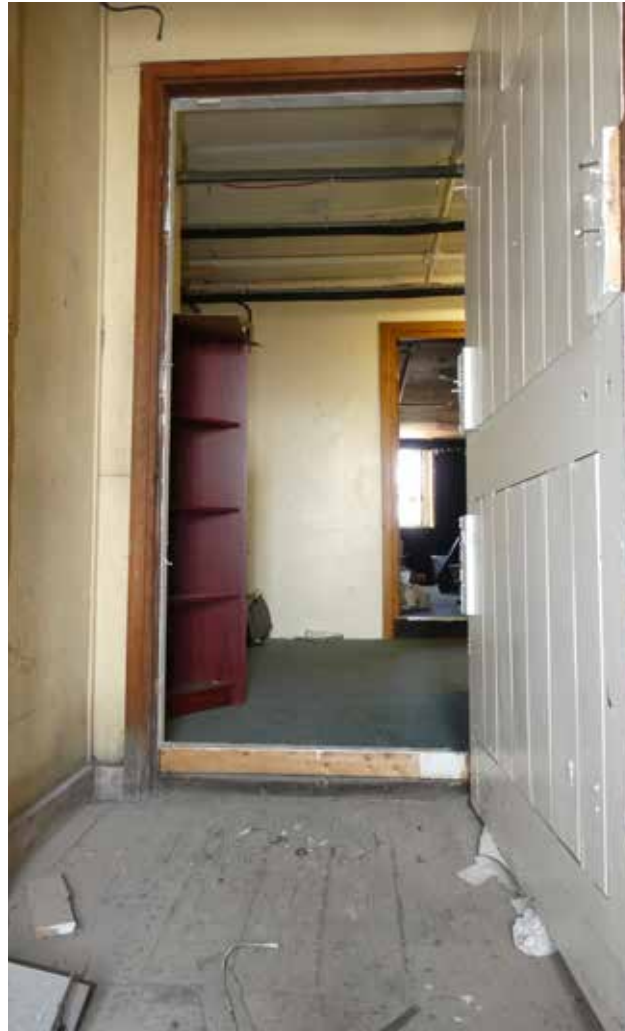
**T024** is a timber half-turn staircase which looks to be early- / mid-Victorian. The stair features timber treads and risers, with bull-nosed ends and timber stringers. The newel is a squared timber post with a depressed / shallow pointed top, and the handrails are also timber – turned to the NE wall (possibly early-20<sup>th</sup> century) and probably late-20<sup>th</sup> century replacement along the SW wall. It is capped at various floors – including to the second floor below with plasterboard. Access from the corridor is via a hefty timber boarded door, which looks to be from the 1960 works, and a plasterboard partition. The NE wall of the stair is made up of timber stud, with plaster over, timber plank, and a high level opening which contains breeze blocks. The NW external wall is brick, partially painted, it contains windows at third and second floor level – metal casements in arched lintels and will bull-nosed cills, bars over the second floor window. The third floor

window is split by an apparent extension of room T022. The SW wall is plastered. Drainage pipes and sprinkler pipes criss-cross the ceiling, plastic conduit is fixed to the walls [Plates 3.79-3.81].

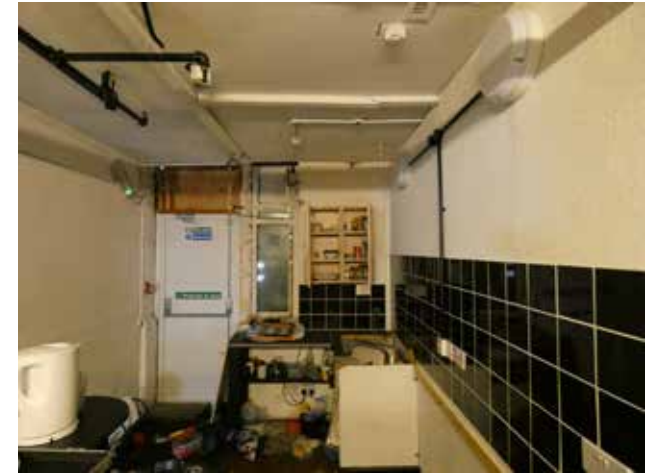
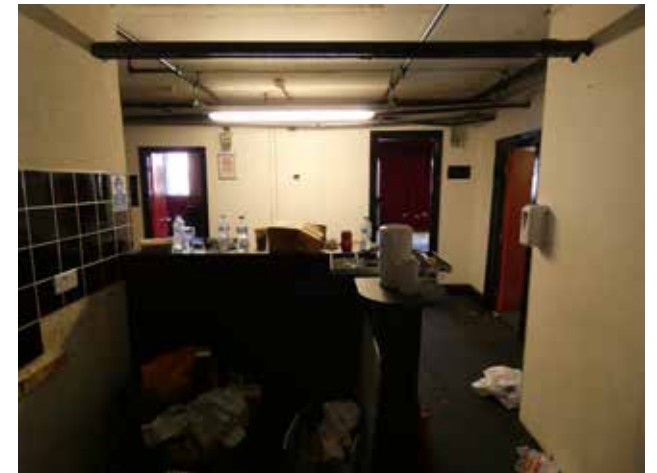
**T026** is located off T003, it is a modern kitchenette, adjacent to a modern fire escape door with a modern narrow timber casement adjacent – set within an original arched opening. Laminate floor in kitchenette areas, with modern kitchen fittings [Plates 3.82-3.83].

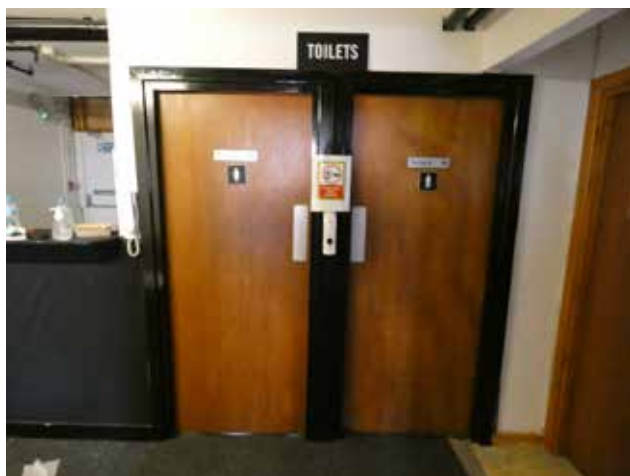
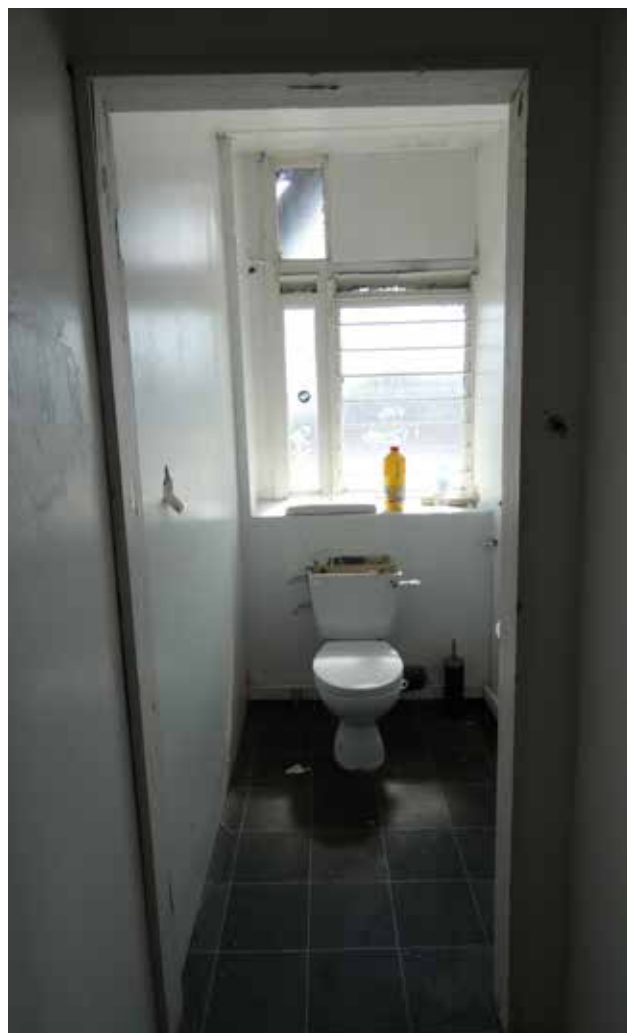
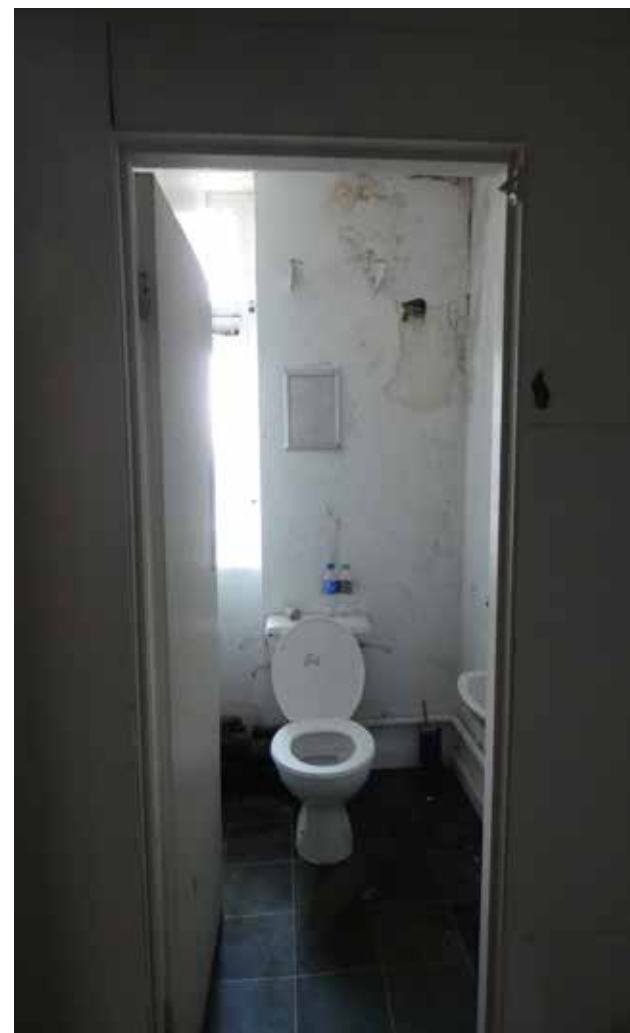
**T027 and T028** are modern WCs, set against the staircore. Modern veneered doors in painted timber frames. Modern tile effect lino, plastered walls and ceiling and modern fittings. Window is barred and partially blocked and divided between the two WCs [Plates 3.84-3.86].

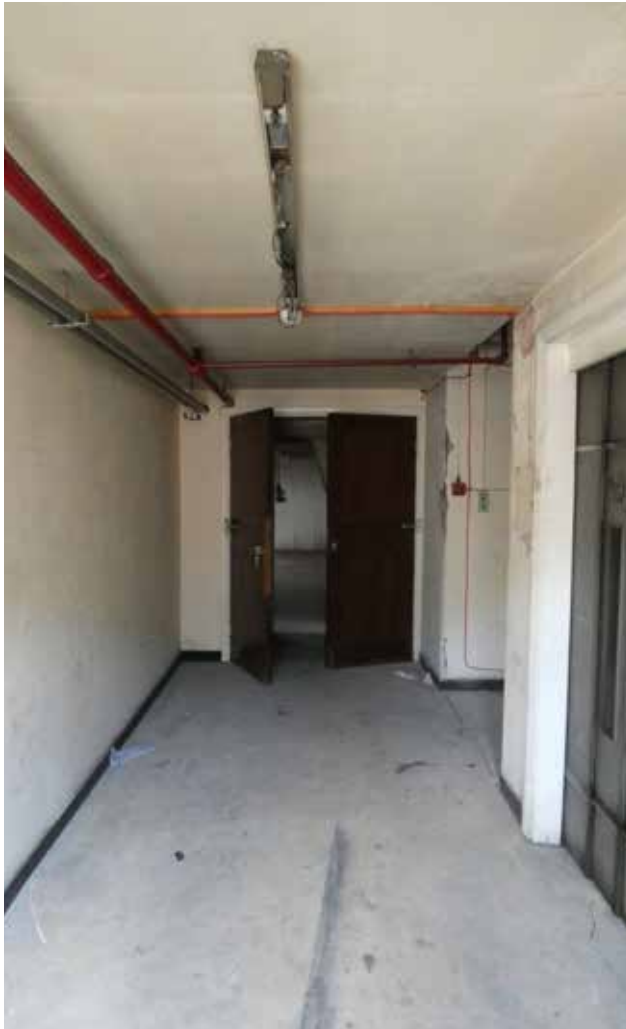
**3.87** FF001

- 1960 lift and staircore, with plastered walls, screed floor and boarded ceiling (FF001). Plaster lost on SW wall, revealing original brickwork. 1960 timber doors lead to FF004 **[Plate 3.87]**.

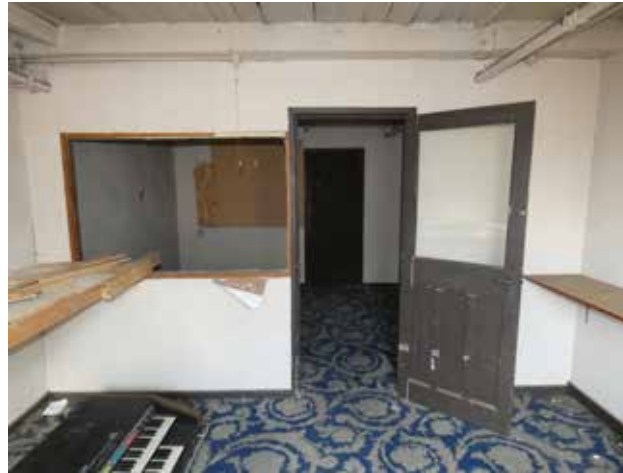
**3.88** FF002 and F003

- Small office / studios – modern timber stud partitions, carpeted floor, timber slatted ceiling (FF002 and FF003) **[Plate 3.88]**.
- Two large open-plan spaces divided by a modern timber studded partition with glazed vision panel (to be removed) (FF004 and FF005) **[Plates 3.89-3.91]**. The floors are historic timber floorboards – of a variety of ages and sizes – the wider more historic boards run NE-SW, whilst the narrower boards run at 90 degrees laterally across the space (see Plates 3.89-3.91). One area appears to frame an infilled hoist opening **[Plate 3.92]**. Some areas of floor have sheet ply over the boards. Walls beneath the clerestory glazing and around rooms FF009 and FF010 are vertical timber tongue and groove – probably early-20<sup>th</sup> century. Clerestory windows are a variety of ages, none appear to be original though some are probably late-19<sup>th</sup> and early-20<sup>th</sup> century timber, with later replacements, some are missing glass **[Plates 3.93-3.94]**. Ceilings feature timber beams running NW-SE, between which is thin timber boarding, some is missing or is overboarded with asbestos

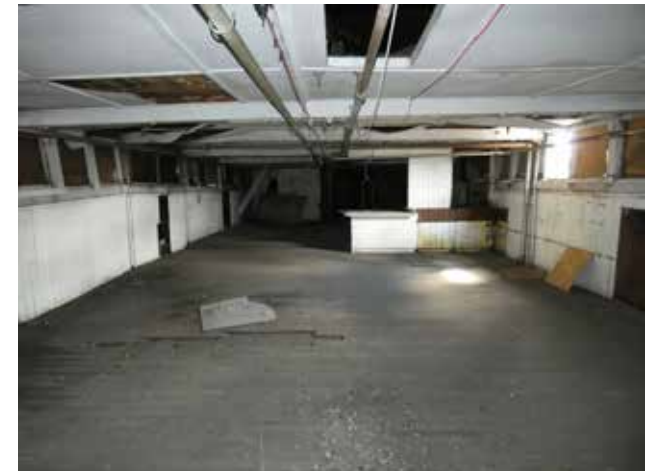
**3.91** FF005

sheeting [see Plate 3.91 and 3.95]. Fixed to the beams and boards is a range of services – a mid-20<sup>th</sup> century sprinkler system, later strip lighting, mid- to late-20<sup>th</sup> century conduit / ceiling roses. At the northern end of FF005 is a service lift with mid-20<sup>th</sup> century outer concertina shutters and boarding externally, early-20<sup>th</sup> century scissor shutters and a timber-panelled lift car **[Plate 3.96]**.

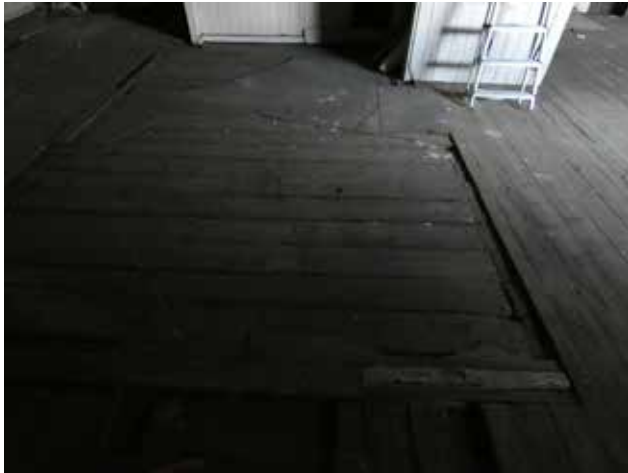
**3.92** Floor with potential infilled hoist, FF004

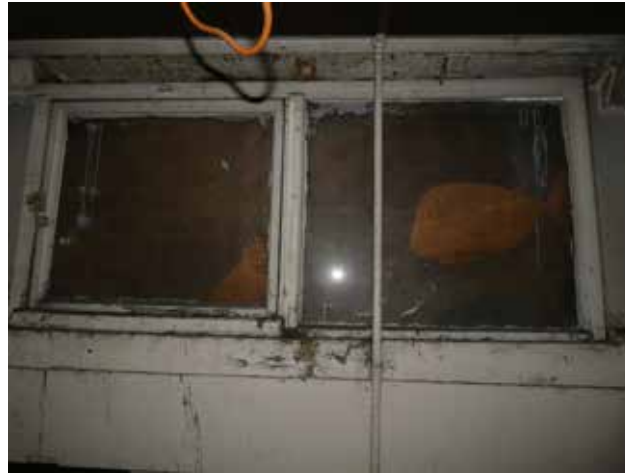
**3.94** Early-20<sup>th</sup> century glazing, FF004

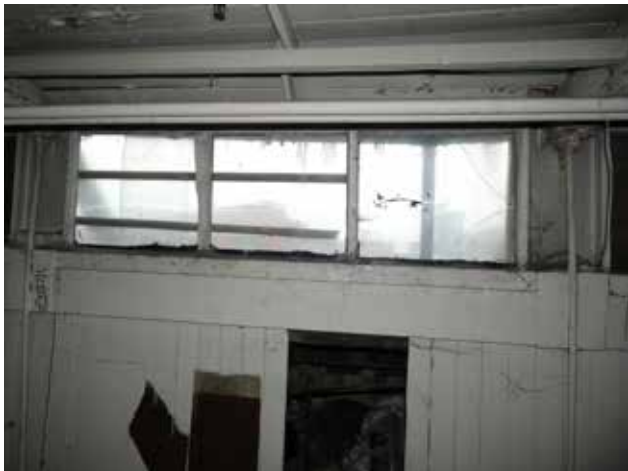
**3.93** Modern reeded glazing, FF004

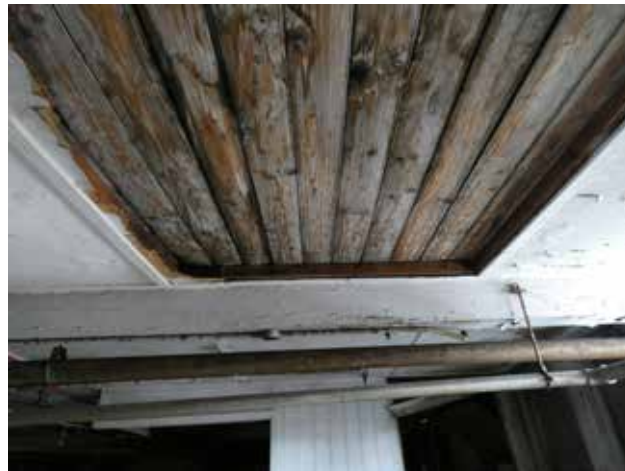
**3.95** Timber boarding to ceiling, FF005

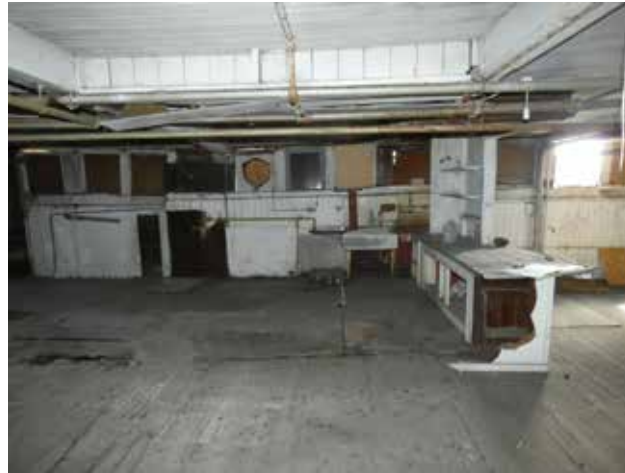
**3.99** *Kitchen, FF008*

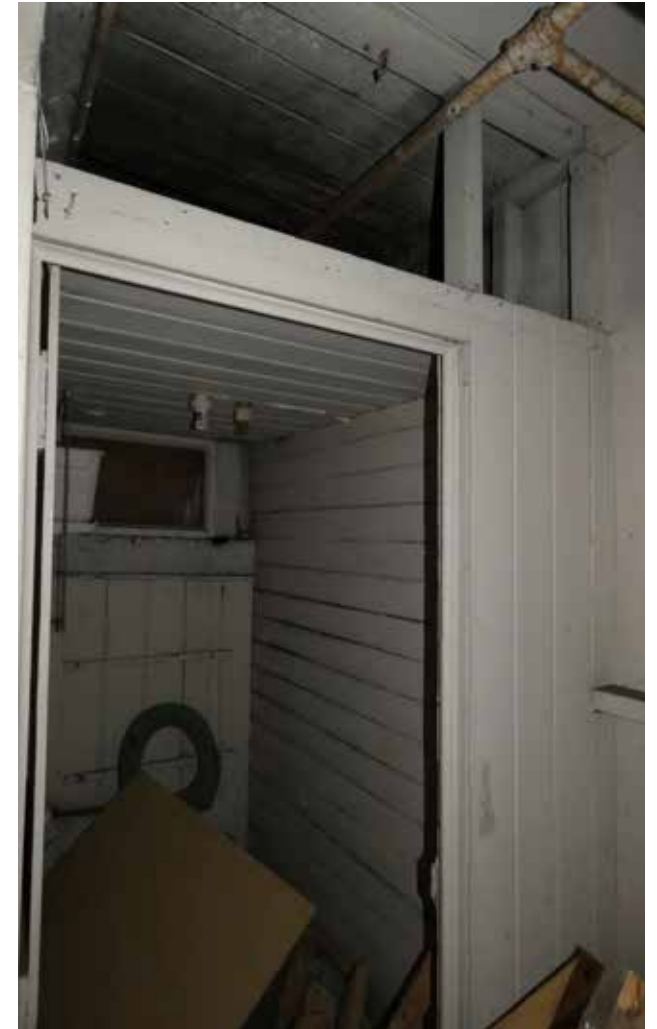
**3.100** *WC, FF009*
