**Project Title:** Premier House

**Task Title :** Vibration Assessment and Movement Monitoring Report

**Report Reference:** 30397-11-PPO-PH-VA-REPORT R3

# Premier House - Vibration Assessment and Movement Monitoring Report

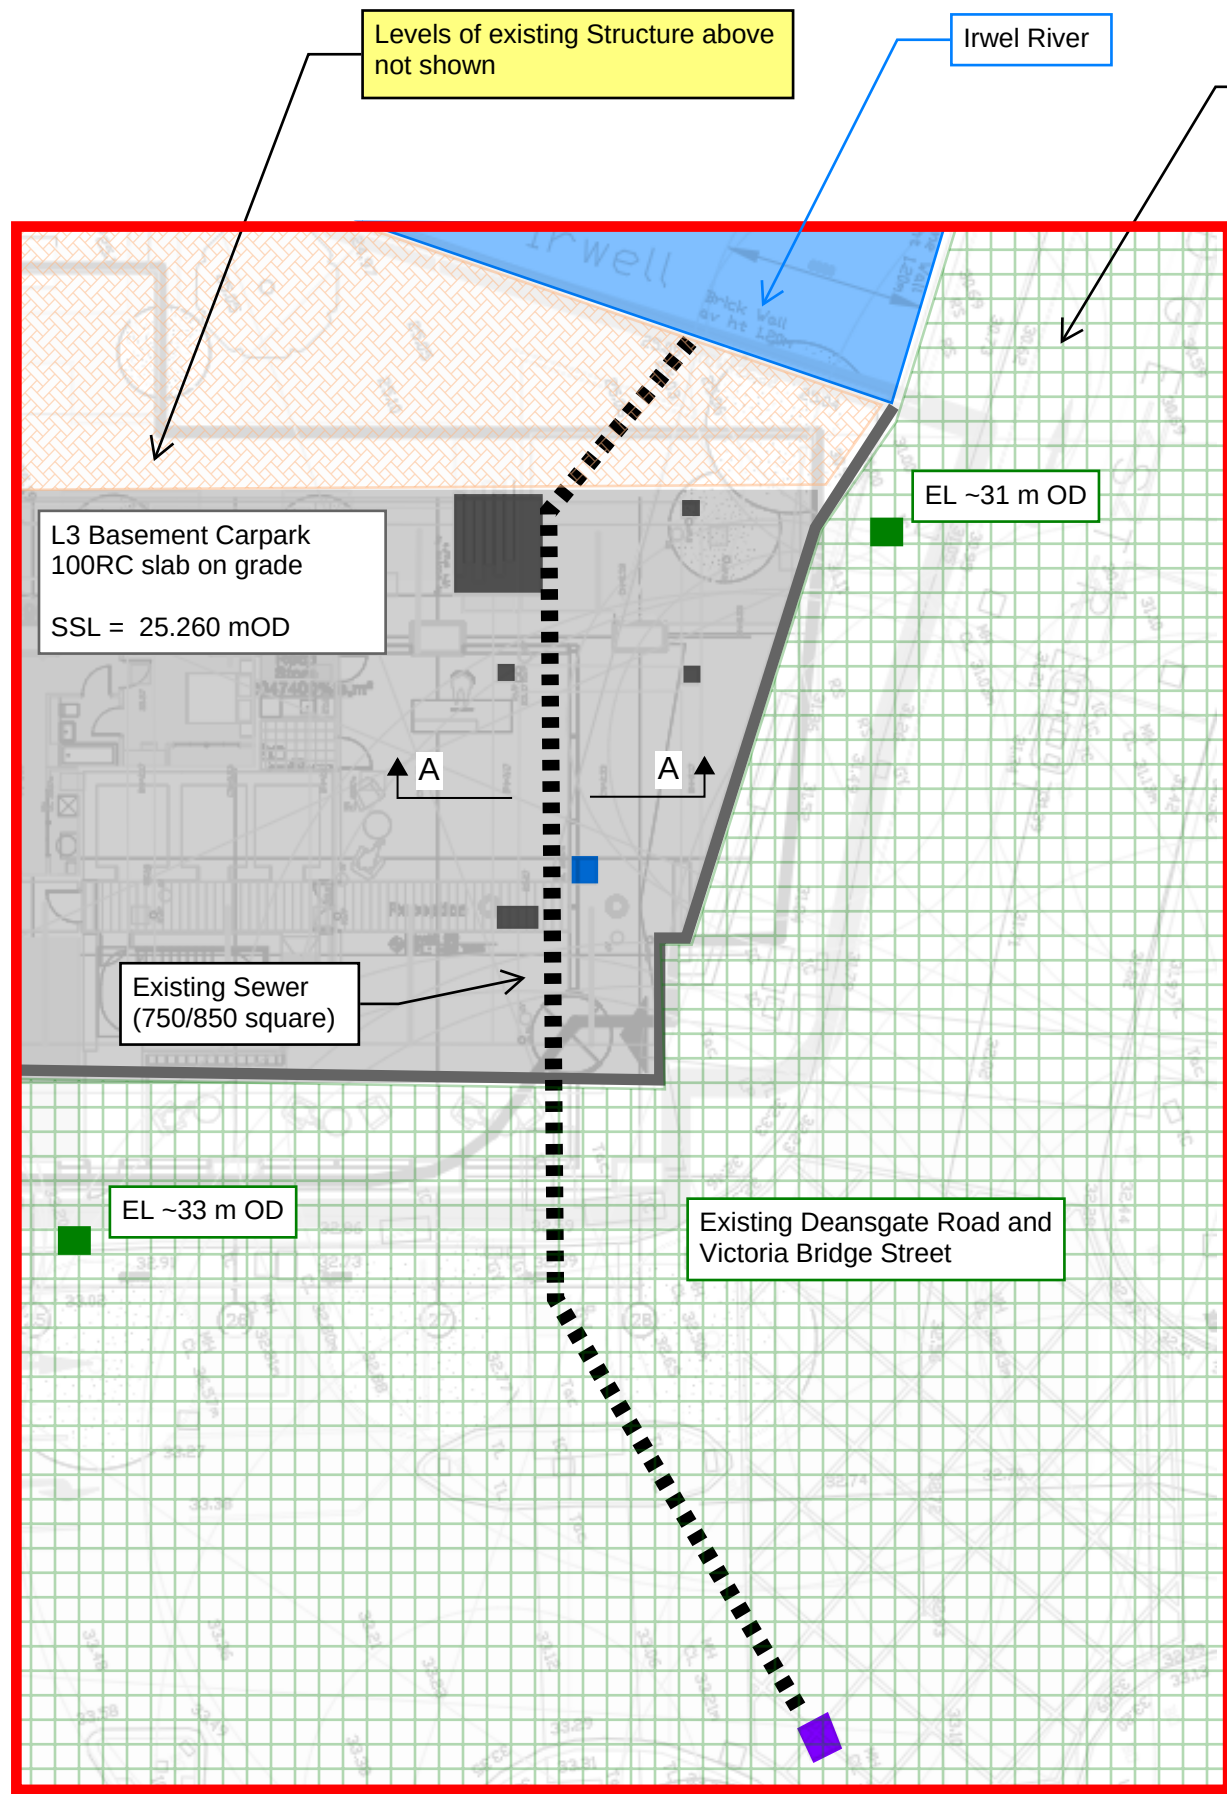
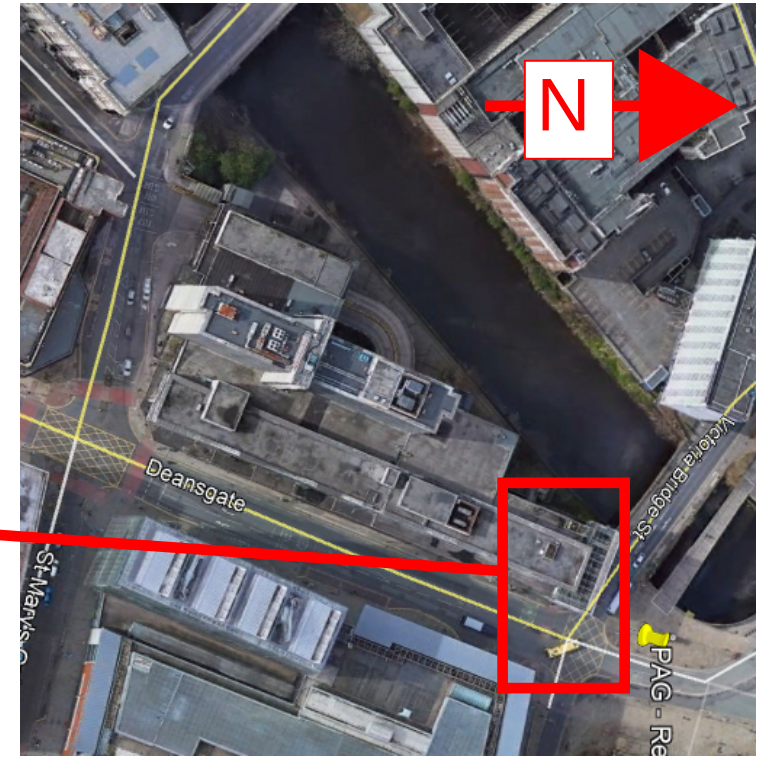
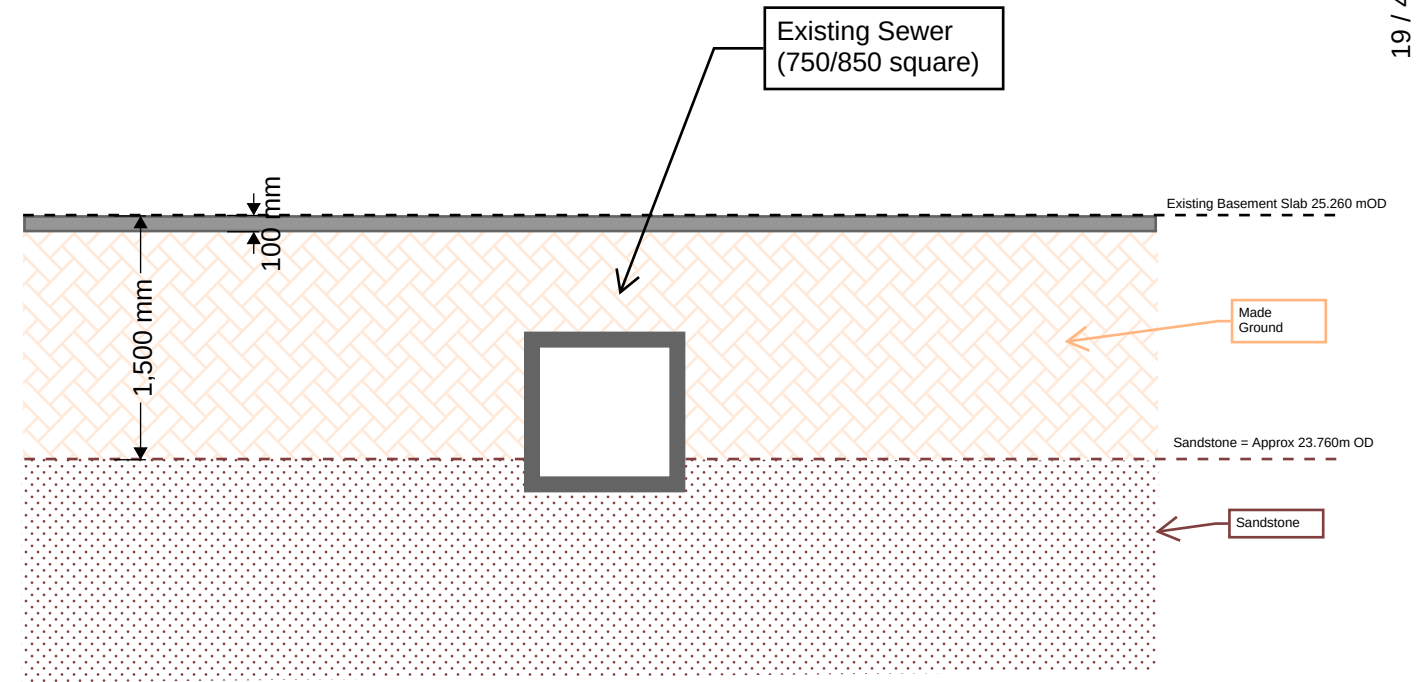
PLAN

During construction of the new residential tower foundations we demolish the sewer at the piling line and construct a new (RC Concrete) sewer under the new foundations from the piling line (site boundary along Deansgate road) to the existing outlet. Existing outlet position will not change.

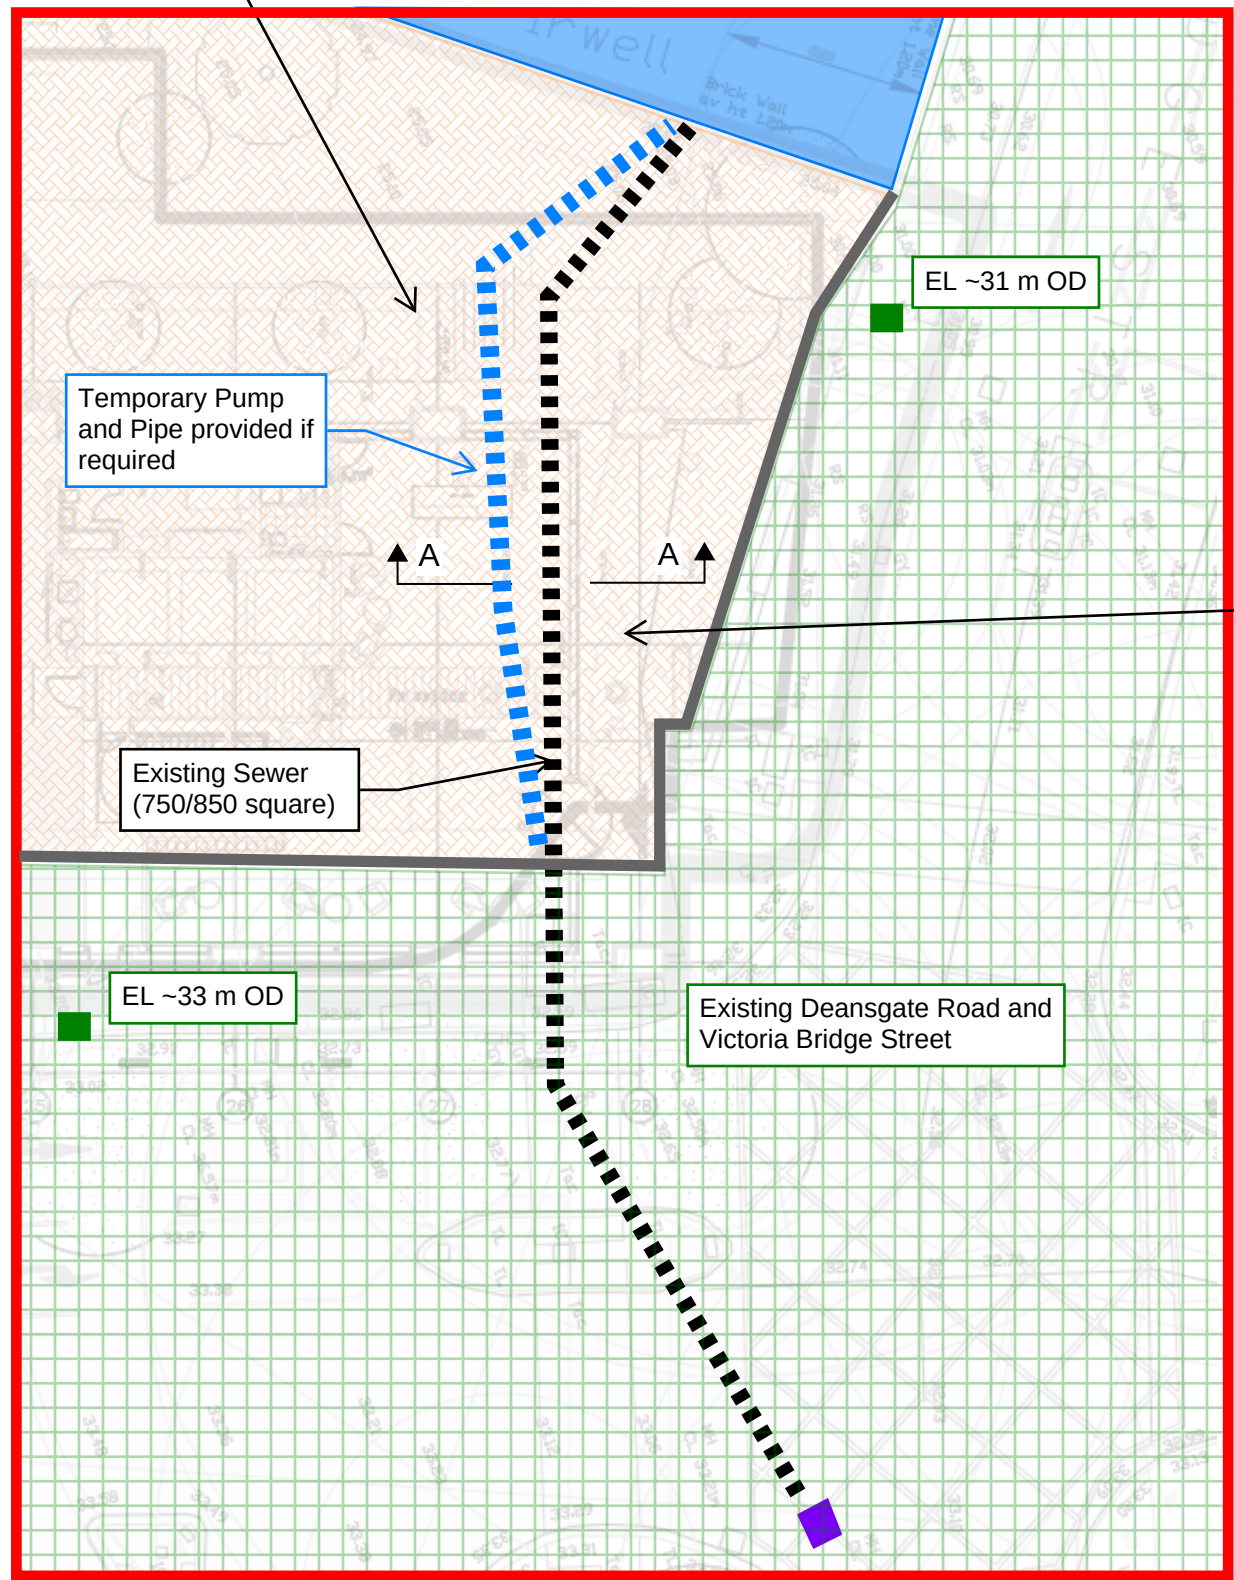
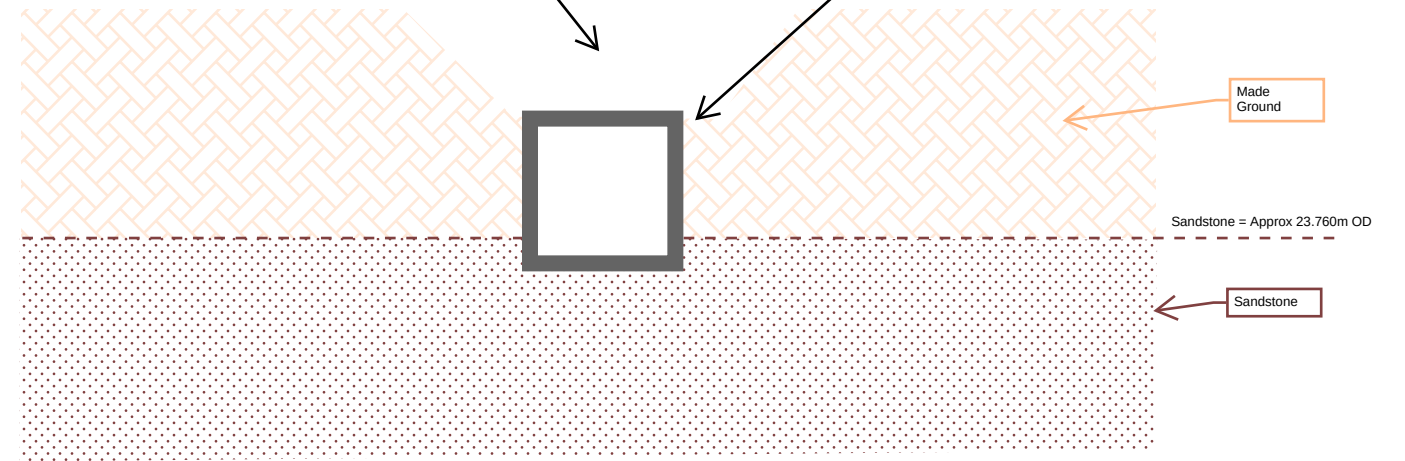
Step 1A - Existing Structure is Demolished

Step 1b - Existing sewer uncovered and exact position surveyed

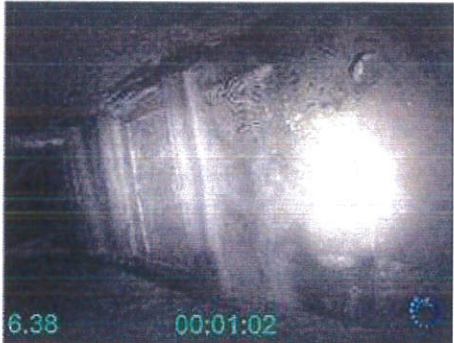
| Pos | Video Ref | Code | Description | Image |
|---|---|---|---|---|
| 00.00m | | MH | Start node type, manhole OV 1 | Image Provided - Ref: 0_0<br><br>6.38 00:01:02 |
