REPORT OF VICTORIA MILL

LOWER VICKERS ST, MANCHESTER M40 7LH

Date of project: 02/08/2021—Ongoing

| <p><b>F.A.O:</b> Medlock</p> <p><b>Author:</b> Lee Armstrong</p> <p><b>Project Description:</b><br/>Rope Access Remedial Works Various</p> <p><b>Technicians who carried out works/inspection:</b><br/>Marc Stirrup Lv 3<br/>Anthony Smith Lv 2<br/>Simon Powers Lv 1<br/>Chris Odonnell Lv 3<br/>Craig Samson Lv 2</p> <p><b>Contents:</b></p> <ul style="list-style-type: none"><li>Introduction</li><li>List of defects provided by Medlock, descriptions of works and links to evidence of works</li></ul> | <p><b>Introduction</b></p> <p>This report shows the evidence of works for all the remedial carried out at Victoria Mill</p> <p><b>NOTE</b></p> <p>Site meeting carried out. Paul Mason the Conservation Officer in attendance to agree scope of works.</p> <p>If you have any questions regarding the project please contact us on 0141 433 8040 or email lee.armstrong@opalaccess.co.uk</p> <p><b>Materials Used On Site</b></p> <p>Hammerite Ultima Matt Black <a href="#">Hammerite Ultima Matt - Hammerite UK</a></p> <p>Blue Cicle Lime <a href="#">Blue Circle Natural Hydraulic Lime 3.5 25kg Travis Perkins</a></

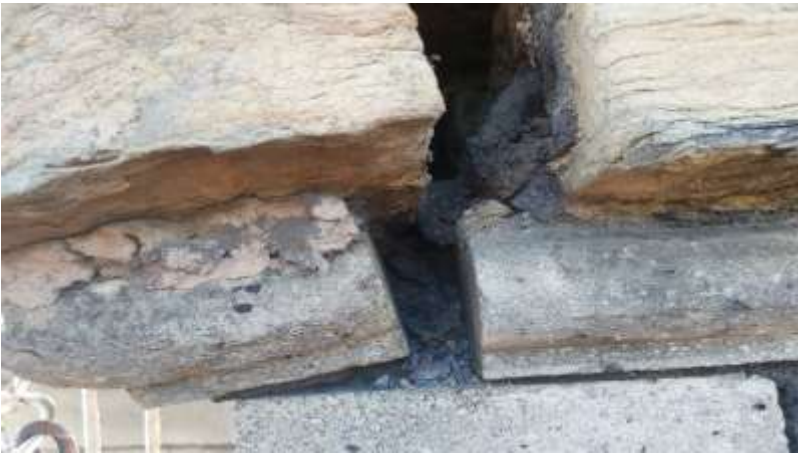
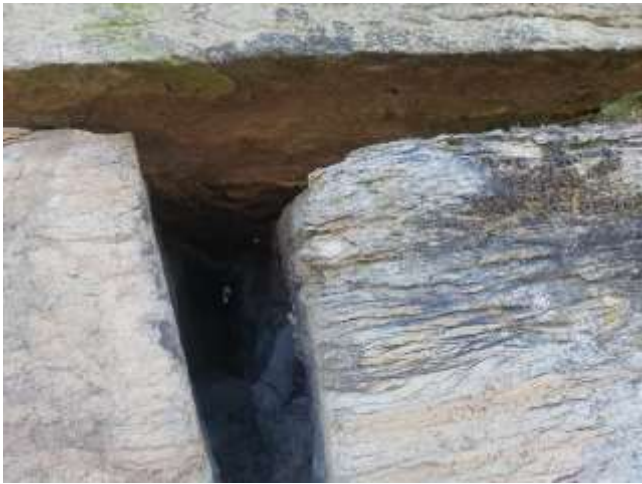
| Name | Status Of Task: | |
|---|---|---|
| 19: North West Elevation: Cracked Brickwork. To lime mortar point up. | Work to be done. Already accounted for. Not additional | To be repaired. NOTE. Top metal work redundant overflow pipe. Pipe penetrates into the building and it is possible it cannot be removed. Other metal work will be removed upon return to site. Brickwork to be replaced. |

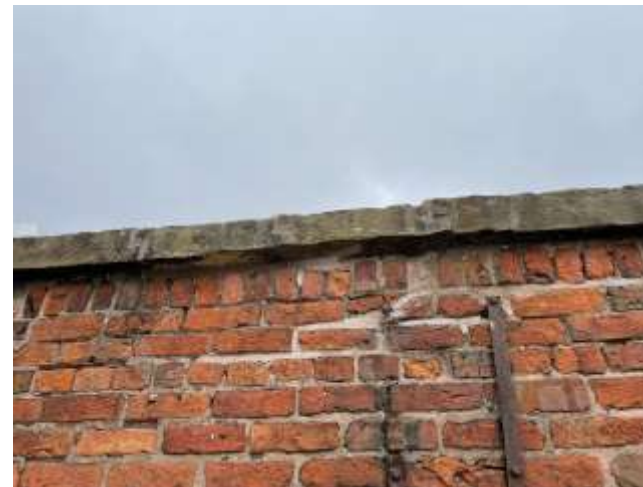
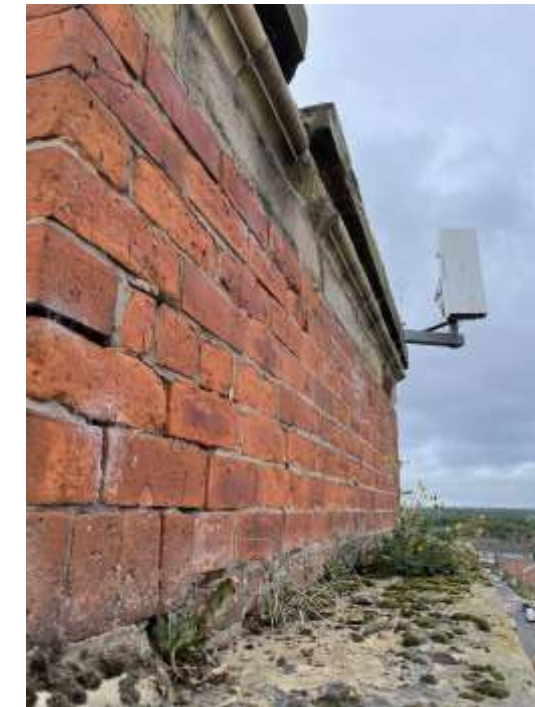
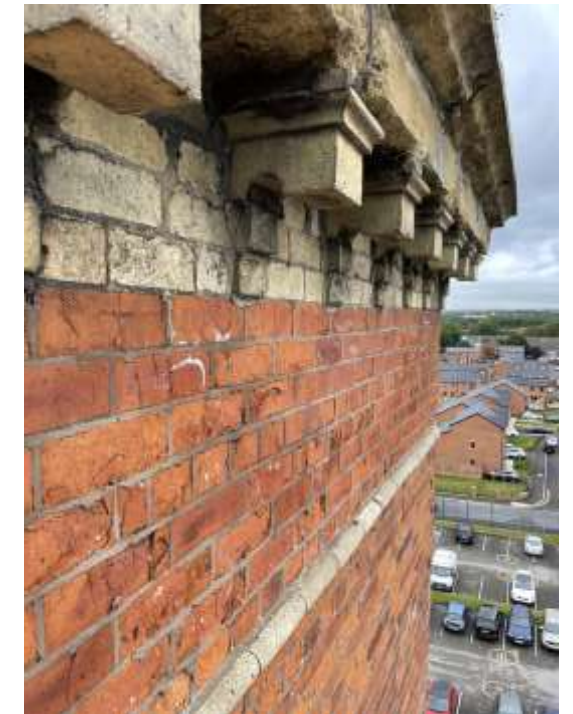
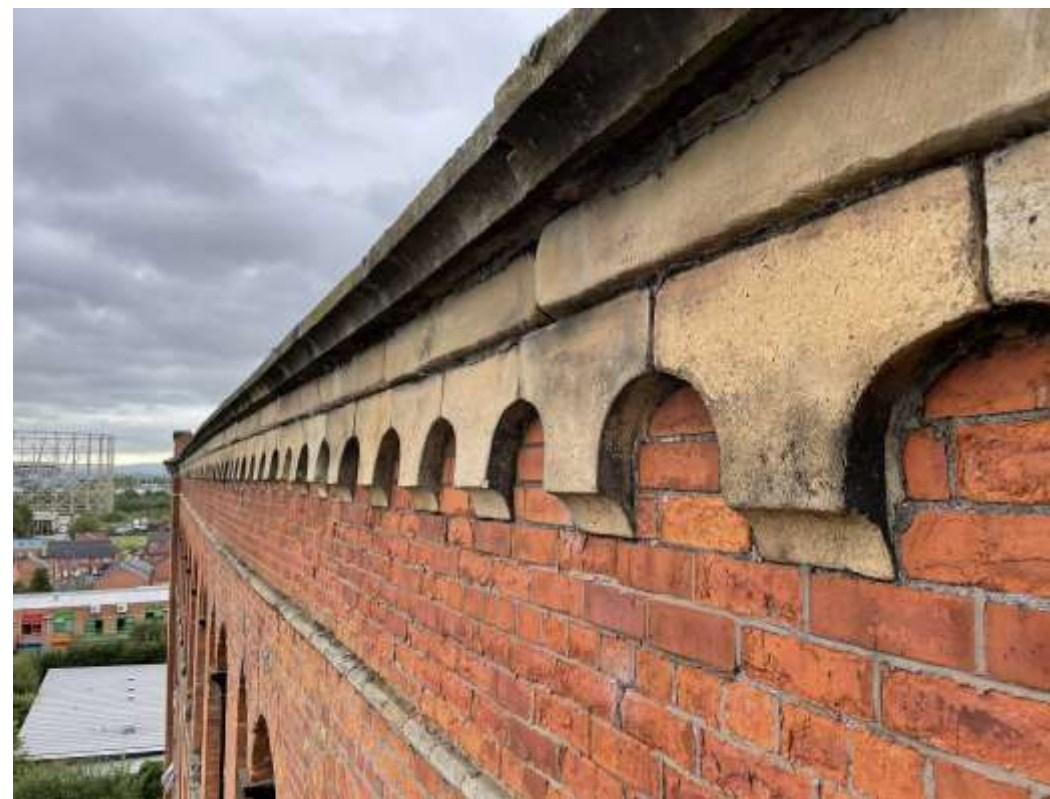
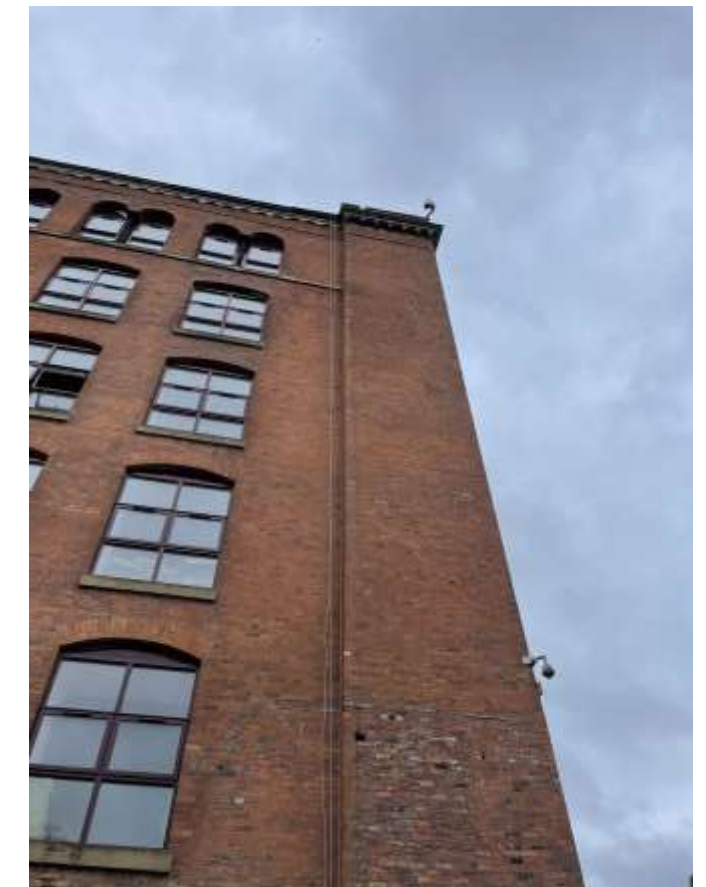
### 1: North East Elevation: Coping / Stones decorative repairs

| Name | Status Of Task: | |
|---|---|---|
| 1 Coping / Stones repairs Multiple | Done: Paul Mason approved on site | Inspection carried out, lime mortar pointing to match existing, coping blocks pinned. Multiple pinning of coping stones. Hitt-1 res and helibar used to pin. Multiple pointing defects repaired |

Inspection carried out, lime mortar pointing to match existing, coping blocks pinned. No Ref picture provided, Opal ref pic of location bottom right. Pointing carried out.

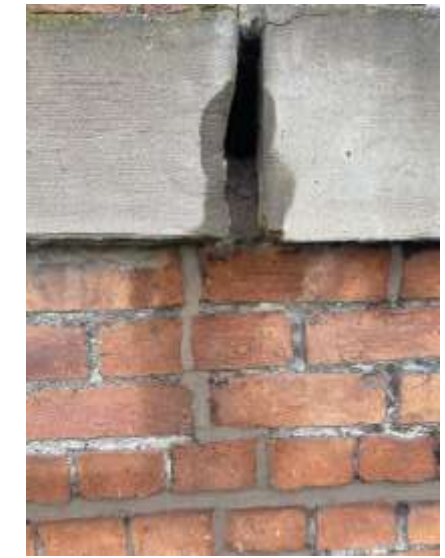
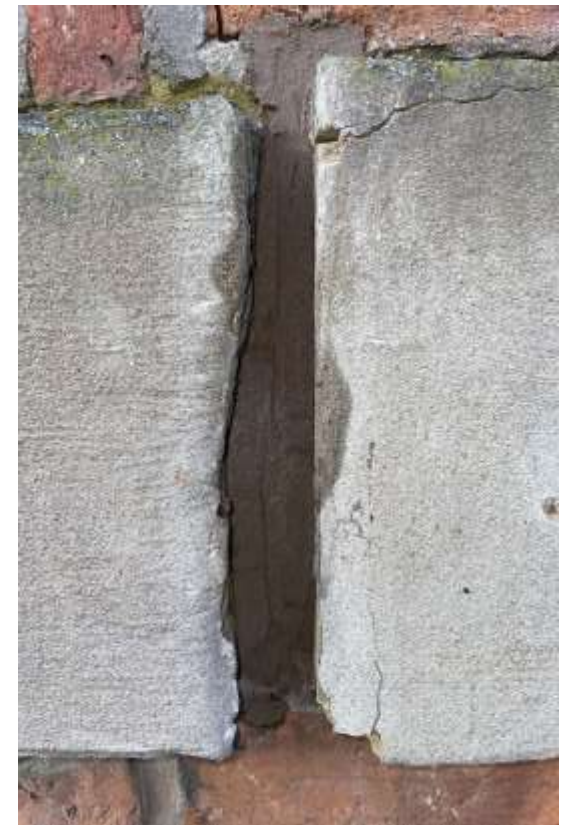
### 8: North East Elevation: Damaged Cornice

| Name | Status Of Task: | |
|---|---|---|
| 8 Damaged cornice | Additional work added | Veg to be removed upon return . Inspected. Structurally sound upon the date of inspection. Check for any other defects and repair: 3 days added |

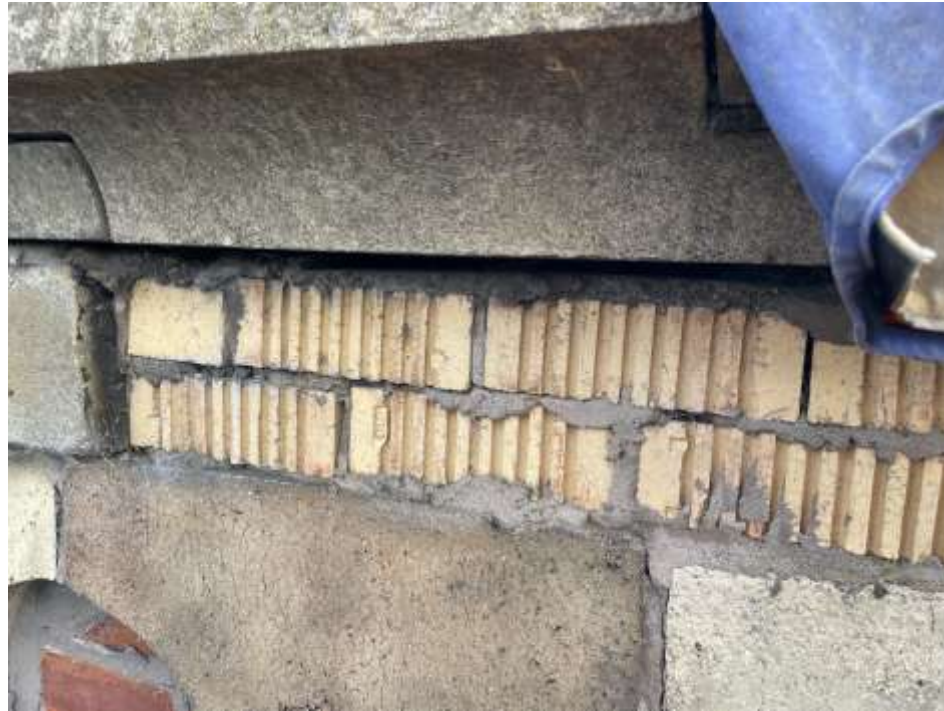
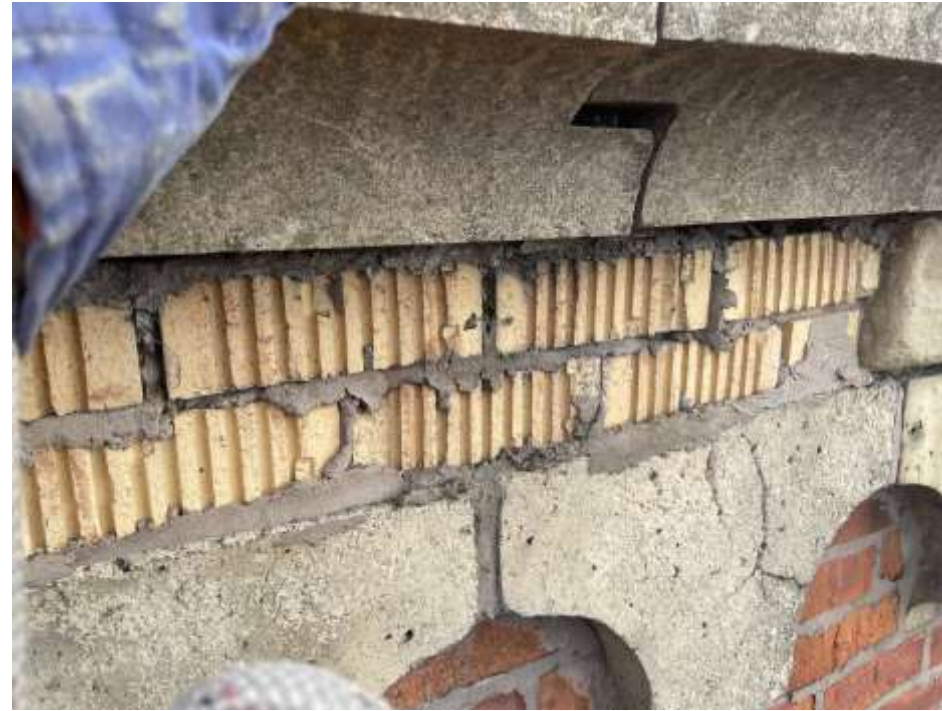
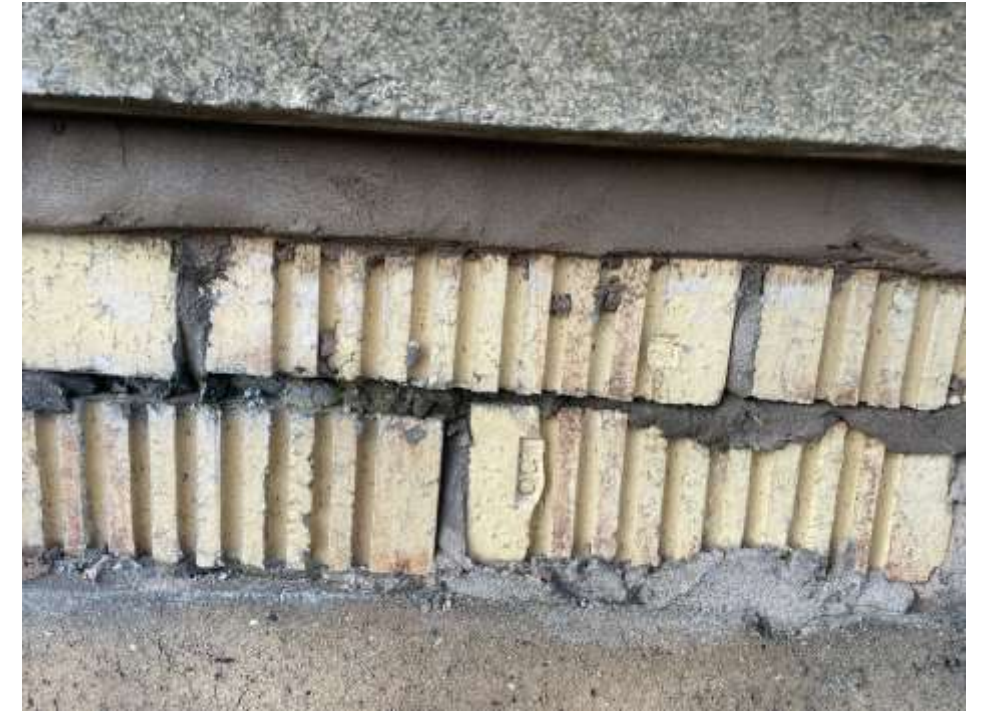
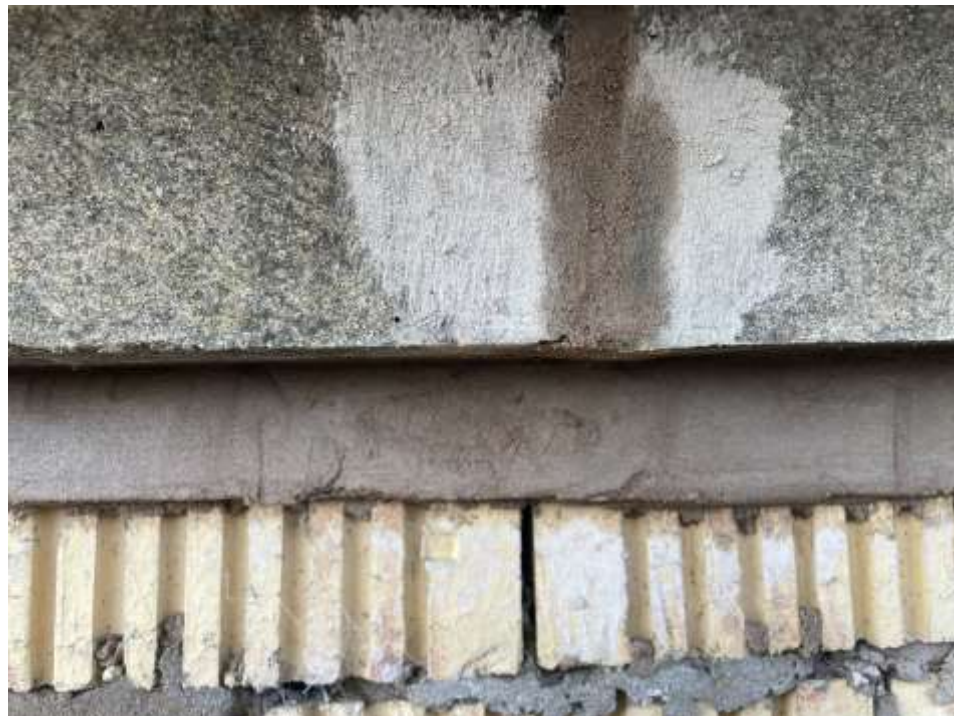
Inspection carried out, coping structurally sound, sealed holes along top with render. Can we closely colour match render to finish ?

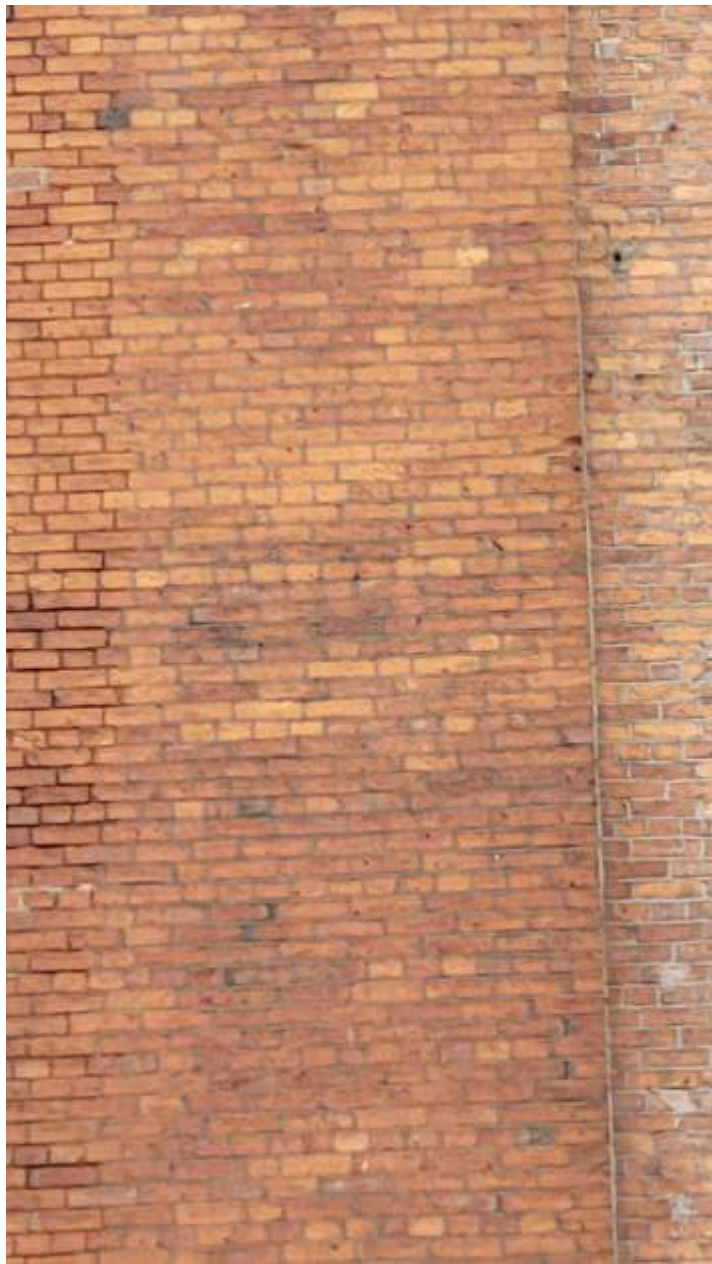
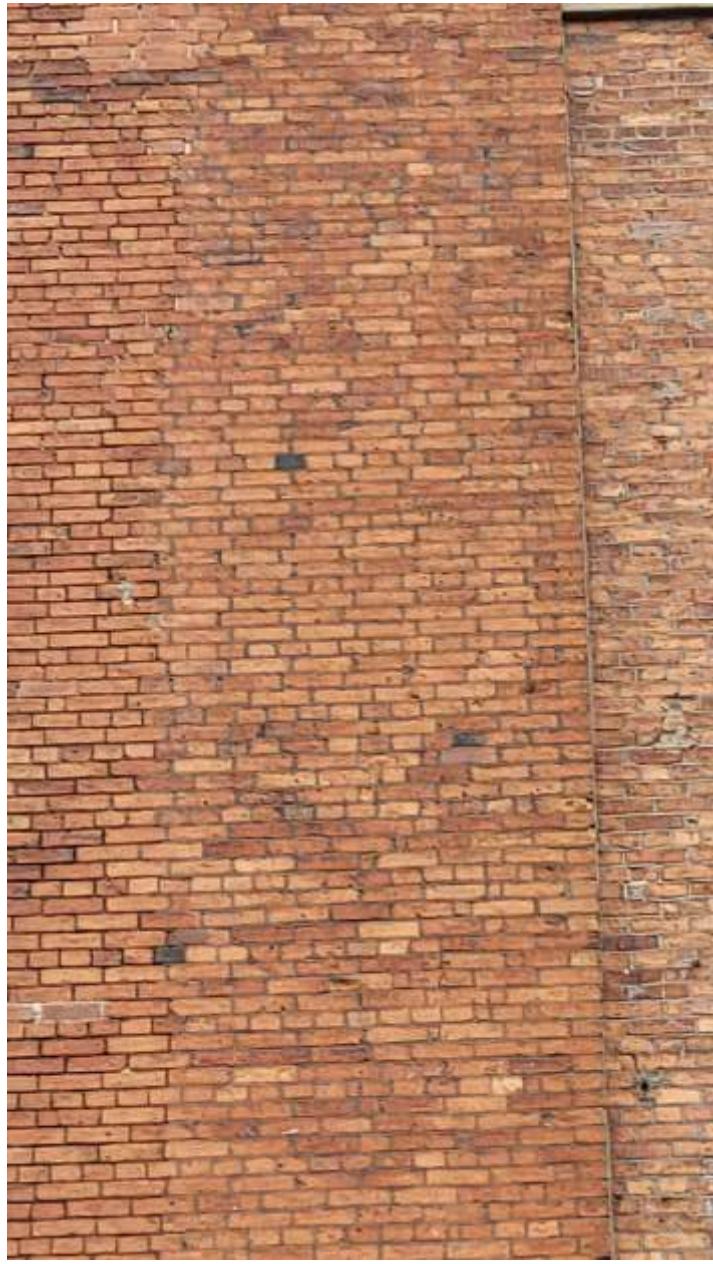
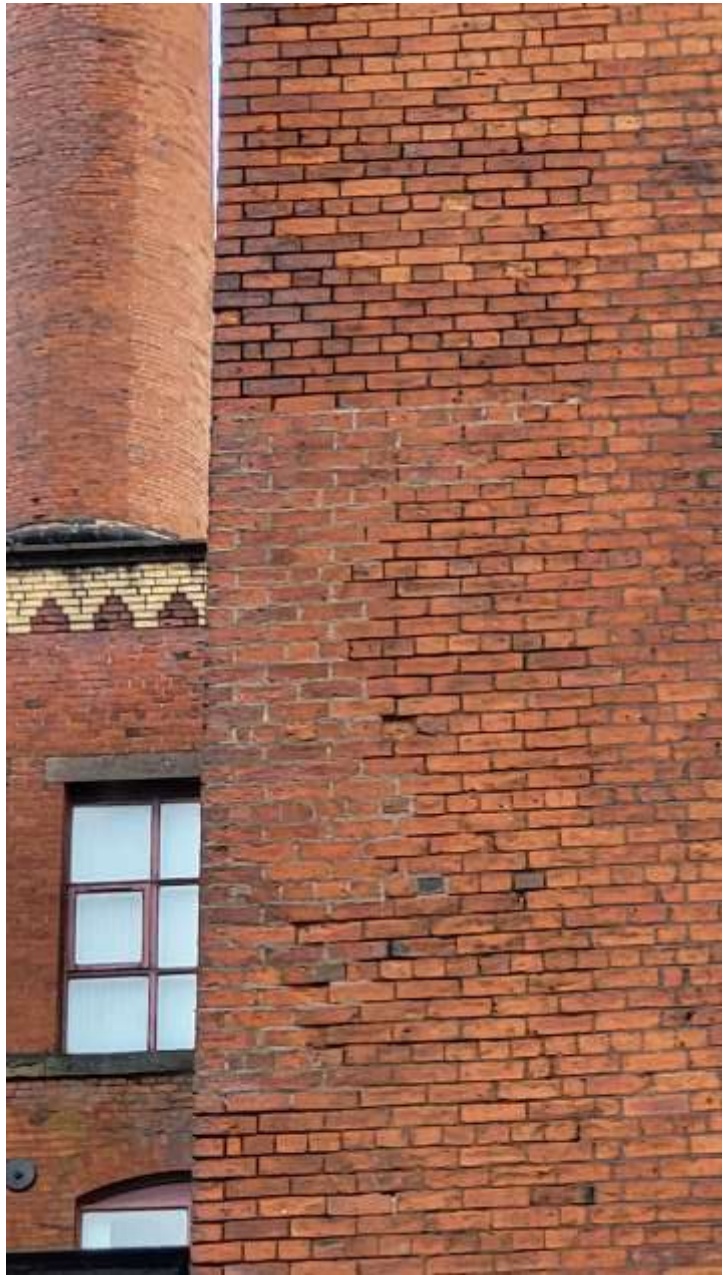
### 3: South East Elevation: Pointing

Inspection carried out. Repointed highlighted area on drawings. Additional work requested by Paul Mason. 7 Days added

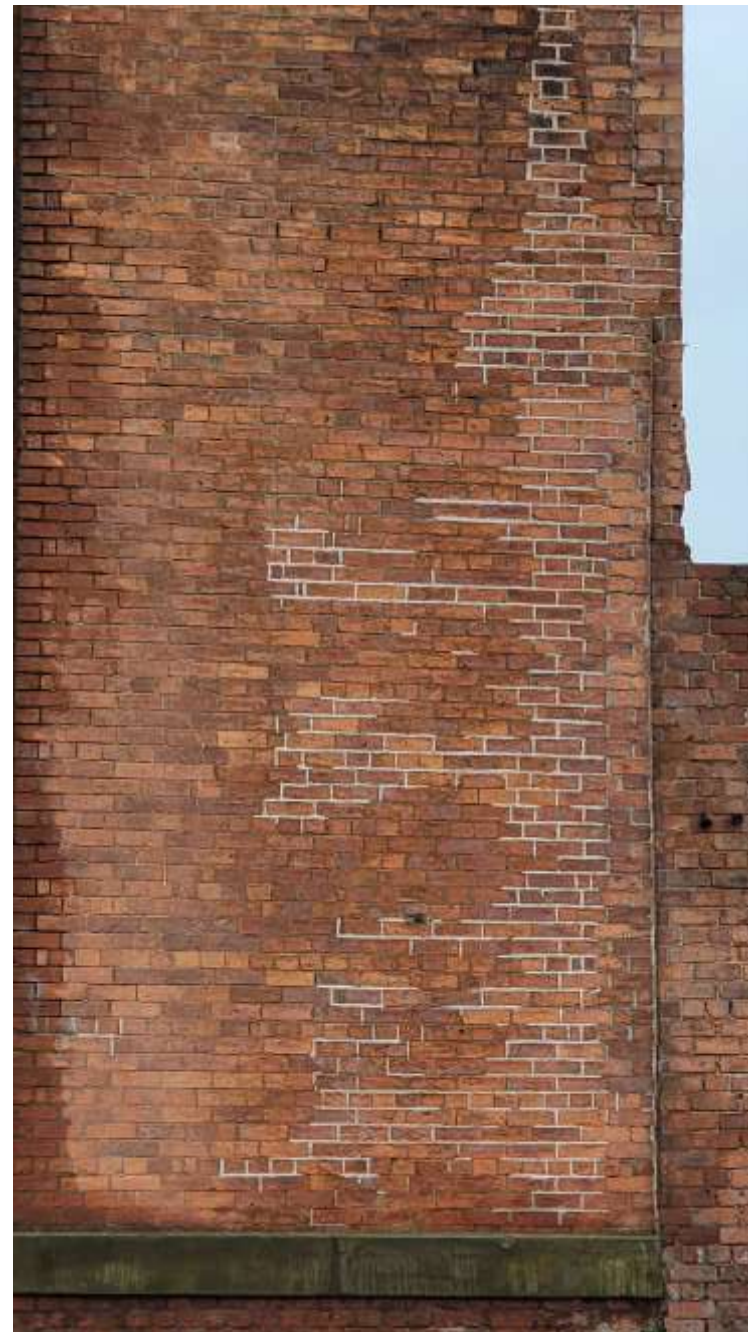
Inspection carried, pointed up bad areas

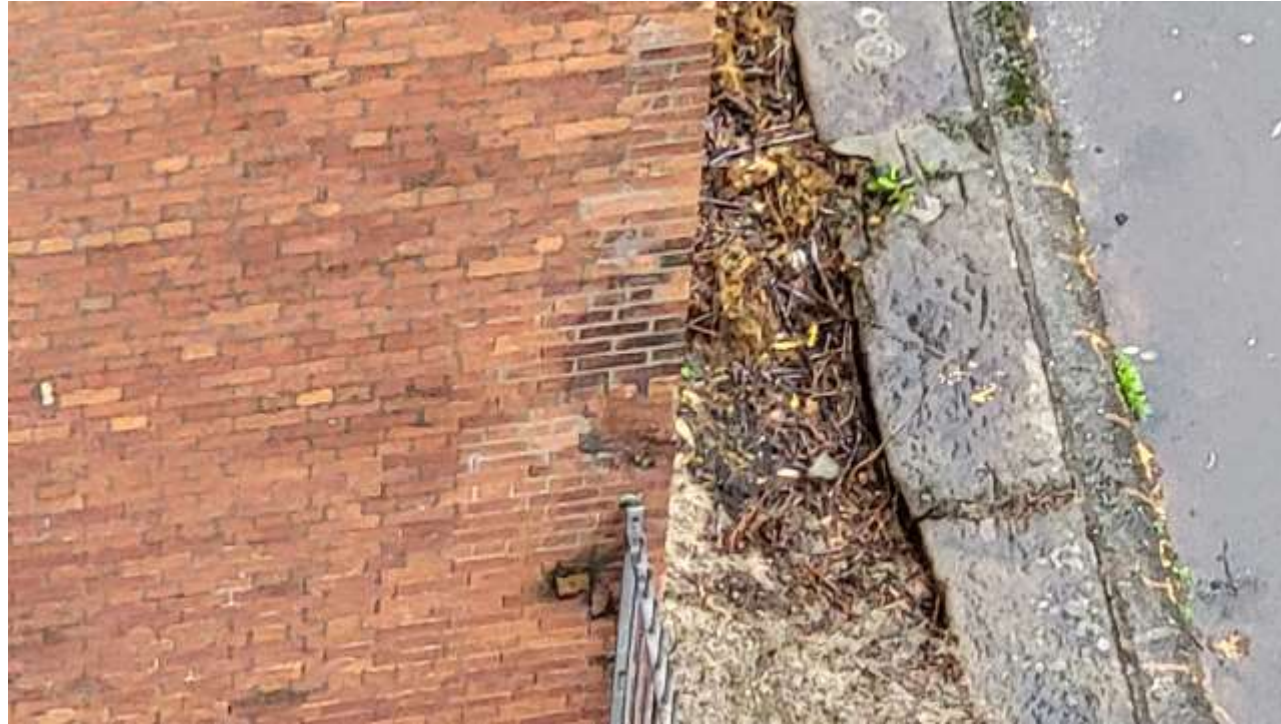
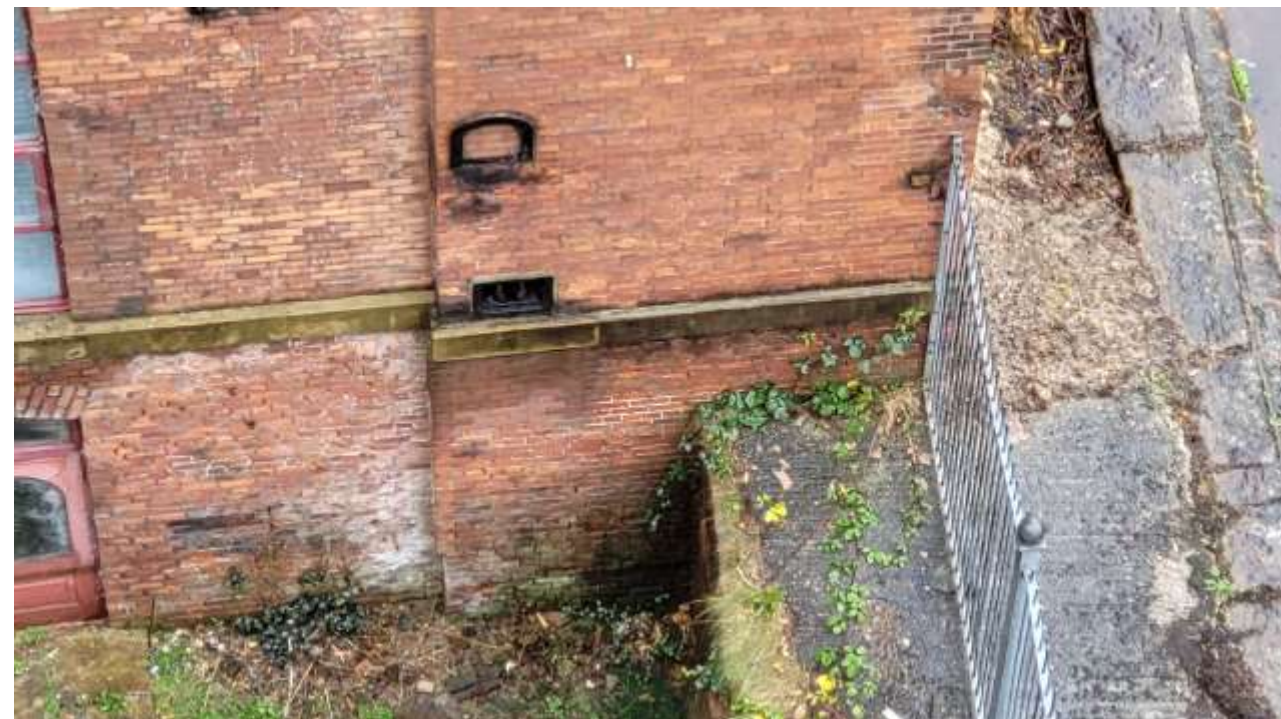
Area inspected and repointed with lime mortar mix carried out. Veg has been removed
