## 40-46 Princess Street, Manchester Paint Analysis

### Report on Findings Report No HPMTA01

ISSUE 01– 18/11/2021

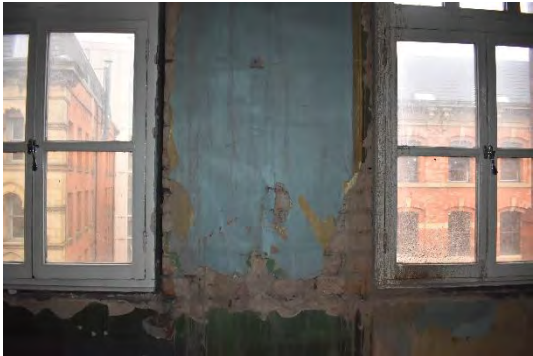
| Sample Ref:PS.01 | Location: 40-46 Princess Street |
|---|---|
| <p>Paint sample removed from:</p> <p>Location: 01 – Level 8 front wall.</p> <p>(The earliest paint layers are shown towards the bottom of the layers shown in the photographs).</p> | |
| <br><br> | <p>X50 – Magnification</p> <p>Current blue paint scheme (2No layers) over wallpaper.</p> <p>4No layers of varying greens</p> <p>Red scheme with varnish over</p> <p>Earliest green paint scheme over lime plaster.</p><br><br><p>X400 -</p> <p>Earliest paint layers.</p> <p>A light green oil paint based on lead carbonate with Verdigris pigment.</p> |
| Early schemes tested for lead | Yes – positive. |

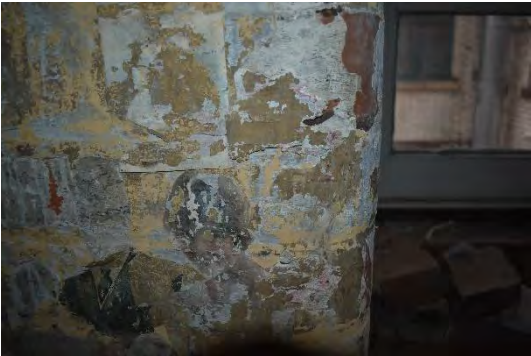
| Sample Ref:PS.02 | Location: 40-46 Princess Street |
|---|---|
| <p>Paint sample removed from:</p> <p>Location: 02 – Level 8 mid/rear wall.</p> <p>(The earliest paint layers are shown towards the bottom of the layers shown in the photographs).</p> | |
| <br> | <p>X100 Magnification</p> <p>Current stone coloured scheme.</p> <p>Earlier white and blue limewash applications.</p> <p>Earliest scheme.</p><br><p>X400 -<br/>Earliest paint layers.</p> <p>A white limewash – note dirt on surface of the paint.</p> <p>Brickwork fragment.</p> |
| Early schemes tested for lead | Yes – negative |

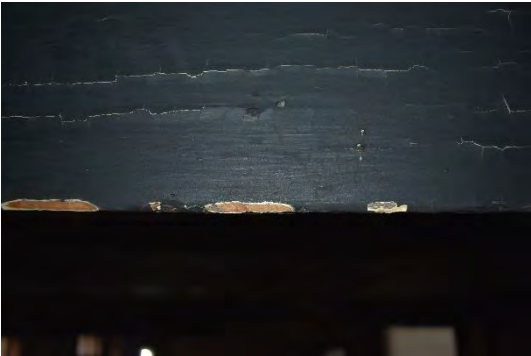
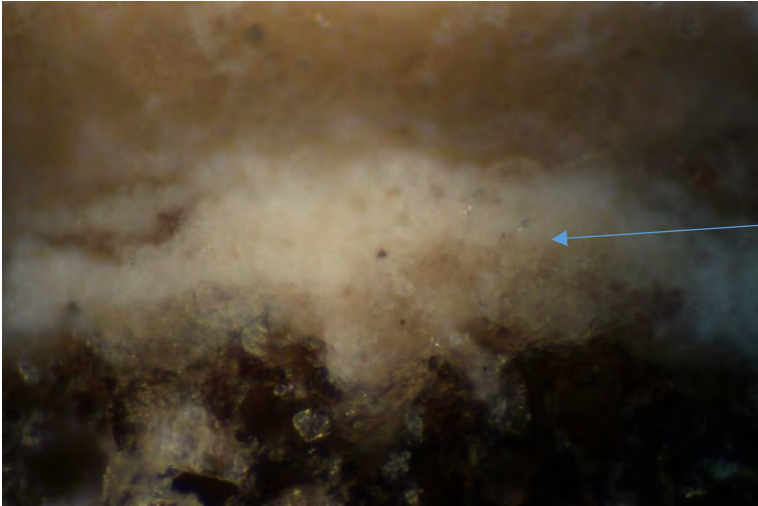
| Sample Ref:PS.03 | Location: 40-46 Princess Street |
|---|---|
| <p>Paint sample removed from:</p> <p>Location: 03 – Level 8 front beam.</p> <p>(The earliest paint layers are shown towards the bottom of the layers shown in the photographs).</p> | |
| <br> | <p>X50 –</p> <p>Current black paint scheme</p> <p>White scheme over earlier blue.</p> <p>4No stone coloured paint applications.</p> <p>Earliest paint layer on timber beam.</p><br><p>X400 -</p> <p>Earliest paint layers.</p> <p>Layer of white oil paint based on lead carbonate.</p> |
| Early schemes tested for lead | Yes – positive. |

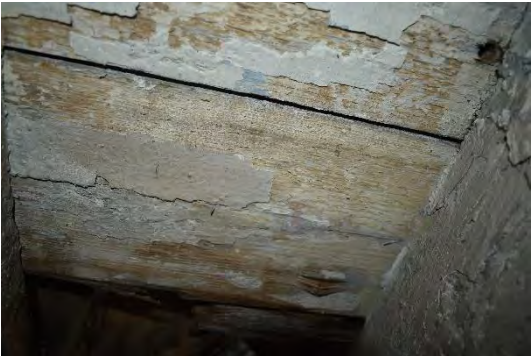
| Sample Ref:PS.04 | Location: 40-46 Princess Street |
|---|---|
| <p>Paint sample removed from:</p> <p>Location: 04 – Level 8 rear soffit.</p> <p>(The earliest paint layers are shown towards the bottom of the layers shown in the photographs).</p> | |
| | <p>X50 –</p> <p>Current visible paint layer – light blue.</p> <p>Approx. 7No layers of blue limewash over original white limewash.</p> <p>Timber fragment</p> <p>X400 -</p> <p>Earliest paint layers.</p> <p>White limewash paint system.</p> |
| Early schemes tested for lead | Yes – negative. |

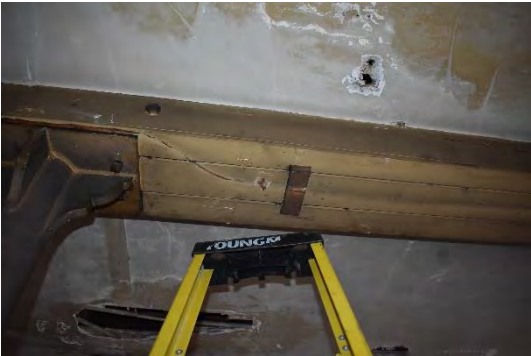
| Sample Ref:PS.05 | Location: 40-46 Princess Street |
|---|---|
| <p>Paint sample removed from:</p> <p>Location: 05 – Level 8 mid beam.</p> <p>(The earliest paint layers are shown towards the bottom of the layers shown in the photographs).</p> | |
| <br> | <p>X100 Magnification–</p> <p>Only 2No paint layers are present in the sample.</p> <p>2No layers of stone coloured paint.</p><br><p>X400 -</p> <p>Earliest paint layers.</p> <p>A light brown oil paint with umber pigments.</p> |
| Early schemes tested for lead | Yes – positive. |

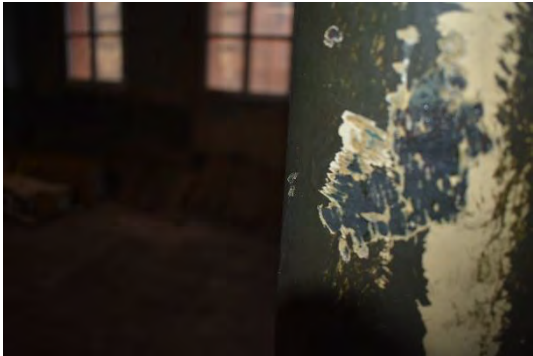
| Sample Ref:PS.06 | Location: 40-46 Princess Street |
|---|---|
| <p>Paint sample removed from:</p> <p>Location: 06 – Level 8 front column.</p> <p>(The earliest paint layers are shown towards the bottom of the layers shown in the photographs).</p> | |
| <br> | <p>X100 Magnification–</p> <p>Current green paint scheme</p> <p>10 separate layers of white and stone coloured coatings (zinc oxide based).</p> <p>Two layers of a rich green paint.</p><br><p>X400 -</p> <p>Earliest paint layers.</p> <p>Later application with similar varnish finish.</p> <p>A rich green oil paint with a varnish finish.</p> |
| Early schemes tested for lead | Yes – positive. |

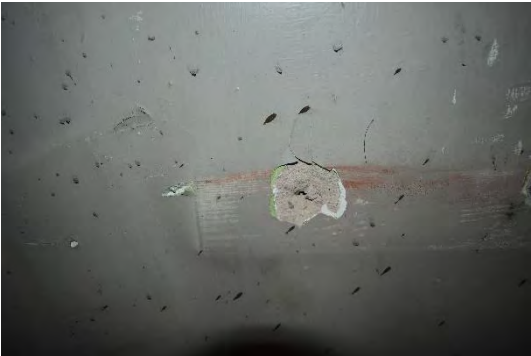
| Sample Ref:PS.07 | Location: 40-46 Princess Street |
|---|---|
| <p>Paint sample removed from:</p> <p>Location: 07 – Level 6 front wall.</p> <p>(The earliest paint layers are shown towards the bottom of the layers shown in the photographs).</p> | |
| <br> | <p>X100 Magnification –</p> <p>Current off-white paint scheme</p> <p>10 separate paint layers are visible.</p><br><p>X400 -</p> <p>Earliest paint layers.</p> <p>Original wall colour – a mid green oil paint based on lead carbonate..</p> <p>Lime plaster</p> |
| Early schemes tested for lead | Yes – positive. |

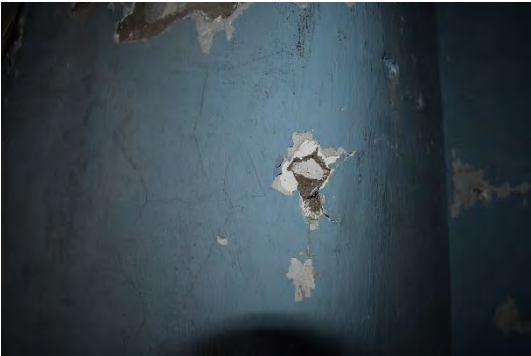
| Sample Ref:PS.08 | Location: 40-46 Princess Street |
|---|---|
| <p>Paint sample removed from:</p> <p>Location: 08 – Level 6 rear wall.</p> <p>(The earliest paint layers are shown towards the bottom of the layers shown in the photographs).</p> | |
| <br> | <p>X50 Magnification –</p> <p>Current mid-blue paint scheme.</p> <p>No separate paint layers are visible.</p> <p>Thick dirt layer over second paint layer – indicating that it was present for some time.</p> <p>Lime plaster</p><br><p>X400 -</p> <p>Earliest paint layers.</p> <p>(The original green paintwork is overpainted with a light blue limewash / distemper).</p> <p>Original paint scheme – a mid-green oil paint.</p> |
| Early schemes tested for lead | Yes – positive. |

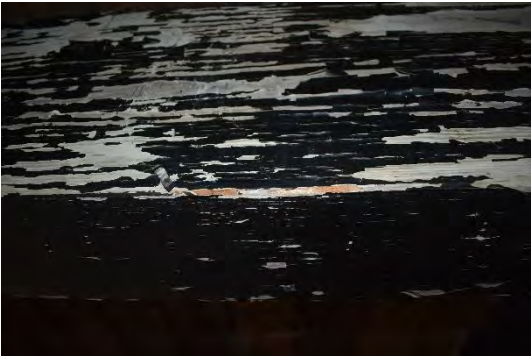
| Sample Ref:PS.09 | Location: 40-46 Princess Street |
|---|---|
| <p>Paint sample removed from:</p> <p>Location: 09 – Level 6 front beam.</p> <p>(The earliest paint layers are shown towards the bottom of the layers shown in the photographs).</p> | |
| <br> | <p>X100 Magnification –</p> <p>Current black paint scheme.</p> <p>Only 3No separate paint layers noted in sample.</p> <p>Timber beam.</p><br><p>X400 -</p> <p>Earliest paint layers.</p> <p>Earliest paint scheme – a light stone coloured oil paint.</p> <p>(The paint is in a very friable condition and easily detached from the substrate. Given the limited number of coatings this earliest coating is unlikely to be the original colour).</p> |
| Early schemes tested for lead | Yes – negative. |

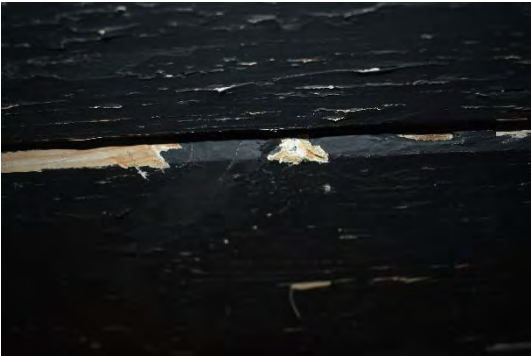
| Sample Ref:PS.10 | Location: 40-46 Princess Street |
|---|---|
| <p>Paint sample removed from:</p> <p>Location: 10 – Level 6 front soffit.</p> <p>(The earliest paint layers are shown towards the bottom of the layers shown in the photographs).</p> | |
| <br> | <p>X100 Magnification–</p> <p>Current black paint scheme.</p> <p>Only 3No separate paint layers are visible.</p> <p>Earliest paint layer.</p><br><p>X400 -</p> <p>Earliest paint layers.</p> <p>Earliest paint scheme – a white lime wash coating.</p> |
| Early schemes tested for lead | Yes – negative. |

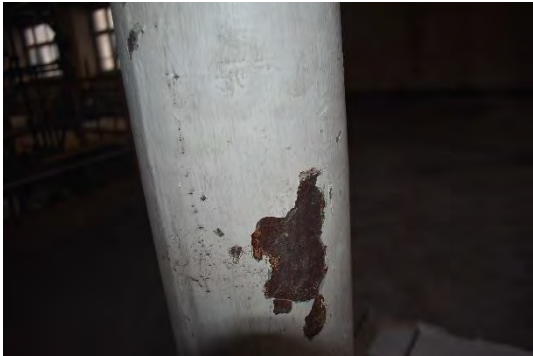
| Sample Ref:PS.11 | Location: 40-46 Princess Street |
|---|---|
| <p>Paint sample removed from:</p> <p>Location: 11 – Level 6 front column.</p> <p>(The earliest paint layers are shown towards the bottom of the layers shown in the photographs).</p> | |
| <br> | <p>X100 Magnification –</p> <p>Current white paint scheme</p> <p>3No modern paint layers based on Titanium whites.</p> <p>3No off whites based on zinc oxides</p> <p>Paint schemes based on lead carbonates.</p> <p>Iron oxide reds</p><br><p>X400 -</p> <p>Earliest paint layers.</p> <p>3No applications of a red iron oxide paint.</p> <p>(Trace of a white – possibly primer layer)</p> |
| Early schemes tested for lead | Yes – negative. |

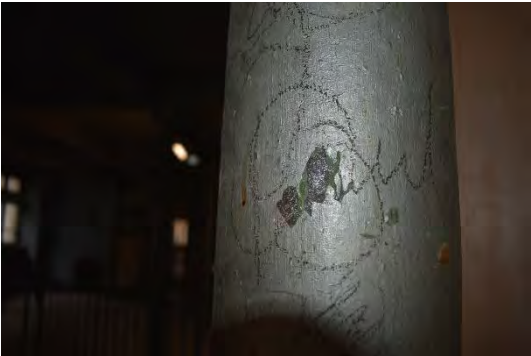
| Sample Ref:PS.12 | Location: 40-46 Princess Street |
|---|---|
| <p>Paint sample removed from:</p> <p>Location: 12 – Level 6 rear column.</p> <p>(The earliest paint layers are shown towards the bottom of the layers shown in the photographs).</p> | |
| <br> | <p>X100 Magnification –</p> <p>Thin layer of aluminium paint over a modern Titanium white.</p> <p>8No layers of green paints.</p> <p>Earliest brown paint layer</p><br><p>X400 -</p> <p>Earliest paint layers.</p> <p>Earliest decorative coating – a mid green oil paint.</p> <p>Earliest paint layer – a mid-brown oil paint (most likely applied at the mill before delivery to site).</p> <p>Each of the green paint layers has a layer of dirt showing that they were present for some time and redecorated regularly.</p> |
| Early schemes tested for lead | Yes – positive. |

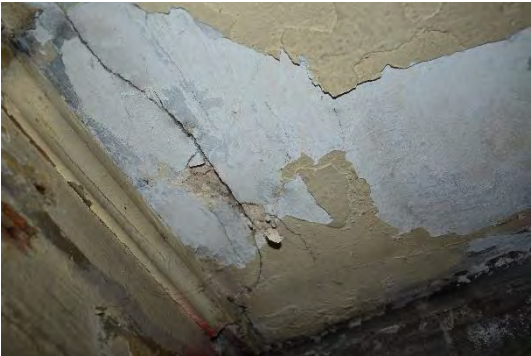
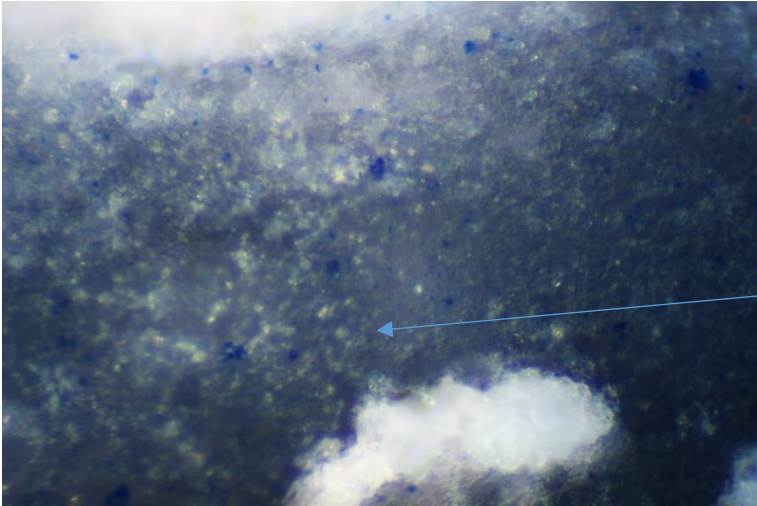
| Sample Ref:PS.13 | Location: 40-46 Princess Street |
|---|---|
| <p>Paint sample removed from:</p> <p>Location: 13 – Level 6 rear soffit.</p> <p>(The earliest paint layers are shown towards the bottom of the layers shown in the photographs).</p> | |
| <br> | <p>X50 Magnification–</p> <p>Current stone coloured paint scheme.</p> <p>Limewash paint layers.</p><br><p>X400 -</p> <p>Earliest paint layers.</p><br><p>Original paint scheme – a light blue limewash.</p> |
| Early schemes tested for lead | Yes – negative. |

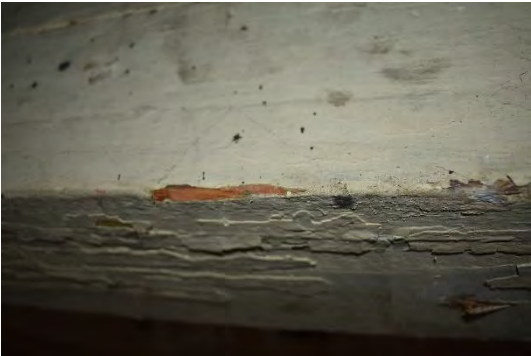
| Sample Ref:PS.14 | Location: 40-46 Princess Street |
|---|---|
| <p>Paint sample removed from:</p> <p>Location: 14 – Level 6 rear beam.</p> <p>(The earliest paint layers are shown towards the bottom of the layers shown in the photographs).</p> | |
| | <p>X100 Magnification–</p> <p>Current off-white paint scheme.</p> <p>7No separate paint layers in the sample.</p> <p>Timber beam.</p> |
| Early schemes tested for lead | Yes – positive. |

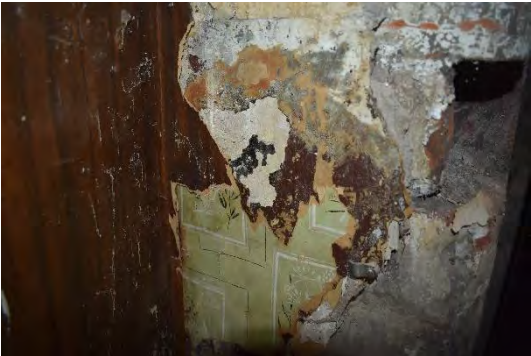
| Sample Ref:PS.15 | Location: 40-46 Princess Street |
|---|---|
| <p>Paint sample removed from:</p> <p>Location: 15 – Level 4 front wall.</p> <p>(The earliest paint layers are shown towards the bottom of the layers shown in the photographs).</p> | |
| <br> | <p>X50 Magnification -</p> <p>Wallpaper</p> <p>White, brown and red paint layers.</p> <p>2No green layers over 2x wallpaper</p> <p>Green and red layers over historic stone coloured layers.</p><br><p>X400 -</p> <p>Earliest paint layers.</p> <p>Original paint scheme – a light brown / stone coloured oil paint.</p> <p>Lime plaster</p> |
| Early schemes tested for lead | Yes – positive. |

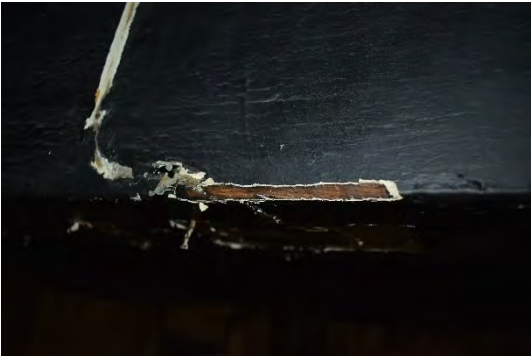
Front beams – The timber beams are heavily charred from fire damage. The earliest coating is a white limewash with some traces of a light brown oil paint. The original decorative paint layers are not present in the sample.

| Sample Ref:PS.16 | Location: 40-46 Princess Street |
|---|---|
| <p>Paint sample removed from:</p> <p>Location: 16 – Level 4 front beam.</p> <p>(The earliest paint layers are shown towards the bottom of the layers shown in the photographs).</p> | |
| <br> | <p>X100 Magnification –</p> <p>Current black paint scheme</p> <p>10 No paint layers are visible in the sample. The most recent is black however prior to this all coats were off-white / white.</p><br><p>X400 -</p> <p>Earliest paint layers.</p><br><p>Earliest paint scheme – a white oil paint.</p> <p>Note: charring to timber.</p> |
| Early schemes tested for lead | Yes – negative. |

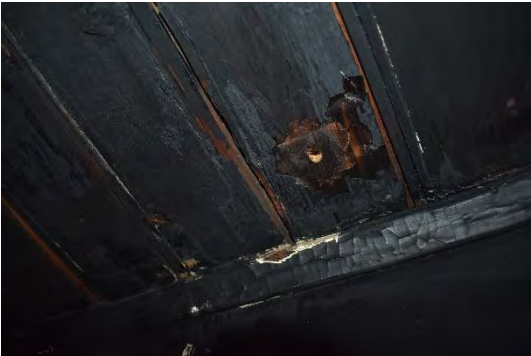
Front soffit – The soffit timbers are similar in condition to the beams with heavy charring. The earliest paint layer is a white limewash which is covered by traces of wallpaper and white and finally black paints. The original decorative schemes are not present in the sample.

| Sample Ref:PS.17 | Location: 40-46 Princess Street |
|---|---|
| <p>Paint sample removed from:</p> <p>Location: 17 – Level 4 front soffit.</p> <p>(The earliest paint layers are shown towards the bottom of the layers shown in the photographs).</p> | |
| | <p>X50 magnification –</p> <p>Current black paint scheme</p> <p>2No layers of off-white</p> <p>Thick layer of limewash over charred timber.</p><br><p>X400 -</p> <p>Earliest paint layers.</p> <p>Earliest paint scheme – a thick layer of an off-white limewash covering the charred timbers.</p> <p>Note: This is unlikely to be the original colour as there is evidence of fire damage.</p> |
| Early schemes tested for lead | Yes – negative. |

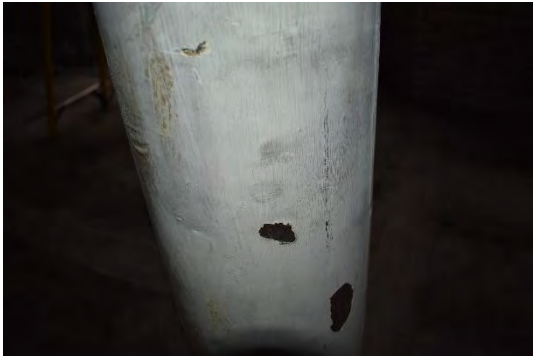
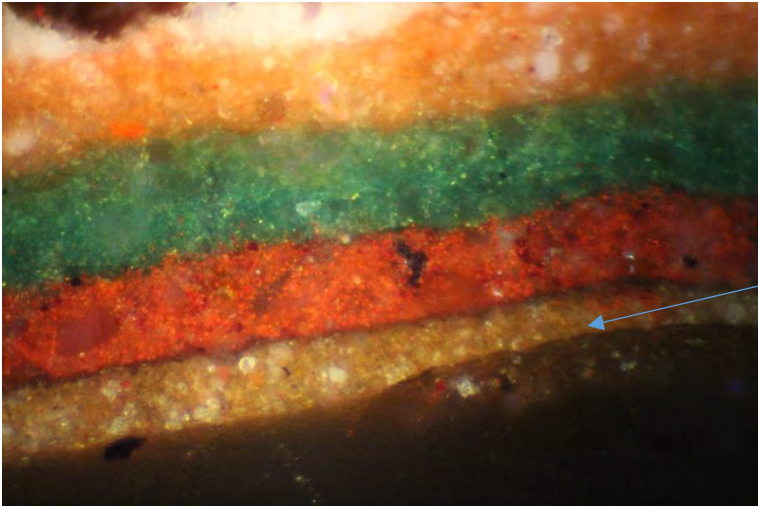
| Sample Ref:PS.18 | Location: 40-46 Princess Street |
|---|---|
| <p>Paint sample removed from:</p> <p>Location: 18 – Level 4 front column.</p> <p>(The earliest paint layers are shown towards the bottom of the layers shown in the photographs).</p> | |
| <br> | <p>X100 Magnification –</p> <p>Current white paint scheme</p> <p>4No layers of modern white gloss and undercoat layers based on Titanium white.</p> <p>6No layers of off-white gloss and undercoat paints based on zinc oxides.</p> <p>Earlier green, red and brown paint schemes.</p><br><p>X400 -</p> <p>Earliest paint layers.</p> <p>Original paint scheme – light brown oil paint (containing lead carbonate).</p> |
| Early schemes tested for lead | Yes – positive. |

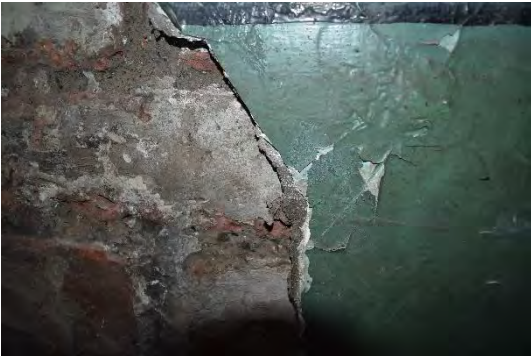
| Sample Ref:PS.19 | Location: 40-46 Princess Street |
|---|---|
| <p>Paint sample removed from:</p> <p>Location: 19 – Level 4 rear wall.</p> <p>(The earliest paint layers are shown towards the bottom of the layers shown in the photographs).</p> | |
| | <p>X100 Magnification –</p> <p>Current green paint scheme.</p> <p>8No separate paint layers present in the sample.</p> <p>Light blue limewash early layers.</p> <p>Lime plaster</p> <p>X400 -</p> <p>Earliest paint layers.</p> <p>Original paint scheme – a light blue limewash</p> |
| Early schemes tested for lead | Yes – negative. |

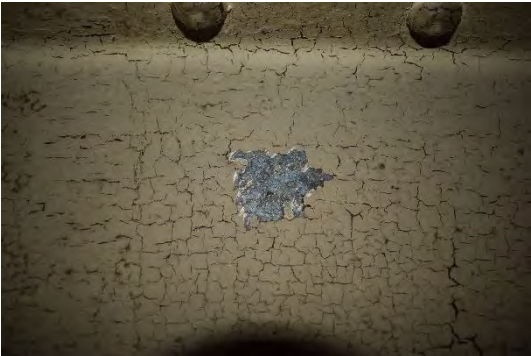
| Sample Ref:PS.20 | Location: 40-46 Princess Street |
|---|---|
| <p>Paint sample removed from:</p> <p>Location: 20 – Level 4 rear beam.</p> <p>(The earliest paint layers are shown towards the bottom of the layers shown in the photographs).</p> | |
| <br> | <p>X100 Magnification –</p> <p>Current stone coloured paint scheme.</p> <p>9No separate paint layers visible in the sample.</p> <p>Thick coating – possibly mill applied.</p><br><p>X400 -</p> <p>Earliest paint layers.</p> <p>Original “finished” paint coating was likely to be the green oil paint layer applied over a white primer.</p> <p>Thick layer of carbon black / red lead oil paint. This is likely to have been applied at the mill before delivery to site.</p> |

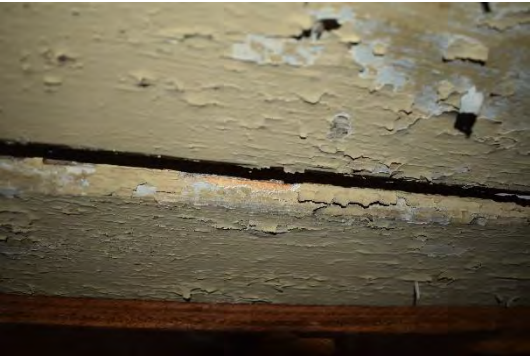
| Sample Ref:PS.21 | Location: 40-46 Princess Street |
|---|---|
| <p>Paint sample removed from:</p> <p>Location: 21 – Level 4 rear soffit.</p> <p>(The earliest paint layers are shown towards the bottom of the layers shown in the photographs).</p> | |
| <br> | <p>X100 Magnification –</p> <p>Current stone coloured paint scheme.</p> <p>The two most recent layers are modern and based on Zinc oxide.</p> <p>4No white / light blue lime wash applications.</p><br><p>X400 -</p> <p>Earliest paint layers.</p> <p>Earliest paint scheme – a white limewash paint.</p> <p>Note: The white limewash includes a small amount of Prussian Blue pigment to off-set its slightly yellow colour.</p> |

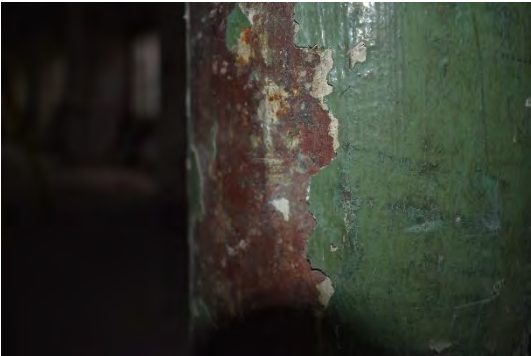
| Sample Ref:PS.22 | Location: 40-46 Princess Street |
|---|---|
| <p>Paint sample removed from:</p> <p>Location: 22 – Level 4 rear column.</p> <p>(The earliest paint layers are shown towards the bottom of the layers shown in the photographs).</p> | |
| <br> | <p>X100 Magnification –</p> <p>Current green paint scheme.<br/>(3No separate green layers are present)</p> <p>Single layer of limewash (later coats partly separated)</p> <p>Thick stone coloured paint layer.</p> <p>Earlier green and red paint schemes.</p><br><p>X400 -<br/>Earliest paint layers.</p> <p>Earliest paint layer – a red oxide oil paint. Later covered by two layers of mid greens.</p> |

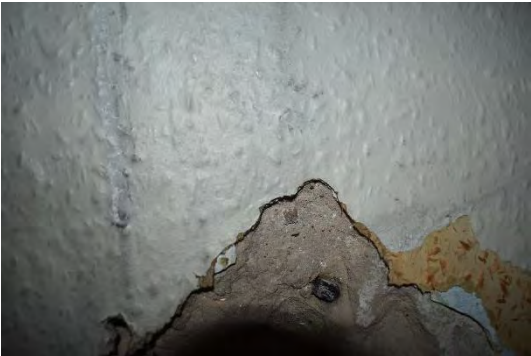
| Sample Ref:PS.23 | Location: 40-46 Princess Street |
|---|---|
| <p>Paint sample removed from:</p> <p>Location: 23 – Level 2 front wall.</p> <p>(The earliest paint layers are shown towards the bottom of the layers shown in the photographs).</p> | |
| <br> | <p>X50 Magnification –<br/>Current light blue paint scheme.</p> <p>Woodchip wallpaper.</p> <p>White paint layer<br/>2No mid green layers.</p> <p>Off-white layer (earliest layer).</p> <p>Lime plaster</p><br><p>X400 -<br/>Earliest paint layers.</p> <p>Original paint scheme – an off-white oil paint based on lead carbonate.</p> |

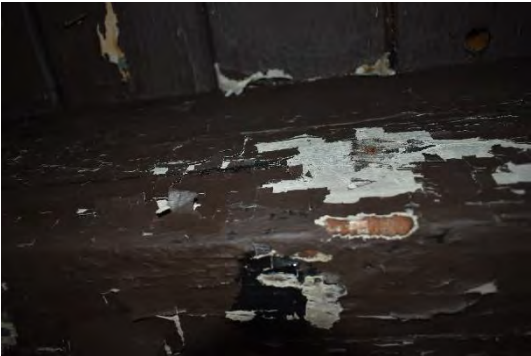
Front beam – The timber beam only has five separate paint layers visible and the timber substrate is heavily charred possibly indicating that the earliest paint layers are missing. The earliest paint layer is a stone coloured limewash which has been overcoated with a zinc white paint then grey and current black paintwork which is currently visible.

| Sample Ref:PS.24 | Location: 40-46 Princess Street |
|---|---|
| <p>Paint sample removed from:</p> <p>Location: 24 – Level 2 front beam.</p> <p>(The earliest paint layers are shown towards the bottom of the layers shown in the photographs).</p> | |
| <br> | <p>X100 Magnification –</p> <p>Current black scheme (paint very friable and easily disturbed).</p> <p>Grey paint layer.<br/>White oil paint</p> <p>A bright zinc oxide white paint layer.</p> <p>Stone coloured limewash / distemper.</p><br><p>X400 -<br/>Earliest paint layers.</p> <p>Earliest paint scheme – a stone coloured limewash / distemper.</p> |

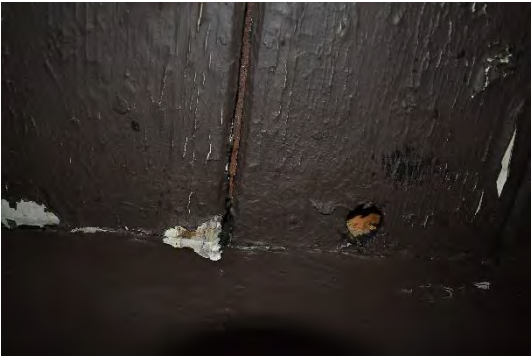
| Sample Ref:PS.25 | Location: 40-46 Princess Street |
|---|---|
| <p>Paint sample removed from:</p> <p>Location: 25 – Level 2 front soffit.</p> <p>(The earliest paint layers are shown towards the bottom of the layers shown in the photographs).</p> | |
| <br> | <p>X100 Magnification –</p> <p>Current black paint scheme.</p> <p>Thick layer of a stone coloured oil paint.</p> <p>White zinc oxide white paint layer.</p> <p>Thick layer of stone coloured lime wash.</p><br><p>X400 -</p> <p>Earliest paint layers.</p> <p>Earliest paint colour – a stone coloured limewash / distemper.</p> |

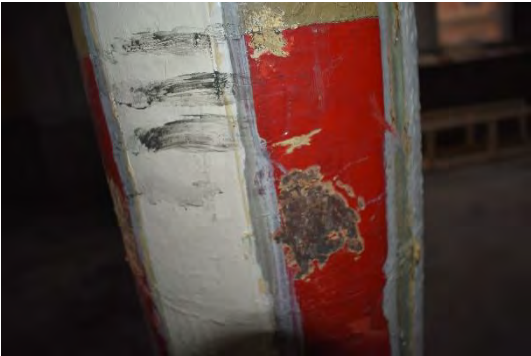
| Sample Ref:PS.26 | Location: 40-46 Princess Street |
|---|---|
| <p>Paint sample removed from:</p> <p>Location: 26 – Level 2 front column.</p> <p>(The earliest paint layers are shown towards the bottom of the layers shown in the photographs).</p> | |
| | <p>X100 Magnification –</p> <p>Current red paint scheme.<br/>17 separate layers are visible in the sample.</p> <p>Earliest red schemes.</p> <p>X400 -<br/>Earliest paint layers.</p> <p>Original paint scheme – a red iron oxide oil paint with a varnish coating bringing the finish to a gloss.</p> |

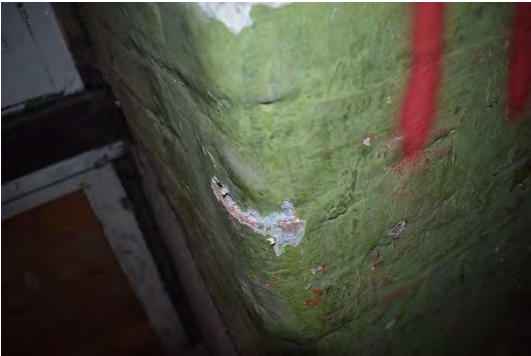
| Sample Ref:PS.27 | Location: 40-46 Princess Street |
|---|---|
| <p>Paint sample removed from:</p> <p>Location: 27 – Level 2 rear wall.</p> <p>(The earliest paint layers are shown towards the bottom of the layers shown in the photographs).</p> | |

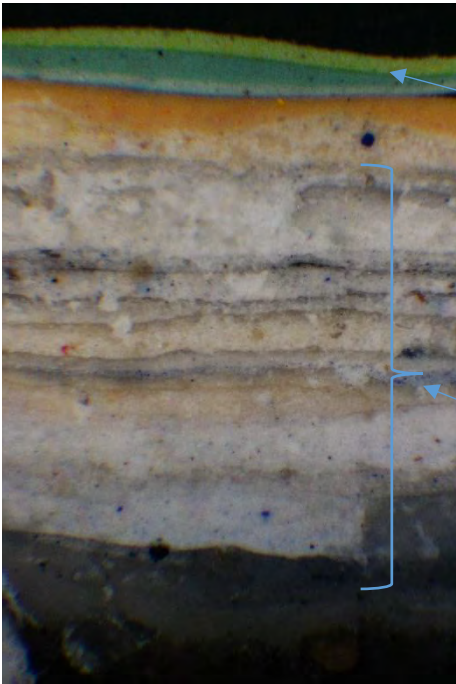
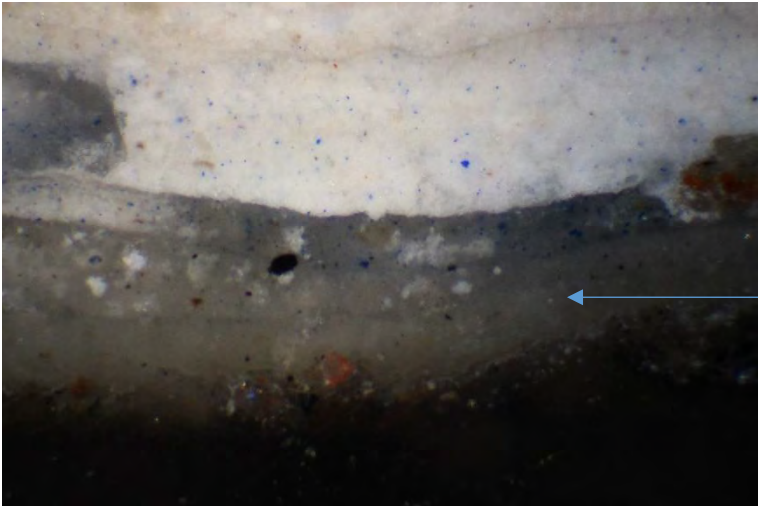
| Sample Ref:PS.27 | Location: 40-46 Princess Street |
|---|---|
| <br> | <p>X50 Magnification –</p> <p>Current green paint scheme with 2 no earlier green / blue schemes.</p> <p>21 separate paint layers are visible in the sample.</p> <p>17 costs of limewash / distemper.</p><br><p>X400 -</p> <p>Earliest paint layers.</p> <p>Original paint scheme – white limewash.</p> |

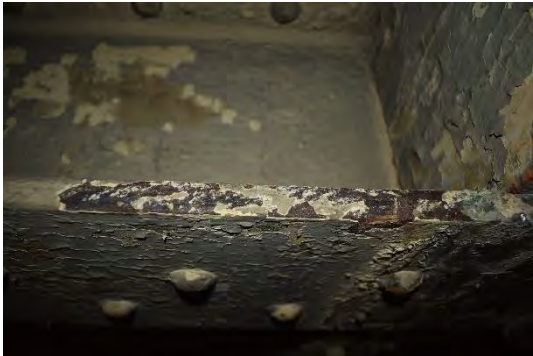
| Sample Ref:PS.28 | Location: 40-46 Princess Street |
|---|---|
| <p>Paint sample removed from:</p> <p>Location: 28 – Level 2 rear beam.</p> <p>(The earliest paint layers are shown towards the bottom of the layers shown in the photographs).</p> | |
| | <p>X50 –</p> <p>Current grey paint scheme.</p> <p>First finished decorative coating green over off-white primer. Note thick dirt layer on surface of the green indicating that it was present for some time.</p><br><p>X400 -</p> <p>Earliest paint layers.</p> <p>Earliest layer – a rough coating likely to be applied at the mill consisting of iron oxide red, carbon black and some red lead pigments.</p> |

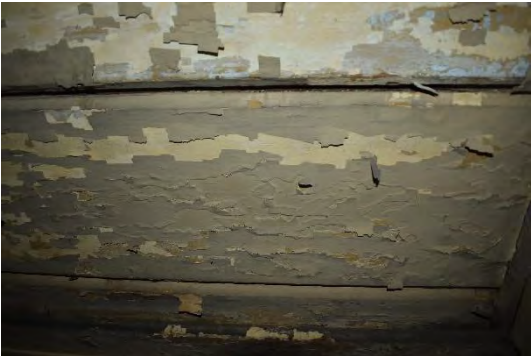
| Sample Ref:PS.29 | Location: 40-46 Princess Street |
|---|---|
| <p>Paint sample removed from:</p> <p>Location: 29 – Level 2 rear soffit.</p> <p>(The earliest paint layers are shown towards the bottom of the layers shown in the photographs).</p> | |
| | <p>X50 Magnification -</p> <p>Current stone coloured paint scheme.</p> <p>8No white / off paint layers.</p> <p>5No light blue lime wash layers.</p><br><p>X400 -</p> <p>Earliest paint layers.</p> <p>Earliest paint scheme – white limewash. Later limewashes tinted with Prussian Blue.</p> |

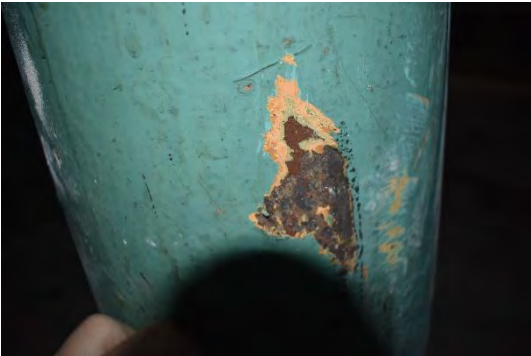
| Sample Ref:PS.30 | Location: 40-46 Princess Street |
|---|---|
| <p>Paint sample removed from:</p> <p>Location: 30 – Level 2 rear column.</p> <p>(The earliest paint layers are shown towards the bottom of the layers shown in the photographs).</p> | |
| <br> | <p>X100 Magnification –</p> <p>Current green paint scheme.</p> <p>Thick orange gloss with matching undercoat based on zinc white.</p> <p>Earlier iron oxide red paint schemes.</p><br><p>X400 -</p> <p>Earliest paint layers.</p> <p>Original paint scheme – red iron oxide oil paint over off-white primer coating.</p> |

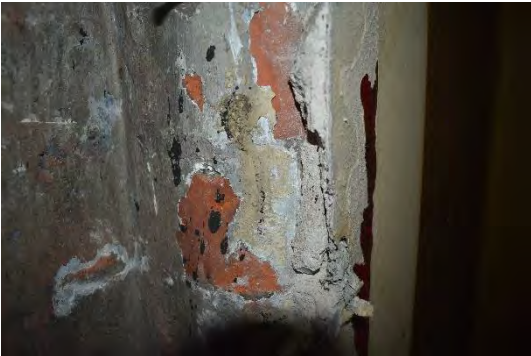
| Sample Ref:PS.31 | Location: 40-46 Princess Street |
|---|---|
| <p>Paint sample removed from:</p> <p>Location: 31 – Level 0 front wall.</p> <p>(The earliest paint layers are shown towards the bottom of the layers shown in the photographs).</p> | |

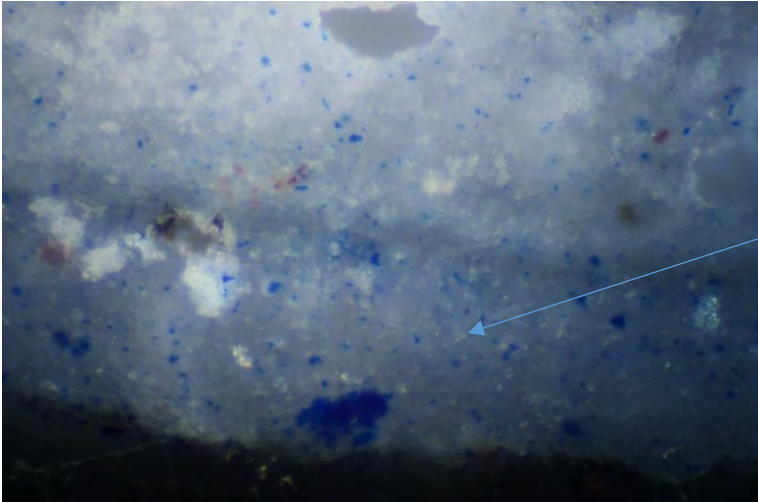
| Sample Ref:PS.31 | Location: 40-46 Princess Street |
|---|---|
| <br> | <p>X50 Magnification –</p> <p>Red faced wallpapers over plaster fill.</p> <p>4No white limewash / distemper paint layers.</p> <p>4No light blue limewash paint layers.</p><br><p>X400 -</p> <p>Earliest paint layers.</p> <p>Earliest paint layer – a white limewash tinted with Prussian Blue pigments.</p> |

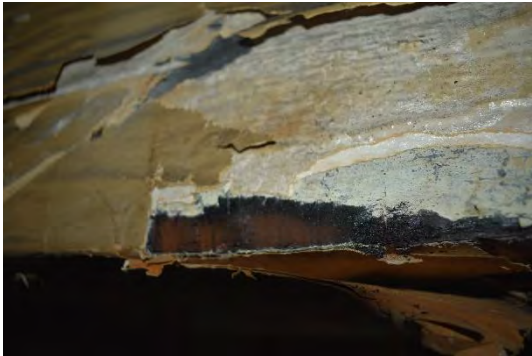
| Sample Ref:PS.32 | | Location: 40-46 Princess Street | |
|---|--|---|--|
| <p>Paint sample removed from:</p> <p>Location: 32 – Level 0 front beam.</p> <p>(The earliest paint layers are shown towards the bottom of the layers shown in the photographs).</p> | | | |
| | | <p>X50 –</p> <p>3No layers of wallpapers over a white zinc oxide based paint.</p> <p>Single layer of white limewash.</p> <p>Note: Timber is heavily charred from fire.</p> | |

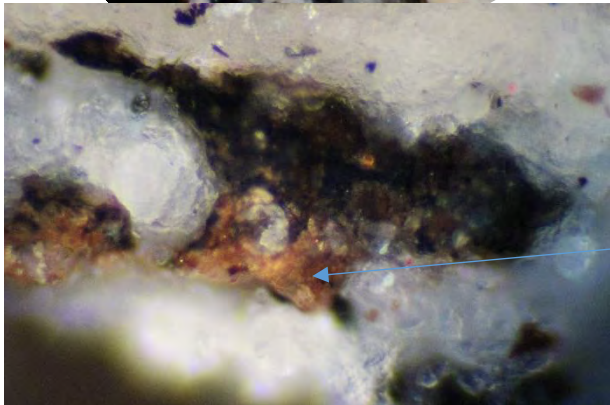
| Sample Ref:PS.32 | | Location: 40-46 Princess Street | |
|---|--|---|--|
| | | <p>X400 -</p> <p>Earliest paint layers.</p> <p>Earliest paint layers – light brown oil paint surrounded by light blue limewash.</p> | |

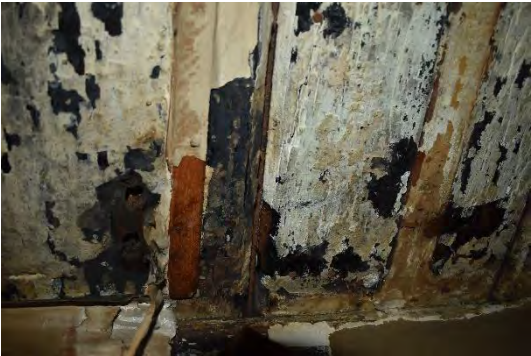
| Sample Ref:PS.33 | Location: 40-46 Princess Street |
|---|---|
| <p>Paint sample removed from:</p> <p>Location: 33 – Level 0 front soffit.</p> <p>(The earliest paint layers are shown towards the bottom of the layers shown in the photographs).</p> | |
| <br> | <p>X50 Magnification –</p> <p>Current visible black paint layer.<br/>Current white visible paint layer.</p> <p>Wallpaper.</p> <p>Heavily charred timber.</p><br><p>X400 -<br/>Earliest paint layers.</p><br><p>Earliest paint layer – a white limewash over charred timber.</p> |

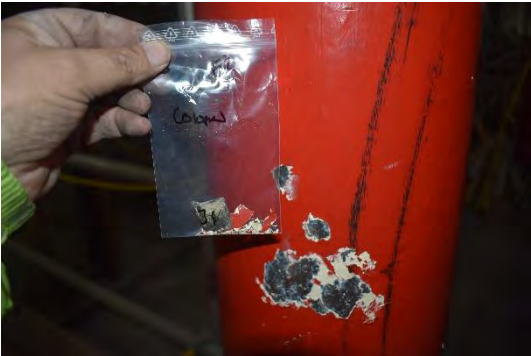
| Sample Ref:PS.34 | Location: 40-46 Princess Street |
|---|---|
| <p>Paint sample removed from:</p> <p>Location: 34 – Level 0 front column.</p> <p>(The earliest paint layers are shown towards the bottom of the layers shown in the photographs).</p> | |
| <br> | <p>X100 Magnification –</p> <p>Current red paint scheme.</p> <p>10No layers of white paint (none based on lead carbonate).</p><br><p>X400 -</p> <p>Earliest paint layers.</p> <p>Earliest paint layer – white oil paint most likely a Lithopone possibly indicating that the original paint finishes have been removed.</p> |

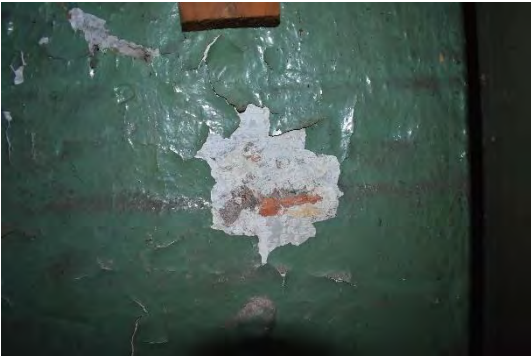
| Sample Ref:PS.35 | Location: 40-46 Princess Street |
|---|---|
| <p>Paint sample removed from:</p> <p>Location: 35 – Level 0 rear wall.</p> <p>(The earliest paint layers are shown towards the bottom of the layers shown in the photographs).</p> | |
| <br> | <p>X50 Magnification -</p> <p>Current green paint scheme.</p> <p>2No earlier red schemes.</p><br><p>10No white and light blue limewash schemes.</p><br><p>X400 -</p> <p>Earliest paint layers.</p><br><p>Earliest paint layer – a white limewash tinted with Prussian Blue pigments.</p> |

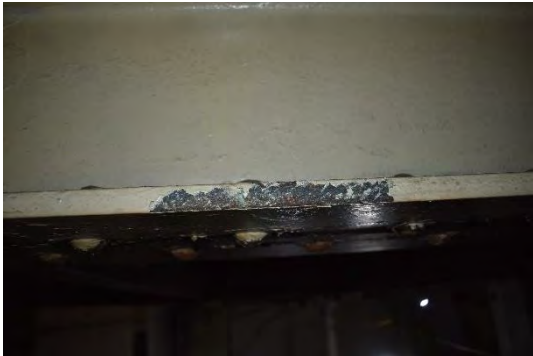
| Sample Ref:PS.36 | Location: 40-46 Princess Street |
|---|---|
| <p>Paint sample removed from:</p> <p>Location: 36 – Level 0 rear beam.</p> <p>(The earliest paint layers are shown towards the bottom of the layers shown in the photographs).</p> | |
| <br> | <p>X100 Magnification –</p> <p>Current off-white paint scheme.</p> <p>6No white / off-white paint schemes with a single black scheme.</p> <p>Earlier 2x green schemes with some evidence of a black/red primer.</p><br><p>X400 -</p> <p>Earliest paint layers.</p> <p>Earliest decorative coating is the light green oil paint scheme. The red/brown primer coating is likely to have been applied at the mill before delivery to site.</p> |

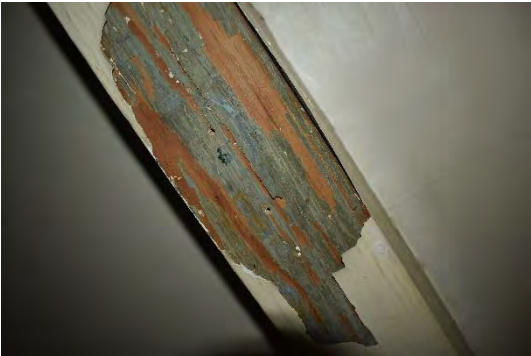
| Sample Ref:PS.37 | Location: 40-46 Princess Street |
|---|---|
| <p>Paint sample removed from:</p> <p>Location: 37 – Level 0 rear soffit.</p> <p>(The earliest paint layers are shown towards the bottom of the layers shown in the photographs).</p> | |

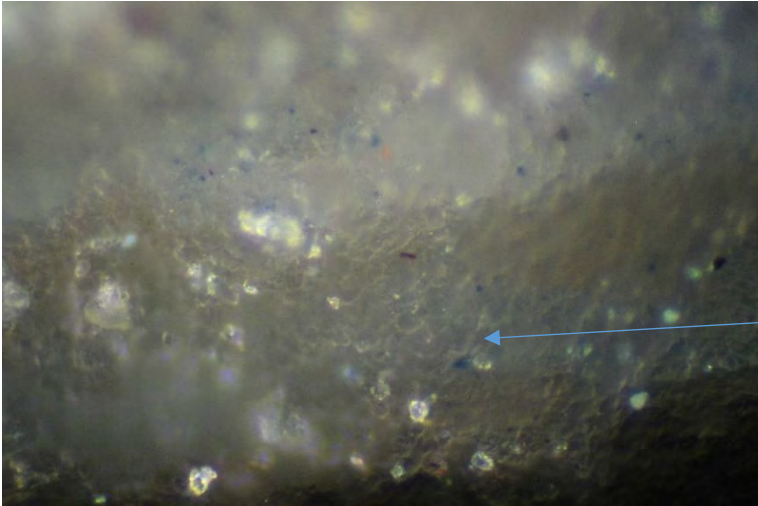
| Sample Ref:PS.37 | Location: 40-46 Princess Street |
|---|---|
| <br> | <p>X100 Magnification –</p> <p>Current off-white decorative scheme.</p> <p>Later white schemes based on zinc oxide with a single black paint layer.</p> <p>Earlier limewash applications.</p><br><p>X400 -</p> <p>Earliest paint layers.</p> <p>Earliest paint layer – a light blue limewash.</p> |

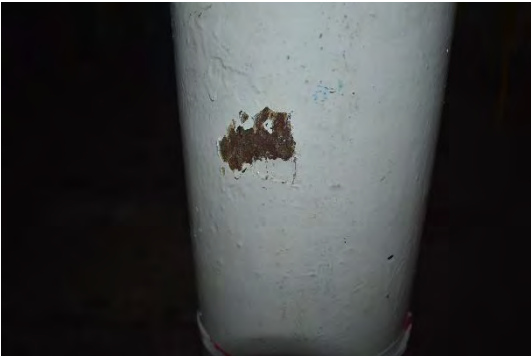
| Sample Ref:PS.38 | Location: 40-46 Princess Street |
|---|---|
| <p>Paint sample removed from:</p> <p>Location: 38 – Level 0 rear column.</p> <p>(The earliest paint layers are shown towards the bottom of the layers shown in the photographs).</p> | |
| <br> | <p>X50 Magnification –</p> <p>Current white paint scheme.</p> <p>12No layers are visible in the sample.</p> <p>Earliest paint coatings – red iron oxide paint layer.</p><br><p>X400 -</p> <p>Earliest paint layers.</p> <p>Earliest decorative paint layer – a red iron oxide based oil paint over a off-white primer.</p> |
