HAMMERSTONE ROAD DEPO

### PERMANENT REPAIR WORKS

## SOUTHERN BOUNDARY WAL

- CUR - 00 - XX - DR - S - 27-000

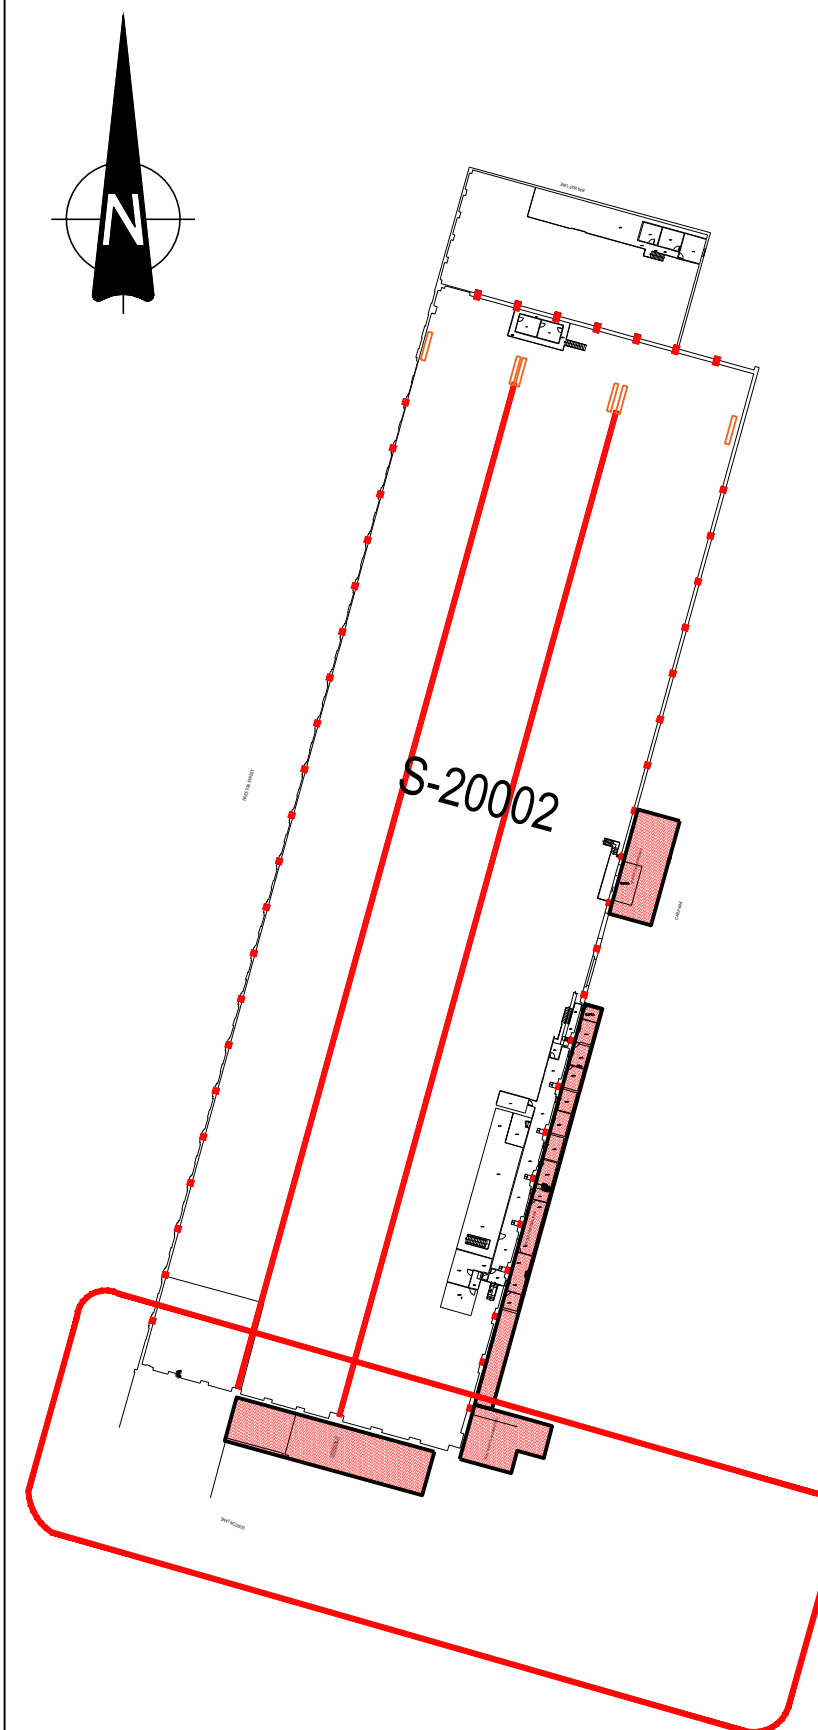
KEY PLAN:

| EXTERNAL SOUTH BOUNDARY WALL | |
|---|---|
| 01 | INFILLED OPENING PARTLY BONDED ON WEST SIDE. |
| 02 | SMALLER INFILLED DOW OPENING WITH REINFORCED CONCRETE LINTEL ABOVE. |
| 03 | CONCRETE SPALLED FIN WEST FACE. REINFORCEMENT HEAVILY CORRODED. |
| 04 | DIAGONAL CRACKING STARTING AT MID HEIGHT CIRCA 5mm DEEP DOWN TO HURLING UP TO ASK (1 METRE LONG). |
| 05 | EMBEDDED STEEL REMAINS OF I BEAM BEARING, JACKING UP SURROUNDING MASONRY. |
| 06 | LOOSE MASONRY UNITS AT TOP OF LEDGE BELOW WALL HEAD. |
| 07 | VEGETATION GROWTH. |
| 08 | SIGN SEPARATION BETWEEN LEDGE AND PRINCIPAL WALL HEAD. STRETCHER COURSE, LAST 4 COURSES, NOT BONDED. |
| 09 | LOSS OF MORTAR TO WALL HEAD. HEAVILY DECAYED. |
| 10 | MISSING AND LOOSE MASONRY UNITS, RAMSHACKLE REPAIRS, SEVERED CROSS BONDS AT HEADER COURSE. TAKE DOWN, REMOVE STEELWORK AND RE-BUILD. |
| 11 | WALL BULGES OUT ON PLAN AND RETURNS AT WALL HEAD. MAXIMUM DISPLACEMENT CIRCA 25mm AT CIRCA 500mm FROM CORNER. CONSTANT ALONG THE BULGE. |
| 12 | WALL HEAD BULGES IN ON PLAN CIRCA 20mm. COPES DISPLACED. |
| 13 | MASONRY INFILL PARTLY BONDED UP TO EXISTING AT INTERFACE. DIFFERENCE OF VERTICALLY AT WALL HEAD DECREASING TOWARDS ROOF LEVEL. |
| 14 | INFILL IN DOOR OPENING IN MASONRY WALL, BUT JOINT UNBONDED TO SURROUNDING STRUCTURE. |
| 15 | REINFORCED CONCRETE LINTEL, CORRODED AND SPALLING. |
| 16 | HEAVILY DECAYED MASONRY FABRIC TOP 1m. |
| 19 | MASONRY ARCH APPEARS DECAYED ALTHOUGH BED JOINT MASONRY ARCHES ABOVE CROWN. |
| 20 | CRACKING CIRCA 5 - 10mm DISPLACEMENT UP FROM PRINCIPAL POINT TO WALL HEAD. |

| EXTERNAL SOUTH BOUNDARY WALL | |
|---|---|
| 32 | DIAGONAL CRACKING FROM BEAM BEARING TO WALL HEAD BOTH SIDES CIRCA 15 - 20mm. BEAM SAGGING AT MID POINT. MASONRY AND BED JOINTS ABOVE BEAM SAGGING. CHECK T BEAM FOR ROT. |
| 39 | SERIOUSLY MASONRY FABRIC DETERIORATION. DEEP PACK POINTING AND INDENT REPAIR REQUIRED ALL EMBEDDED STEEL. |

2. THE MASONRY FABRIC OF THE WALL IS IN POOR CONDITION IN PLACES. BRICK INDENT PATTERN (AS 353) LOCATIONS ACCORDING TO ELEVATION ABOVE AS WELL AS DEEP PACK REPAIRING WITH COMPATIBLE MORTAR ALONG ITS LENGTH WILL BE REQUIRED THROUGHOUT.

3. THE WALL IS ACTING AS A CONTAINMENT RETAINING WALL FOR THE HAMMERTONE SITE AT THE BOUNDARY WITH GORTON LAKE. THE REDUCTION IN LEVEL ON THE CAR PARK SIDE WILL REVEAL CURRENTLY BURIED MASONRY AND ALLOWANCE SHOULD BE MADE FOR WORKS TO THIS SITE. ALLOW FOR AN 100 INDENT REPAIRS AND THE WHOLE ELEVATION BOTH EXPOSED AND BURIED SHOULD BE CLEANED AND REPAIRED.

AREA OF MASONRY WALL TO BE CAREFULLY TAKEN DOWN TO MAX. 2m HEIGHT. REMAINING MASONRY TO BE REPOINTED AND INDENT REPAIR AS REQUIRED. REDUCED WALLHEAD TO BE COVERED WITH COPING STONES.
-

AREAS REQUIRING BRICK INDENT REPAIR
-

WALL HEIGHT TO BE CAREFULLY REDUCED AND ALL SOUND BRICKS TO BE CLEANED, RECLAIMED AND USED AS PART OF REPAIR WORKS.
