## BS5837:2012 TREE SURVEY / Arboricultural Impact Assessment

Customer No: MBHDE05  
Document No: 800722  
09/10/2021

Site Address:  
Ardwick Service Station  
Chancellor Lane  
Manchester M12 6JZ

Site: FS664 Ardwick Service Station, Chancellor Lane, Manchester M12 6JZ

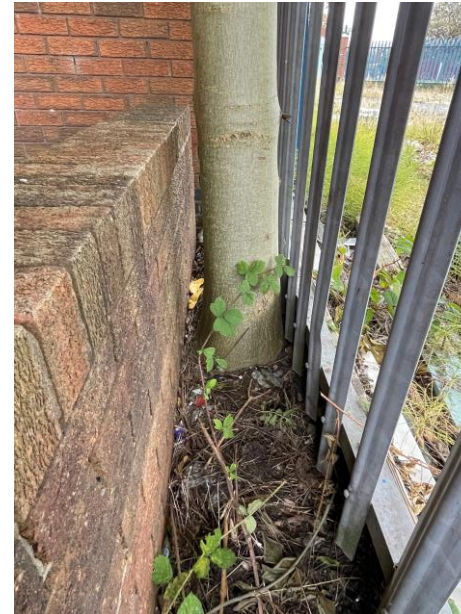
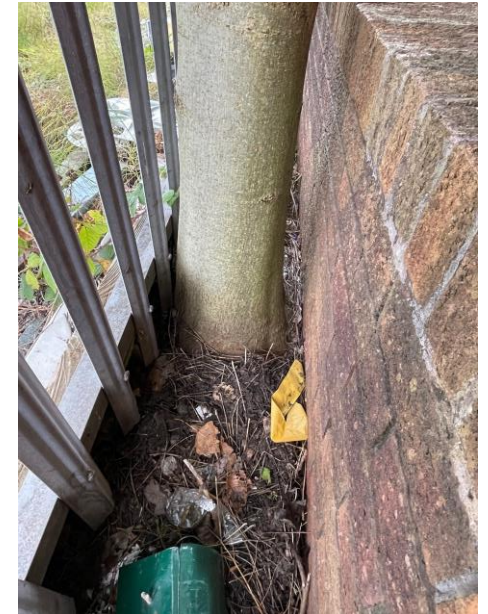
**The Current impact** on the site is that the tree is about as big as it can get before damage occurs to the wall alongside the path and the boundary fence. The crown is already impacting directly on the roof and gutter of the Sales Building.

T1 Ash trunk already pressed against the wall and security fence

Given the above assessment of the tree, its age, location and negative desirability for retention and Classification, the recommendation must be to Fell the tree and Poison the stump to prevent regrowth.

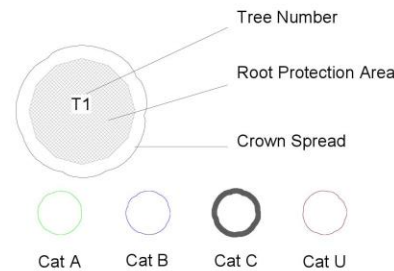
Root Protection Area of 18.15m2 adjusted to maintain a likley root spread due to the Sales Building foundations likely to be preventing root access.

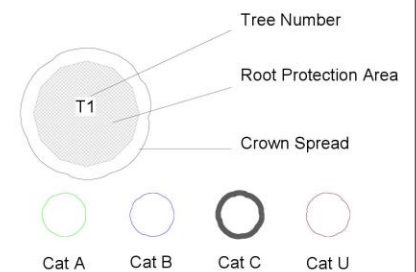
Prudent management will be to fell and poison the tree regardless of the proposed development
