# Drainage Report

**MMUIOS**  
**99 OXFORD ROAD**  
**MANCHESTER**  
**MANCHESTER**

**AQUASPEED DRAIN SERVICES**  
**Surveyor: RYAN HITCHCOCK**  
**INFO@AQUASPEED.CO.UK**  
**01942 886722**

**MMUIOS 99 OXFORD ROAD MANCHESTER - CCTV Survey Report : 01/10/21**

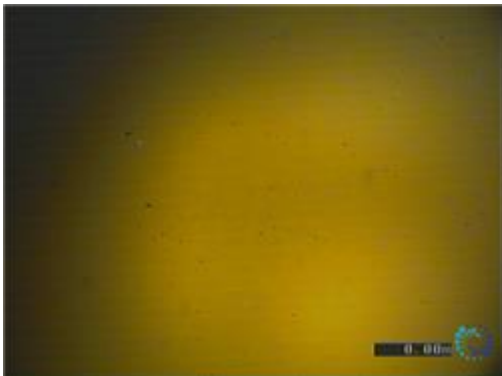
| Pos | Video Ref | Code | Description | Image |
|---|---|---|---|---|
| 05.20m | | OCF | Finish node type, other special chamber U/S | Image Provided - Ref: 0_9999<br> |

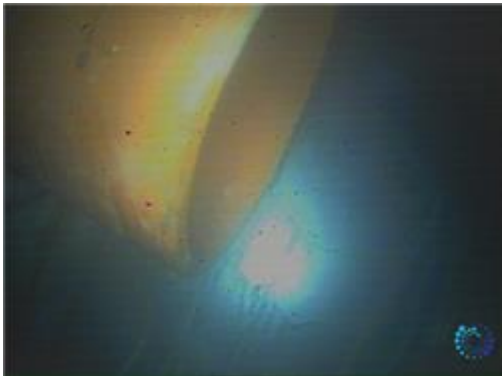
| Pos | Video Ref | Code | Description | Image |
|---|---|---|---|---|
| 07.00m | | GYF | Finish node type Gully U/S1 | <p>Image Provided - Ref: 1_9999</p> |

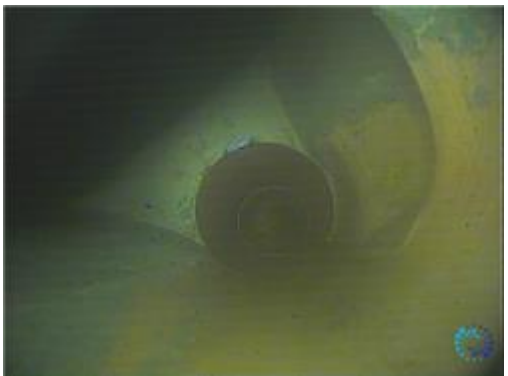
| Pos | Video Ref | Code | Description | Image |
|---|---|---|---|---|
| 14.40m | | MHF | Finish node type, manhole EXMH238 | Image Provided - Ref: 2_9999<br> |

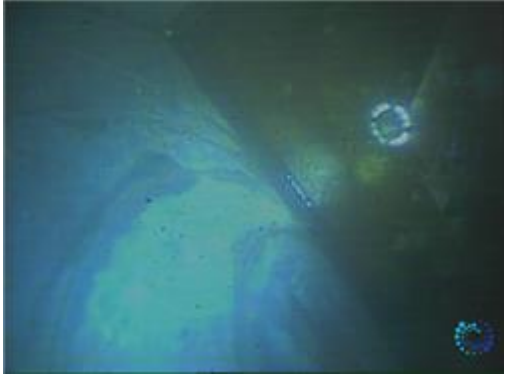
| Pos | Video Ref | Code | Description | Image |
|---|---|---|---|---|
| 04.80m | | OCF | Finish node type, other special<br>chamber<br>U/S1 | <p>Image Provided - Ref: 3_9999</p> |

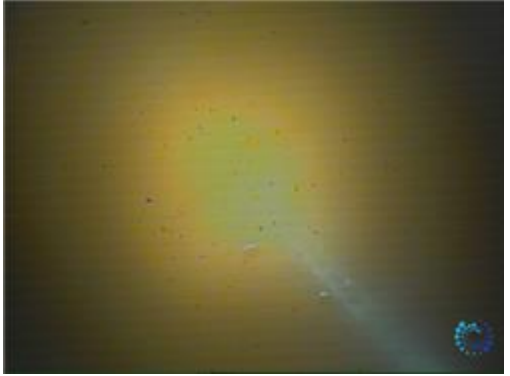
| Pos | Video Ref | Code | Description | Image |
|---|---|---|---|---|
| 03.20m | | BRF | Finish node type, major connection without manhole MAIN | <p>Image Provided - Ref: 4_9999</p> |

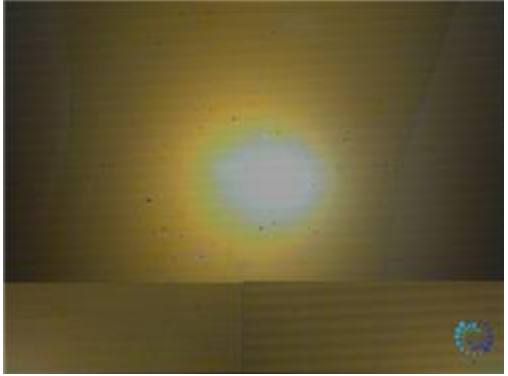
| Pos | Video Ref | Code | Description | Image |
|---|---|---|---|---|
| 02.30m | | BRF | Finish node type, major connection without manhole MAIN | <p>Image Provided - Ref: 5_9999</p> |

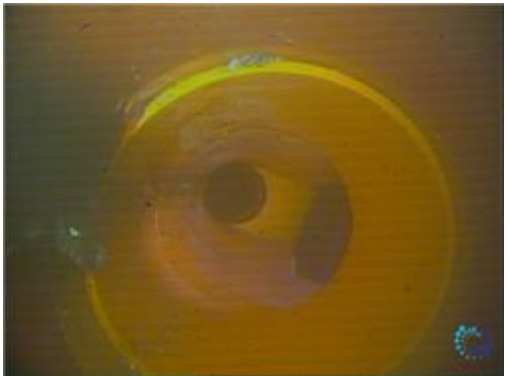
| Pos | Video Ref | Code | Description | Image |
|---|---|---|---|---|
| 02.00m | | BRF | Finish node type, major connection without manhole D/S | Image Provided - Ref: 6_9999<br> |

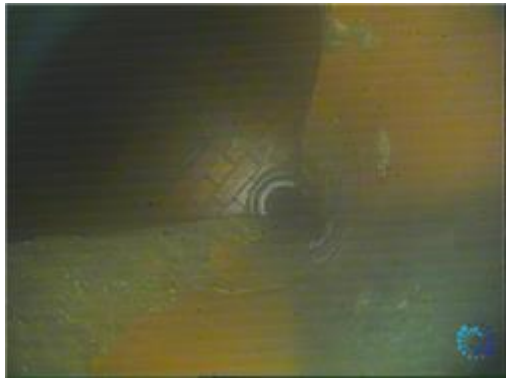
| Pos | Video Ref | Code | Description | Image |
|---|---|---|---|---|
| 15.60m | | MHF | Finish node type, manhole EXMH237 | Image Provided - Ref: 7_9999<br> |

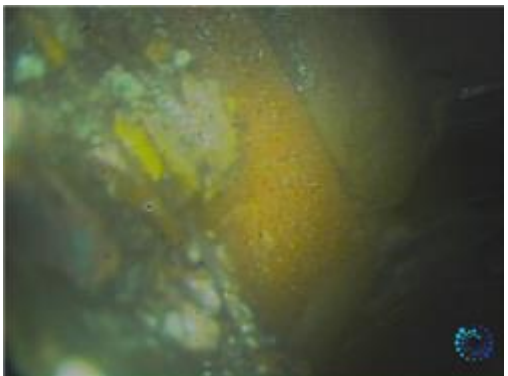
| Pos | Video Ref | Code | Description | Image |
|---|---|---|---|---|
| 04.50m | | MHF | Finish node type, manhole EXMH236 | Image Provided - Ref: 9_9999<br> |

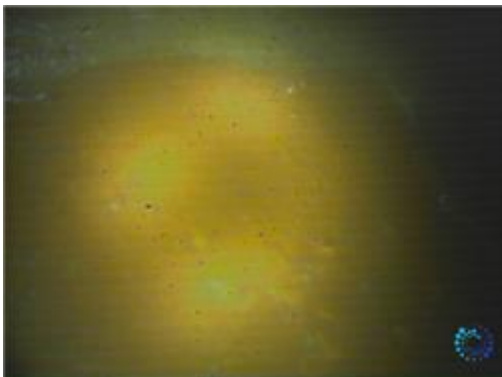
| Pos | Video Ref | Code | Description | Image |
|---|---|---|---|---|
| 03.72m | | MHF | Finish node type, manhole EXMH237 | <p>Image Provided - Ref: 10_9999</p> |

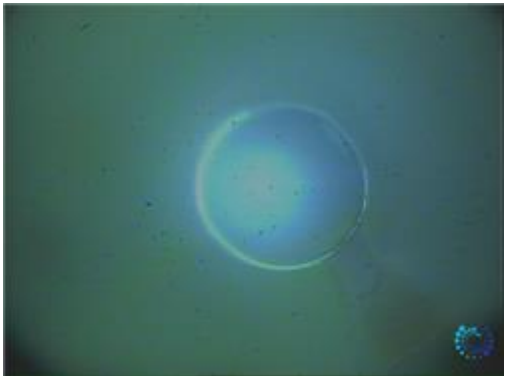
| Pos | Video Ref | Code | Description | Image |
|---|---|---|---|---|
| 04.50m | | OCF | Finish node type, other special chamber SVP | <p>Image Provided - Ref: 11_9999</p> |

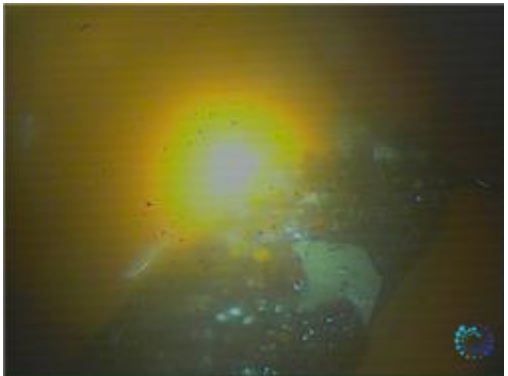
| Pos | Video Ref | Code | Description | Image |
|---|---|---|---|---|
| 01.30m | | BRF | Finish node type, major connection without manhole MAIN | <p>Image Provided - Ref: 12_9999</p> |

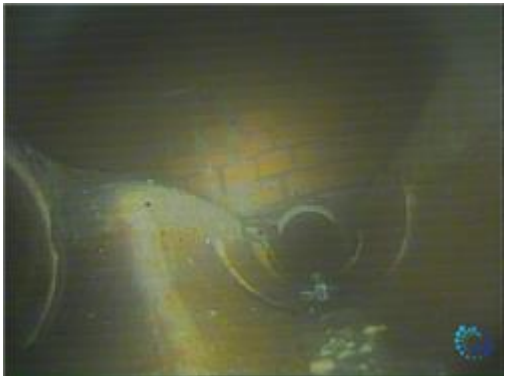
| Pos | Video Ref | Code | Description | Image |
|---|---|---|---|---|
| 11.67m | | MHF | Finish node type, manhole EXMH236 | <p>Image Provided - Ref: 13_9999</p> |

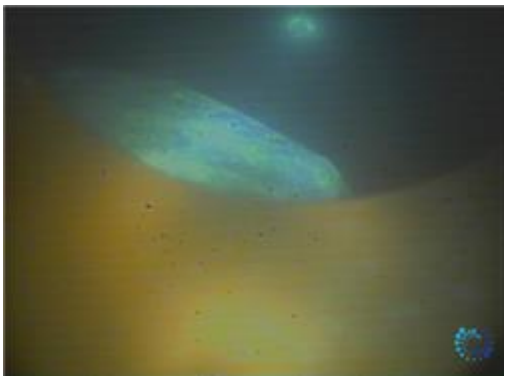
| Pos | Video Ref | Code | Description | Image |
|---|---|---|---|---|
| 03.44m | | OCF | Finish node type, other special chamber DU5 | Image Provided - Ref: 14_9999<br> |

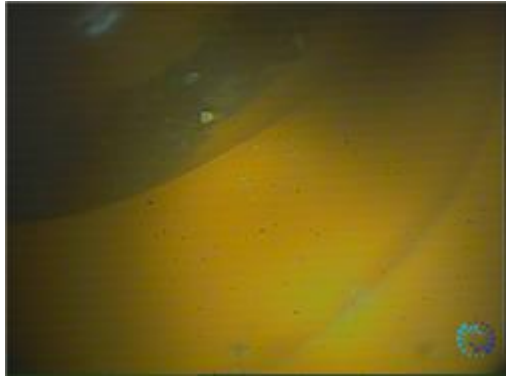
| Pos | Video Ref | Code | Description | Image |
|---|---|---|---|---|
| 01.30m | | BRF | Finish node type, major connection without manhole MAIN | <p>Image Provided - Ref: 16_9999</p> |

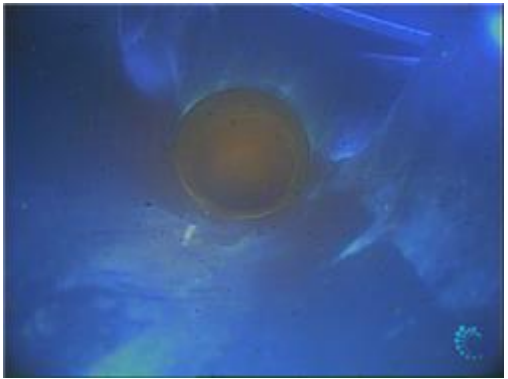
| Pos | Video Ref | Code | Description | Image |
|---|---|---|---|---|
| 03.87m | | MHF | Finish node type, manhole<br>FW4 | <p>Image Provided - Ref: 17_9999</p> |

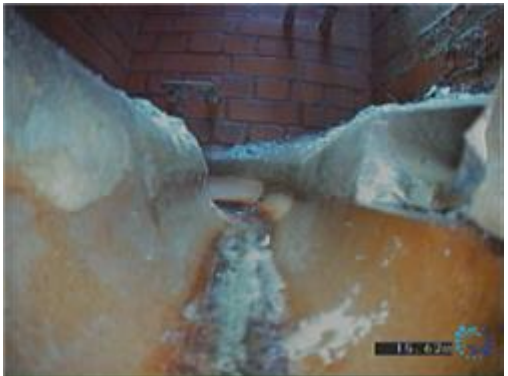
| Pos | Video Ref | Code | Description | Image |
|---|---|---|---|---|
| 15.62m | | MHF | Finish node type, manhole EXMH235 | <p>Image Provided - Ref: 18_9999</p> |

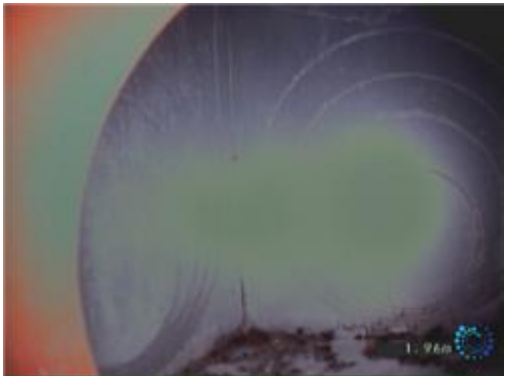
| Pos | Video Ref | Code | Description | Image |
|---|---|---|---|---|
| 01.96m | | OCF | Finish node type, other special chamber<br>SLOT DRAIN | <p>Image Provided - Ref: 19_9999</p> |

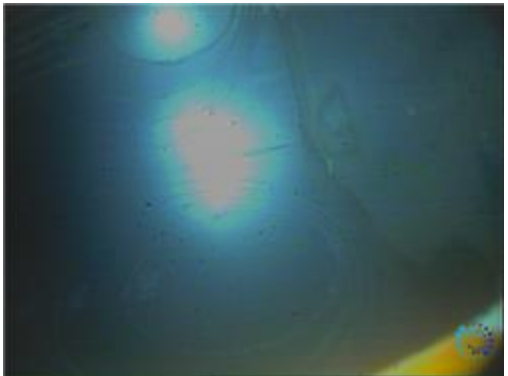
| Pos | Video Ref | Code | Description | Image |
|---|---|---|---|---|
| 01.00m | | OCF | Finish node type, other special chamber<br>SLOT DRAIN | <p>Image Provided - Ref: 20_9999</p> |

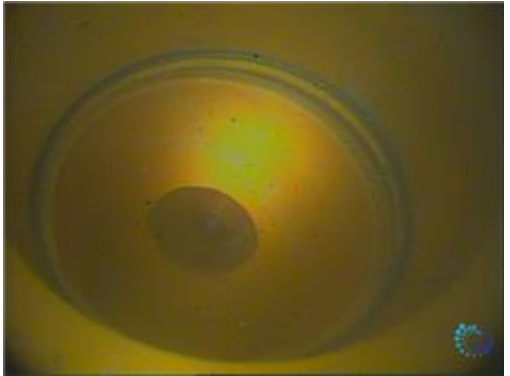
| Pos | Video Ref | Code | Description | Image |
|---|---|---|---|---|
| 01.30m | | MHF | Finish node type, manhole EXMH234 | <p>Image Provided - Ref: 21_9999</p> |

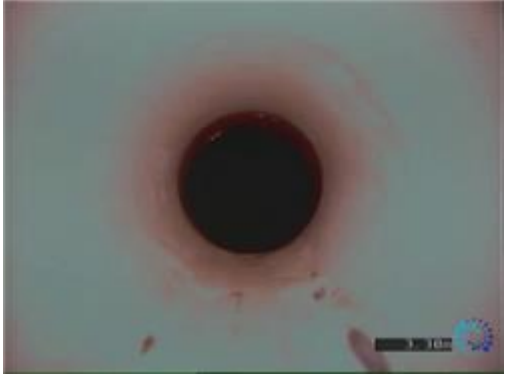
| Pos | Video Ref | Code | Description | Image |
|---|---|---|---|---|
| 03.30m | 0:00:19 | REM | General remark<br>PATCH LINER FITTED | Image Provided - Ref: 22_2<br> |

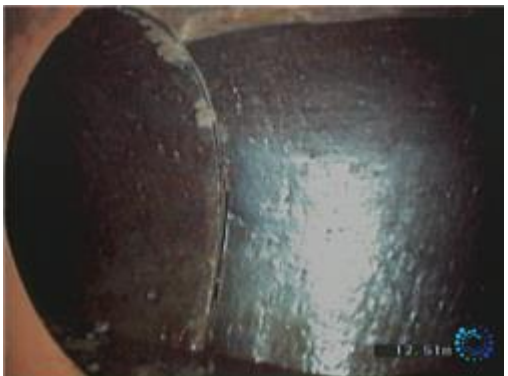
| Pos | Video Ref | Code | Description | Image |
|---|---|---|---|---|
| 12.51m | | BRF | Finish node type, major connection without manhole DOWNSTREAM | Image Provided - Ref: 22_9999<br> |
