# Asbestos Refurbishment Survey

72 Errwood Road

Manchester

M19 2QH

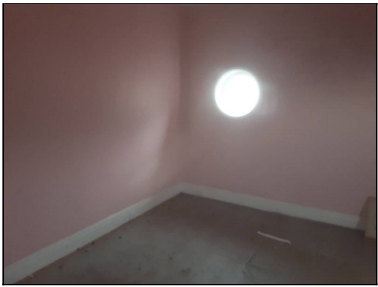
| | Survey Date: | Lead Surveyor | Survey Type | Floor | Analysis |
|---|---|---|---|---|---|
| | Main building | Master bedroom 101 | No suspect materials found | N/A | |

| | Survey Date: | Lead Surveyor | Survey Type | Floor | Analysis |
|---|---|---|---|---|---|
| Recommended action | | No further action required | | | |

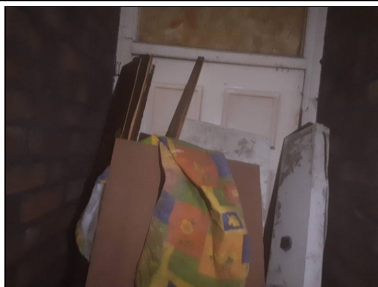
| | Survey Date: | Lead Surveyor | Survey Type | Floor | Analysis |
|---|---|---|---|---|---|
| Surveyor comments | | One to holder one to fuse | | | |

| | Survey Date: | Lead Surveyor | Survey Type | Floor | Analysis |
|---|---|---|---|---|---|
| Recommended action | | A - Urgent Removal | | | |

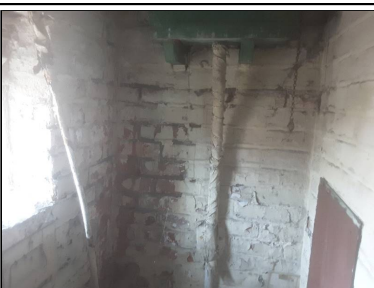
| | Survey Date: | Lead Surveyor | Survey Type | Floor | Analysis |
|---|---|---|---|---|---|
| | 8 Mar 2021 to 9 Mar 2021 | Richard Watson | Refurbishment Survey | External | No Asbestos Detected |
