## Phase IV Validation Completion Report

Prospect House School  
Blackley

Reference: 30186-SUT-ZZ-00-RP-G-704-0001

Date: January 2022

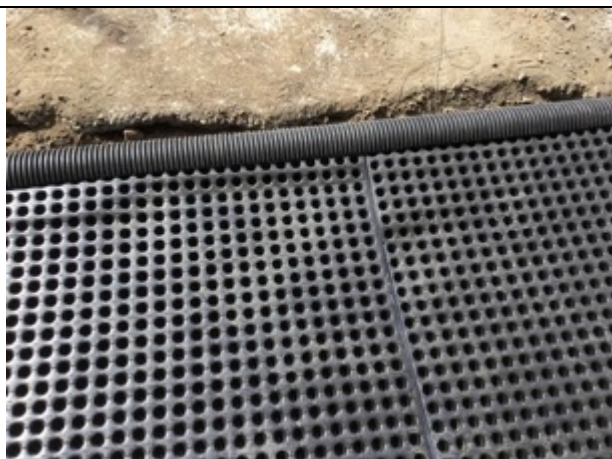
"T" piece with slotted pipe

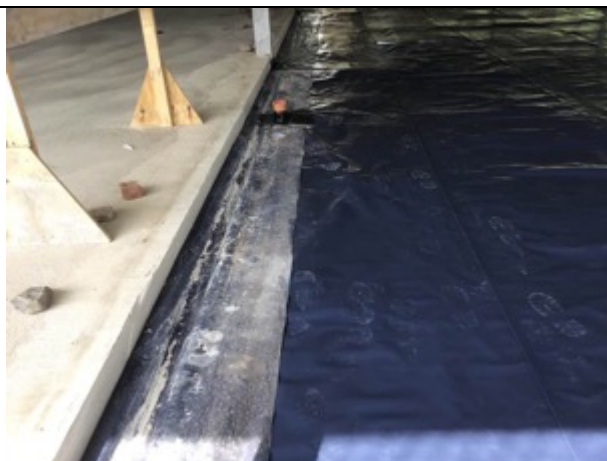
Joint to previously installed membrane

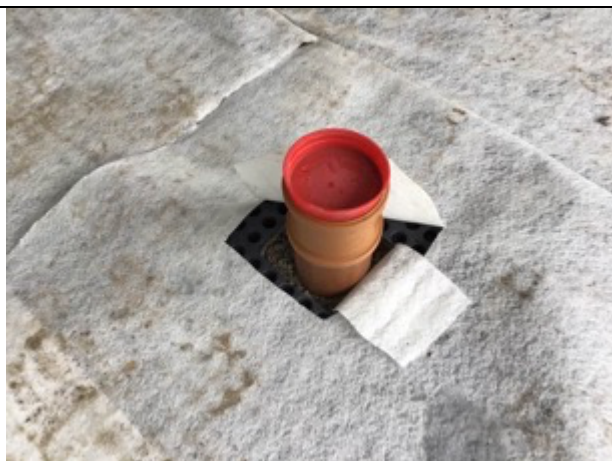
Venting cut around pipe penetration

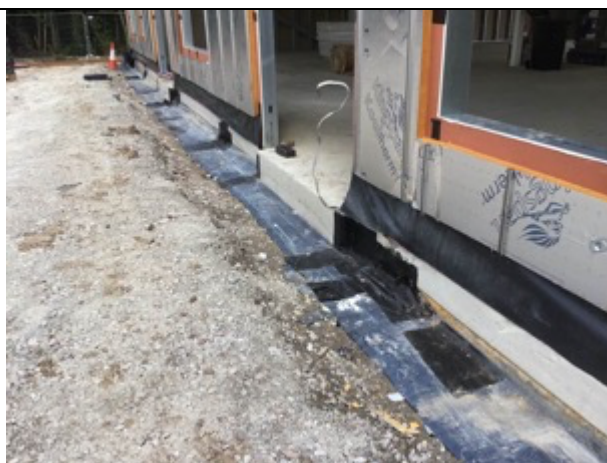
Perimeter edge and stanchions sealed

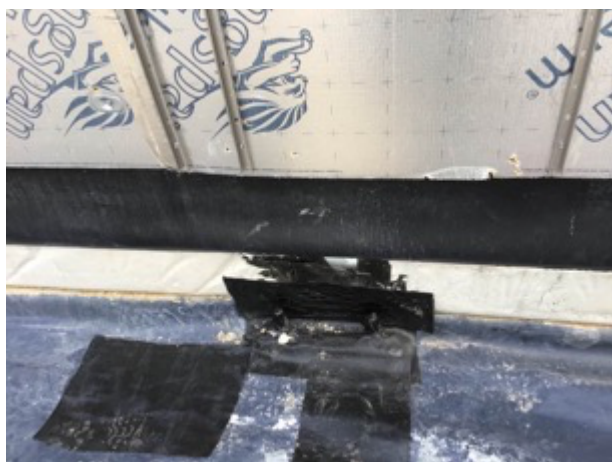
Stanchion seal using SAGM
