| ELR: MAJ | Structure No: 289 | Mileage: | Examination date: 07/09/2020 |
| Name: Castlefield Viaduct | | | Type: Viaduct |
| Carrying/Over: Disused rail / Canal, rail, road & land | | | No. of spans: 8 |

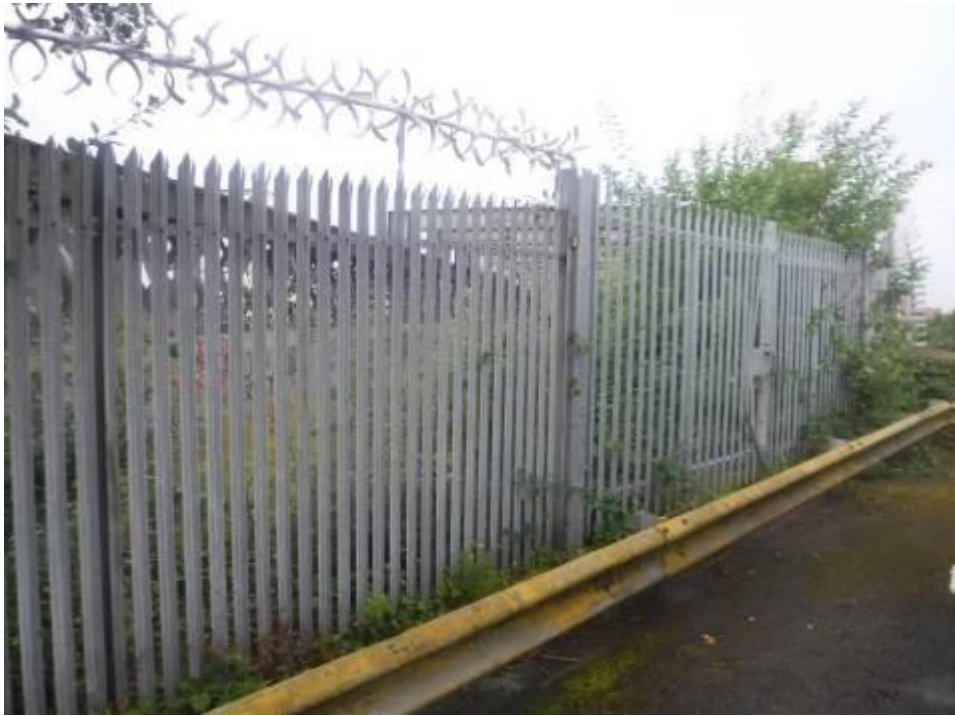
Photograph 7: Palisade fencing to east end

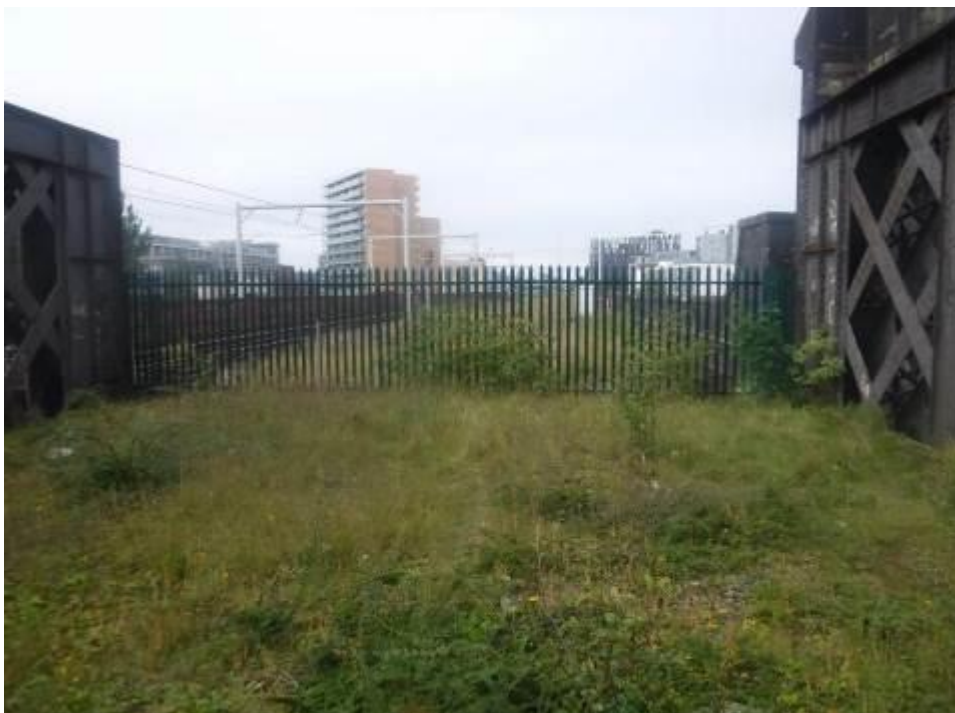
Photograph 8: Palisade fencing to west end

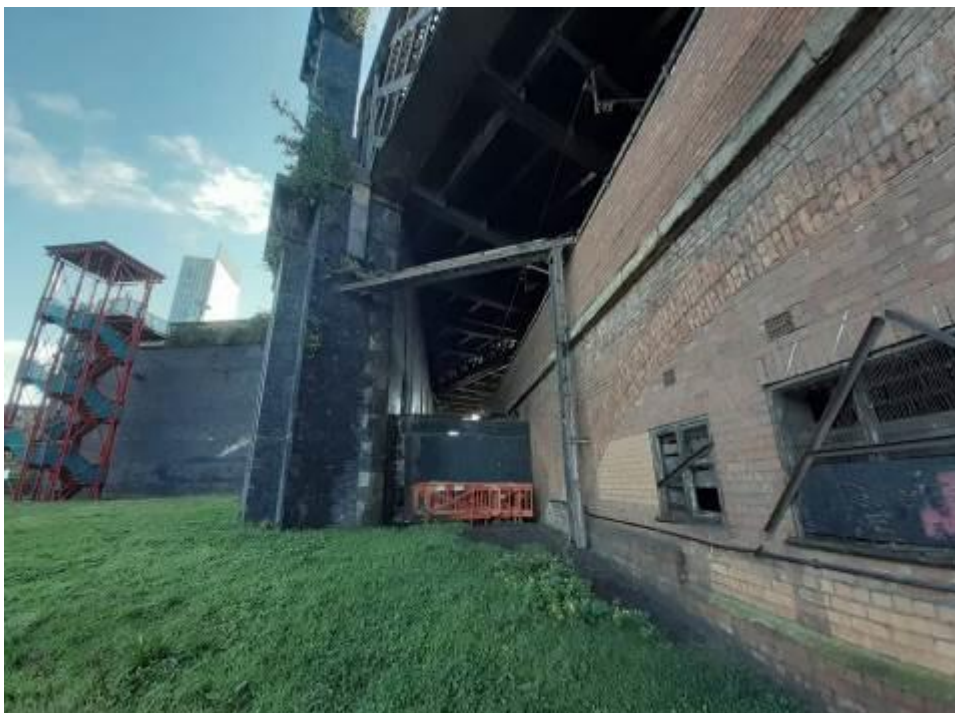
Fencing blocked access to the abutment. (photos 18)

Photograph 18: Fencing blocking access to east abutment

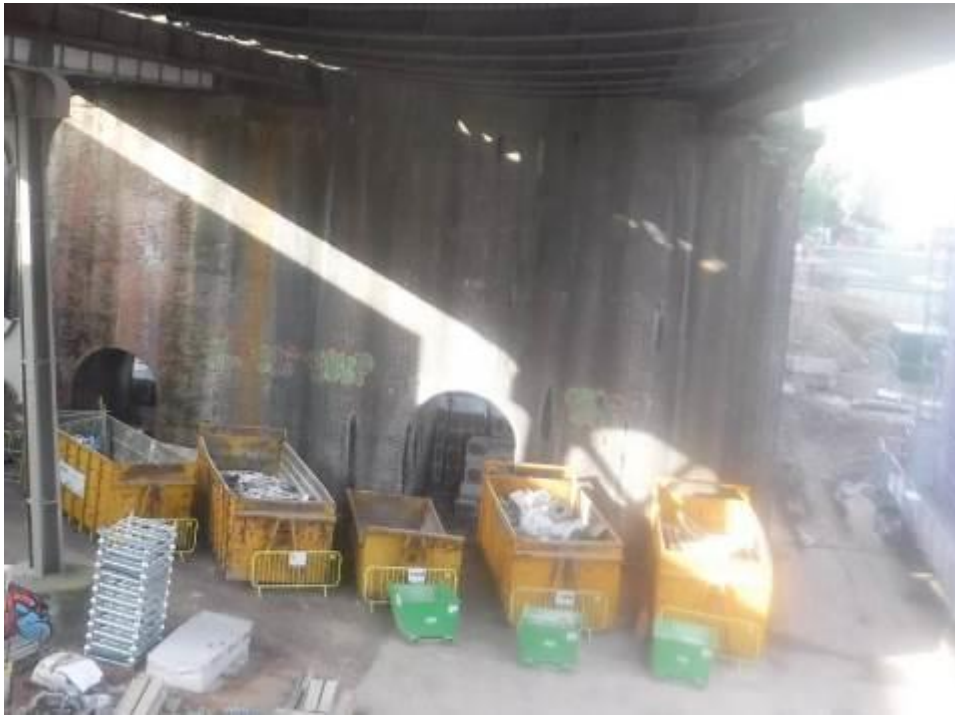
#### **West Abutment** (photo 19)

Photograph 19: General view of west abutment

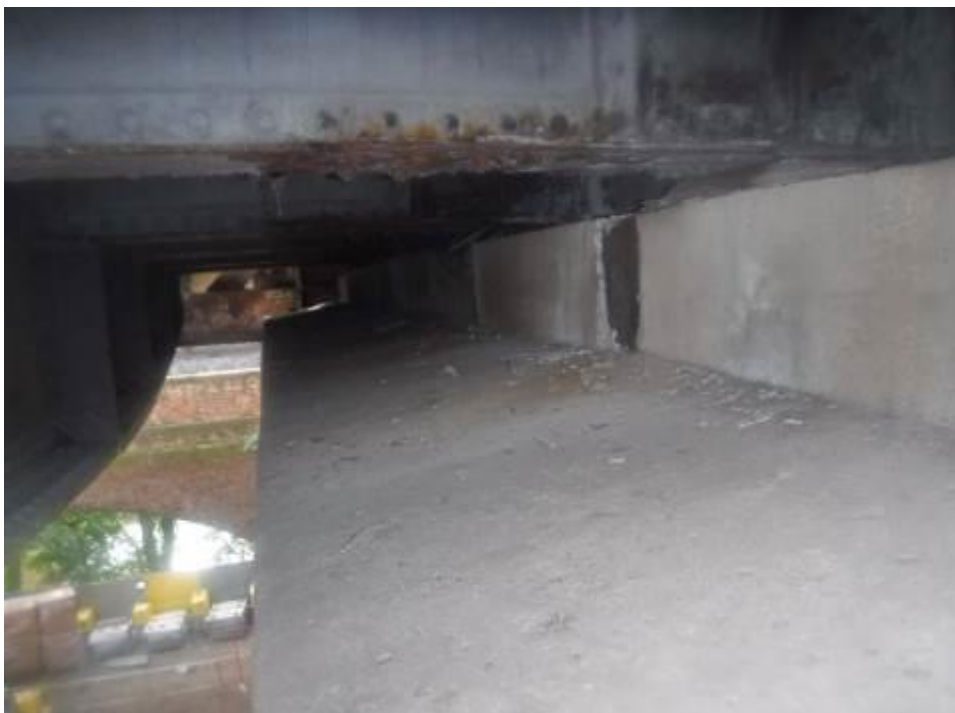
There were spot areas of green staining throughout the abutment. The brickwork had been largely re-pointed. The bearing shelf was generally in fair condition. (photo 20) The bearing of the north main external girder had loss of thickness of up to 8mm with spot loss of section of up to 100 x 30mm with rust debris to the shelf beneath. (photos 21 & 22) There was debris to the bearing shelf adjacent to the north bearing. (photo 23) The bearing of the south main external girder had loss of thickness of up to 10mm with spot loss of section of up to 60 x 10mm with rust debris to the shelf beneath. (photos 24 & 25) The bearings of the main internal girders had loss of thickness of up to 4mm to the base plates. (photo 26)

Photograph 20: General view of bearing shelf to west abutment

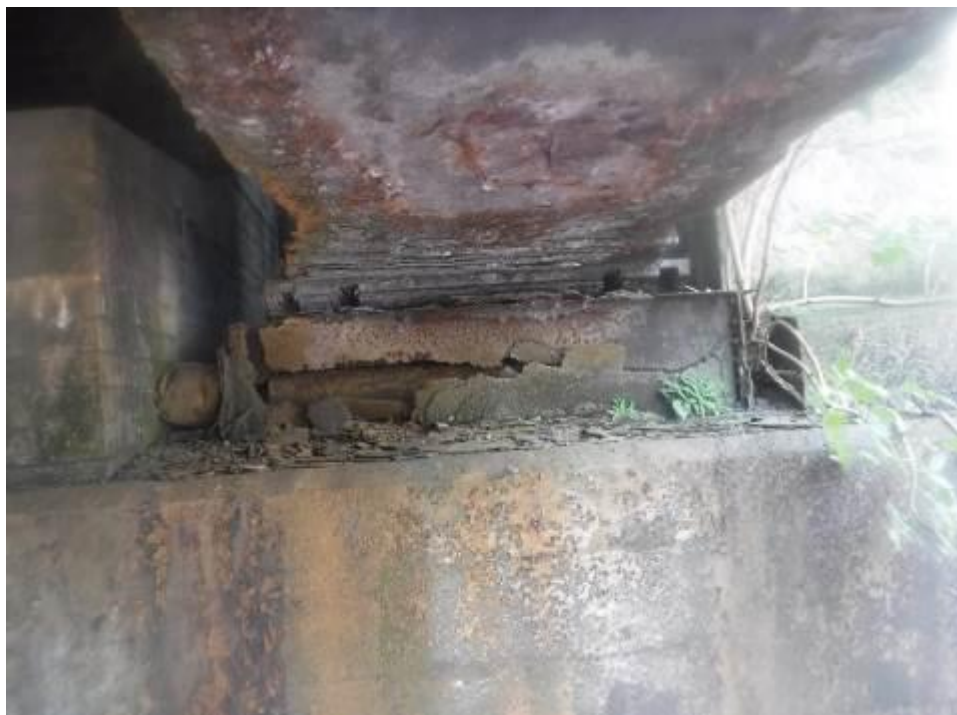
Photograph 21: Loss of thickness & loss of section to north bearing of west abutment

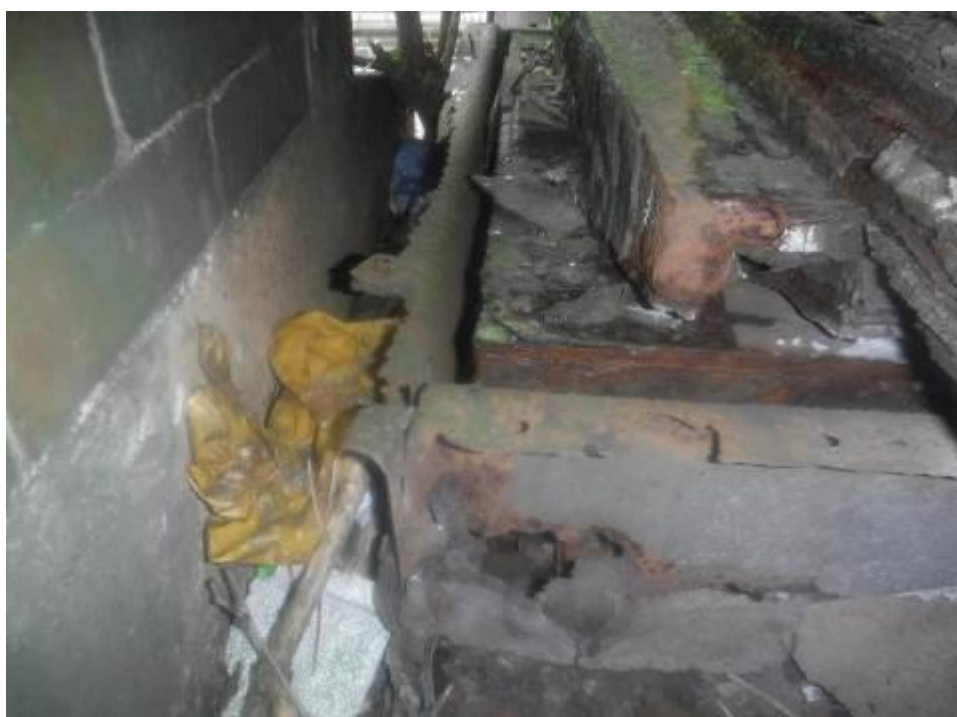
Photograph 22: Loss of thickness & loss of section to north bearing of west abutment

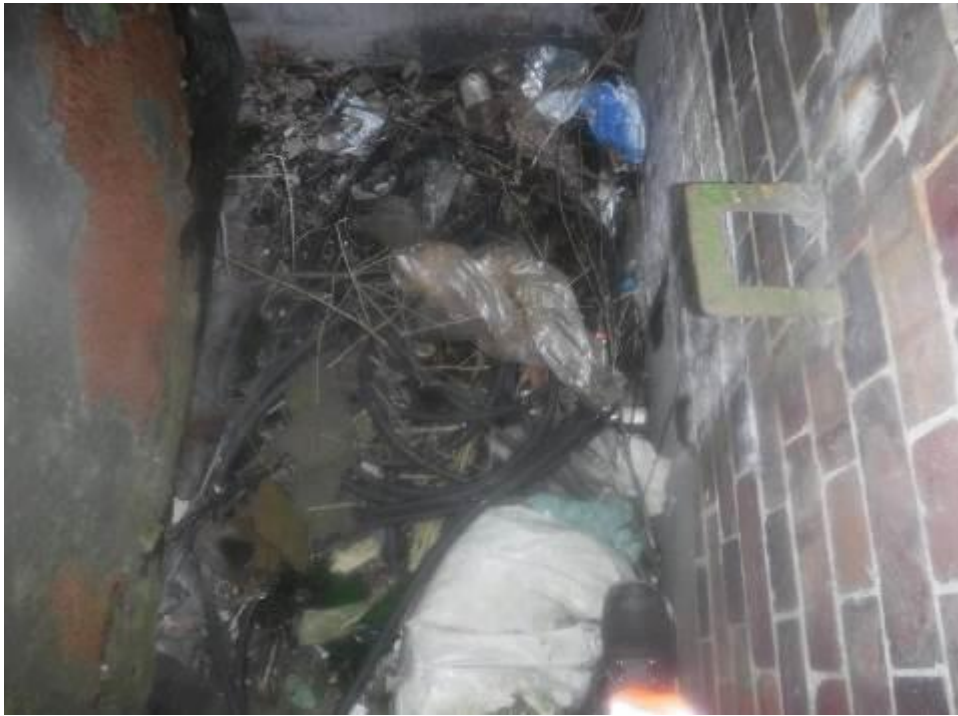
Photograph 23: Debris to bearing shelf adjacent to north bearing of west abutment

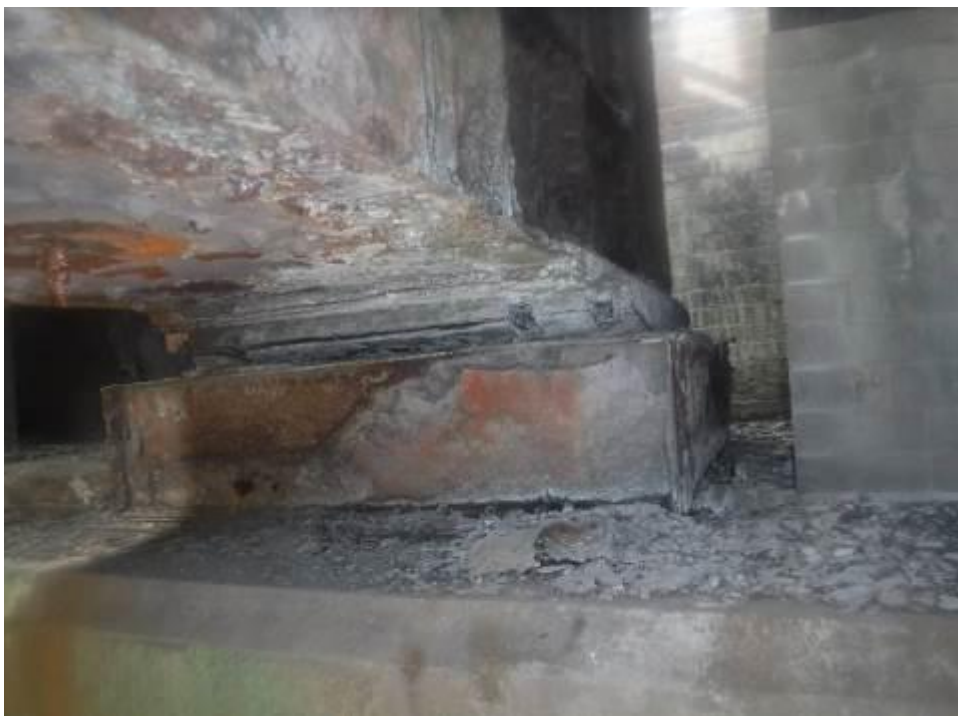
Photograph 24: Loss of thickness & loss of section to south bearing of west abutment

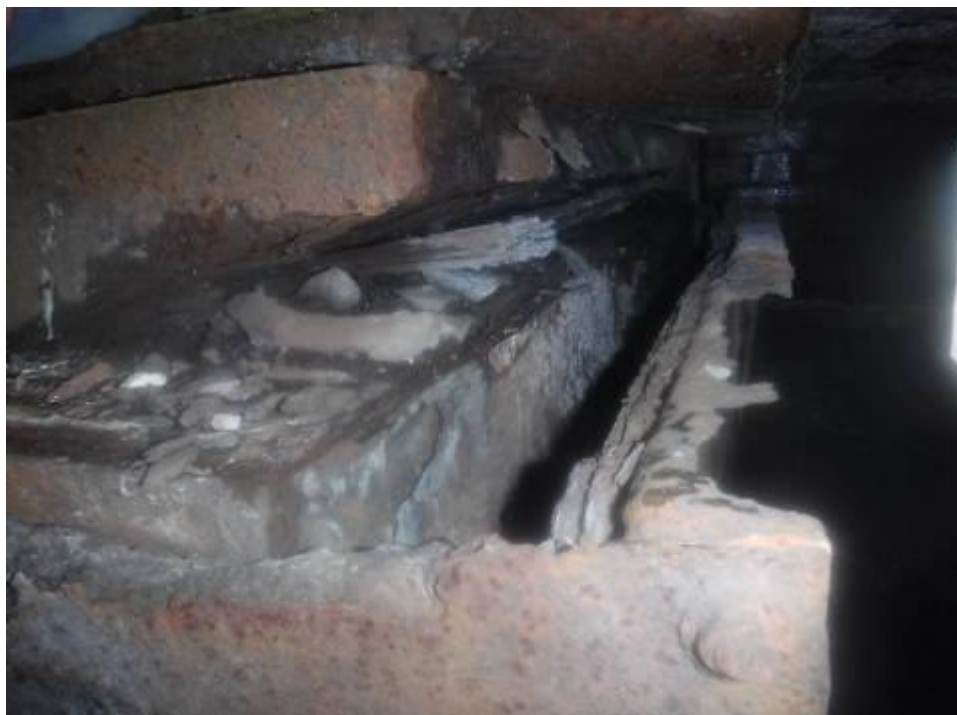
Photograph 25: Loss of thickness & loss of section to south bearing of west abutment

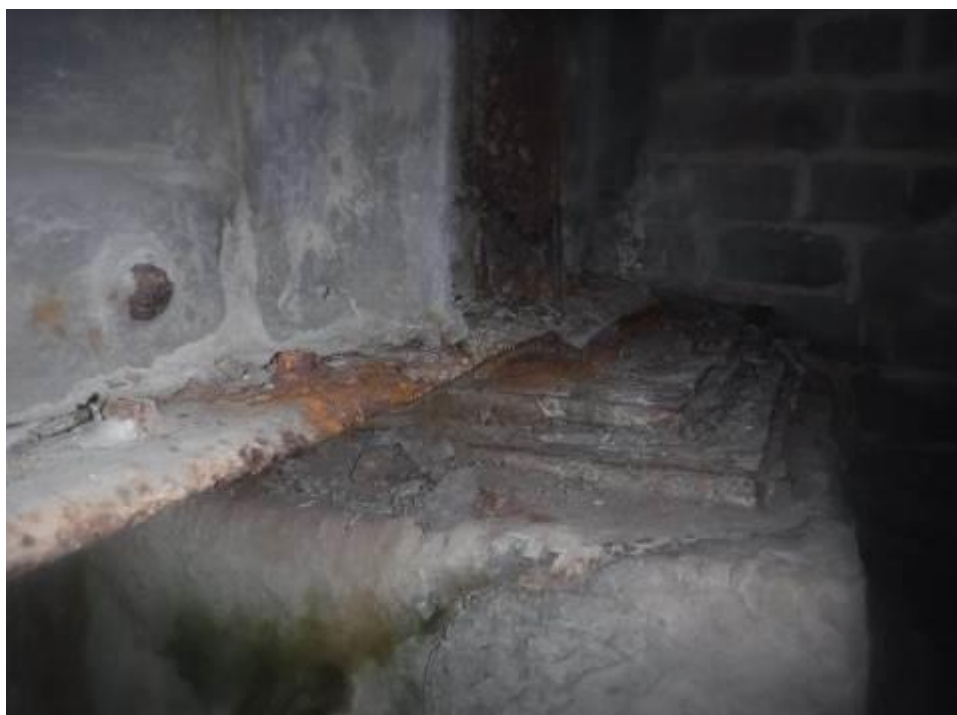
Photograph 26: Typical loss of thickness to MGI bearings of west abutment

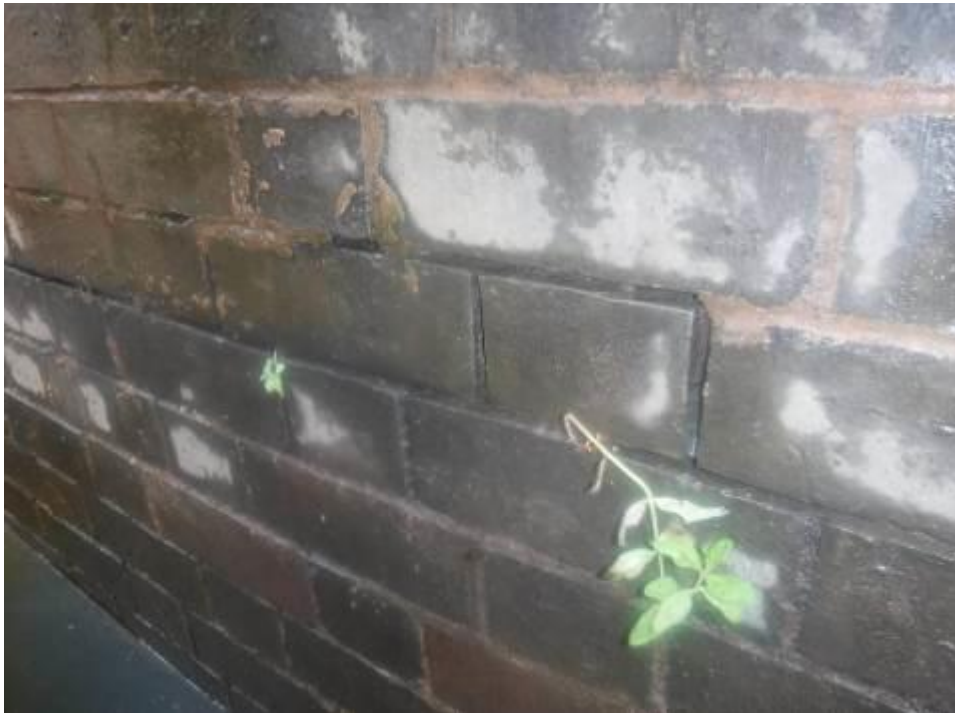
1. 3No. missing bricks and 2No. bricks displaced outwards by +80mm. (photo 27)
2. Spot areas of seepage, water staining and leachate deposits totalling 9m<sup>2</sup>. (photo 28)
3. Area of mortar loss, 2000 x 500 x up to 30mm, with light vegetation growth. (photo 29)
4. 2No. areas of non-offensive graffiti. (photo 28)
5. Area of spalled concrete to bearing plinth, 300 x 200 x up to 50mm. (photo 30)
6. Area of spalled concrete to bearing plinth, 300 x 20 x up to 20mm.
7. Area of rust debris to bearing plinth, 600 x 300mm. (photo 31)
8. Vertical fracture through concrete to bearing plinth, 300 x 1mm. (photo 32)
9. Sapling growing to bearing shelf, 30mm in diameter. (photo 33)
10. Area of missing / spalled brickwork, possibly due to vehicle strike, 120 x 150 x up to 30mm. (photo 34)

Photograph 29: Area of mortar loss with spot vegetation growth to west abutment

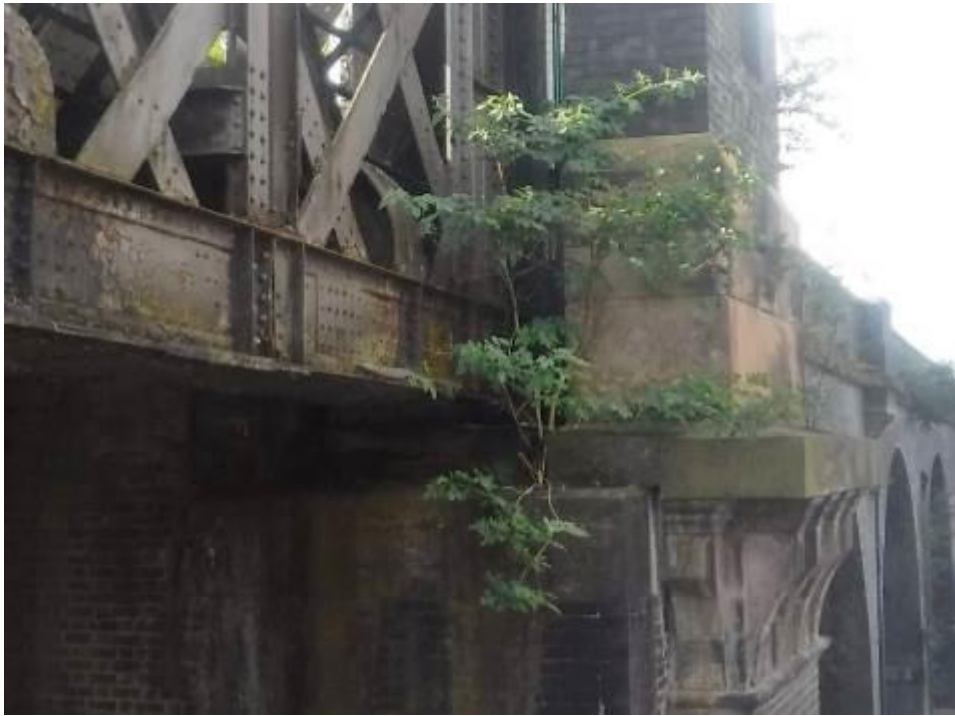
Photograph 33: Sapling growth to bearing shelf of west abutment

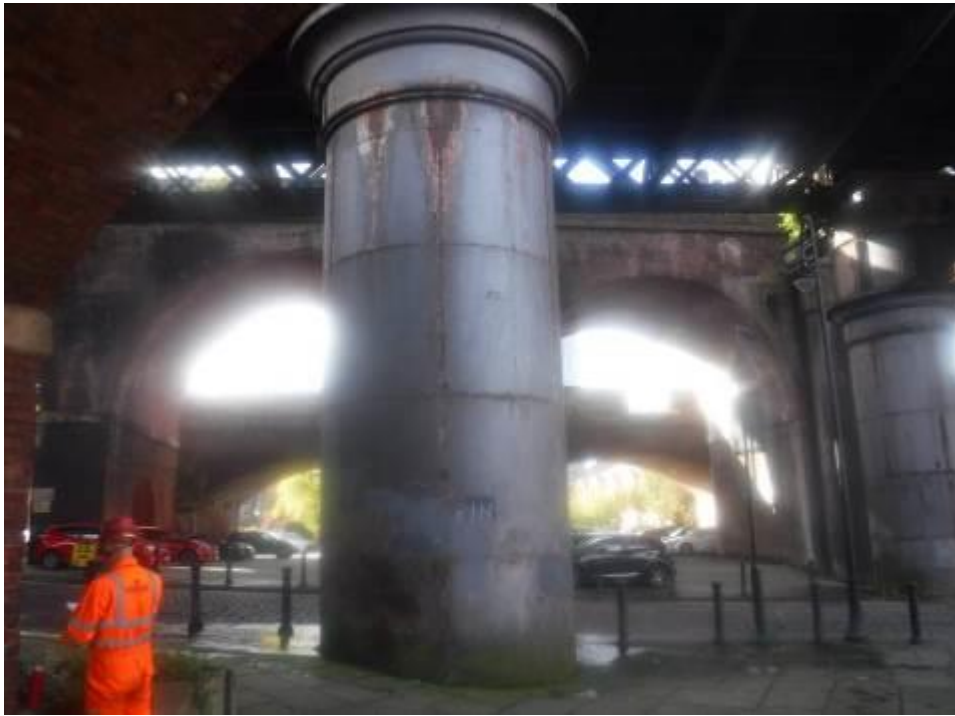
**North column: (photo 35)** There were areas of hairline map cracking to paintwork, paint loss and surface corrosion throughout, especially to the panel joints. The top section of the column had widespread paint loss and surface corrosion. There was light debris to the top of the pier.

Photograph 35: General view of pier 1, north column

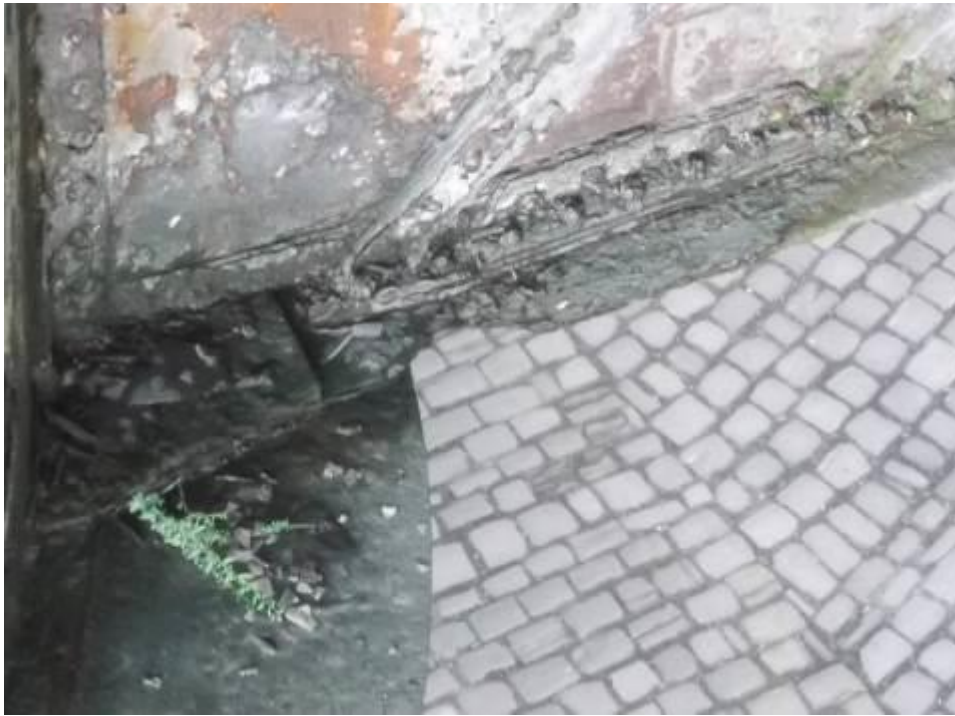
**Interconnecting truss: (photo 36)** The truss was in fair condition with spot areas of paint loss and surface corrosion. There was an area of loss of section to the north end of the lower west flange, 30 x 10mm. (photo 37)

Photograph 37: Area of loss of section to interconnecting truss of pier 1

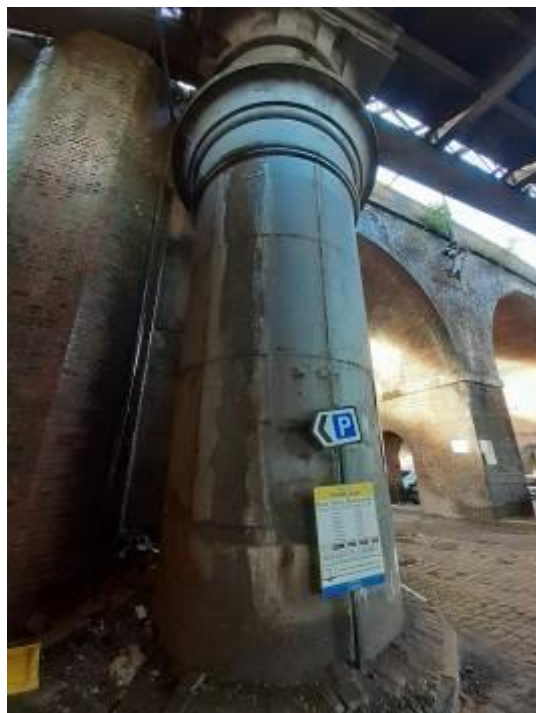
**Extra column to centre of south side of span: (photo 38)** There were areas of hairline map cracking to paintwork, paint loss and surface corrosion throughout, especially to the panel joints.

Photograph 38: General view of extra column to span 1

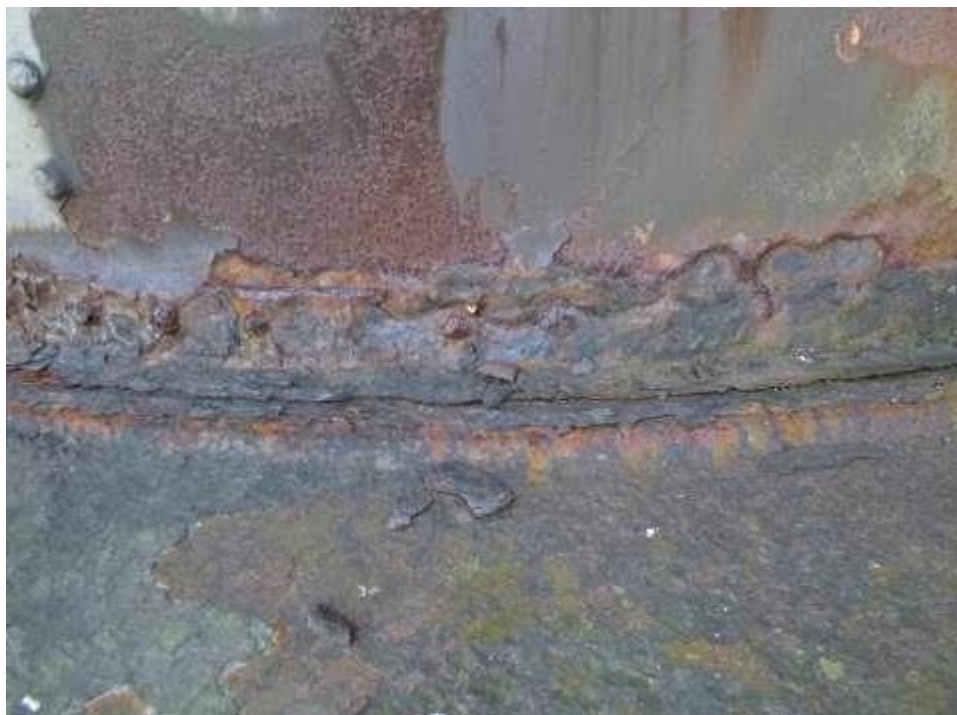
1. Diagonal hairline fracture, 160mm in length.
2. Area of loss of thickness to lower angle, 2000 x 80 x up to 10mm. (photo 39)
3. Area of loss of section to upper angle, 3000 x 80mm. (photo 40)
4. Area of loss of thickness, 1100 x 300 x up to 4mm.
5. Area of loss of section to lower angle, 700 x 80mm.
6. Area of loss of section to upper angle, 1000 x 80mm.
7. Area of vegetation growth. (photo 41)
8. Horizontal fracture, 4000 x 1mm. (photo 42)
9. Vertical fracture, 1200 x up to 15mm, with area of vegetation growth to base. (photo 43)
10. Area of seepage with associated algae growth. (photo 44)

Photograph 39: Area of loss of thickness to north column of pier 1

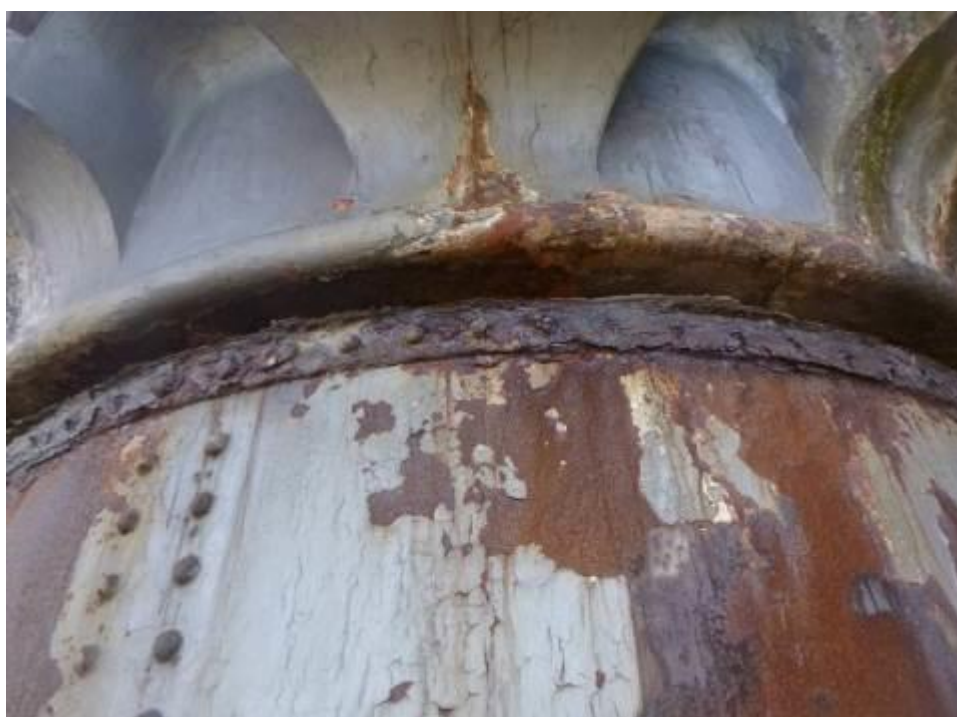
Photograph 40: Area of loss of section to north column of pier 1

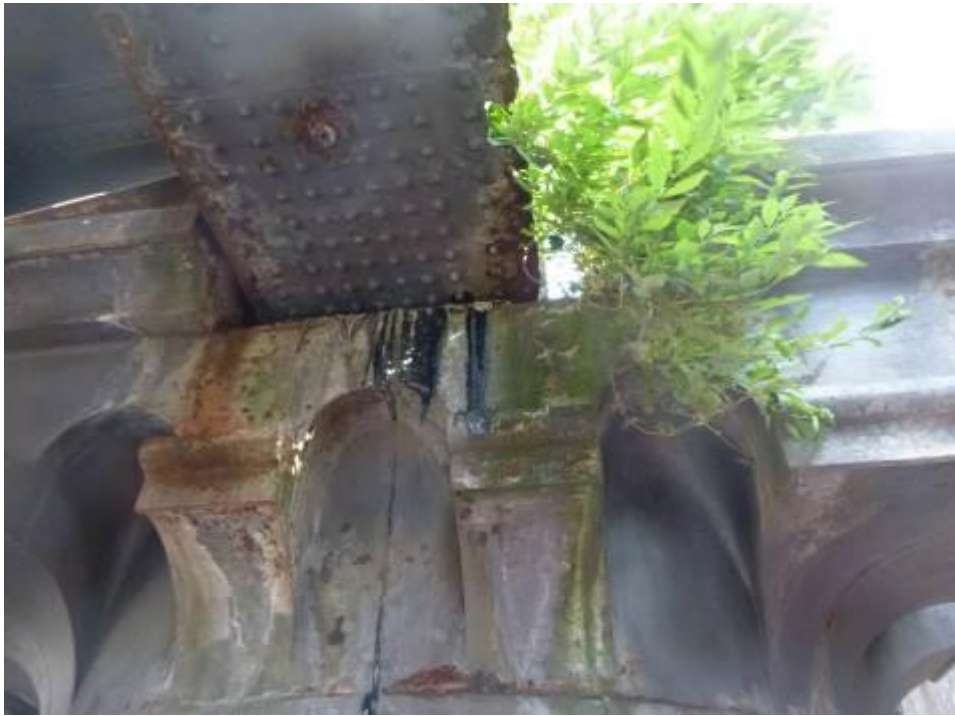
Photograph 41: Area of vegetation growth to south column of pier 1

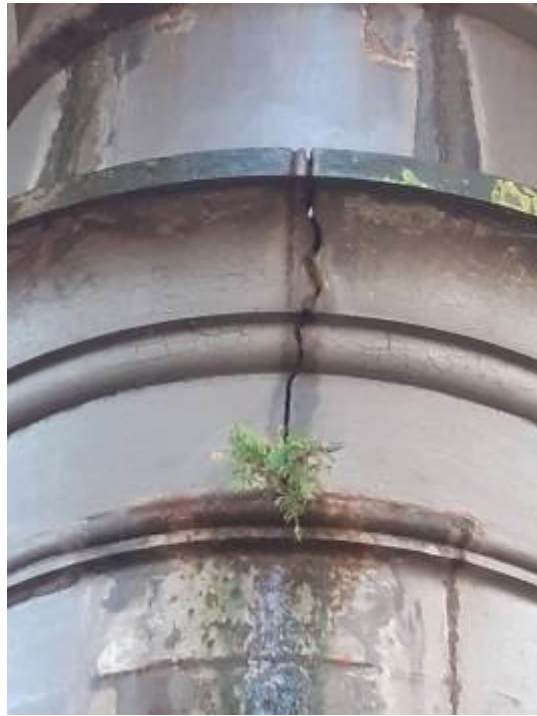
Photograph 43: Vertical fracture & vegetation growth to extra column of pier 1

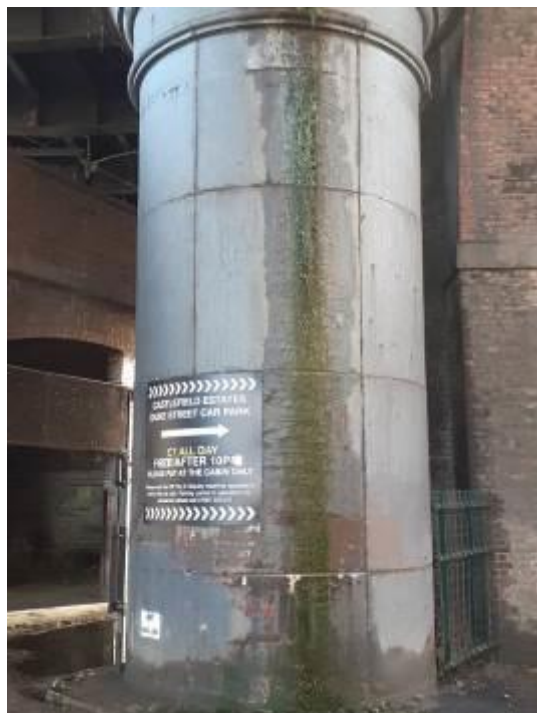
Photograph 44: Area of seepage & algae growth to extra column of pier 1

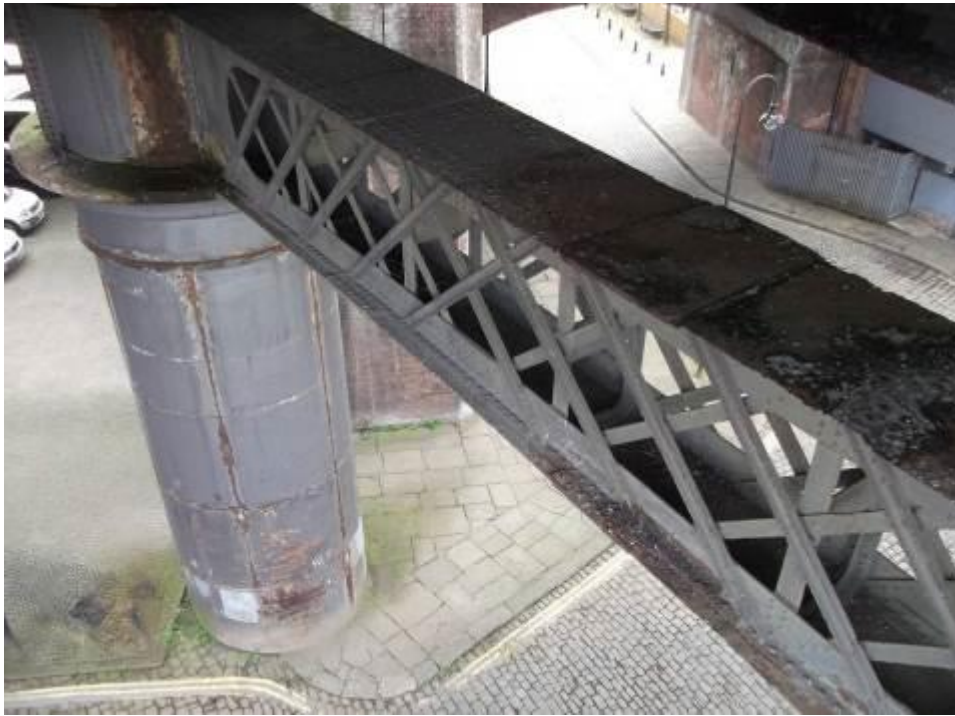
Photograph 45: General view of pier 2, south column and interconnecting truss of pier 2

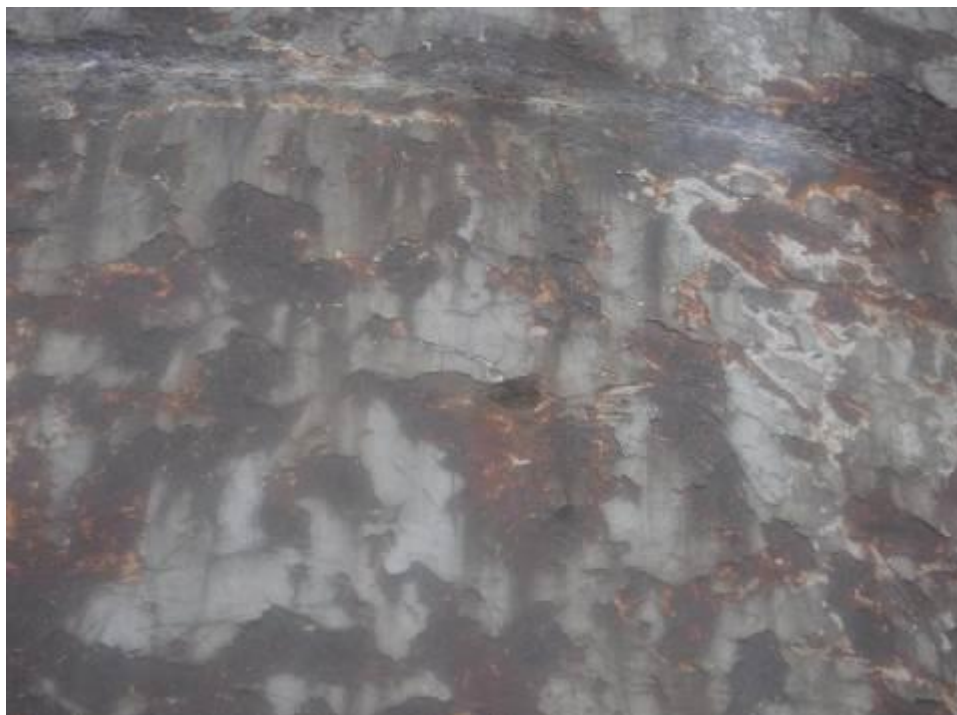
Photograph 47: Area of loss of thickness to north column of pier 2

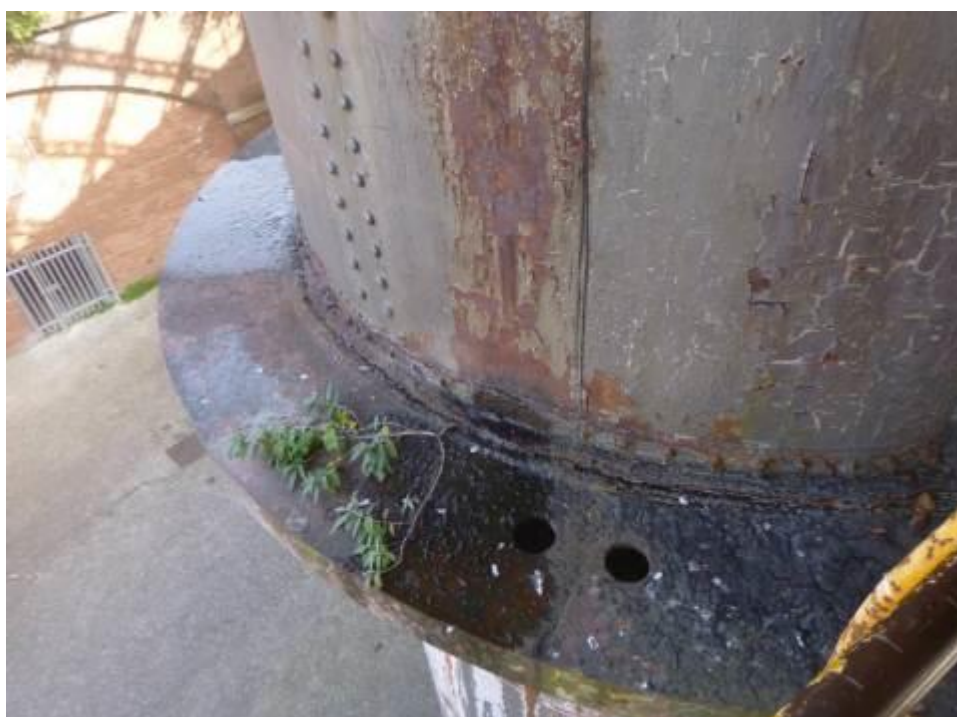
Photograph 48: Area of loss of section to lower angle of north column of pier 2

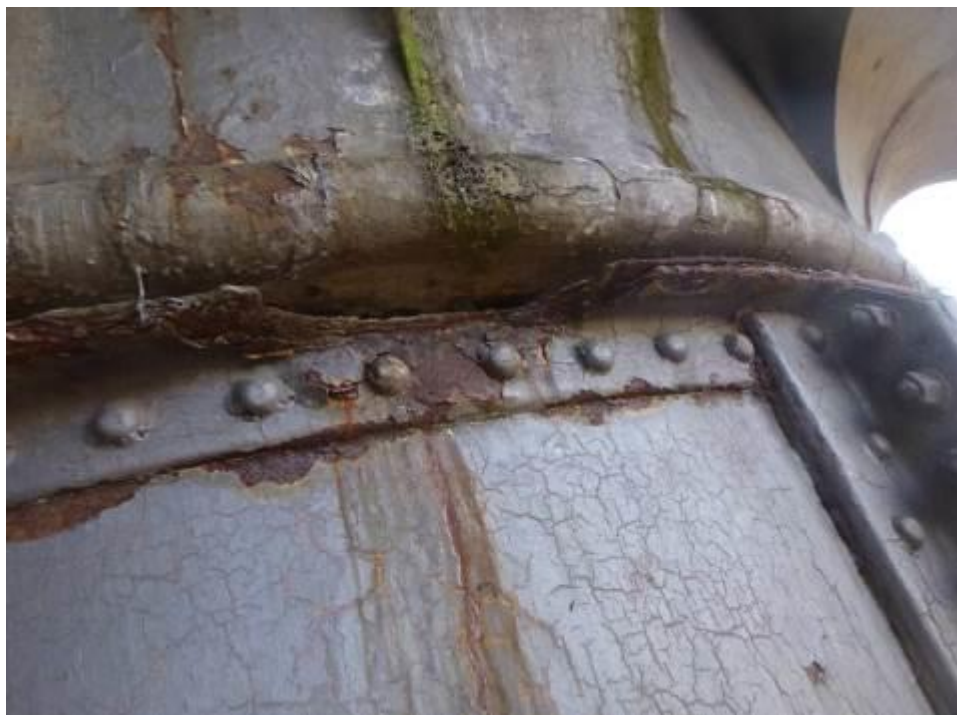
Photograph 49: Area of loss of section to upper angle of north column of pier 2

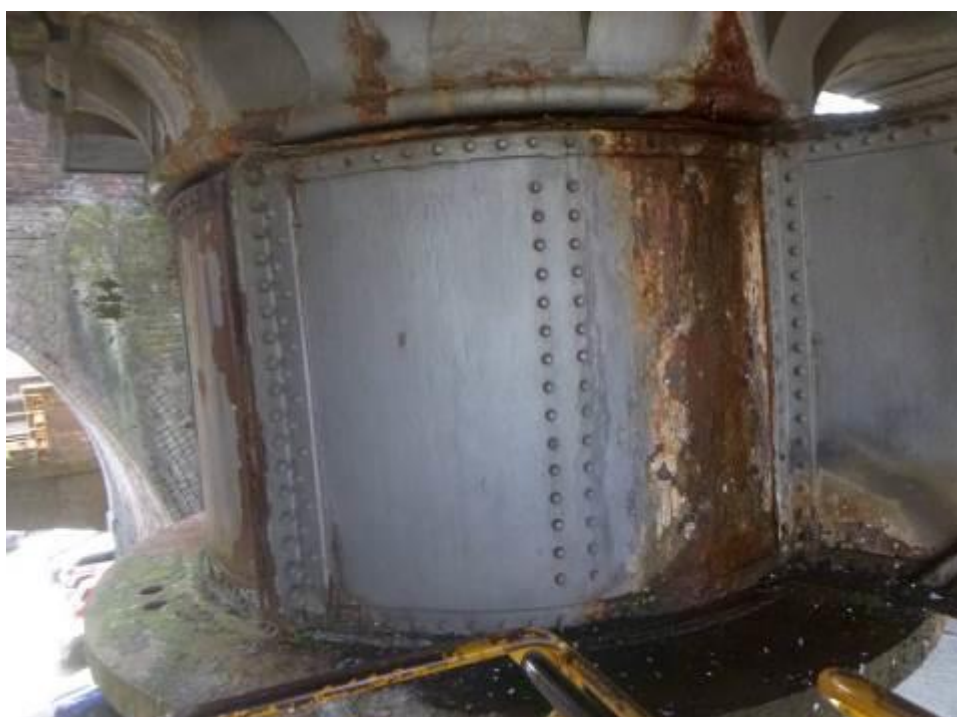
17. Area of loss of section to upper angle, 2000 x 80mm.
18. Area of seepage with associated loss of thickness, 1500 x 400 x up to 3mm. [\(photo 50\)](#)

Photograph 50: Area of seepage & loss of thickness to south column of pier 2

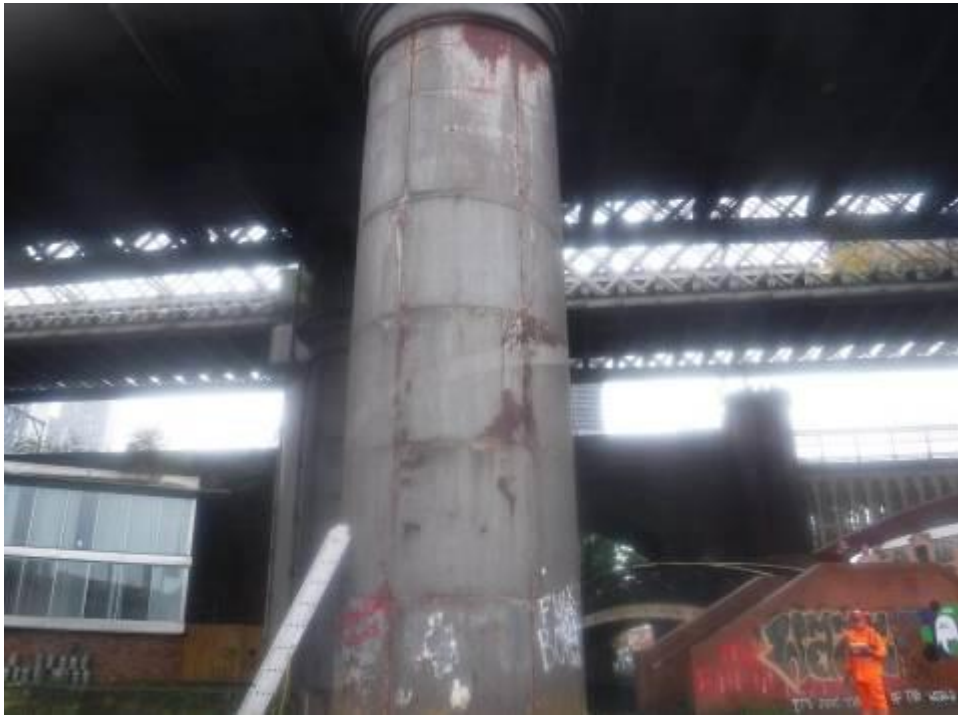
Photograph 53: General view of north column of pier 3

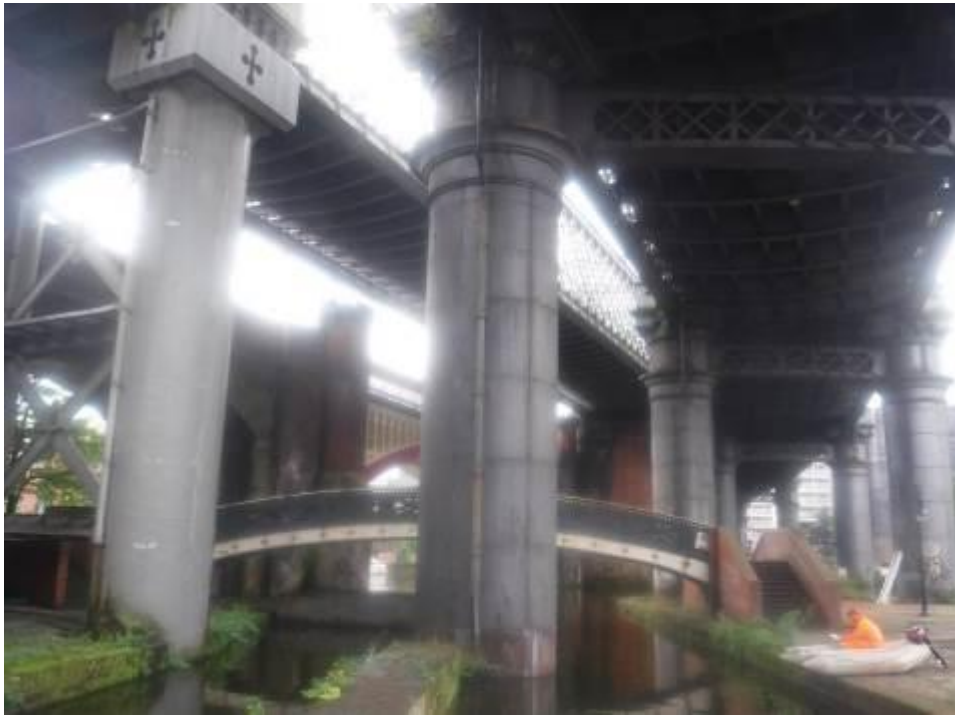
Photograph 55: General view of south column of pier 3

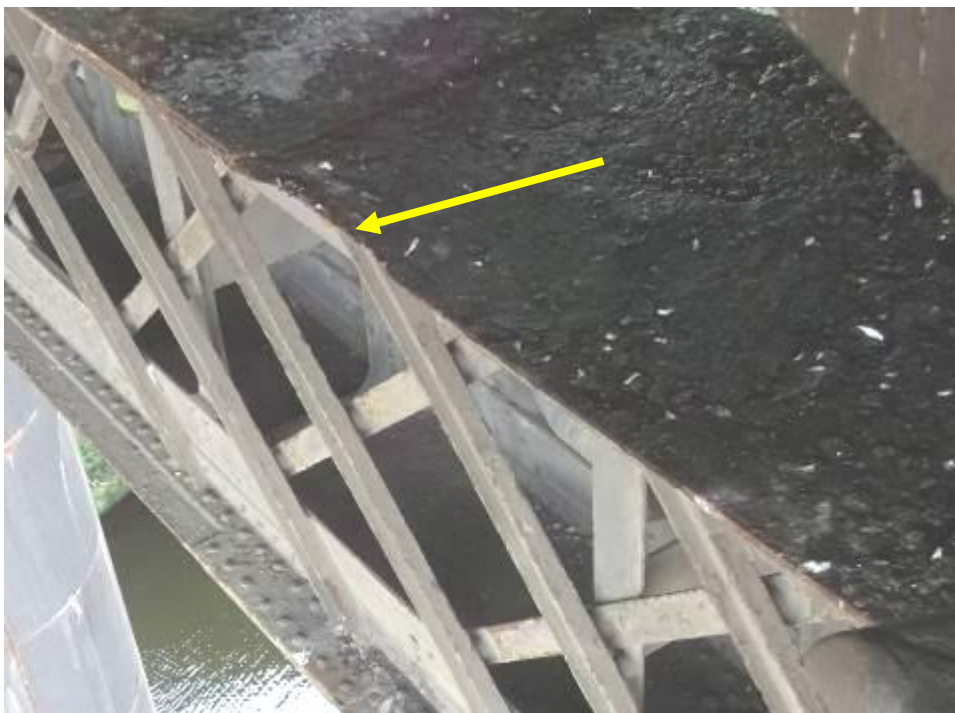
Photograph 56: Area of loss of section to interconnecting truss of pier 3

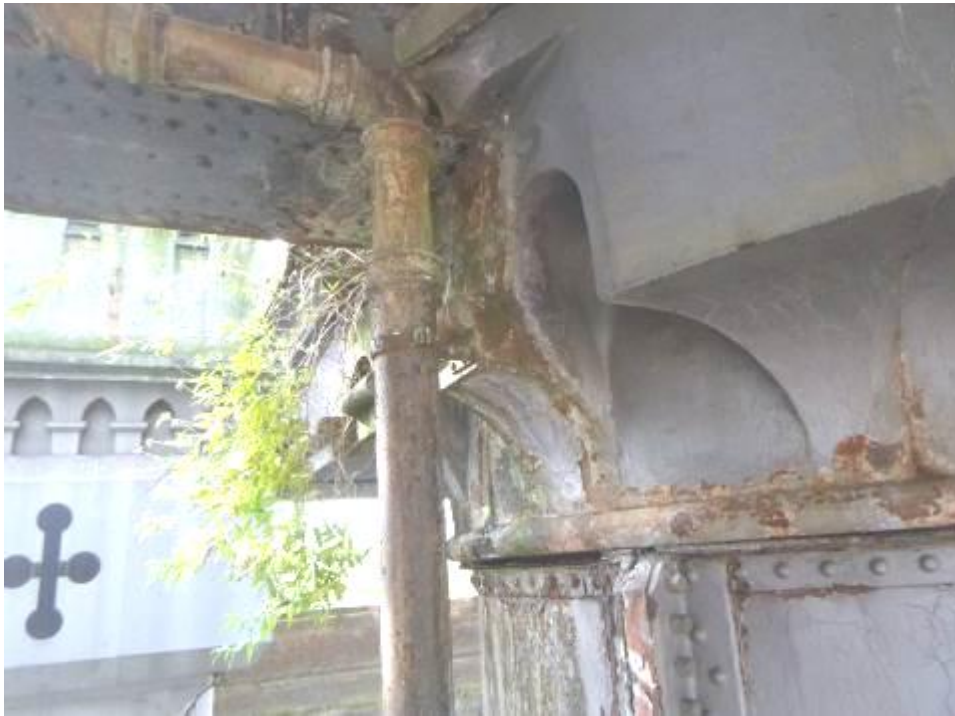
Photograph 59: Area of seepage, vegetation growth & loss of thickness to south column of pier 3

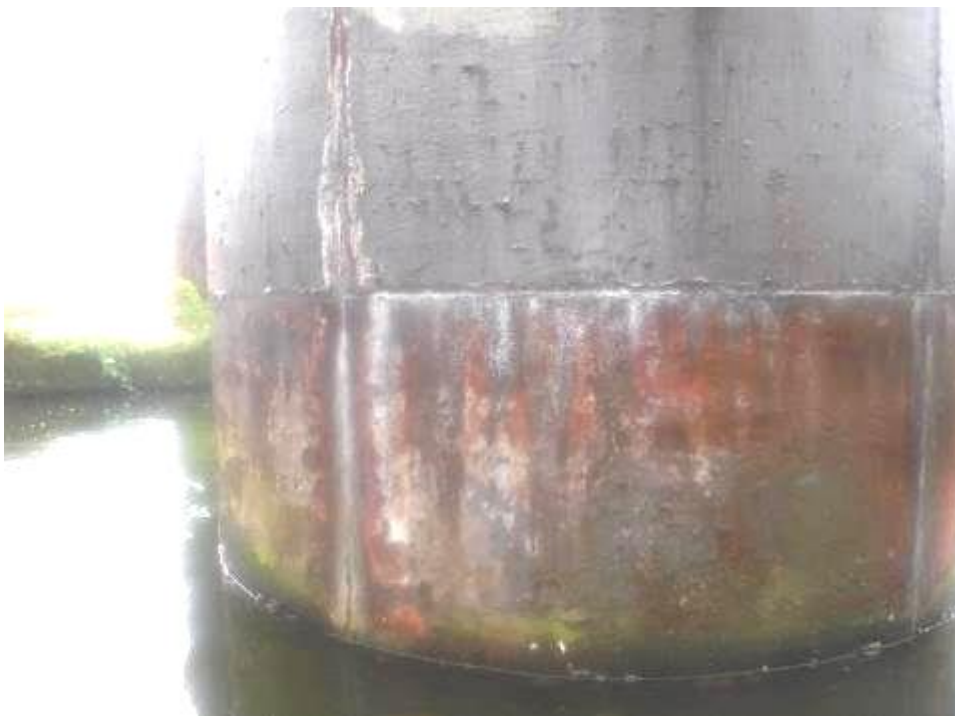
Photograph 60: Area of loss of thickness to south column of pier 3

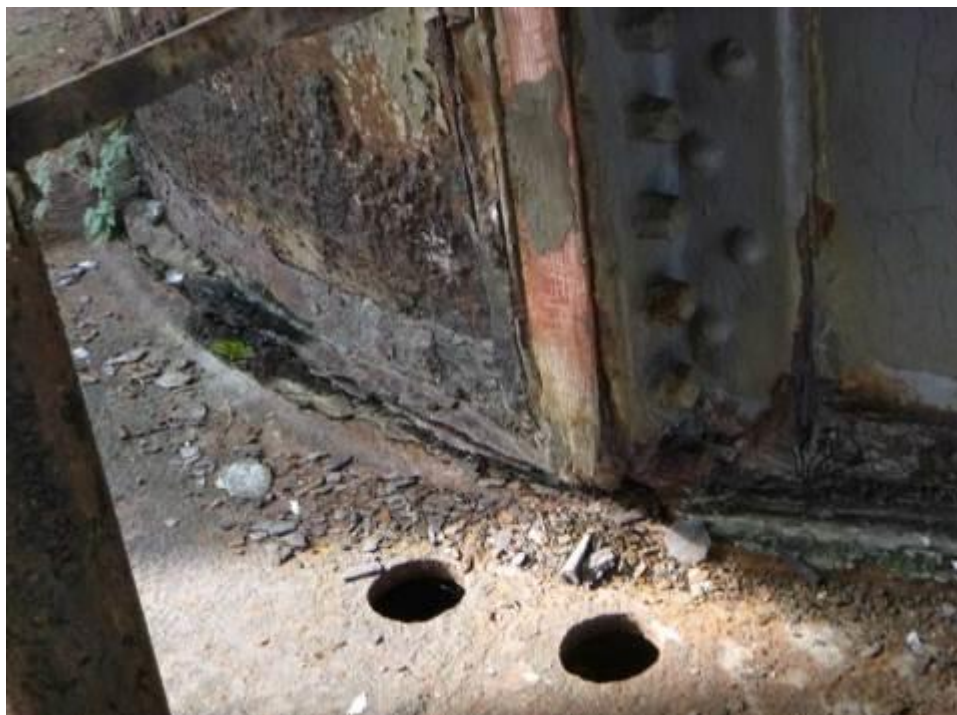
Photograph 61: Area of loss of section to south column of pier 3

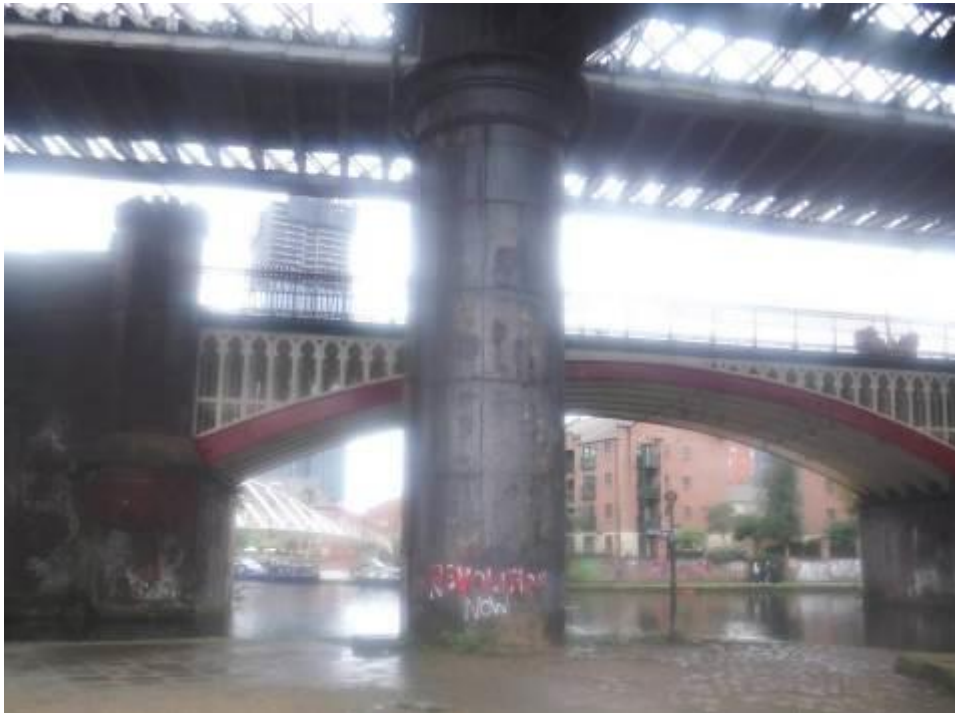
**South column:** [\(photo 63\)](#) There were areas of hairline map cracking to paintwork, paint loss and surface corrosion throughout, especially to panel joints.

Photograph 63: General view of south column of pier 4
