| ELR: MAJ | Structure No: 289 | Mileage: | Examination date: 07/09/2020 |
| Name: Castlefield Viaduct | | | Type: Viaduct |
| Carrying/Over: Disused rail / Canal, rail, road & land | | | No. of spans: 8 |

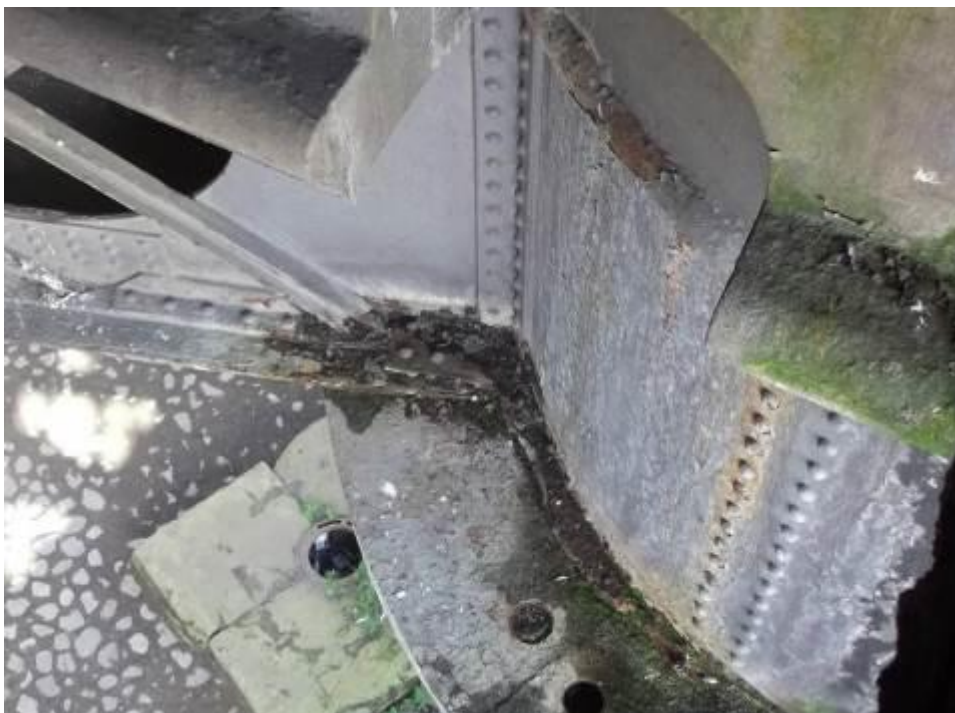
**Interconnecting truss:** The truss was in fair condition with spot areas of paint loss and surface corrosion. There was an area of loss of thickness to the lower east flange at the connection point to the north column, 300 x 200 x up to 4mm. [\(photo 64\)](#)

Photograph 64: Area of loss of thickness to interconnecting truss of pier 4

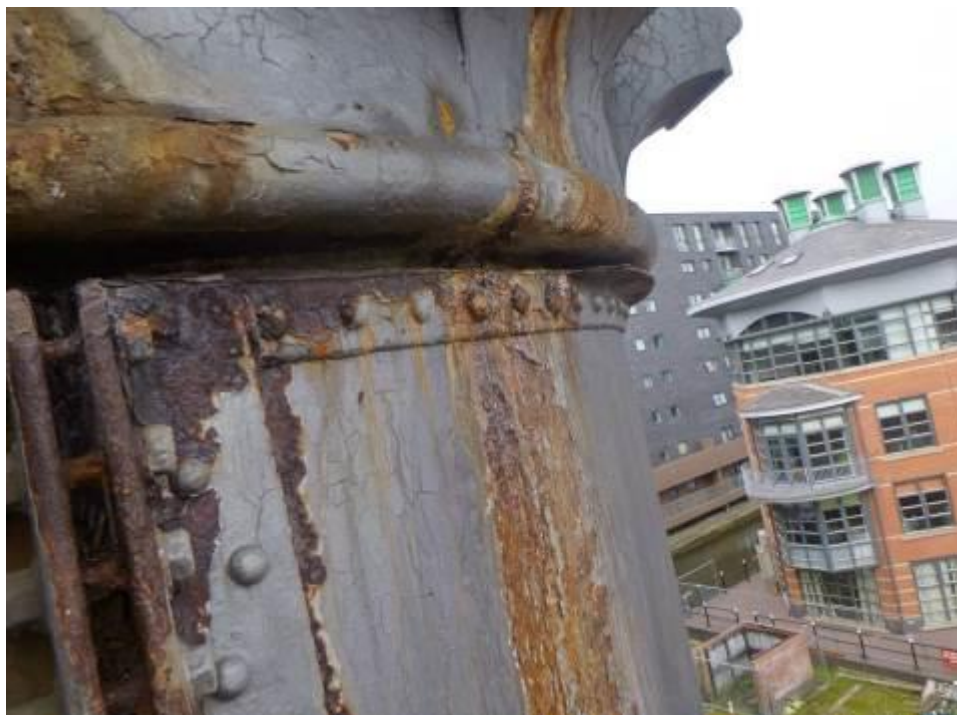
1. Area of loss of section to upper angle, 3000 x 80mm. [\(photo 65\)](#)
2. Area of loss of thickness to lower angle, 3000 x 80 x up to 6mm, with loss of section, 2000 x 60mm.

Photograph 65: Area of loss of section to upper angle of north column of pier 4

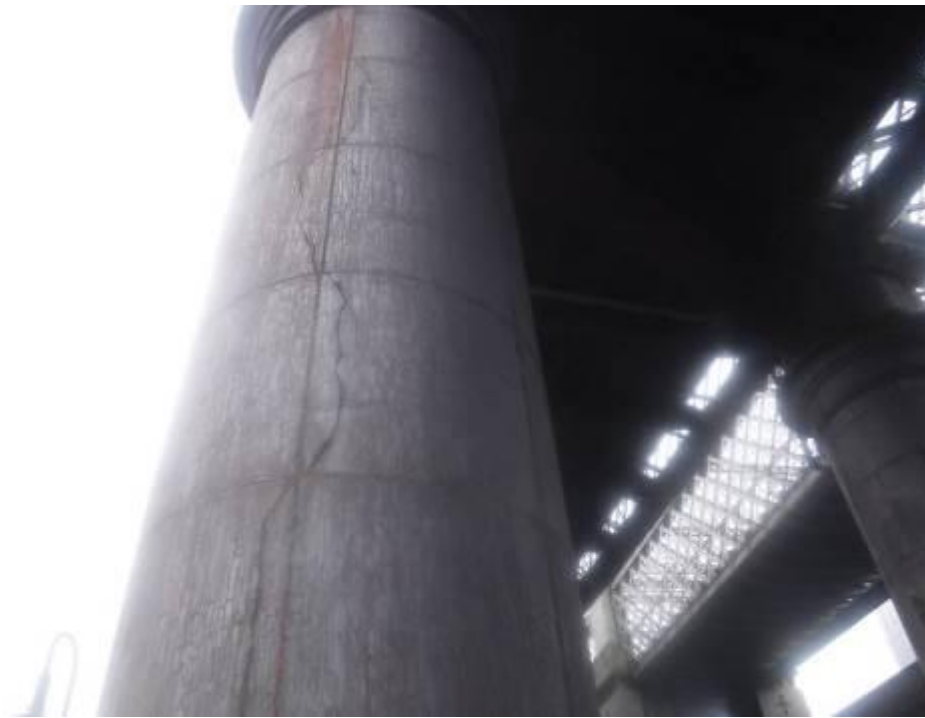
13. Area of seepage and loss of thickness, 1500 x 300 x up to 3mm. [\(photo 68\)](#)
14. Vertical fracture, 2000 x up to 2mm. [\(photo 69\)](#)
15. Vertical fracture, 2000 x up to 2mm. [\(photo 69\)](#)

16. Vertical fracture, 2000 x up to 2mm. [\(photo 69\)](#)
17. Vertical fracture, 2000 x up to 2mm. [\(photo 69\)](#)
18. Vertical fracture, 2000 x up to 2mm. [\(photo 69\)](#)

Photograph 69: Vertical fractures to north column of pier 4

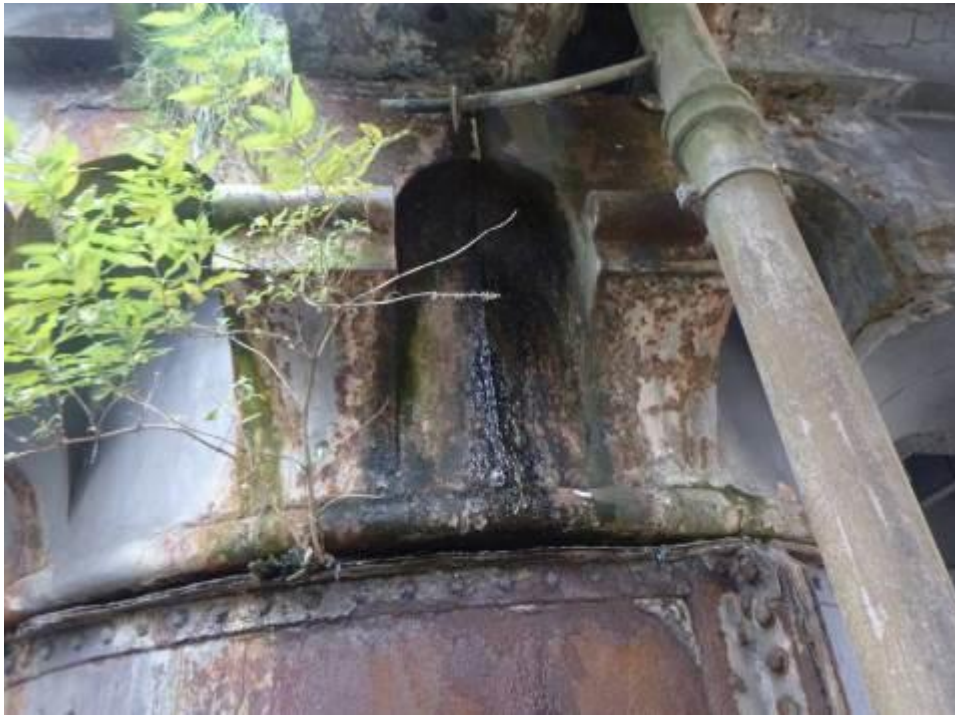
Photograph 73: Area of seepage & vegetation growth to south column of pier 4

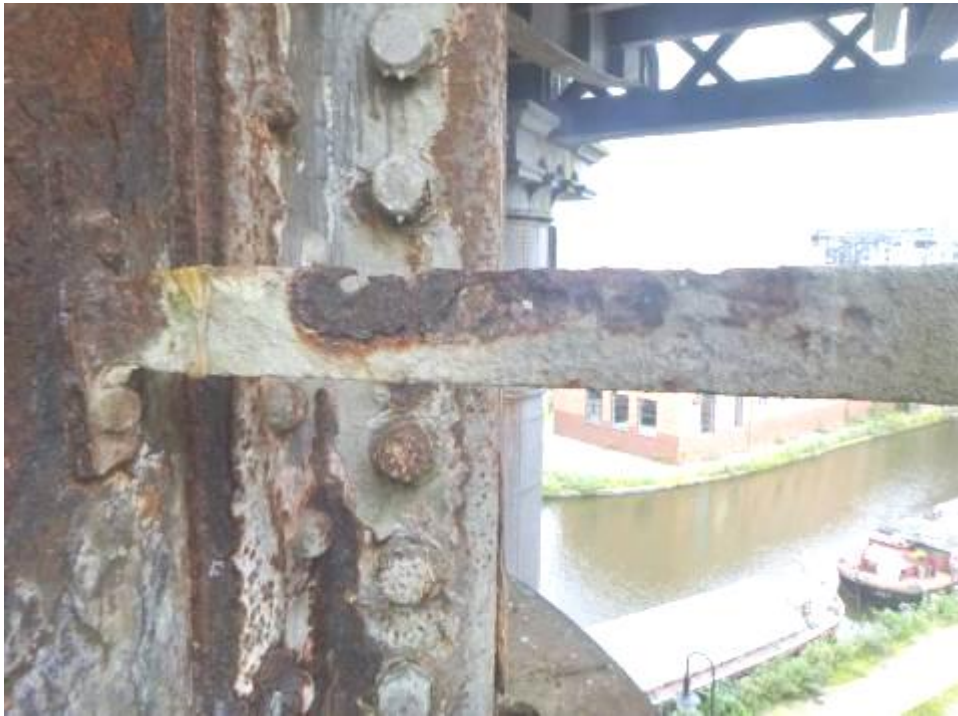
- 23. Vertical fracture, 1800 x up to 2mm. [\(photo 71\)](#)
- 24. Vertical fracture, 900 x up to 2mm. [\(photo 71\)](#)
- 25. Vertical branched fracture, 2000 x up to 2mm. [\(photo 72\)](#)
- 26. Vertical hairline fracture, 400mm in length.
- 27. Vertical fracture, 600 x 1mm.
- 28. Area of loss of thickness to upper angle, 4000 x 80 x up to 3mm, with loss of section 2000 x 70mm.
- 29. Vertical fracture, 2000 x 1mm.
- 30. Area of seepage and spot vegetation growth. [\(photo 73\)](#)
- 31. Area of loss of thickness, 1500 x 1000 x up to 5mm.
- 32. Area of loss of thickness, 100 x 120 x up to 2mm. [\(photo 74\)](#)
- 33. Vertical fracture, 2000 x 1mm. [\(photo 74\)](#)
- 34. Area of loss of thickness to drainpipe bracket, 80 x 30 x up to 5mm, with loss of section, 60 x 15mm. [\(photo 75\)](#)

Photograph 75: Area of loss of thickness to drainpipe bracket of south column of pier 4

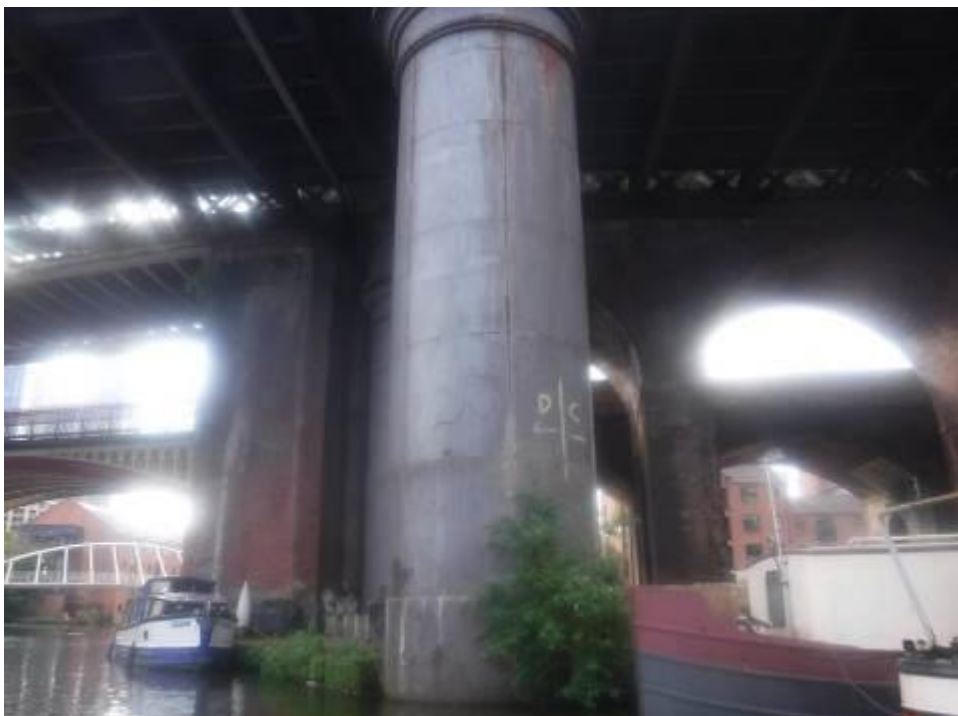
**North column:** [\(photo 76\)](#) There were areas of hairline map cracking to paintwork, paint loss and surface corrosion throughout, especially to panel joints.

Photograph 76: General view of north column of pier 5

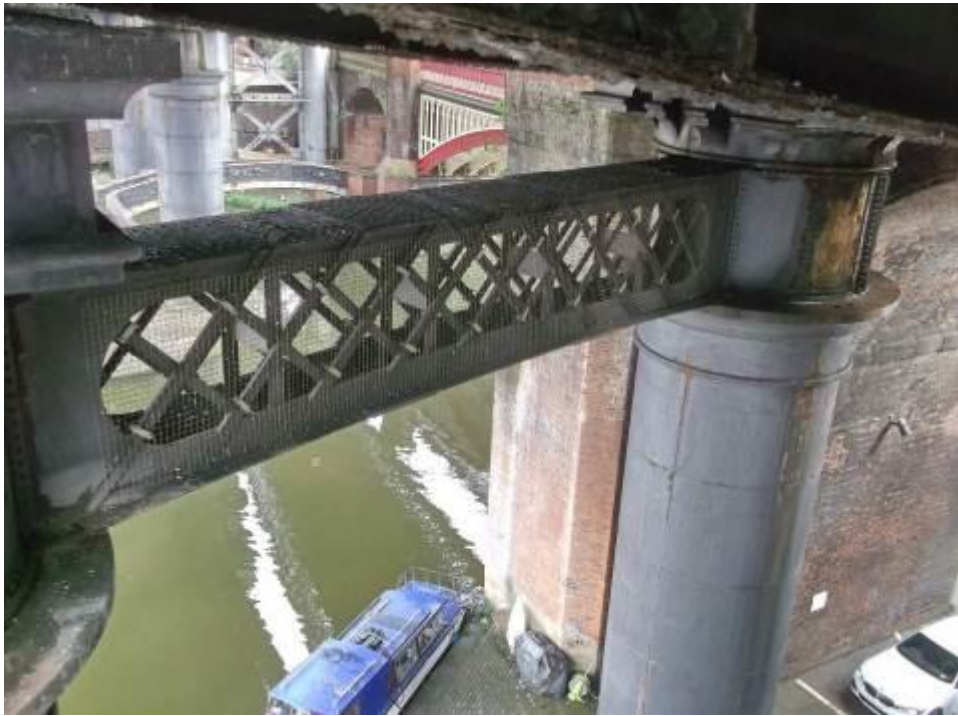
**Interconnecting truss:** [\(photo 77\)](#) The truss was in fair condition with spot areas of paint loss and surface corrosion. There were 4No. areas of loss of thickness to the web at connection points with both pier columns, each 600 x 150 x 1mm.

Photograph 77: General view of interconnecting truss of pier 5

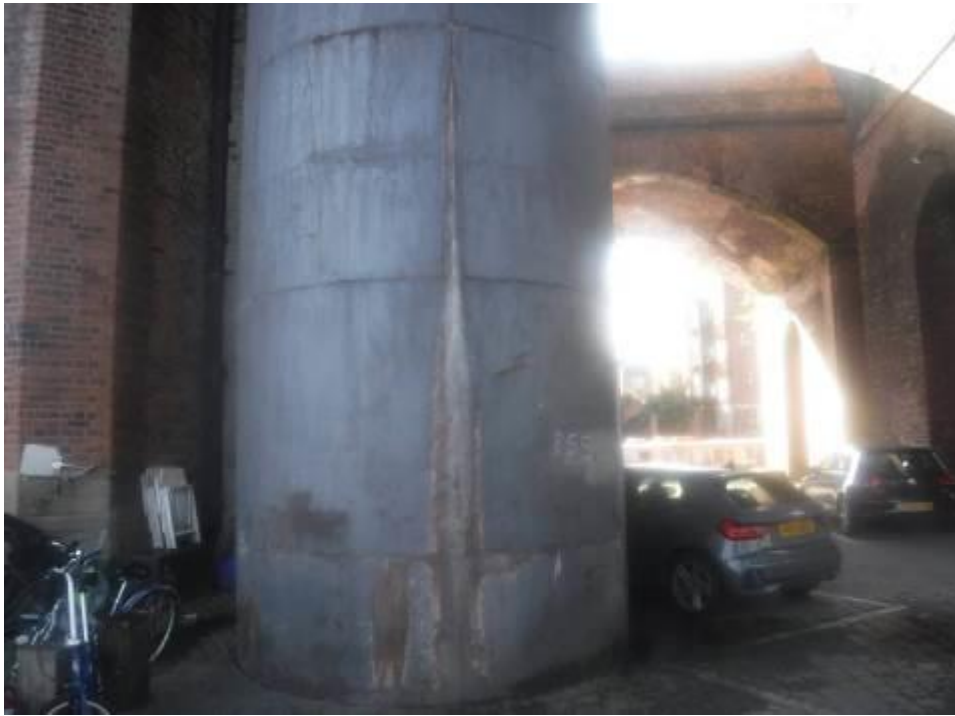
1. Horizontal hairline fracture, 1000mm in length.
2. Vertical fracture, 5000 x up to 2mm. [\(photo 78\)](#)
3. Vertical fracture, 5000 x 1mm.
4. Area of loss of thickness, 5000 x 200 x 1mm. [\(photo 79\)](#)
5. Diagonal hairline fracture, 1200mm in length.
6. Area of loss of thickness, 5000 x 200 x 1mm.

Photograph 79: Area of loss of thickness to south column of pier 5

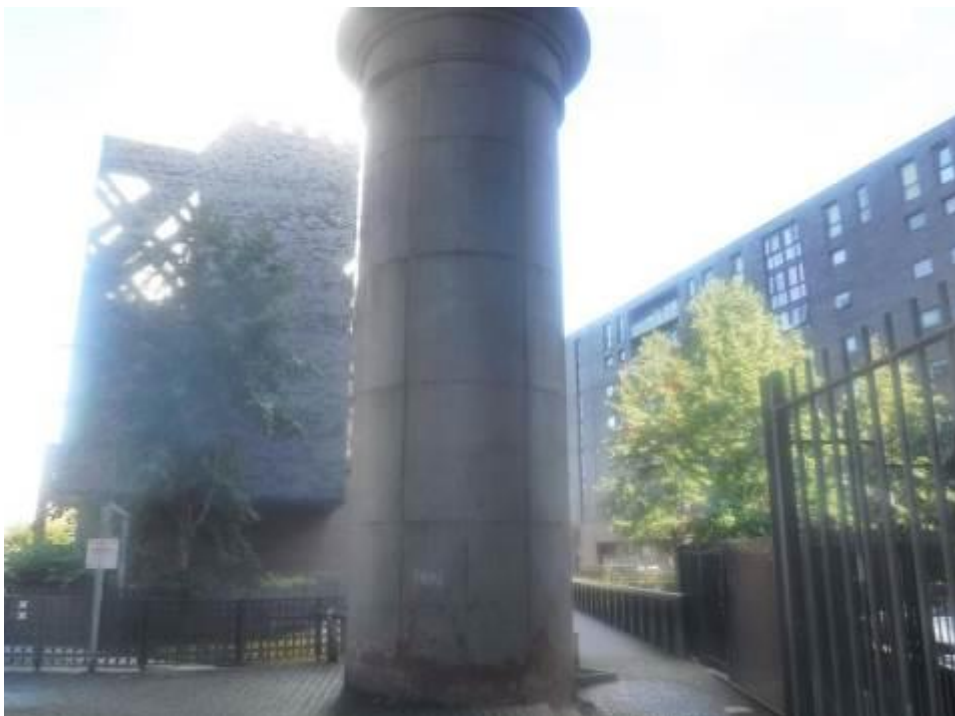
**North column:** [\(photo 80\)](#) There were areas of hairline map cracking to paintwork, paint loss and surface corrosion throughout, especially to panel joints.

Photograph 80: General view of north column of pier 6

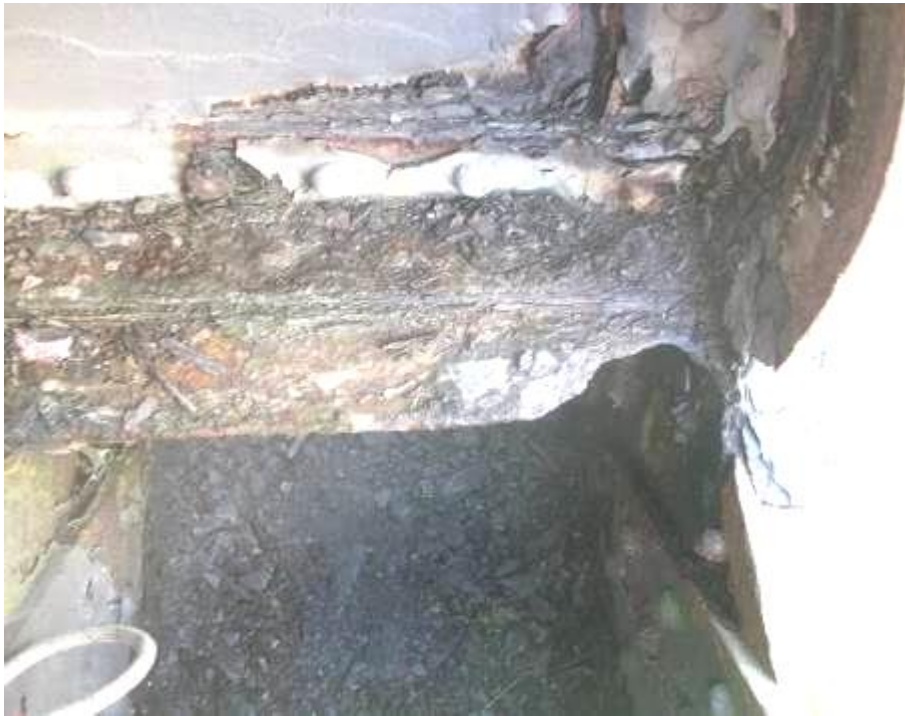
**Interconnecting truss:** The truss was in fair condition with spot areas of paint loss and surface corrosion. There were 2No. areas of loss of thickness, 300 x 100 x up to 4mm, with loss of section, 40 x 20mm, to the bottom flanges at each column. [\(photo 81\)](#)

Photograph 81: Area of loss of thickness to interconnecting truss of pier 6

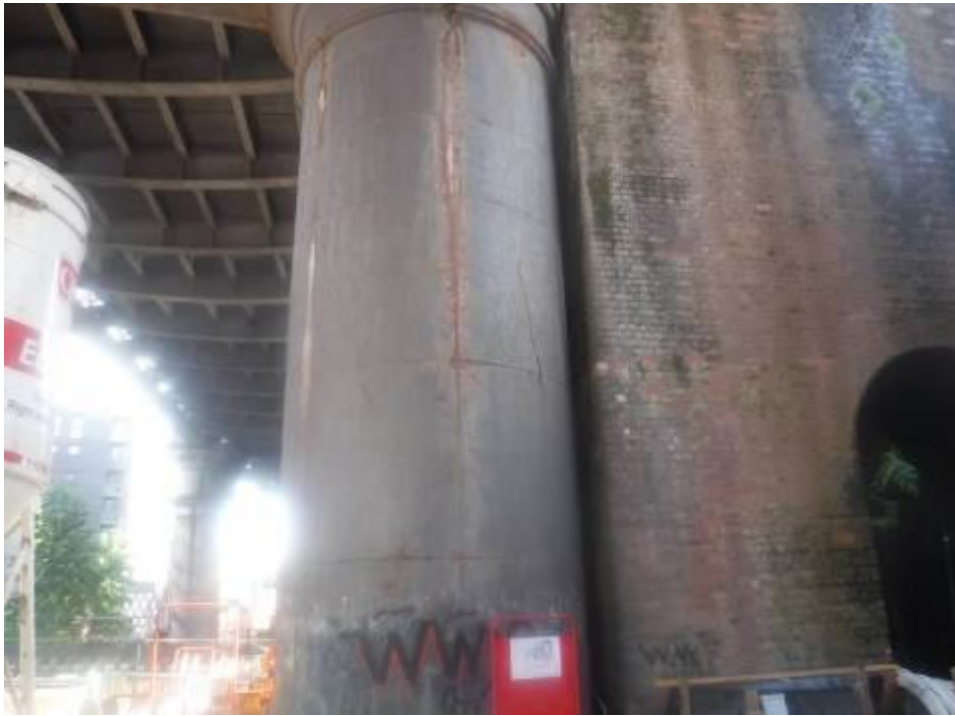
**South column:** [\(photo 83\)](#) There were areas of hairline map cracking to paintwork, paint loss and surface corrosion throughout, especially to panel joints. There was light, non-offensive graffiti to the base of the column.

Photograph 83: General view of south column of pier 7

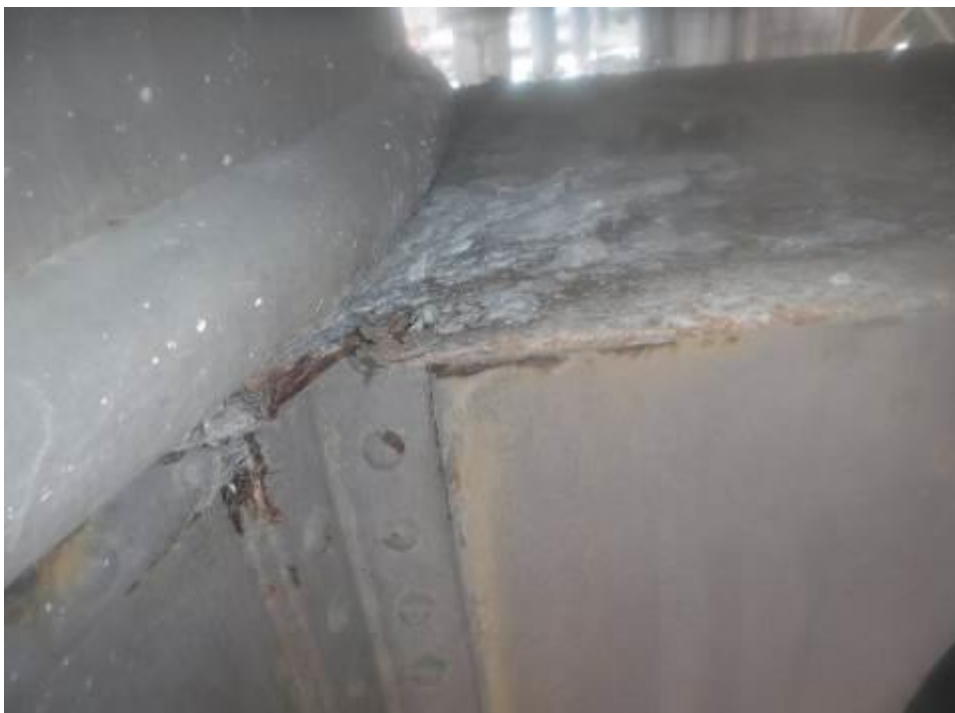
**Interconnecting truss:** The truss was in fair condition with spot areas of paint loss and surface corrosion. There was an area of loss of thickness to the lower west flange at the connection point with the north column, 300 x 200 x up to 8mm, with loss of section 150 x 100mm. There was an area of loss of section to the upper west flange at the connection point with the north column, 100 x 100mm. [\(photo 84\)](#) There was an area of loss of thickness to the lower west flange at the connection point with the south column, 450 x 200 x up to 3mm. There was an area of loss of section to the upper west flange at the connection point with the south column, 300 x 30mm.

Photograph 84: Area of loss of section to interconnecting truss of pier 7

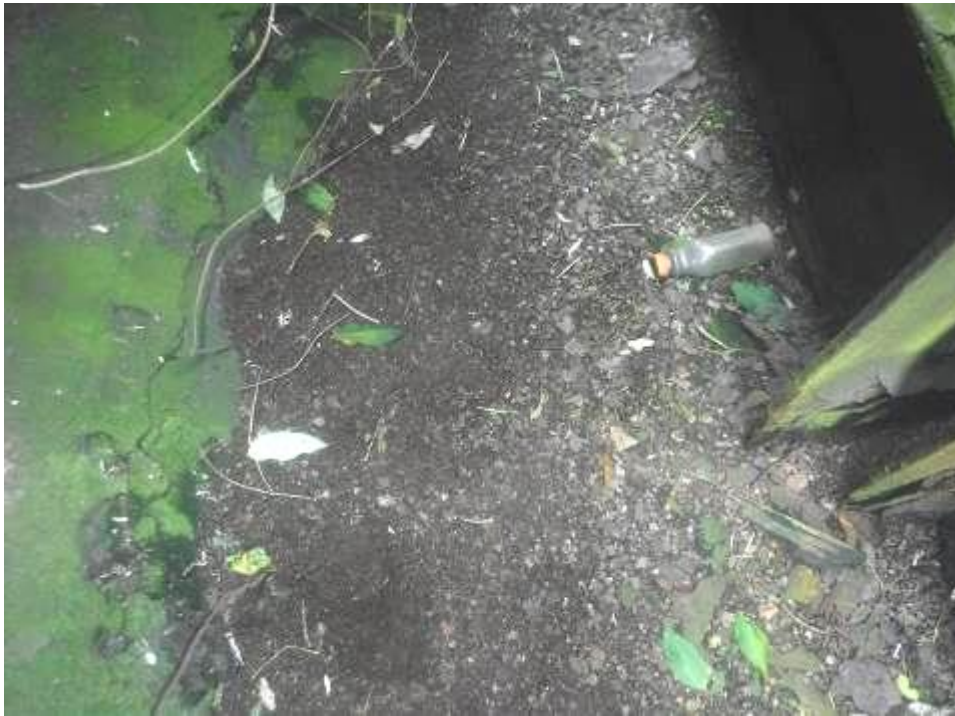
The castle façades to the tops of the piers were in fair condition with spot areas of paint loss and surface corrosion throughout. **(photos 89, 90 & 91)** The south column façades were in close proximity to the adjacent Metrolink bridge and OLE. **(92)** There were spot areas of loss of thickness of up to 2mm and rust jacking of up to 15mm to the panel joints. **(photo 93)** Tie bar connections were in fair condition. **(photo 94)** There was thick debris to the tops of the pillars within the façades. **(photo 95)**

Photograph 95: Typical debris to tops of piers within castle façades

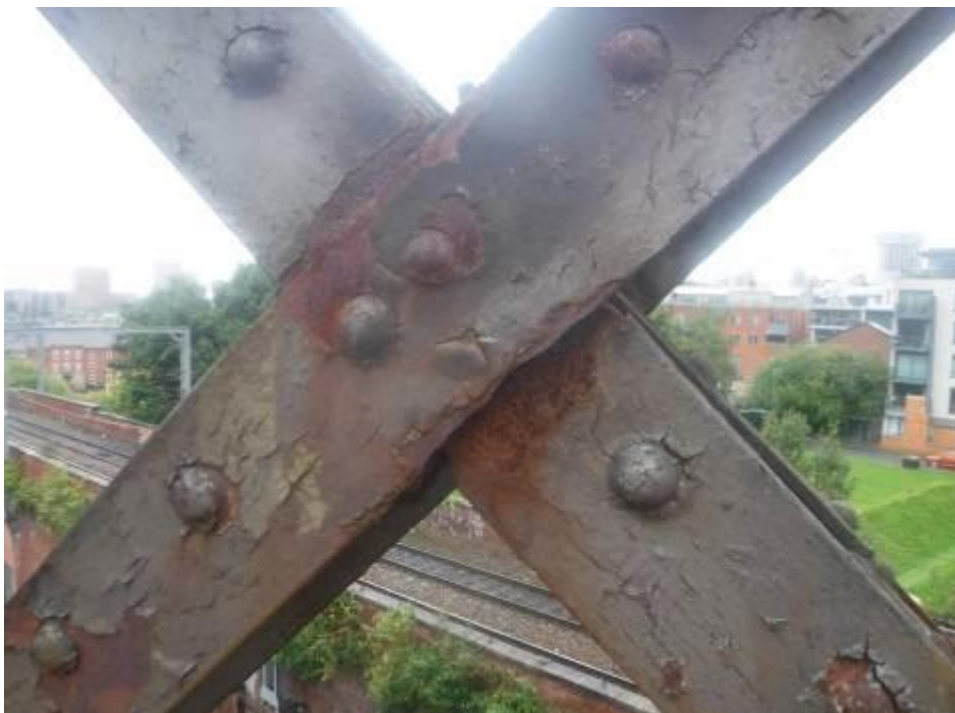
- = Where the diagonal members met a loss of thickness of 5-8mm was found over a length of 30-50mm at all four points. **(photo 96)**
- = 5-20% loss of section to the edges of the diagonal braces which connect the diagonal members. This was generally over a length of 100-200mm.

Photograph 96: Typical loss of thickness to truss section diagonal member joints

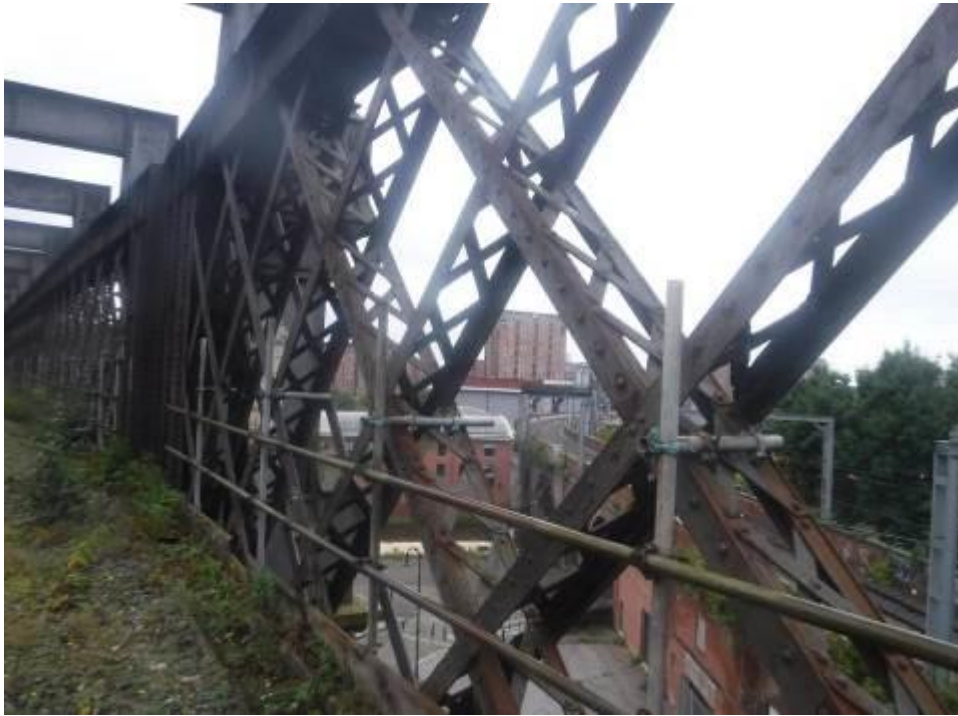
Photograph 99: General view of north truss of span 2

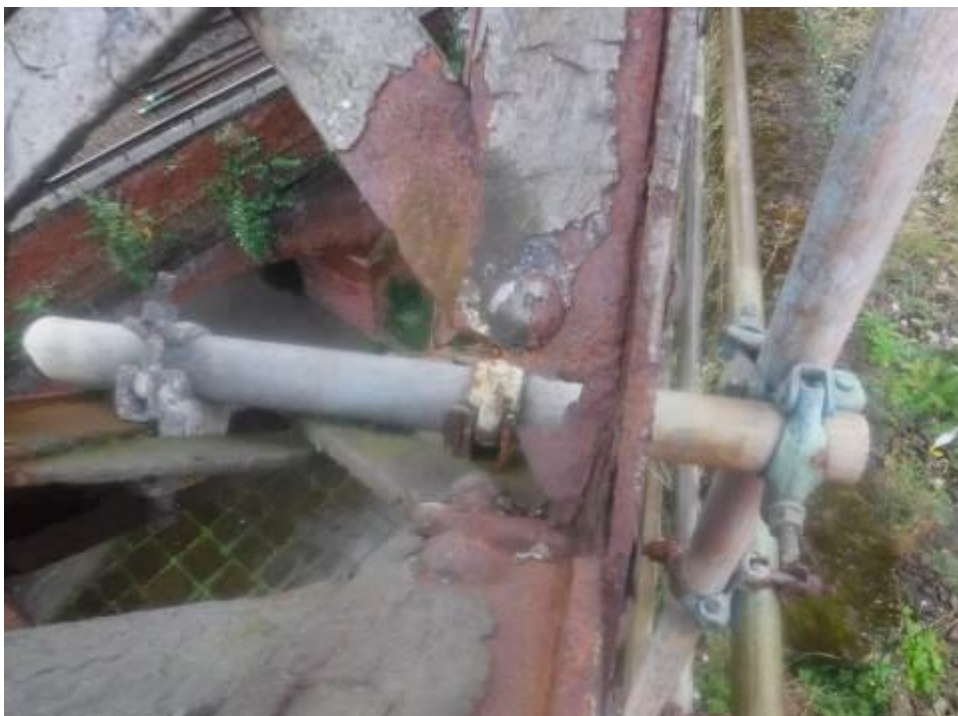
Photograph 100: Loss of section to diagonal member of north truss of span 2

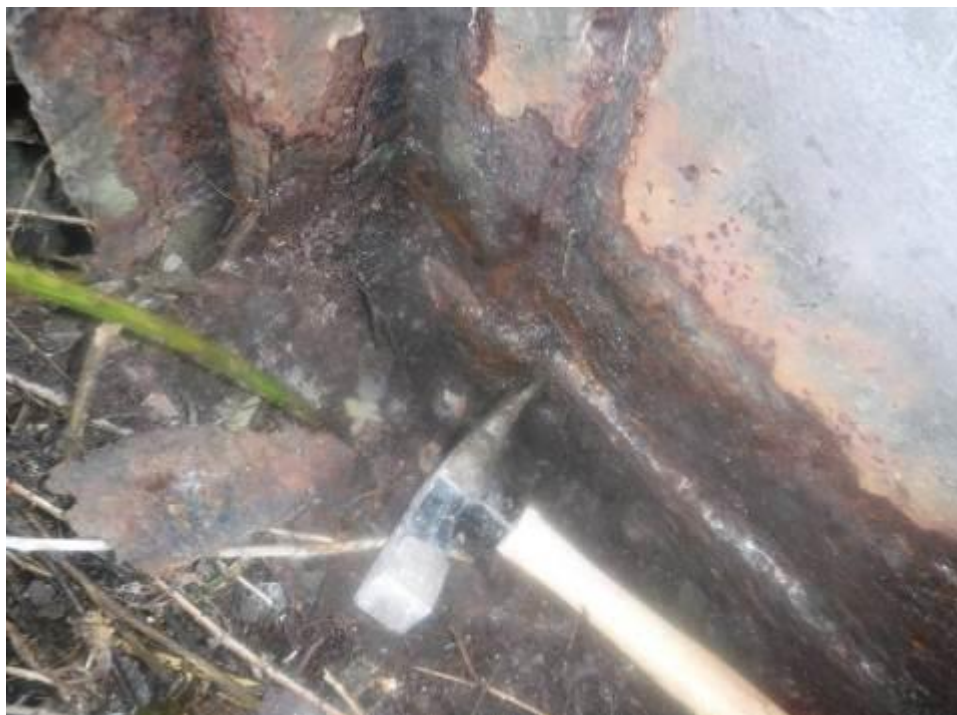
Photograph 101: Loss of thickness / delamination to base of end plate of north truss of span 2

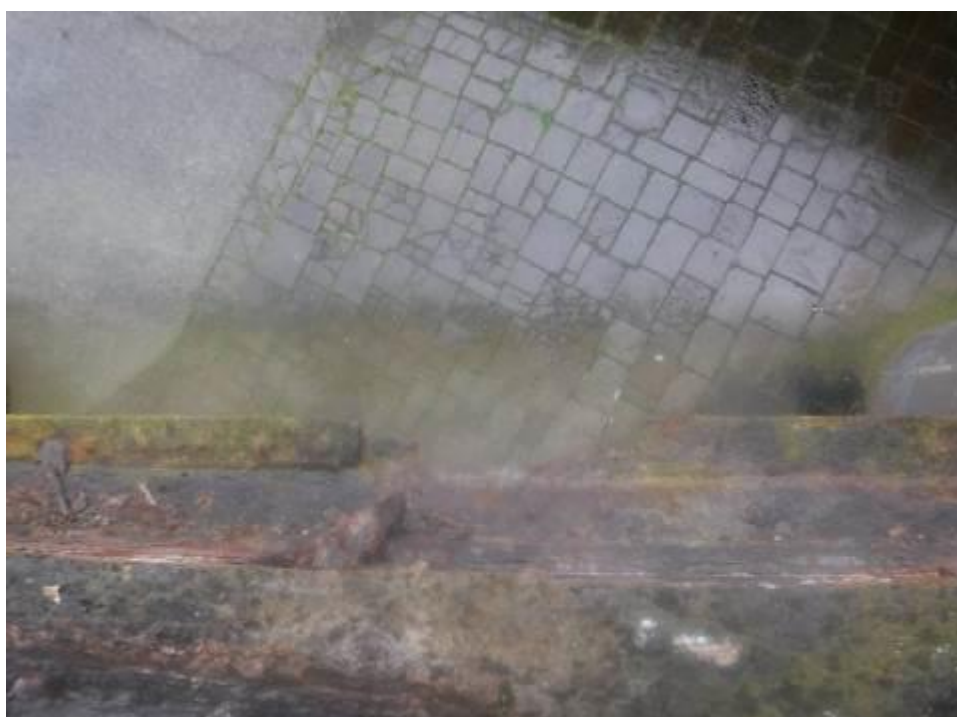
Photograph 102: Loss of section to bottom boom, bottom flange of north truss of span 2

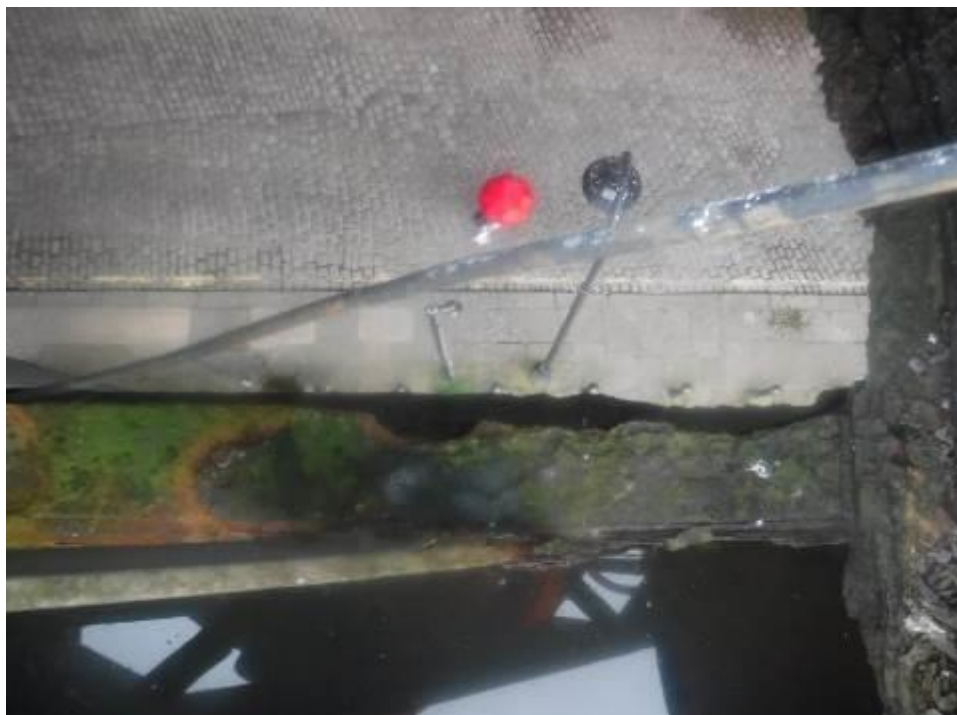
Photograph 103: Loss of section to bottom boom, top flange to north truss of span 2

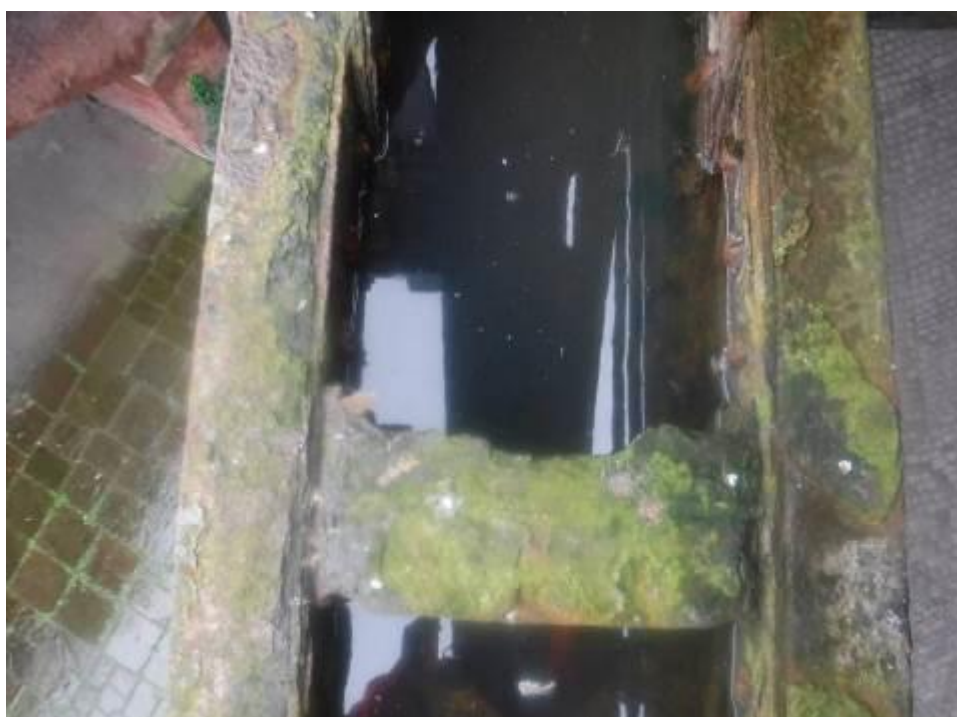
Photograph 104: Loss of section to bottom boom internal stiffener of north truss of span 2

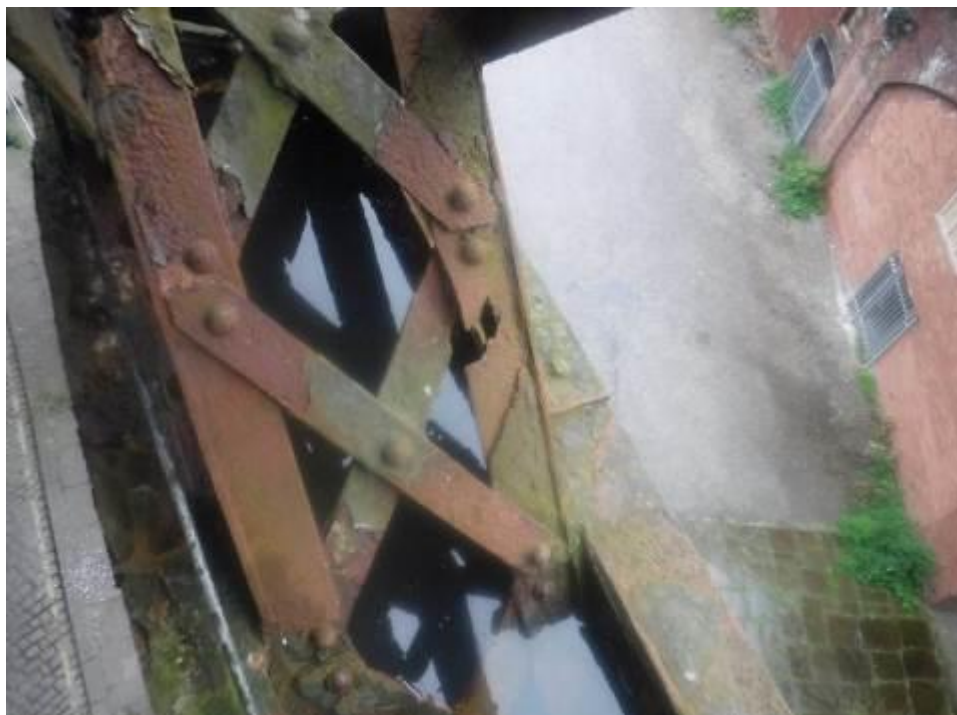
Photograph 105: Loss of section to diagonal bracing of north truss of span 2

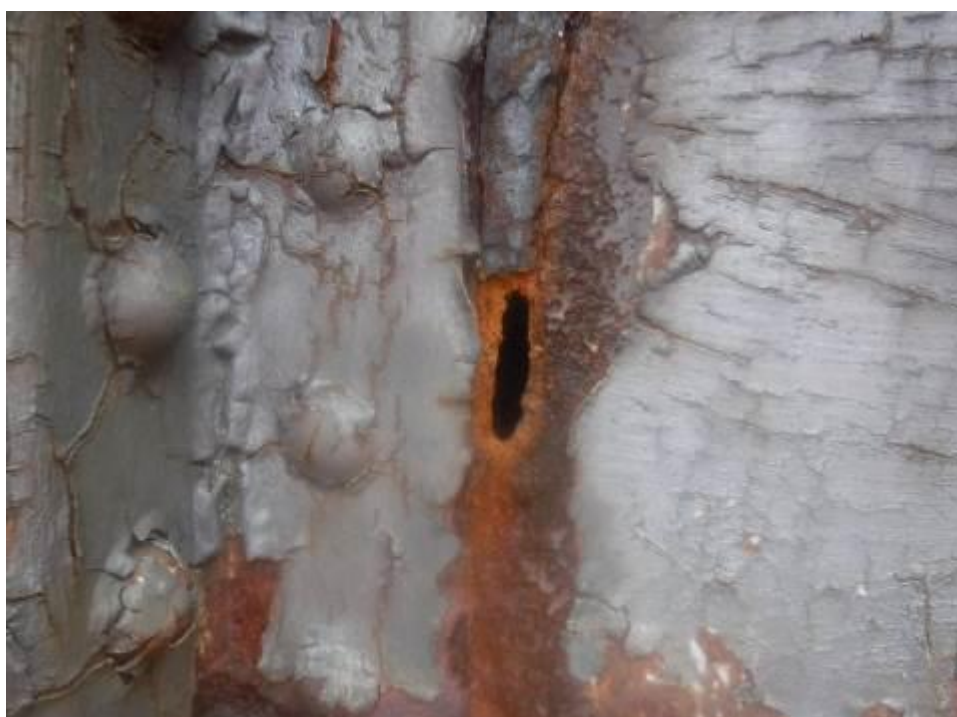
Photograph 106: Loss of section to vertical section plate of north truss of span 2

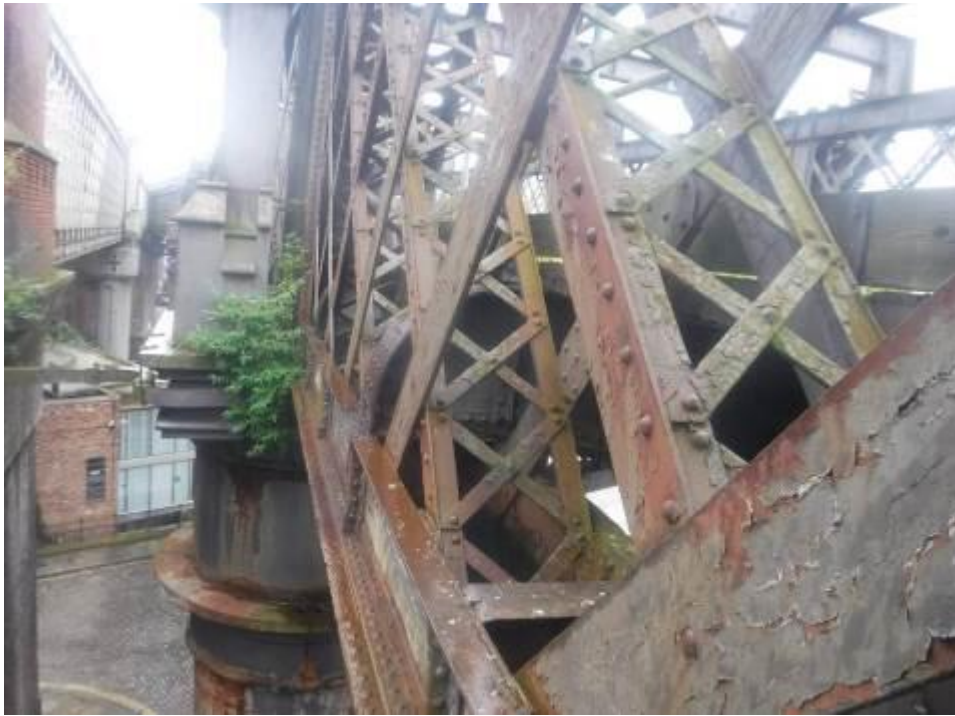
Photograph 107: General view of south truss of span 2

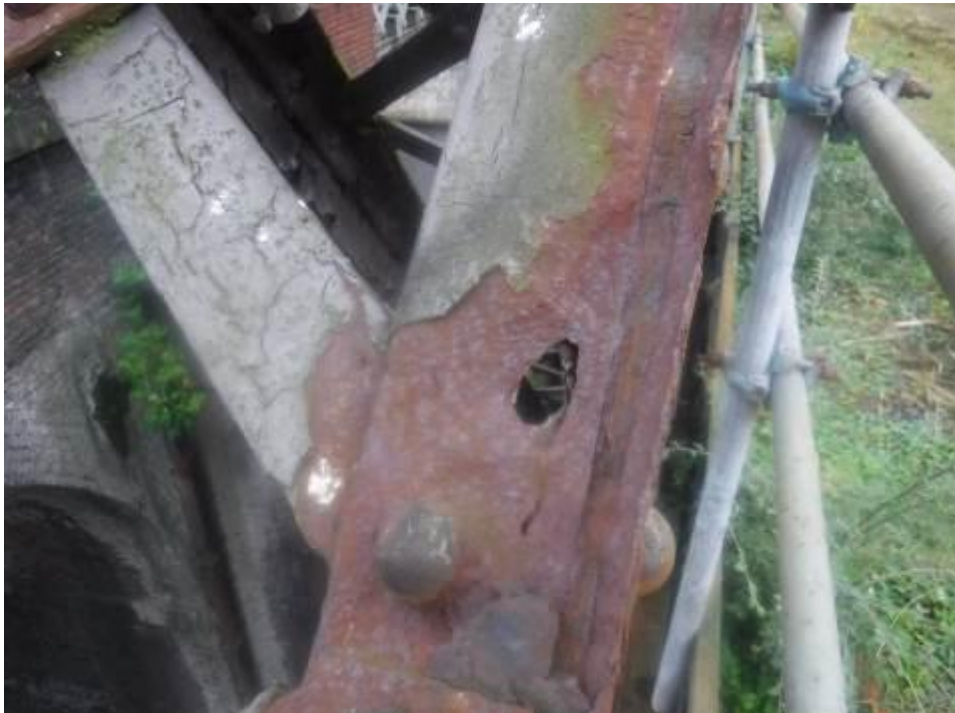
Photograph 109: Loss of section to diagonal bracing of south truss of span 2

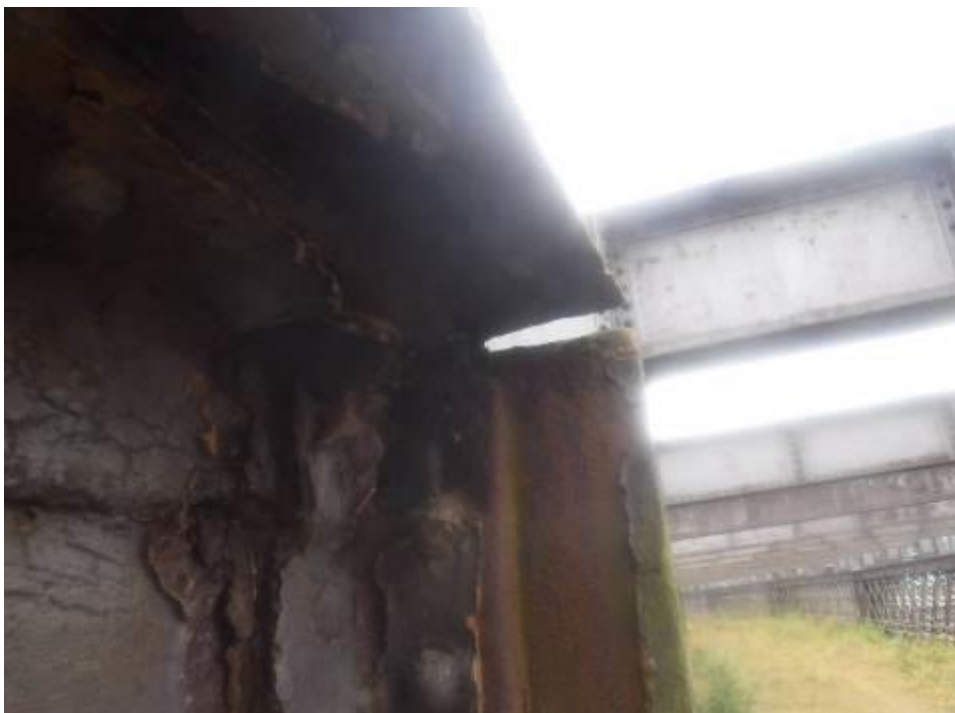
Photograph 110: Split to end plate corner of south truss of span 2

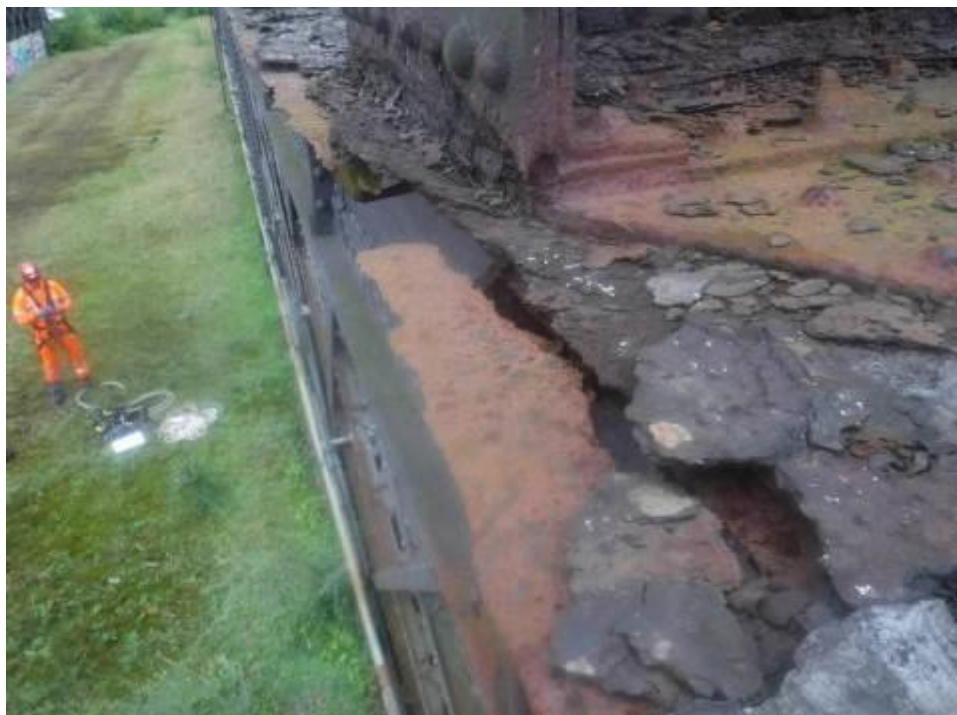
Photograph 111: Loss of section to top boom, top flange of south truss of span 2

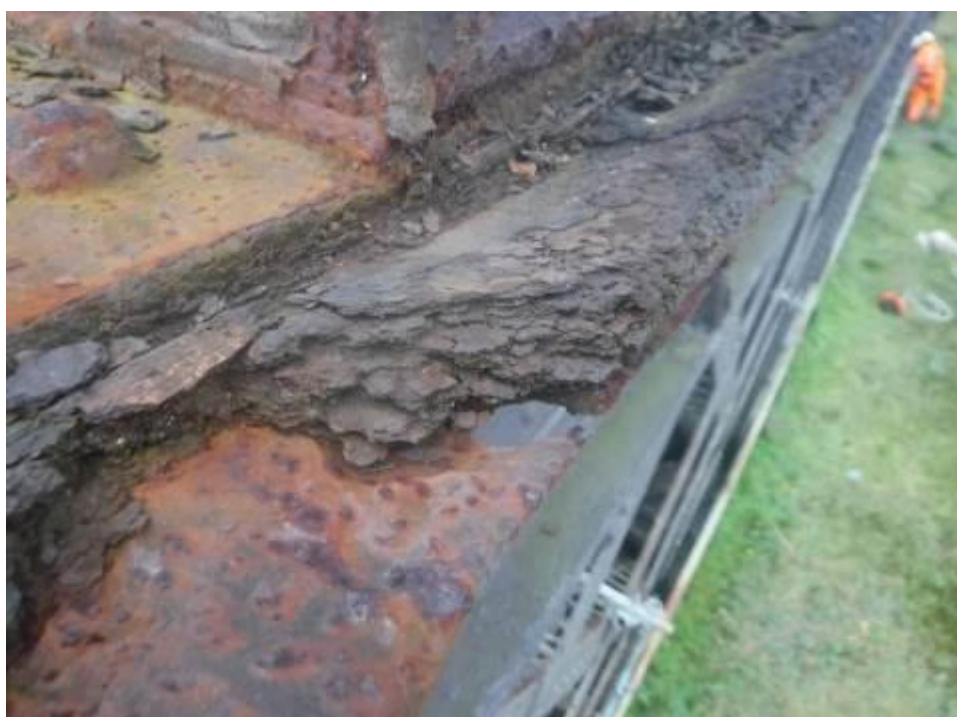
Photograph 112: Loss of section to top boom, top flange of south truss of span 2

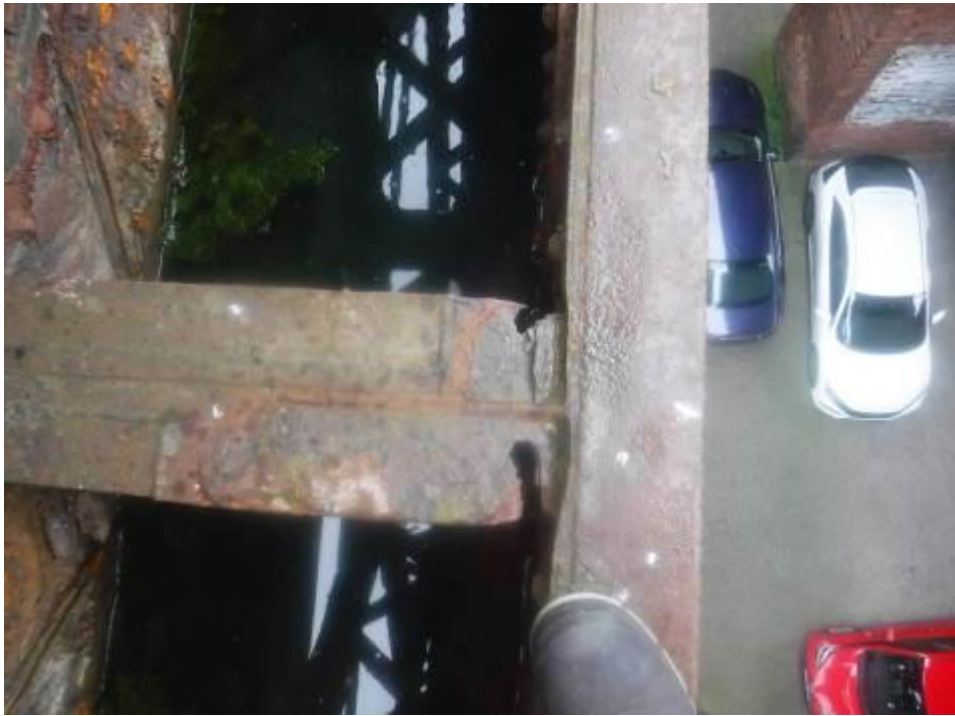
Photograph 113: Loss of section to bottom boom internal stiffener of south truss of span 2

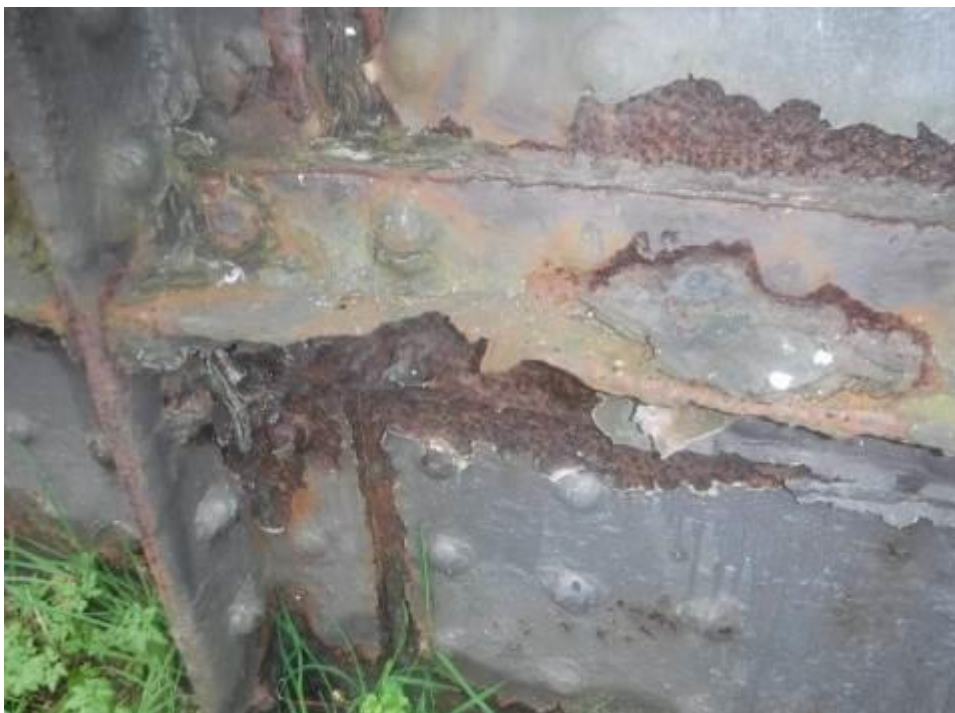
Photograph 114: Loss of section to vertical section above pier of south truss of span 2

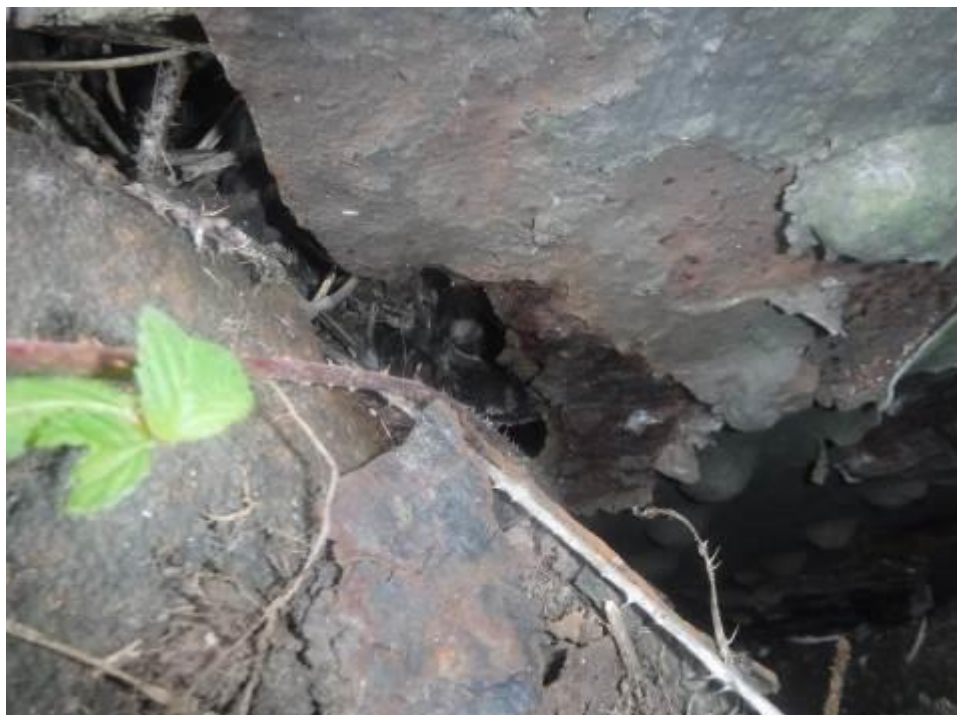
Photograph 115: Loss of section to end plate flange of north truss of span 3

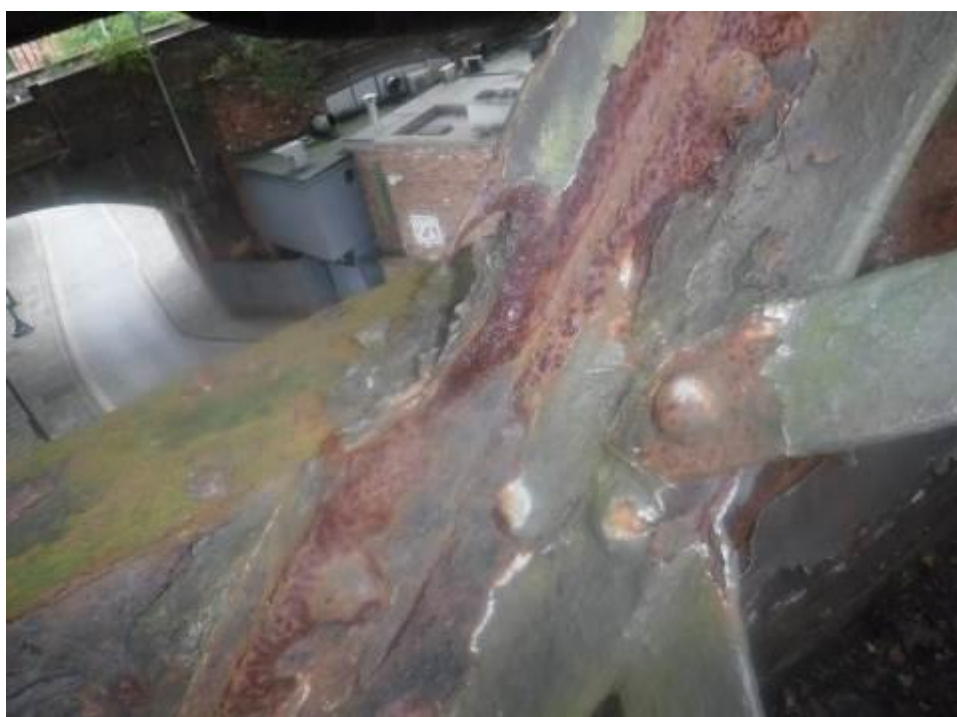
Photograph 116: Loss of section to diagonal member of north truss of span 3
