| ELR: MAJ | Structure No: 289 | Mileage: | Examination date: 07/09/2020 |
| Name: Castlefield Viaduct | | | Type: Viaduct |
| Carrying/Over: Disused rail / Canal, rail, road & land | | | No. of spans: 8 |

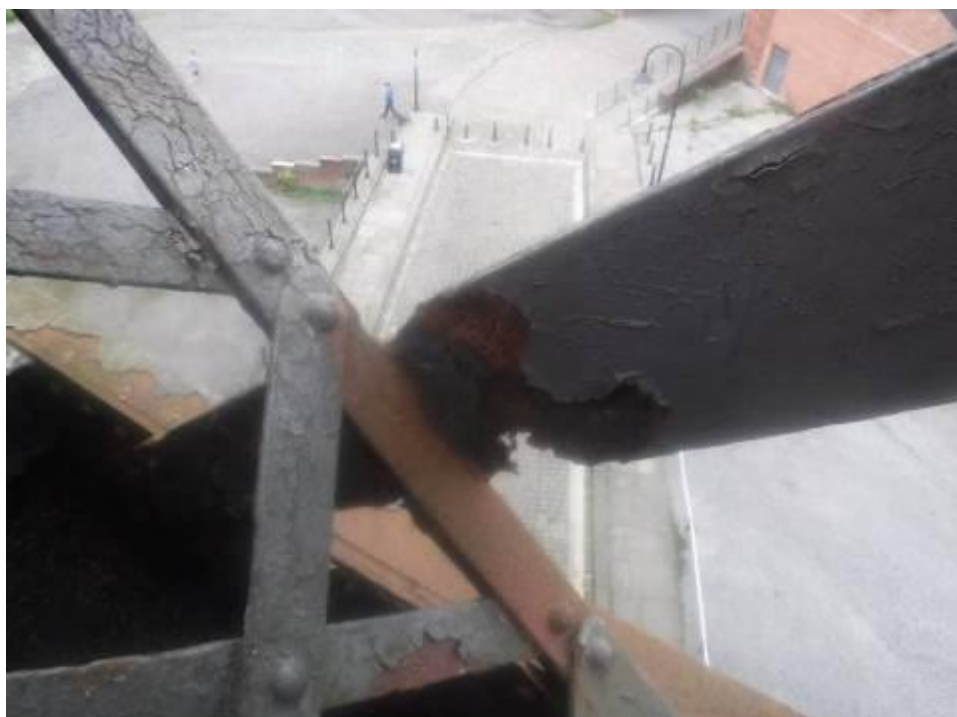
Photograph 117: Loss of section to diagonal bracing of north truss of span 3

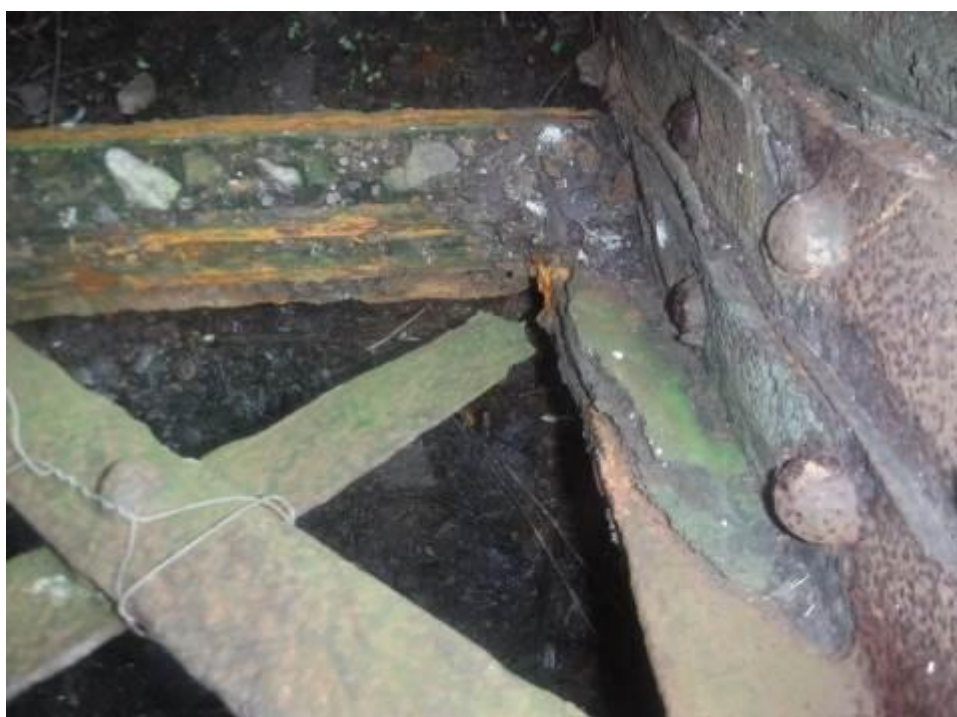
Photograph 118: Loss of section to diagonal bracing of north truss of span 3

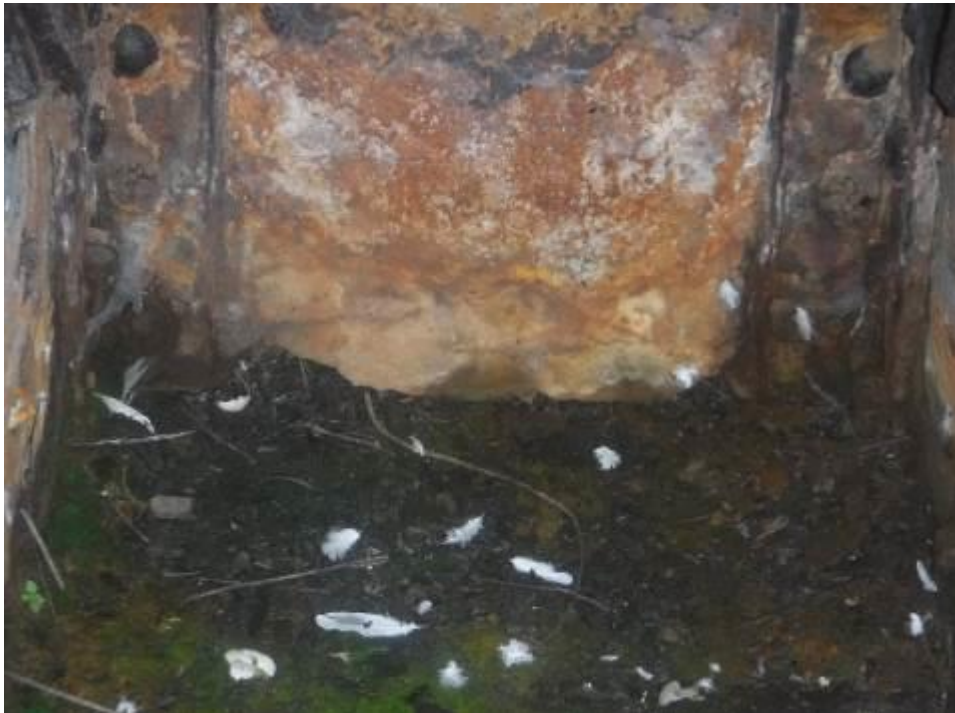
Photograph 119: Loss of thickness & section to end plate of north truss of span 3

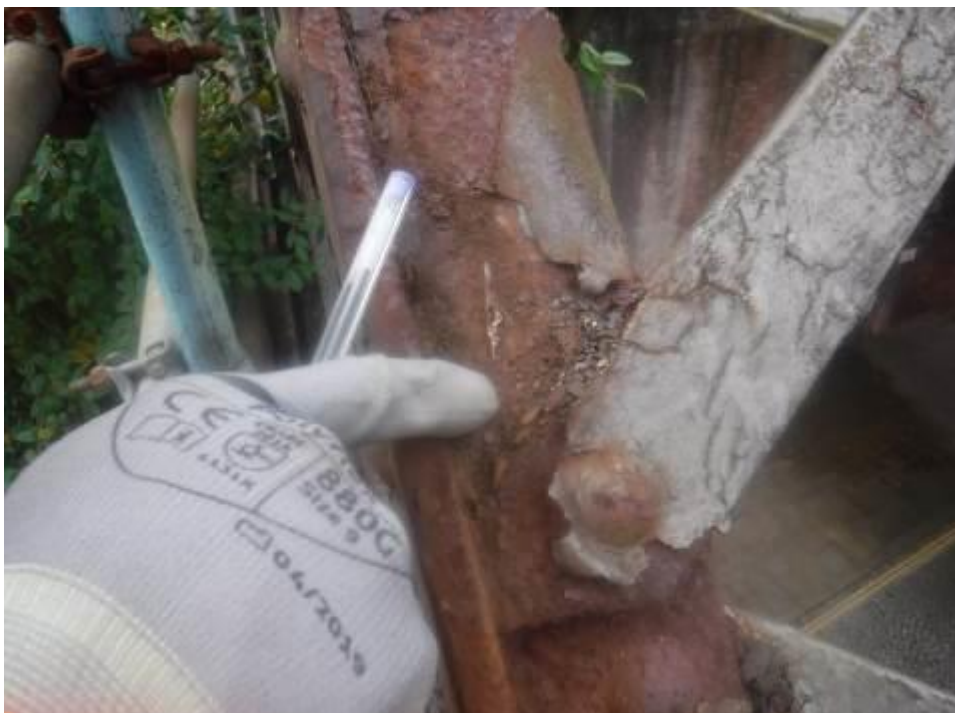
Photograph 120: Loss of thickness to diagonal member of south truss of span 3

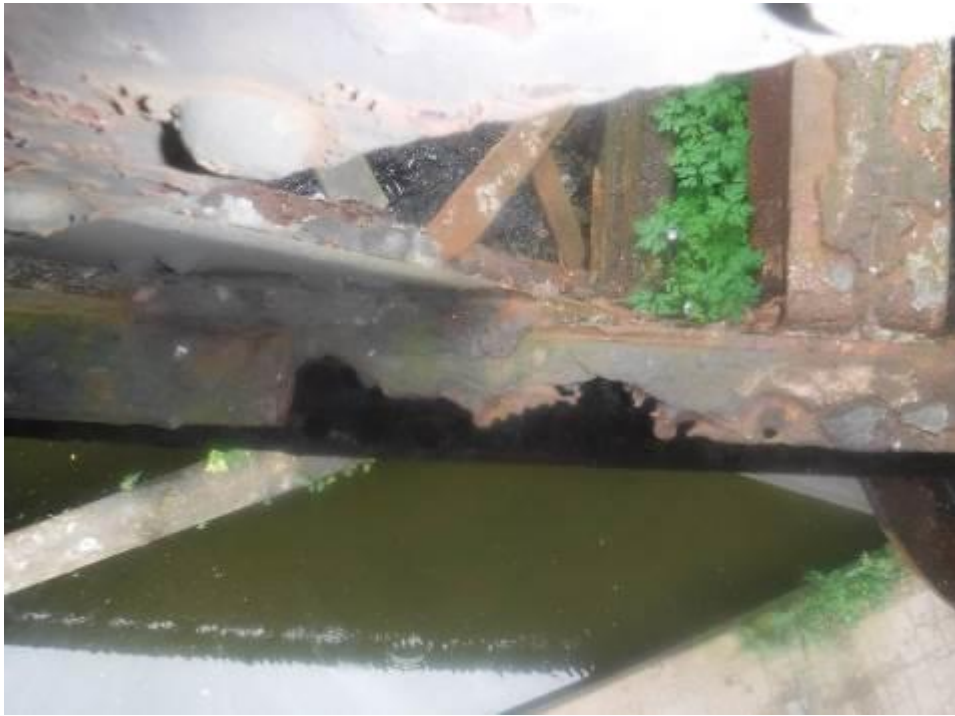
Photograph 121: Loss of section to bottom boom, top flange of south truss of span 3

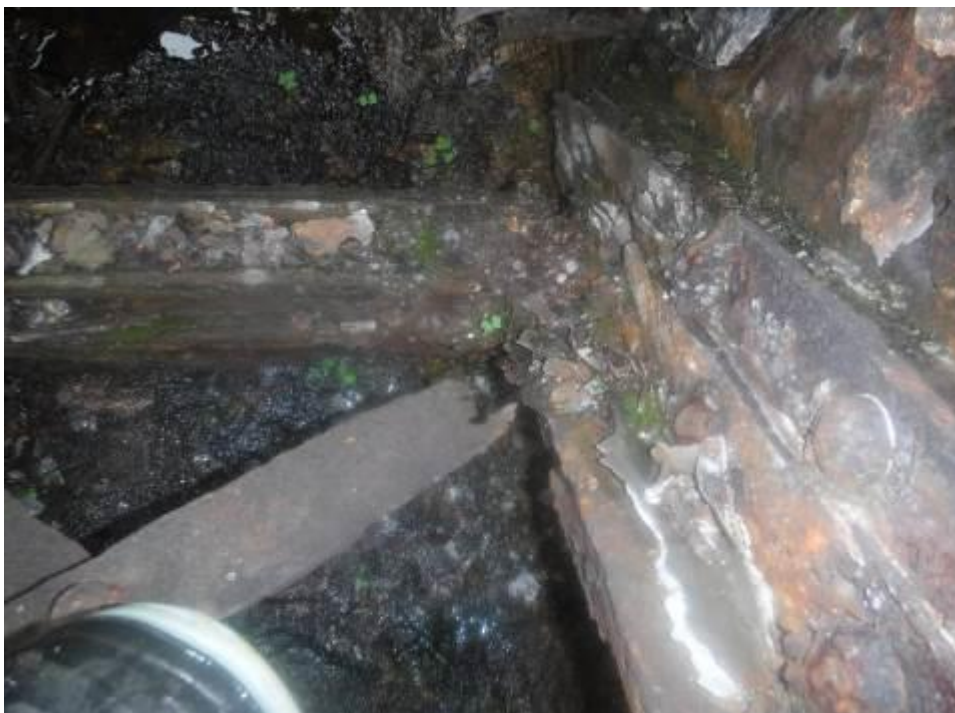
Photograph 122: Loss of section to diagonal bracing of south truss of span 3

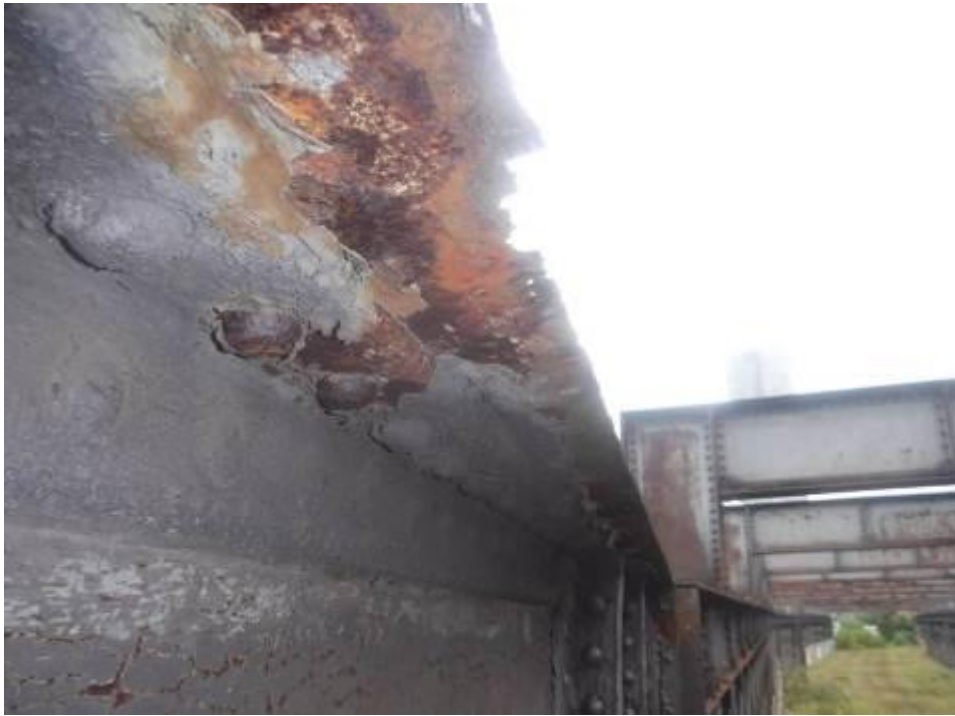
Photograph 123: Loss of section to top boom, top flange of north truss of span 4

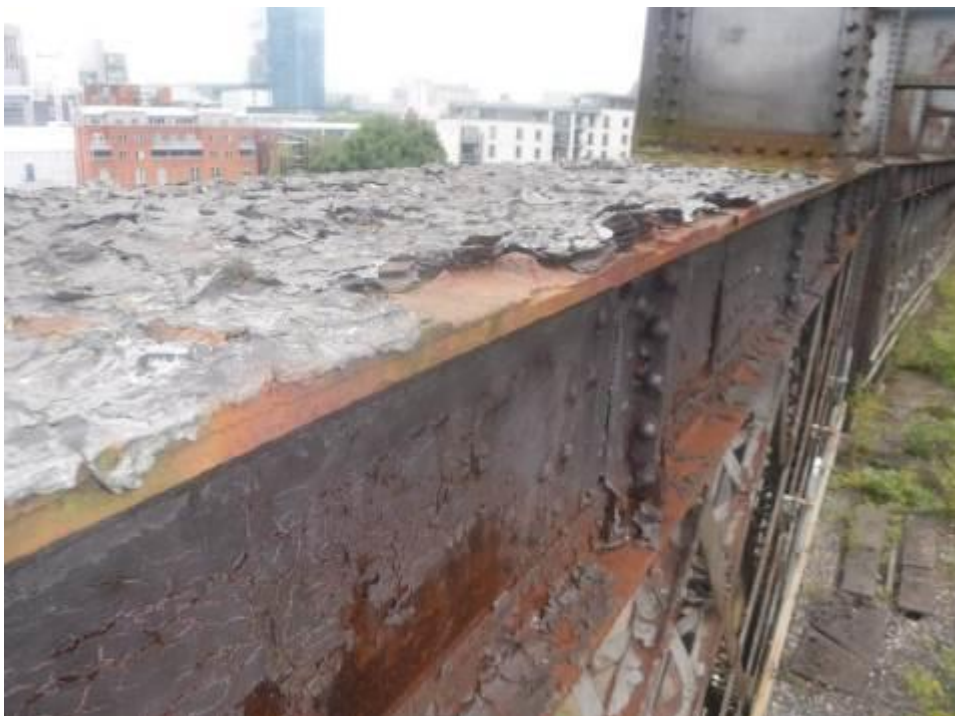
Photograph 124: Loss of thickness to top boom, top flange of north truss of span 4

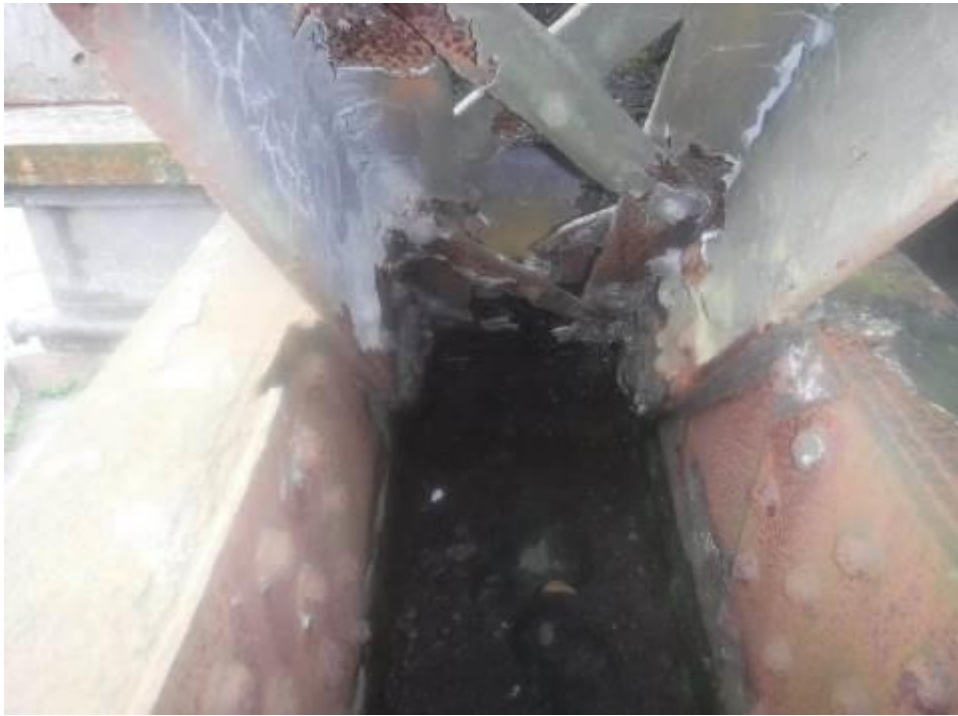
Photograph 125: Loss of section to diagonal bracing of north truss of span 4

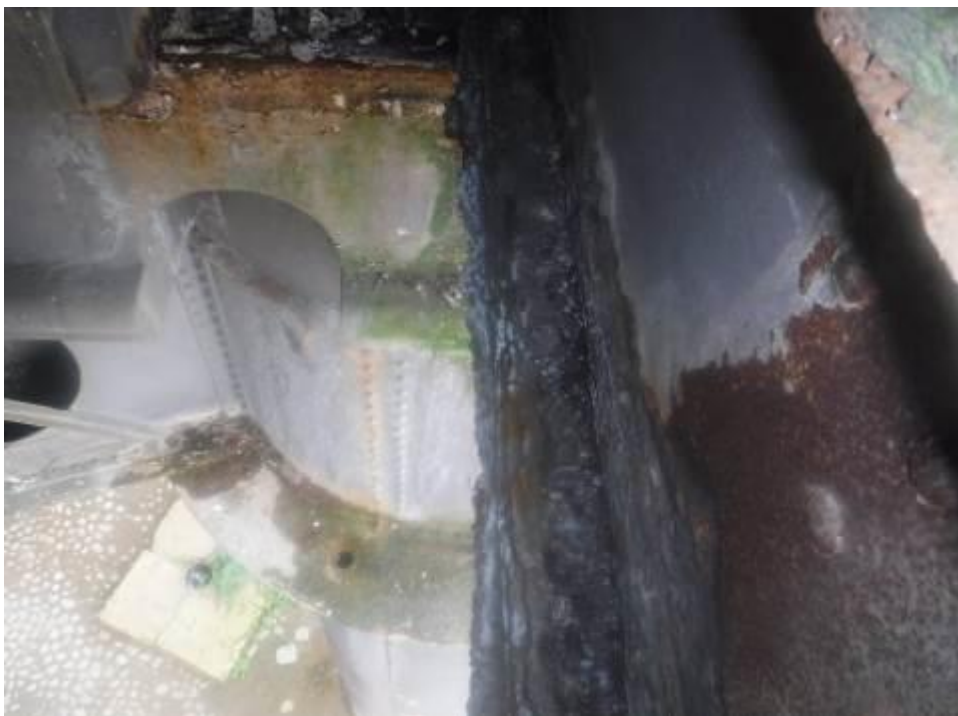
Photograph 126: Loss of section to bottom boom, bottom flange of north truss of span 4

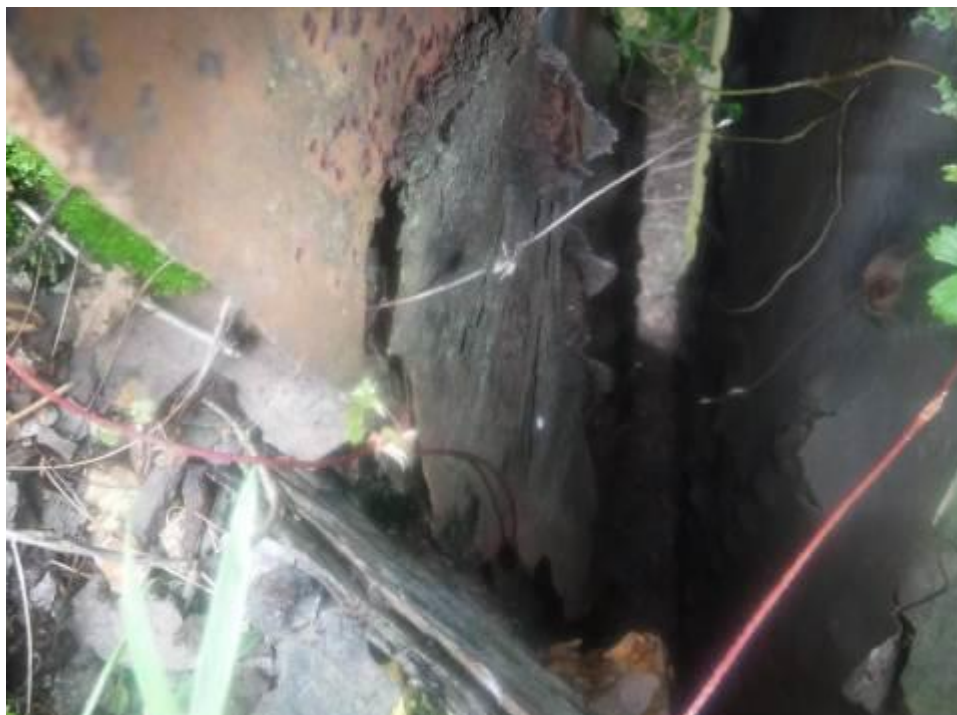
Photograph 129: Loss of section to end plate of south truss of span 4

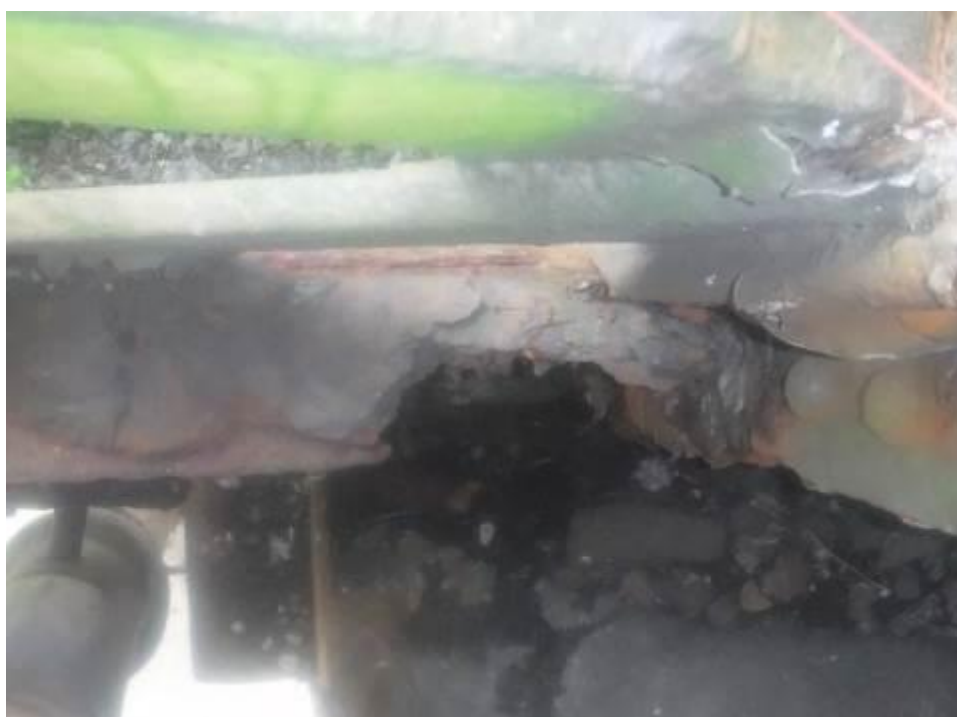
Photograph 130: Loss of thickness & section to bottom boom, top flange of south truss of span 4

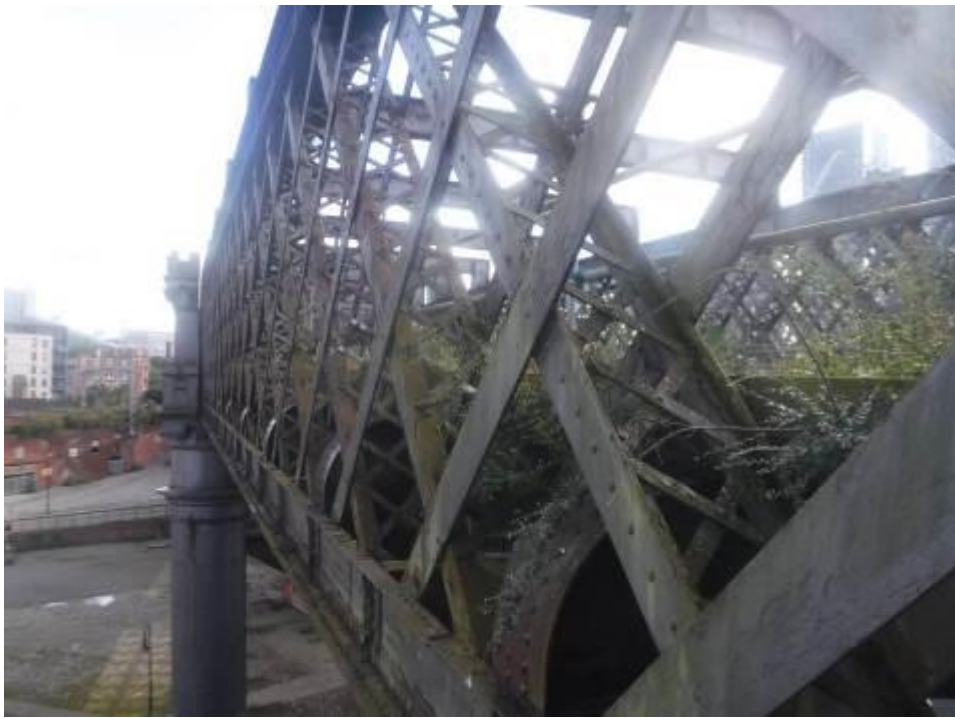
### Span 5 North Truss (photo 131)

Photograph 131: General view of north truss of span 5

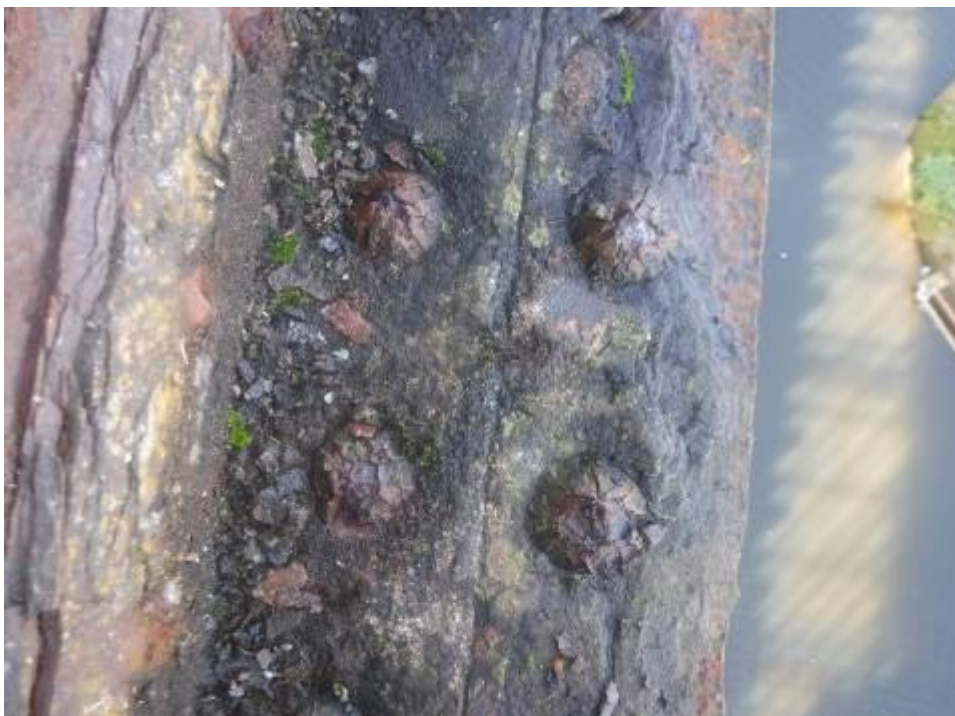
There were minor areas of pooling throughout the bottom boom. There was loss of thickness of 1mm throughout bottom boom stiffeners with spiking to lower flange rivets. (photo 132)

Photograph 132: Typical spiking to lower flange rivets of north truss of span 5

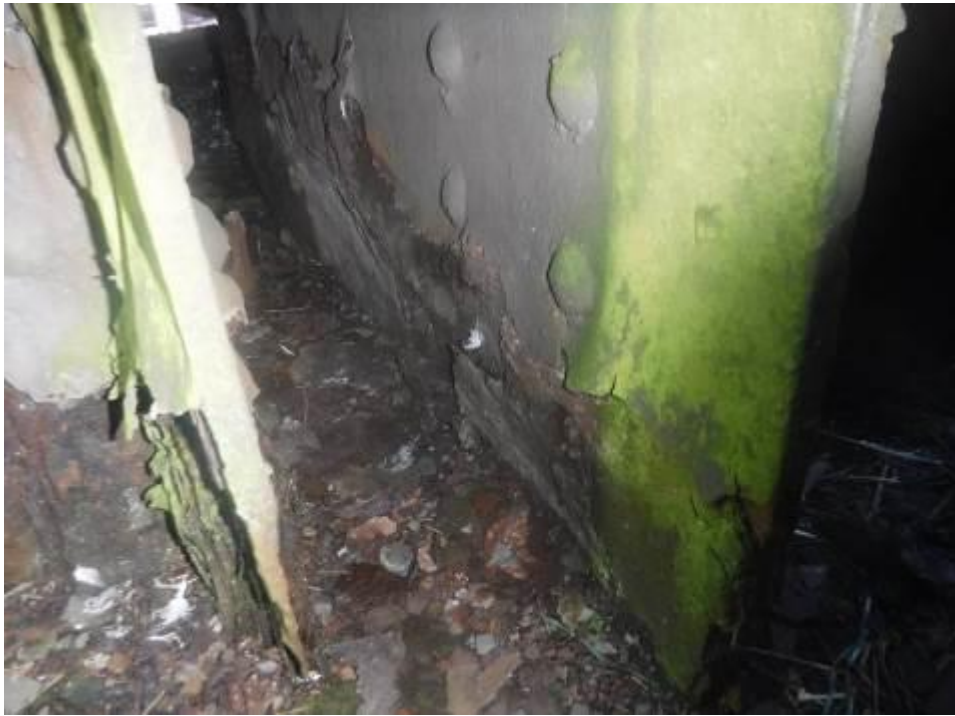
Photograph 133: Loss of thickness to end beam of north truss of span 5

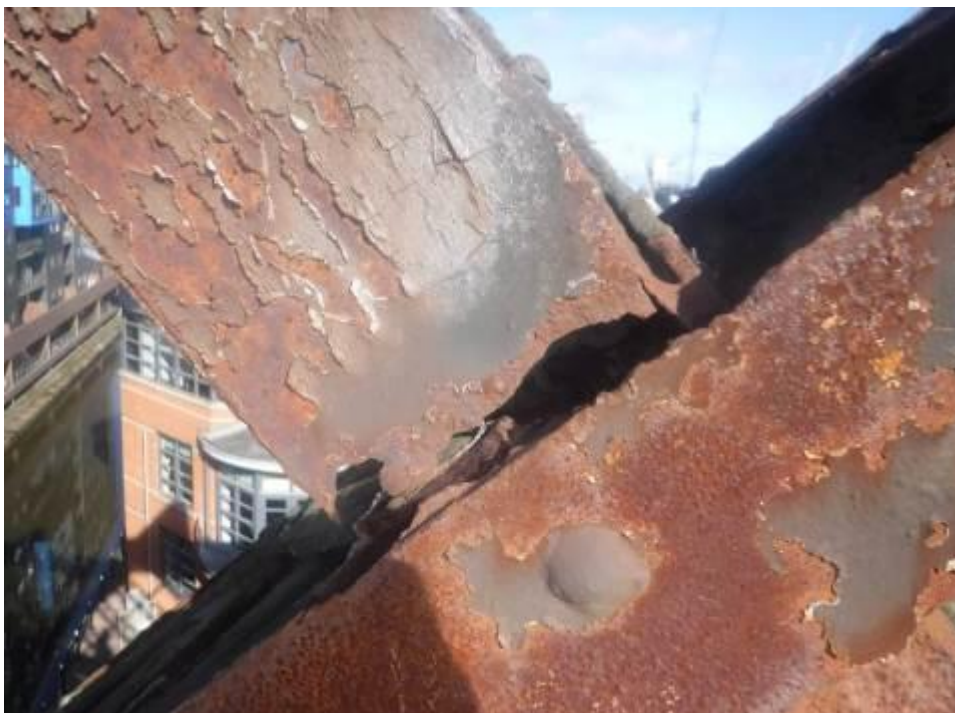
Photograph 134: Loss of section to diagonal member of north truss of span 5

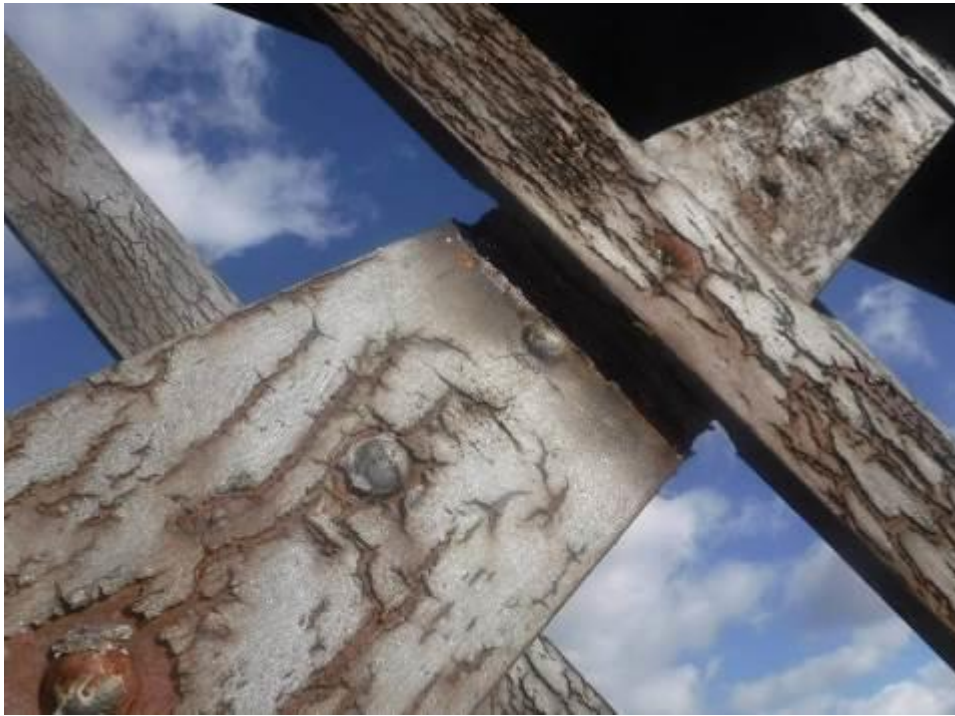
Photograph 135: Loss of thickness to diagonal bracing of north truss of span 5

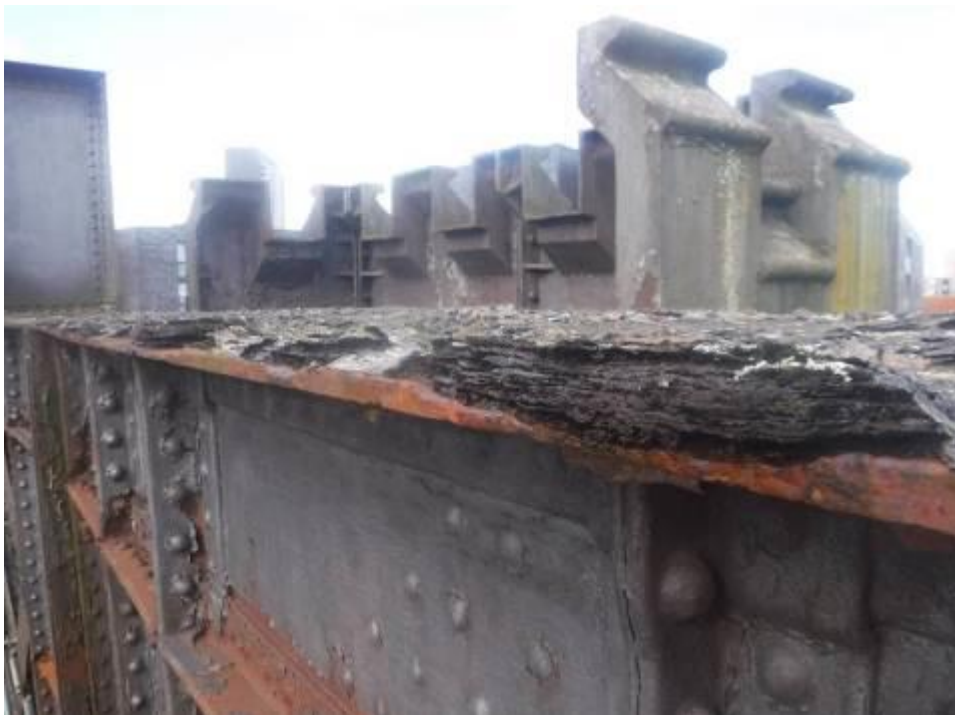
Photograph 137: Loss of thickness to top boom, top flange of north truss of span 5

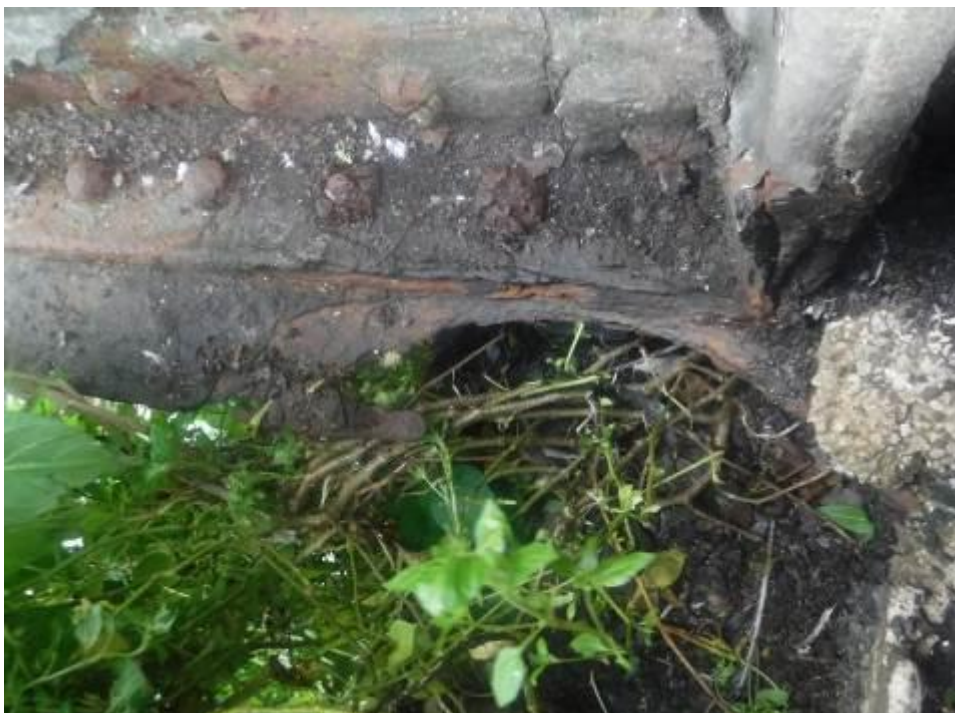
Photograph 138: Loss of section to bottom boom, bottom flange of north truss of span 5

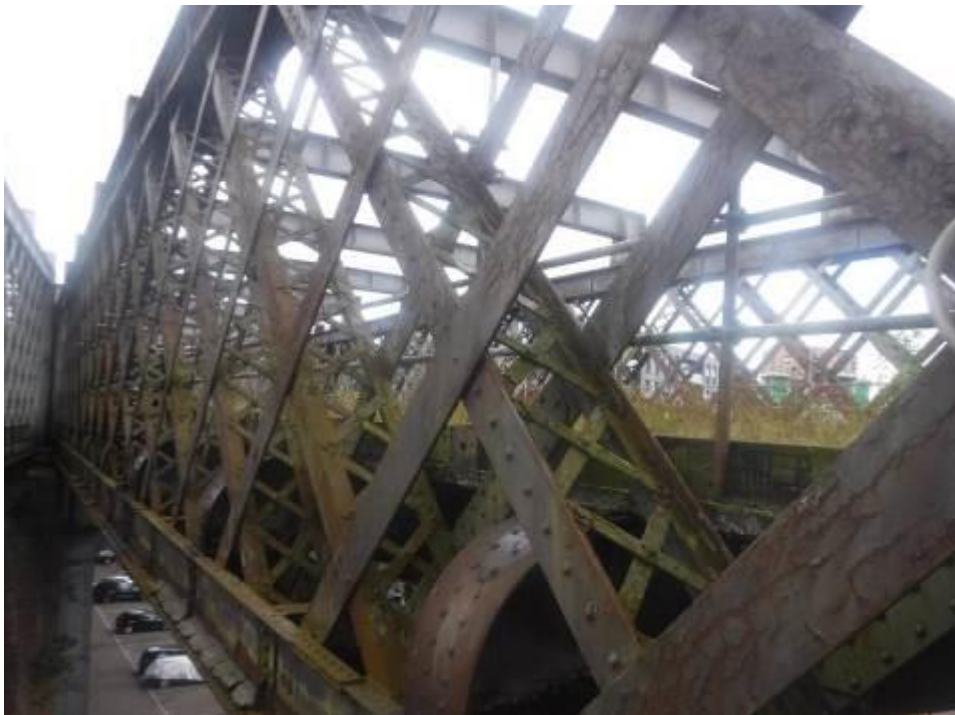
#### Span 5 South Truss (photo 139)

Photograph 139: General view of south truss of span 5

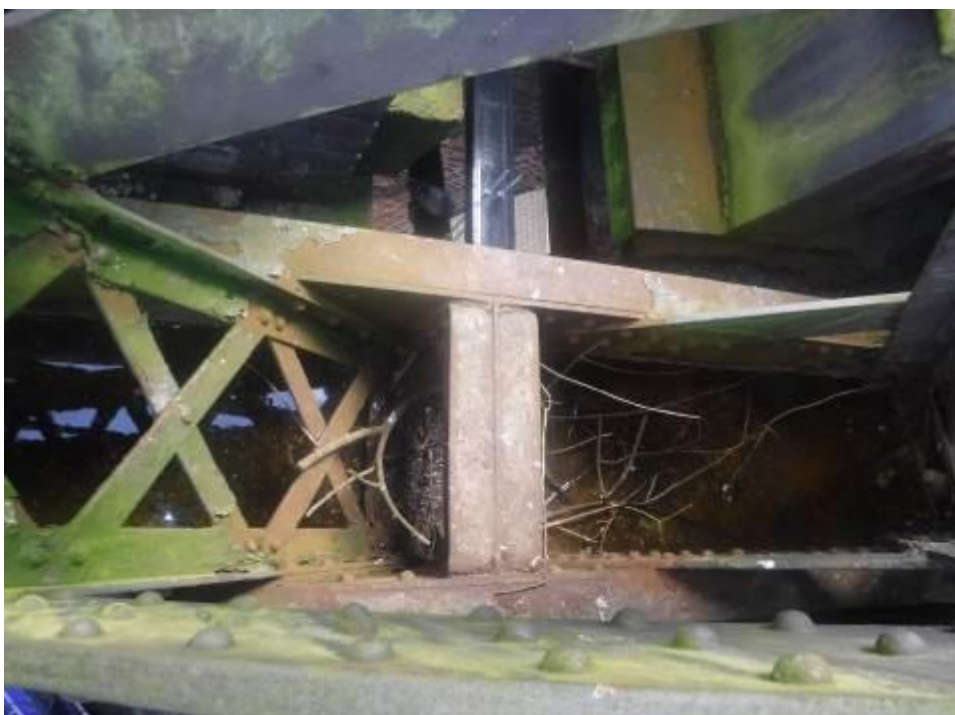
There was pooling with debris build-up throughout the bottom boom. (photo 140) There was loss of thickness to 1mm throughout the top flange of the top boom. There was loss of thickness of up to 2mm throughout bottom boom stiffeners with spiking to lower flange rivets.

Photograph 140: Typical pooling & debris to bottom boom of south truss of span 5

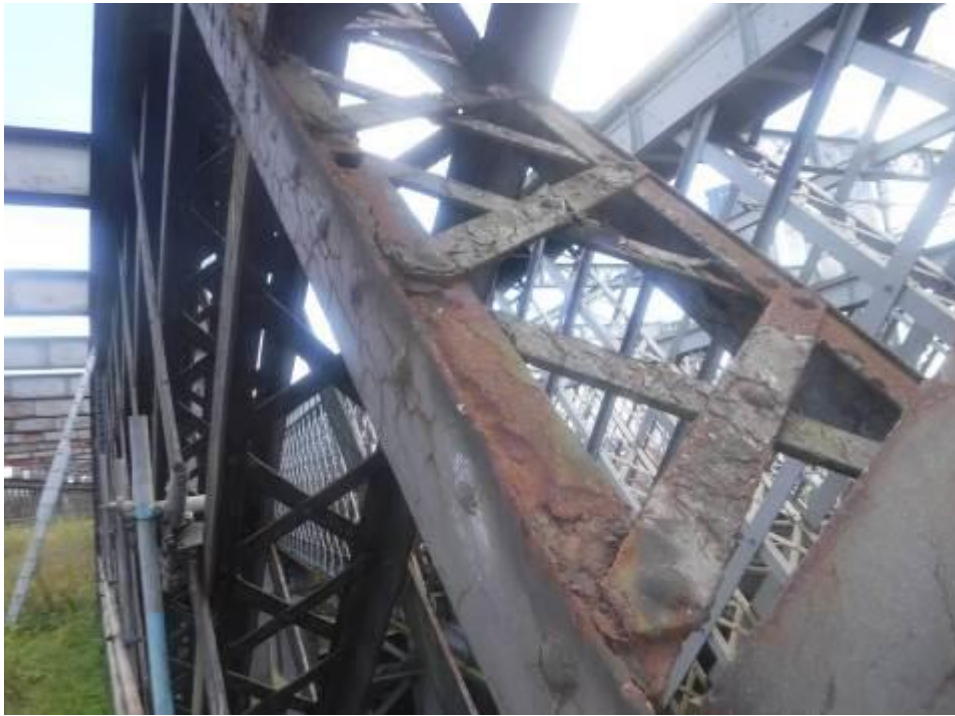
Photograph 141: Loss of thickness & section to diagonal bracing of south truss of span 5

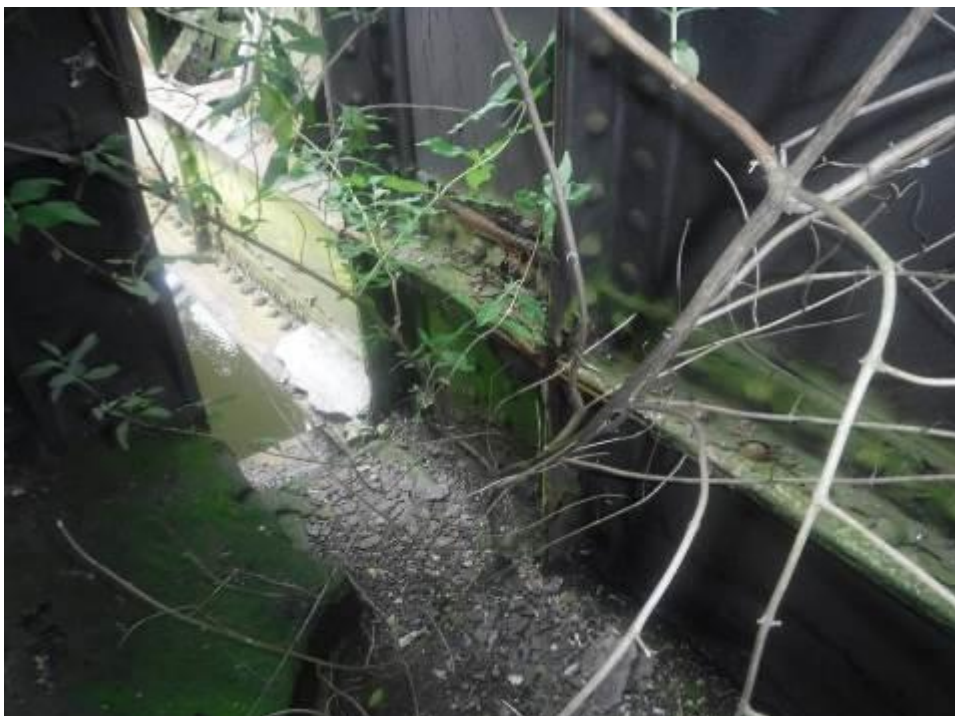
Photograph 142: Sapling growth to end beam void of south truss of span 5

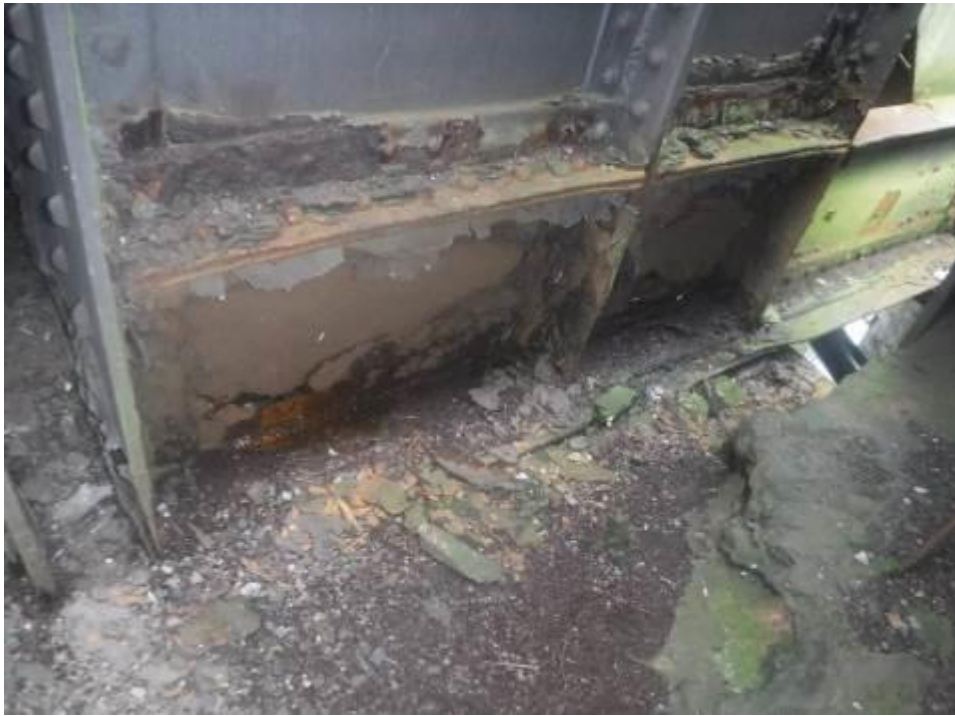
Photograph 145: Loss of thickness to end beam stiffeners of south truss of span 5

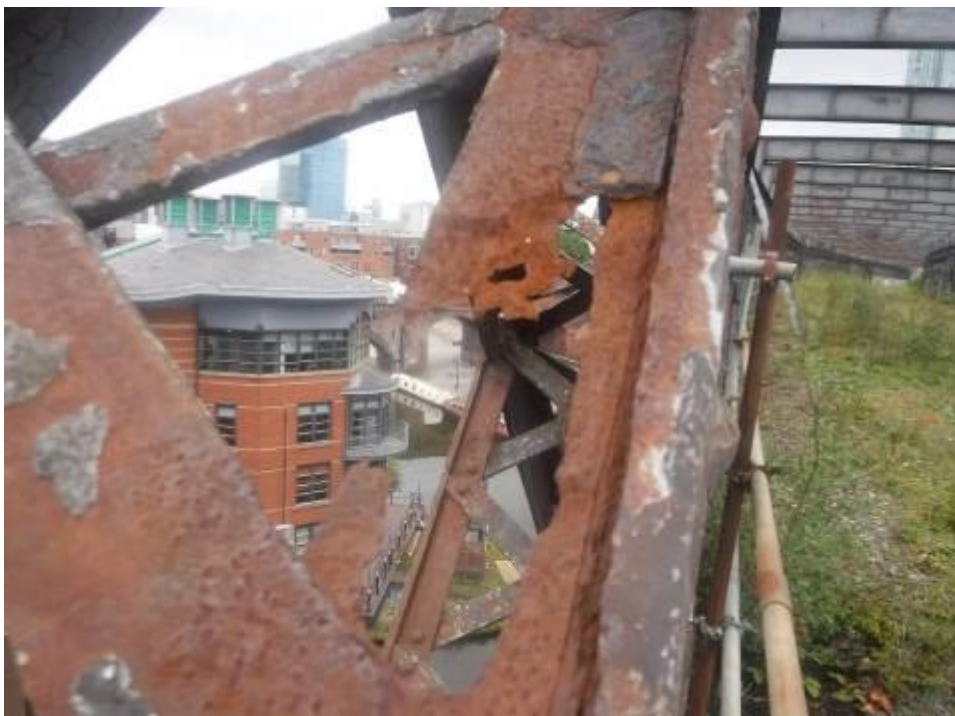
Photograph 146: Loss of thickness & section to diagonal member of north truss of span 6

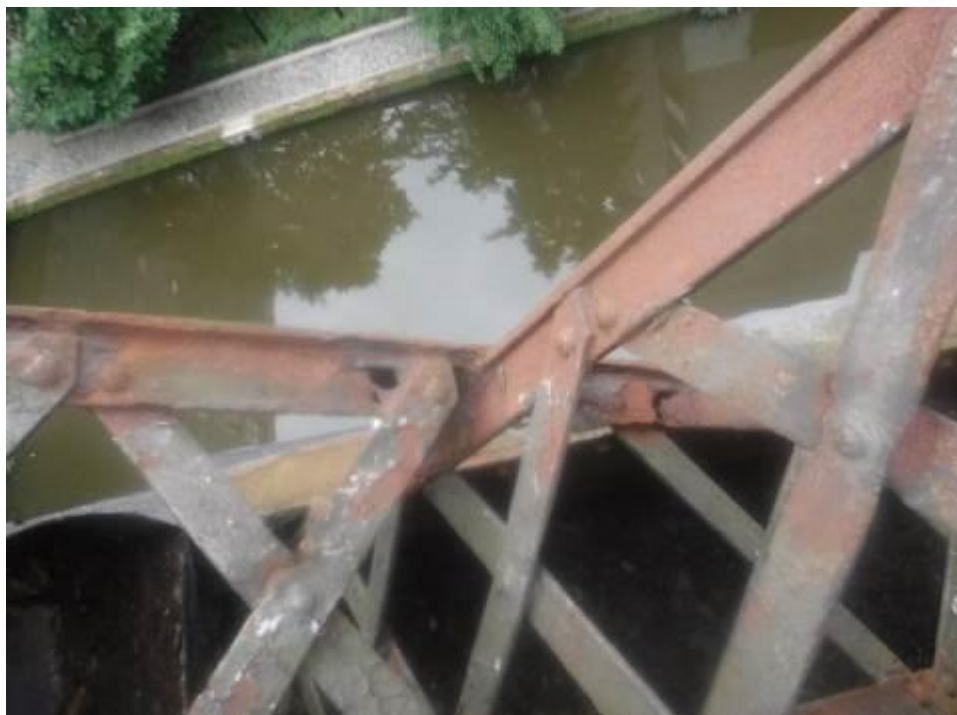
Photograph 147: Loss of thickness & section to diagonal member of north truss of span 6

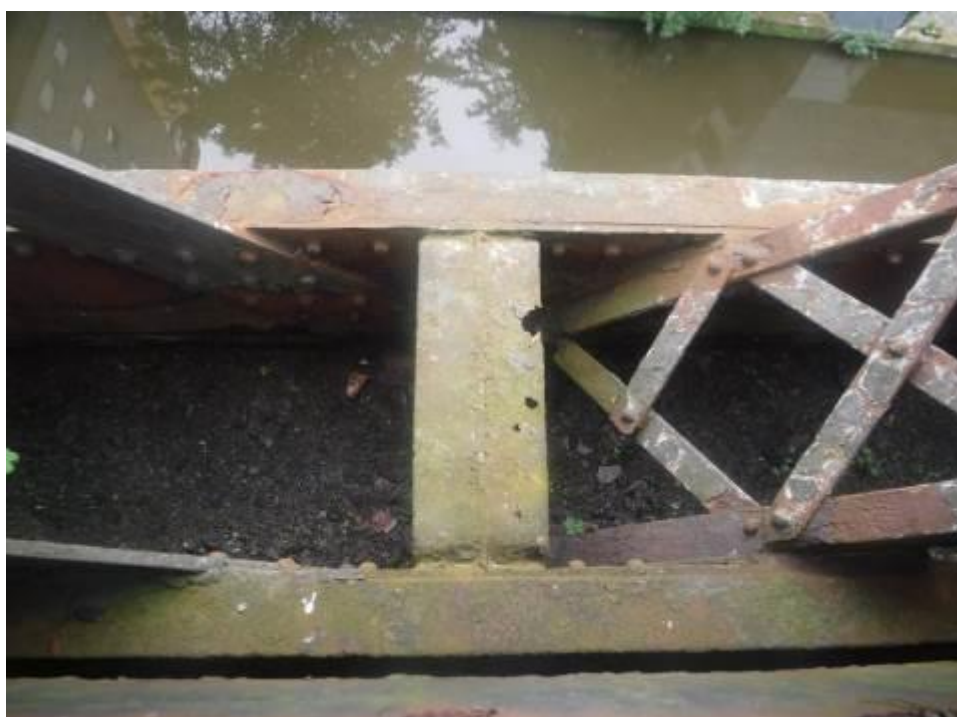
Photograph 148: Loss of section to bottom boom internal stiffener of north truss of span 6

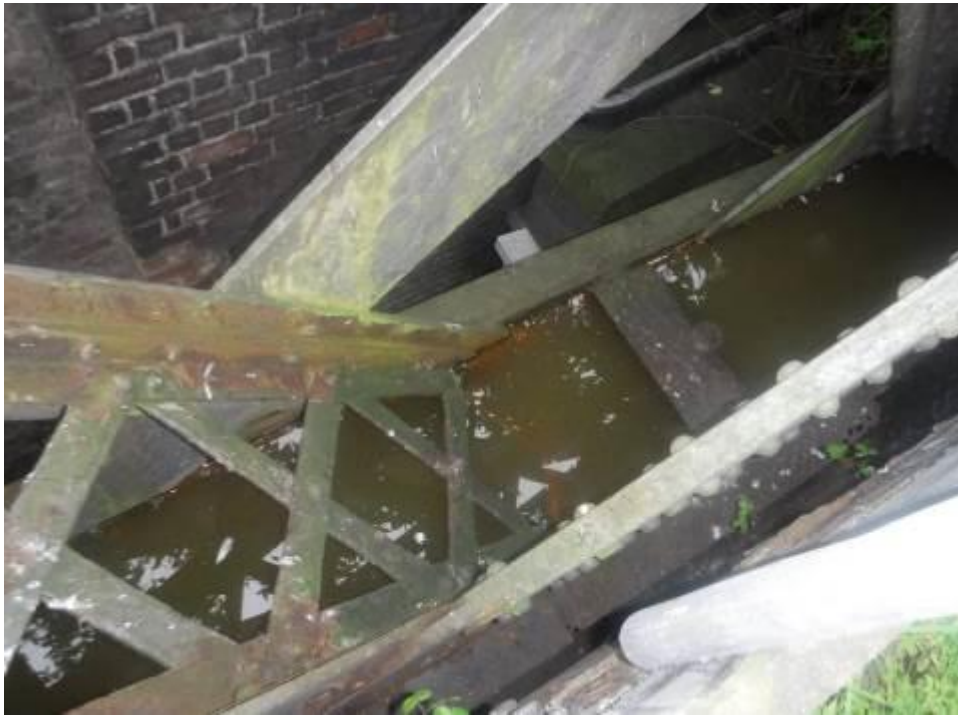
There was flooding throughout the trough of the bottom boom. (photo 149) Previously reported defects to the lowest diagonal bracings could not be verified as they were below the water level, these have been left in the table below for reference but marked in red.

Photograph 149: Typical flooding to bottom boom of south truss of span 6

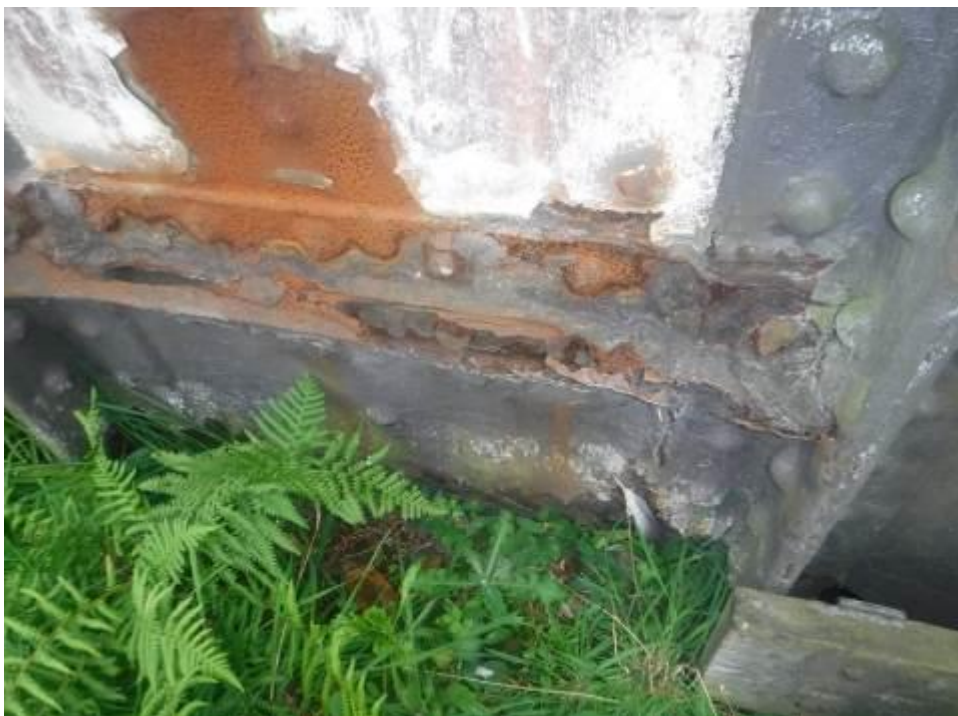
Photograph 150: Loss of section to end plate stiffener of south truss of span 6

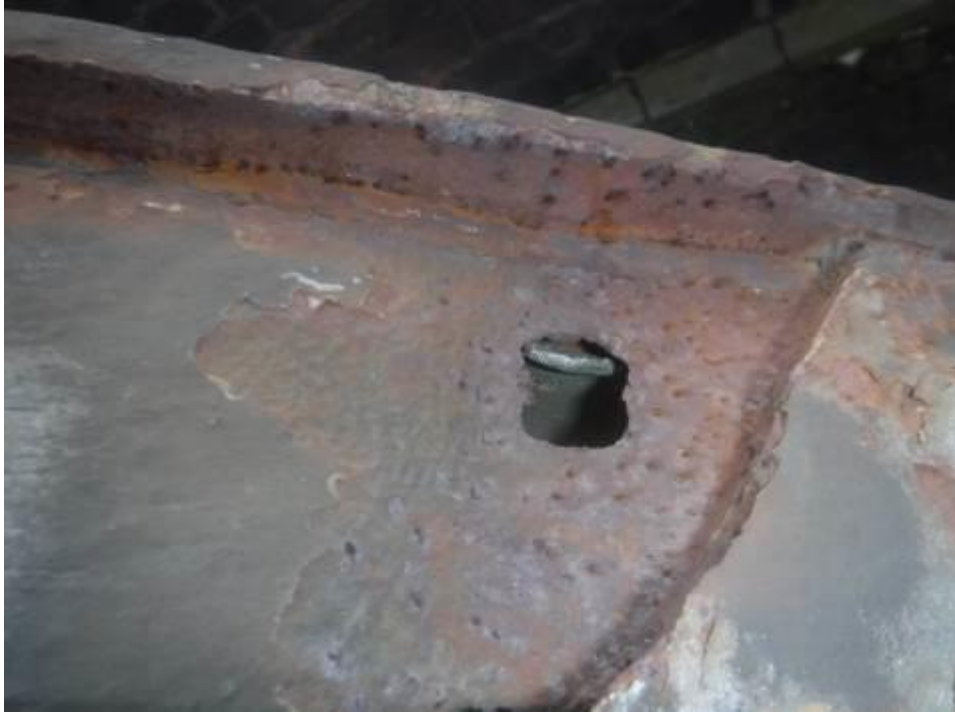
Photograph 151: Loss of section to bottom boom, bottom flange of south truss of span 6

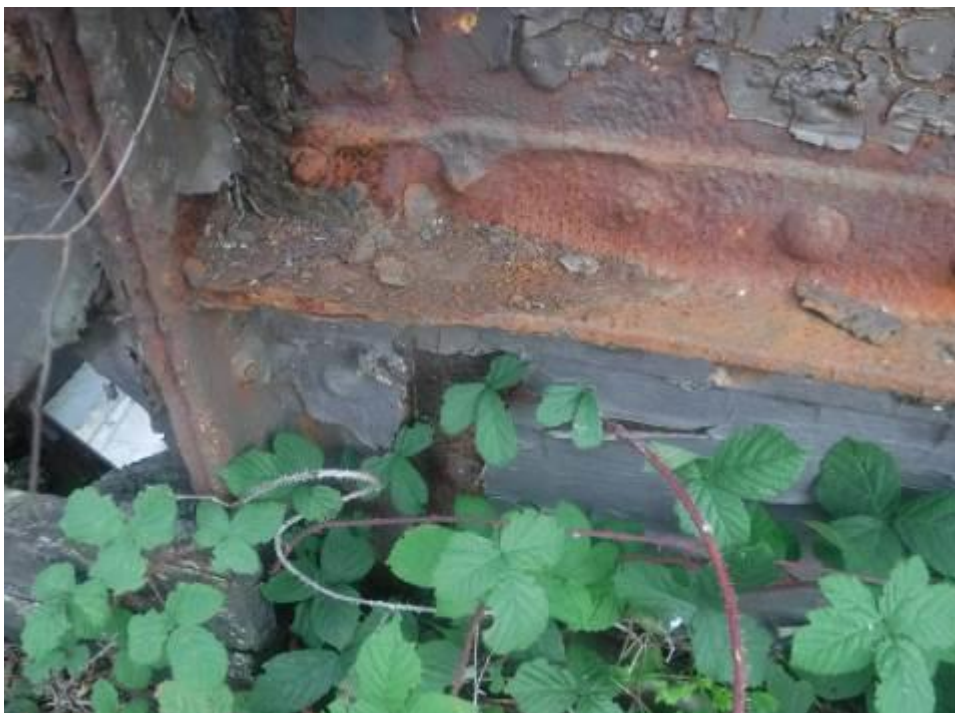
Photograph 152: Loss of thickness to end section, lower horizontal stiffener of north truss of span 7

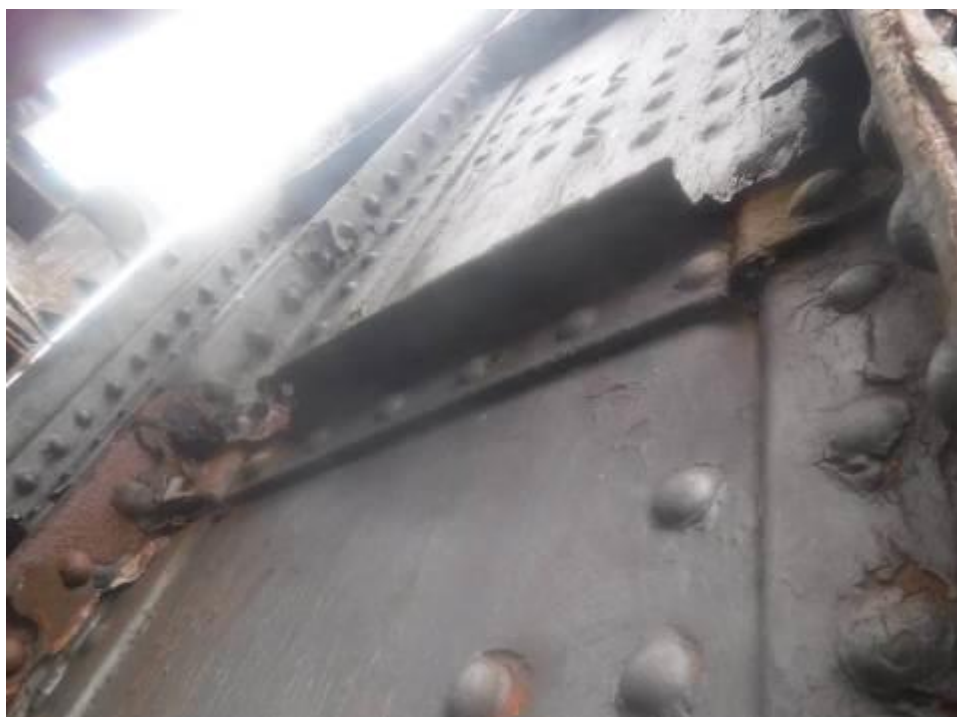
Photograph 153: Loss of section to end section upper horizontal stiffener of north truss of span 7
