| ELR: MAJ | Structure No: 289 | Mileage: | Examination date: 07/09/2020 |
| Name: Castlefield Viaduct | | | Type: Viaduct |
| Carrying/Over: Disused rail / Canal, rail, road & land | | | No. of spans: 8 |

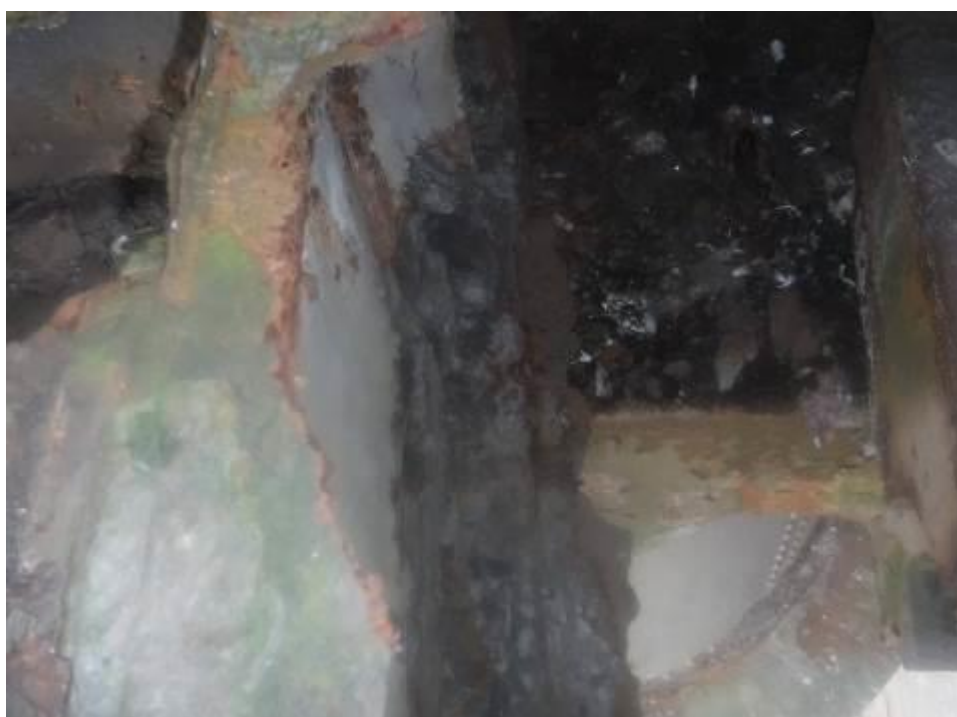
Photograph 154: Loss of section to bottom boom, top & bottom flanges of north truss of span 7

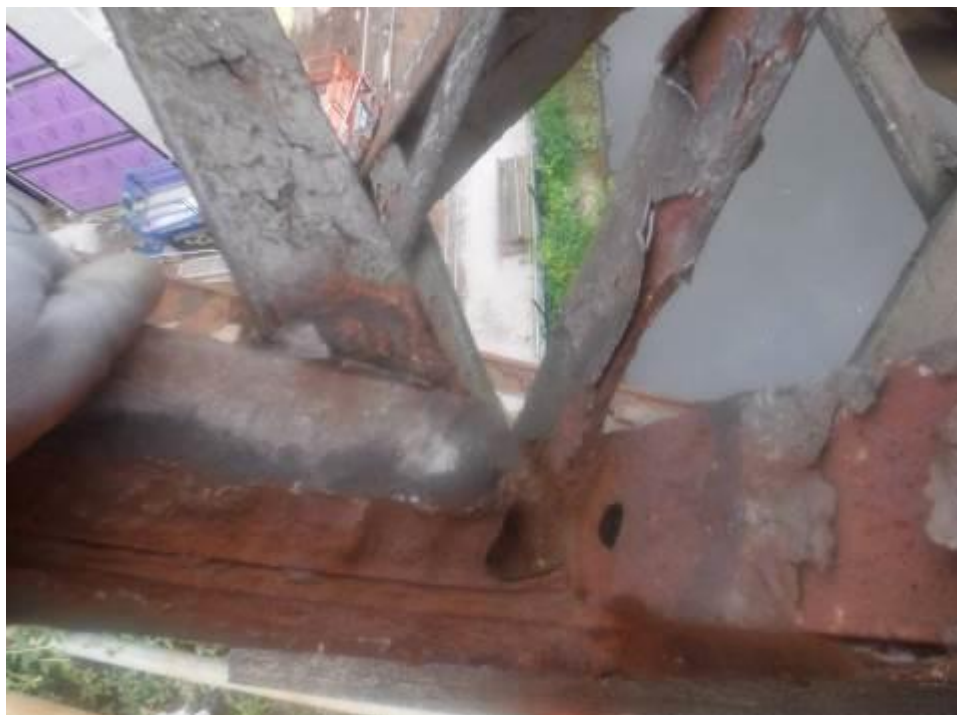
Photograph 155: Loss of thickness & section to diagonal member of north truss of span 7

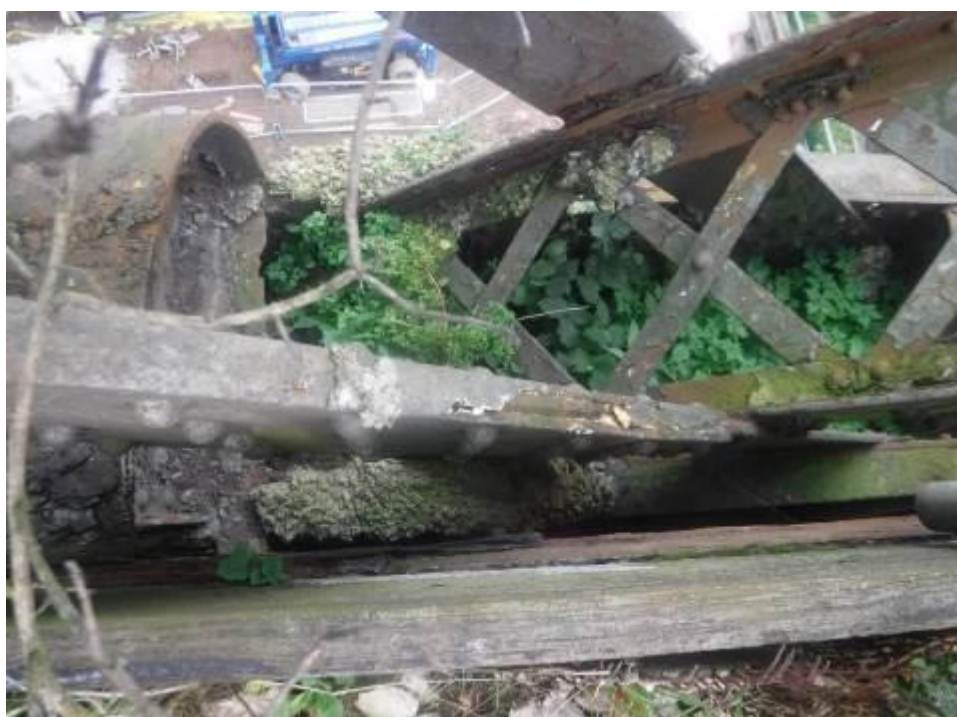
Photograph 156: Concrete & vegetation growth to bottom boom of north truss of span 7

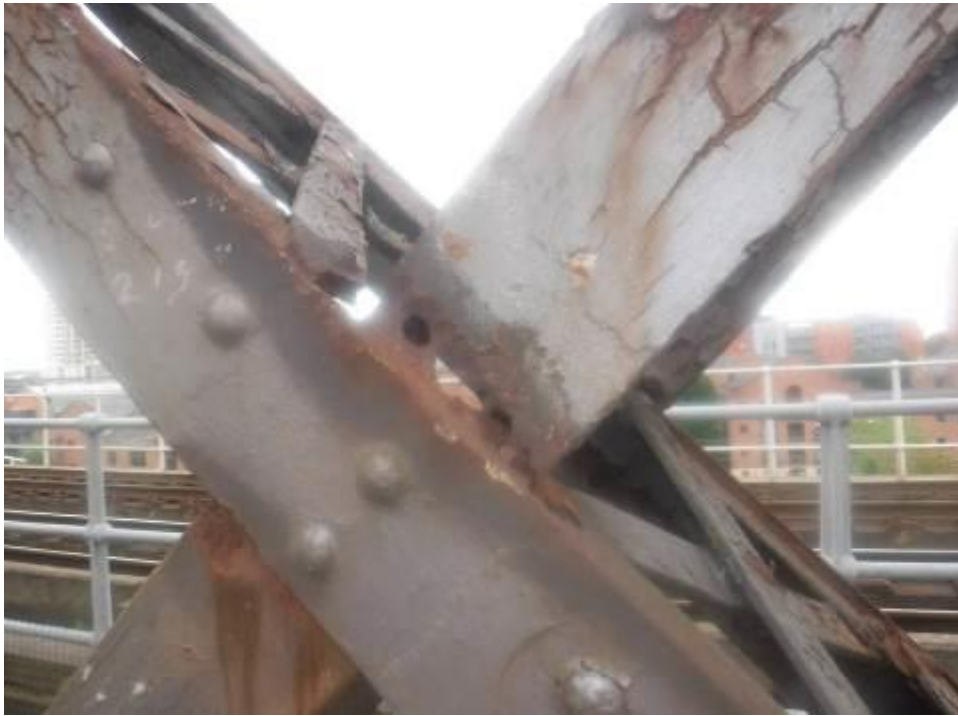
Photograph 159: Loss of thickness & section to diagonal member of south truss of span 7

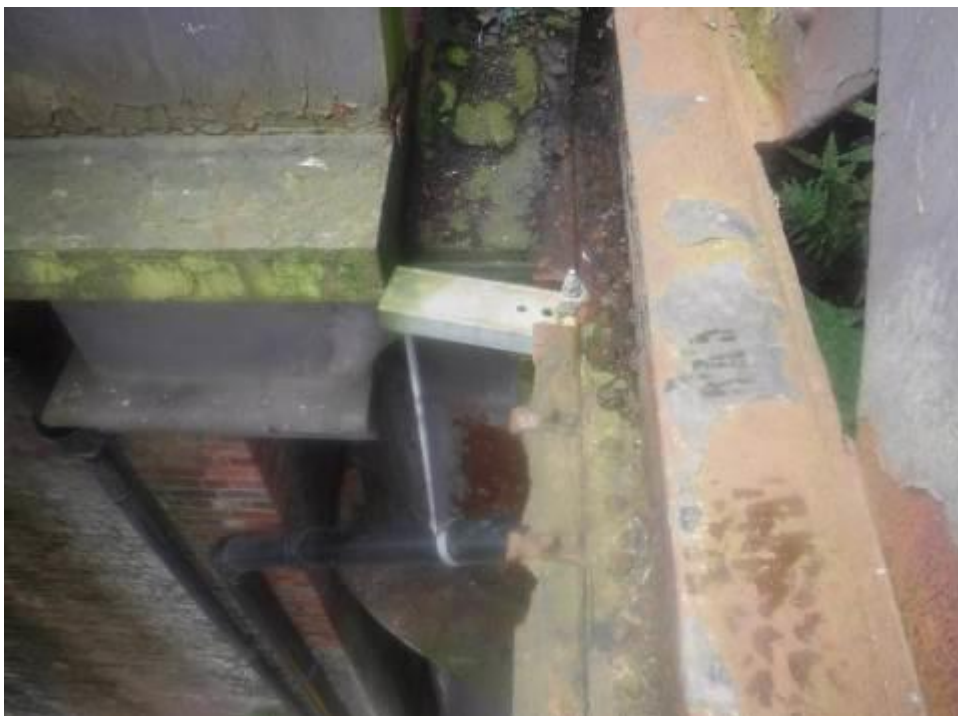
Photograph 160: Loss of section to bottom boom, bottom flange of south truss of span 7

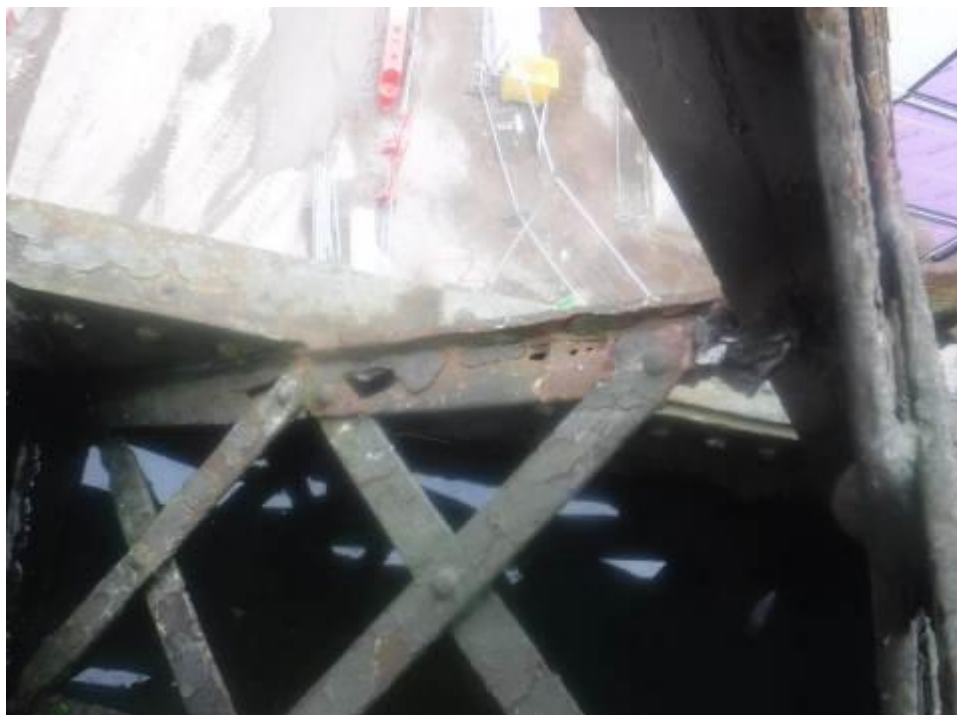
Photograph 163: Loss of section to diagonal bracing of north truss of span 8

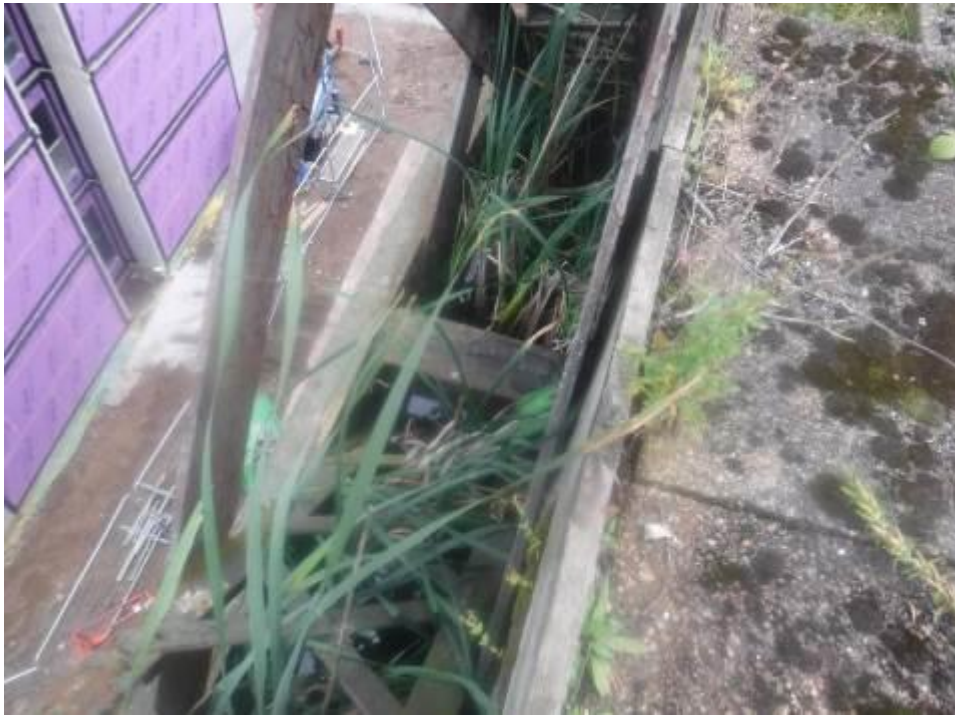
Photograph 165: Vegetation growth to bottom boom of north truss of span 8

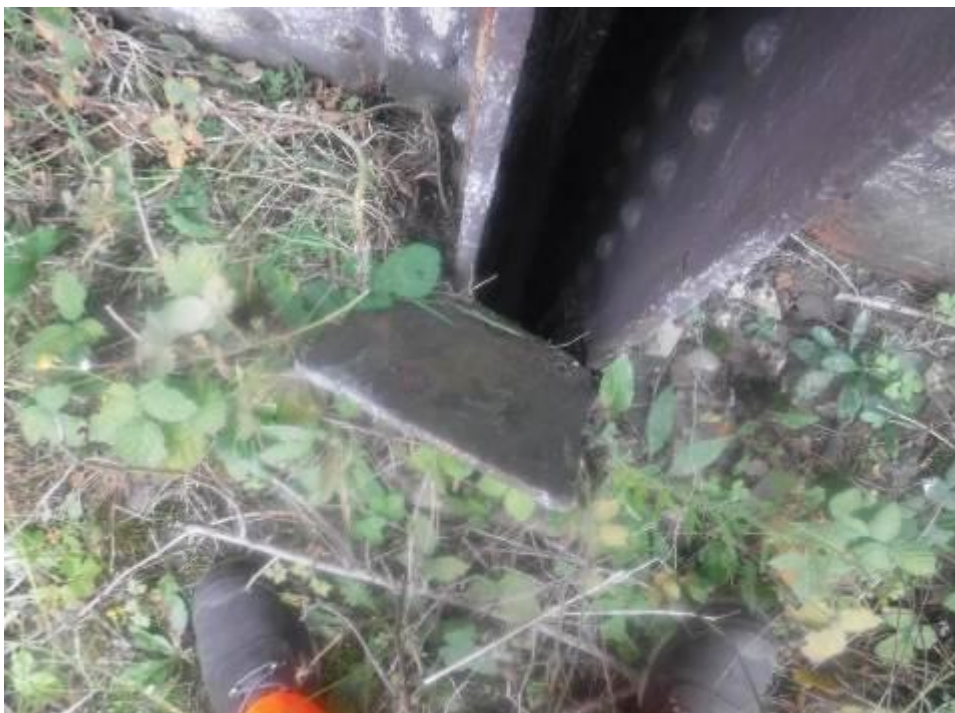
Photograph 166: Deformed & detached ballast plate to north truss of span 8

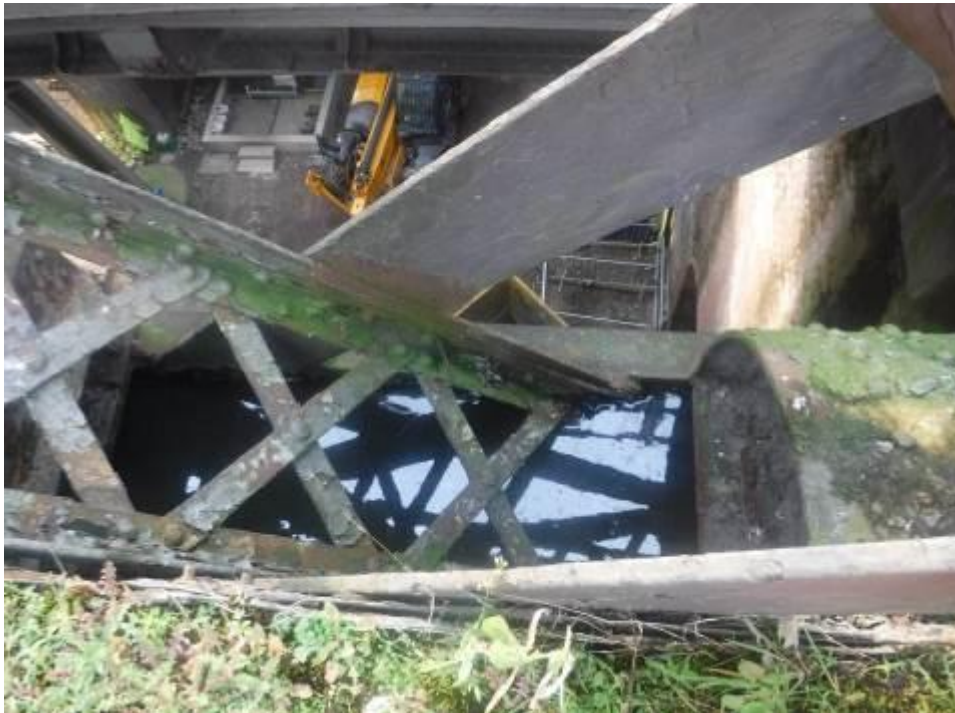
Photograph 167: Typical flooding to bottom boom of south truss of span 8

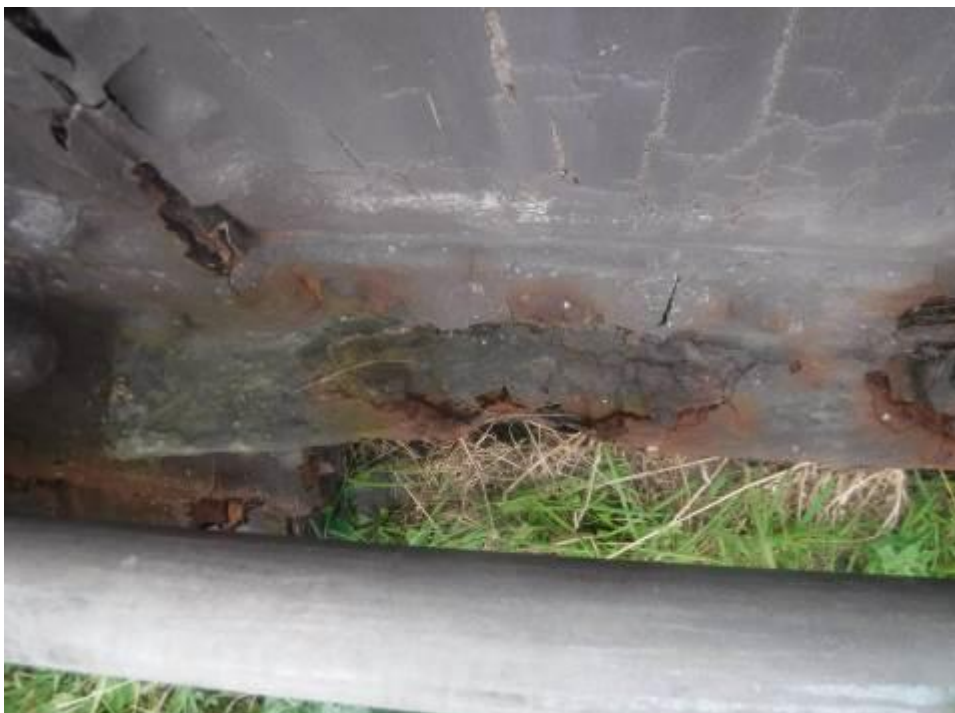
Photograph 168: Loss of thickness & section to lower web stiffener of south truss of span 8

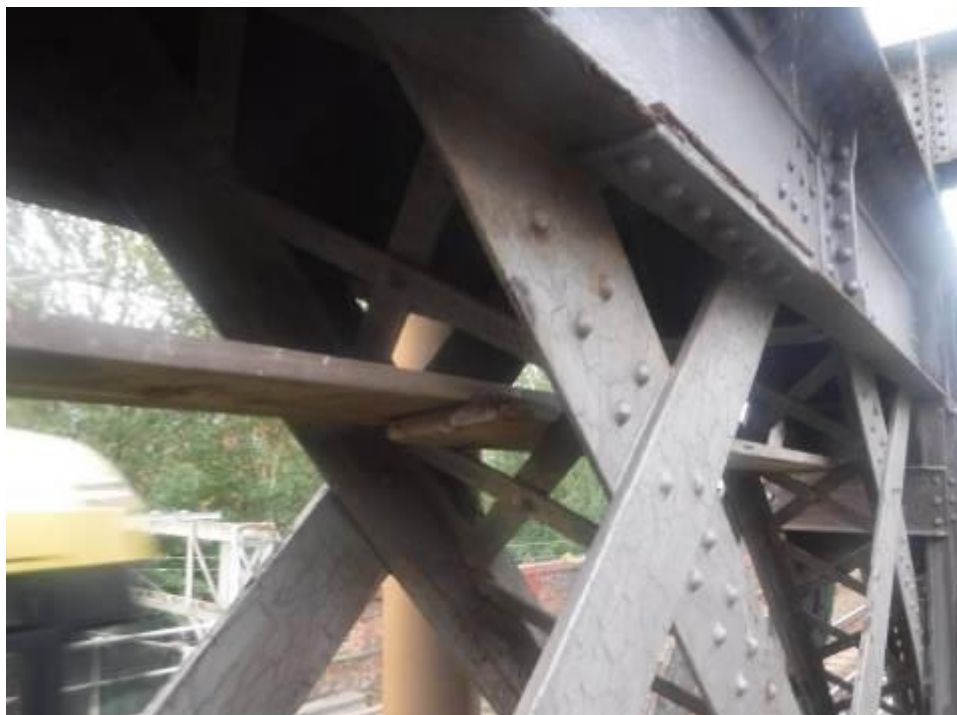
Photograph 171: Scaffold boards to diagonal bracing of south truss of span 8

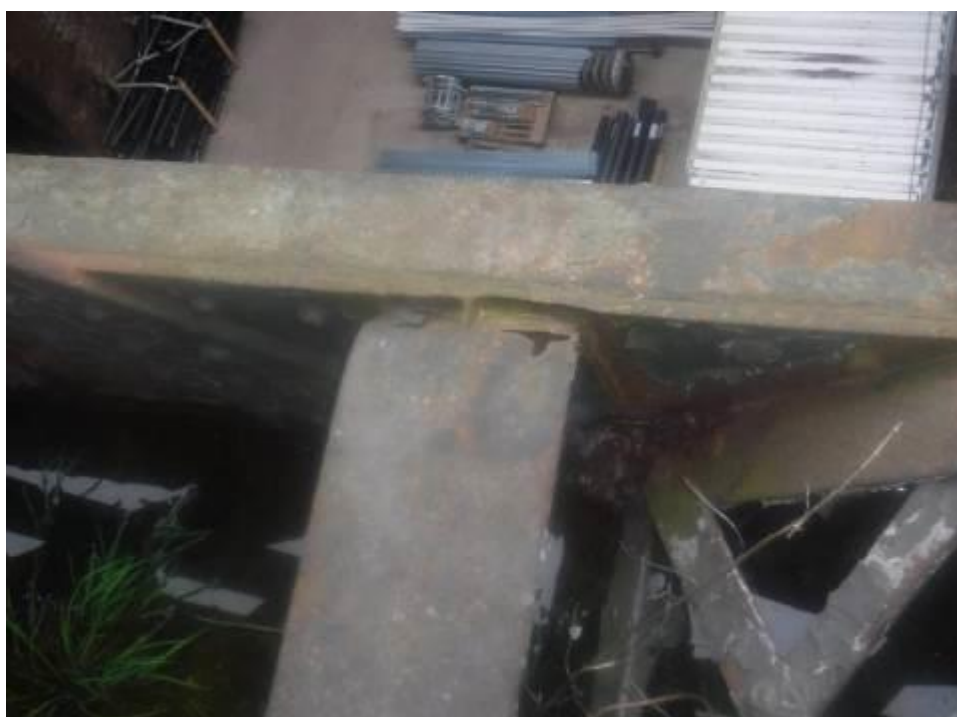
Photograph 172: Loss of section to bottom boom stiffener of south truss of span 8

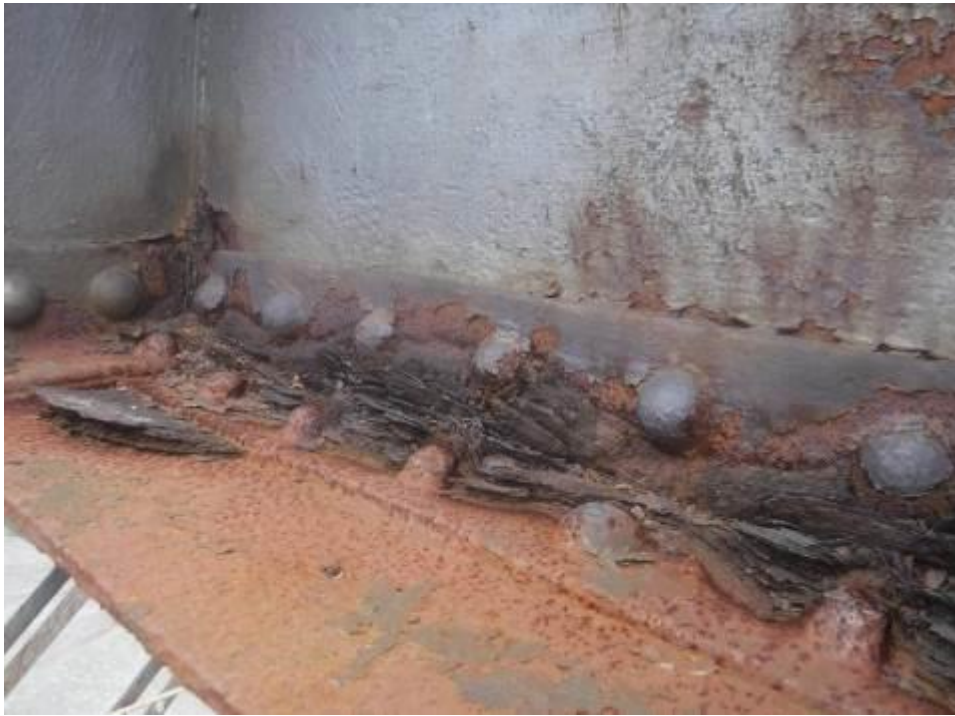
Photograph 175: Typical loss of thickness to west bottom angles of upper transverse steelworks

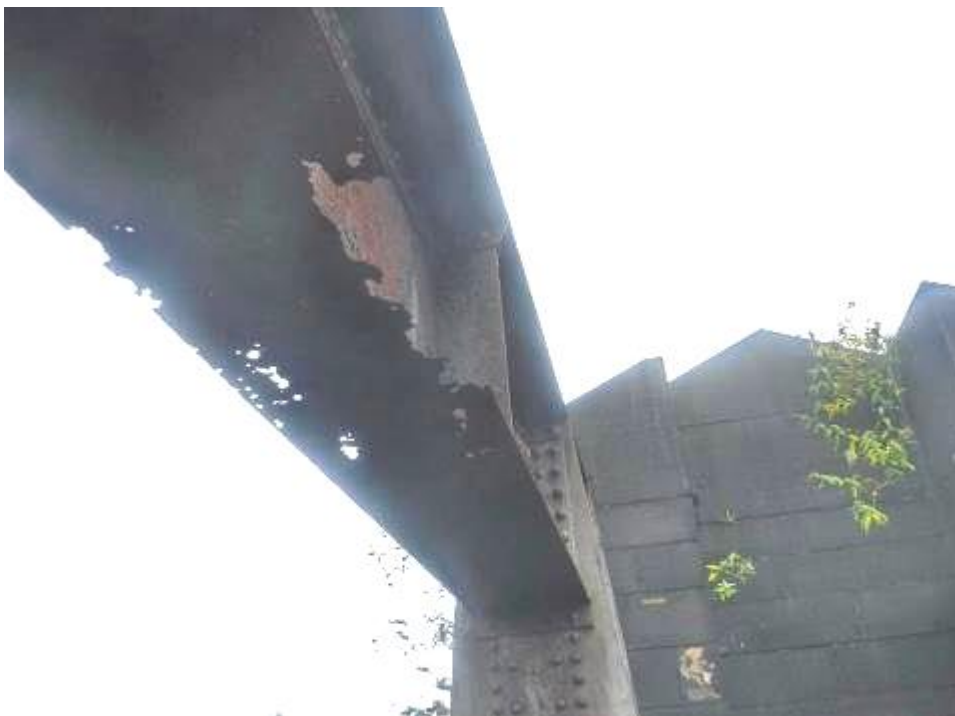
Photograph 176: Loss of section to upper transverse steelwork T1

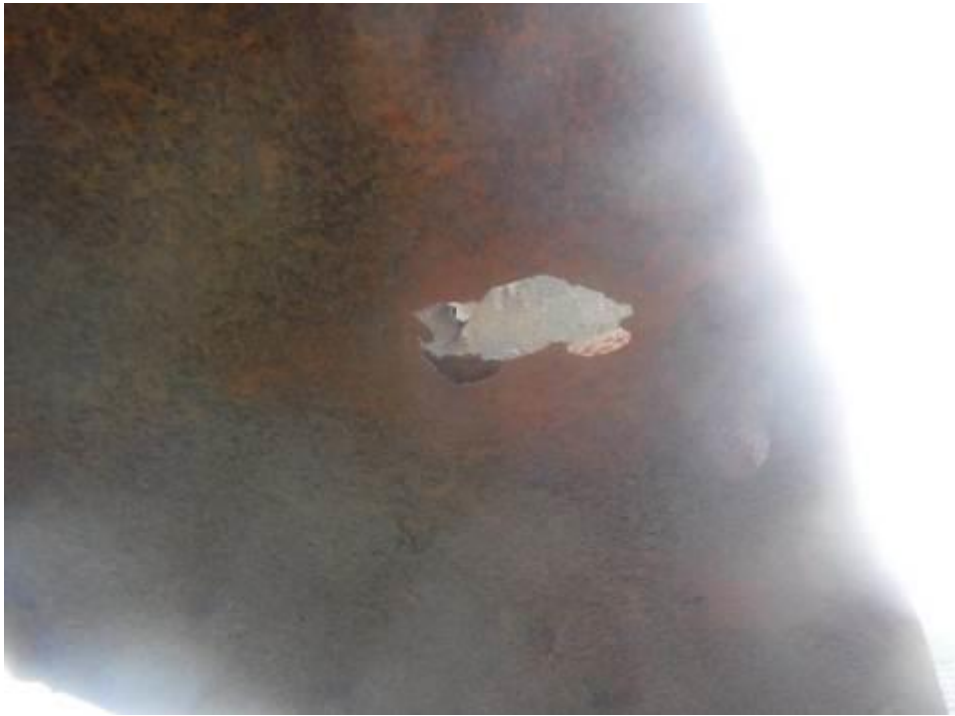
Photograph 177: Loss of section to upper transverse steelwork T21

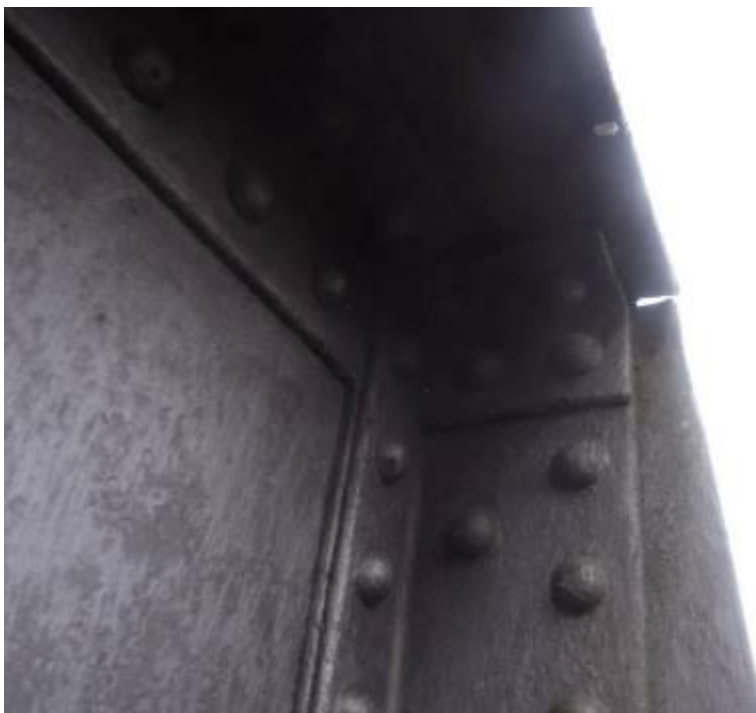
Photograph 178: Loss of section to upper transverse steelwork T27

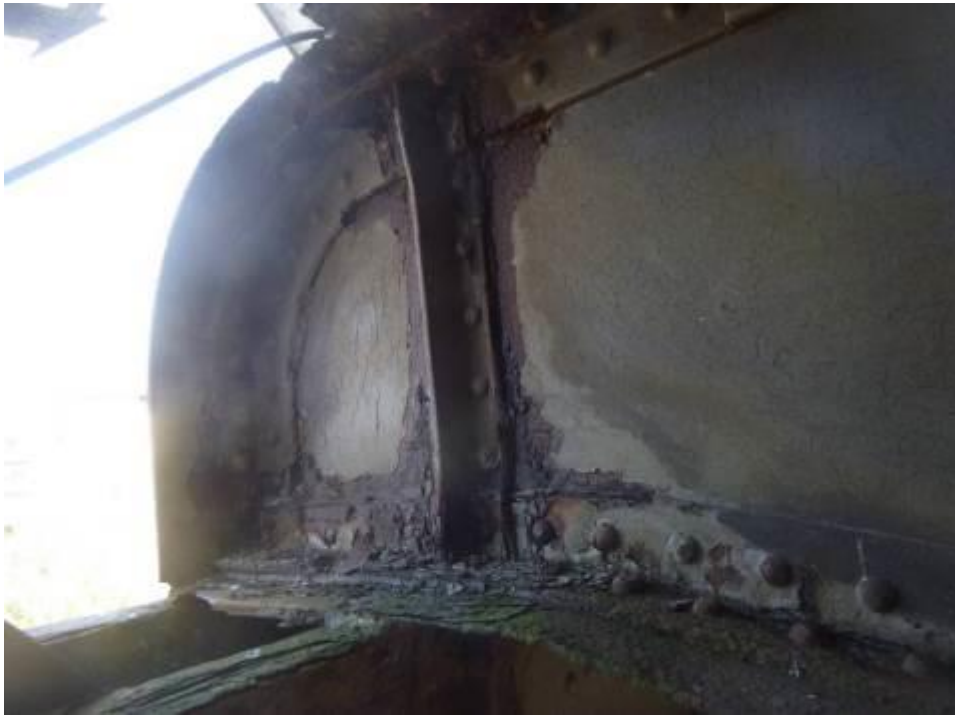
Photograph 179: Typical loss of thickness to transverse girders of soffit of span 2 at MGE connections

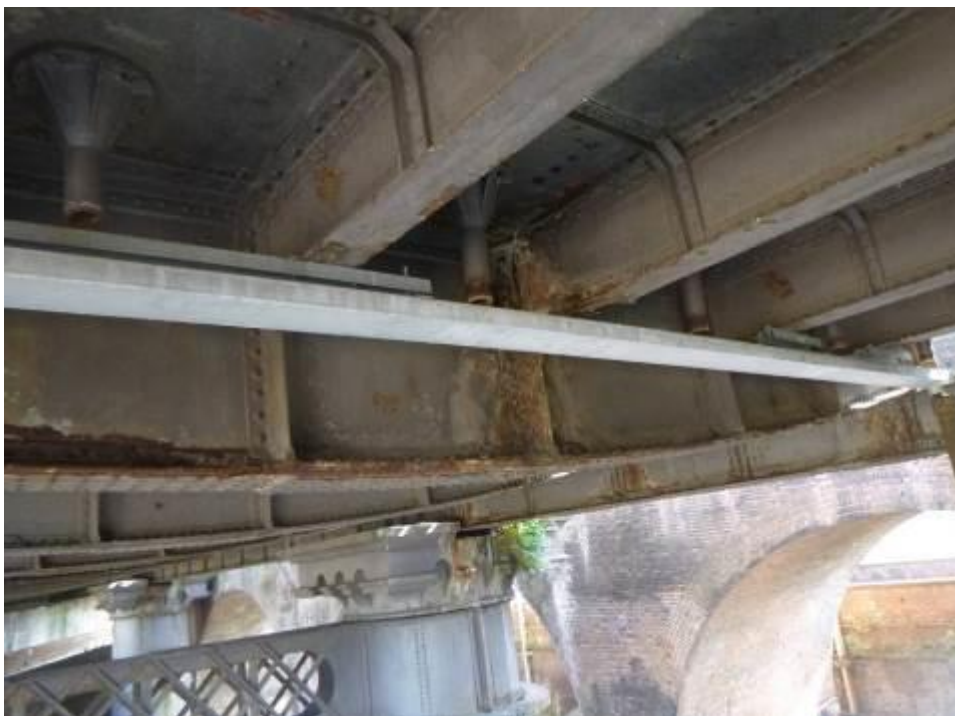
Photograph 180: New gutter system to soffit of span 2

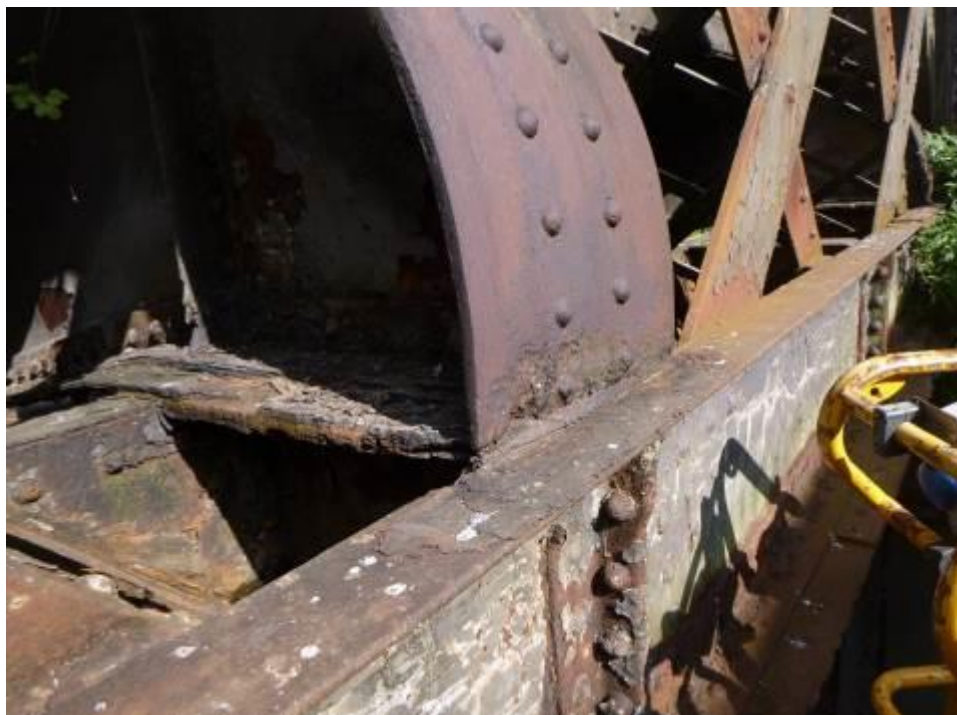
Photograph 181: Loss of thickness to T18 of soffit of span 2

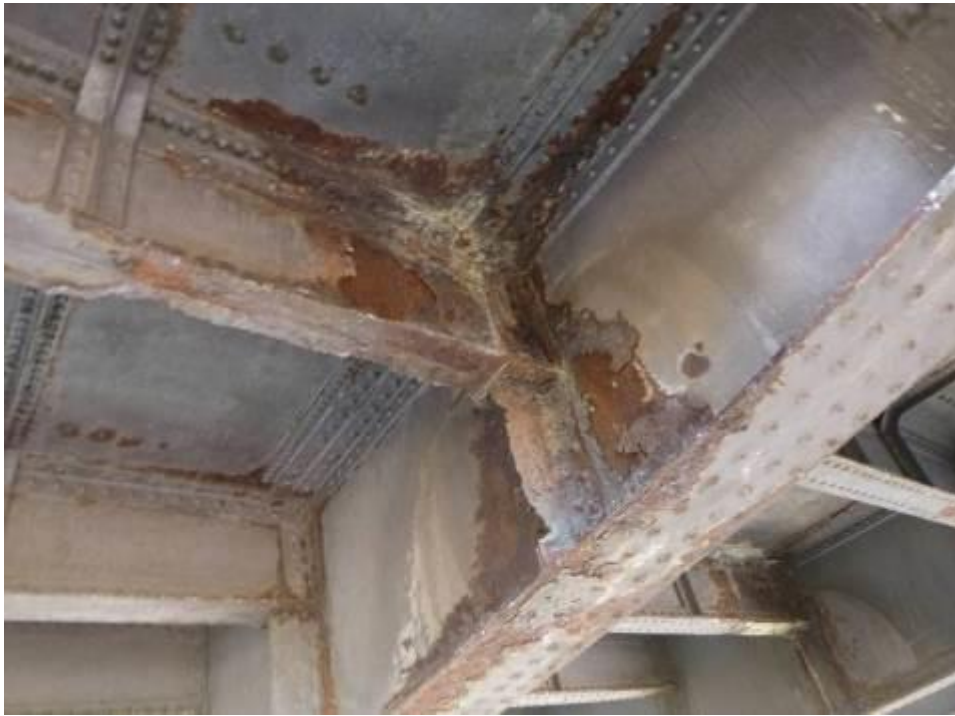
Photograph 183: Loss of thickness & section to T20 & MGI2 of soffit of span 2

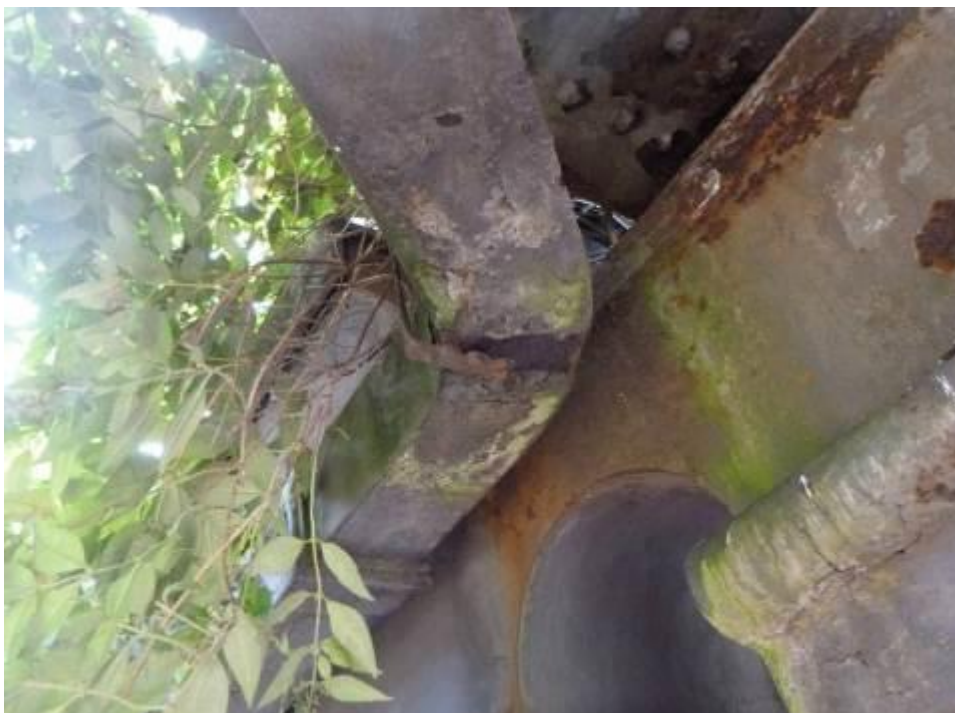
41. The old gutter in between T19 and T20 had knife edging along all the top edges throughout and had completely corroded through at one point towards the north. 2No. brackets had loss of section at the MGE fixing points. **(photo 184)**
42. Bottom flange of MGE to a knife edge over 1200 x 100mm.
43. Vegetation growing within bottom boom with ponding water.

Photograph 184: Loss of section to brackets of old guttering between T19 & T20 of soffit of span 2

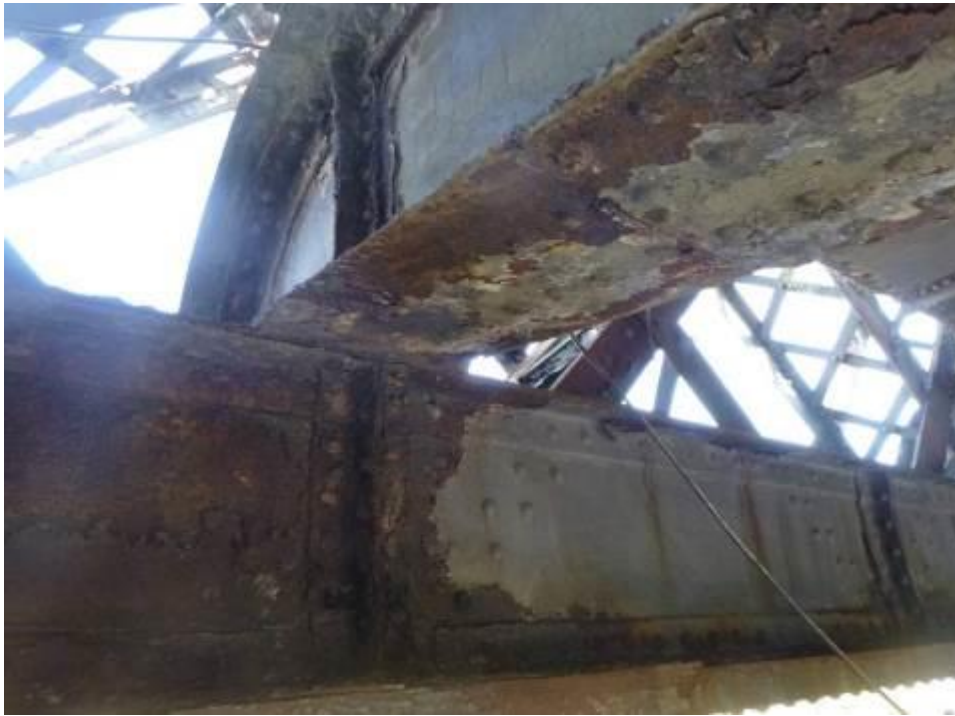
1. There was 7mm loss of thickness over 320 x 200mm of the top flange of T21. There was total loss of section to four rivet heads. There was loss of section to the bottom flange over 150 x 100mm.
2. Below an area of seepage there was 10% loss of thickness to the vertical stiffener and deck plates over the piers. There was 7mm loss of thickness to 1600 x 200mm of the south truss north bottom flange.
3. There was loss of section measuring 130 x 15mm to the lower flange on the west side of T24. The remainder was down to knife edge thickness.
4. There was 7mm loss of thickness to the vertical stiffener beneath the edge of the deck on both sides.
5. There was up to 5mm loss of thickness to the bottom flange and almost complete loss of section to 70% of rivet heads in the area. **(photo 187)**

Photograph 187: Loss of thickness & section to T26 of soffit of span 3

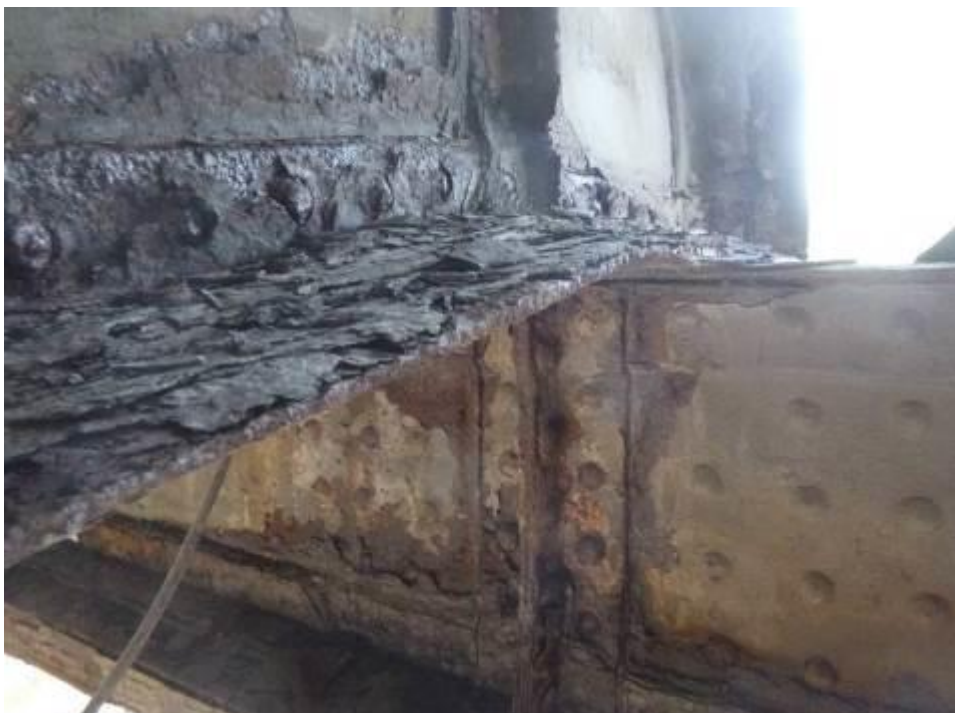
9. The lower flange of T31 over the south truss was in worse condition than general. There was 7mm loss of thickness to 400 x 100mm and 3-4mm pitting to the adjacent (inner) along 600 x 100mm. **(photo 188)**

Photograph 188: Loss of thickness & pitting to T31 of soffit of span 3

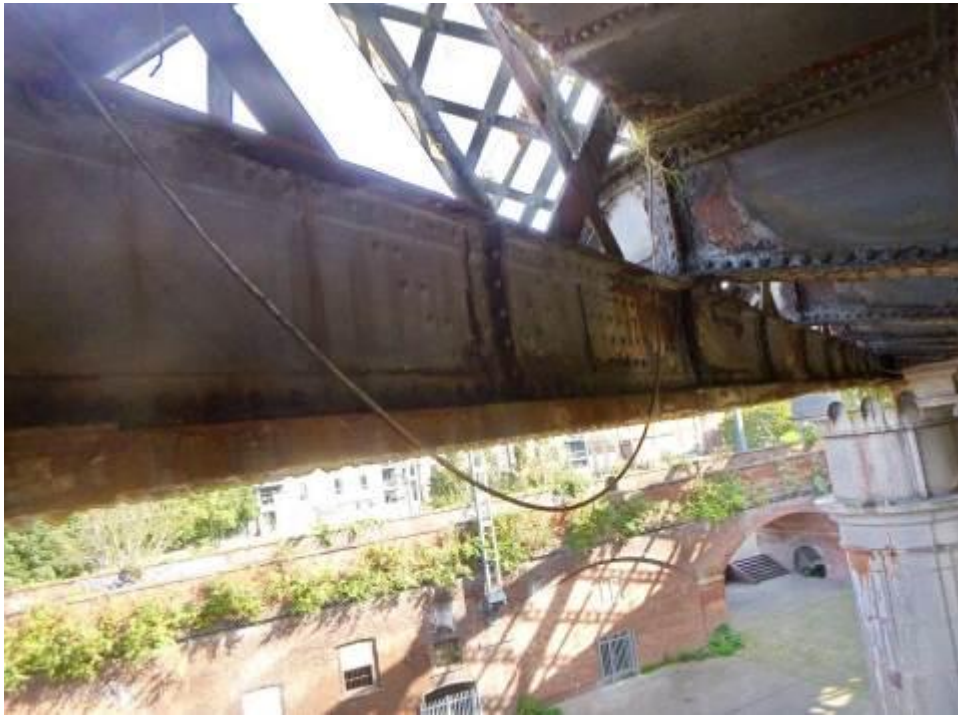
27. Area of loss of thickness to T22 lower flanges reduced over 600 x 700mm, to a knife edge.
28. Loss of section to deck stiffener, 100 x 100mm. Loss of thickness to deck around fault of up to 7mm.
29. There was a lighting cable hanging down by 300mm. [\(photo 191\)](#)
30. There was 8mm loss of thickness to the MGI2, deck and T21 measuring 1000 x 700mm. [\(photo 192\)](#)

Photograph 191: Lighting cable hanging down by MGE2 of soffit of span 3

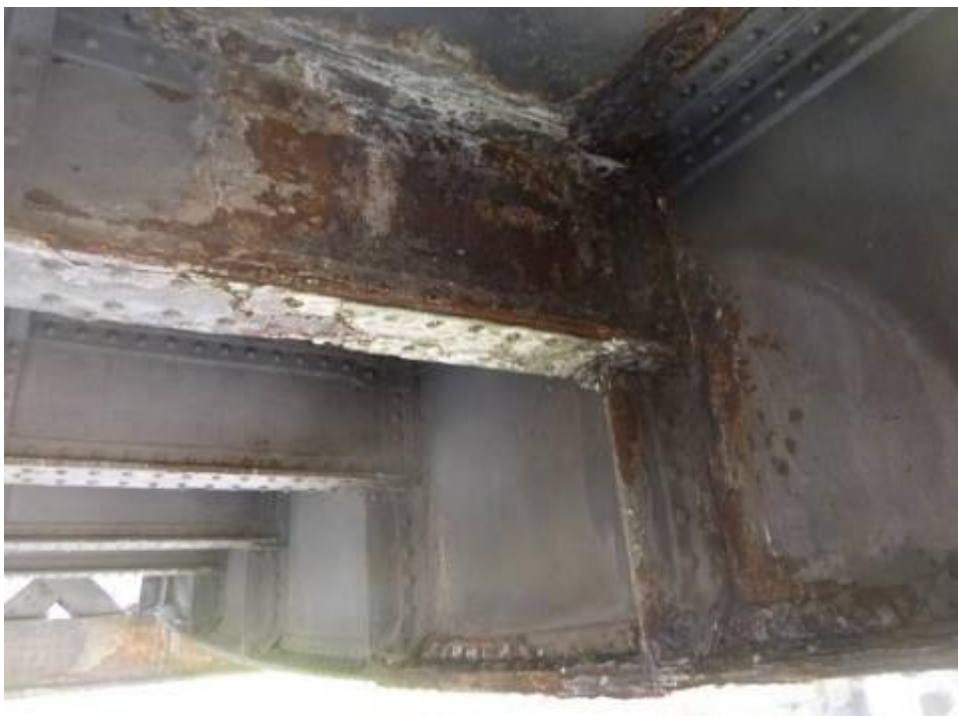
Photograph 192: Loss of thickness to MGI2, deck & T21 of soffit of span 3

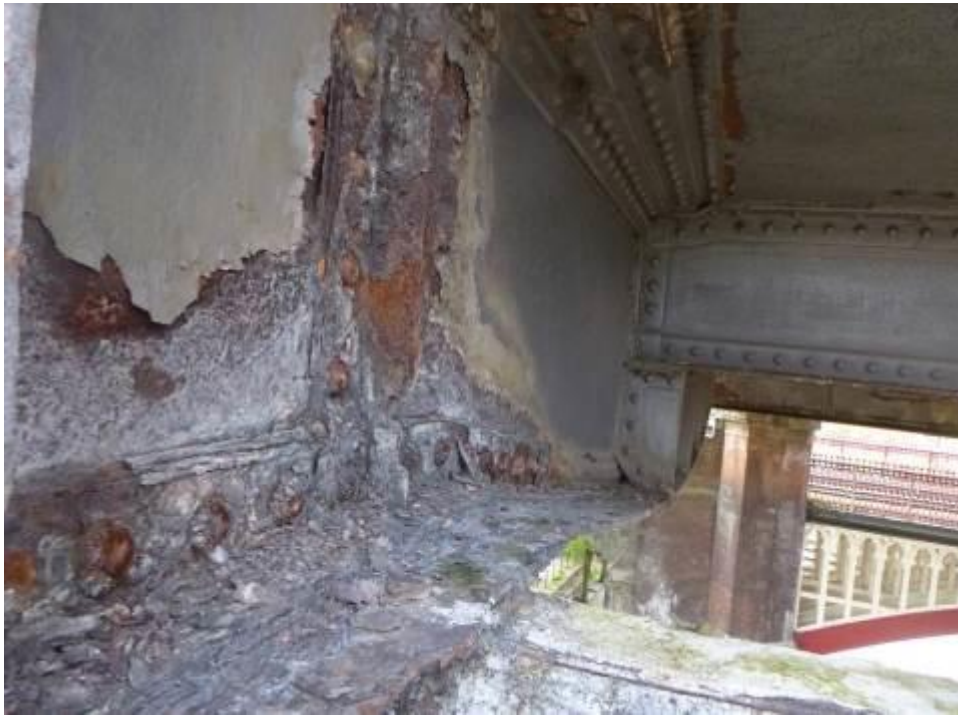
Photograph 195: Loss of thickness to vertical stiffener of T36 to soffit of span 4

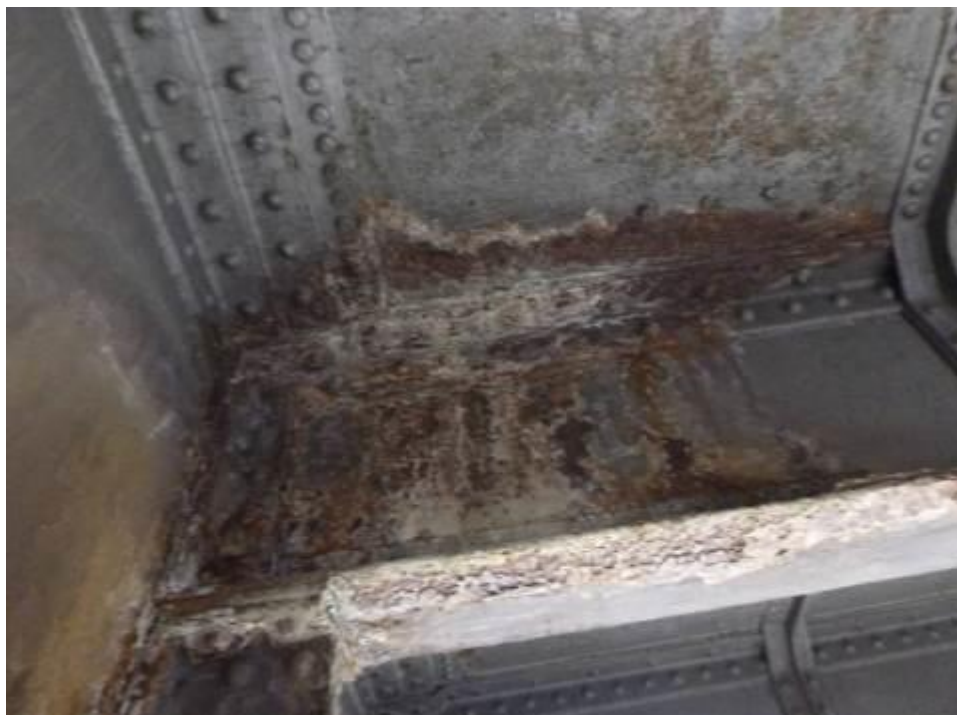
19. There was an area measuring 900 x 100mm with 2-3mm loss of thickness to the top and bottom flanges. There was also 1mm pitting to a 400 x 400mm area on MGI4. **(photo 197)**

Photograph 197: Loss of thickness & pitting to MGI4 of soffit of span 4

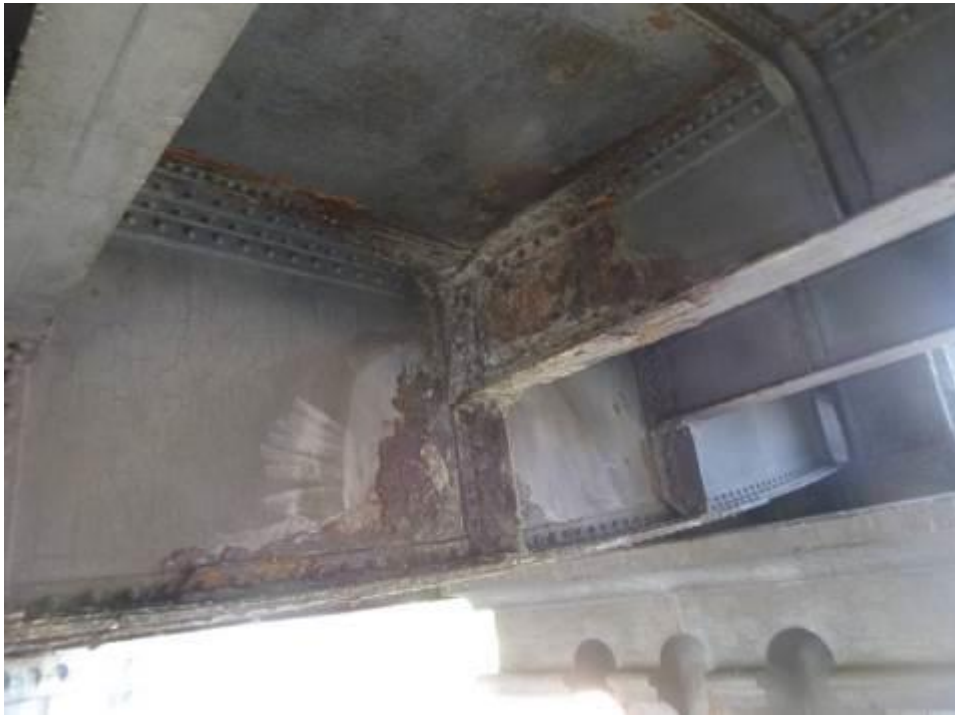
25. There was 5mm loss of thickness over 2000 x 2000mm to T33 at junction with MGI2 with 600 x 30mm loss of section to bottom flange of MGI2. **(photo 199)**

Photograph 199: Loss of thickness to T33 & section to MGI2 of soffit of span 4

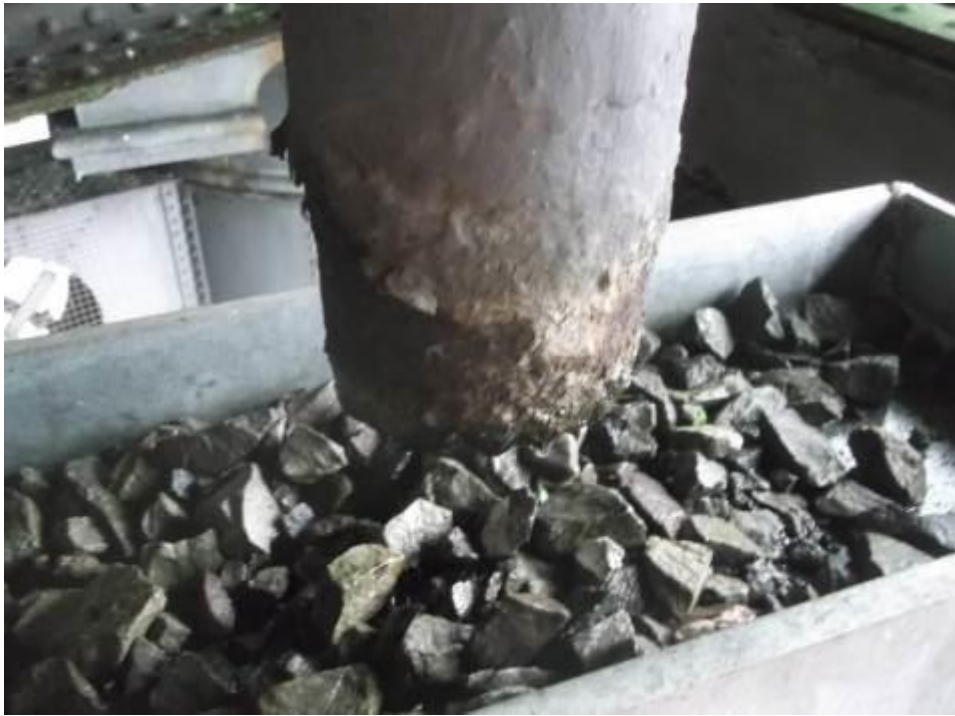
A new gutter system had been installed since the previous detailed examination; this was half full of ballast. **(photos 201)** The inner side of the upper flange on the MGE had up to 7mm loss of thickness over 200 x 200mm. The vertical bracing on the MGE had 100% loss of section over 150 x 50mm and surface corrosion for 350 x 50mm. The lower flange on the transverse edges had up to 3mm loss of thickness over 1000 x 100mm. On the upper flange of the MGE there were four rivets with 100% loss of section. The deck edge / angle / riser had loss of thickness of up to 6mm throughout. **(photo 202)**

Photograph 201: Ballast to new gutter system of soffit of span 5

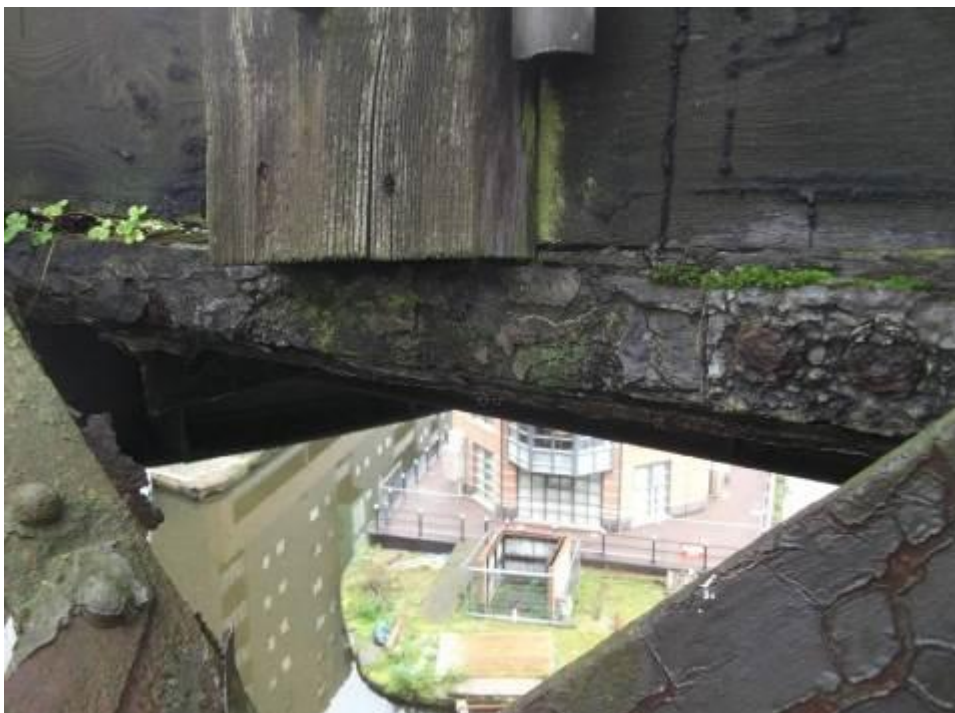
Photograph 202: Typical loss of thickness to deck edge / angle / riser of soffit of span 5

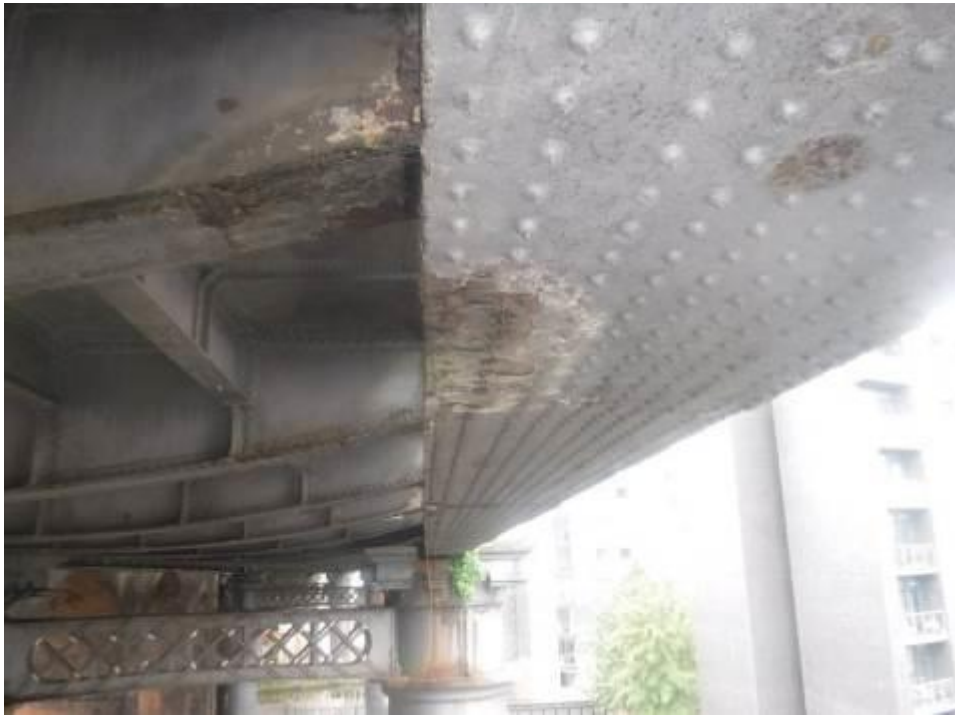
4. At the intersection between MGI1 and T47 there was 100% paint loss and surface corrosion to an area measuring 400 x 200mm. [\(photo 204\)](#)
5. There was 2mm loss of thickness over 1000 x 300mm to the bottom flange of MGE1, this defect repeated sporadically throughout the girder. [\(photo 205\)](#)

Photograph 205: Loss of thickness to MGE1 of soffit of span 5
