| ELR: MAJ | Structure No: 289 | Mileage: | Examination date: 07/09/2020 |
| Name: Castlefield Viaduct | | | Type: Viaduct |
| Carrying/Over: Disused rail / Canal, rail, road & land | | | No. of spans: 8 |

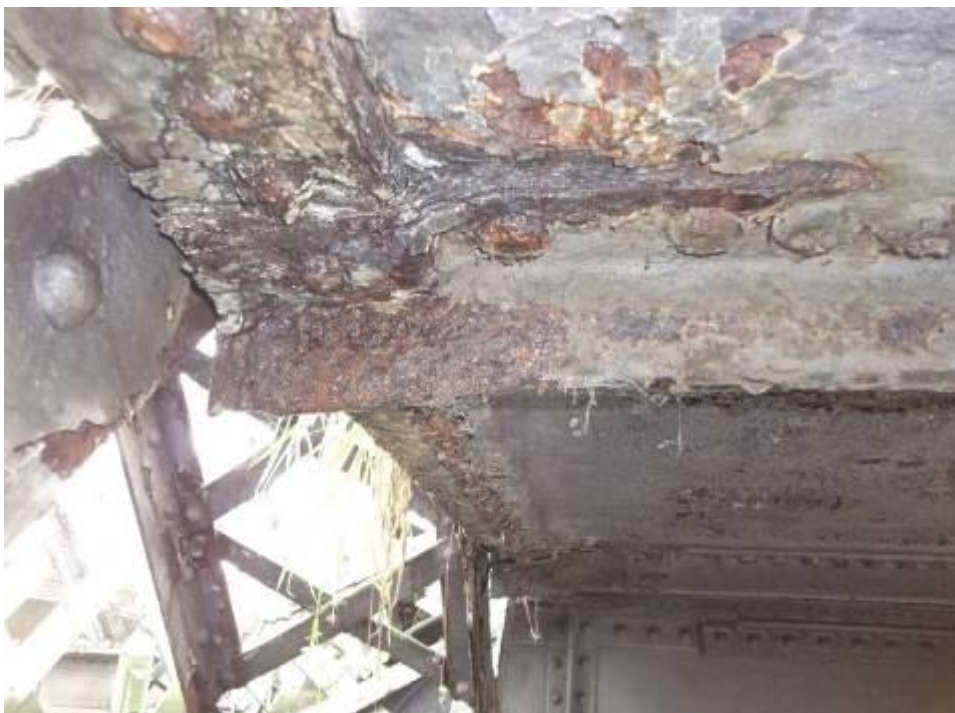
11. There was 5mm loss of thickness to bottom flange of MGE over 400 x 100mm with loss of section, 400 x 80mm. [\(photo 206\)](#)
12. Loss of thickness to deck stiffener of up to 10mm, 1000 x 6mm.

Photograph 206: Loss of thickness & section to MGE2 of soffit of span 5

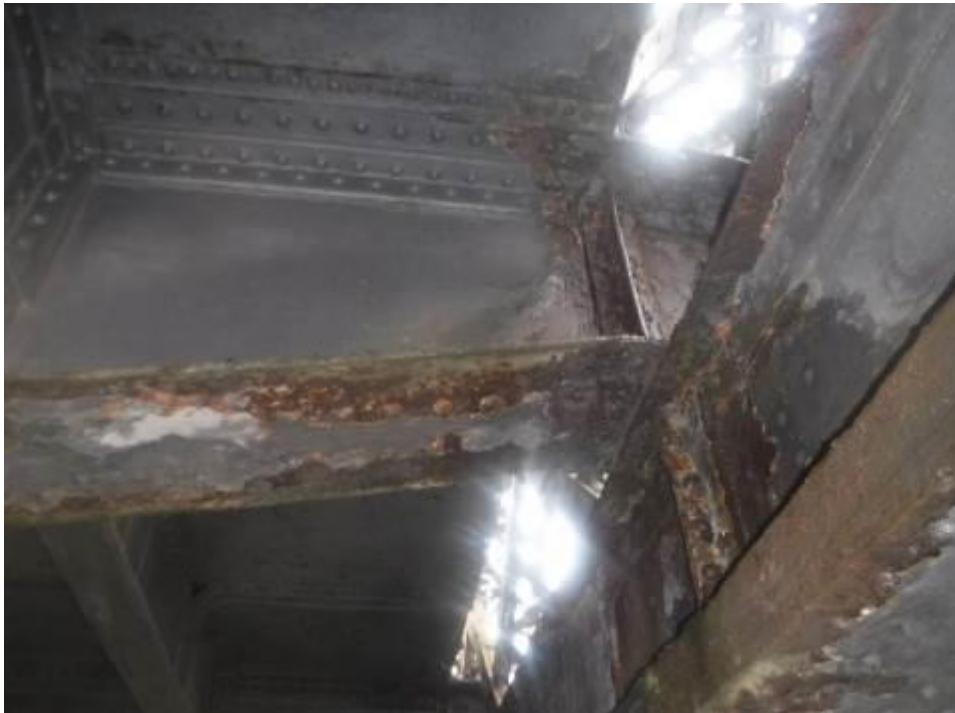
There was 6mm loss of thickness to 150 x 100mm of the upper flange on the inner section of the MGE. There was 4mm loss of thickness to 350 x 100mm of the lower flange on the MGE. (photo 207) There was 15% loss of paint work, 10% cracked paintwork, 1% spotting corrosion and 3% exposed steel corrosion with up to 2mm pitting to the transverses.

Photograph 207: Typical loss of thickness to T50 – T57 at MGE connections to soffit of span 6

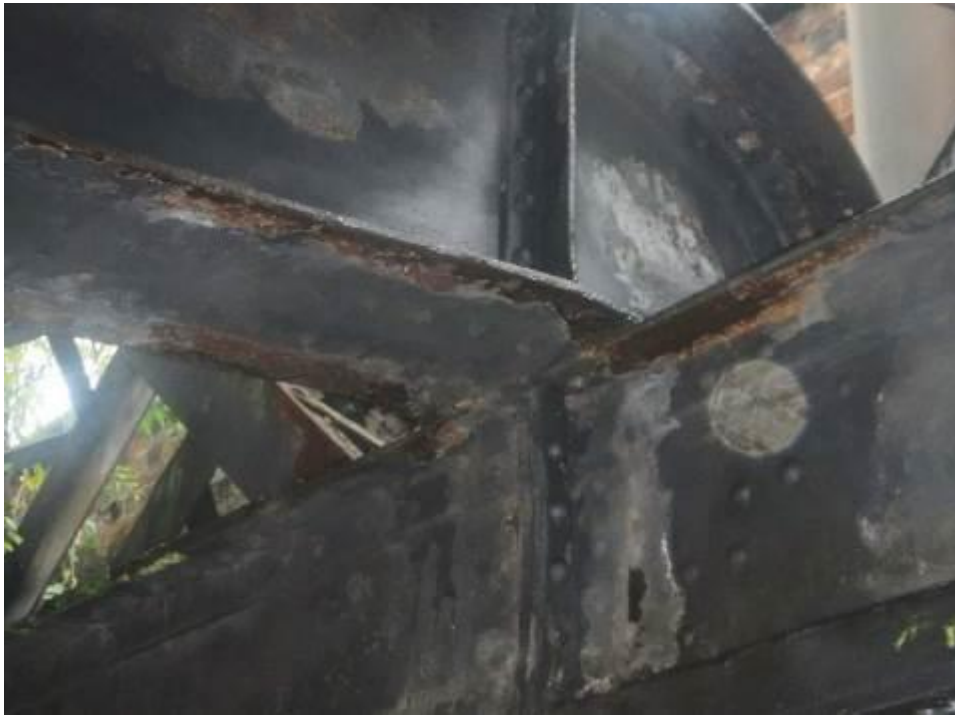
17. There was 3mm loss of thickness over 120 x 100mm the top and bottom flanges of the transverse which connected to the lower boom.
18. There was 3mm loss of thickness over 120 x 100mm the top and bottom flanges of the transverse which connected to the lower boom. **(photo 209)**

Photograph 209: Loss of thickness to T57 at MGE2 connection to soffit of span 6

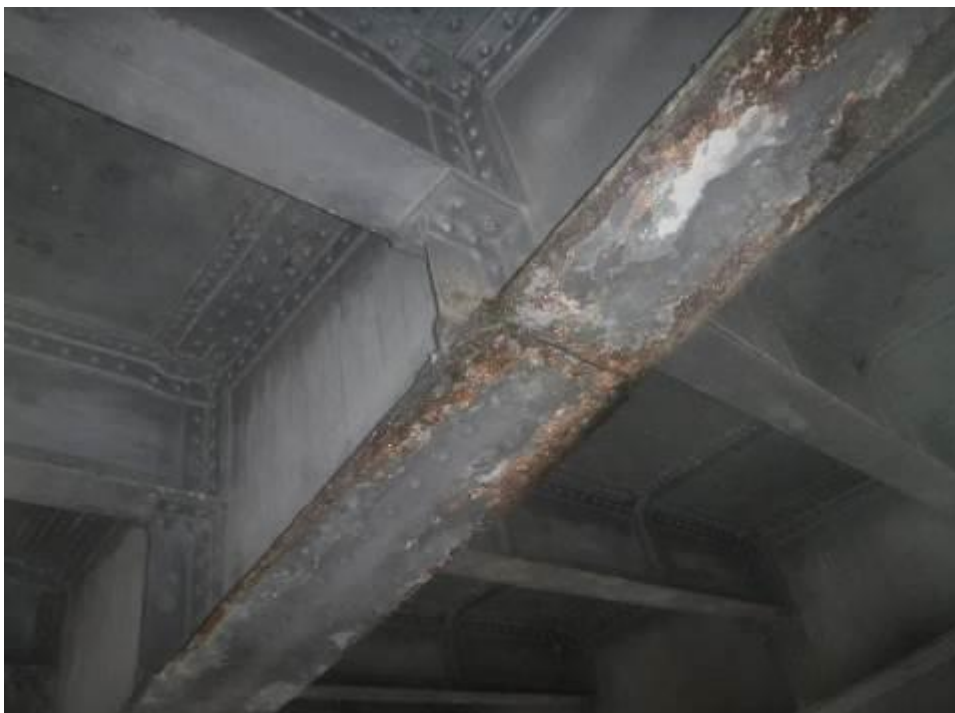
30. There was corrosion and up to 2mm pitting over 800 x 200mm of MGI2.
31. There was corrosion over an area measuring 400 x 100mm on the lower flange of T57 near MGI2. [\(photo 210\)](#)

Photograph 210: Corrosion to T57 of soffit of span 6

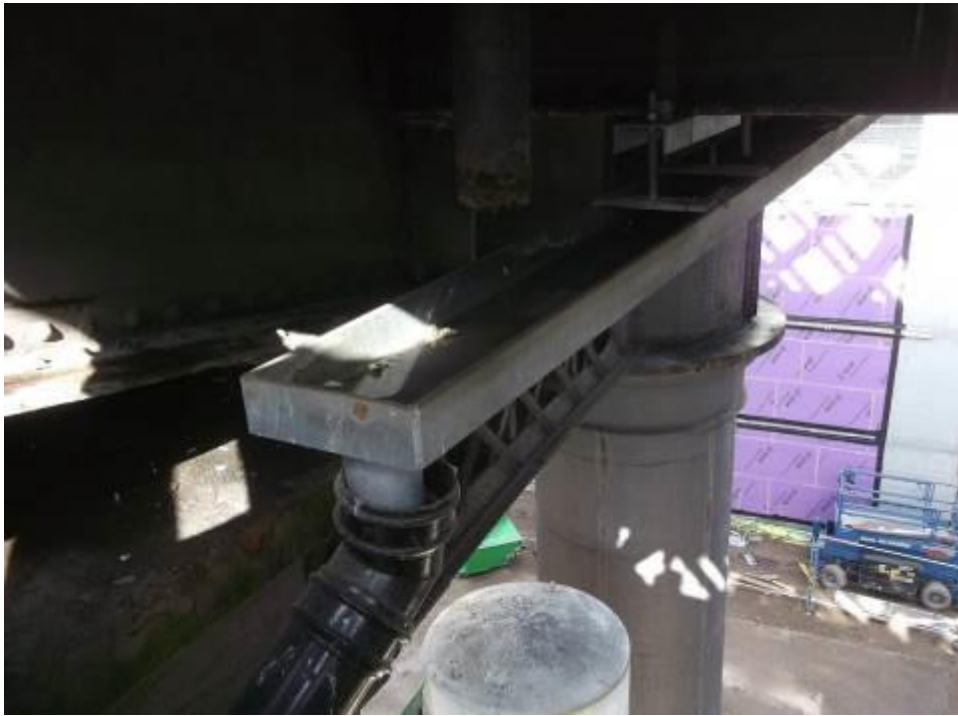
A new gutter system had been installed since the previous detailed examination. [\(photo 211\)](#) Where the transverse beams met the north main girder, there was loss of thickness of up to 2mm with some minor spots of loss of section at the overlap with MGE1. All transverse girders had minor loss of section to top and bottom flanges and loss of thickness to flange angles, first stiffeners and web edges. Deck stiffeners to the edges had loss of thickness typically 300 x 80 x up to 3mm. [\(photo 212\)](#)

Photograph 211: New gutter system to soffit of span 7

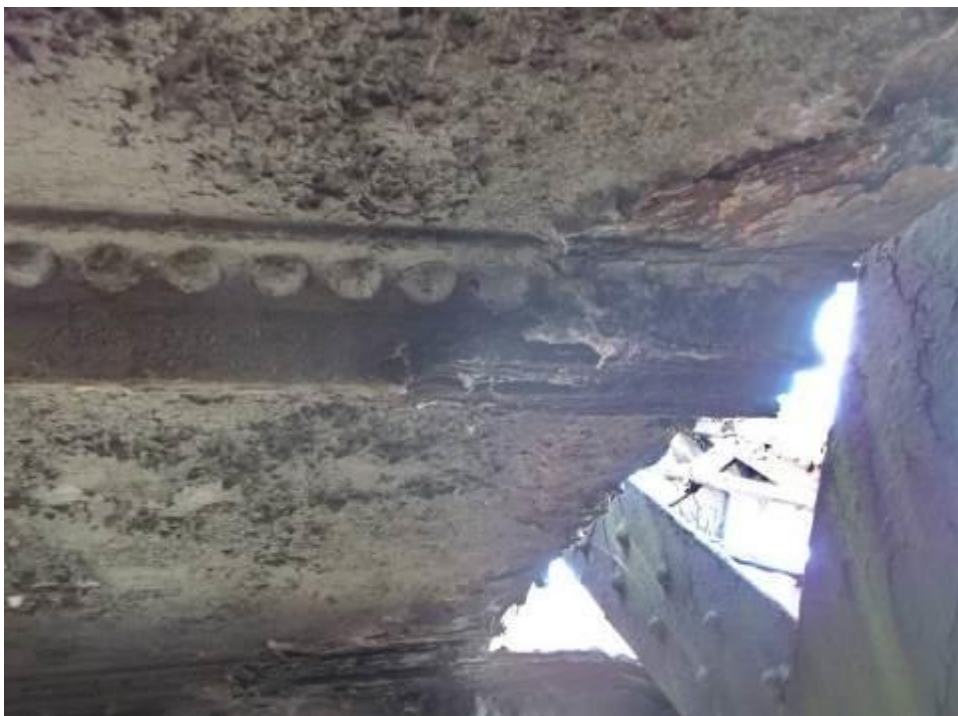
Photograph 212: Typical loss of thickness to deck stiffeners to edges of soffit of span 7

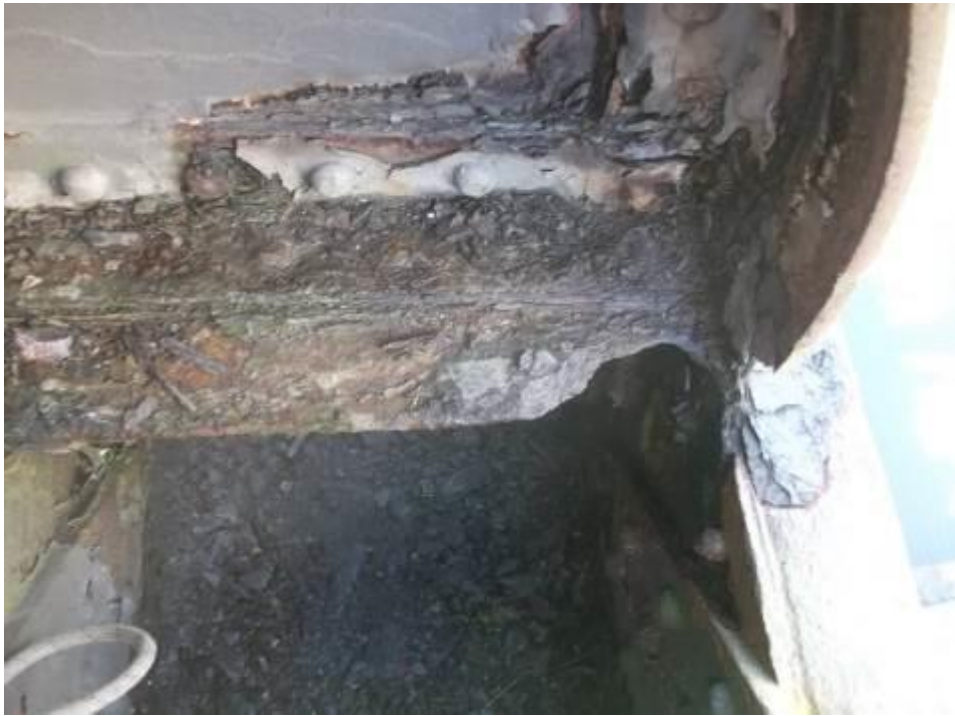
10. Severe loss of thickness with frequent loss of section (up to 300 x 100mm) to braces within MGE1 between T66 and T70.
11. There was 100% paint loss and up to 12mm loss of thickness to an area measuring 3000 x 200mm on the bottom flange of T66. There was loss of section to 120 x 60mm. **(photo 213)**

Photograph 213: Loss of section to T66 of soffit of span 7

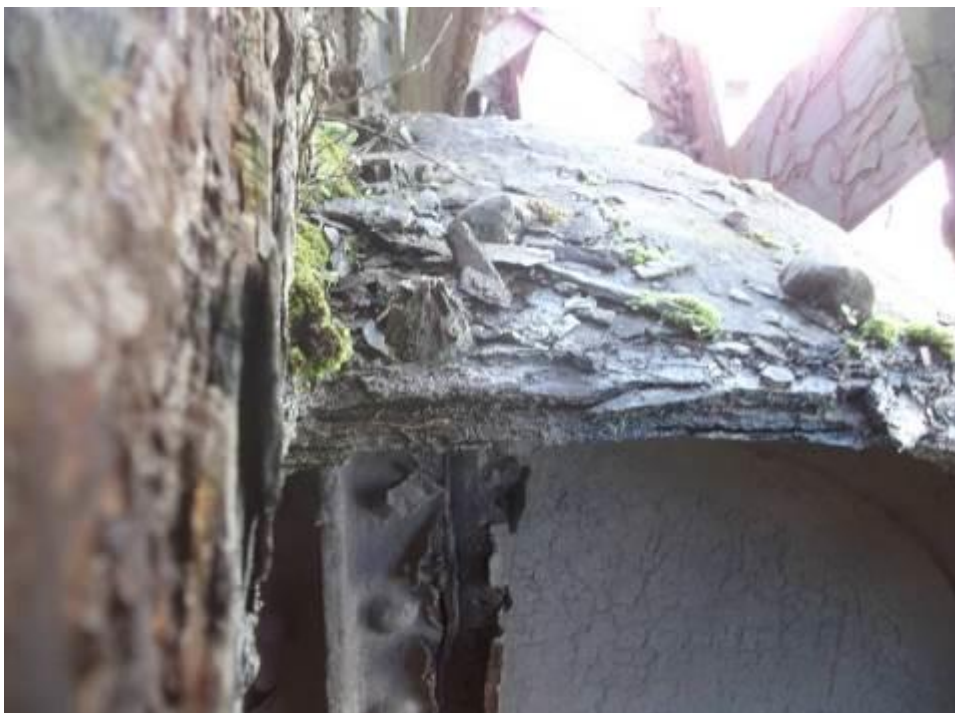
12. Loss of thickness of up to 10mm to bottom flanges, top flanges and stiffener of T64 with loss of section to top flange of 70 x 40 on both sides, loss of section to bottom flange of 450 x 30 on both sides and complete loss of section to rivets on outer face. **(photo 214)**

Photograph 214: Loss of thickness to T64 of soffit of span 7

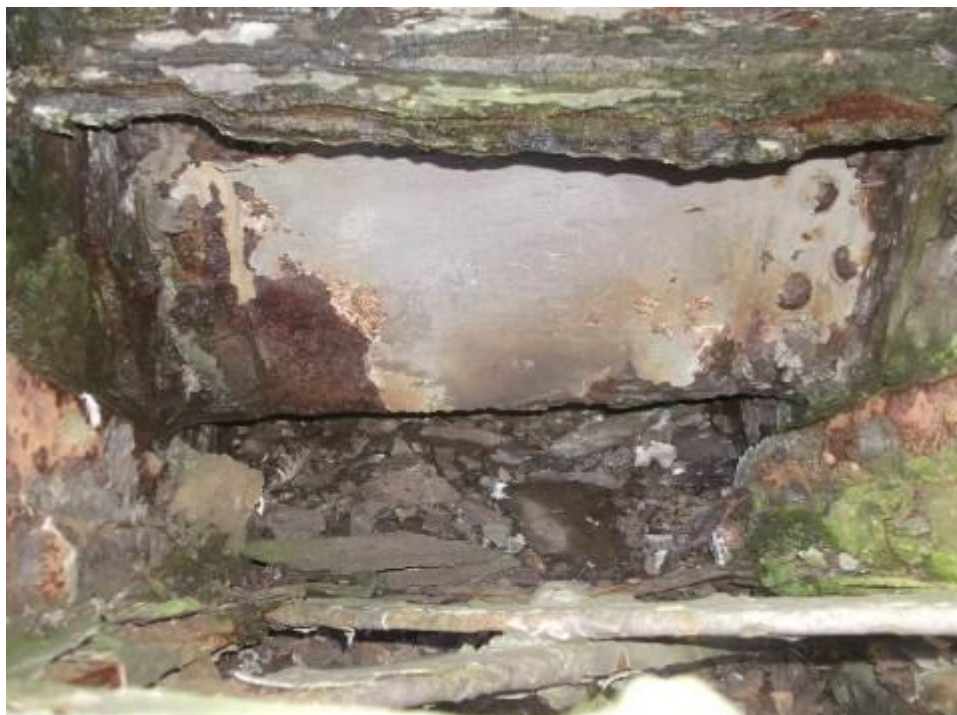
15. Loss of section to internal braces within MGE1 between T63 and T64, typically 20 x 20mm. **(photo 215)**
16. Loss of section to bottom flange of MGE1 below T63, 1000 x 100mm, and loss of section to top flange in same location, 250 x 70mm.

Photograph 215: Typical loss of section to MGE1 internal braces between T63 & T64 of soffit of span 7

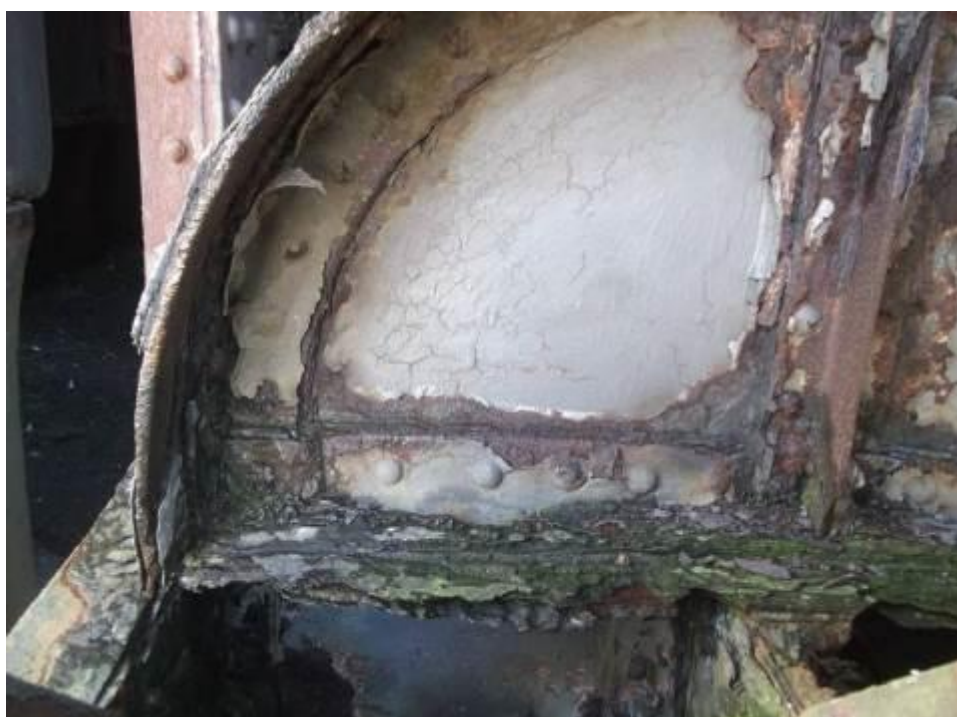
17. Loss of section to either side of bottom flange of T63 at junction with MGE1, 500 x 95mm and 150 x 80mm. There was 50% paint loss and 5mm loss of thickness to an area measuring 700 x 250mm on the stiffener and web of T63. **(photo 216)**

Photograph 216: Loss of thickness & section T63 at MGE1 connection of soffit of span 7

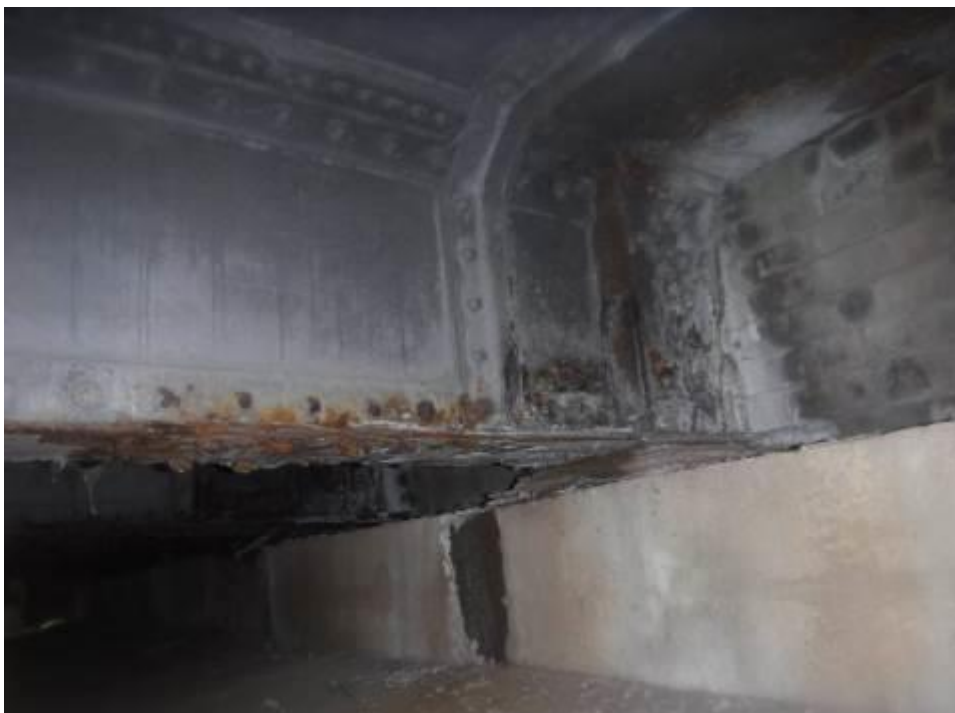
A new gutter system had been installed since the previous detailed examination. Loss of thickness to upper flange of lower boom of MGE1 to a depth of 3 to 4mm, 80% of boom affected. Deck edges & risers were typically in poor condition with 250mm wide strips of heavy corrosion to plate, angle, rivets & deck stiffeners. **(photo 217)** MGIs at bearing points had loss of thickness to back plates, top flanges and stiffeners, typically 500 x 300 x up to 6mm, loss of section to back plates averaging 200 x 20mm, loss of thickness to bottom flanges typically 1000 x 200 x up to 8mm and loss of section to bottom flanges averaging 500 x 20mm. **(photo 218)**

Photograph 218: Typical loss of thickness & section to MGIs at bearing points of soffit of span 8

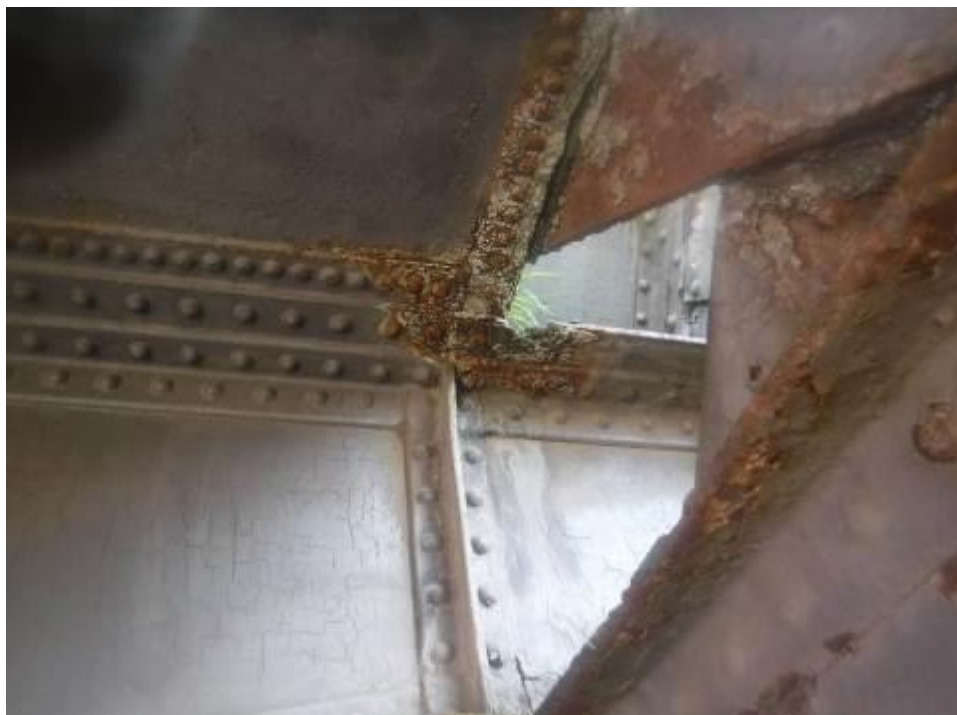
1. There was 4mm loss of thickness to the top flange of T74 over an area measuring 400 x 120mm and loss of section over 100 x 40mm. **(photo 219)**
2. There was 3mm loss of thickness to the lower flange of T74 over an area measuring 250 x 250mm.

Photograph 219: Loss of thickness & section to T74 of soffit of span 8

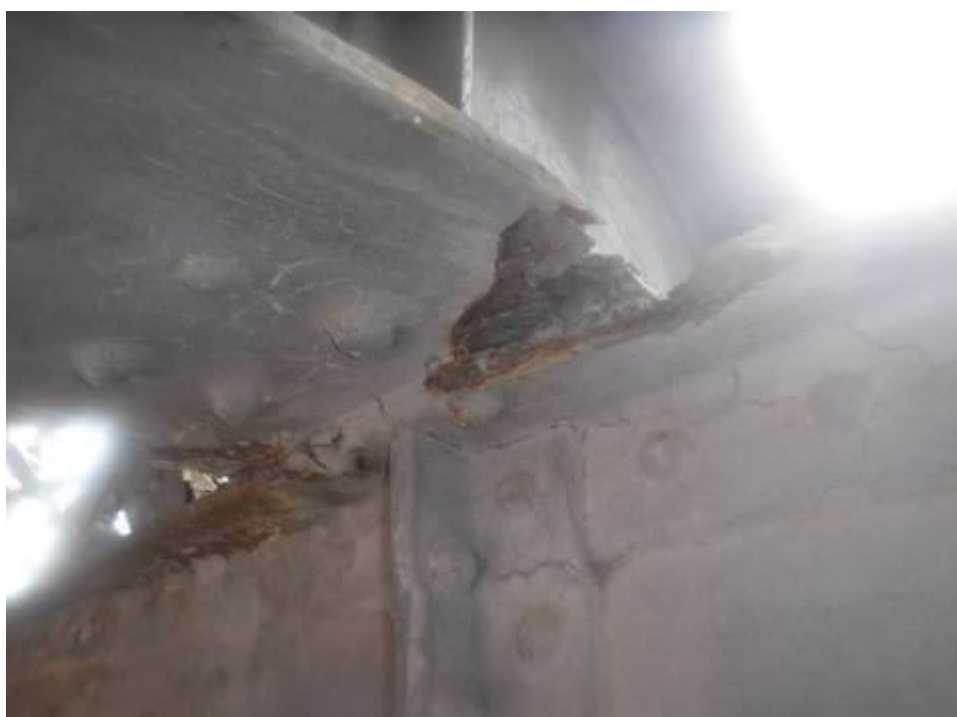
11. There was 4mm loss of thickness to the top flange of T80 over an area measuring 400 x 100mm. There were six missing or spiked rivets.
12. There was loss of section measuring 100 x 80mm to the lower flange of T80. **(photo 220)**

Photograph 220: Loss of section to T80 of soffit of span 8

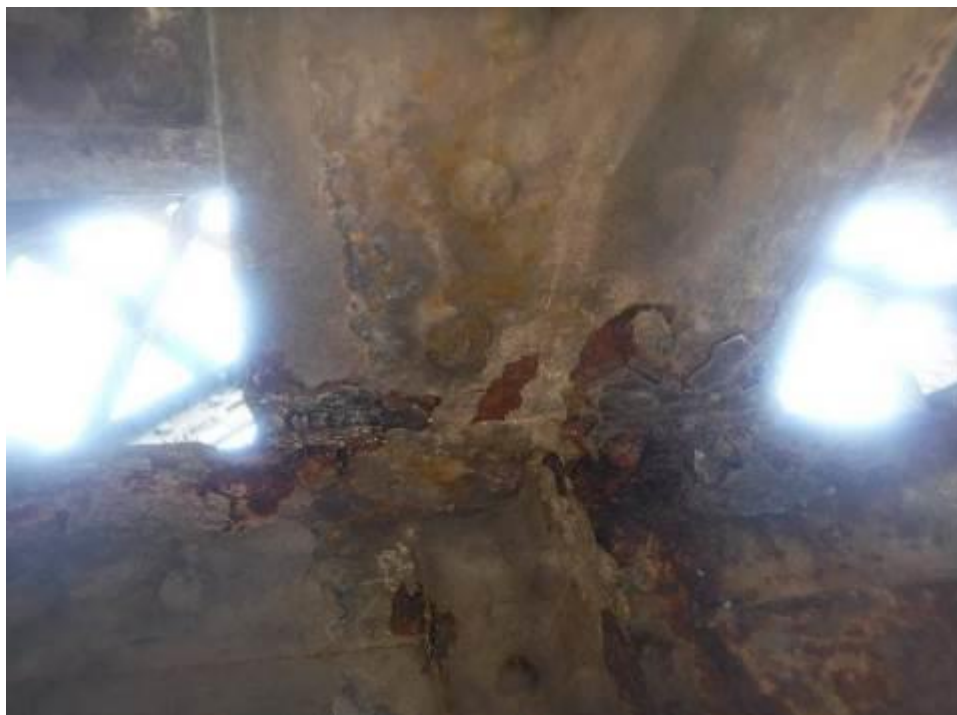
31. There was loss of section measuring 40 x 30mm to the lower flange of T78. **(photo 221)**

Photograph 221: Loss of section to T78 of soffit of span 8

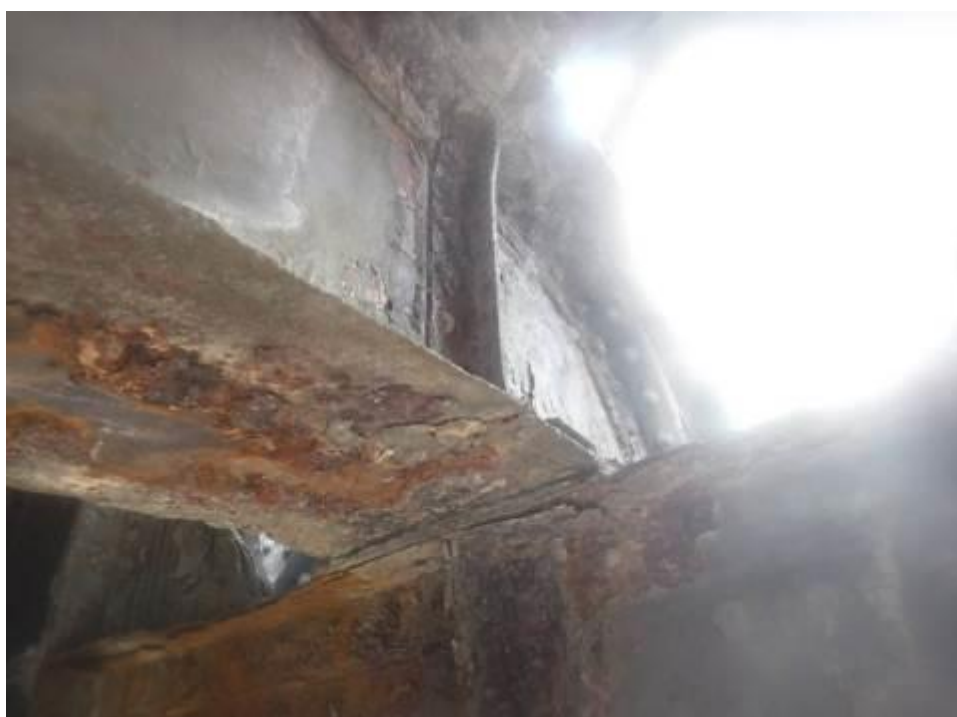
50. There was 4mm loss of thickness over an area measuring 400 x 800mm to the top flange of T84. There were fourteen missing or spiked rivets.
51. There was 3mm loss of thickness over an area measuring 900 x 150mm to the lower flange of T84. [\(photo 222\)](#)

Photograph 222: Loss of thickness to T84 of soffit of span 8

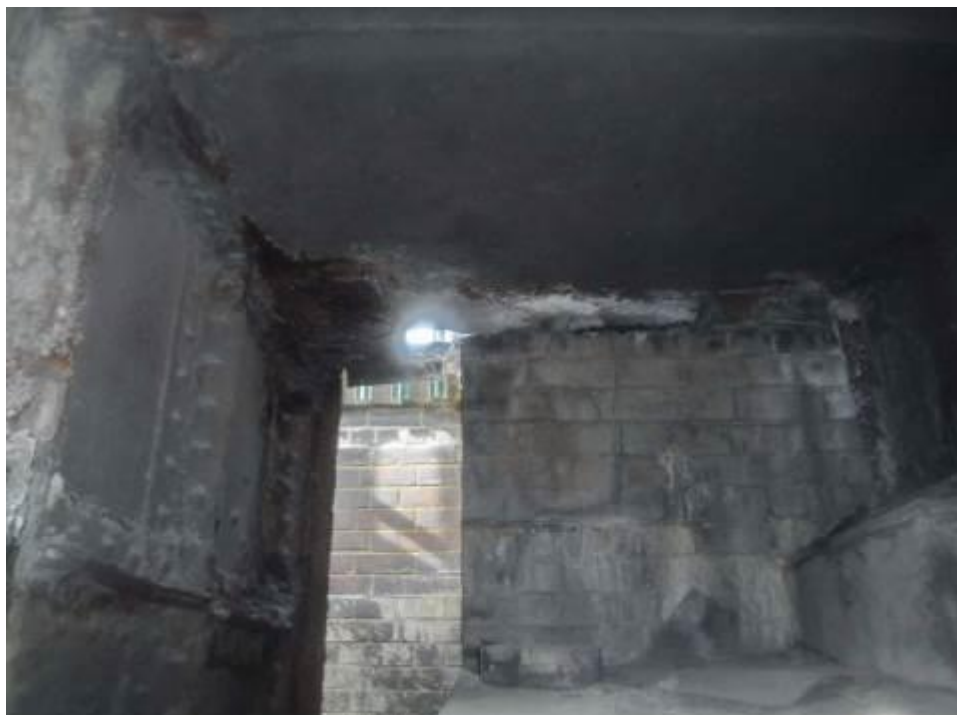
52. Up to 60% of the paint work was crazed and there was spot corrosion to 1mm depth.
53. There was loss of section measuring 300 x 300mm to the deck. [\(photo 223\)](#)

Photograph 223: Loss of section to deck of soffit of span 8

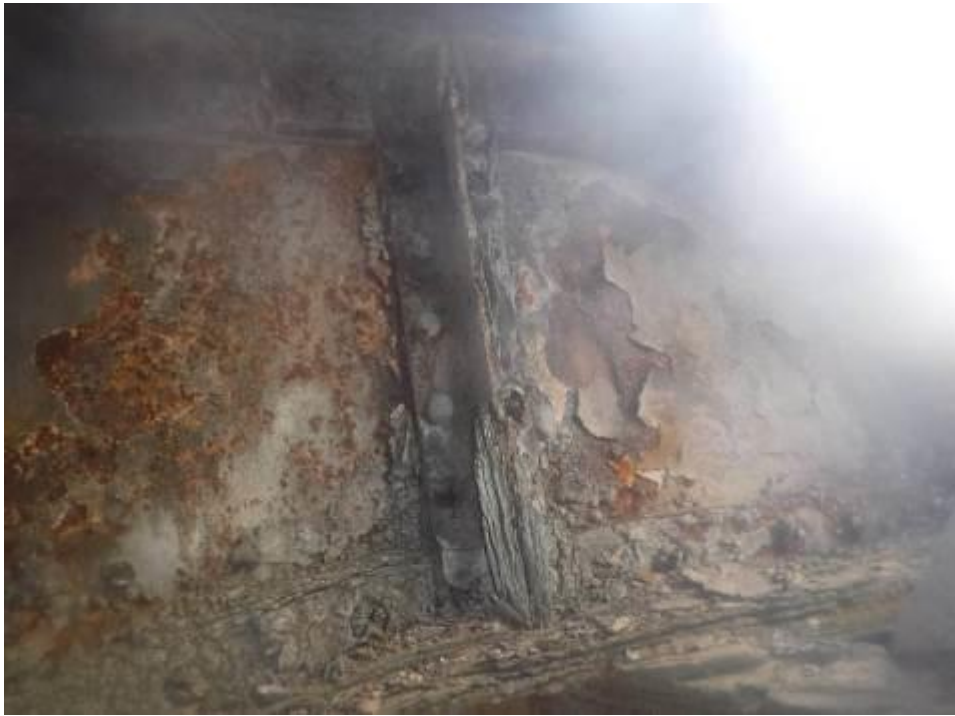
87. Area between T74 & T76 – connection with MGE poor, heavy loss of thickness throughout with rust debris to bottom flange, rivet heads spiked & missing. [\(photo 225\)](#)

Photograph 225: Typical loss of thickness to T74 – 76 at connection with MGE1 of soffit of span 8

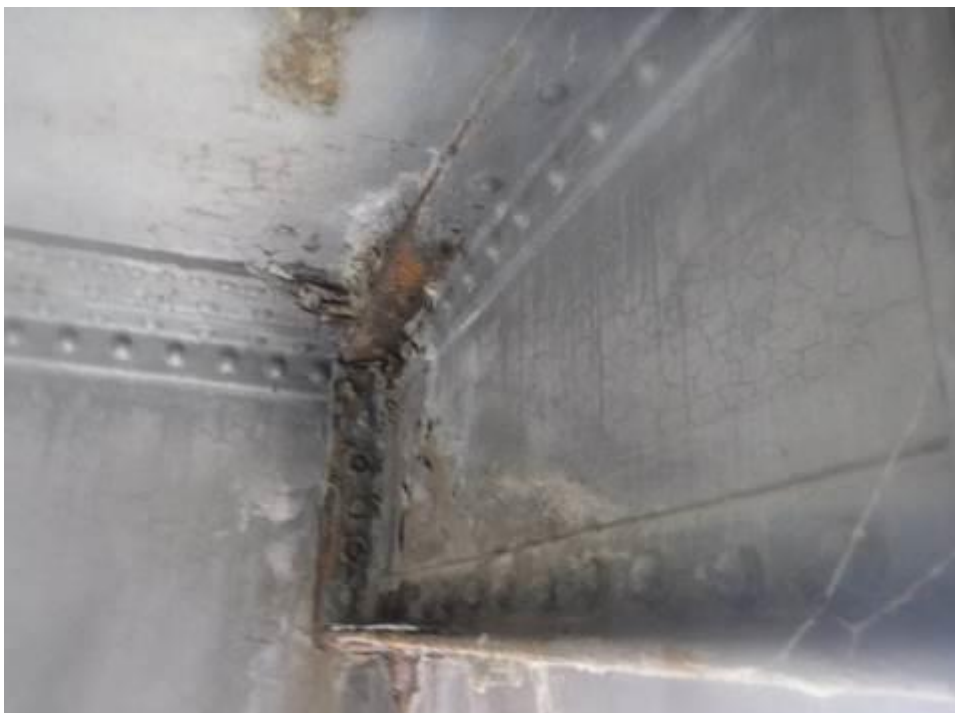
88. There was 3mm loss of thickness over 500 x 300mm to MGI / T81 / deck. [\(photo 226\)](#)
89. There was 4mm loss of thickness over 1200 x 750mm to the deck with loose rust debris to the top of ballast wall. [\(photo 227\)](#)

Photograph 226: Loss of thickness to MGI3 / T81 / deck of soffit of span 8

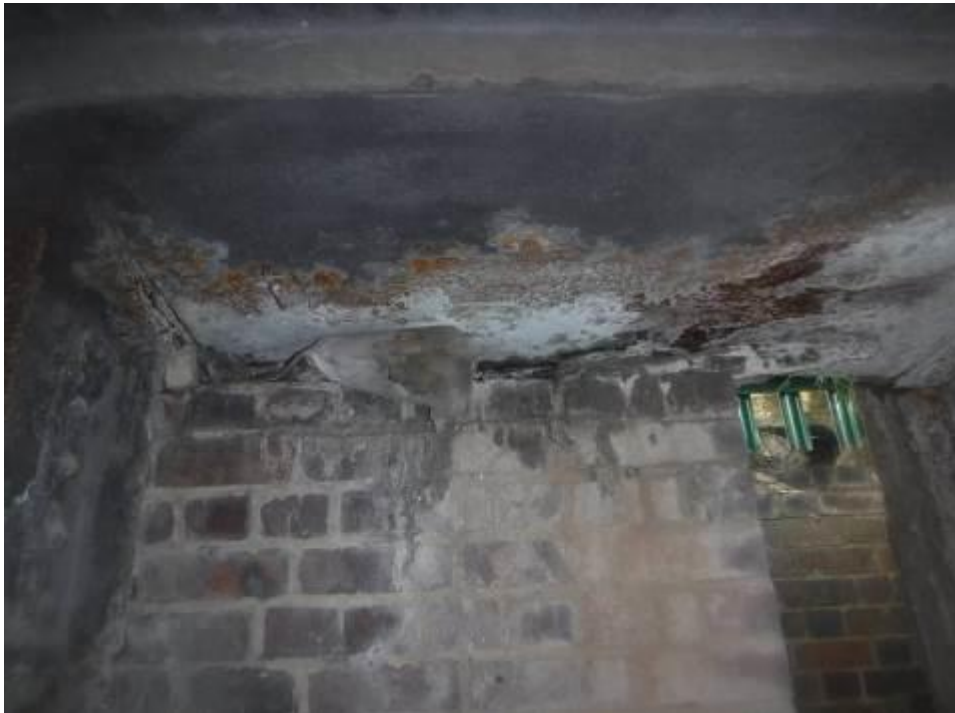
Photograph 227: Loss of thickness to deck & loose rust debris to ballast wall of soffit of span 8

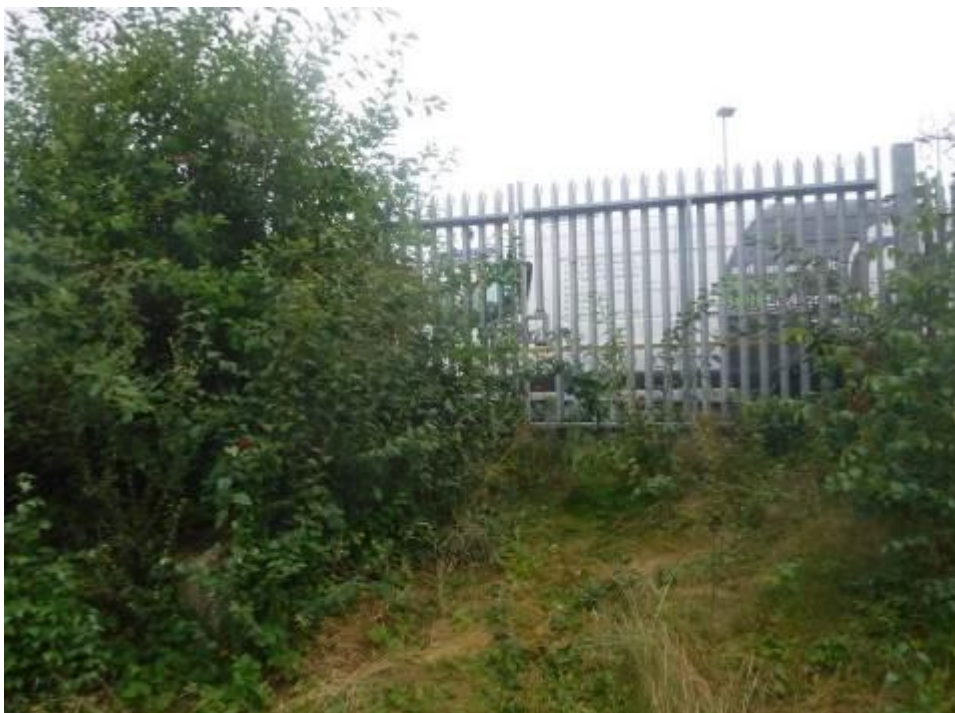
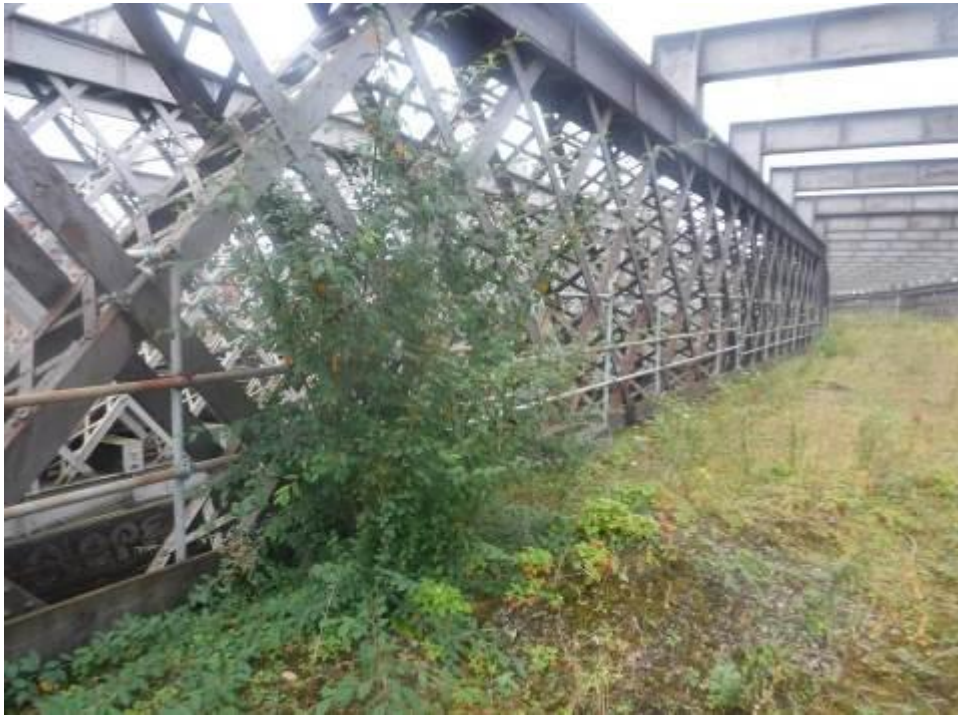
The top of the bridge (formerly the track top) was vegetated throughout, mainly with grass and weeds growing from the deck. **(photos 228 & 229)** Ballast boards along each edge of the deck held in place with scaffold bars were in fair condition although fixings were generally in poor condition. **(photos 230, 231 & 232)** There were no ballast boards in place over span 8. **(photo 233)**

Photograph 228: Typical vegetation growth to top of deck

Photograph 229: Typical vegetation growth to top of deck

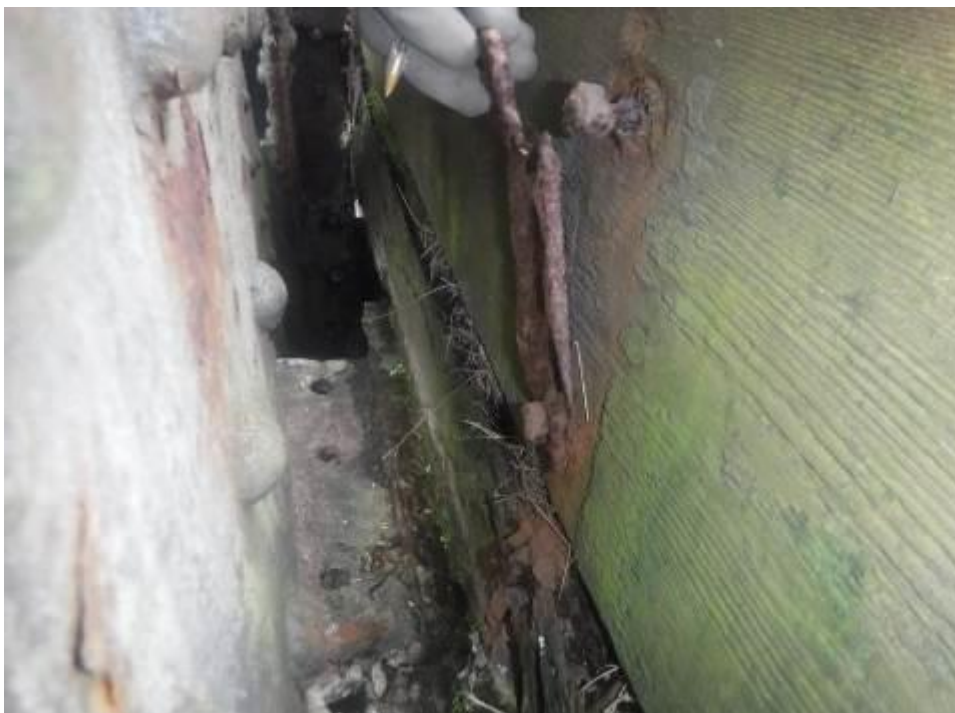
Photograph 232: Typical condition of ballast board fixings to top of deck

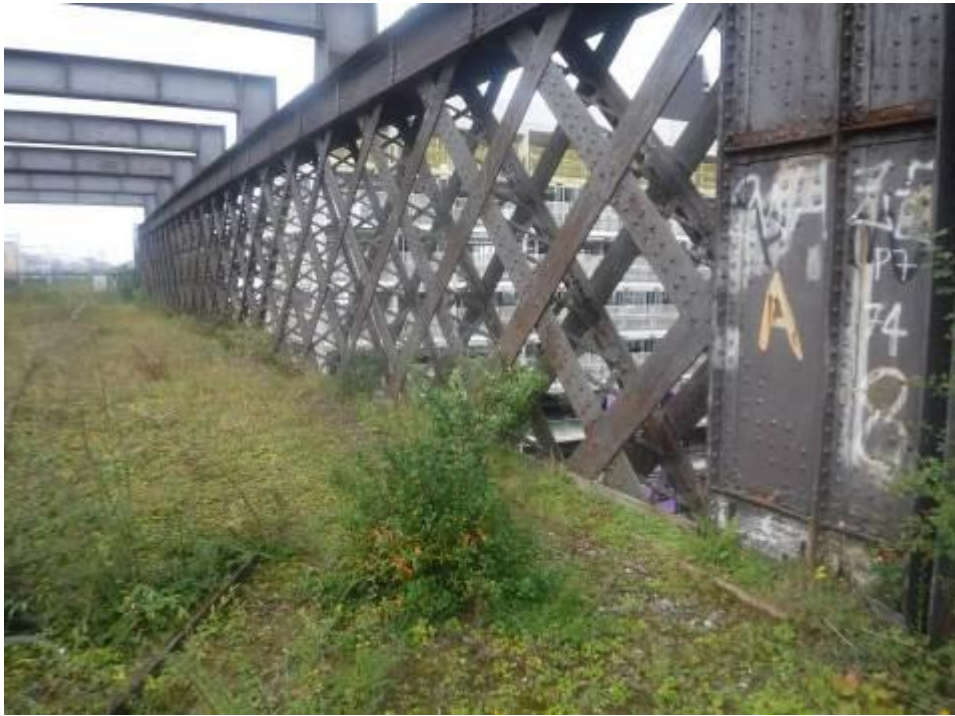
Photograph 233: No ballast boards to span 8 top of deck

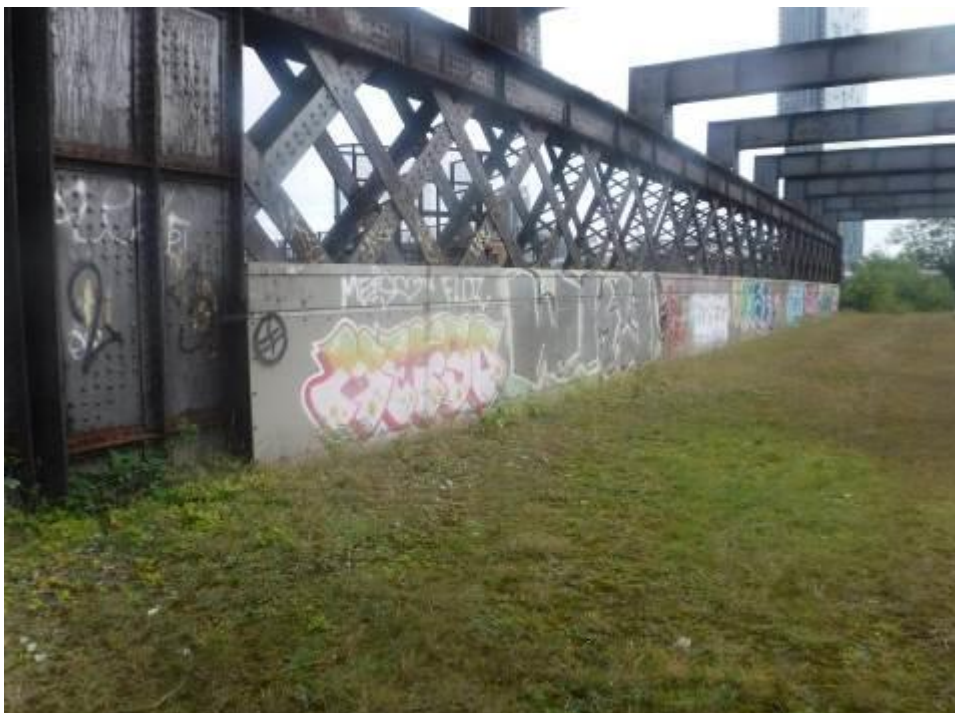
There was non-offensive graffiti throughout the barrier fence in front of the east end of the north truss. **(photo 234)**

Photograph 234: Graffiti to barrier fence to east end of north truss

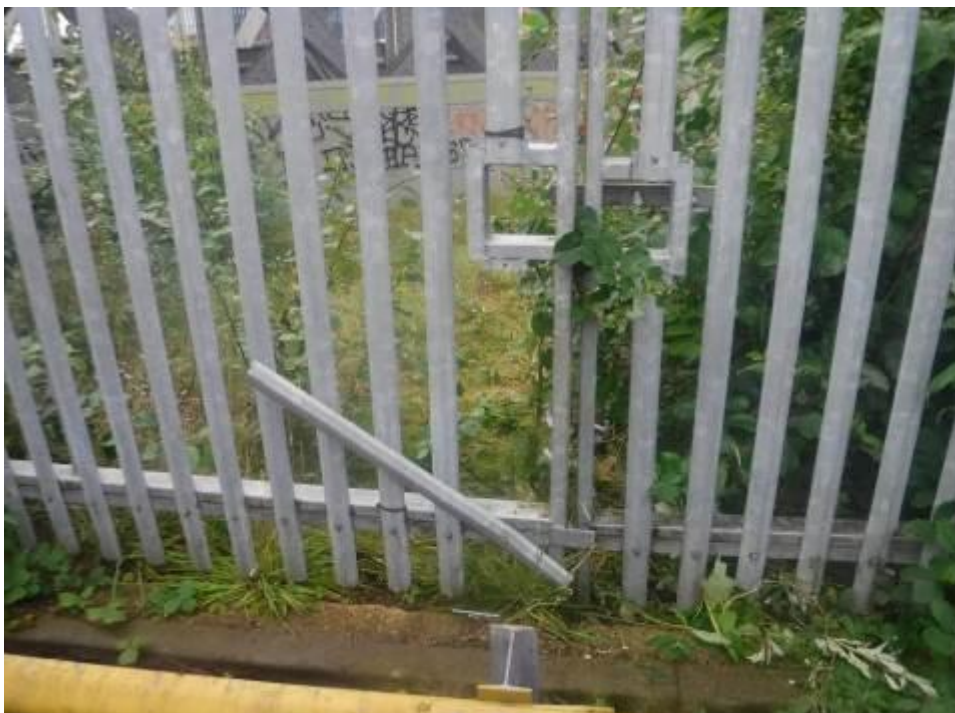
Palisade fencing to the east end of the top of the deck was in fair condition with 1No. loose vertical strut to the gate. **(photo 238)** Anti-vandal fencing to the corners of the palisade fencing was in good condition. **(photo 239)** Palisade fencing to the west end of the top of the deck was in good condition. **(photo 240)**

Photograph 238: Loose vertical strut to palisade fencing to east end of top of deck

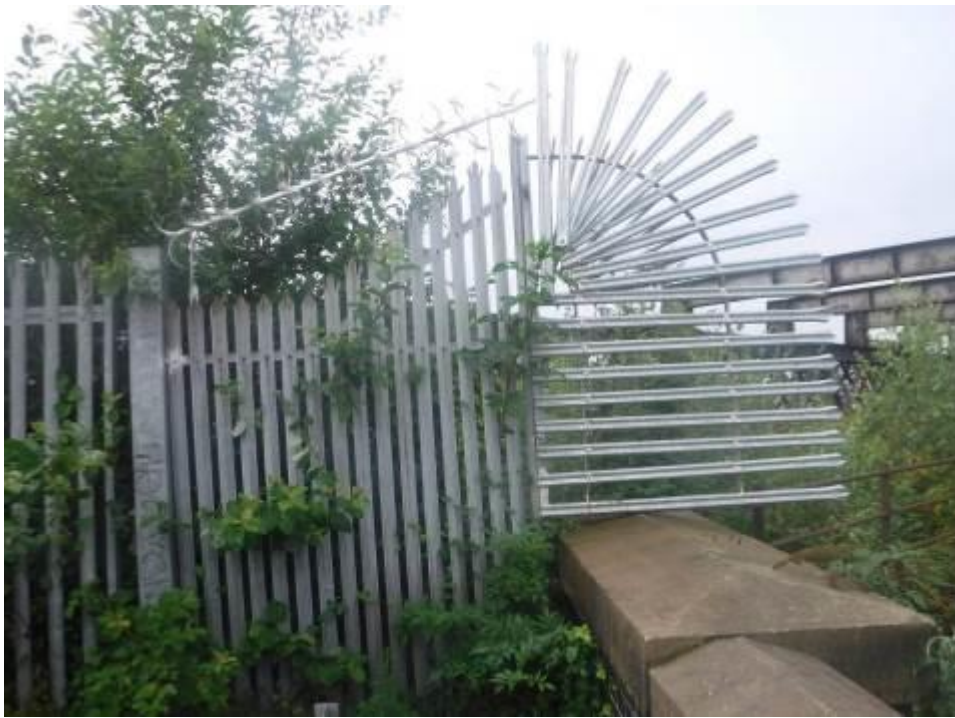
Photograph 239: General view of anti-vandal fencing to top of deck

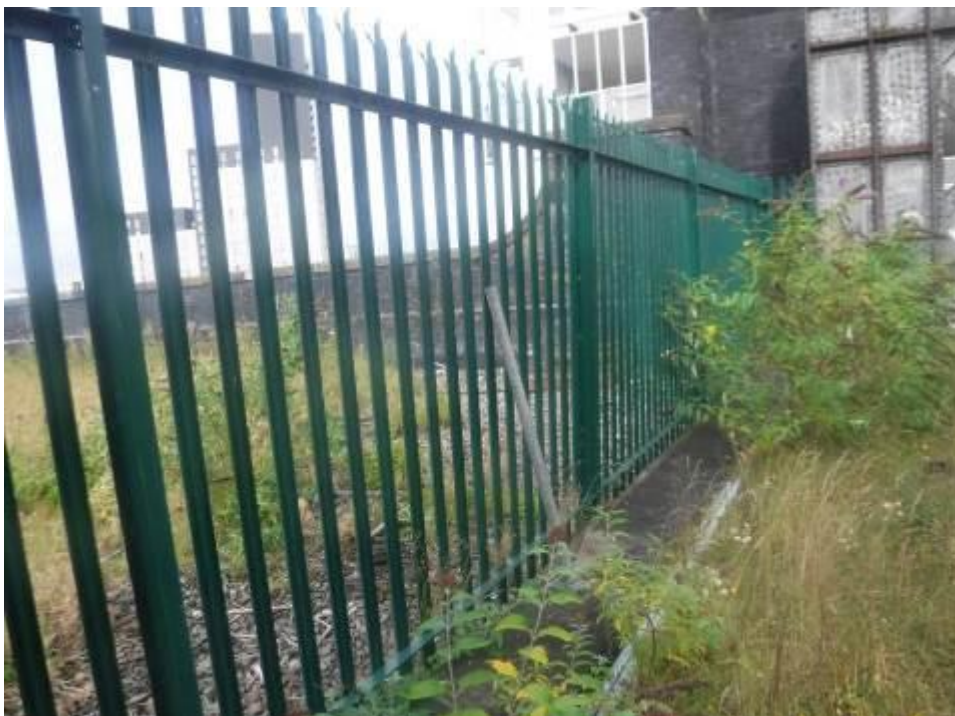
Photograph 240: General view of palisade fencing to west end of top of deck
