# Cheshire Tree Surveys and Arboriculture

**A report on a tree at 11A/13 Cresswell Grove, Manchester**

**Paul Hanson – LANTRA Professional Tree Inspector**

**6<sup>th</sup> October 2021**

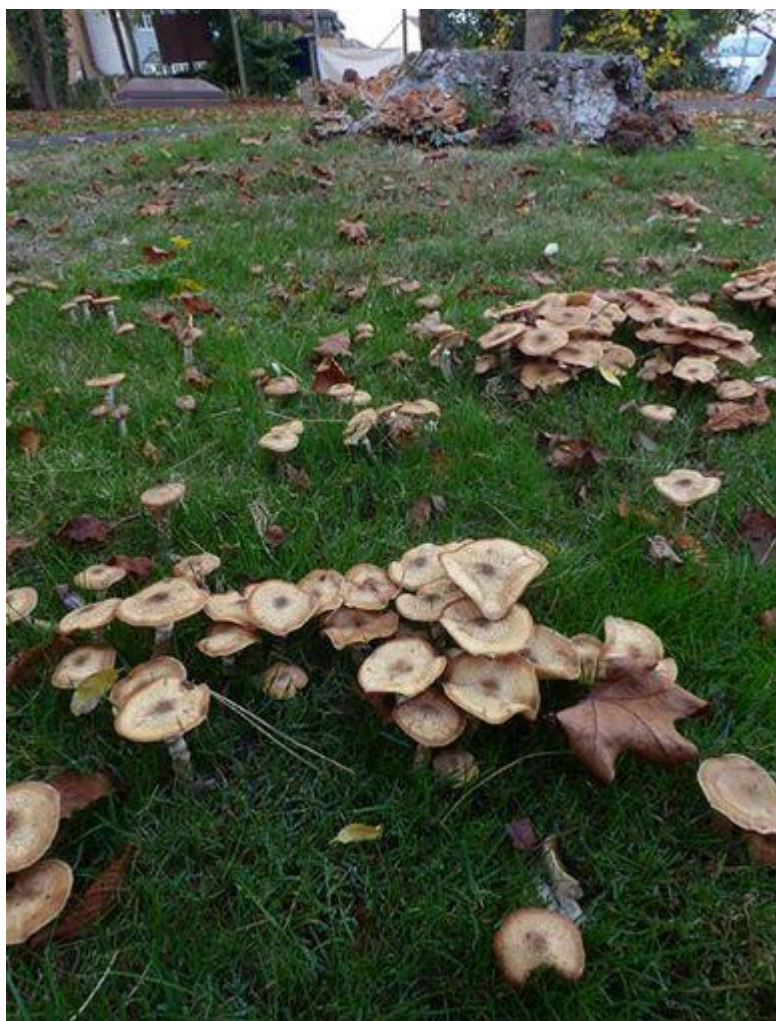
The first thing I noted on this tree , were some fungal fruiting bodies, which were disintergrating on the root plate of the tree,I believed these to be Armillaria mella (honey fungus) photographs and details below. The tree has exposed roots and also what appears to be a girdling root.

A cluster of mature caps growing on sycamore roots in Billericay, Essex.

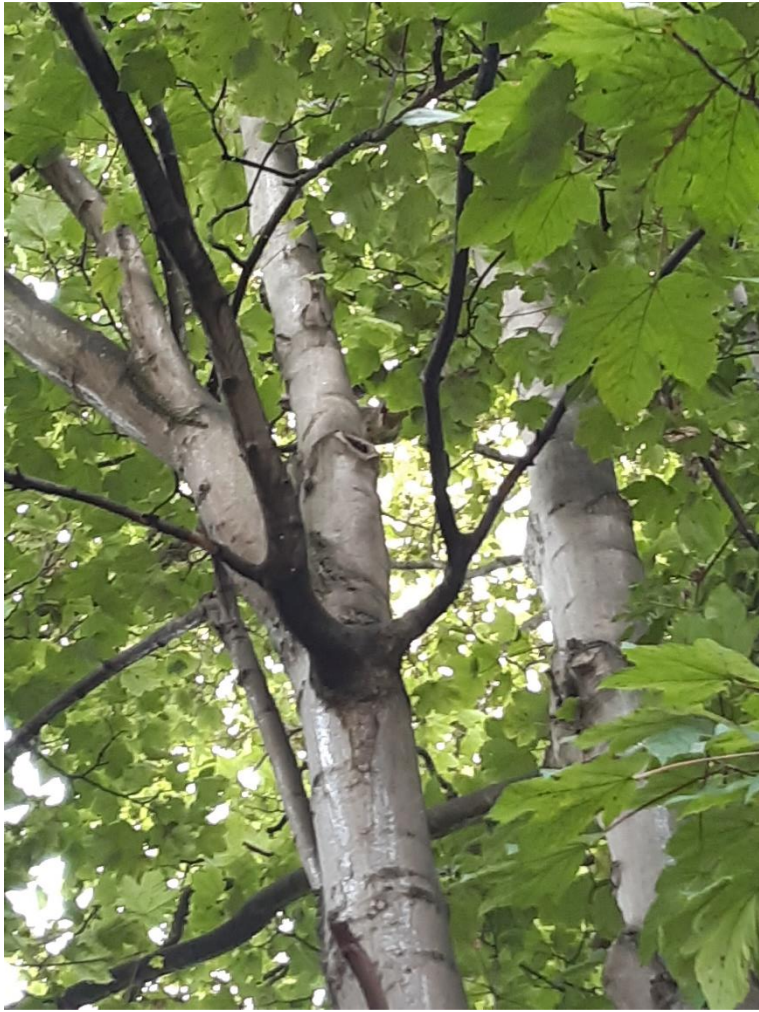
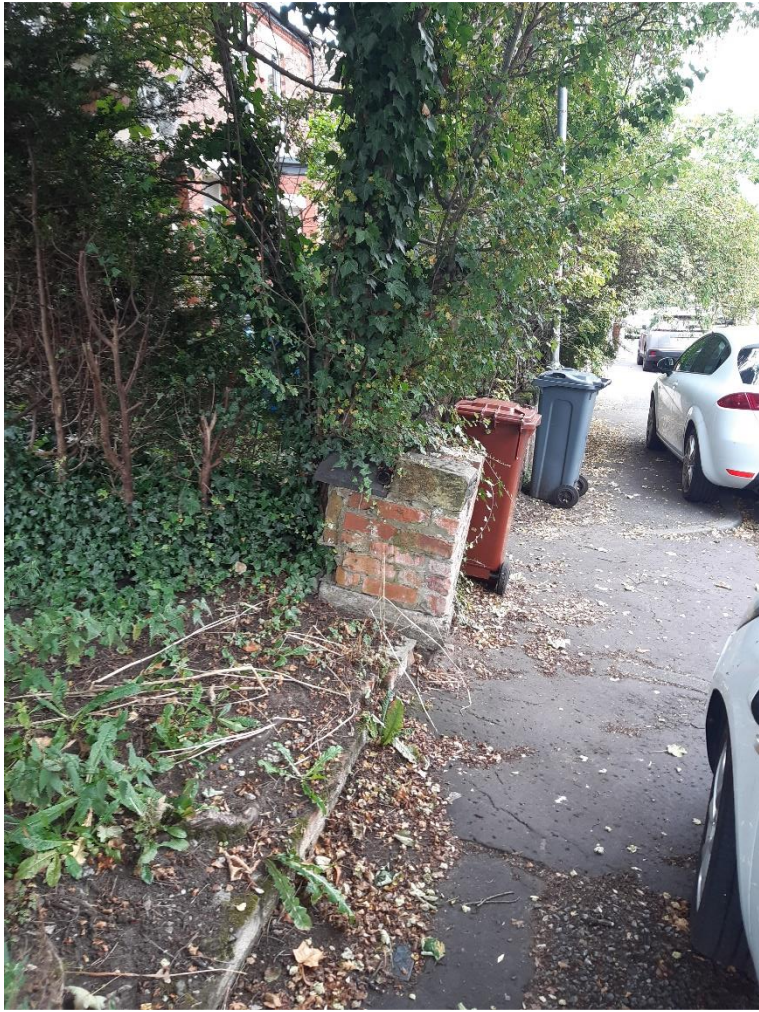
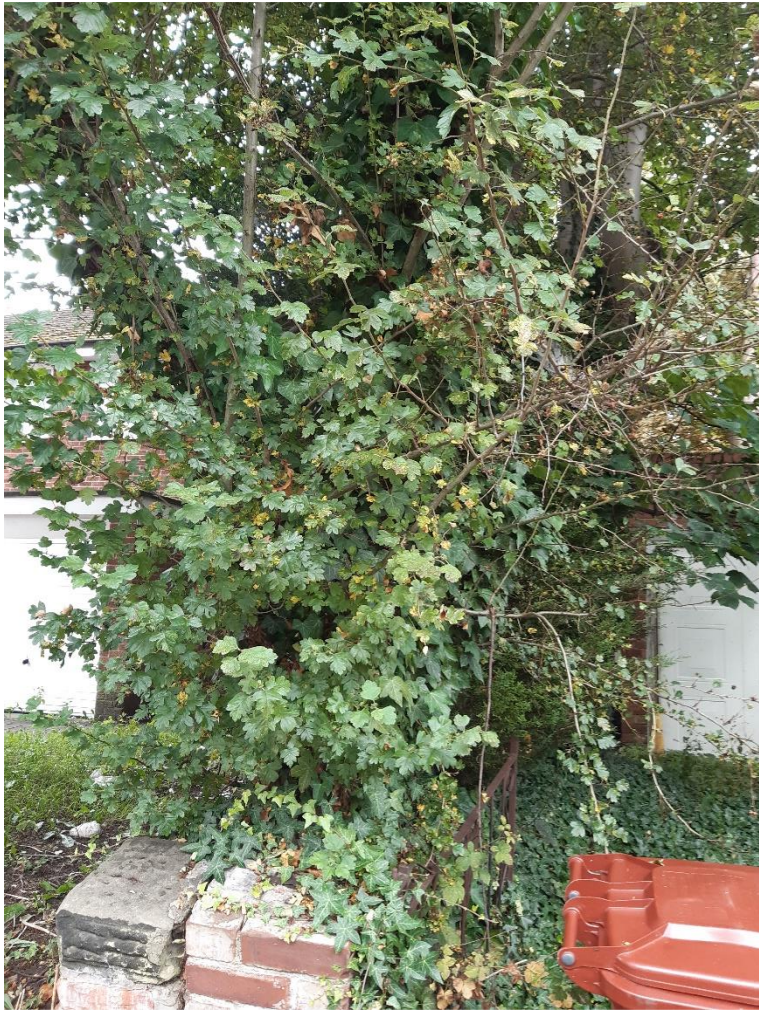
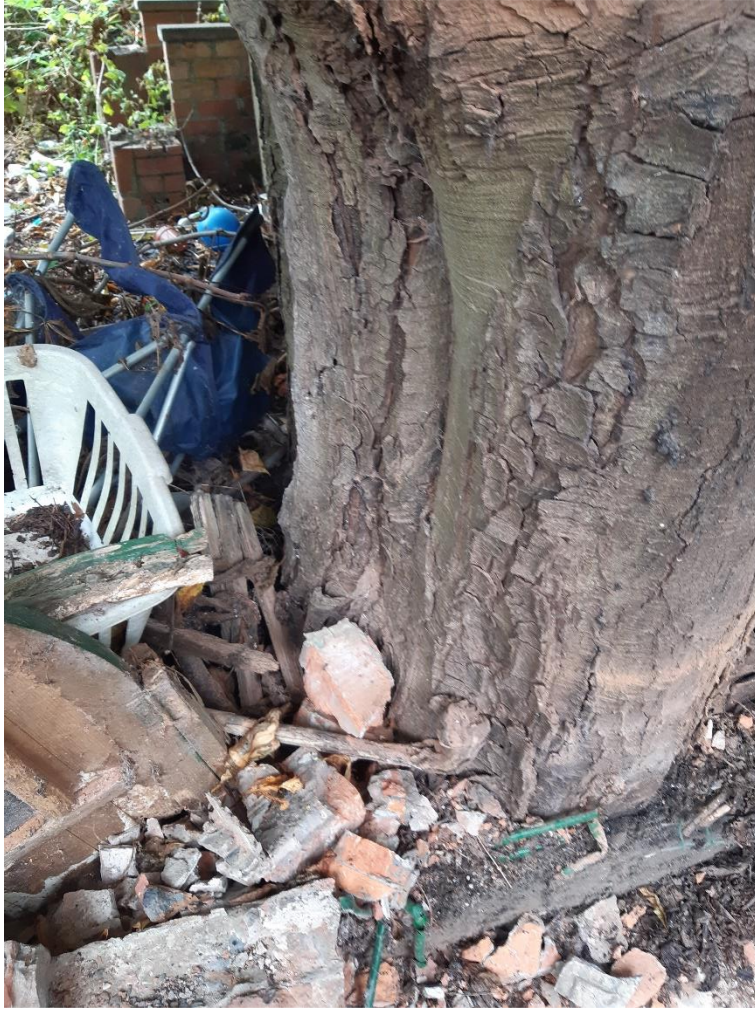
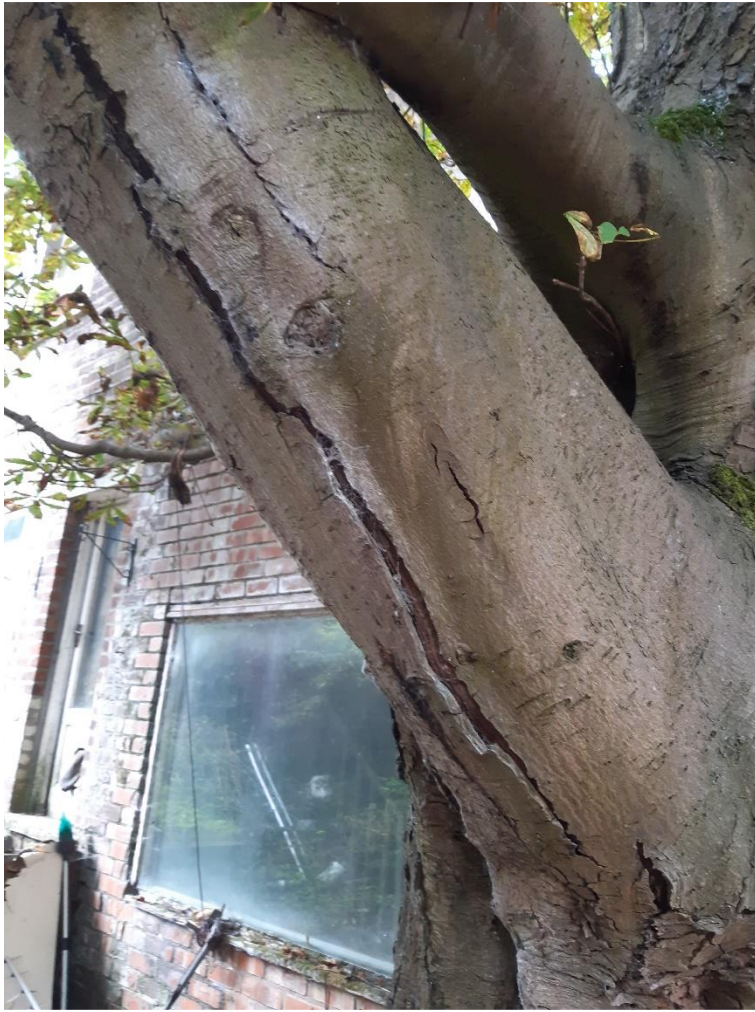
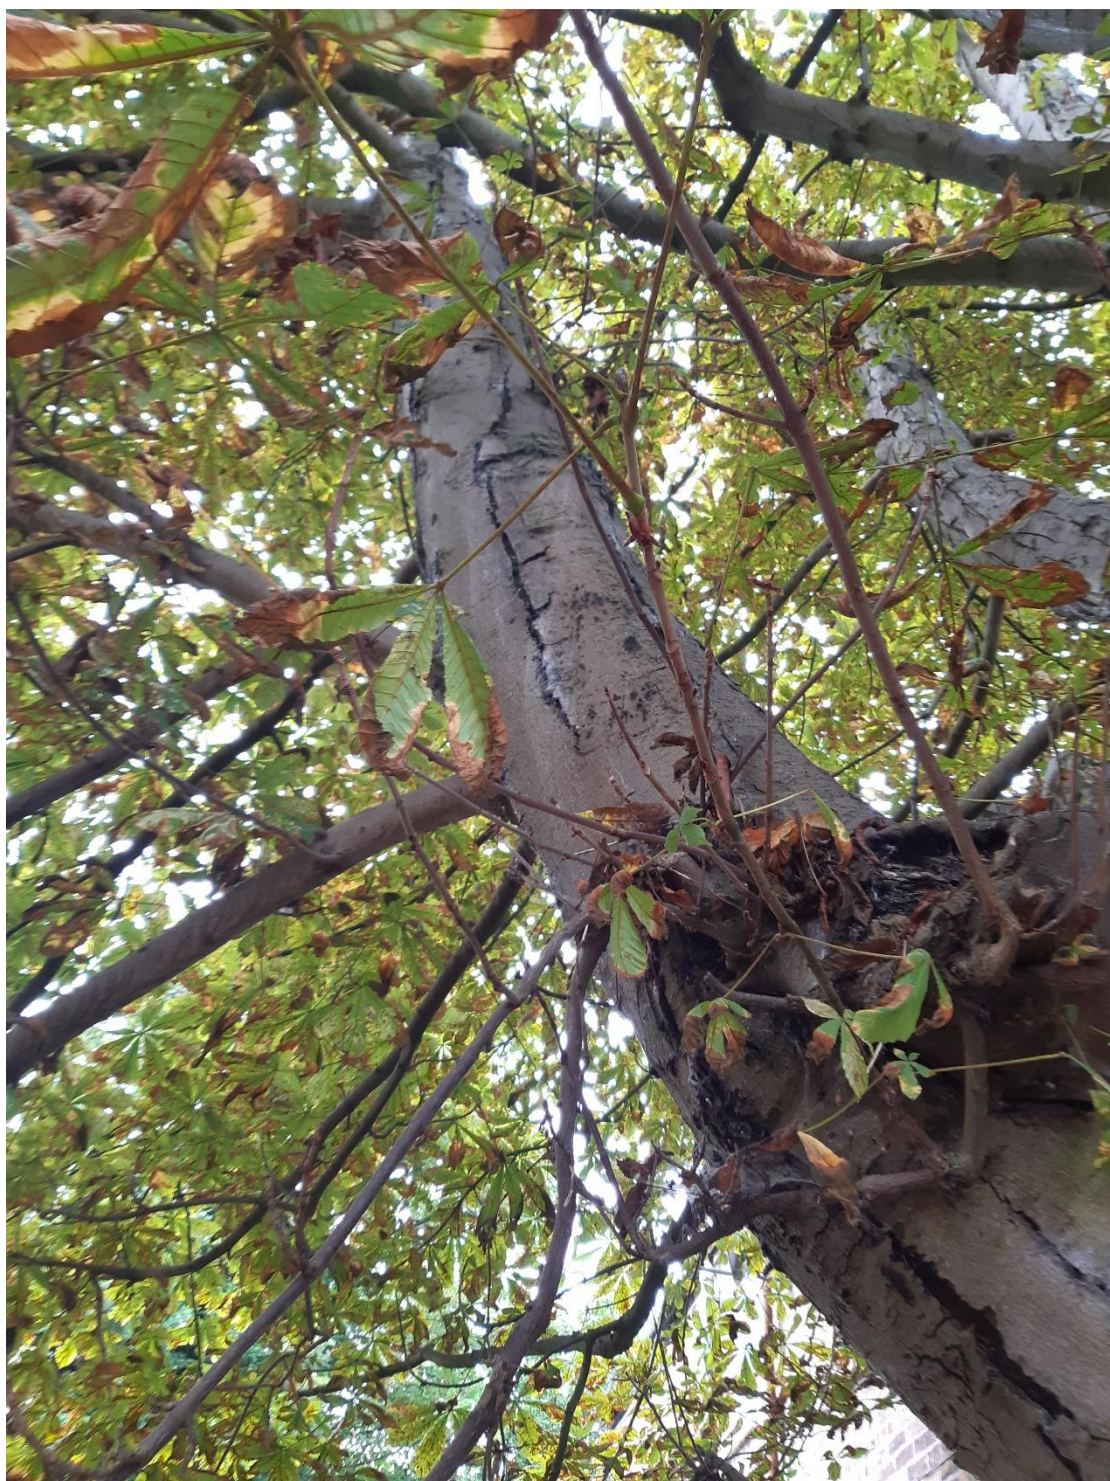
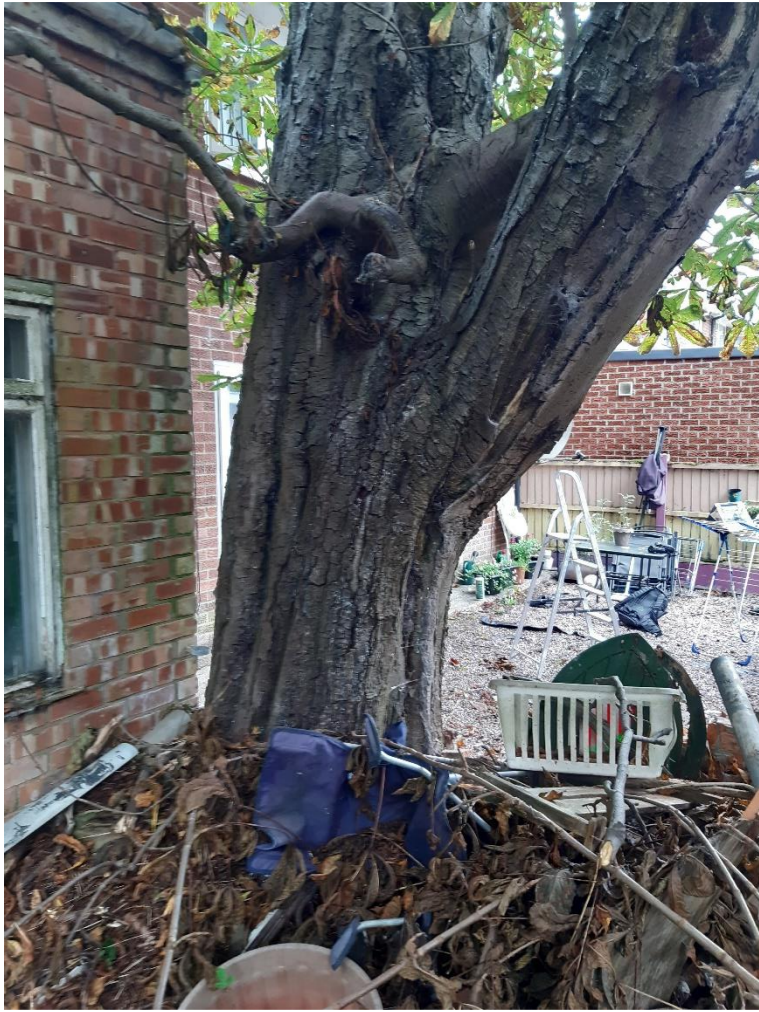
Bifurcated stem on tree 3

The root system is lifting the driveway paving stones . moving my attention to the canopy of the tree, I noted several bad branch unions,photographs below.

The tree is between the two properties touching the roofs of them, it is possible that squirrels are using the tree to ingress into the properties to nest. I noted several bad branch unions in the crown, the tree is being suppressed by tree 2. I also noted high in the canopy some bleeding cankers. I also noted some tar spot of sycamore on the foliage. This tree is extremely close to the houses and in the event of a catastrophic failure would cause some serious damage to the properties.

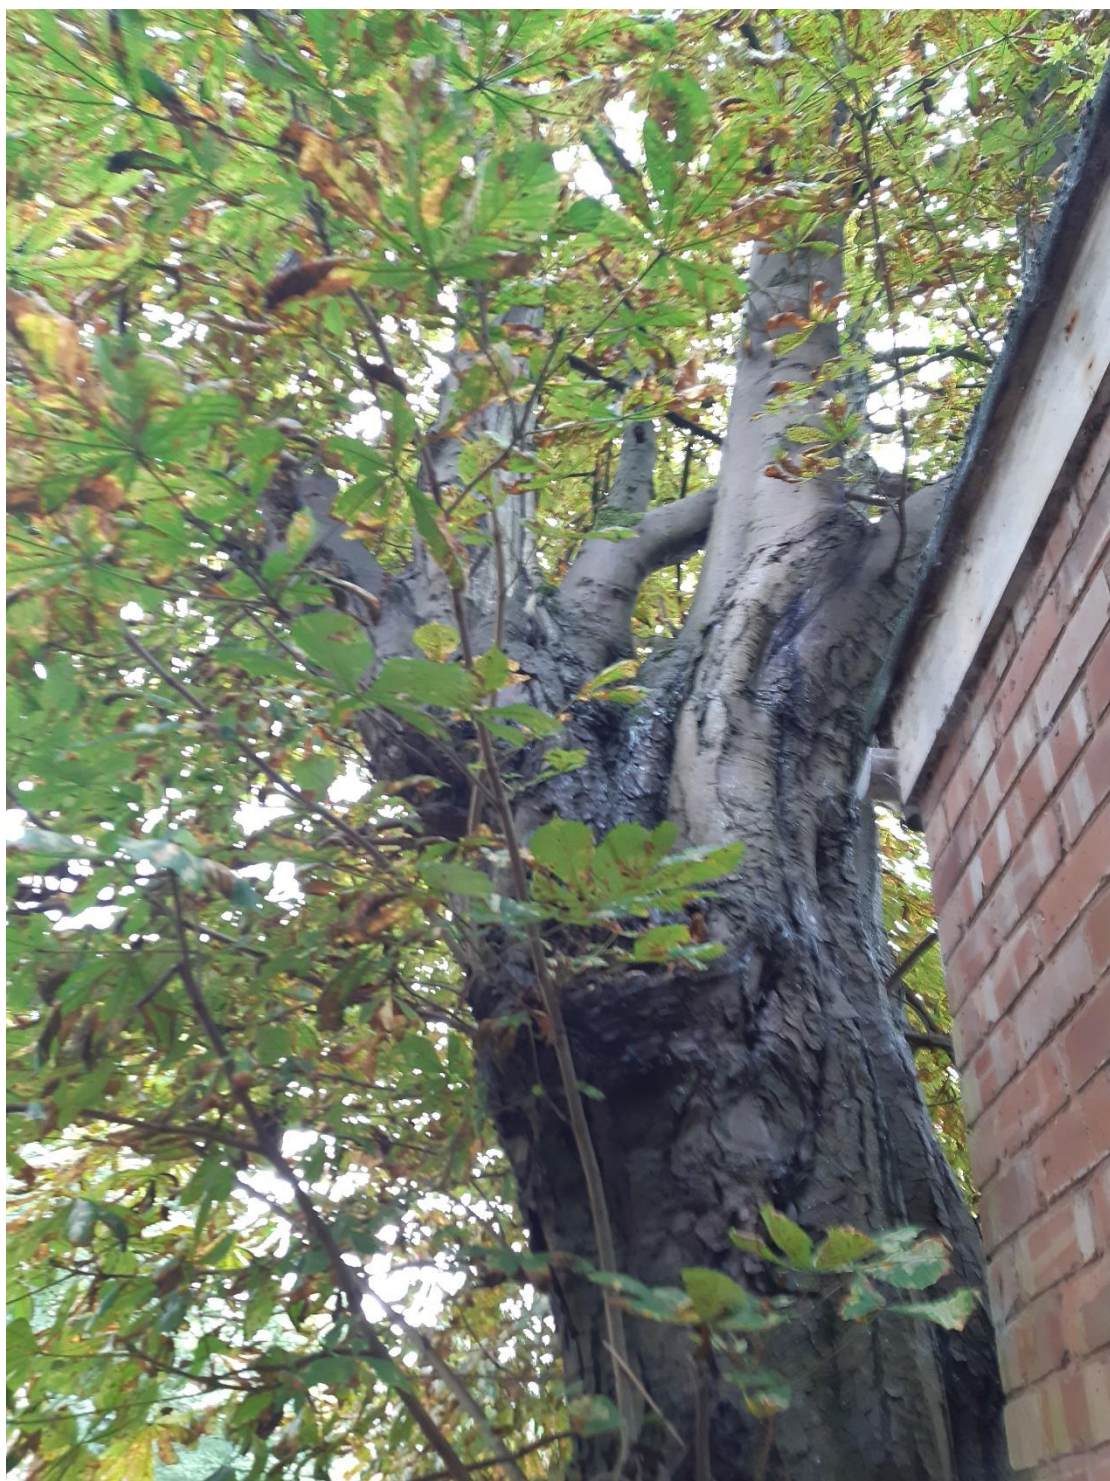
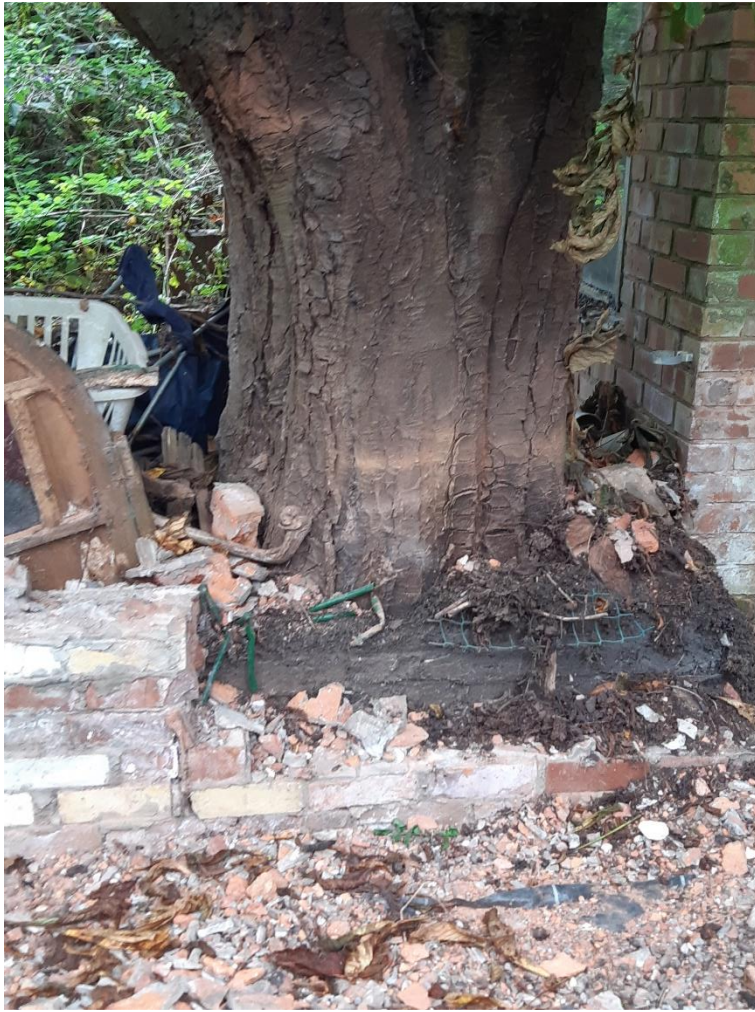
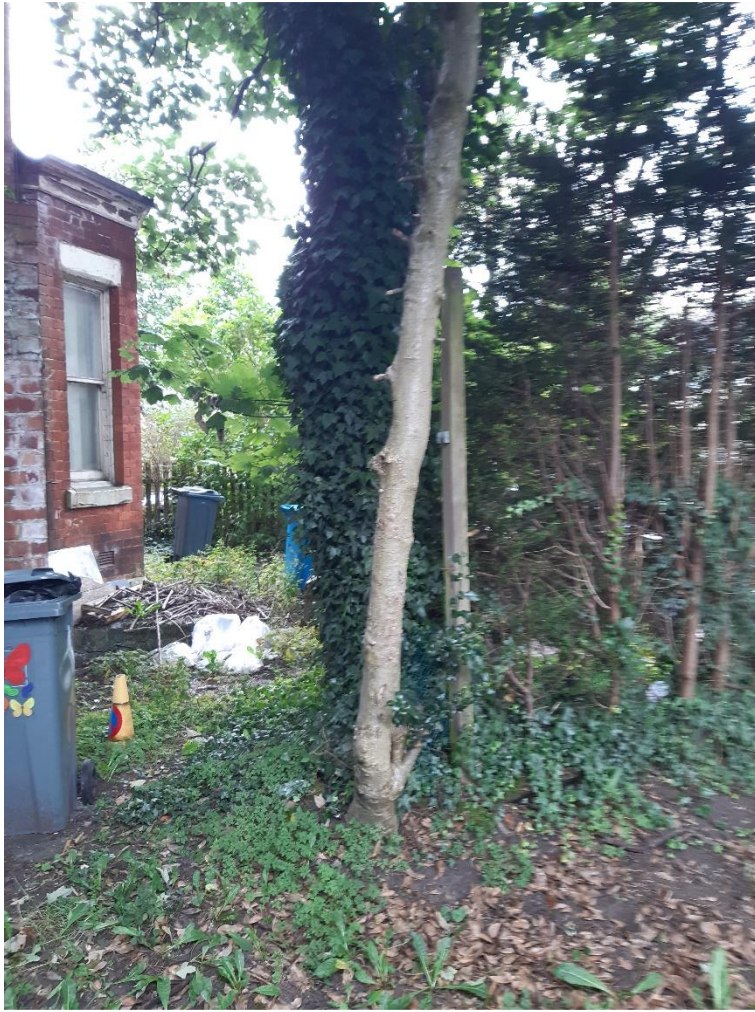
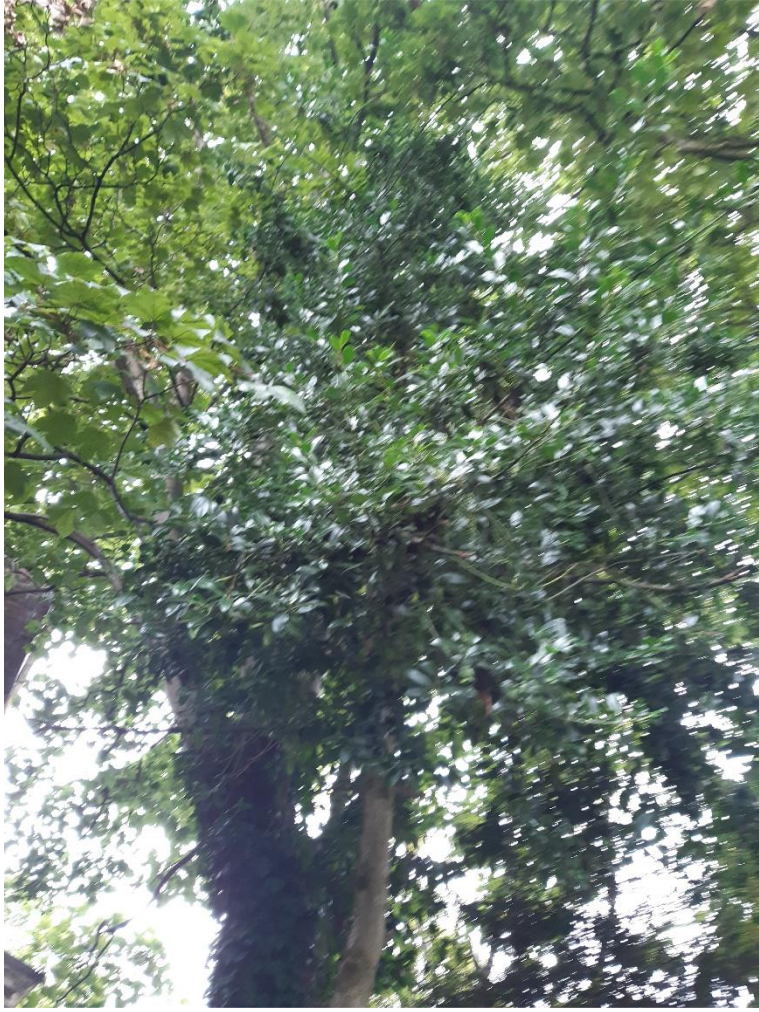
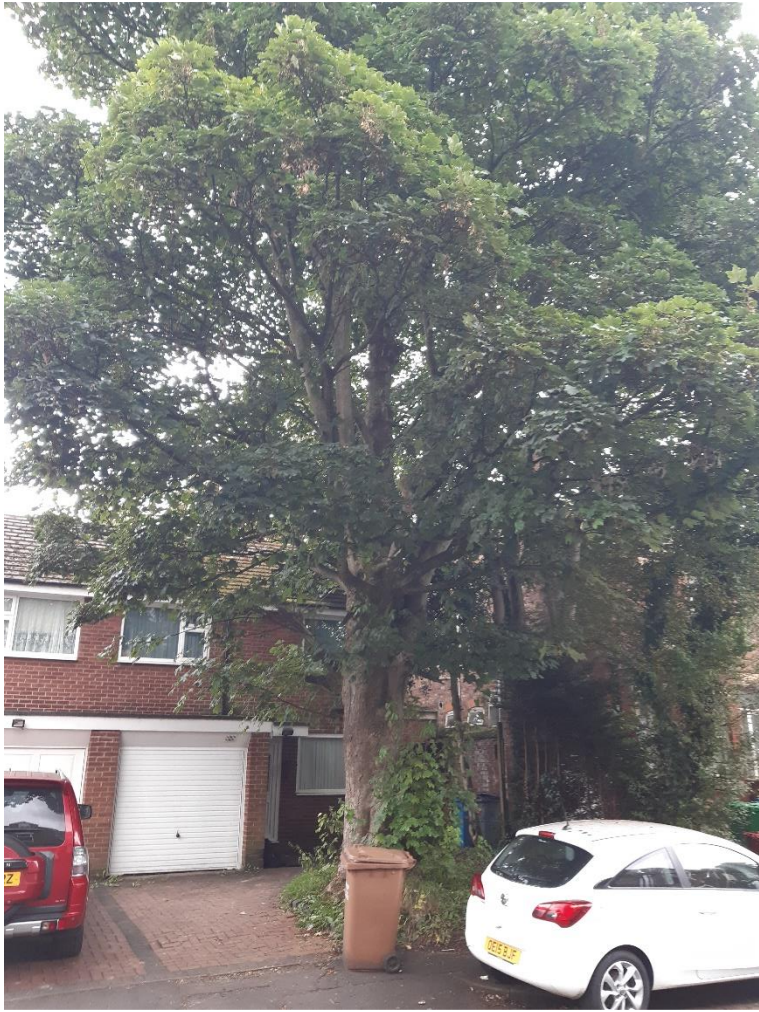
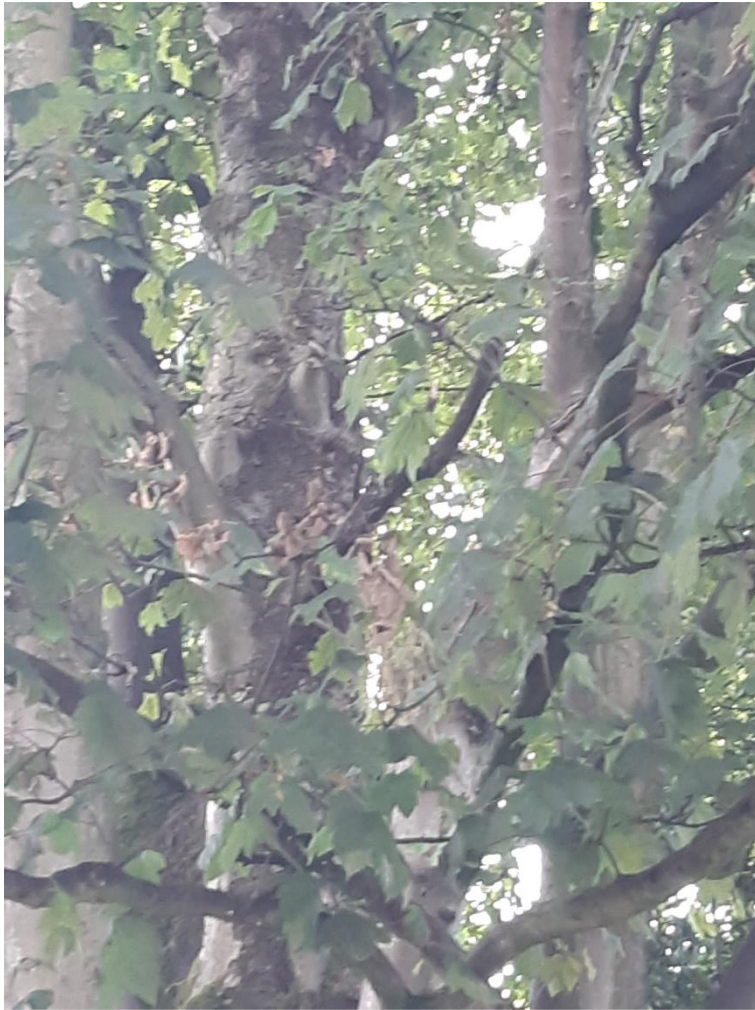
The first thing I noted was that the tree had pushed over the partition wall dividing the properties (the reason why my client engaged my services) causing extensive damage to the wall beyond repair. This in turn had left some of the root system exposed, which could then lead to an infection from the armillaria fungal spores, from the fungal fruiting bodies found in the front garden. The canopy condition was extremely poor, with some evidence of Horse chestnut leaf miner in the foliage (*cameraria ohridella*).
