**Project Name:** BELLE VUE DOG TRACK

**Project Description:** CCTV

**Project Date:** 14/10/2021

**Inspection Standard:** MSCC5 Sewers & Drainage GB (SRM5 Scoring)

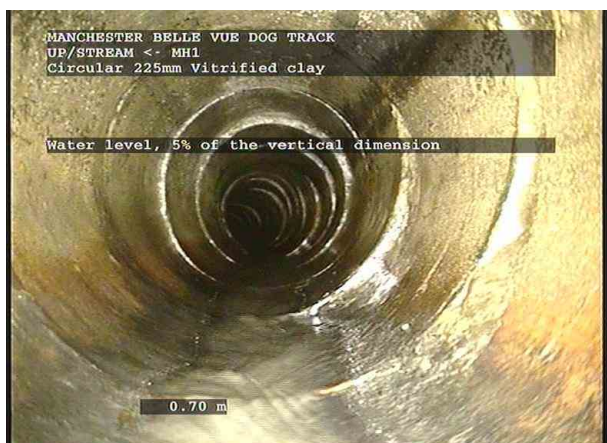
UP\_STREAMX\_dc96f3bc-e703-4ab2-b3ab-300574ae9bea\_20  
211014\_093915\_868.jpg, 00:00:08, 0.70 m  
General photograph taken at this point

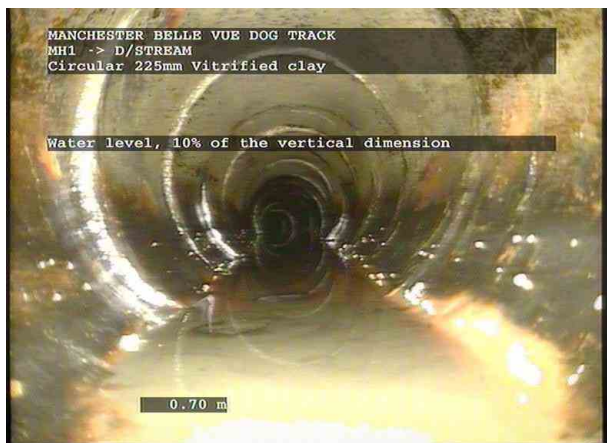
MH1X\_e9a1a224-545b-4b5a-8a49-53b6129fd250\_20211014\_104229\_278.jpg, 00:00:06, 0.70 m  
General photograph taken at this point

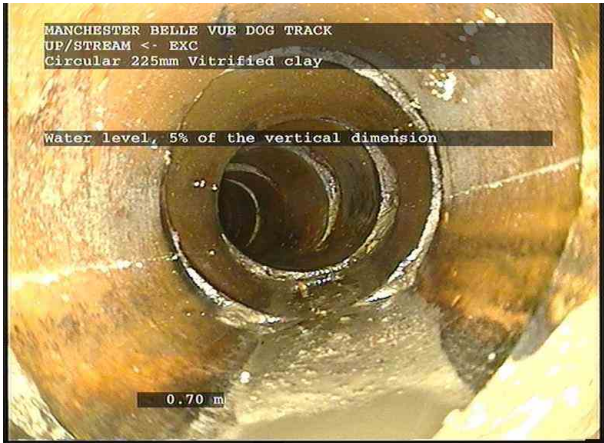
UP\_STREAMX\_9f4d2968-7657-44ce-8f90-a3b63a70552b\_20  
211115\_101627\_087.jpg, 00:00:06, 0.70 m  
General photograph taken at this point

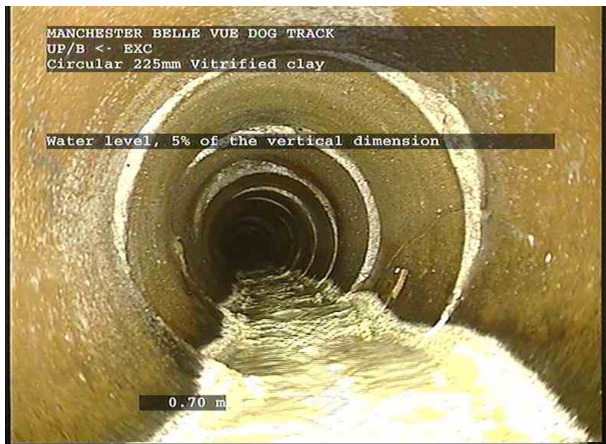
UP\_BX\_4d9fa507-f3b1-406c-9075-88eeae661ec\_20211115\_102318\_365.jpg, 00:00:06, 0.70 m  
General photograph taken at this point
