**Project Name:** John Southworth - Mayton Street - PJ00417102  
**Project Status:** Complete  
**Project Date:** 17/08/2021  
**Lanes Division:** Manchester

As requested, we have recently carried out a drainage CCTV survey at the site location and our full and detailed findings are contained in the attached CCTV report which you can review at your leisure.

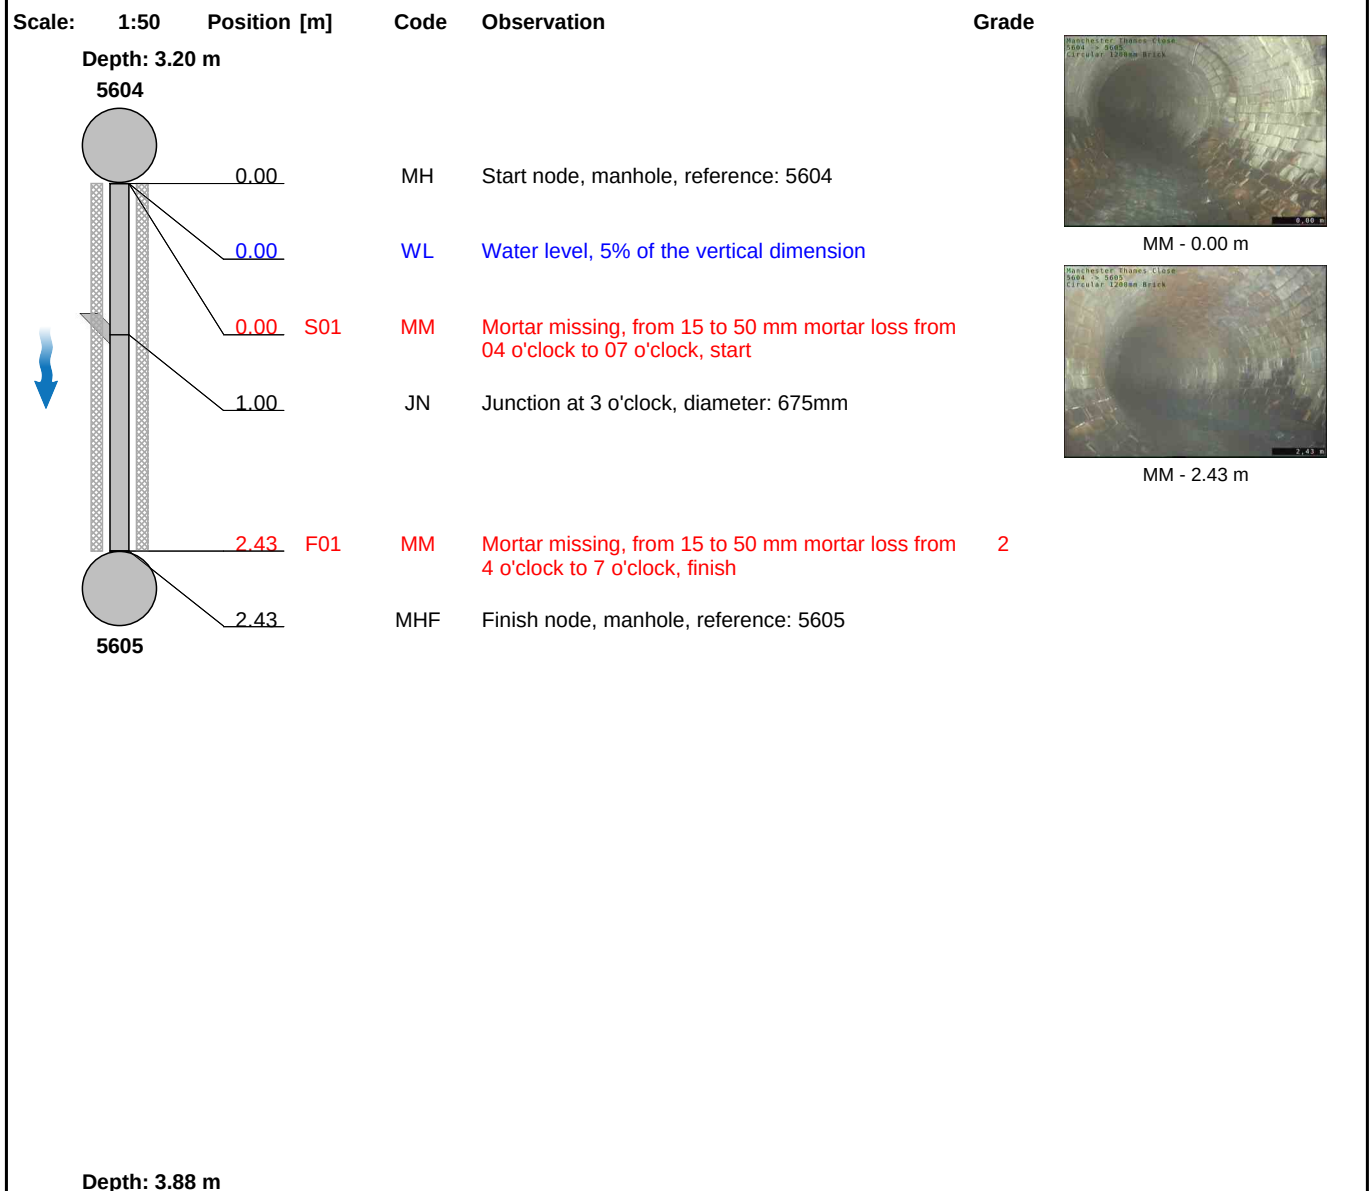
1, 00:00:04, 0.00 m  
Mortar missing, from 15 to 50 mm mortar loss from 04 o'clock to 07 o'clock, start

2, 00:00:31, 2.43 m  
Mortar missing, from 15 to 50 mm mortar loss from 4 o'clock to 7 o'clock, finish

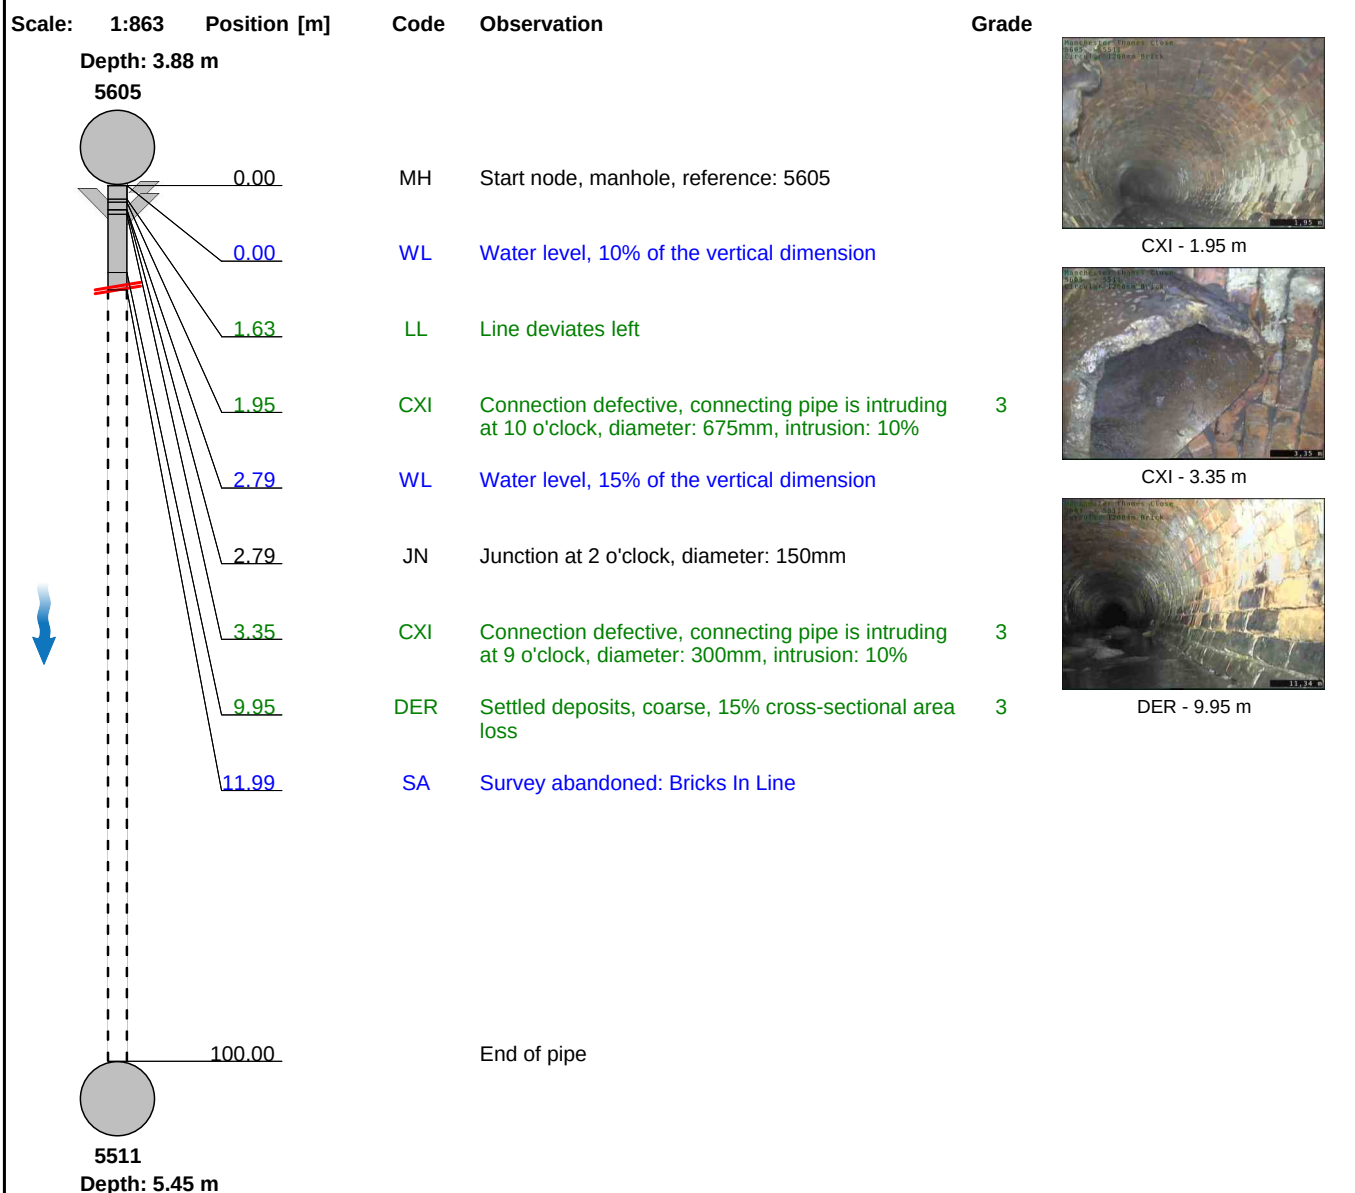
1, 00:00:16, 1.95 m  
Connection defective, connecting pipe is intruding at 10 o'clock, diameter: 675mm, intrusion: 10%

2, 00:00:29, 3.35 m  
Connection defective, connecting pipe is intruding at 9 o'clock, diameter: 300mm, intrusion: 10%
