# Drainage Report

**MMI 105**  
**99 OXFORD ROAD**  
**MANCHESTER**

**AQUASPEED DRAIN SERVICES**

## 99 OXFORD ROAD MANCHESTER - CCTV Survey Report : 30/09/21

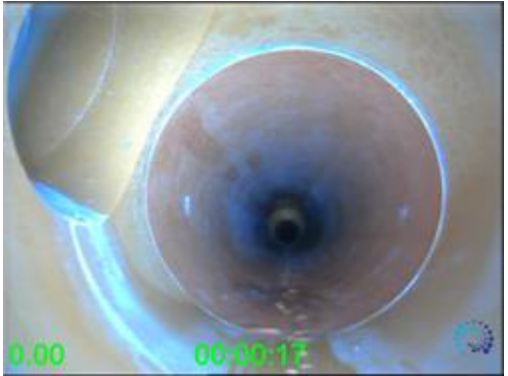
| Pos | Video Ref | Code | Description | Image |
|---|---|---|---|---|
| 00.10m | 0:00:17 | JN | Junction at 10 o'clock: 100mm Diameter | Image Provided - Ref: 1_2<br> |

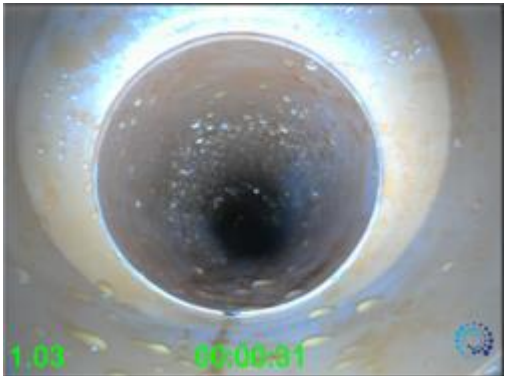
| Pos | Video Ref | Code | Description | Image |
|---|---|---|---|---|
| 01.03m | 0:00:31 | SC | Dimension of drain/sewer changes: 100mm Diameter | Image Provided - Ref: 1_3<br> |

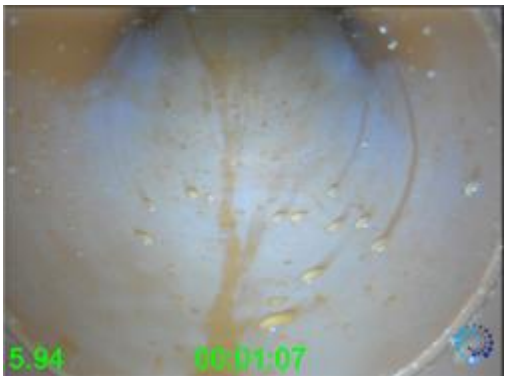
| Pos | Video Ref | Code | Description | Image |
|---|---|---|---|---|
| 05.94m | 0:01:07 | LUF | Line of drain/sewer deviates up [full] | Image Provided - Ref: 1_4<br> |

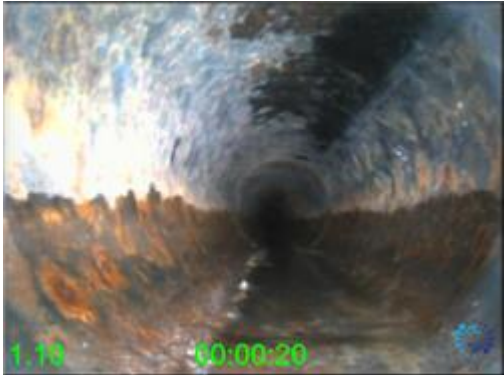
| Pos | Video Ref | Code | Description | Image |
|---|---|---|---|---|
| 01.10m | 0:00:20 | MCCI | Material of pipe changes to<br>Cast Iron | Image Provided - Ref: 2_2<br> |

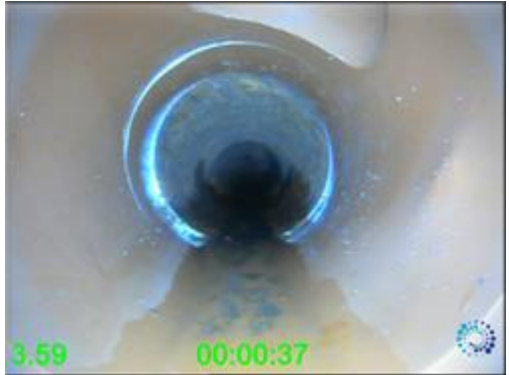
| Pos | Video Ref | Code | Description | Image |
|---|---|---|---|---|
| 03.59m | 0:00:37 | JN | Junction at 01 o'clock: 100mm<br>Diameter | <p>Image Provided - Ref: 4_2</p> |

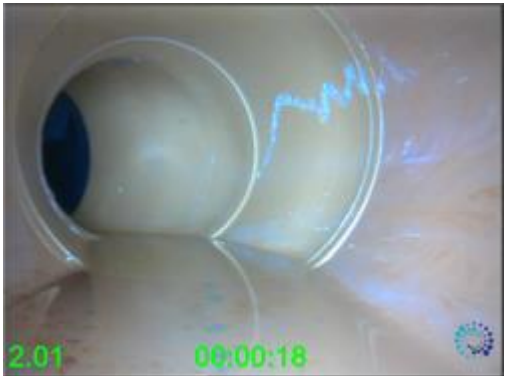
| Pos | Video Ref | Code | Description | Image |
|---|---|---|---|---|
| 02.01m | 0:00:18 | LLQ | Line of drain/sewer deviates left [quarter] | Image Provided - Ref: 6_3<br> |

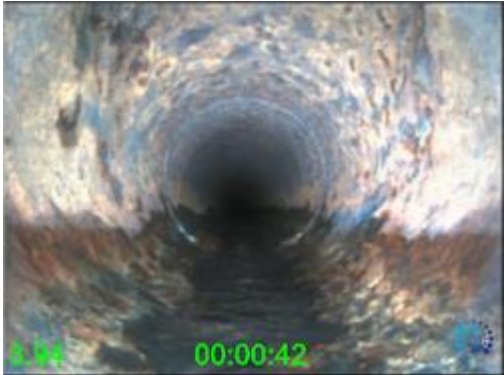
| Pos | Video Ref | Code | Description | Image |
|---|---|---|---|---|
| 03.94m | 0:00:42 | JN | Junction at 12 o'clock: 150mm<br>Diameter | Image Provided - Ref: 7_2<br> |

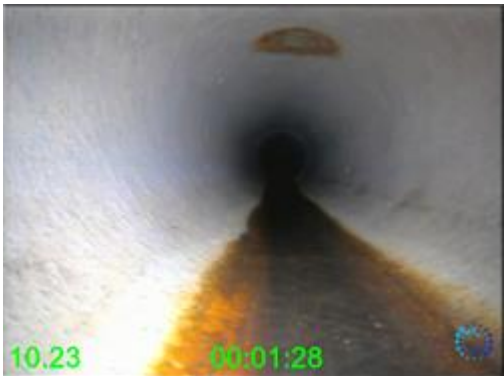
| Pos | Video Ref | Code | Description | Image |
|---|---|---|---|---|
| 10.23m | 0:01:28 | MCVC | Material of pipe changes to<br>Vitrified Clay (i.e. all clayware) | Image Provided - Ref: 7_3<br> |

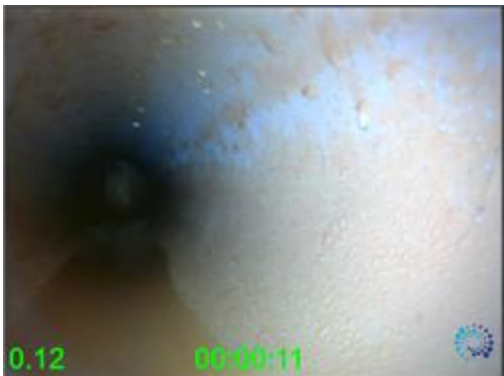
| Pos | Video Ref | Code | Description | Image |
|---|---|---|---|---|
| 00.12m | 0:00:11 | MCPVC | Material of pipe changes to<br>Polyvinyl Chloride | Image Provided - Ref: 8_2<br> |

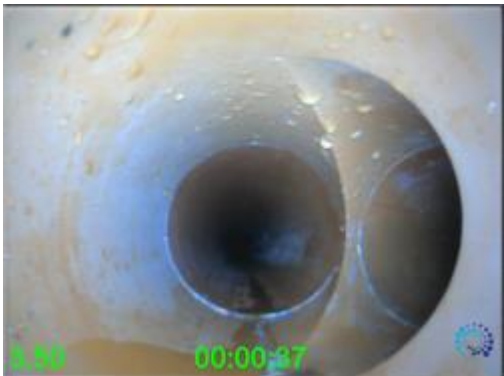
| Pos | Video Ref | Code | Description | Image |
|---|---|---|---|---|
| 03.50m | 0:00:37 | JN | Junction at 03 o'clock: 100mm<br>Diameter | Image Provided - Ref: 8_3<br> |

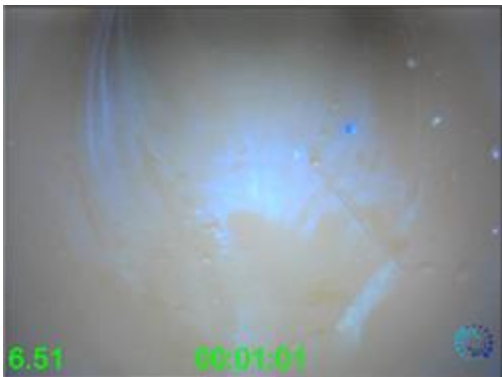
| Pos | Video Ref | Code | Description | Image |
|---|---|---|---|---|
| 06.51m | 0:01:01 | LUF | Line of drain/sewer deviates up [full] | <p>Image Provided - Ref: 8_4</p> |

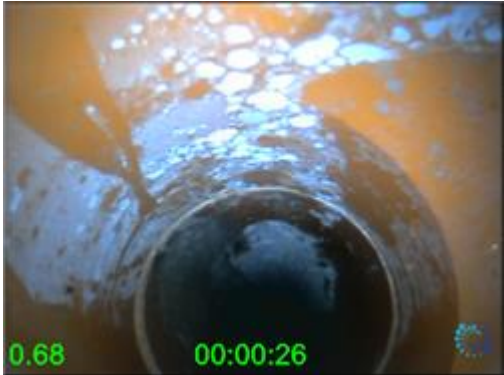
| Pos | Video Ref | Code | Description | Image |
|---|---|---|---|---|
| 00.68m | 0:00:26 | JN | Junction at 03 o'clock: 100mm Diameter | Image Provided - Ref: 9_2<br> |

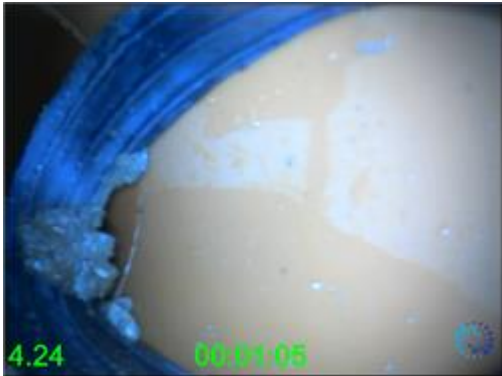
| Pos | Video Ref | Code | Description | Image |
|---|---|---|---|---|
| 04.24m | 0:01:05 | REM | General remark<br>PUSHING THROUGH TO THE<br>MANHOLE | Image Provided - Ref: 9_4<br> |

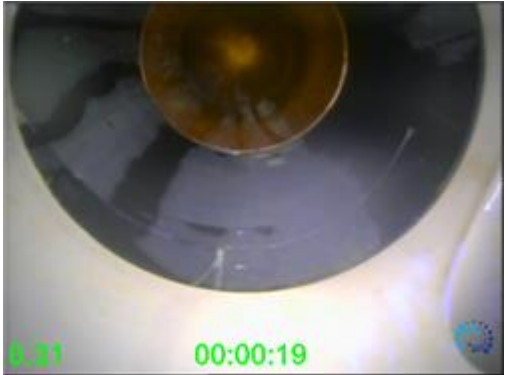
| Pos | Video Ref | Code | Description | Image |
|---|---|---|---|---|
| 00.31m | 0:00:19 | JN | Junction at 03 o'clock: 35mm Diameter | Image Provided - Ref: 14_2<br> |

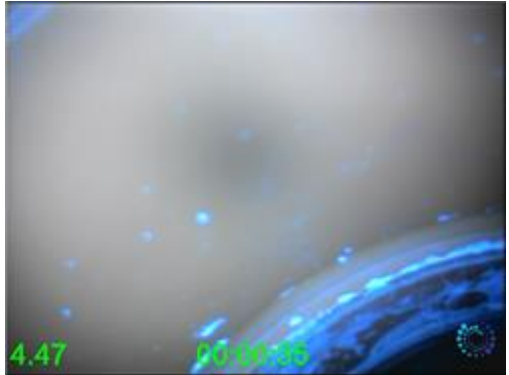
| Pos | Video Ref | Code | Description | Image |
|---|---|---|---|---|
| 04.47m | 0:00:35 | LDH | Line of drain/sewer deviates down [half] | Image Provided - Ref: 15_2<br> |

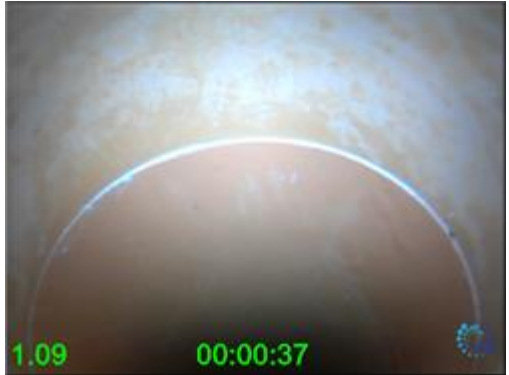
| Pos | Video Ref | Code | Description | Image |
|---|---|---|---|---|
| 01.09m | 0:00:38 | LDH | Line of drain/sewer deviates down [half] | <p>Image Provided - Ref: 17_2</p> |

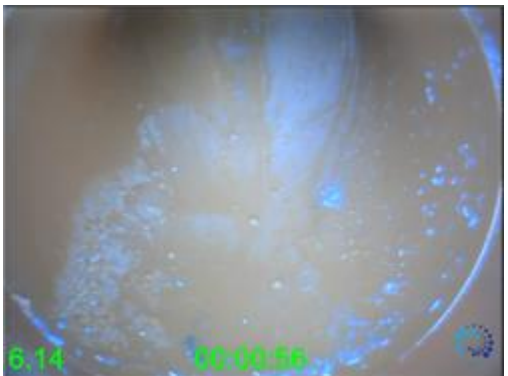
| Pos | Video Ref | Code | Description | Image |
|---|---|---|---|---|
| 06.14m | 0:00:57 | LUF | Line of drain/sewer deviates up<br>[full] | Image Provided - Ref: 18_2<br> |

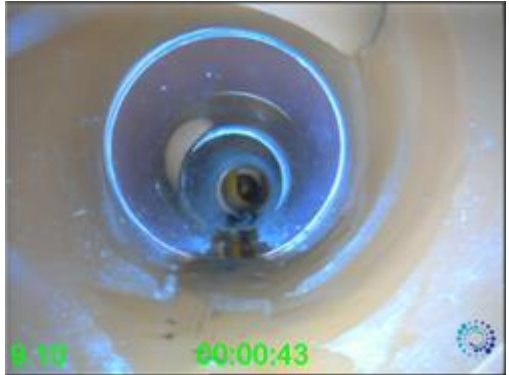
| Pos | Video Ref | Code | Description | Image |
|---|---|---|---|---|
| 09.10m | 0:00:43 | JN | Junction at 01 o'clock: 100mm<br>Diameter | <p>Image Provided - Ref: 19_2</p> |

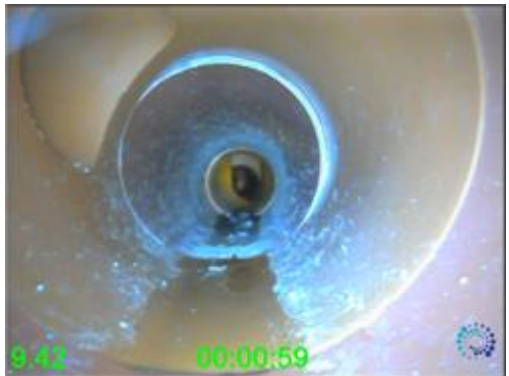
| Pos | Video Ref | Code | Description | Image |
|---|---|---|---|---|
| 09.42m | 0:00:59 | JN | Junction at 10 o'clock: 100mm<br>Diameter | <p>Image Provided - Ref: 19_3</p> |

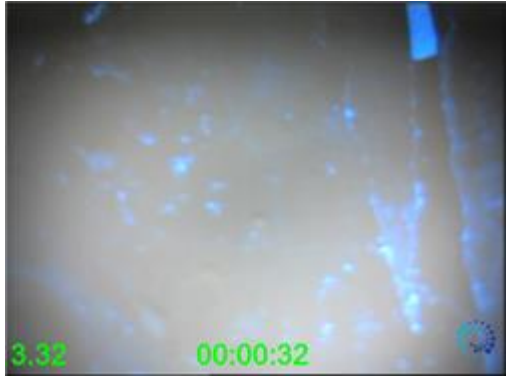
| Pos | Video Ref | Code | Description | Image |
|---|---|---|---|---|
| 03.32m | 0:00:32 | LUF | Line of drain/sewer deviates up<br>[full] | <p>Image Provided - Ref: 20_2</p> |

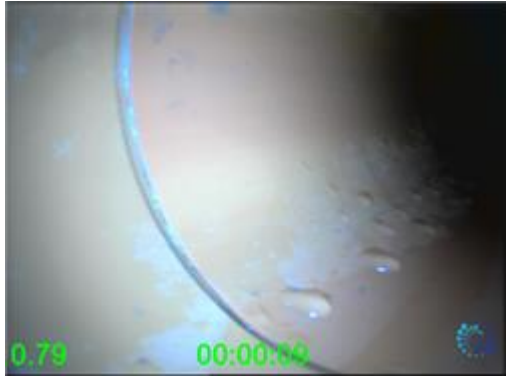
| Pos | Video Ref | Code | Description | Image |
|---|---|---|---|---|
| 00.79m | 0:00:09 | LRQ | Line of drain/sewer deviates<br>right [quarter] | <p>Image Provided - Ref: 21_2</p> |

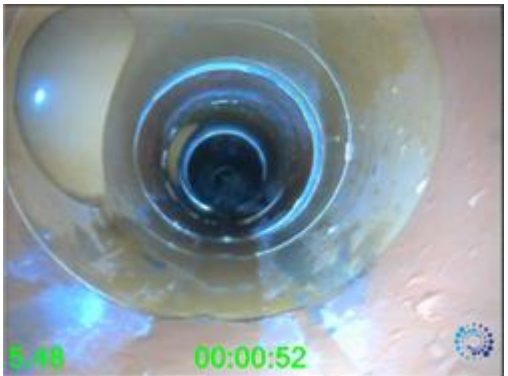
| Pos | Video Ref | Code | Description | Image |
|---|---|---|---|---|
| 05.48m | 0:00:52 | JN | Junction at 09 o'clock: 100mm Diameter | Image Provided - Ref: 22_3<br> |

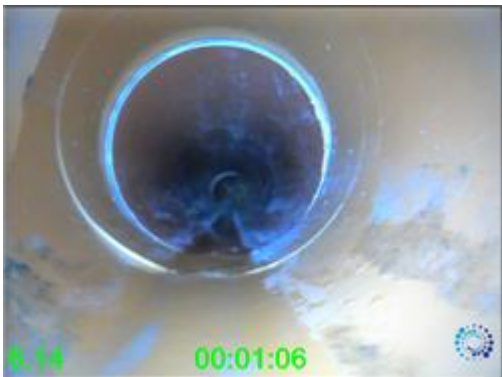
| Pos | Video Ref | Code | Description | Image |
|---|---|---|---|---|
| 06.14m | 0:01:06 | JN | Junction at 10 o'clock: 100mm Diameter | <p>Image Provided - Ref: 22_4</p> |

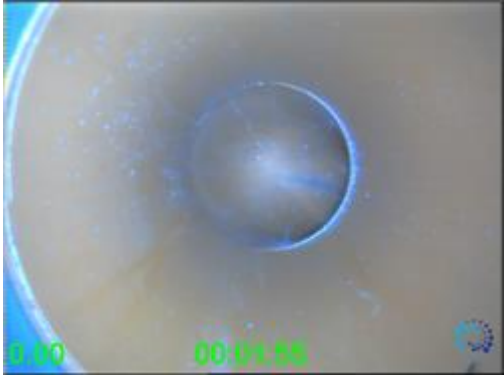
| Pos | Video Ref | Code | Description | Image |
|---|---|---|---|---|
| 00.00m | 0:00:00 | WL | Water level: 5%<br>Height/Diameter | Image Provided - Ref: 23_1<br> |

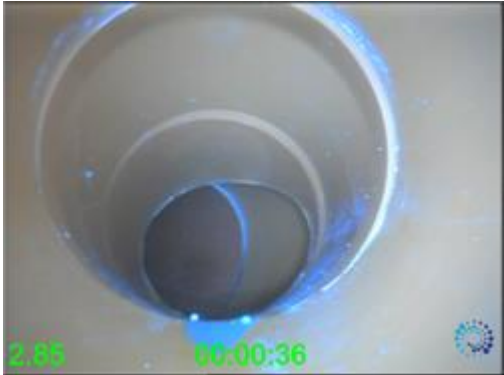
| Pos | Video Ref | Code | Description | Image |
|---|---|---|---|---|
| 02.85m | 0:00:36 | LDQ | Line of drain/sewer deviates<br>down [quarter] | Image Provided - Ref: 23_2<br> |

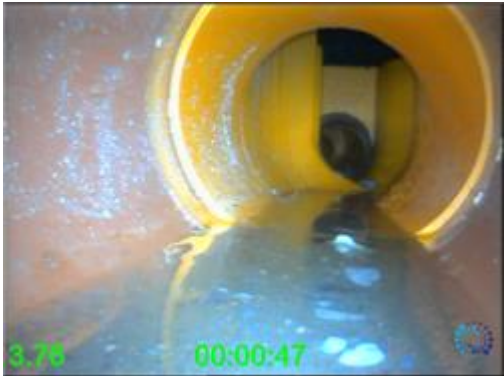
| Pos | Video Ref | Code | Description | Image |
|---|---|---|---|---|
| 03.76m | 0:00:47 | REM | General remark<br>MAIN CARRIER | Image Provided - Ref: 23_3<br> |

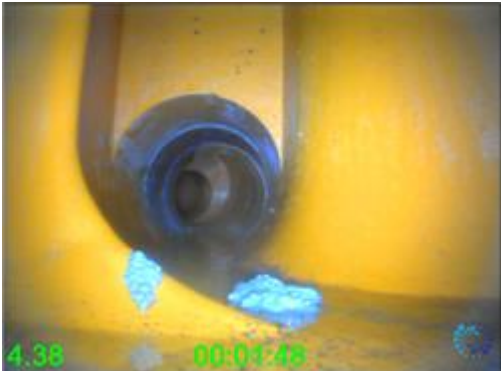
| Pos | Video Ref | Code | Description | Image |
|---|---|---|---|---|
| 04.38m | | MHF | Finish node type, manhole CW 05 | <p>Image Provided - Ref: 23_9999</p> |

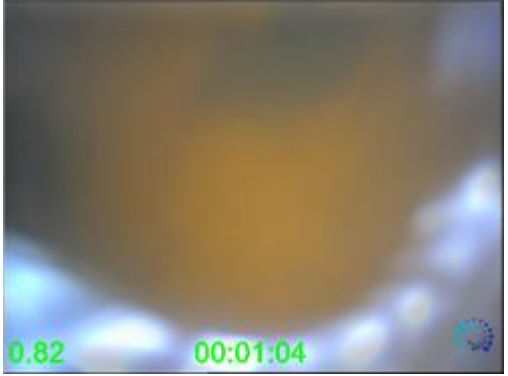
| Pos | Video Ref | Code | Description | Image |
|---|---|---|---|---|
| 00.80m | | GYF | Finish node type Gully<br>MAIN CARRIER - IN LINE<br>TRAP | <p>Image Provided - Ref: 24_9999</p> |

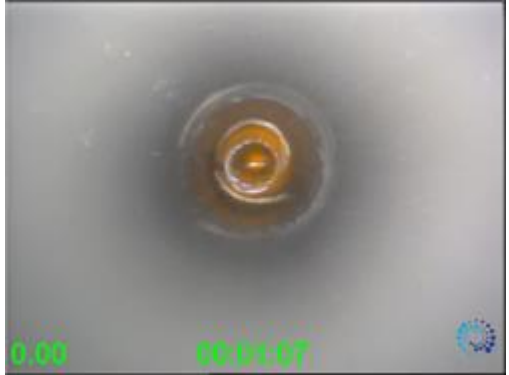
| Pos | Video Ref | Code | Description | Image |
|---|---|---|---|---|
| 00.00m | 0:00:00 | WL | Water level: 5% Height/Diameter | Image Provided - Ref: 25_1<br> |

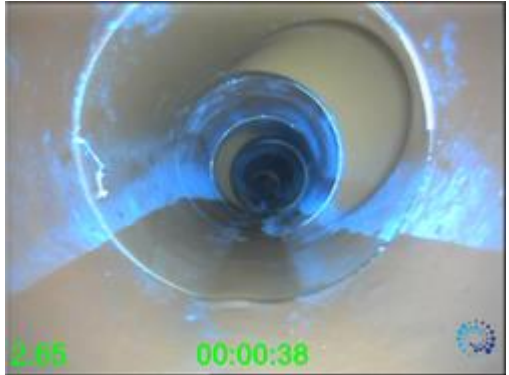
| Pos | Video Ref | Code | Description | Image |
|---|---|---|---|---|
| 02.65m | 0:00:38 | JN | Junction at 02 o'clock: 100mm Diameter | Image Provided - Ref: 25_2<br> |

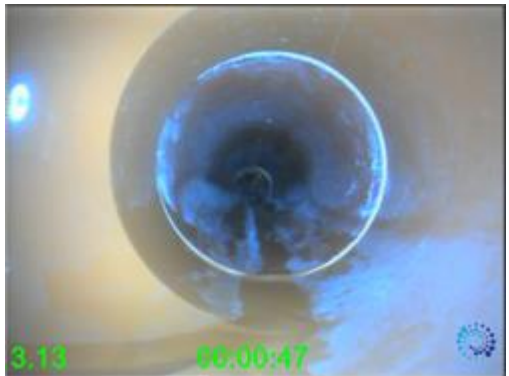
| Pos | Video Ref | Code | Description | Image |
|---|---|---|---|---|
| 03.13m | 0:00:47 | JN | Junction at 09 o'clock: 100mm Diameter | Image Provided - Ref: 25_3<br> |

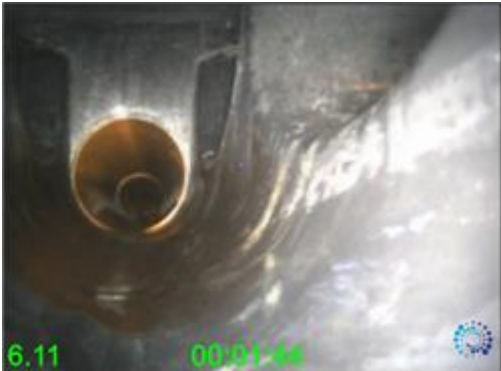
| Pos | Video Ref | Code | Description | Image |
|---|---|---|---|---|
| 06.10m | | MHF | Finish node type, manhole<br>FW 2 | <p>Image Provided - Ref: 25_9999</p> |

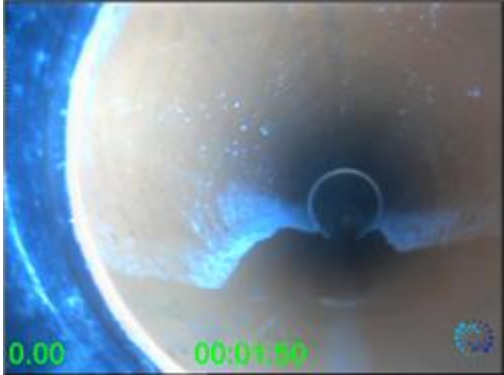
| Pos | Video Ref | Code | Description | Image |
|---|---|---|---|---|
| 00.00m | 0:00:00 | WL | Water level: 5%<br>Height/Diameter | <p>Image Provided - Ref: 26_1</p> |

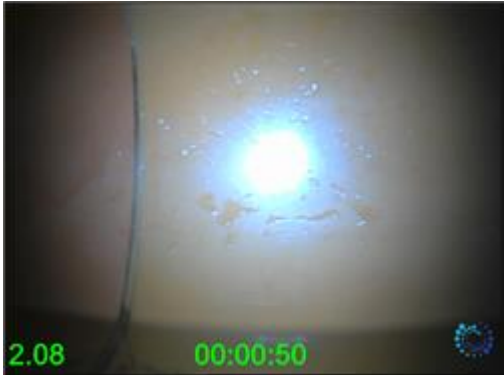
| Pos | Video Ref | Code | Description | Image |
|---|---|---|---|---|
| 02.07m | | BRF | Finish node type, major<br>connection without manhole<br>MAIN CARRIER | <p>Image Provided - Ref: 26_9999</p> |

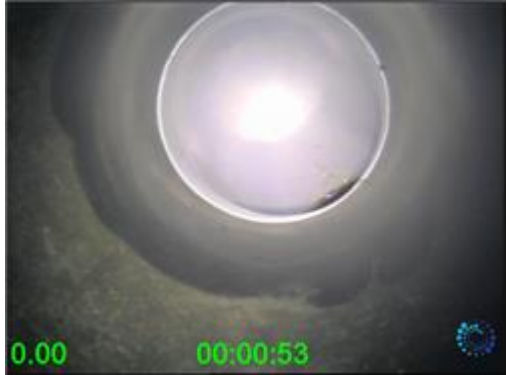
| Pos | Video Ref | Code | Description | Image |
|---|---|---|---|---|
| 00.00m | 0:00:00 | WL | Water level: 5% Height/Diameter | <p>Image Provided - Ref: 27_1</p> |

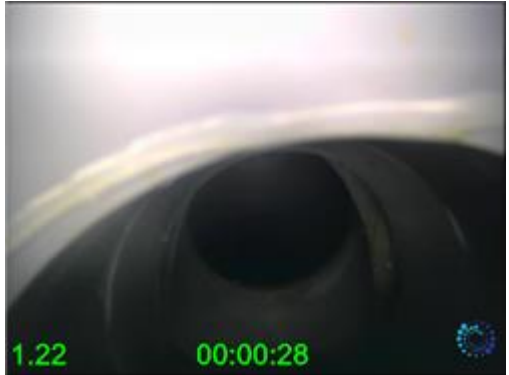
| Pos | Video Ref | Code | Description | Image |
|---|---|---|---|---|
| 01.22m | 0:00:28 | LDF | Line of drain/sewer deviates down [full] | <p>Image Provided - Ref: 27_2</p> |

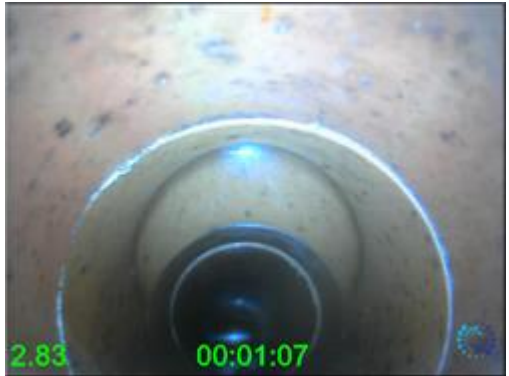
| Pos | Video Ref | Code | Description | Image |
|---|---|---|---|---|
| 02.83m | 0:01:07 | JN | Junction at 12 o'clock: 100mm Diameter | <p>Image Provided - Ref: 27_3</p> |

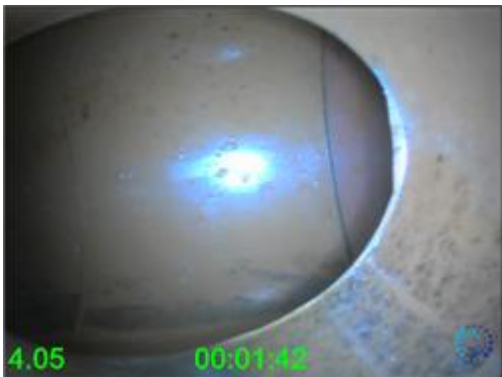
| Pos | Video Ref | Code | Description | Image |
|---|---|---|---|---|
| 04.05m | | BRF | Finish node type, major connection without manhole<br>MAIN CARRIER | <p>Image Provided - Ref: 27_9999</p> |
