# Castlefield Viaduct

Arup Report – 3 September 2021

# Executive Summary

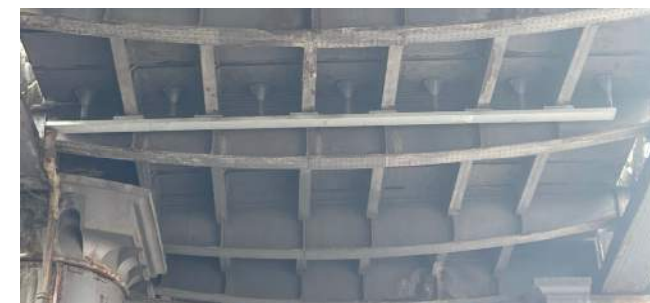
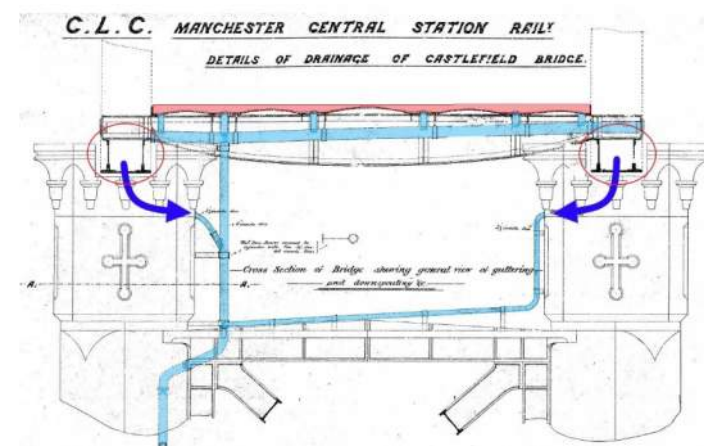
Figure 3-5: Section Through Viaduct with Additional Drainage Collectors Under Deck

Photograph and diagram of the drainage system

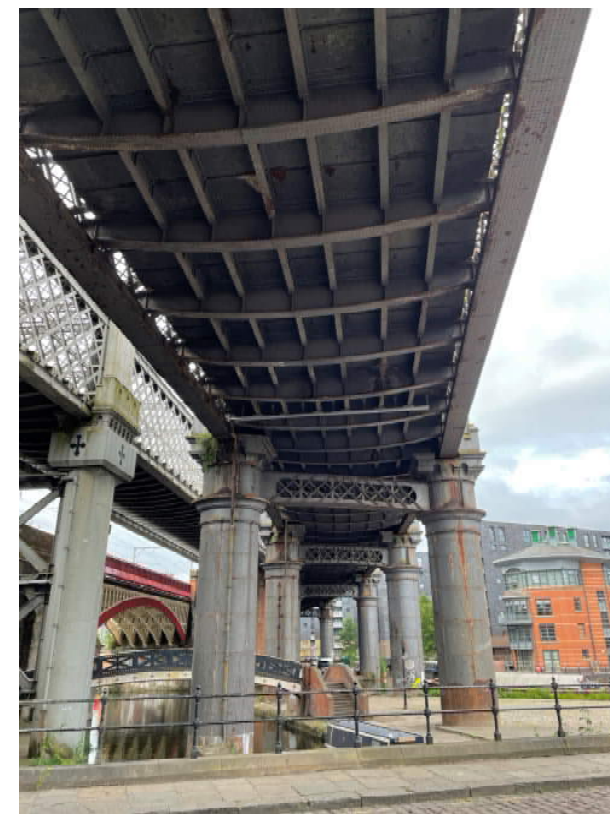
View showing the soffit of the viaduct

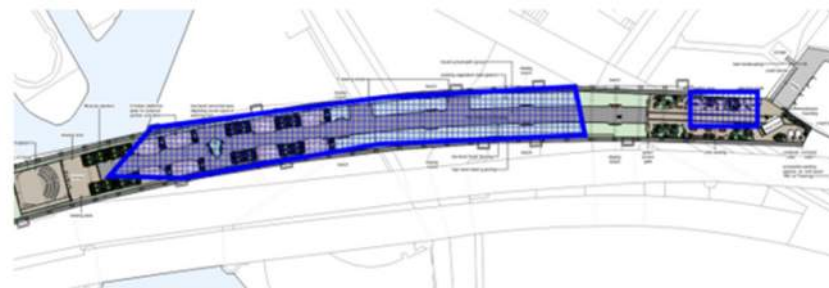
Figure 2 - Approximate extents of soffit review

Arup visited the Castlefield viaduct (*Figure 1*) on 30.06.2021 to conduct a walkover and observe the general condition of the steel structure. The approximate extents of the section of viaduct inspected is indicated by the blue shaded areas on *Figure 2*. This accounts for approximately 150m, and includes 4 main spans between piers spread over two locations. The section between the two shaded area was reviewed but with reduced visibility. In attendance was Adam Morgan and Daniel Green. Conditions were dry, bright, partial cloud, approx. 19 degrees.

The structure was only accessible from below, so observations in this note are limited.
