# Glazing Options Matrix Report

## **Non-Intrusive Condition Survey into the Glazed Façade Elements Report**

07055/HB/RS/54314/WL/02

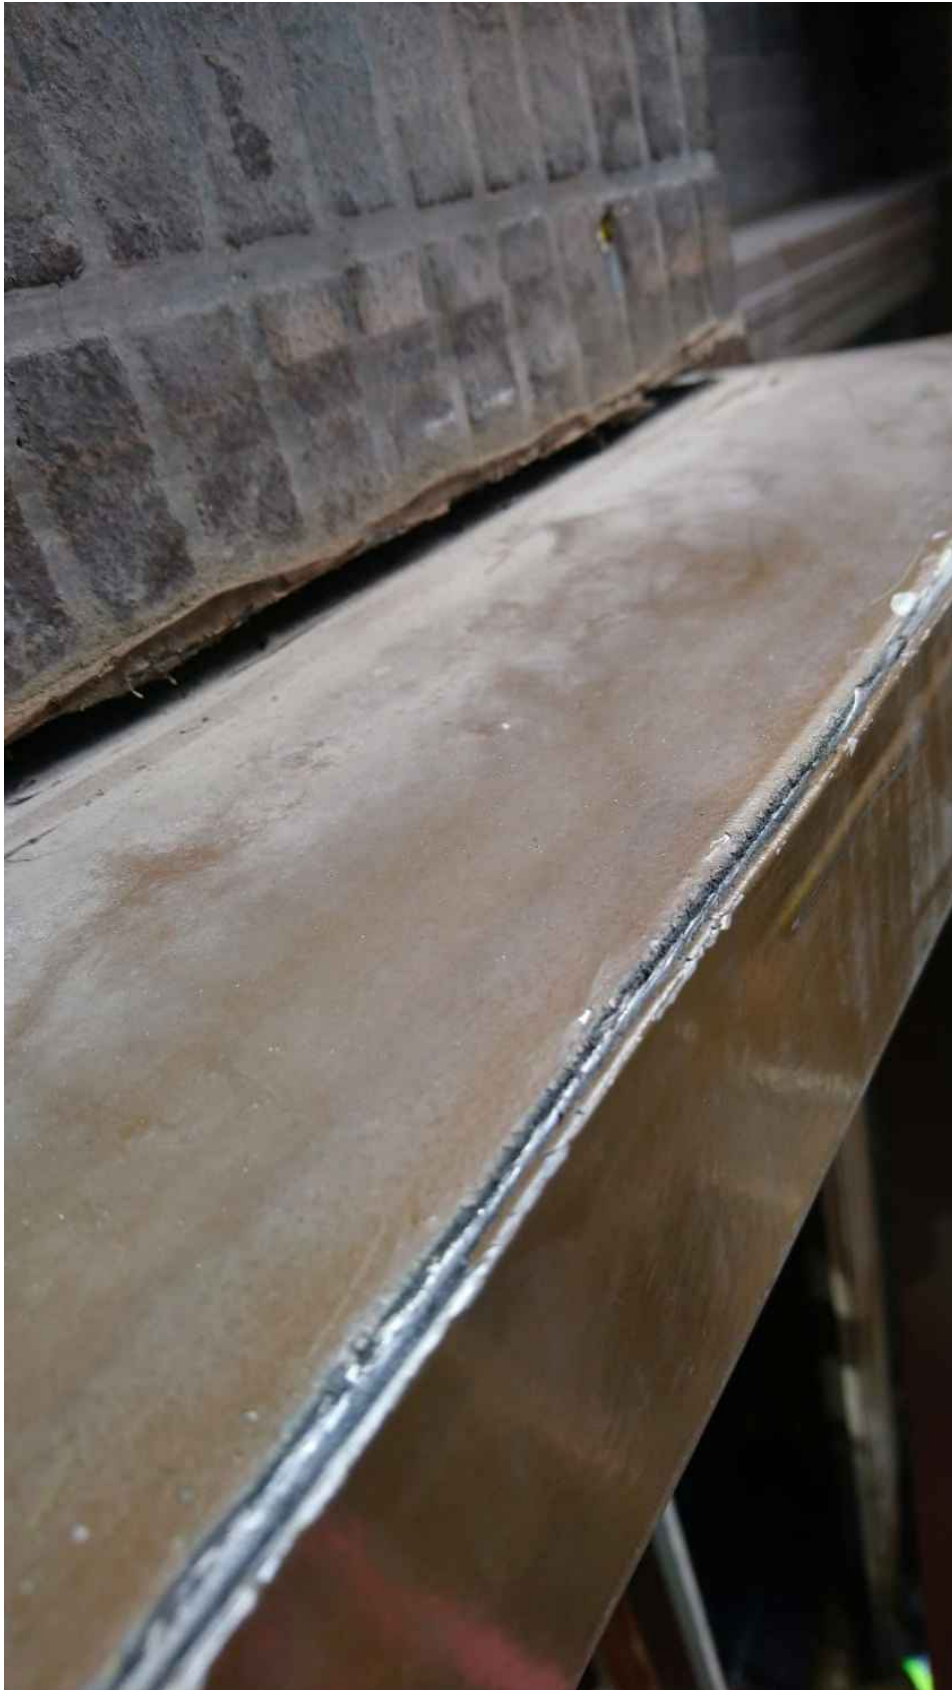
Cut in existing pressing at head of window.

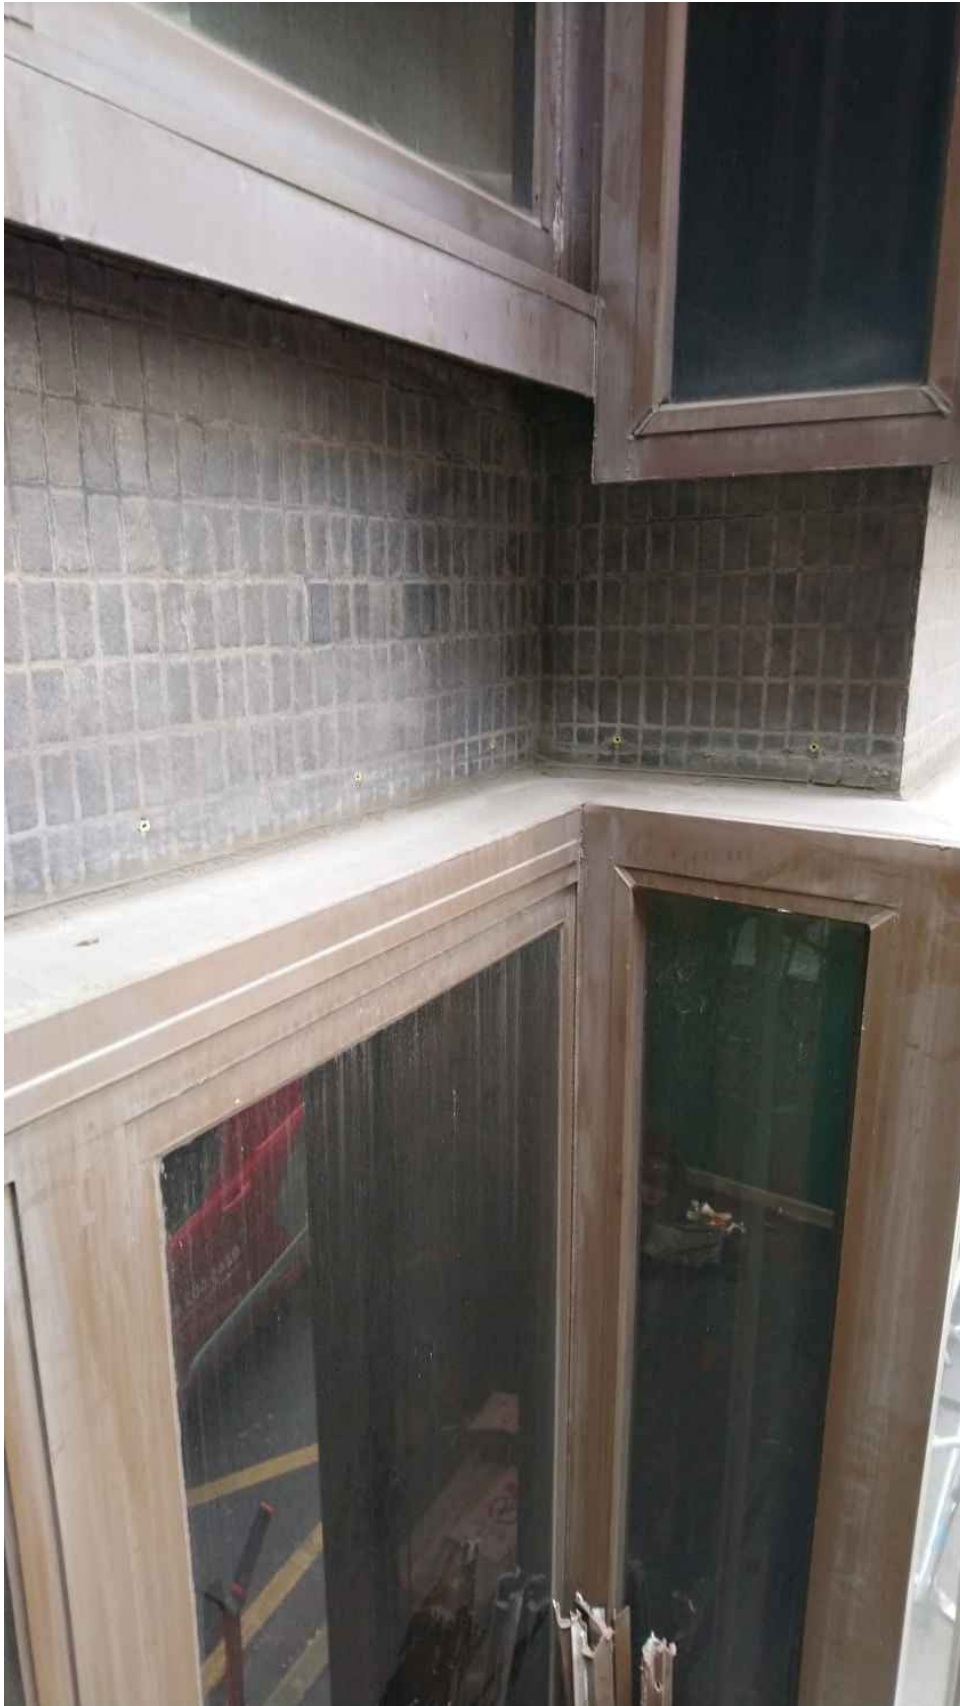
Pressing above window as existing

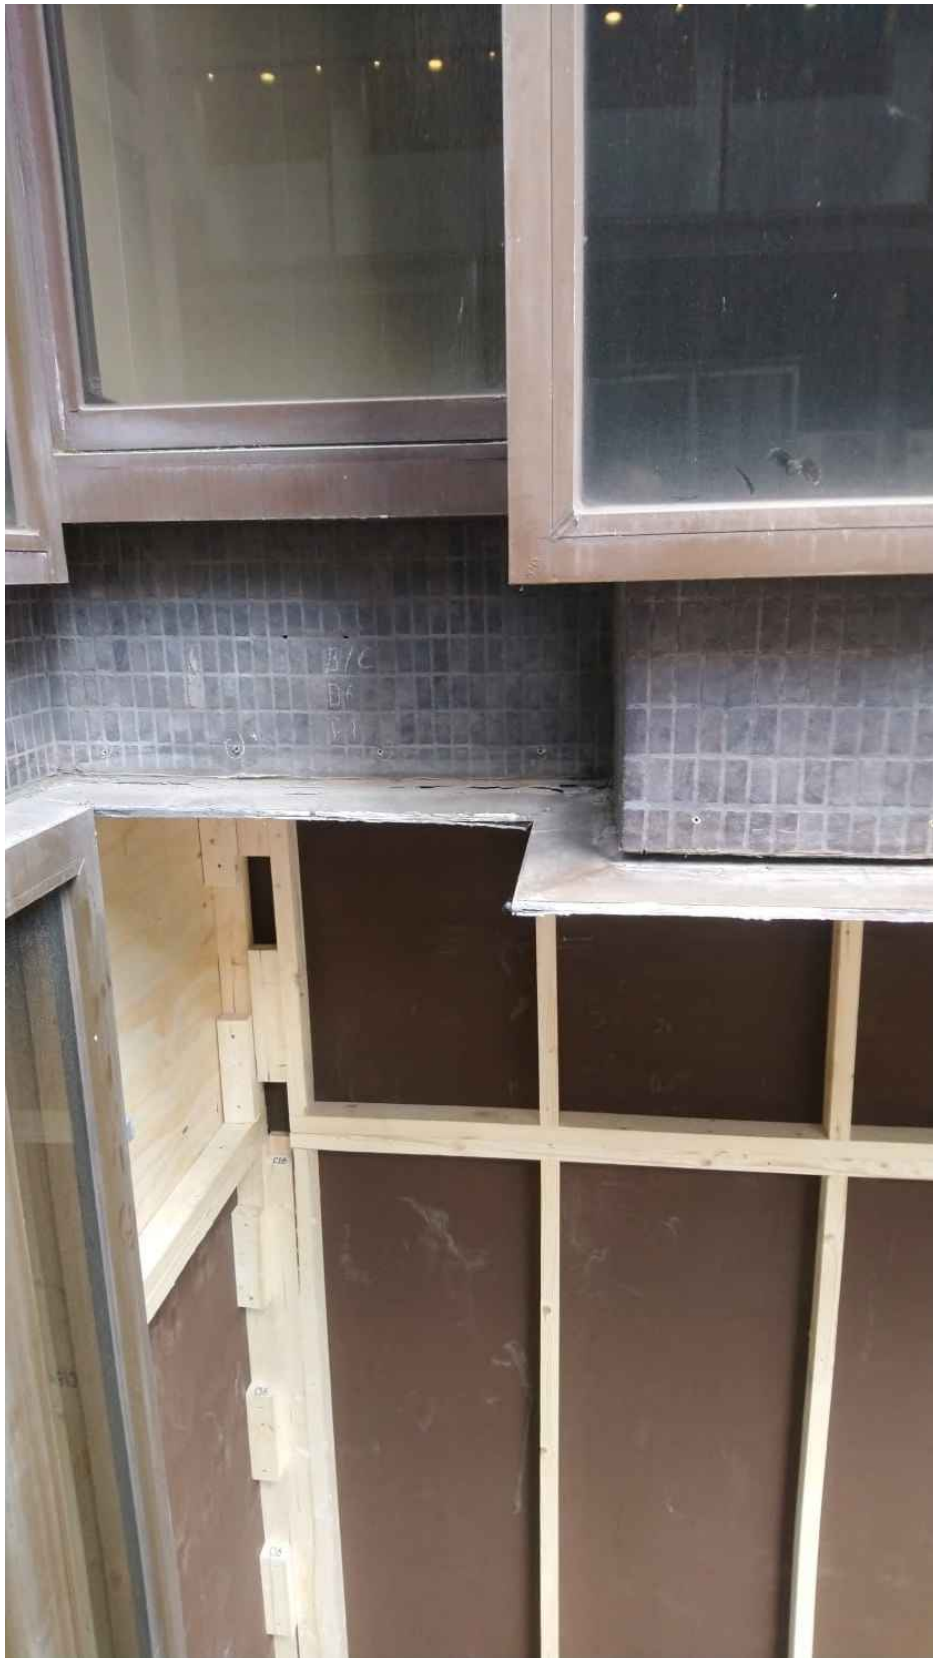
Head pressing cut and left in situ, existing window removed
