## Schedule of Condition

Slade Lane Neighbourhood Centre

for Myriad Foundation

Slade Lane M13 0QJ

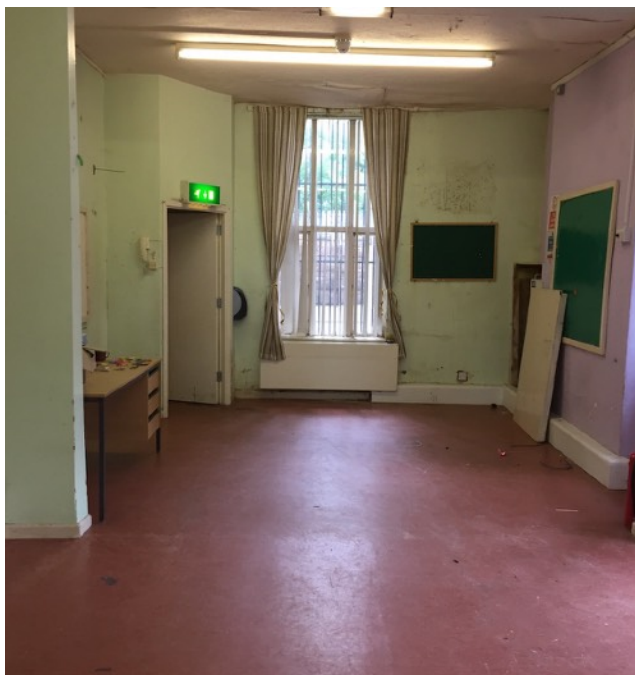
View towards rear window

**Walls** - Plaster & painted in reasonable condition with mdf skirting throughout; surface mounted electric cables including fire safety fixings

**Floors** - Vinyl floor covering throughout in poor condition, existing timber floor not inspected

**Ceiling** - Painted wall covering in poor condition; surface mounted electric cable; surface mounted strip lighting & fire safety equipment

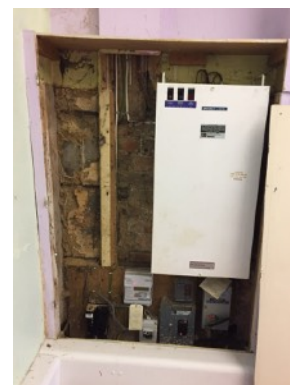
Wall mounted services

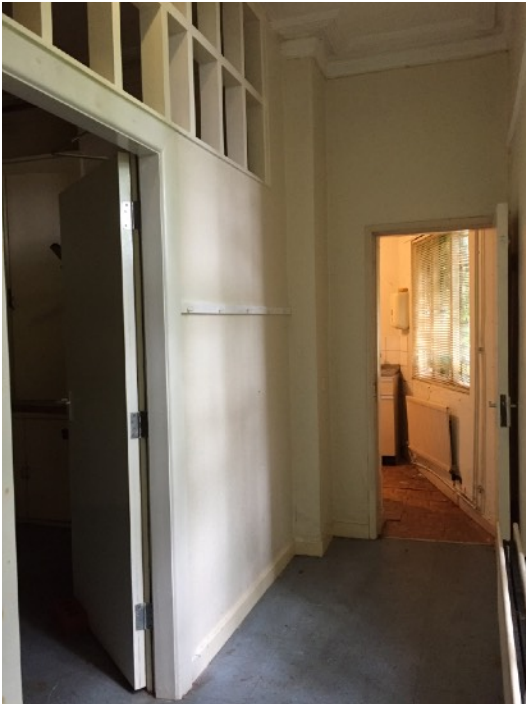
View towards kitchen

**Walls** - Painted textured wall covering in reasonable condition with timber skirting throughout; painted lightweight timber partition,

**Floors** - Vinyl tile floor covering throughout in poor condition, existing timber floor not inspected

**Ceiling** - Painted lath and plaster ceiling in reasonable condition; surface mounted electric cable; surface mounted strip lighting

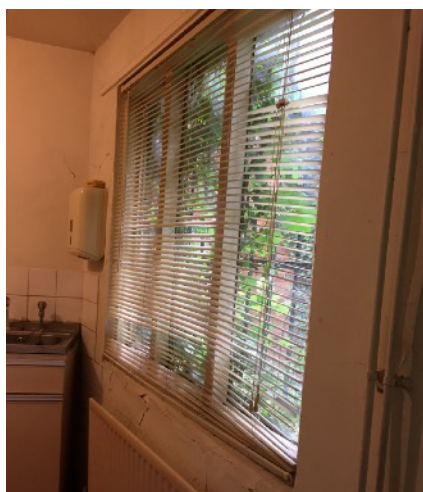
Window facing rear

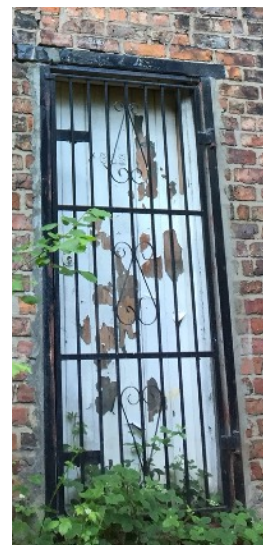
Exit door to side

**Door** - Painted imber panelled door inoperable with black painted metal security grille fixed to external wall in reasonable condition.

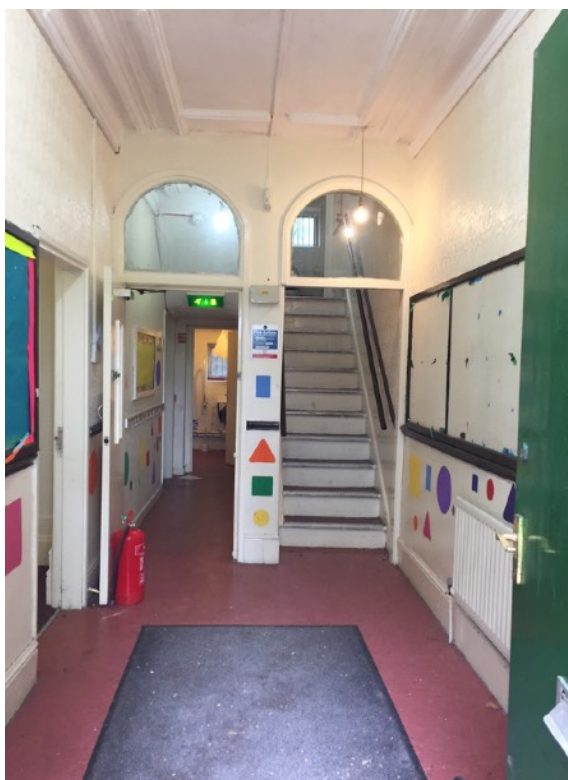
Main entrance at front elevation

**Door** - External painted timber door with solid over panel and aluminium ironmongery in poor condition; internal fire glazed fire door with aluminium ironmongery and glazed over panel in reasonable condition.

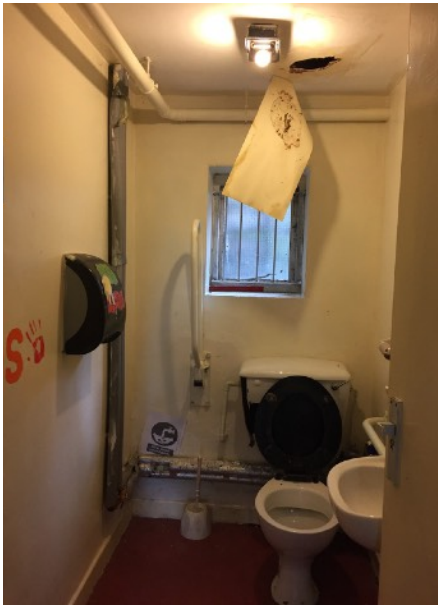
Disabled toilet

**Walls** - Plaster & painted in poor condition with 100mm skirting throughout; surface mounted electric cables; surface mounted heating pipes;

**Floors** - Vinyl tile floor covering throughout in poor condition, existing timber floor not inspected

**Ceiling** - Painted wall covering in poor condition with hole in ceiling in one location; surface mounted electric cable; surface mounted lighting, surface mounted fire alarm

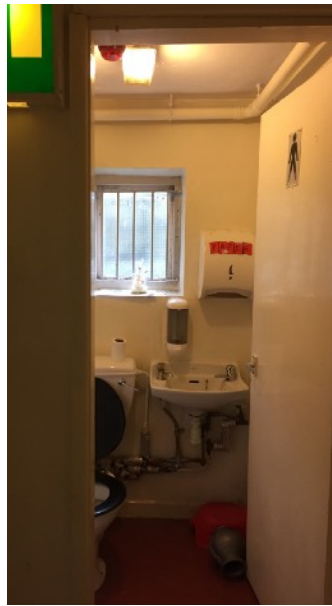
Men's toilet

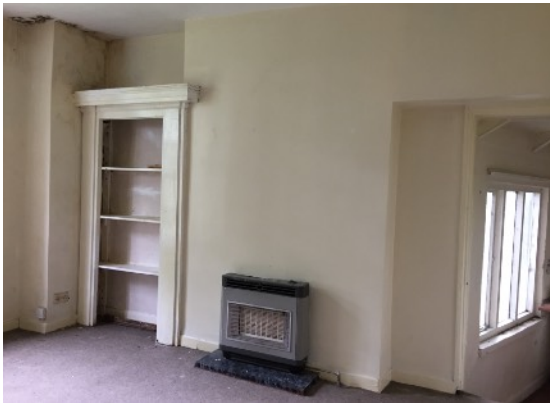
Existing chimney breast with electric heater

**Walls** - Plaster & painted with low skirting throughout in poor condition and water damage patches facing external walls; surface mounted electric cables

**Ceiling** - Plaster & painted in poor condition with water damage and damp along external walls; surface mounted lighting

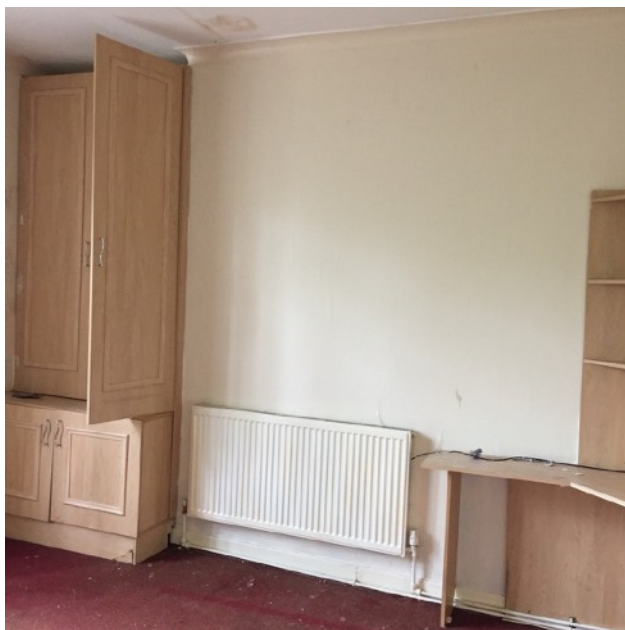
Wall with built in cabinets

**Fixtures & Fittings** - Fixed shelving and cabinets in one wall recess; two fixed desk units

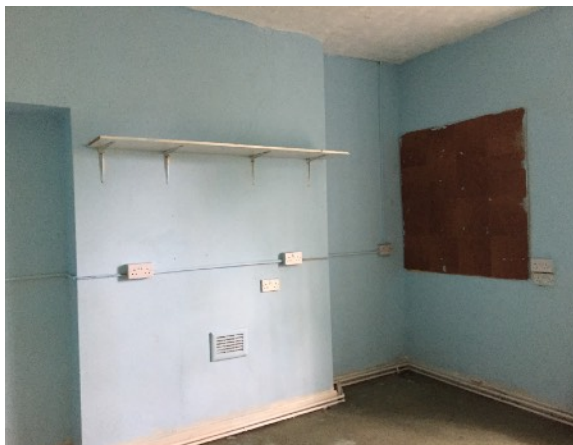
Side external wall

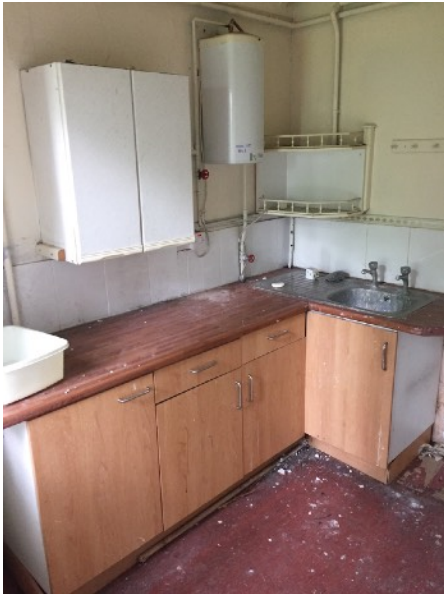
Side pantry

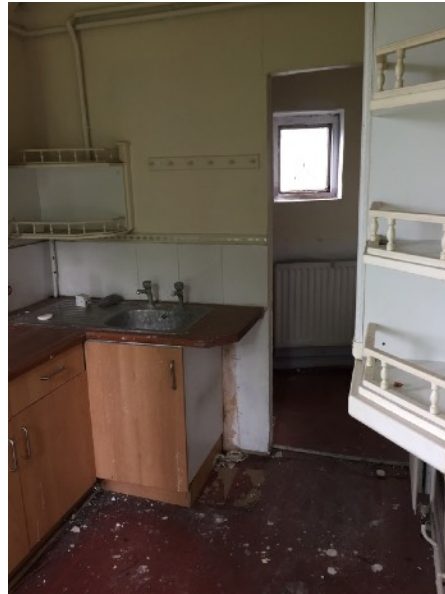
Facing rear window

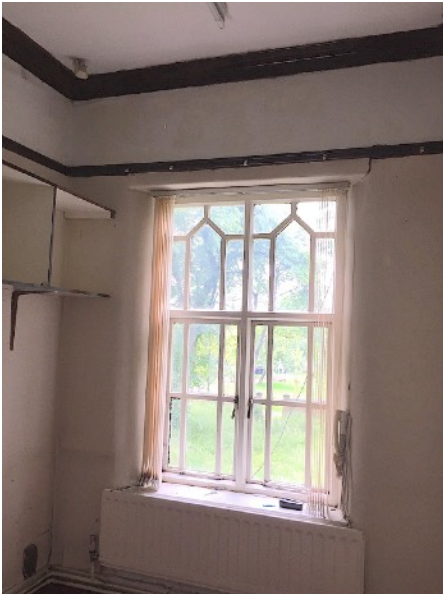
Window facing front elevation

**Walls** - Plaster & painted low skirting; painted picture rail

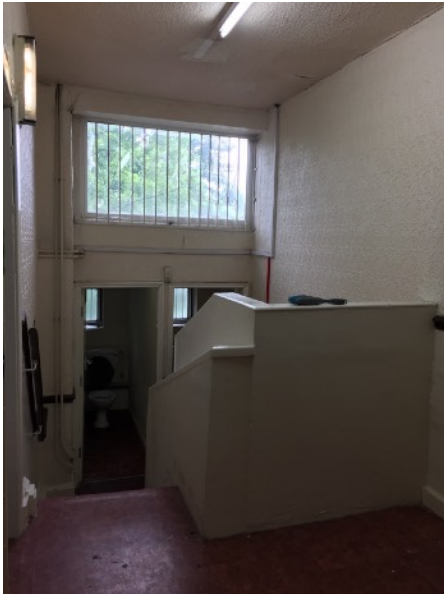
High level glazed opening facing rear

**Walls** - Painted textured wall covering and low skirting; painted picture rail

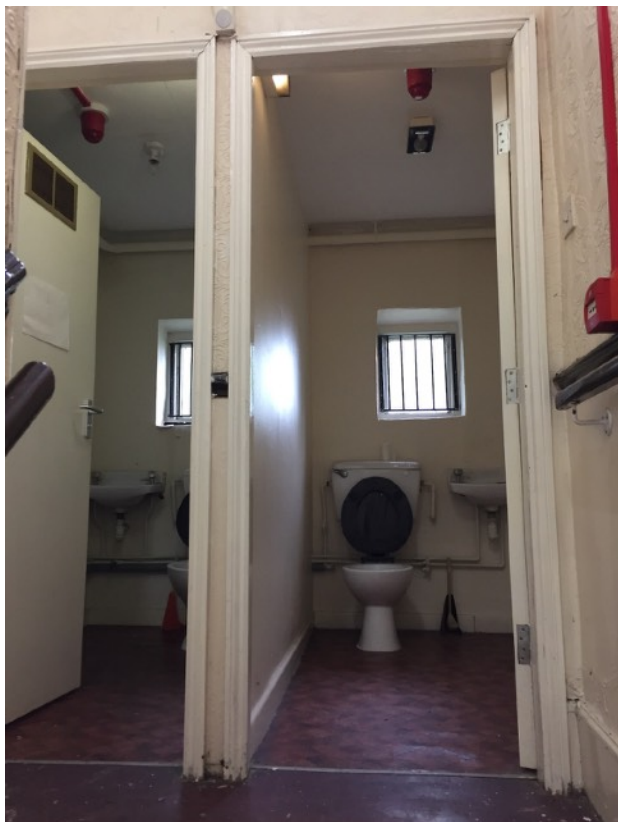
Toilets at mid-landing level

**Walls** - Plaster & painted with low skirting in reasonable condition; painted picture rail

**Sanitaryware** - Toilets and wall mounted wash hand basins not inspected;

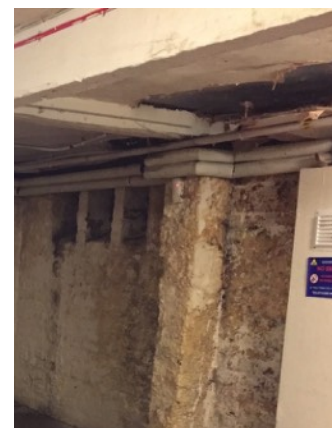
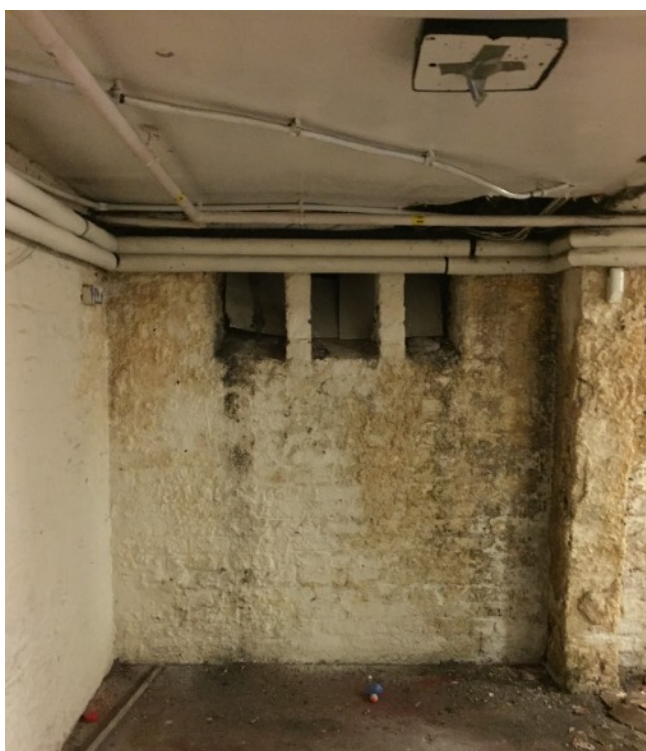
Main chamber

**Walls** - Brick painted throughout; damp & water damage has calcified paint finish on front external side

**Floors** - Painted screed in poor condition; some breakout patches along front external wall

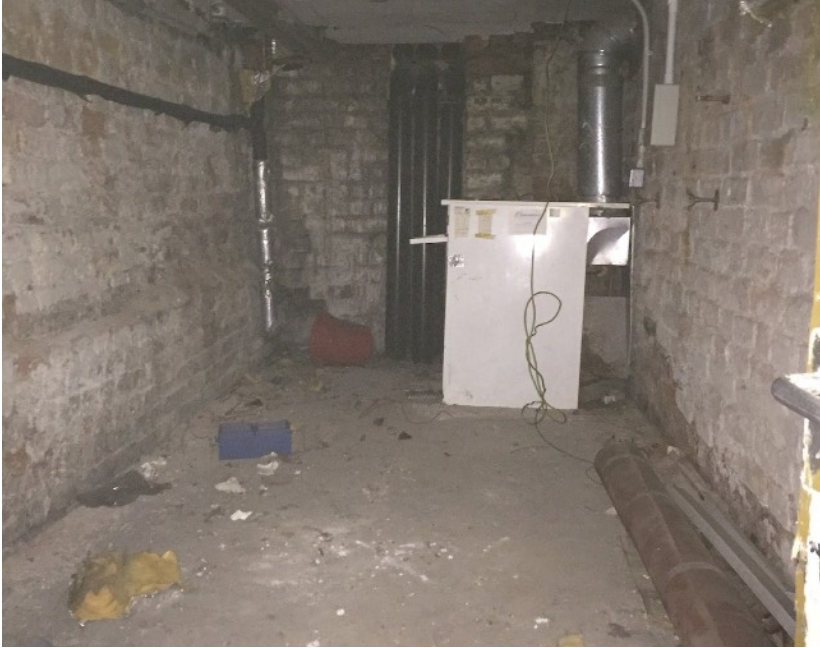
Side chamber

**Walls** - Brick throughout; single internal leaf with hatch between inner chamber
