# Drainage Report

Prepared For  
**First Choice Groundworks**

Site  
**Portway  
Wythenshaw**

## First Choice Groundworks Portway Wythenshaw - CCTV Survey Report : 28/01/21

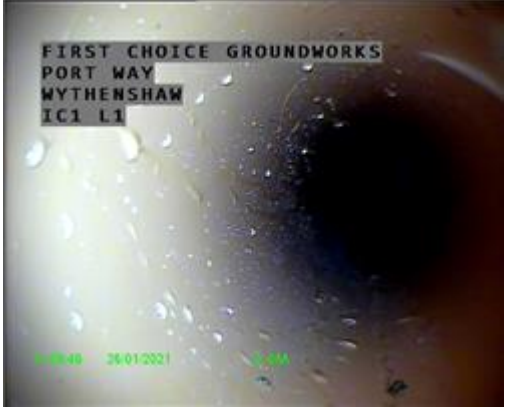
| Pos | Video Ref | Code | Description | Image |
|---|---|---|---|---|
| 00.00m | | MH | Start node type, manhole<br>IC1 L1 | Image Provided - Ref: 0_0<br> |
| 00.00m | 0:00:00 | WL | Water level: 0%<br>Height/Diameter | |
| 01.10m | 0:00:48 | LUF | Line of drain/sewer deviates up<br>[full] | |
| 01.10m | | OCF | Finish node type, other special<br>chamber<br>INLINE | |

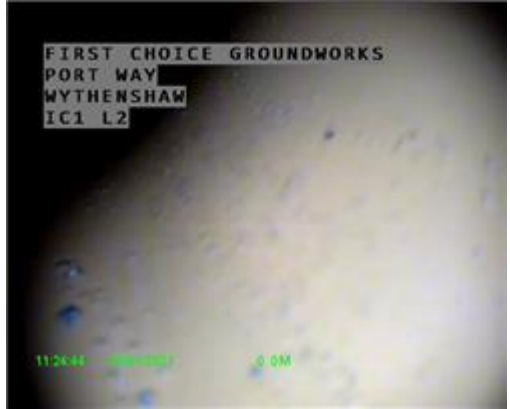
| Pos | Video Ref | Code | Description | Image |
|---|---|---|---|---|
| 00.00m | | MH | Start node type, manhole<br>IC1 L2 | Image Provided - Ref: 1_0<br> |
| 00.00m | 0:00:00 | WL | Water level: 0%<br>Height/Diameter | |
| 07.80m | 0:01:07 | LUF | Line of drain/sewer deviates up<br>[full] | |
| 07.80m | | OCF | Finish node type, other special<br>chamber<br>RESTBEND | |

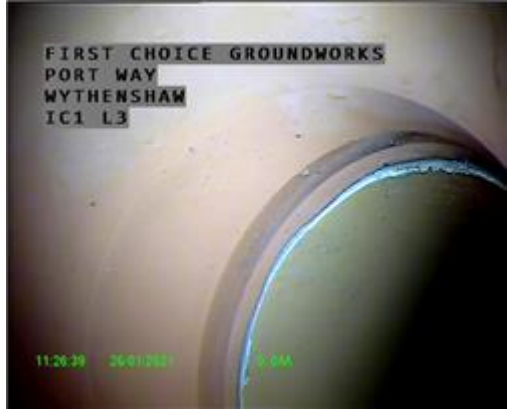
| Pos | Video Ref | Code | Description | Image |
|---|---|---|---|---|
| 00.00m | | MH | Start node type, manhole<br>IC1 L3 | Image Provided - Ref: 2_0<br> |
| 00.00m | 0:00:00 | WL | Water level: 0%<br>Height/Diameter | |
| 00.00m | 0:00:08 | LRF | Line of drain/sewer deviates<br>right [full] | |

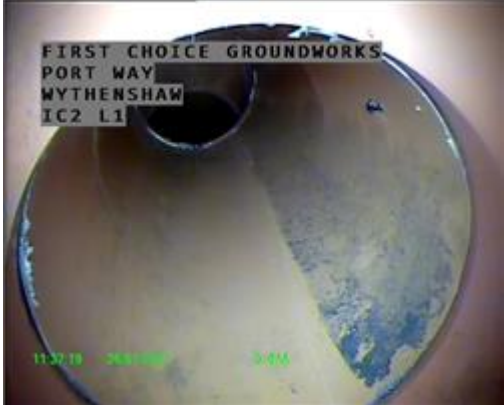
| Pos | Video Ref | Code | Description | Image |
|---|---|---|---|---|
| 00.00m | | MH | Start node type, manhole<br>IC2 L1 | Image Provided - Ref: 3_0<br> |
| 00.00m | 0:00:00 | WL | Water level: 0%<br>Height/Diameter | |
| 00.00m | 0:00:00 | LUF | Line of drain/sewer deviates up<br>[full] | |

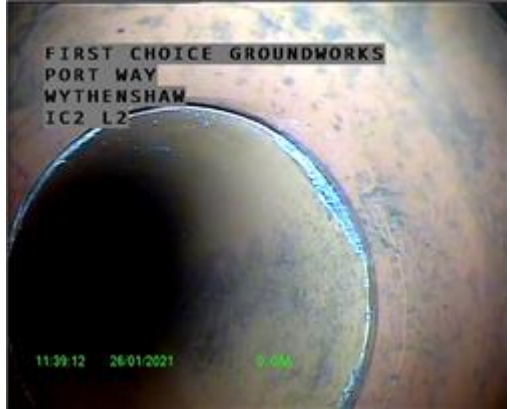
| Pos | Video Ref | Code | Description | Image |
|---|---|---|---|---|
| 00.00m | | MH | Start node type, manhole<br>IC2 L2 | Image Provided - Ref: 4_0<br> |
| 00.00m | 0:00:00 | WL | Water level: 0%<br>Height/Diameter | |
| 00.40m | 0:00:17 | LLH | Line of drain/sewer deviates<br>left [half] | |

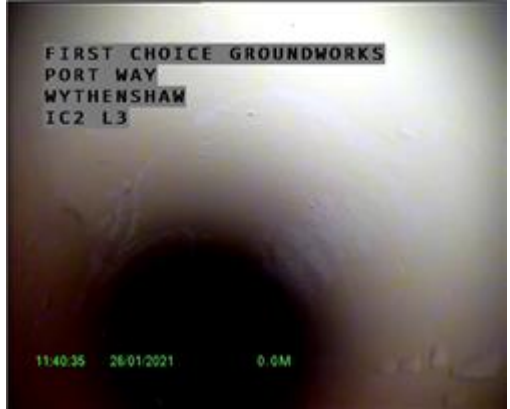
| Pos | Video Ref | Code | Description | Image |
|---|---|---|---|---|
| 00.00m | | MH | Start node type, manhole IC2 L3 | <p>Image Provided - Ref: 5_0</p> |
| 00.00m | 0:00:00 | WL | Water level: 0% Height/Diameter | |
| 02.80m | 0:00:24 | LRH | Line of drain/sewer deviates right [half] | |

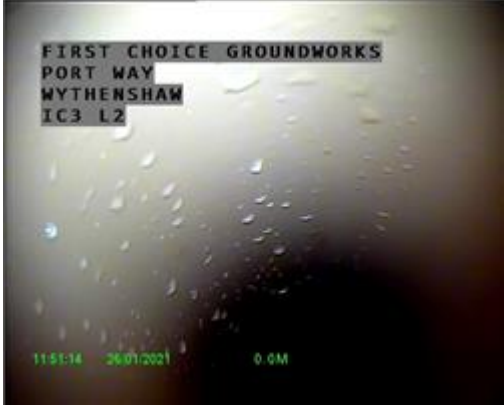
| Pos | Video Ref | Code | Description | Image |
|---|---|---|---|---|
| 00.00m | | MH | Start node type, manhole<br>IC3 L2 | Image Provided - Ref: 7_0<br> |
| 00.00m | 0:00:00 | WL | Water level: 0%<br>Height/Diameter | |
| 01.00m | | MHF | Finish node type, manhole<br>IC4 | |

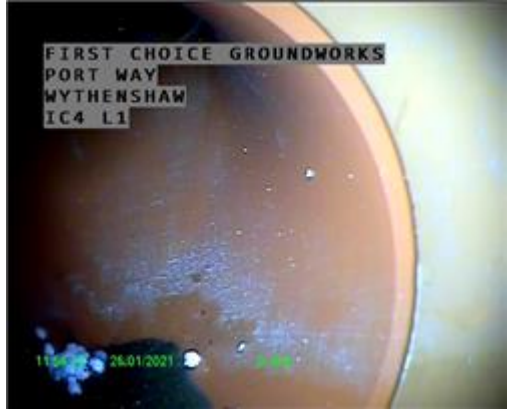
| Pos | Video Ref | Code | Description | Image |
|---|---|---|---|---|
| 00.00m | | MH | Start node type, manhole<br>IC4 L1 | Image Provided - Ref: 8_0<br> |
| 00.00m | 0:00:00 | WL | Water level: 0%<br>Height/Diameter | |
| 00.10m | 0:00:08 | LUF | Line of drain/sewer deviates up<br>[full] | |

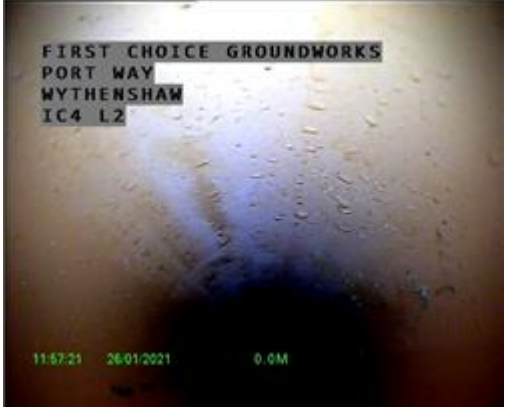
| Pos | Video Ref | Code | Description | Image |
|---|---|---|---|---|
| 00.00m | | MH | Start node type, manhole<br>IC4 L2 | Image Provided - Ref: 9_0<br> |
| 00.00m | 0:00:00 | WL | Water level: 0%<br>Height/Diameter | |
| 07.80m | | MHF | Finish node type, manhole<br>IC5 | |

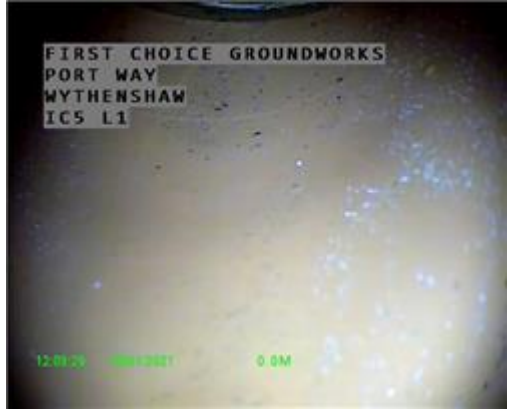
| Pos | Video Ref | Code | Description | Image |
|---|---|---|---|---|
| 00.00m | | MH | Start node type, manhole<br>IC5 L1 | Image Provided - Ref: 10_0<br> |
| 00.00m | 0:00:00 | WL | Water level: 0%<br>Height/Diameter | |
| 00.00m | 0:00:06 | LUF | Line of drain/sewer deviates up<br>[full] | |

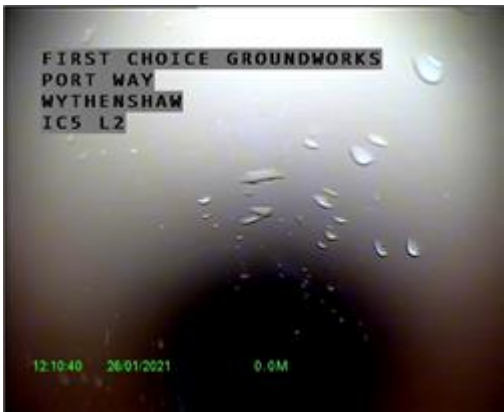
| Pos | Video Ref | Code | Description | Image |
|---|---|---|---|---|
| 00.00m | | MH | Start node type, manhole<br>IC5 L2 | Image Provided - Ref: 11_0<br> |
| 00.00m | 0:00:00 | WL | Water level: 0%<br>Height/Diameter | |
| 05.30m | | MHF | Finish node type, manhole<br>IC6 | |

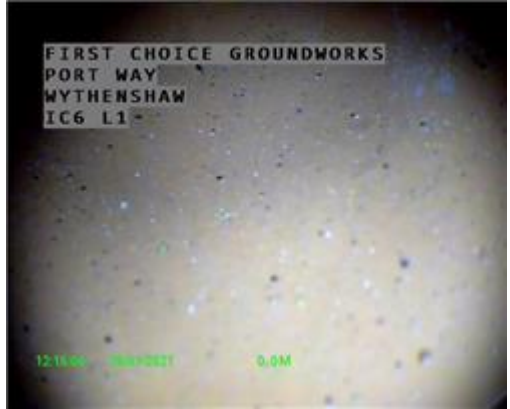
| Pos | Video Ref | Code | Description | Image |
|---|---|---|---|---|
| 00.00m | | MH | Start node type, manhole<br>IC6 L1 | Image Provided - Ref: 12_0<br> |
| 00.00m | 0:00:00 | WL | Water level: 0%<br>Height/Diameter | |
| 00.00m | 0:00:00 | LUF | Line of drain/sewer deviates up<br>[full] | |

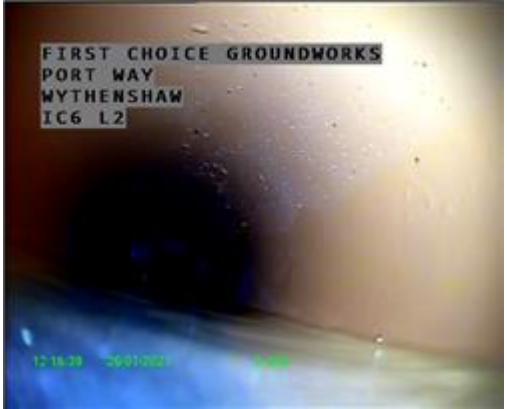
| Pos | Video Ref | Code | Description | Image |
|---|---|---|---|---|
| 00.00m | | MH | Start node type, manhole<br>IC6 L2 | Image Provided - Ref: 13_0<br> |
| 00.00m | 0:00:00 | WL | Water level: 0%<br>Height/Diameter | |
| 00.50m | | MHF | Finish node type, manhole<br>IC7 | |

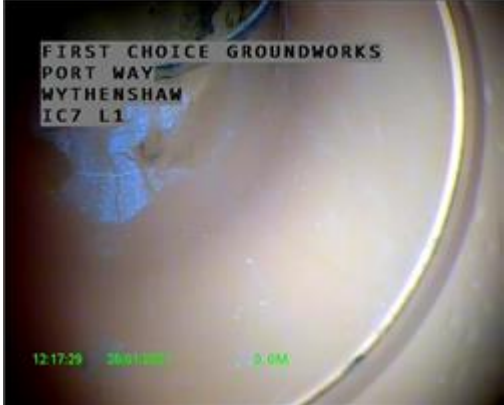
| Pos | Video Ref | Code | Description | Image |
|---|---|---|---|---|
| 00.00m | | MH | Start node type, manhole<br>IC7 L1 | Image Provided - Ref: 14_0<br> |
| 00.00m | 0:00:00 | WL | Water level: 0%<br>Height/Diameter | |
| 00.00m | 0:00:02 | LUF | Line of drain/sewer deviates up<br>[full] | |

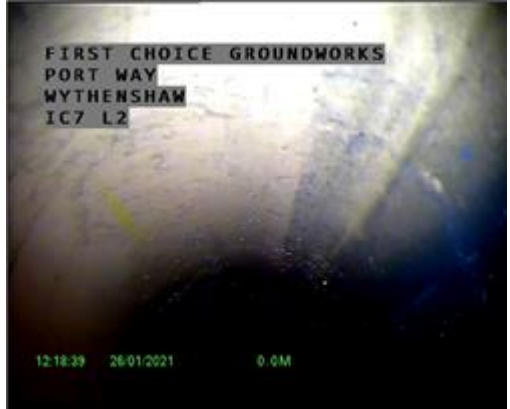
| Pos | Video Ref | Code | Description | Image |
|---|---|---|---|---|
| 00.00m | | MH | Start node type, manhole<br>IC7 L2 | Image Provided - Ref: 15_0<br> |
| 00.00m | 0:00:00 | WL | Water level: 0%<br>Height/Diameter | |
| 05.30m | 0:00:47 | LRH | Line of drain/sewer deviates<br>right [half] | |

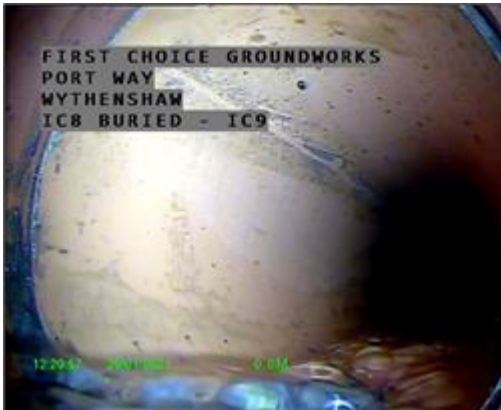
| Pos | Video Ref | Code | Description | Image |
|---|---|---|---|---|
| 00.00m | | MH | Start node type, manhole<br>IC8 BURIED | Image Provided - Ref: 16_0<br> |
| 00.00m | 0:00:00 | WL | Water level: 0%<br>Height/Diameter | |
| 00.00m | 0:00:01 | LRQ | Line of drain/sewer deviates<br>right [quarter] | |
