## **PHASE 1 CONTAMINATED LAND RISK ASSESSMENT REPORT**

**Project No. 1701-6450**

**Dappa Homes Limited**

**White House Club**

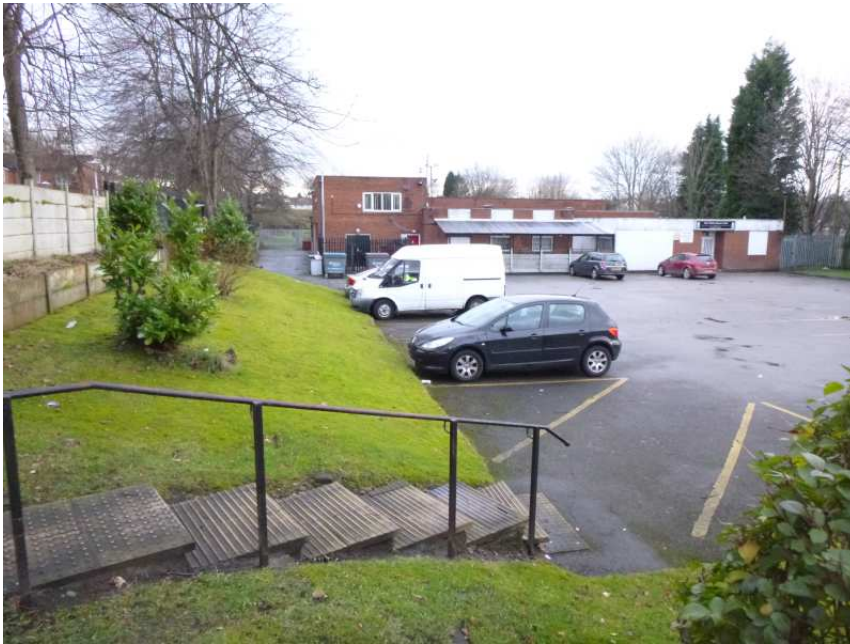
View of front of the club house

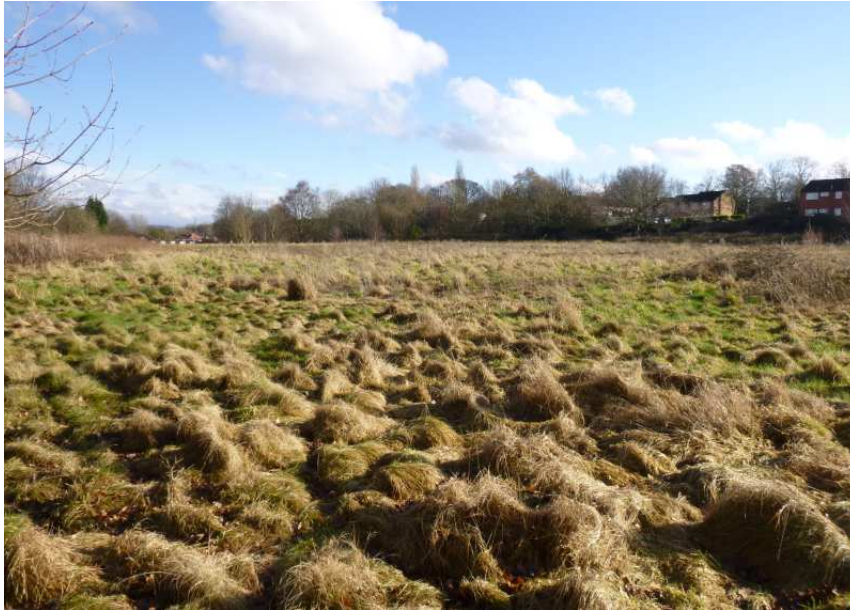
View across the upper playing pitch from the north west corner.

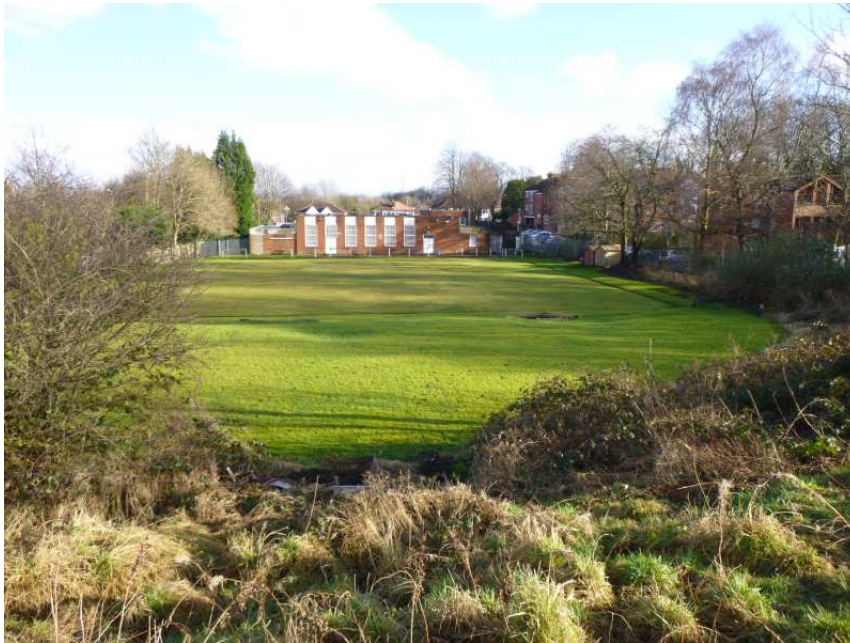
View of the lower elevation of the club and bowling green.

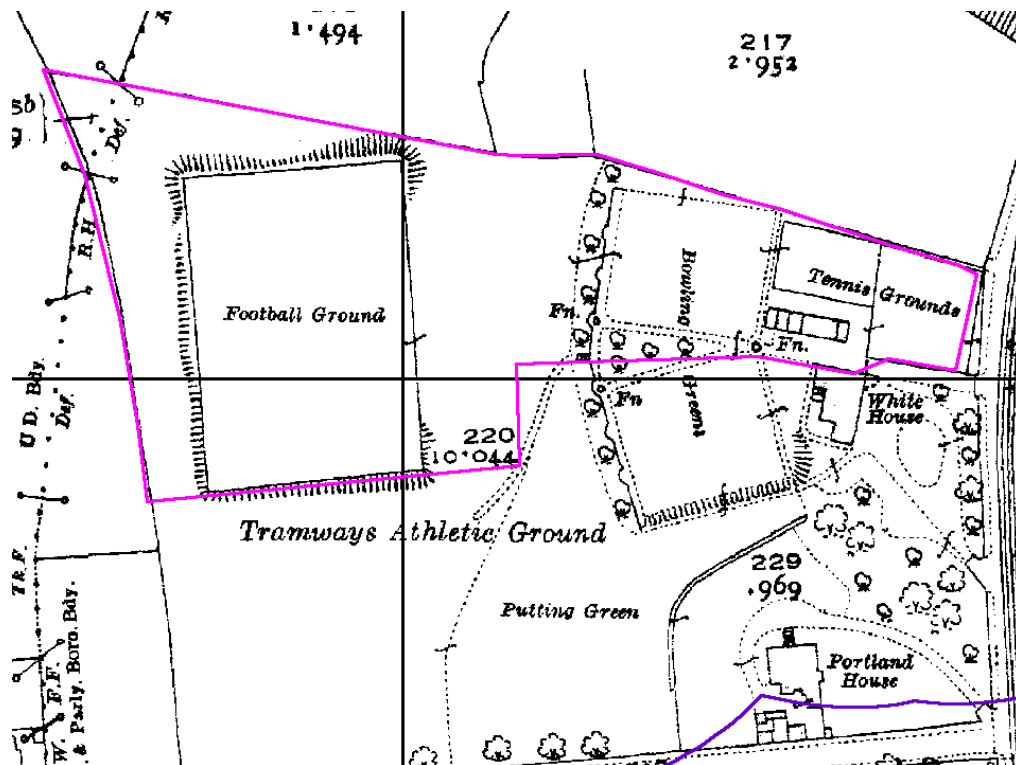
The 1:2500 map of 1922 shows that the site is now occupied by the “Tramways Athletic Ground”. The eastern portion of the site has the tennis courts and the building shown on the previous mapping. There are two bowling greens the one to the south inset in to the slope. The football pitch to the west appears to be slightly elevated with the slope lines shown on the mapping.

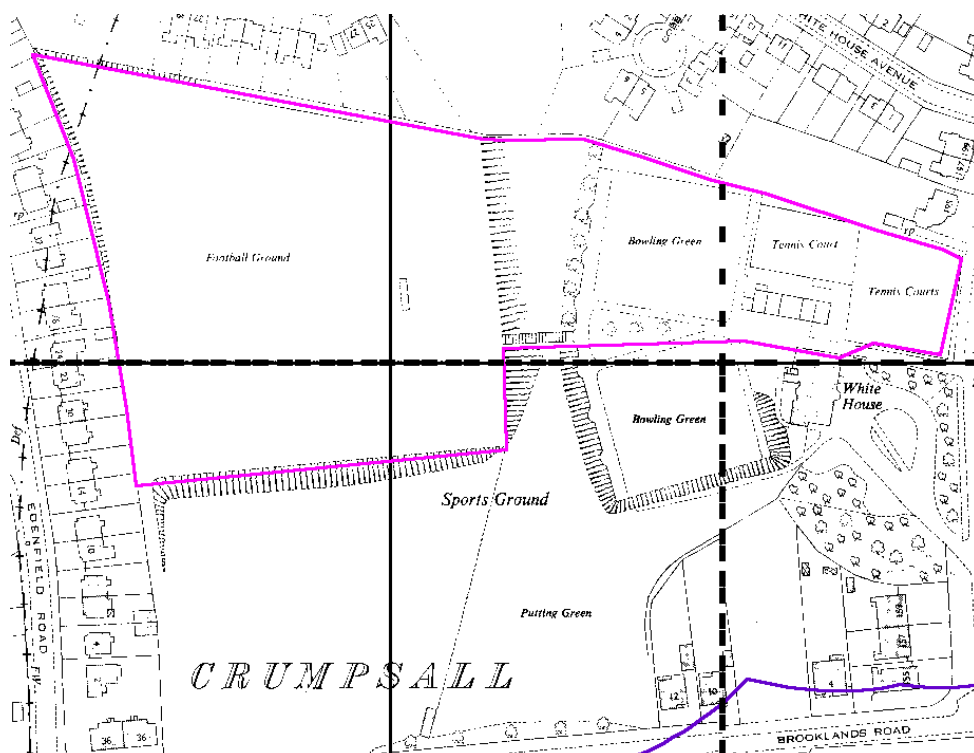
The 1:2500 1952 map below, shows the site. The map shows that there has been extensive building of pitch platforms. The football pit on the site is shown to have been extended with a large slope down on the eastern side, the off site bowling green is now shown with a raised slope on the western boundary. The other parts of

the site remain the same.

In conclusion, it is apparent that between the early 1920's and the 1950's the sports ground was developed and extended. It would appear that the main football pitch has been constructed on a fill platform. Some of the fill used may have come from excavations for the pitch to the south. Also the fill could have been brought to the site.

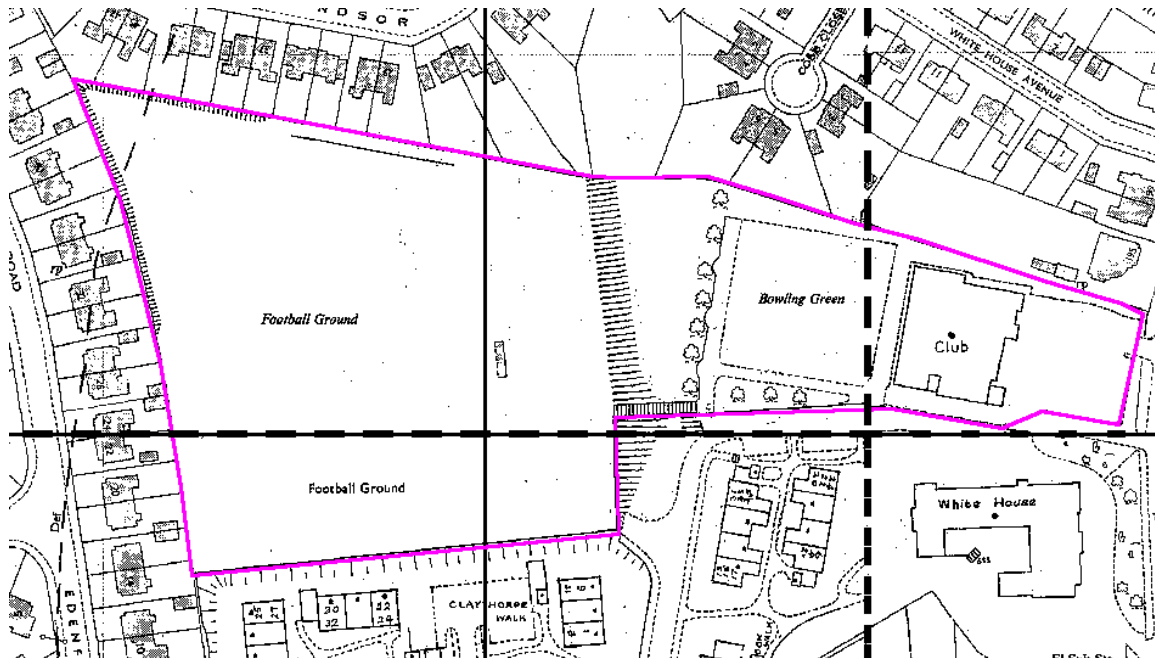
The 1979-1987 map shows the site has changed. The club house has been redeveloped. The south bowling green and the southern pitch area have been developed for housing. The slope between the bowling green and the football pitch is clearly shown.

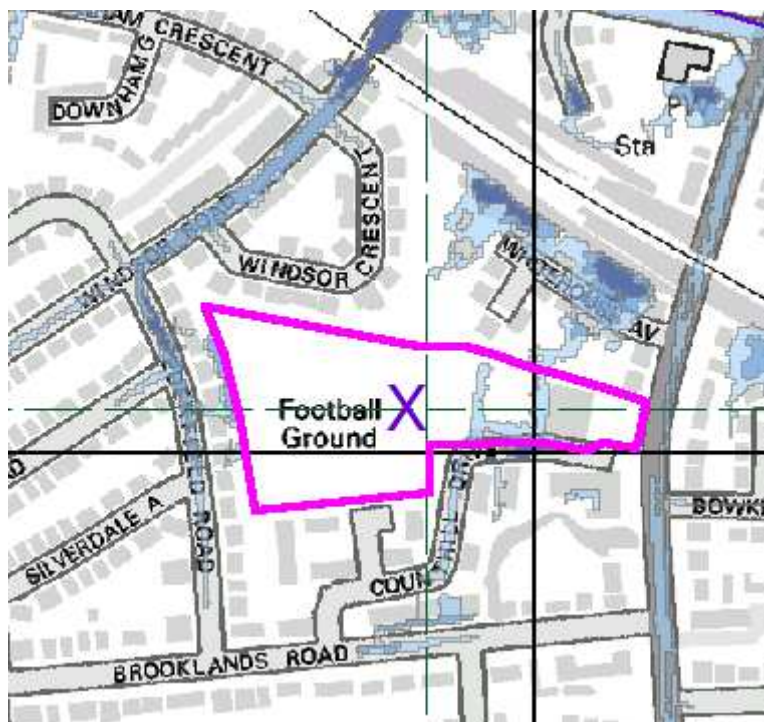
The site is not located within an area at risk from flooding from rivers with out or with defences. The EA/NRW map shows the potential for surface water flooding as shown on the extract of the plan below.
