**Project Name:** HYDE ROAD MANCHESTER

**Project Date:** 28/05/2021

**Inspection Standard:** MSCC5 Sewers & Drainage GB (SRM5 Scoring)

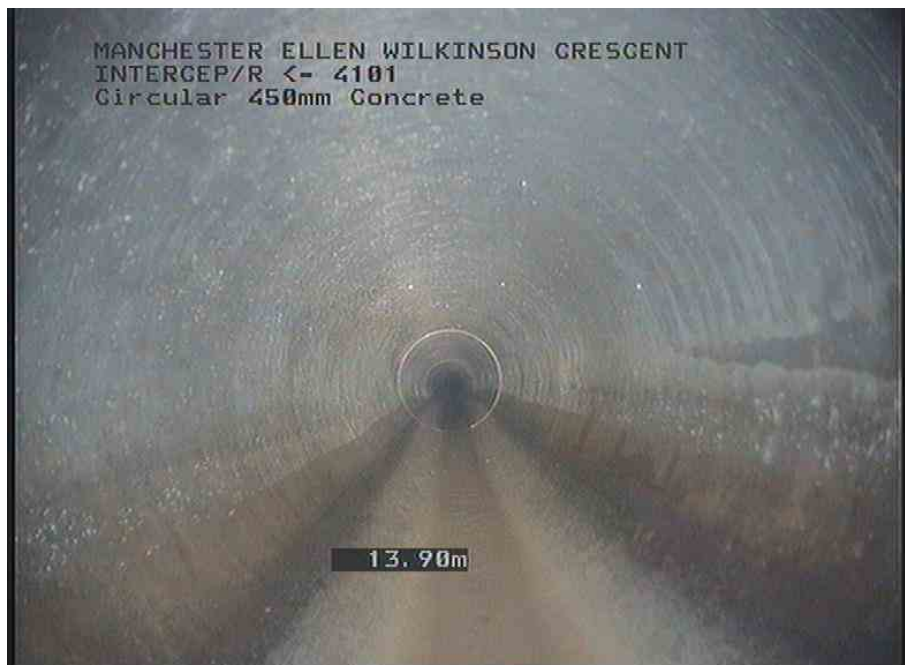
INTERCEP\_RX\_2876364e-c4a0-4ee3-a1a3-e668f9e6e0d9\_20210528\_084622\_664.jpg,  
00:01:31, 13.90 m  
General photograph taken at this point

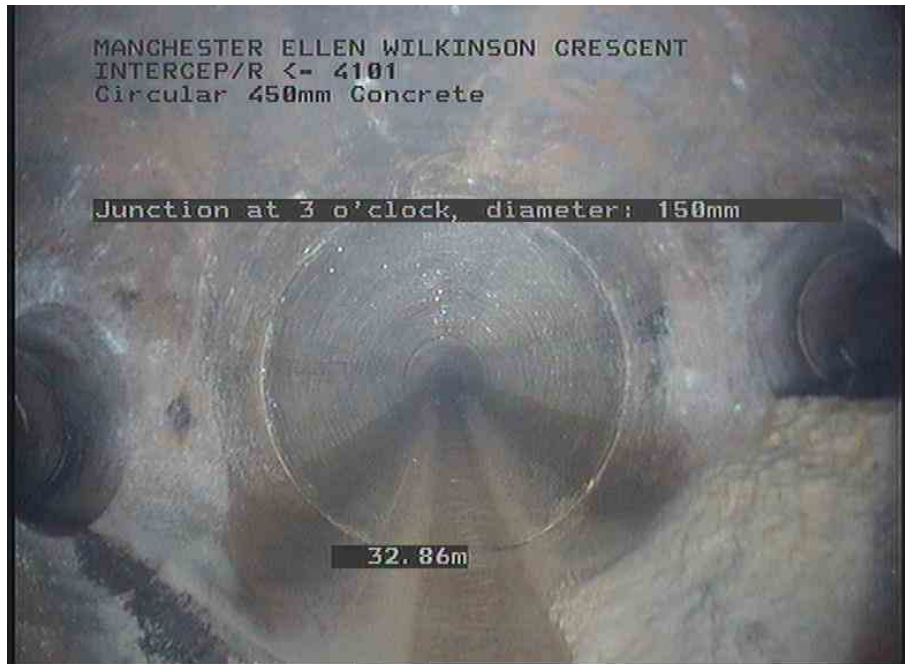
INTERCEP\_RX\_f6d7f7cb-5dd1-47cf-b30e-0568daee0fad\_20210528\_084832\_815.jpg, 00:03:21,  
32.86 m  
Junction at 3 o'clock, diameter: 150mm

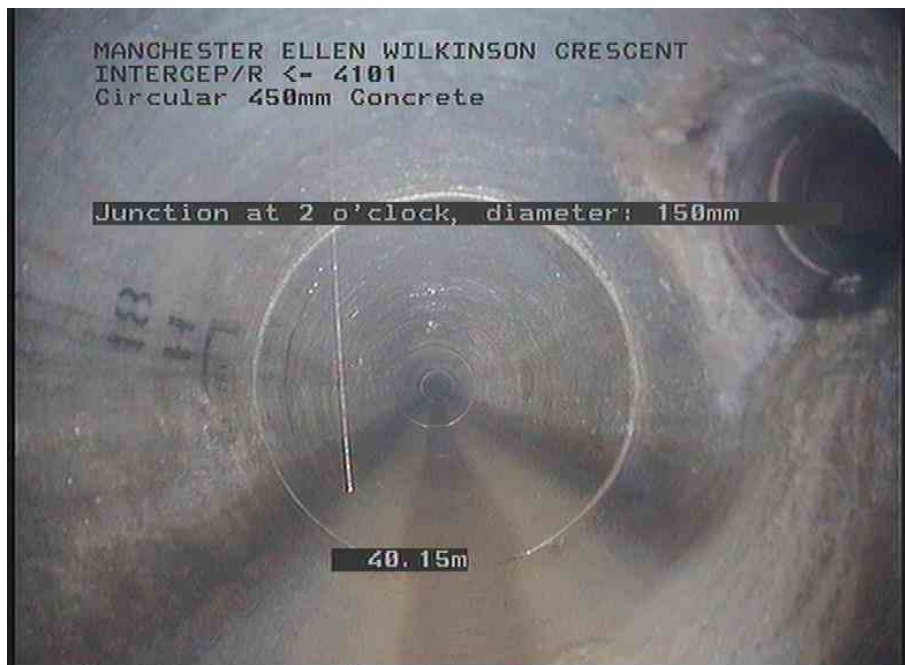
INTERCEP\_RX\_cd6b0d6c-0e6d-47eb-a074-e3ba2ef13056\_20210528\_084932\_089.jpg,  
00:04:05, 40.15 m  
Junction at 2 o'clock, diameter: 150mm

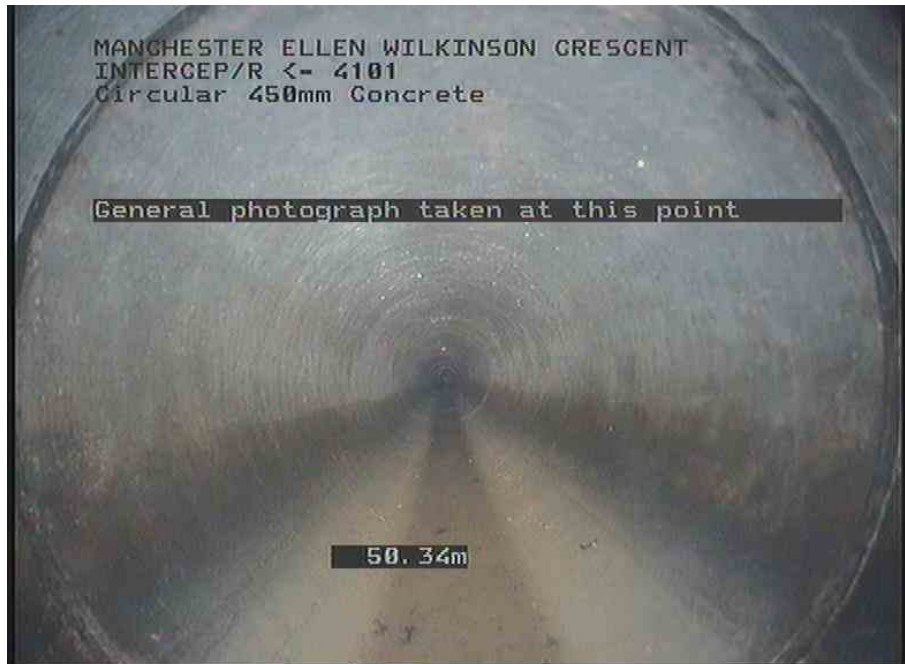
INTERCEP\_RX\_4def1fbd-323b-409a-aaea-c79f1b9cb3b9\_20210528\_085019\_045.jpg,  
00:04:49, 50.34 m  
General photograph taken at this point

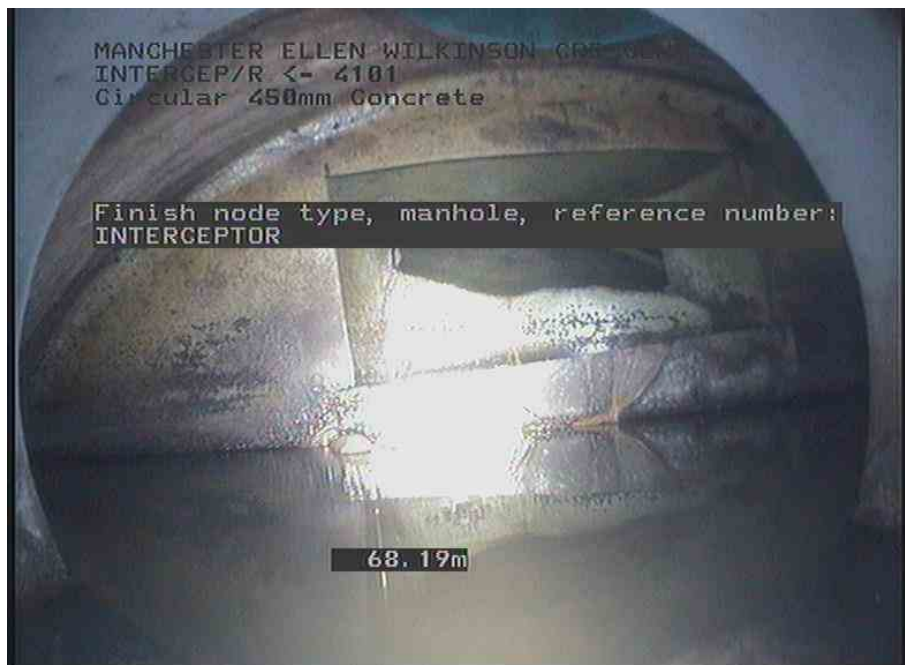
INTERCEP\_RX\_fc4a4c18-5b76-43fb-8716-3fbc42e12d4b\_20210528\_085237\_815.jpg,  
00:06:38, 68.19 m  
Finish node type, manhole, reference number: INTERCEPTOR

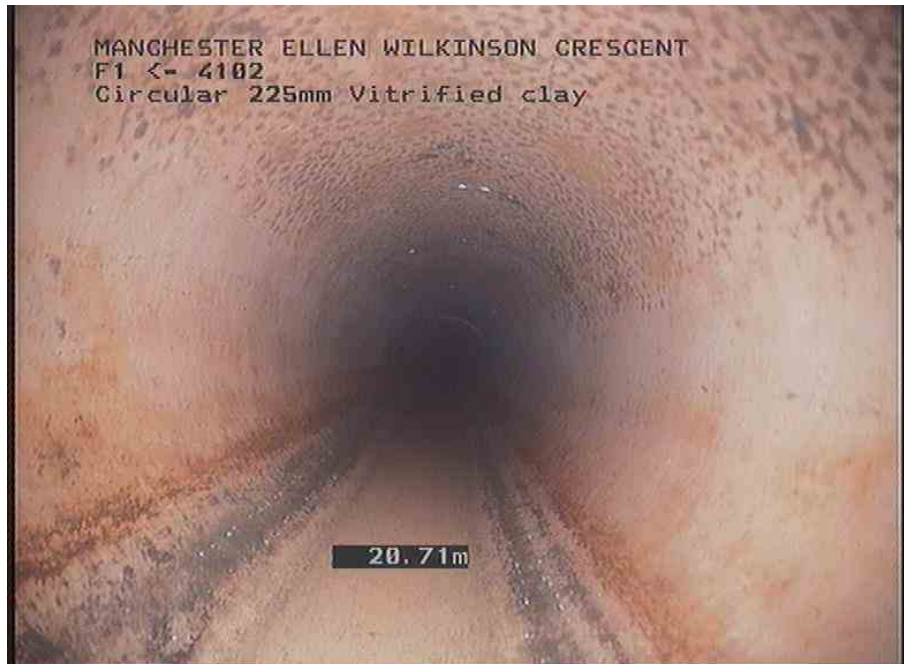
F1X\_b8bdfec5-7464-4f2a-ae94-7f5e583612e7\_20210528\_095135\_284.jpg, 00:03:27, 20.71 m  
General photograph taken at this point

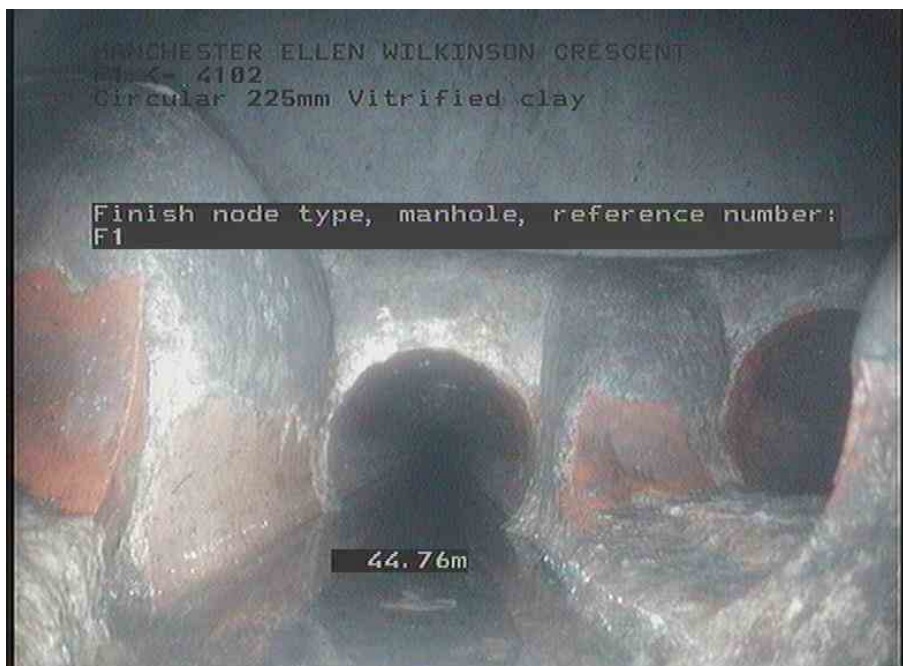
F1X\_8b620709-54cb-4123-a4f0-ca9736f09bd8\_20210528\_095601\_695.jpg, 00:07:10, 44.76 m  
Finish node type, manhole, reference number: F1
