**Manchester College – Wythenshawe Park Earthworks and drainage**

## **KNIGHT, KAVANAGH, and PAGE (KKP)**

Report Date: 16<sup>th</sup> May 2021

Visit Date: 22<sup>nd</sup> March 2021

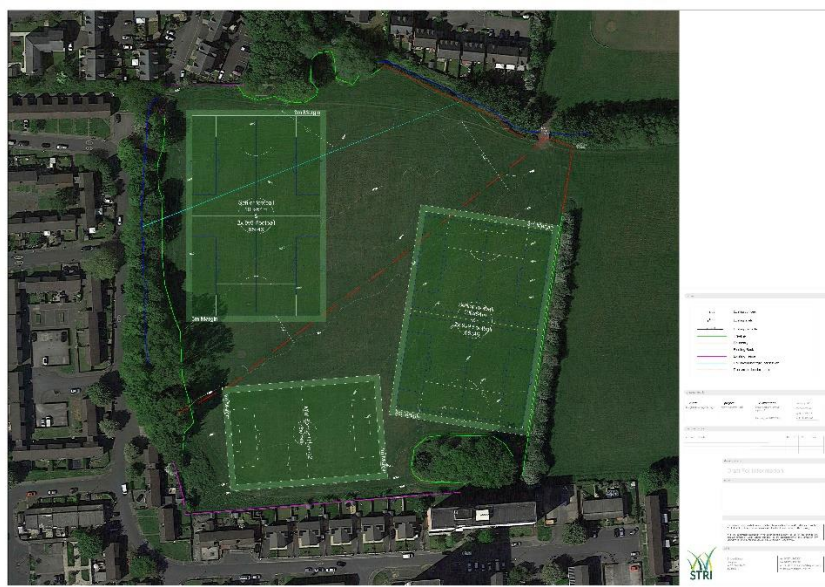
**Figure 3: STRI proposed pitch layout within Wythenshawe Park.**

The new site could potentially accommodate two full size football pitches and a smaller U12/13 pitch within the site footprint. Figure 3 shows the STRI proposed layout which also includes the potential for four Mini's (U8/9 age group) to be gained from within the two larger pitches. The proposed layout aims to maximise the available space whilst providing an increased amount of playing fields.

The proposed site could potentially offer multiple pitch layouts however Figure 3 illustrates what is believed to be the best solution and provision. With the installation of pipe drainage, the potential for sports pitch development is great added to which Baguley Brook offers a positive drainage discharge mechanism, the precedent for which has already been set by surrounding sports pitches already draining into it.

Below are indicative costings and have allowed for the regrading works on the three pitch areas shown on Figure 3 as well as drainage of the entire playing field area (i.e., both primary and secondary drainage) at 5 and 0.5 metre centres, respectively. The total figure is approximately £230K plus VAT, and allowing for a 10% contingency sum on top of this, would increase the total to £253K plus VAT. This offers a total drainage solution for the site and should further discussion be required about the details STRI would be happy to continue the discussion.

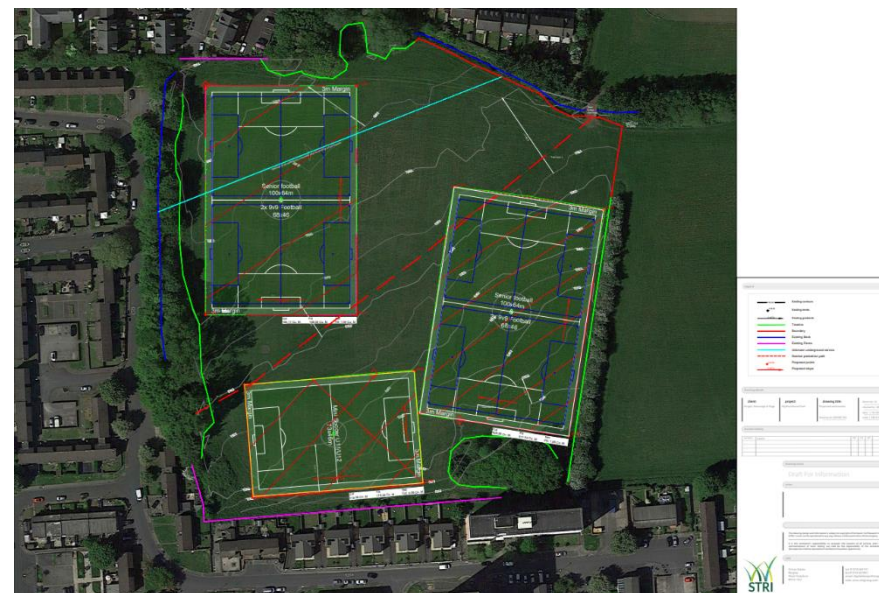
**Figure 4: STRI Earthworks calculations for the proposed pitch layout within Wythenshawe Park.**

STRI have undertaken a desktop analysis and calculation exercise to determine quantities and volumes of earthworks and drainage requirements for the proposed pitch layout as shown in Figure 4. These calculations consider the Sport England regulations for surface slopes and levels and have aimed to create uniform playing surfaces whilst minimising the earthworks requirements as best as possible. The existing site grade/levels do not allow for a uniform surface to be created, hence the requirement for the Earthwork calculations.
