CLIENT AMBASSADOR THEATRE GROUP

PROJECT MANCHESTER OPERA HOUSE

TITLE WINDOW REPAIR - W10-LG

DRAWING NUMBER 19-143- WR10

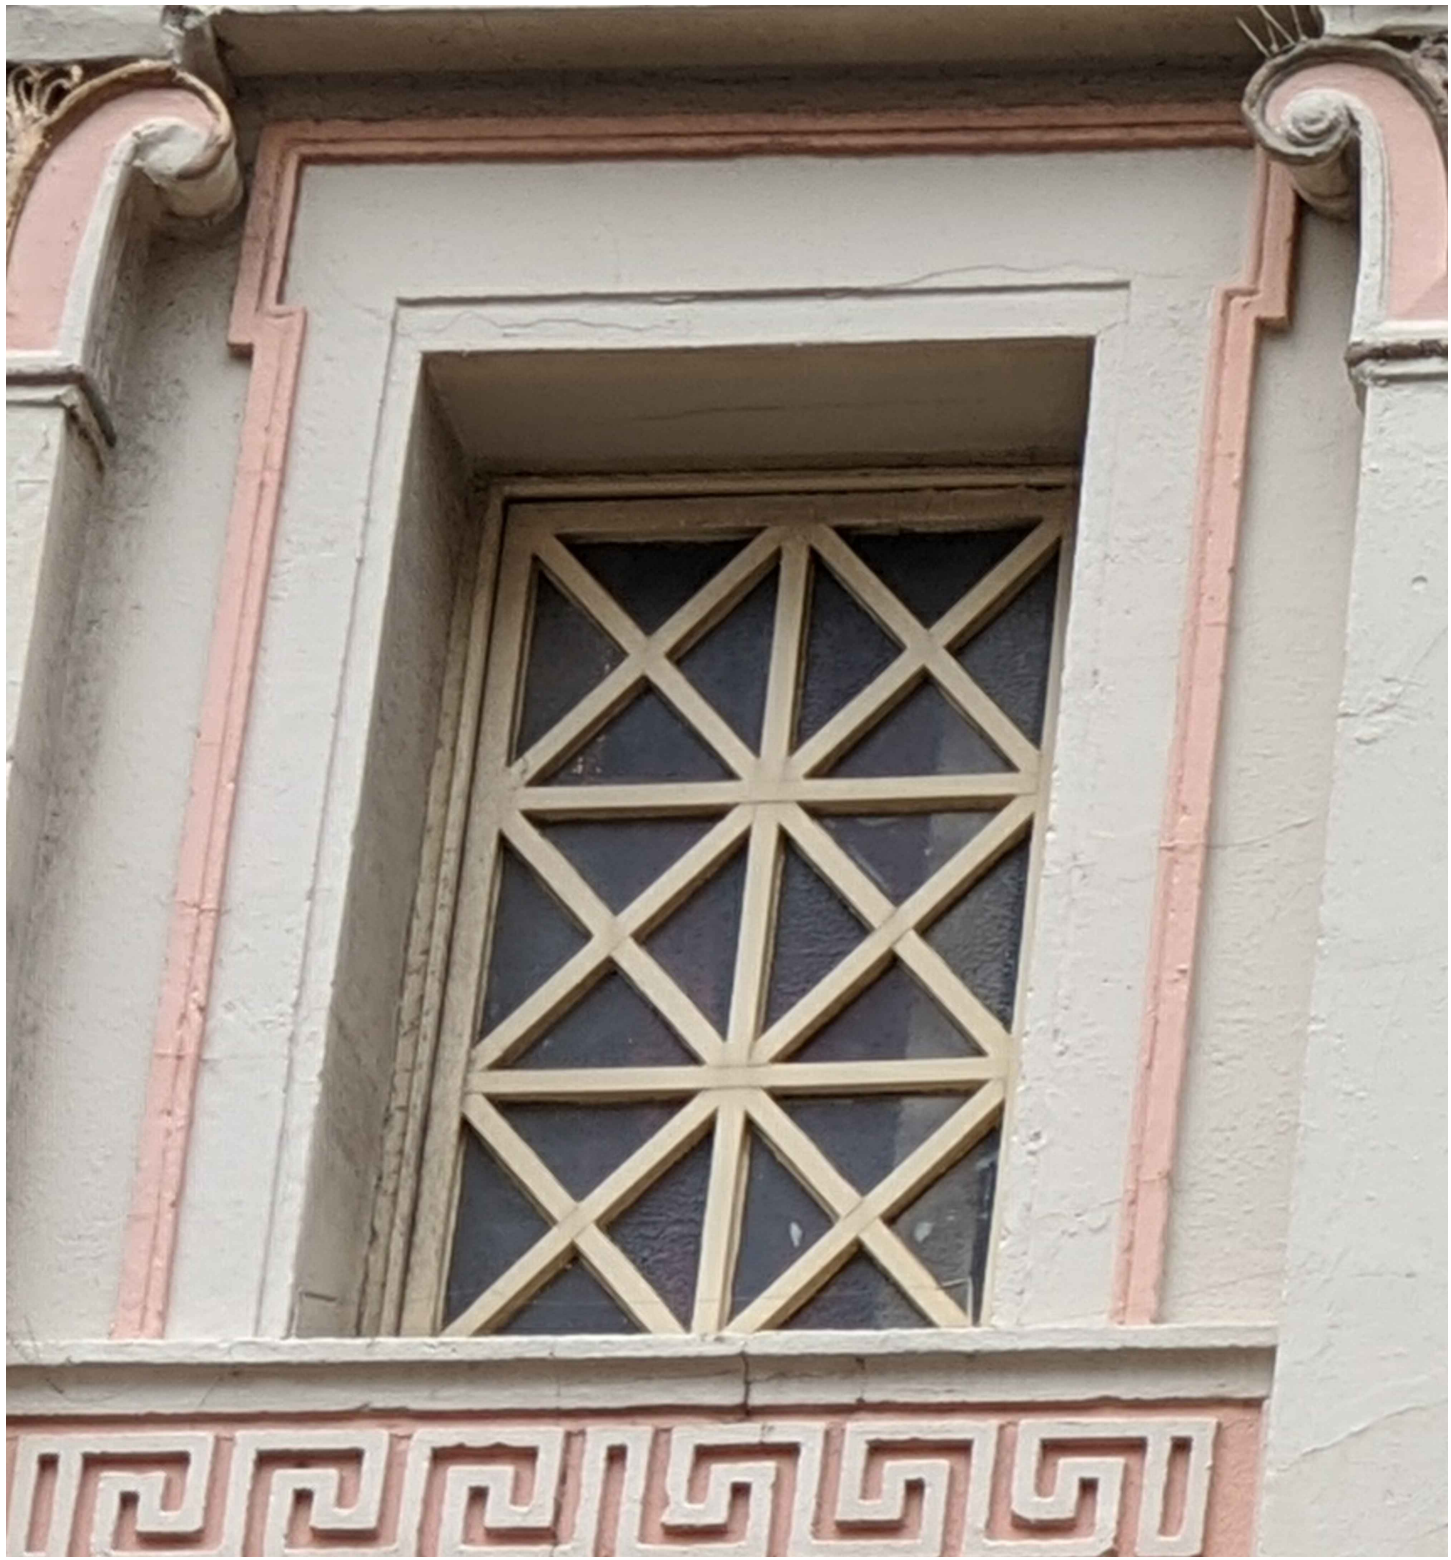
# W10-LG

Once casement has been removed and the existing frame has been left in-situ, check frame and cill for and damage or rot. Record areas and inform CA.  
N.B Access to window will need to be external.

Where external cills are to be replaced - replicate the profile of the existing cill in a durable hardwood such as oak incorporating a drip detail to the underside. Any new cill parts should be butt jointed below the casement frame. Finish using linseed oil based paint as described above in the colour to match the existing colour.
