**MANCHESTER OPERA HOUSE.**

**DESIGN, ACCESS AND HERITAGE STATEMENT**

**FOR THE REPAIR OF FAÇADE RENDER AND DECORATION**

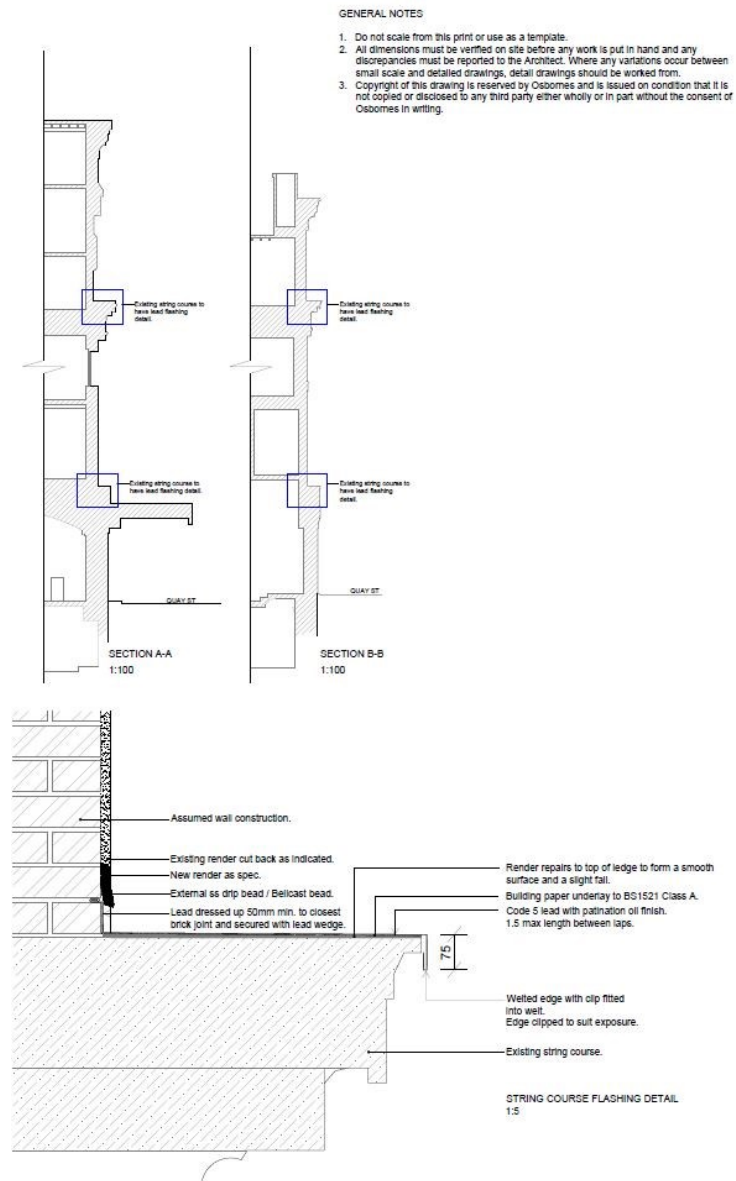
The drawings highlight that the front West corner of the building has the most issues with the render with a greater amount of cracking and delamination. In these areas it is proposed that the render is removed in its entirety and a new Keim Universal render is applied. The keim render should offer greater flexibility and uses mesh reinforcement within the render.
