## BASEMENT

The basement contains remnants of machinery in the form of; a cast-iron bulkhead to the crane loading doors and an integral rail for sliding doors, cast iron corrugated fireproof shutters and doors to the original hoist and some pulleys and cables. The manufacturer's name of Edward Wood and Company survives on a name plaque. They were one of the largest iron foundries in Manchester.

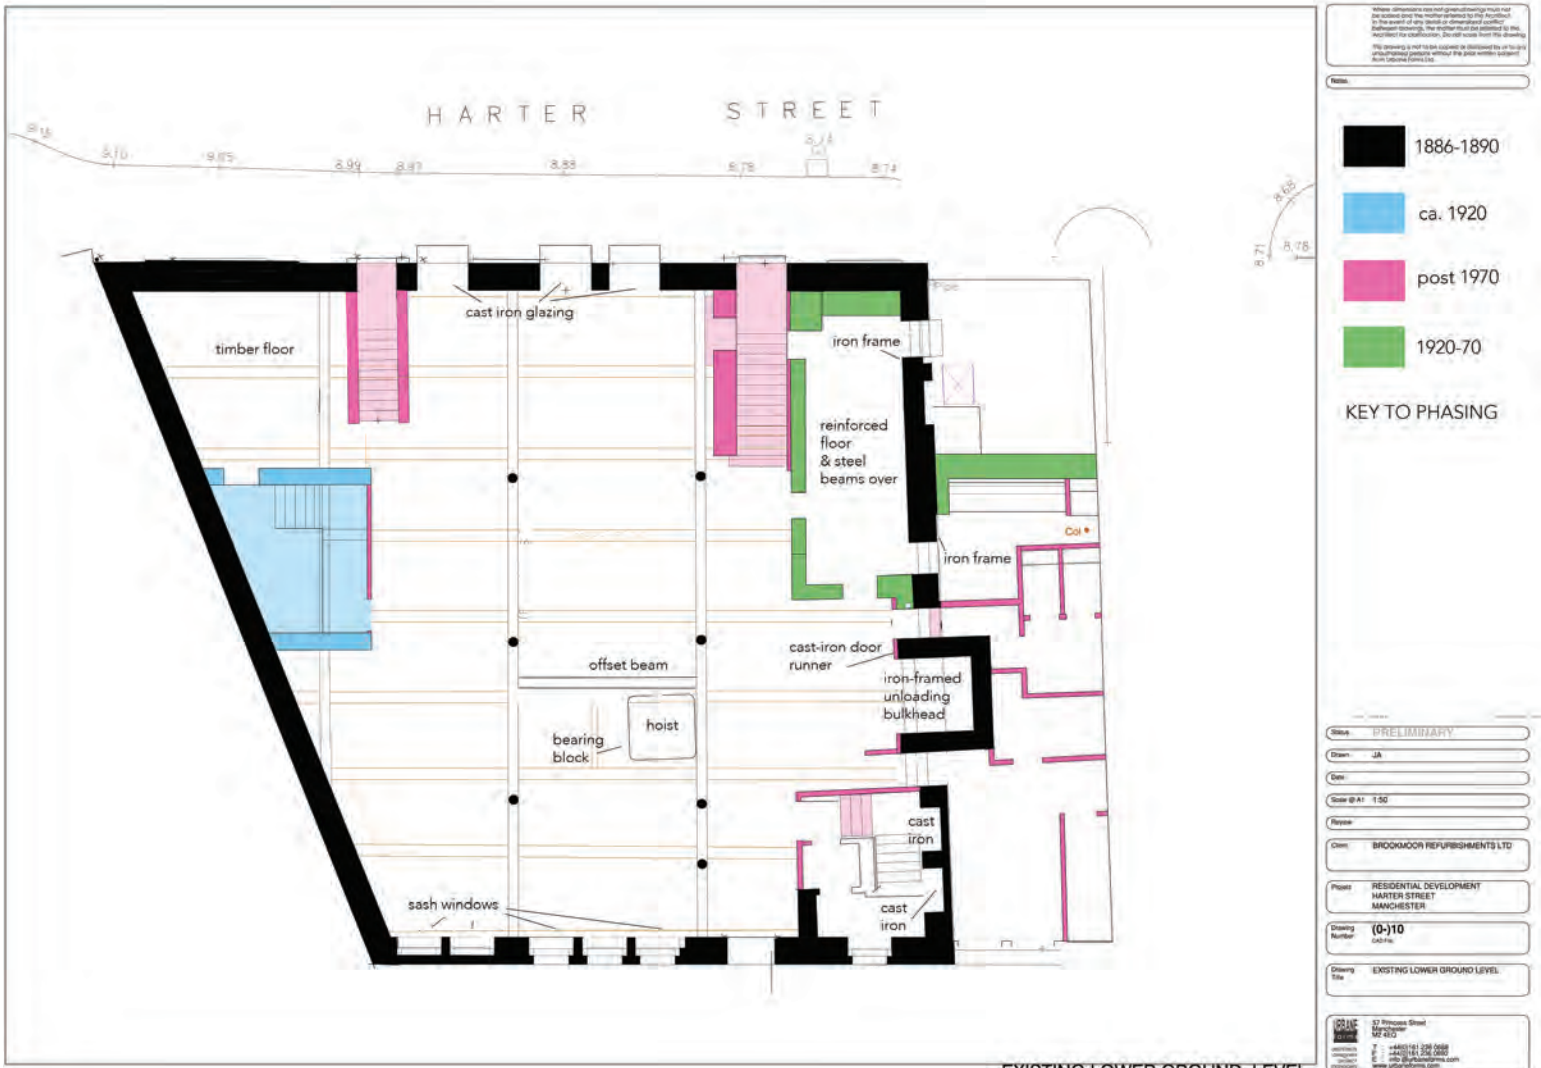
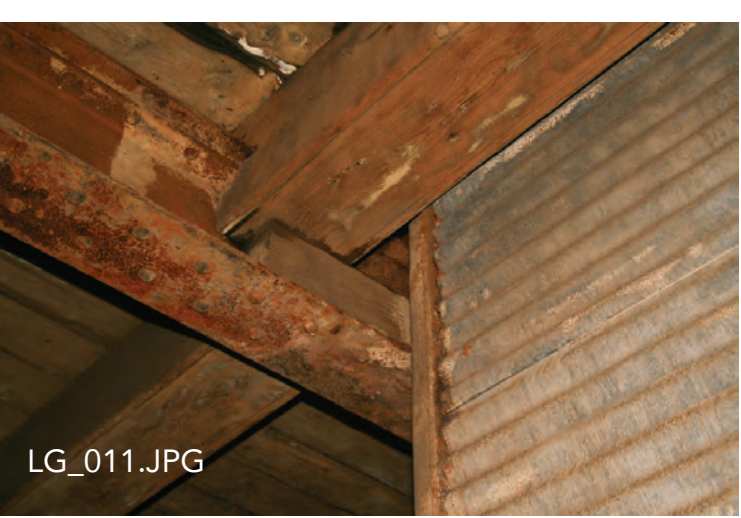
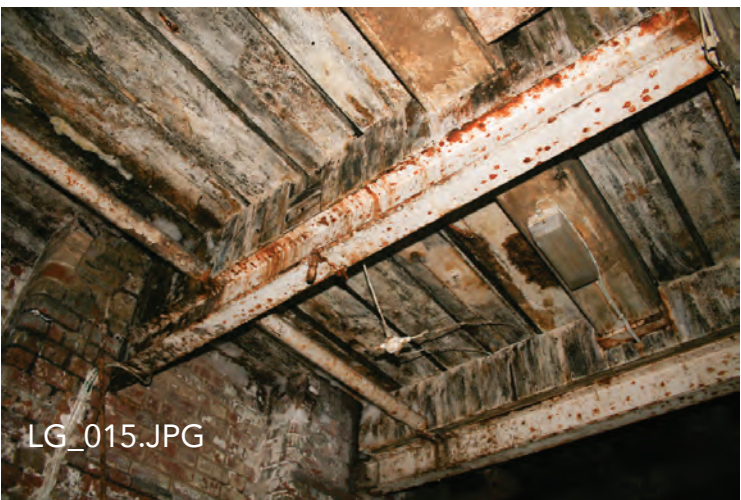
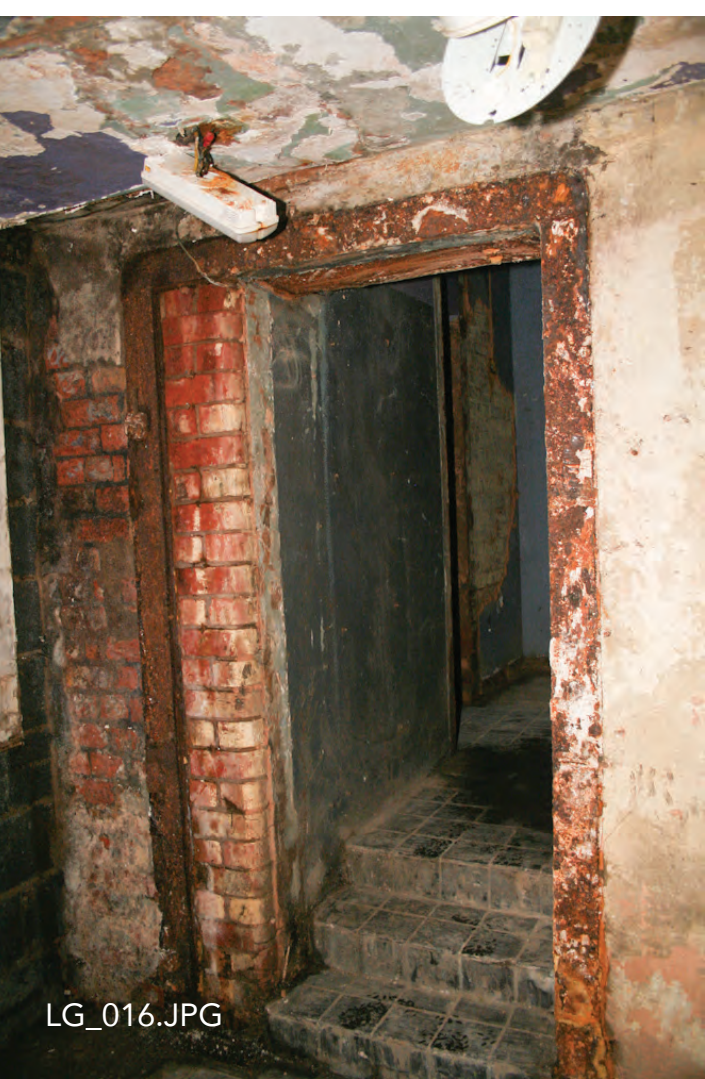
Above - inserted steel and timber beams (LG\_015.JPG) and iron framed doorway to steam engine / boiler (LG\_016.JPG). These alterations are of little value without associated machinery & context.

Below - ground floor stud partition walls and brick pier to second staircase, both early 20th century modifications, of medium significance. Below right - cast-iron columns and wrought-iron beams complete, and of high significance.

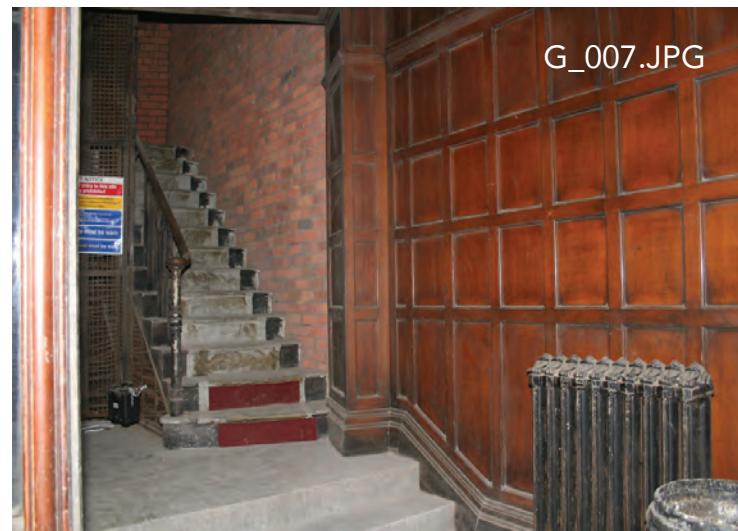
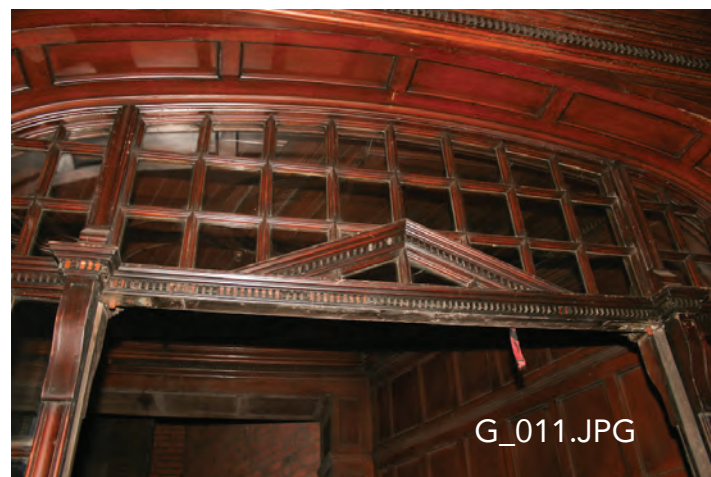
Oak panelling and glazed screen dating from ca 1920, incorporating classical triangular pediment, dentilled moulding, cornice and console brackets, with coffered panelled ceiling, and recesses for the panelled doors. The details are characteristic of the classical revival of the first decades of the C20.

Rear wall with sash windows. The far three windows, closest to the stove, have timber-lined sashes. The inside walls of the office were plastered, butting up to the timber linings. The remaining sashes to the warehouses were set within rounded moulded brickwork, which was probably lime-washed (see detail of different treatments - bottom right).

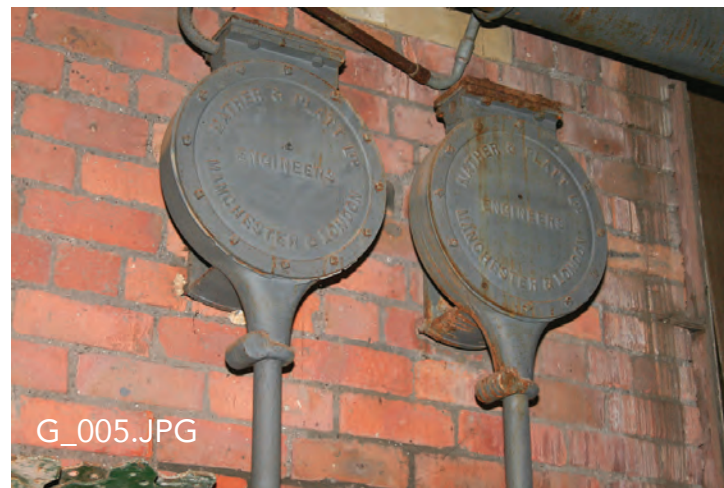
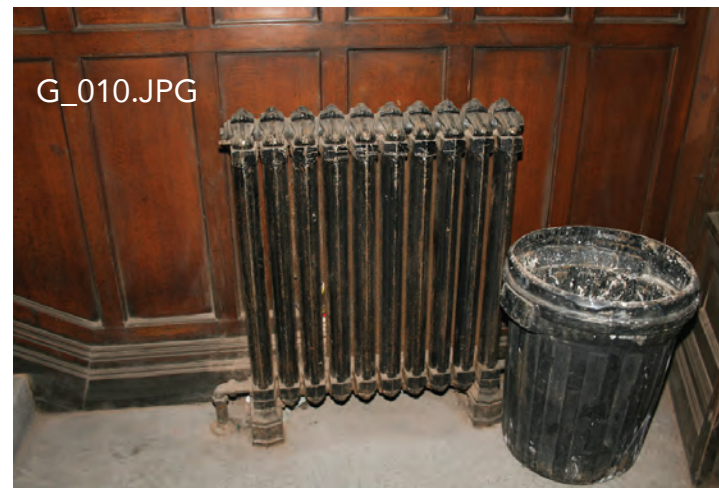
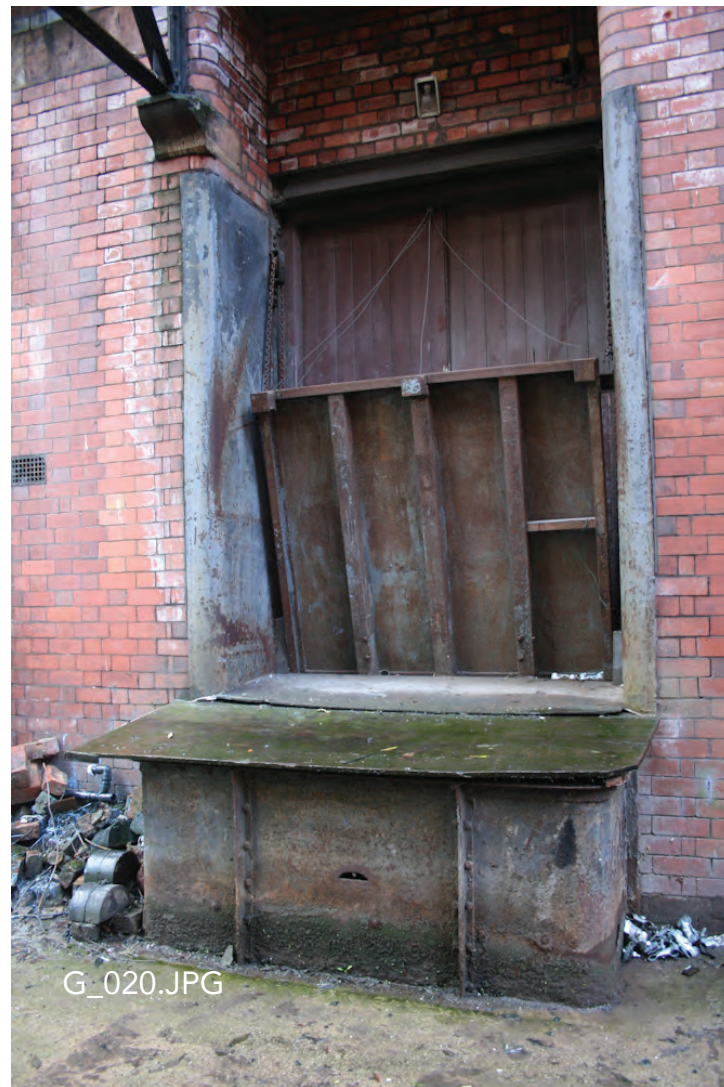
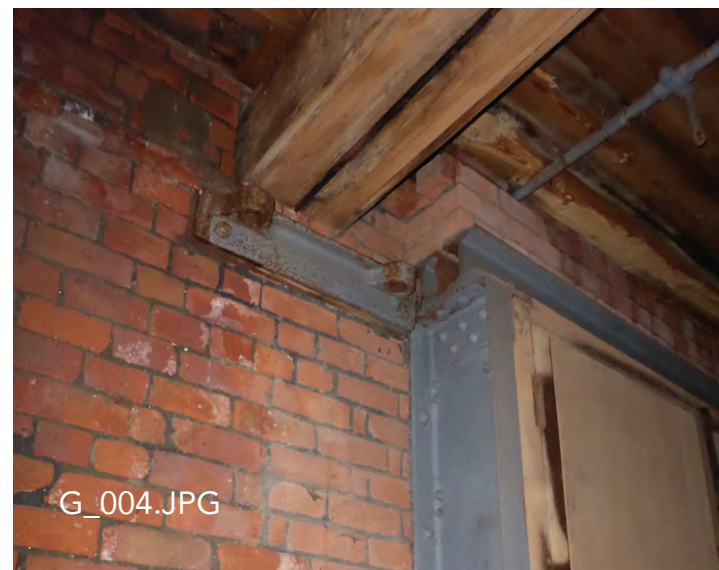
Above left - Mather and Platt electrical engineers fittings. Right - cast iron radiator to lobby.

Left - external view of the loading bay, with wrought-iron panelled bulkhead and "draw-bridge", and metal framed opening. Below - internal view of opening with metal-framed doorway.

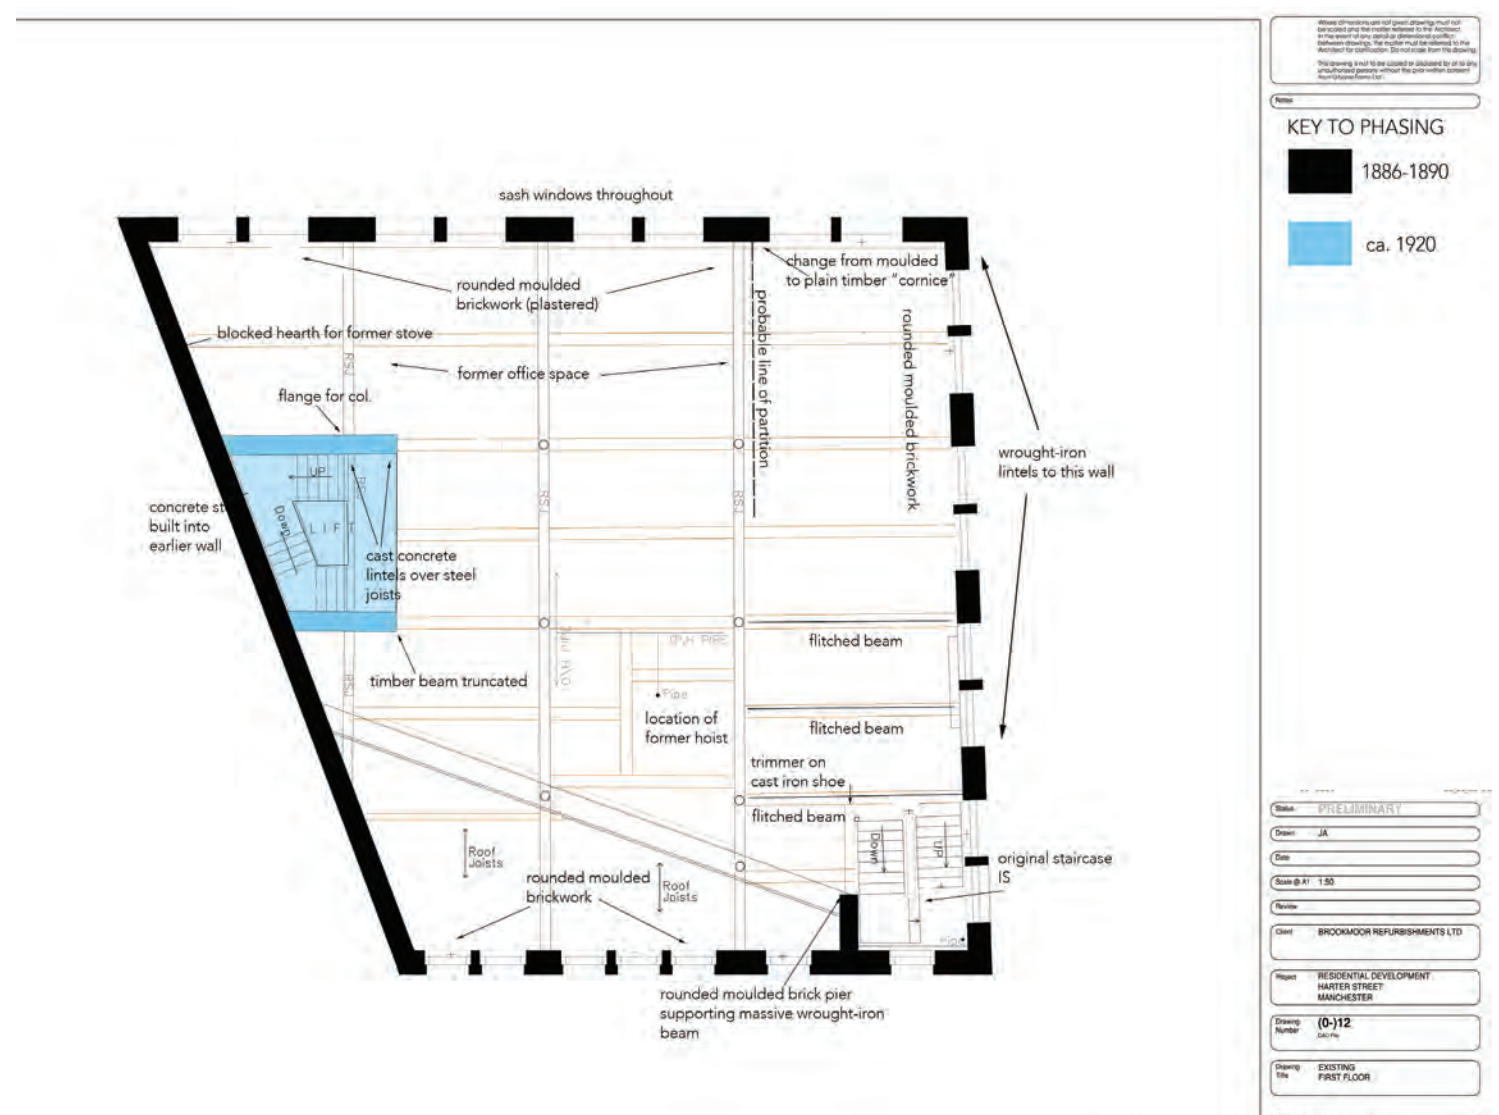
Timber staircase to first floor is complete at this level, with only a section of balustrade missing to the landing. The brick pier to the staircase forms the edge of the staircase bay. The pier supports a massive wrought-iron beam. Timber staircase with hardwood handrail and square section stick balusters. Soffit of stairs boarded and originally painted, now stripped.

Level of significance - high (level 3)

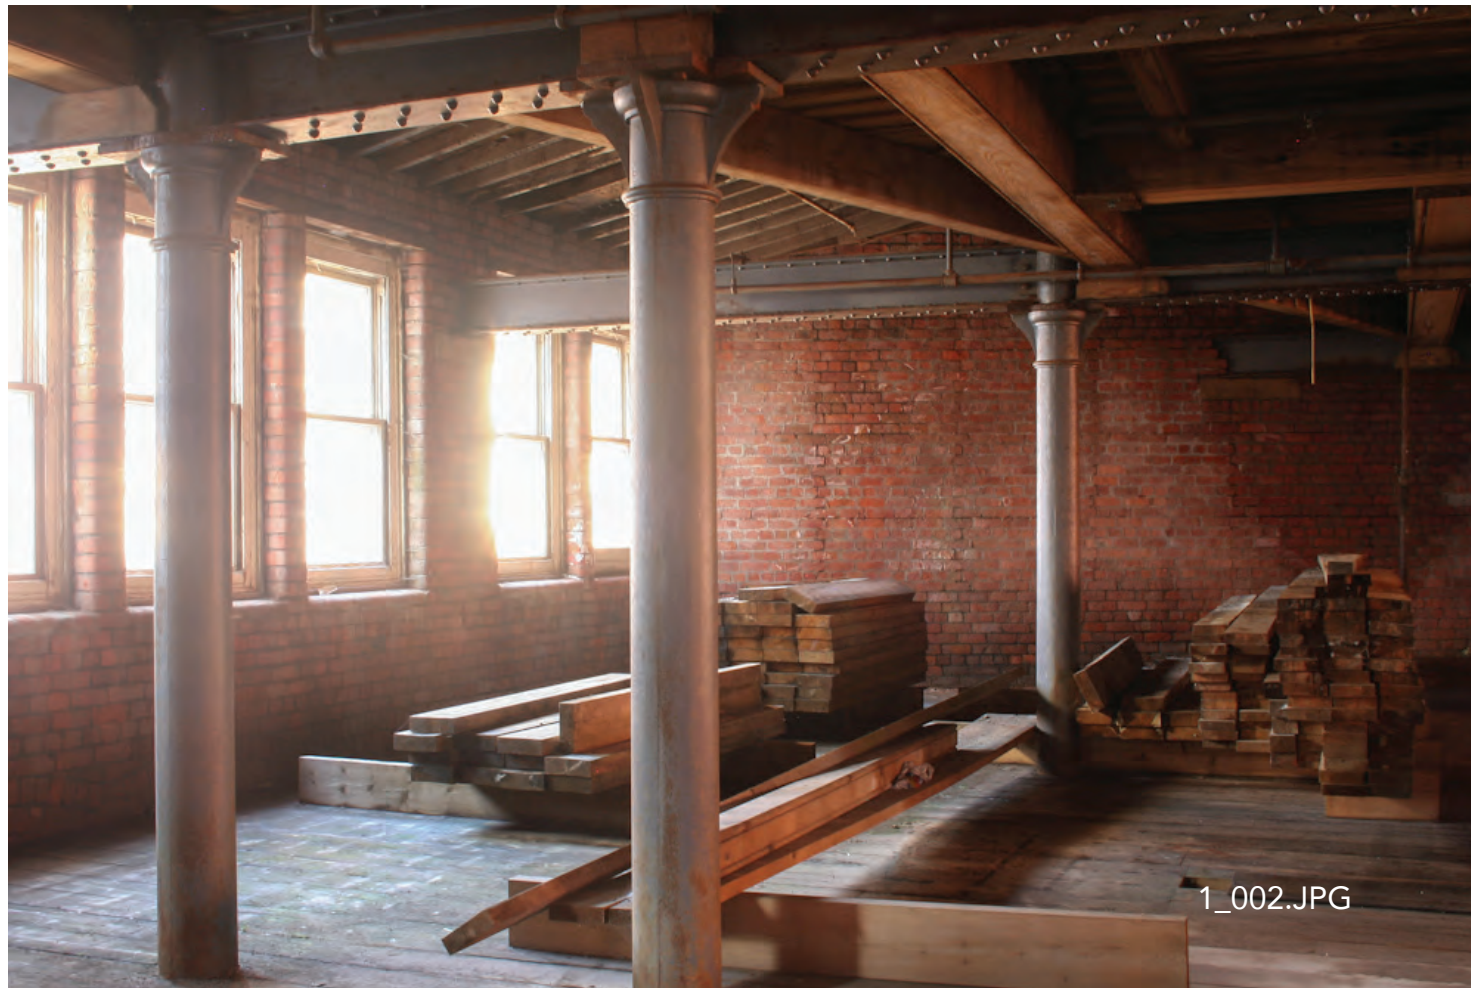
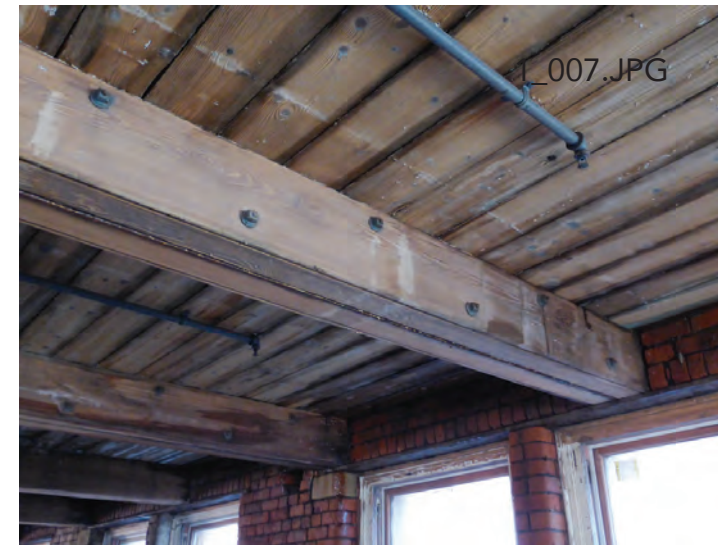
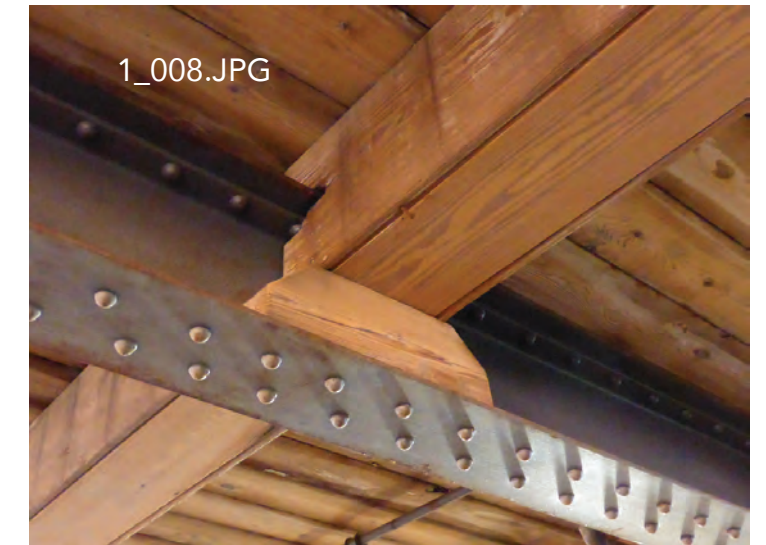
Flitched beam (one of three) with pairs of Scots pine axial beams encasing a wrought iron plate, tied with coach bolts.

Right - cast-iron shoes set within the outer load-bearing wall support a timber trimmer, which supports the ends of the floorboards. This is shaped in two sections; the moulded cornice detail (to the left) is adopted for the office spaces, whilst the plainer section with a plain bead moulding (to the right) is adopted for the warehouse. This marks the alignment of a former partition.

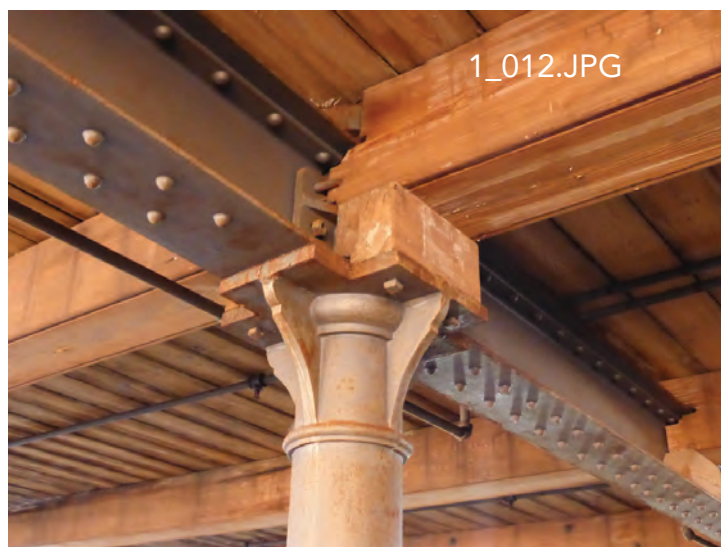
Cast-iron columns with paired and cruciform flanges support wrought iron riveted beams, with bolted and riveted connections. Massive structural wrought-iron beam, with multiple riveted plates, supports brick external load-bearing wall of the three floors above.

Level of significance - high on completeness of structure (4).

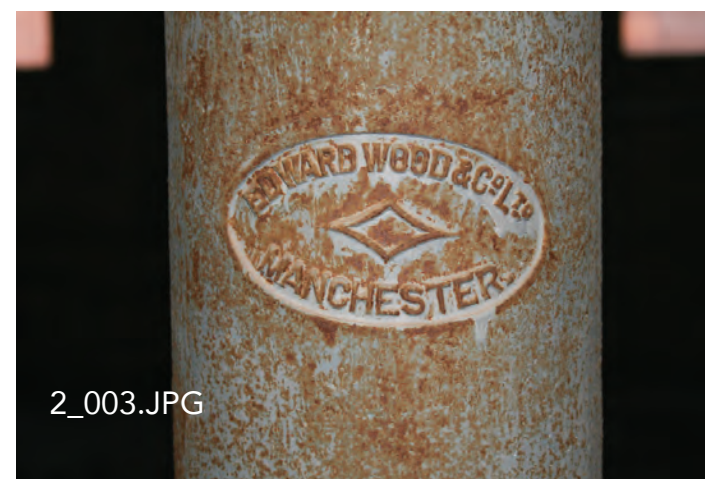
2\_003.JPG

Cast iron post with cast manufacturer's inscription - Edward Wood & Co. Ltd. At this level the structure and frame is complete, with no evidence of internal partitions, of high significance (level 3). Staircase is complete, with only stick balusters to landing missing.

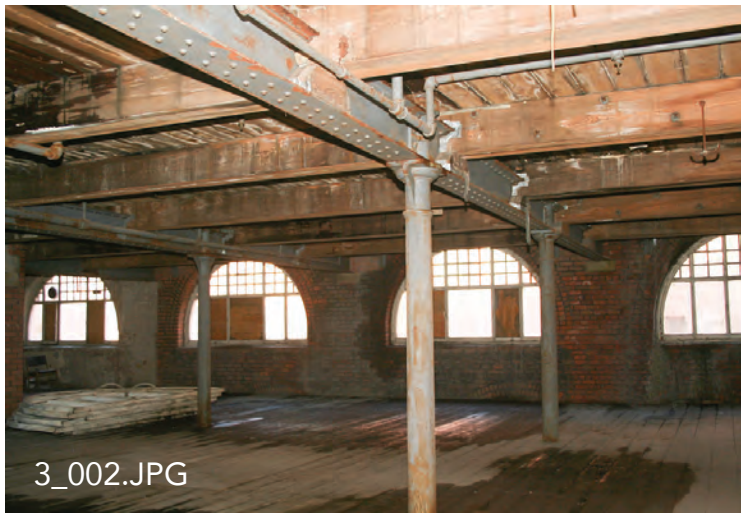
3\_002.JPG

Top left - "thermal" or semi-circular windows, with casements. Left - view towards inserted staircase and lift shaft.

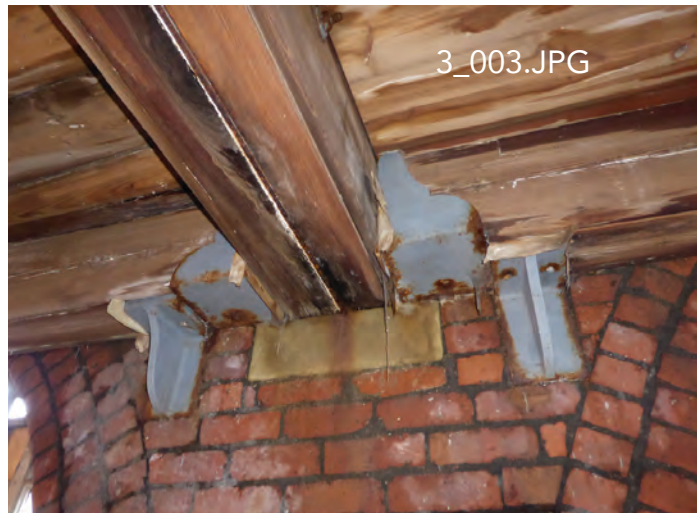
3\_003.JPG

Above - detail of flitched beam to south wall, with cast iron shoes at the junction of the timber beams, and cast-iron corbel brackets, with flanges, for supporting the timber trimmers. The structure is strong and integrated, as built - high significance (level 3).

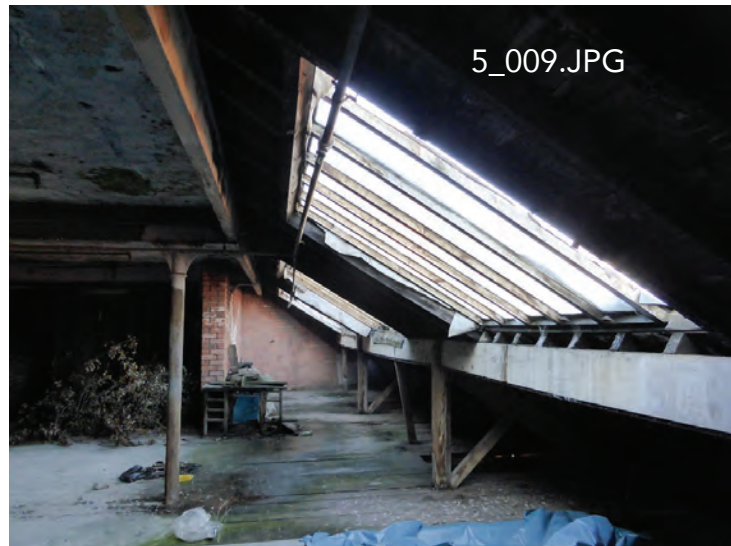
5\_009.JPG

Below right - skylights are a remnant of a continuous bank.

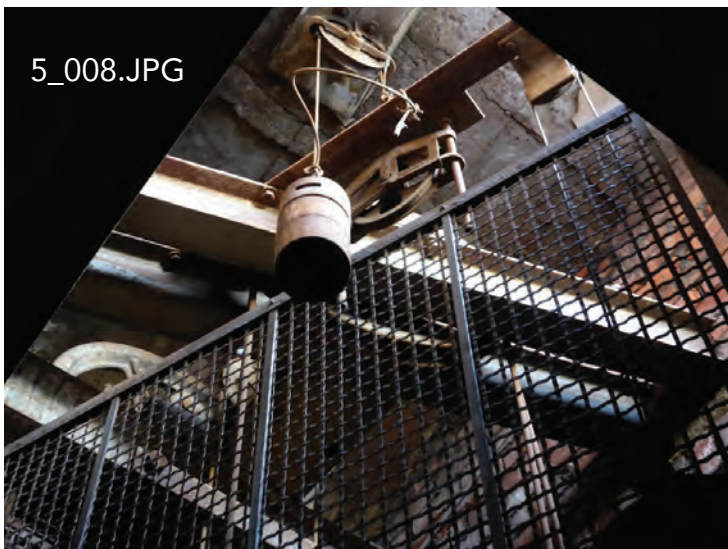
5\_008.JPG

Bottom right - cast-iron column with flanges cast into the capital on the same skewed alignment as the I-section wrought iron beams. The fit is poor and appears unfinished. Skylights to the west have been removed.
