## 2 Swinbourne, Withington

### Photographic schedule - House 1<sup>st</sup> floor

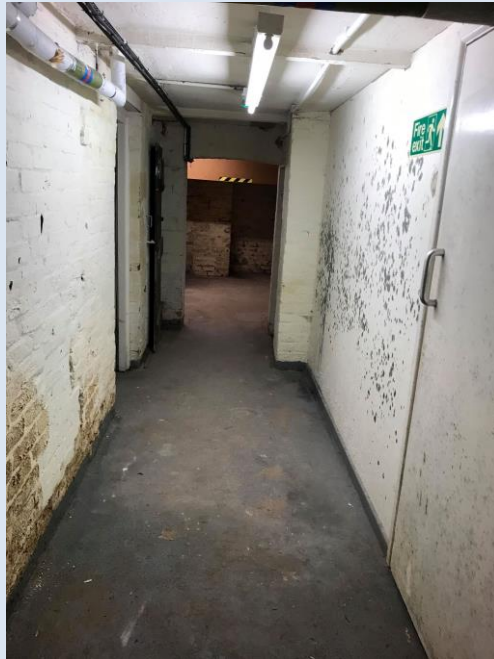
27

The hallway is showing significant signs of damp and mold, which will need addressing.

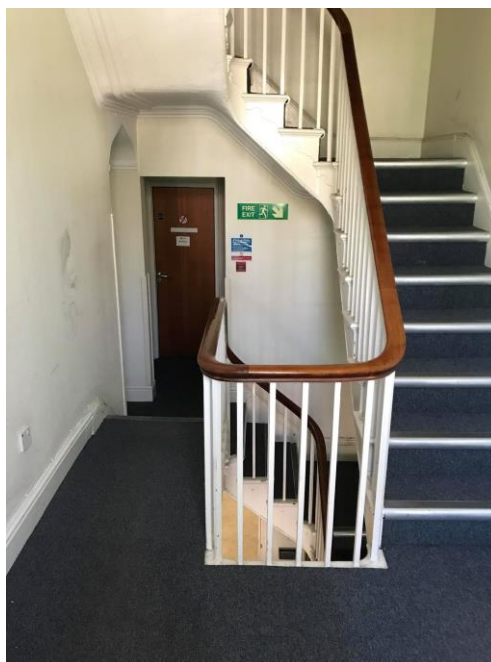
41

The entire hallway appeared to be in good condition with no noticeable defects.

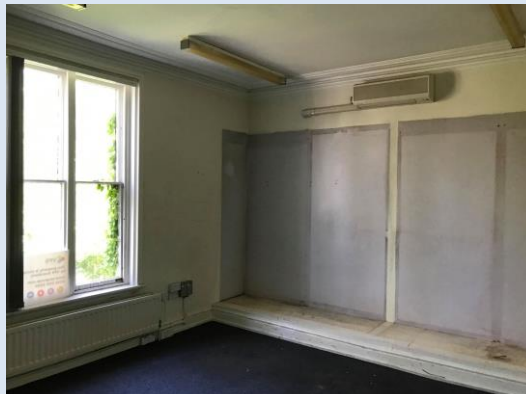
46

The office has clearly had large shelving units removed, these units were sat on a raised platform. It is not clear what the raised platform is for. There is an air conditioning unit in the room. The window in the room is numbered 15 and is a wooden sash construction, it appeared to be in good condition upon inspection but did have some ivy on it externally.

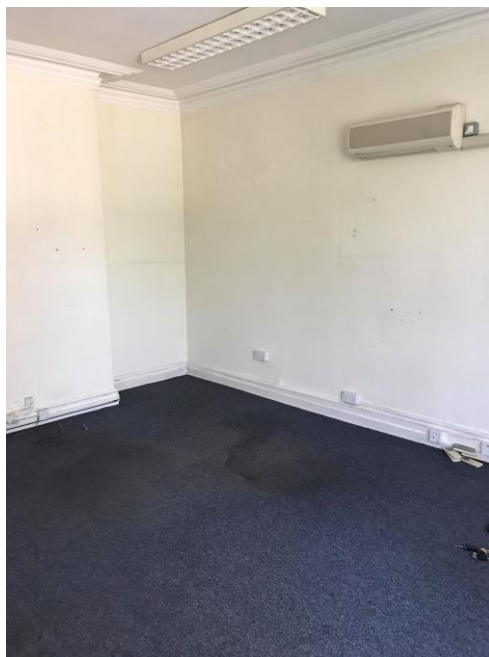
50

This office has a large bay window numbered 13 at the front. The room its self was in good condition with no obvious defects. There is an air-con unit in the room

The window itself is a wooden sash construction and is in a good condition internally but there are visible signs of flaking paint on the exterior

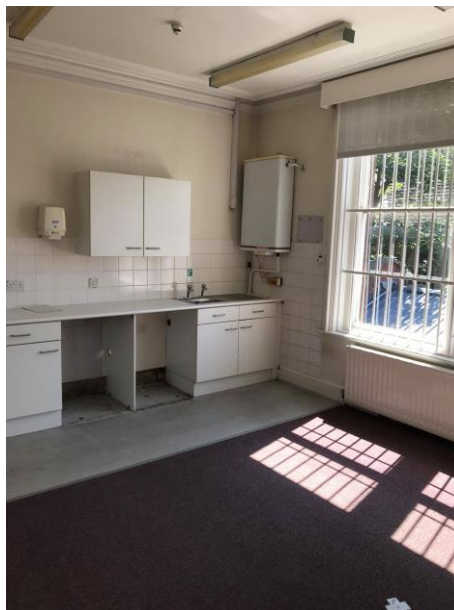
61

The staff room is a large room with higher ceiling than found elsewhere on the first floor. It has a small kitchen area which was worn but all appeared to be operational. The window numbered 19 is very large and has security bars internally. The window looks to have been refitted but is in good condition internally but externally the paint is flaking.

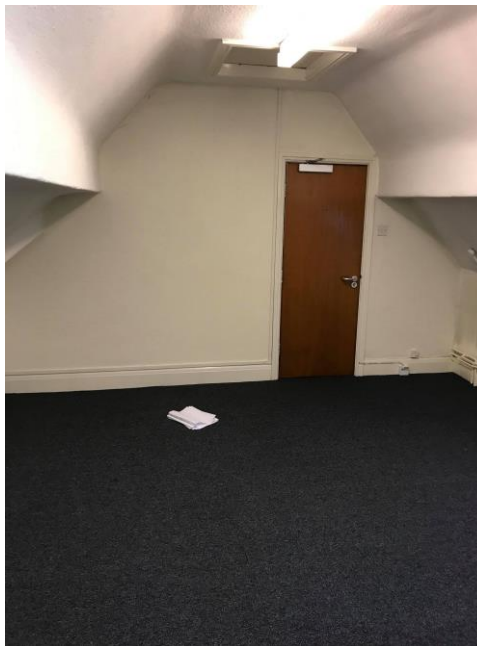
69

The room on inspection had no clear signs of any damage. The roof structure cut significantly into the workspace and the beam supporting the roof cut most of the light out from the small single dormer window. The window is numbered 19 and is a metal frame which is in good condition, however the window has had an extractor fan retrofitted.

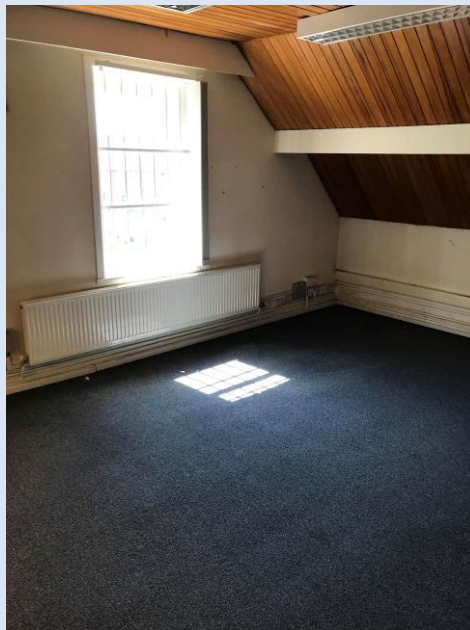
79

There are a pair of two offices at the back of the building on the second floor that are at a lower height than the second floor meeting room. The rooms are in good condition except for the ivy working its way in through the window. The windows in this back office area numbered 20 & 21 and are a wooden construction. The windows both have security bars internally and are in good condition apart from the ivy externally on 20 and an area of peeling paint on the sill of 21. There were no noticeable defects in the offices, which are separated by height and a glass partition.
