# Ancoats Dispensary Condition Survey

Great Places

**Project number:** P4352

Report Title: Condition Survey

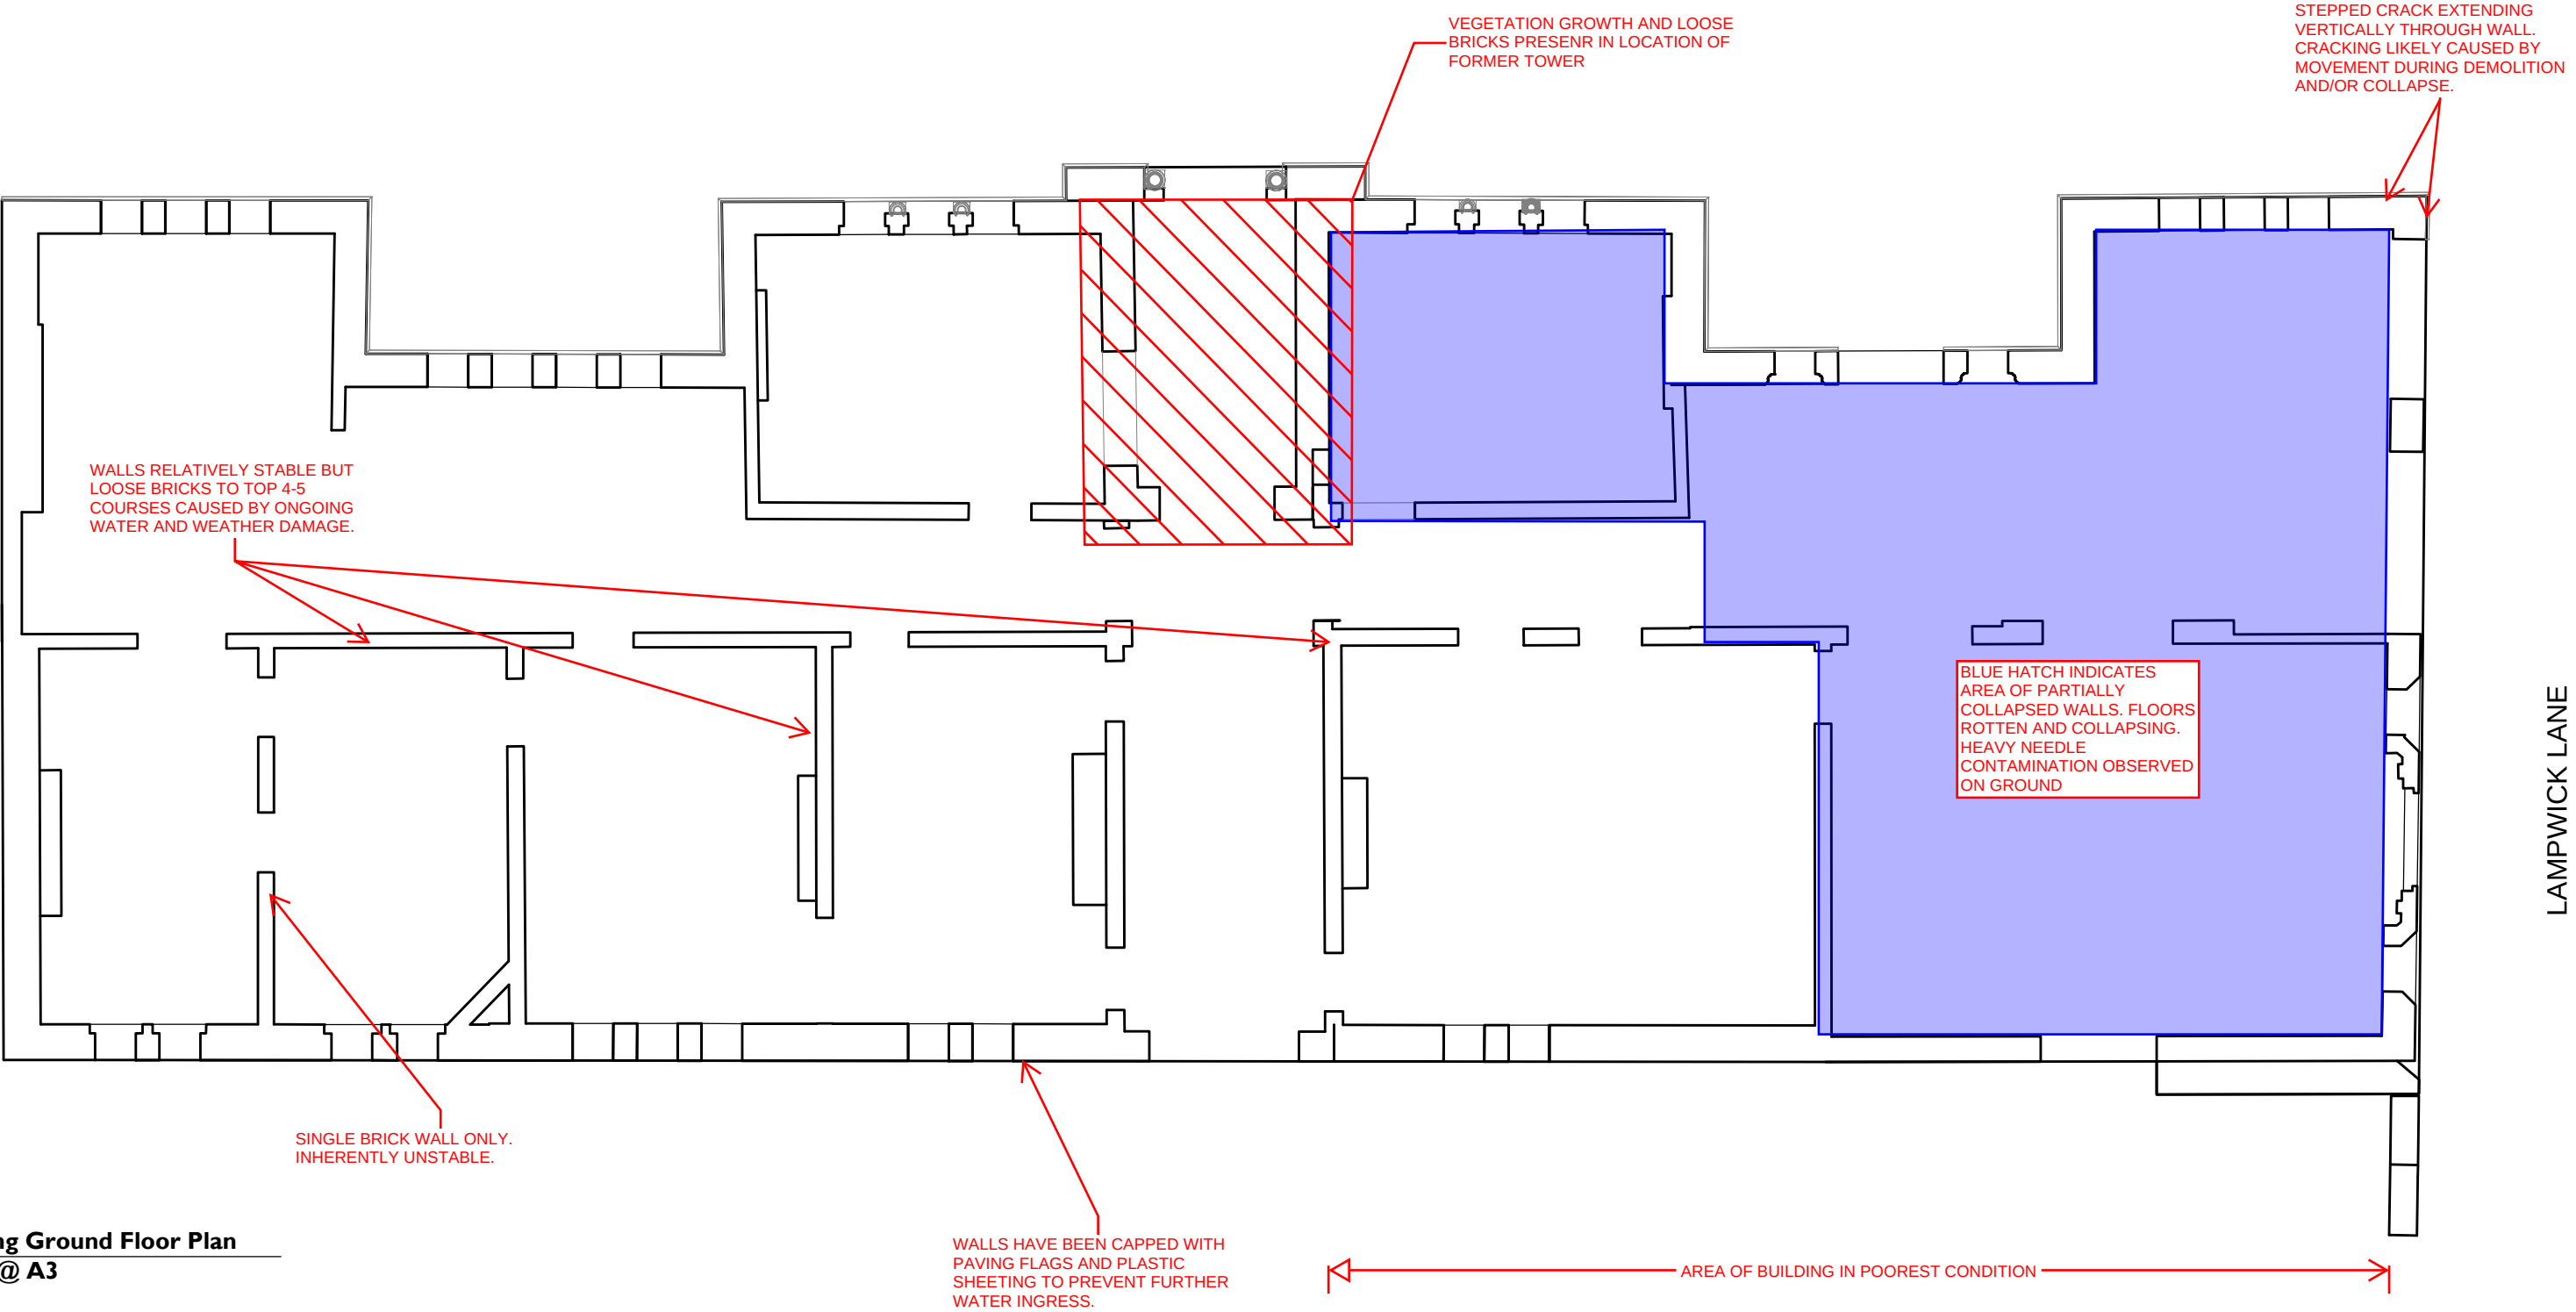
FIGURE 22

I Existing Ground Floor Plan  
100 1:100 @ A3

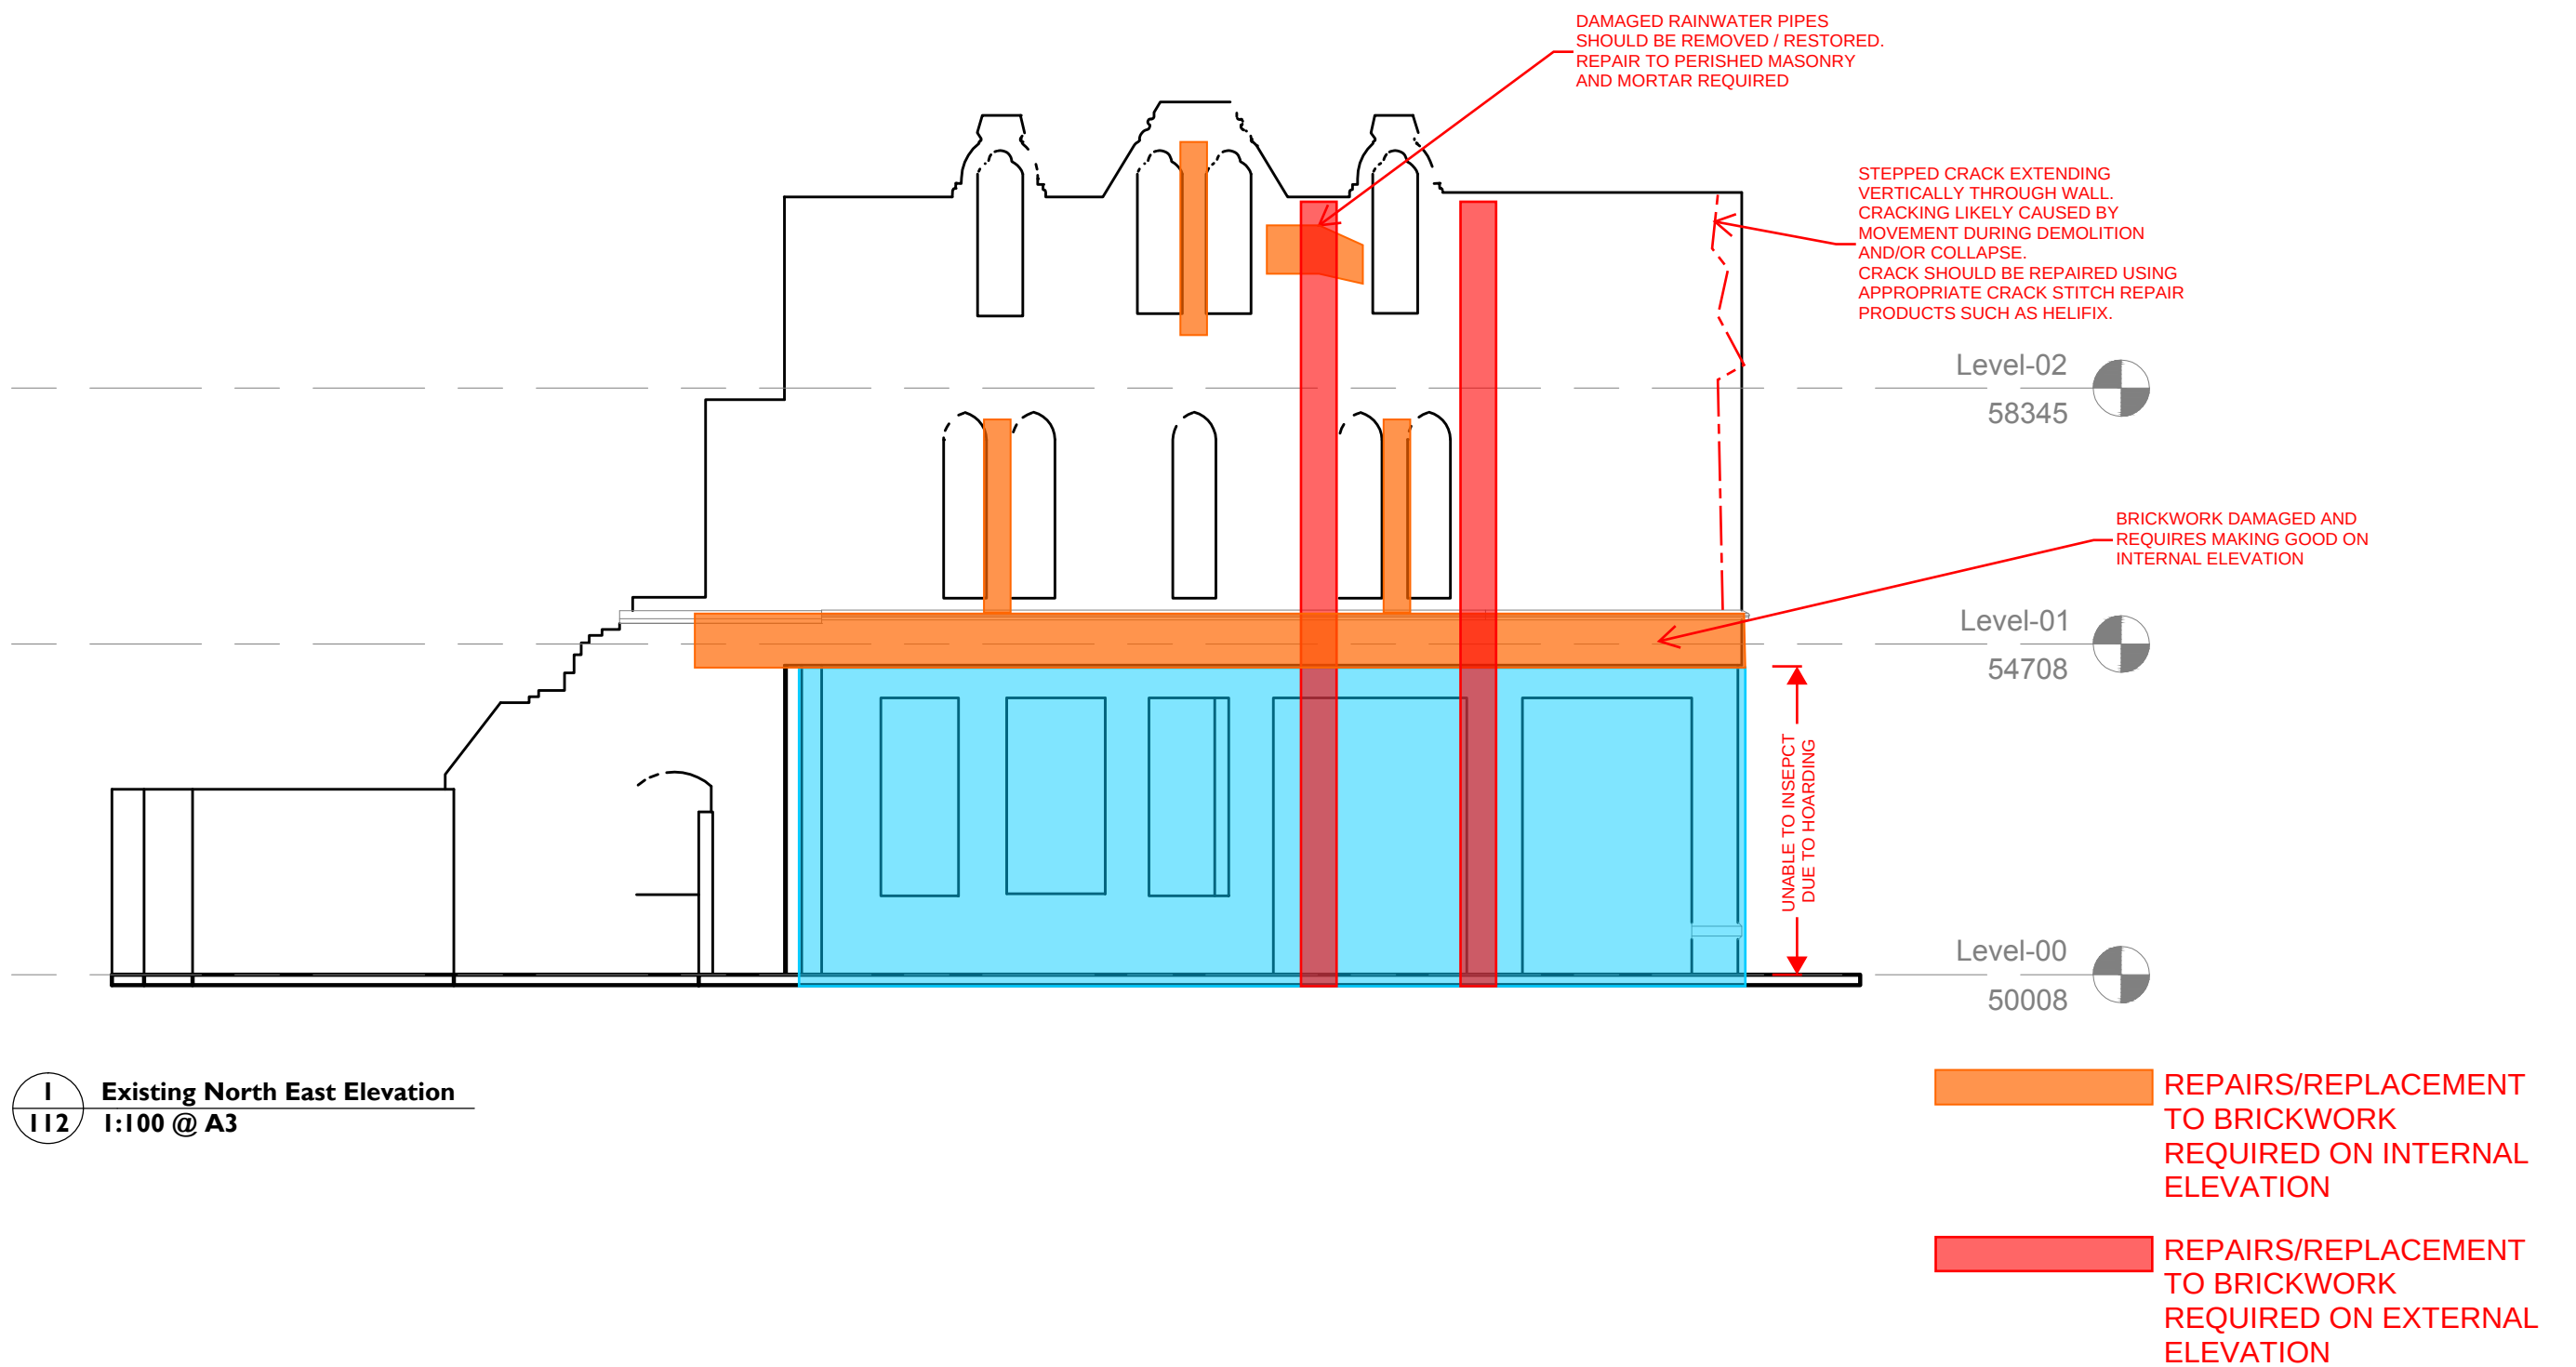
**FIGURE 24**

- REPAIRS/REPLACEMENT TO BRICKWORK REQUIRED ON INTERNAL ELEVATION
- REPAIRS/REPLACEMENT TO BRICKWORK REQUIRED ON EXTERNAL ELEVATION

- Remedial cavity ties should be installed through mortar joints to replace any corroded original ties
- Vegetation growth, namely Buddleia, is present numerous areas and should be treated and removed to stop further damage to the masonry. Local repointing/re-bedding of brickwork should be carried out to make good after raking out perished mortar
