**Network Rail NW&C  
Works Delivery (Buildings)**

**Project Title:** Deansgate Station

**Report Title:** Condition Report & Proposals

**Project No:** 169388

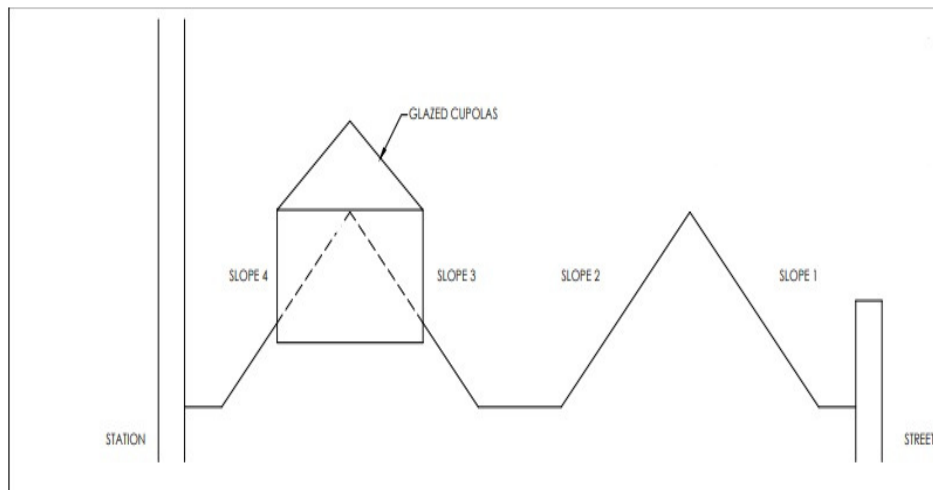
PLATE 1

The RBA conducted a non-intrusive survey of the roof area on the 23<sup>rd</sup> November 2021. On inspection it was noted that the roof has had several patch repairs over the lifetime of the structure. A proportion of the external roof layout was not surveyed, that is the interaction of the square couples' slope 4 and the masonry wall see plate 1, to the rear due to its location. The areas that were surveyed, the RBA has the following recommendations.

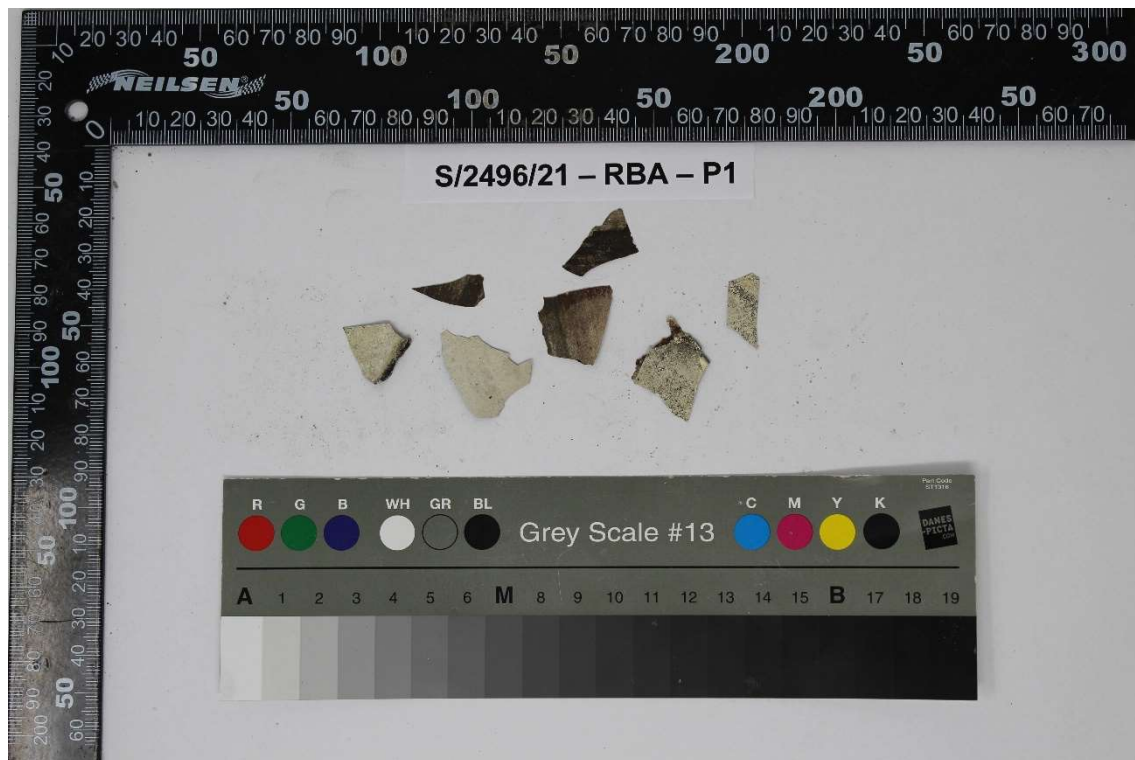
Plate 1 – General shot of Paint Sample P1.

5.1.15 Paint samples were taken from the cupolas and sent for lab testing. Results show evidence of a oil based system consistent of an alk d pol mer. n general, oil based s stems are compatible with products containing simialr components. herefore it is recommended that the manufacturer s guidance is obtained if an alternati e paint s stem is considered for o ercoating of this existing oil based paint s stem
