## Building Condition Report

32-34 Laystall Street  
Manchester  
M1 2JZ  
UK.

**28th of March 2018**

**BUILDING SURVEY: 32-34 Laystall Street, Manchester.**

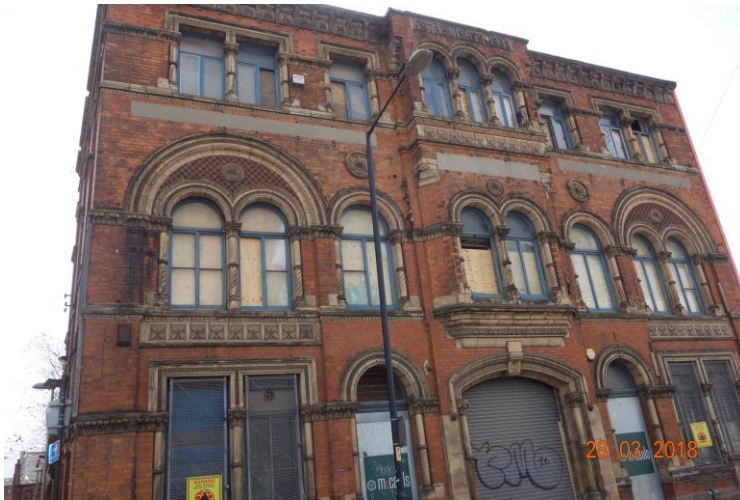
**Photograph No. 5.**

**Photograph No. 5** – A great example of the global view of the front of the building.

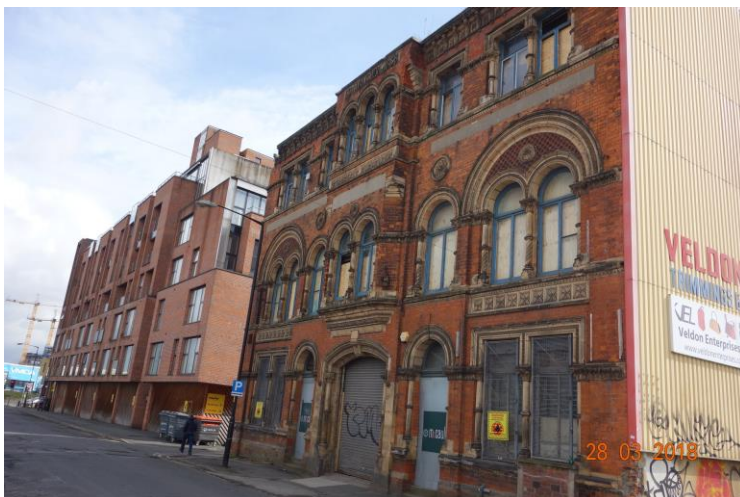
**Photograph No. 10** – Reveals a global view of the vista of the street.

This building ties in pretty well with the neighbouring modern construction.

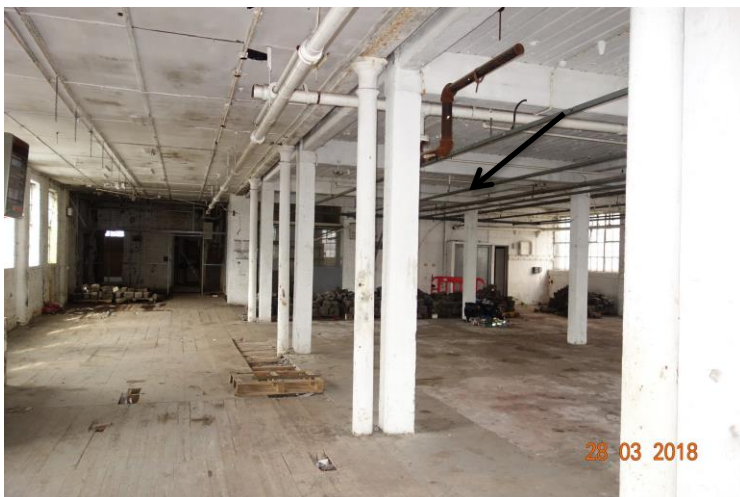
**Photograph No. 14** – Exposes a global view of the internal structure of the building. This photograph highlights what is a typical internal industrial structure - cast iron uprights, timber floors and ceilings.

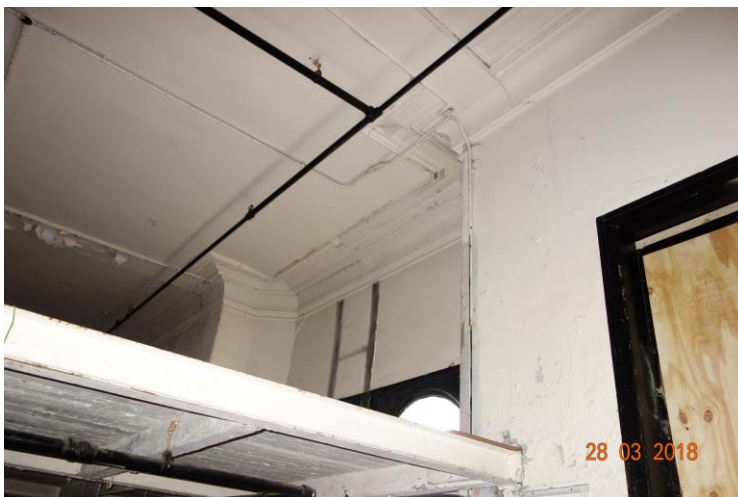
**Photograph No. 18** – Identifies the small mezzanine floor area.

It is important to point out that there is no evidence that the front elevation of the building is suffering as a result of ingress of water.

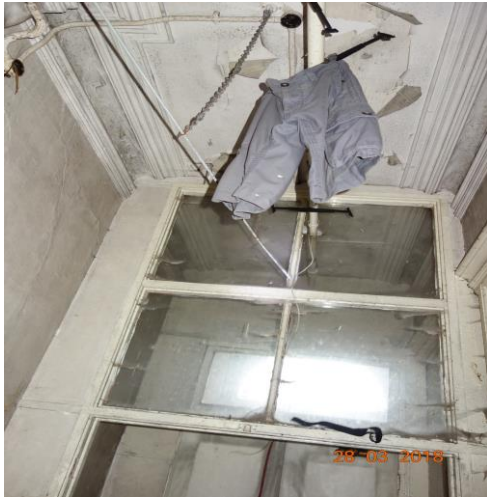
**Photograph No. 31.**

**Photograph No. 31** – Identifies the hall area of Building No.2.

This photograph shows that the original cornice is still in place.

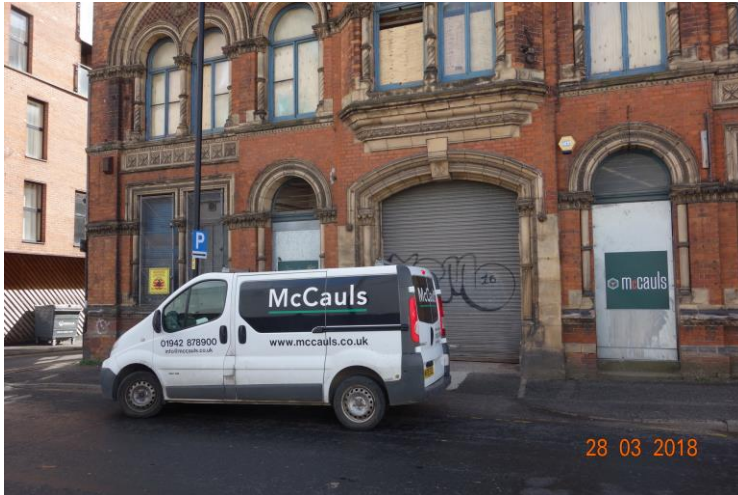
**Photograph No. 39.**

**Photograph No. 39** – This photograph demonstrates the 3 number of entrance doors located on the ground floor.

In my opinion additional security should be put in place. Currently the metal has been pulled off the timber work and therefore there is a risk of squatters entering the property.

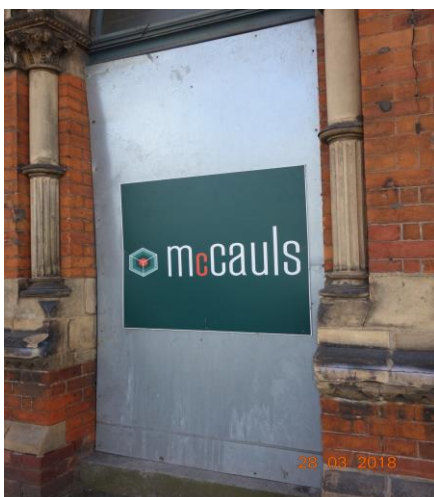
**Photograph No. 44.**

**Photograph No. 44** – This photograph indicates the entrance door.

In my opinion this door should be solidly secured thus eliminating any unauthorised access into the property.

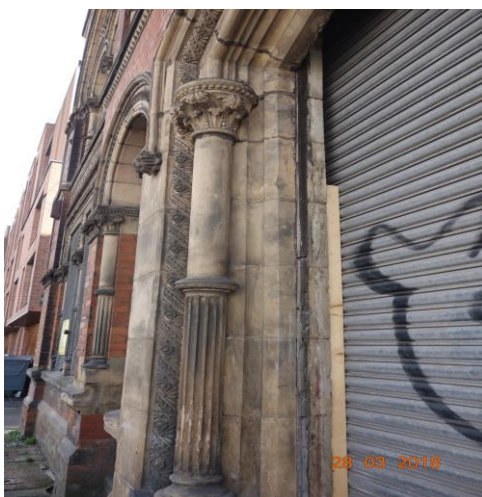
**Photograph No. 46.**

**Photograph No. 46** – This photograph shows a global view of the extent of mixture of colours which have been used on the building.

We have a combination of both buff terracotta ornate works and red hard wired cut brick.
