# W14-LG

**OSBORNES**CHARTEREDARCHITECTS  
The Balconies • Hanley Swan • Malvern • Worcestershire • WR8 0DN  
T: 01484 311303 E: architecture@osbornesarchitects.com F: 01484311255 W: osbornesarchitects.com  
CLIENT AMBASSADOR THEATRE GROUP  
PROJECT MANCHESTER OPERA HOUSE  
TITLE WINDOW REPAIR - W14-LG  
SCALE 1:5; NTS @ A1  
DATE MAR 2020  
DRAWN AML DRAWING NUMBER 19-143- WR14

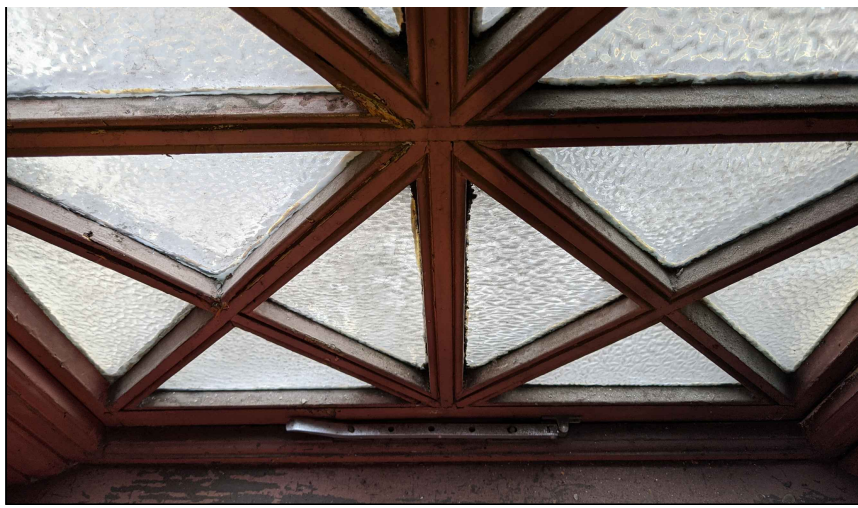
Window W14-LG

Once casement has been removed and the existing frame has been left in-situ, check frame and cill for and damage or rot. Record areas and inform CA.

Where external cills are to be replaced - replicate the profile of the existing cill in a durable hardwood such as oak incorporating a drip detail to the underside. Any new cill parts should be butt jointed below the casement frame. Finish using linseed oil based paint as described above in the colour to match the existing colour.
