**Project Name:** Caddick Construction Limited - Openshaw Campus - PJ372741  
**Project Number:** PJ372741  
**Project Date:** 11/06/2020  
**Inspection Standard:** MSCC4 Sewers & Drainage GB (SRM4 Scoring)

**Lanes**  
Group Plc

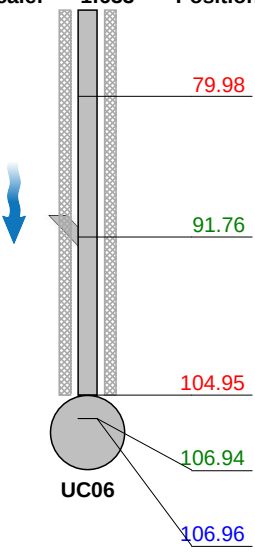
| | 79.98 | MB | Missing bricks at 12 o'clock | 4 |
| | 91.76 | CXI | Connection intruding at 2 o'clock, diameter: 150mm, intrusion: 5% | 2 |
| | 104.95 | MB | Missing bricks from 1 o'clock to 2 o'clock | 4 |
