**PROJECT NO. AMP-44787/1****MCC M&E CONDITION SURVEY****PROJECT Name: Building Fabric Repairs**

Document No: AMP-44787/1-ME

Mechanical Works Survey in relation to External Fabric cladding repairs

January 2021

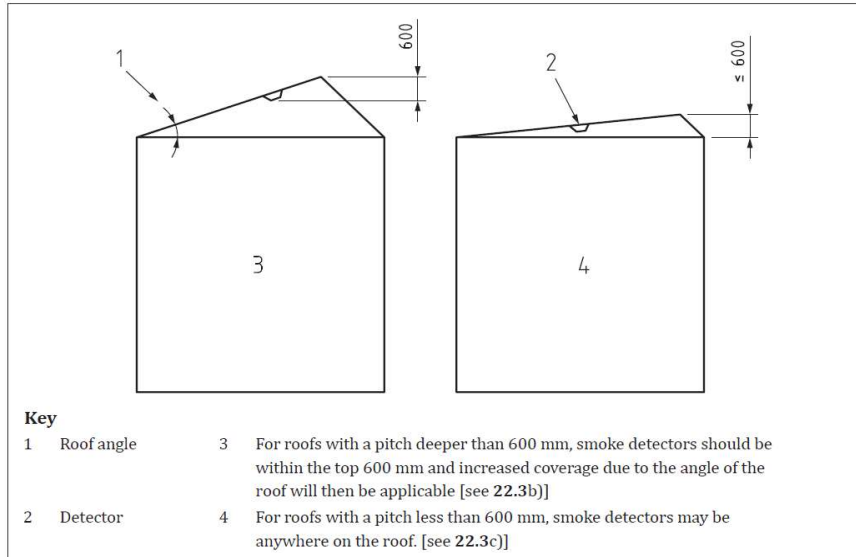
It appears that the smoke detectors within the sports hall are too low for current regulation compliance. Although not my primary area of expertise it would appear from looking from floor level that the position of the detectors is outside that of 600mm from the pitch as stated in BS 5839-1 (2017).

Excerpt from BS 5839-1 regarding smoke detector positioning
