**Report No:** LTM0240.ADDR.01

**Project:** 32 Hampton Road  
Chorlton-Cum-Hardy  
M21 9LA

# Advanced Decay Detection Report

- VALID - Validator
  - Professional Member of the Consulting Arborist Society
  - Professional member of the Arboricultural Association
- 1.0.3 I was instructed by Mr Marcus Redmond with reference to the potential decay within the tree at the front of the property at 12 Wellington Road in Timperley.  
Tree Number: T1  
Species: Hybrid Black Poplar (Populus Nigra)

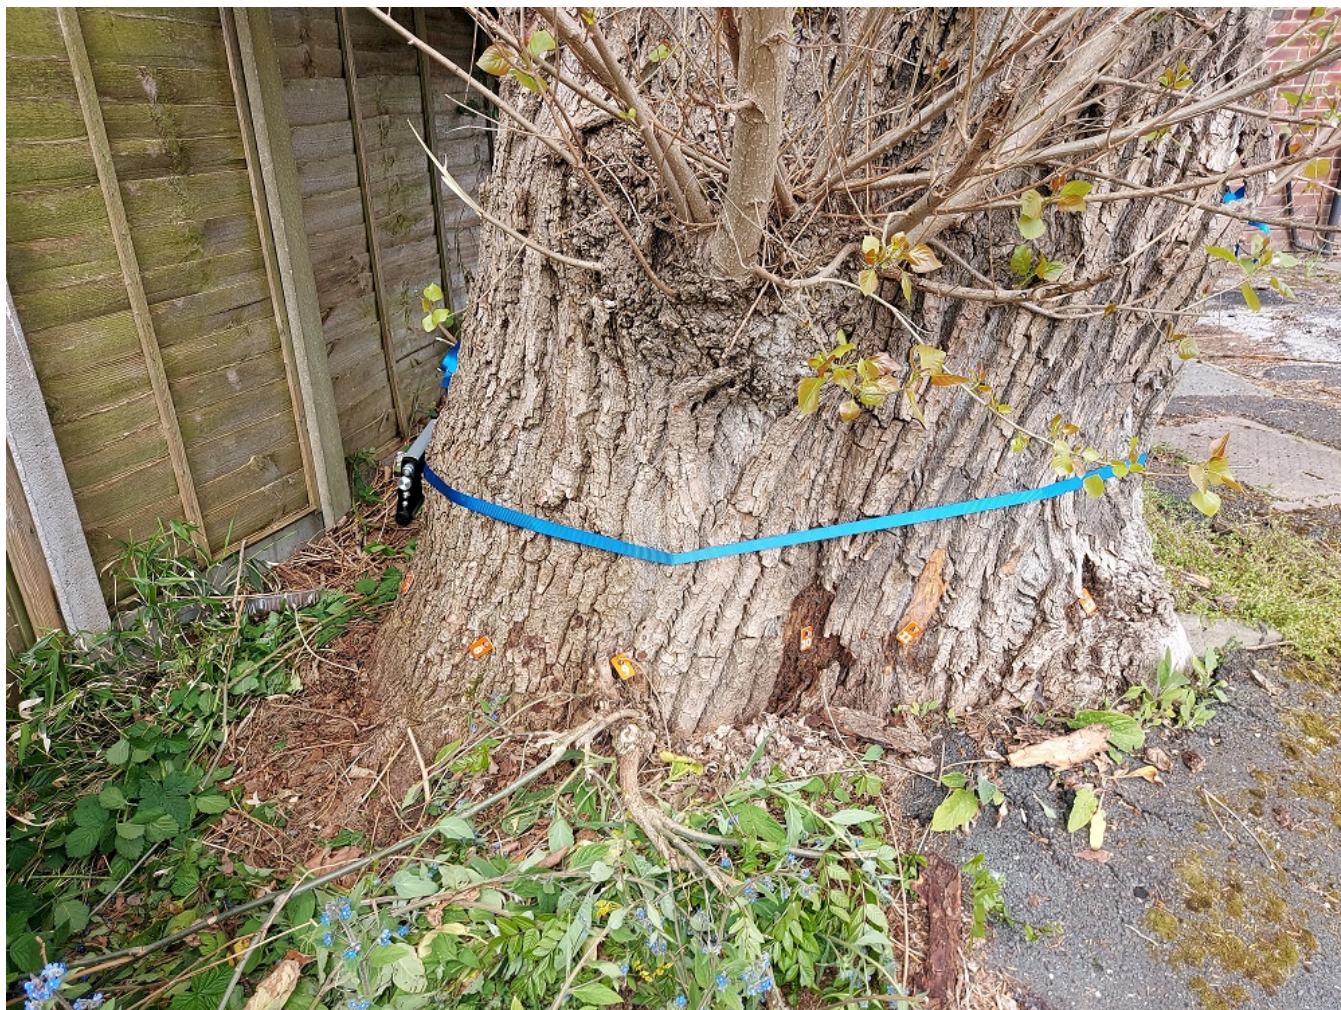
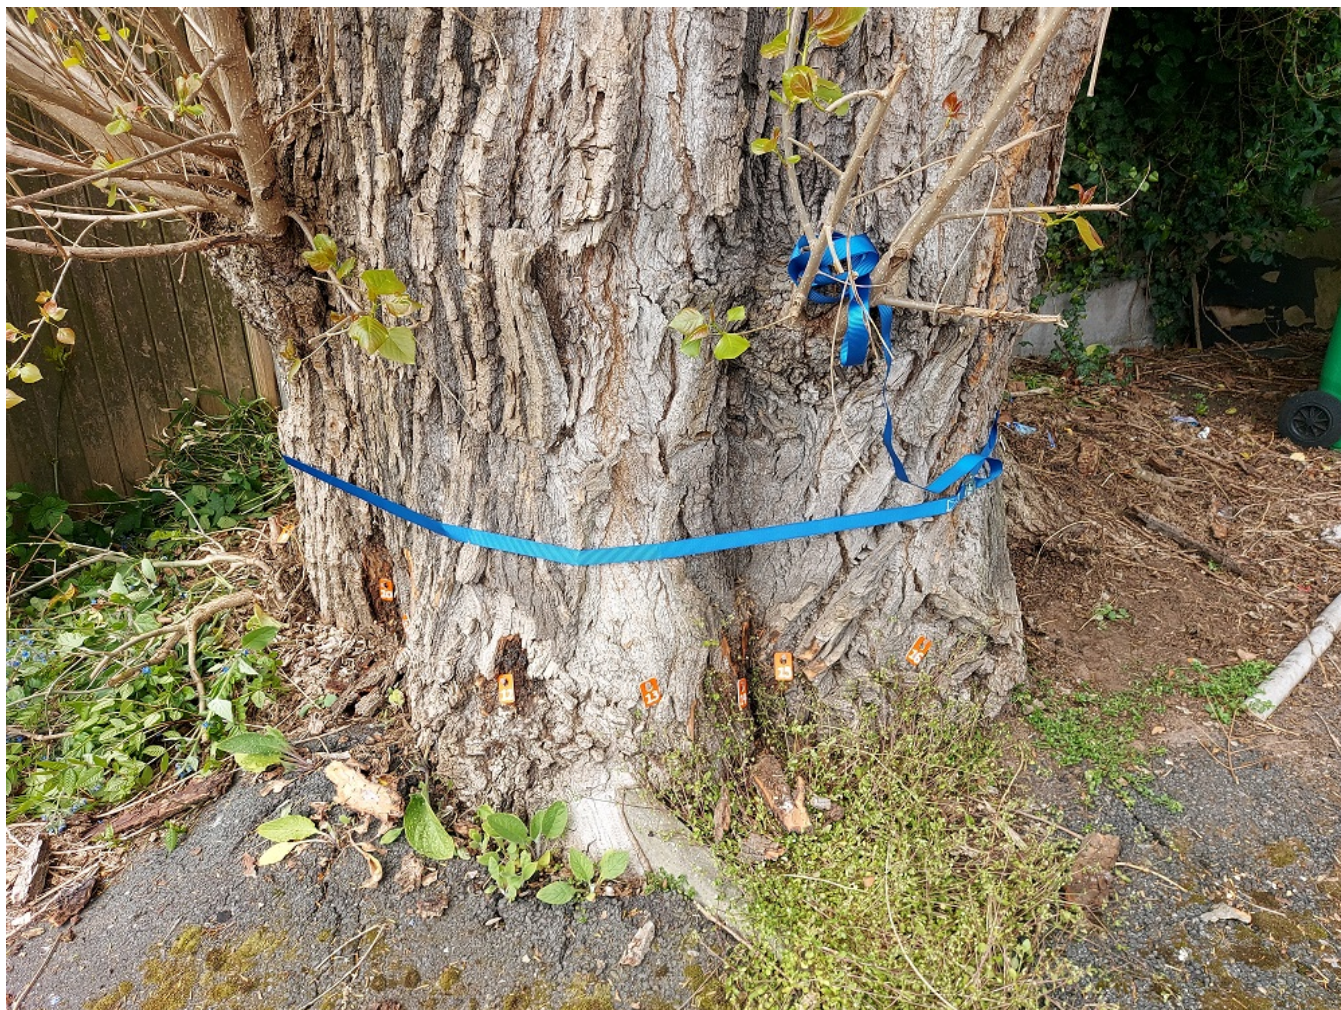
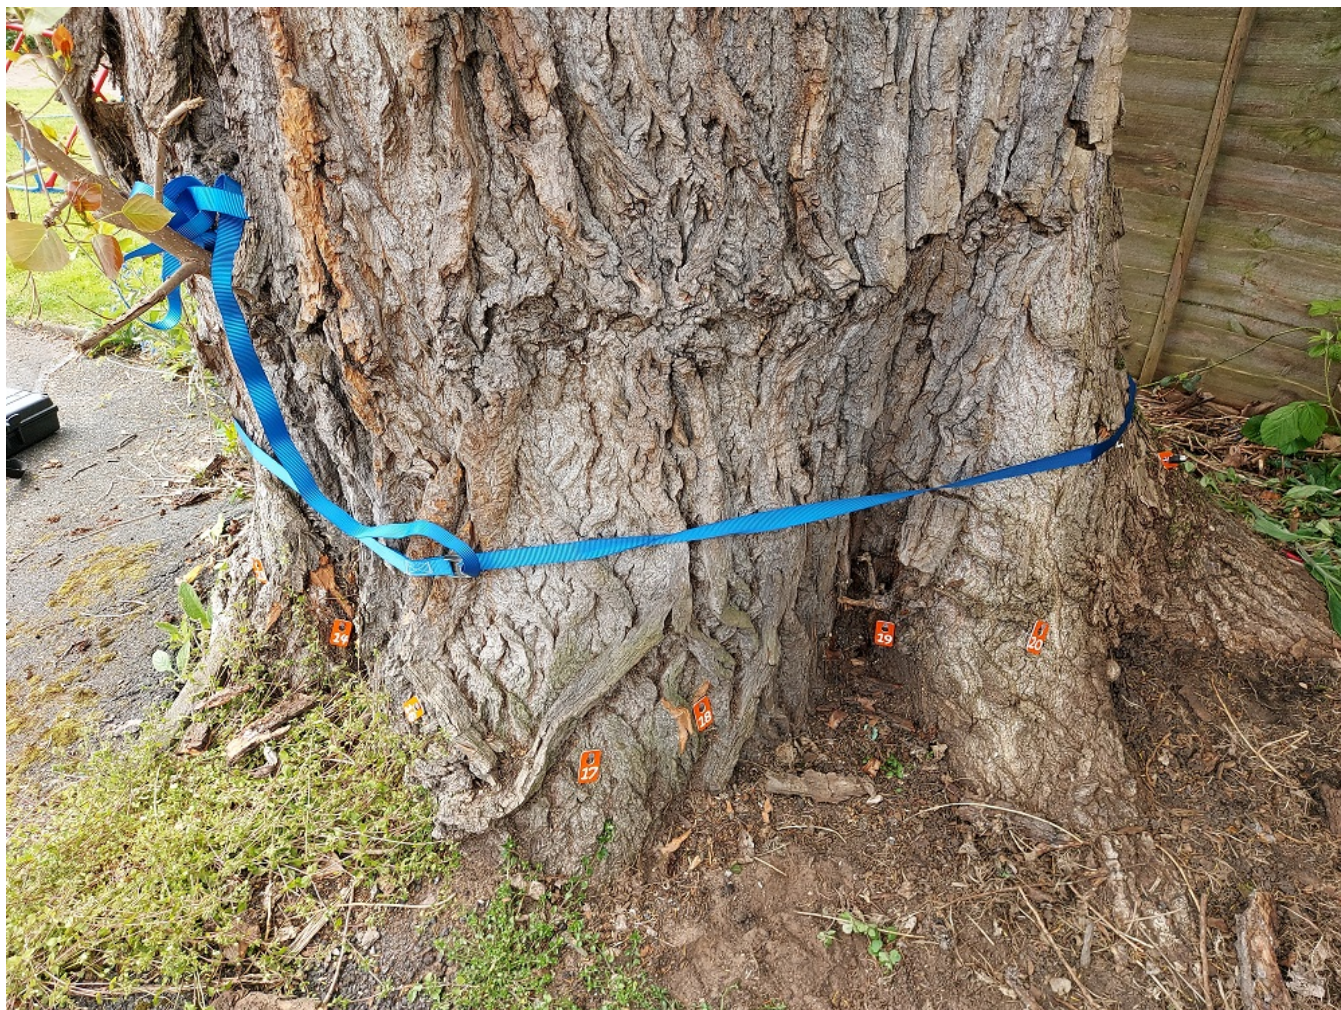
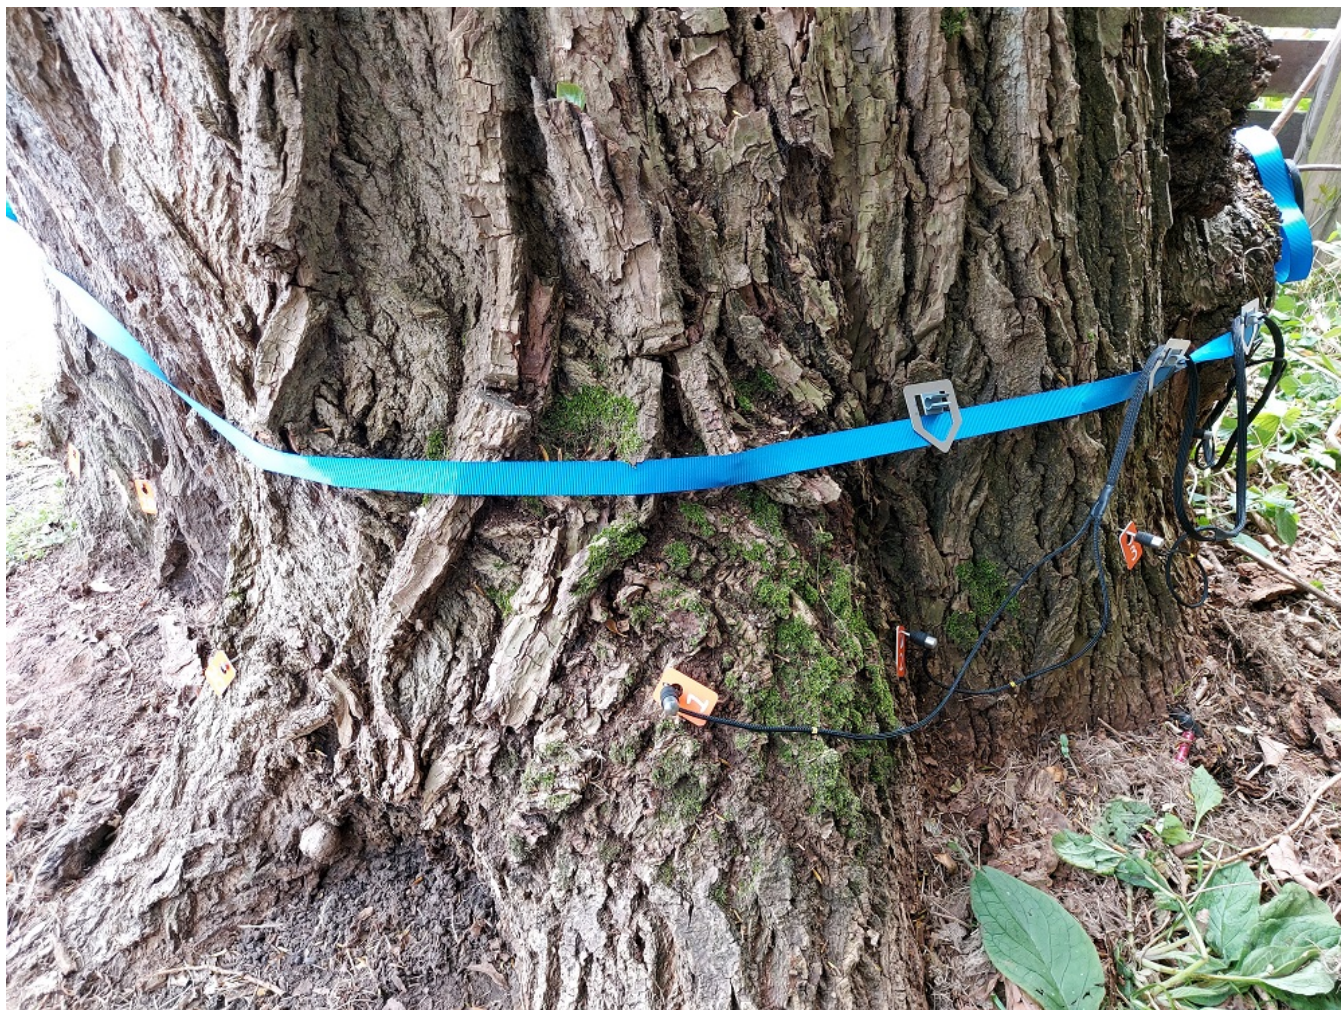
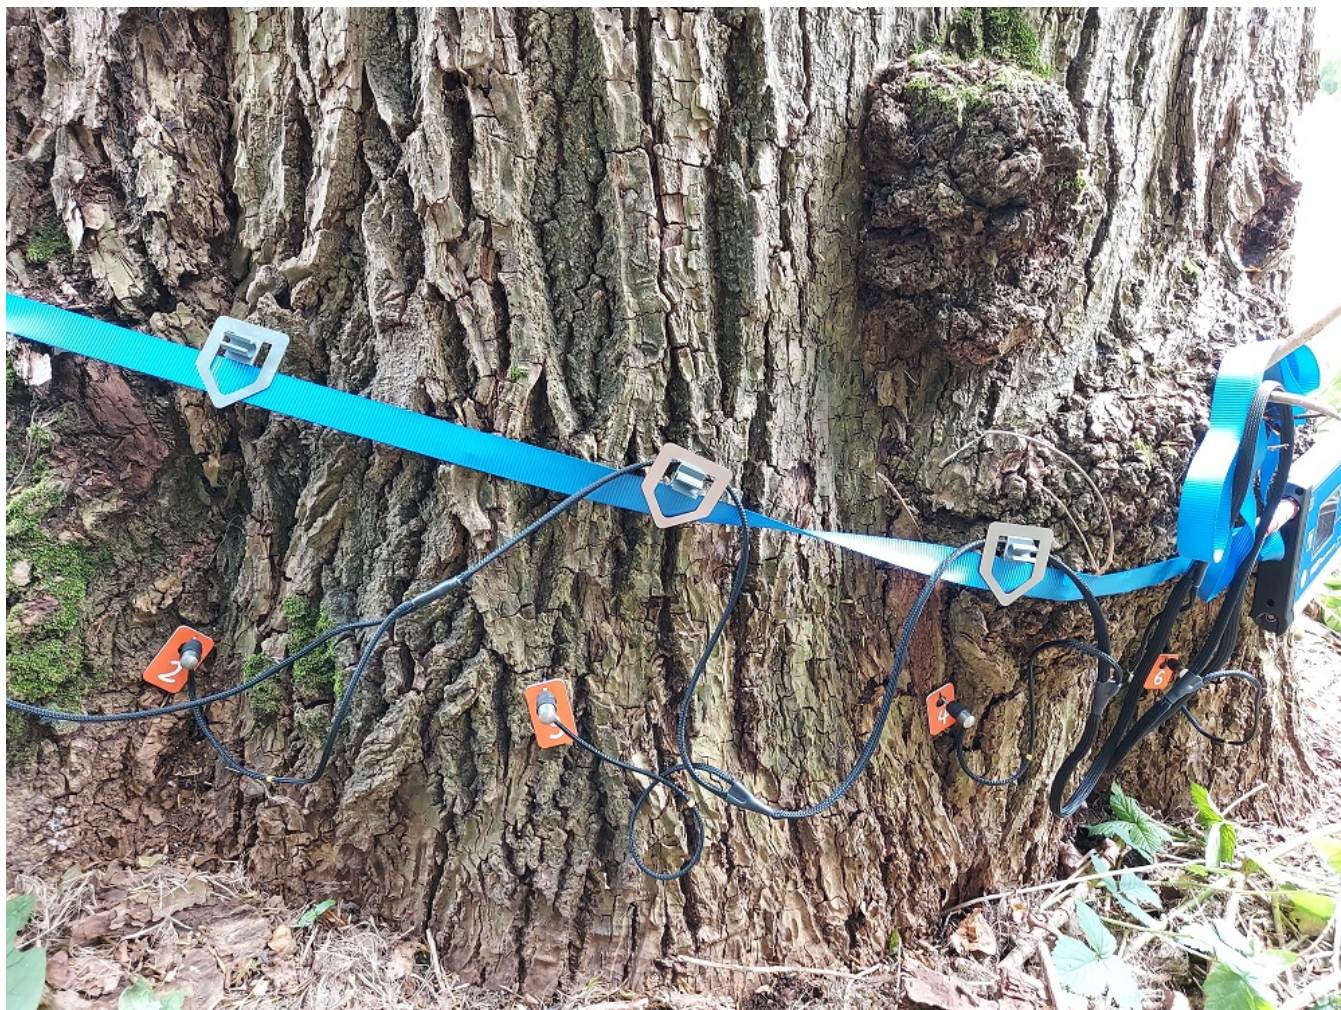
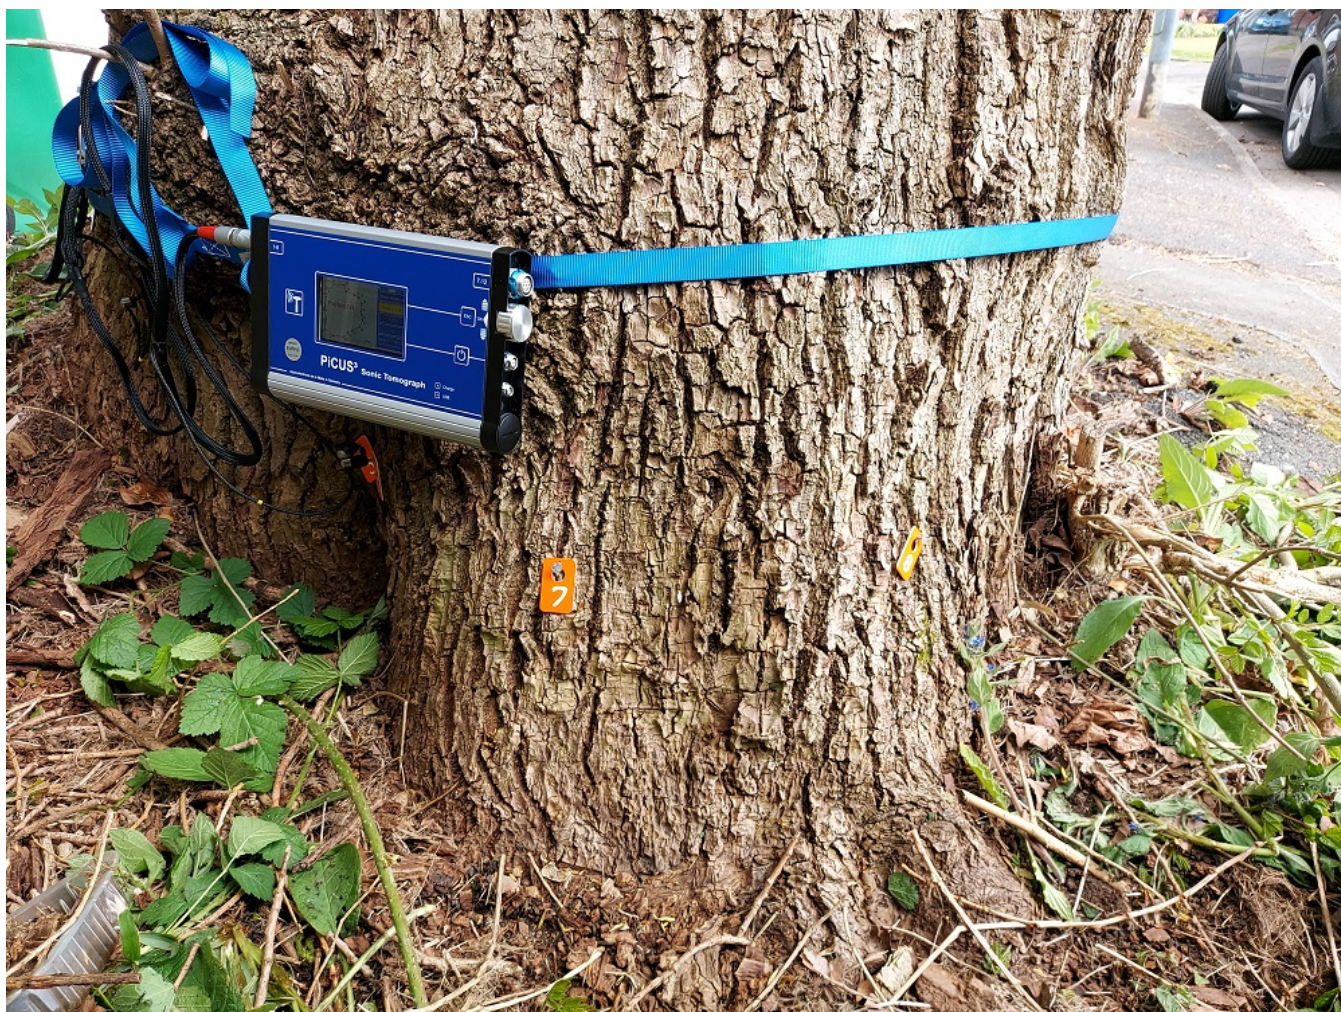
- 5.0.1 The results of the Picus test clearly show that there is not extensive decay levels within the main stem at 20cm. There is, however, evidence of early degradation of the wood but this is of little concern at this time. A cavity is present at 3m on the main stem which will require further investigation.
- 5.0.2 The PiCUS Image can be found below:
