# **Hexagon Tower**

Deterioration of Cladding  
Pre-planning Report

March 2021

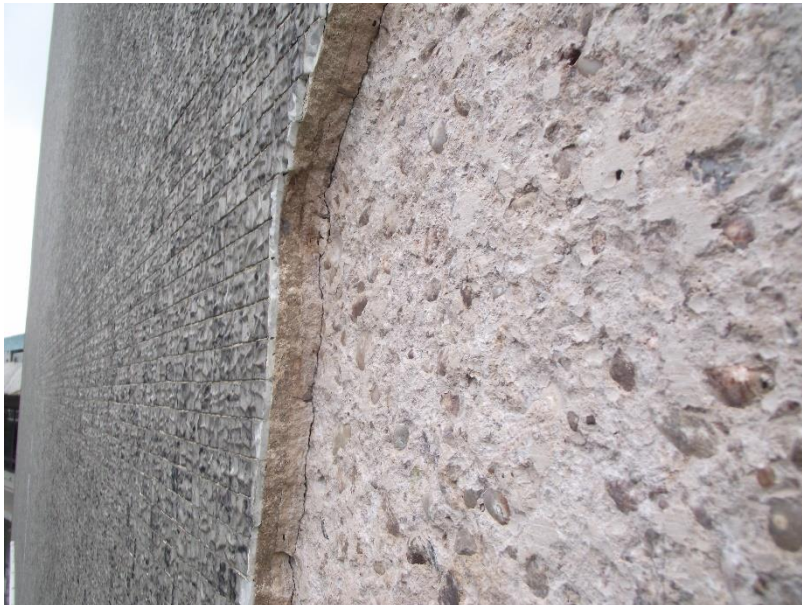
Where cladding has spalled or has been removed due to being deemed unsafe, debonding failure has been observed to be occurring almost exclusively at the interface between the concrete and the adhesive mortar. An example of this is shown in Figure 2.3.

Petrographic analysis was undertaken to investigate the composition and condition of each of the layers of the cladding system and the underlying concrete. Investigation of two cores taken from the south elevation of the main tower did not find any evidence of deterioration of the materials (for example due to reactive components). The debonding of cladding is therefore considered to be restricted to the interface between the render and the concrete, rather than due to processes occurring within the bulk of the materials.

**Figure 2.3: Failure of the cladding at the concrete-adhesive render interface**

The petrographic investigation found an abundance of microcracks near to the concrete surface, most likely resulting from mechanical preparation of the surface to receive the adhesive mortar. The presence of microcracks beneath the concrete surface is expected to weaken the cohesive strength of the interface. In addition, no evidence of primers or bonding coats was found between layers.

It is likely that the ingress of water behind the cladding, leading to expansive freeze-thaw action during winter months, is the principal cause of debonding. The presence of sub-surface cracks within the concrete reduces the strength of the material and can provide an accelerated path for

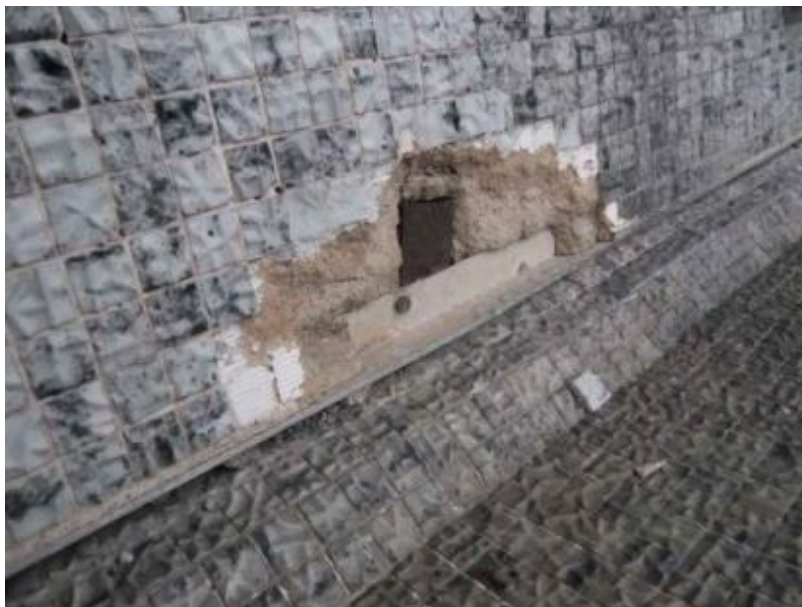
In addition to the debonding of sections of the cladding at the concrete-mortar interface, localised instances of spalling caused by corrosion of reinforcing steel or other embedded steel objects have been observed. It is not considered that the corrosion of reinforcement is a large contributor to the failure of the cladding at this time. However, the presence of isolated areas of spalled concrete due to corrosion may indicate an emerging problem. An example of an area of spalling due to corrosion is shown in Figure 2.4.

**Figure 2.4: Area of spalling due to corrosion of an embedded steel object**

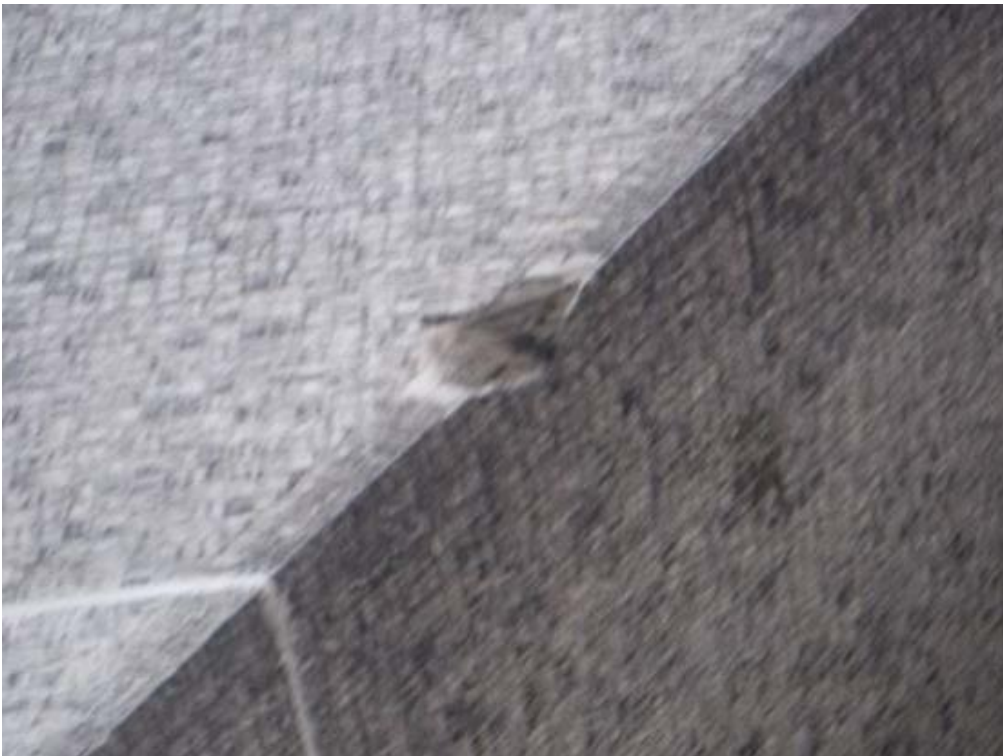
**Photo B.8: A view showing a 'new' area of spalling to the 1st storey of the north elevation**

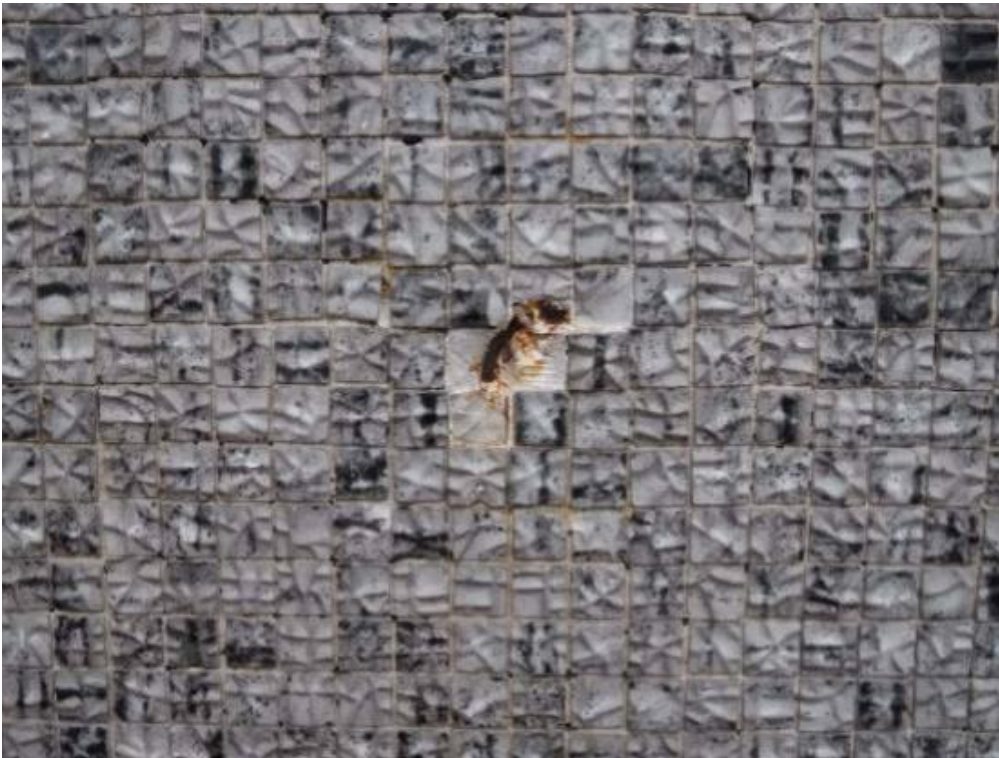
**Photo B.11: A view showing an area of spalling with exposed steel in the 11th storey of the south elevation**

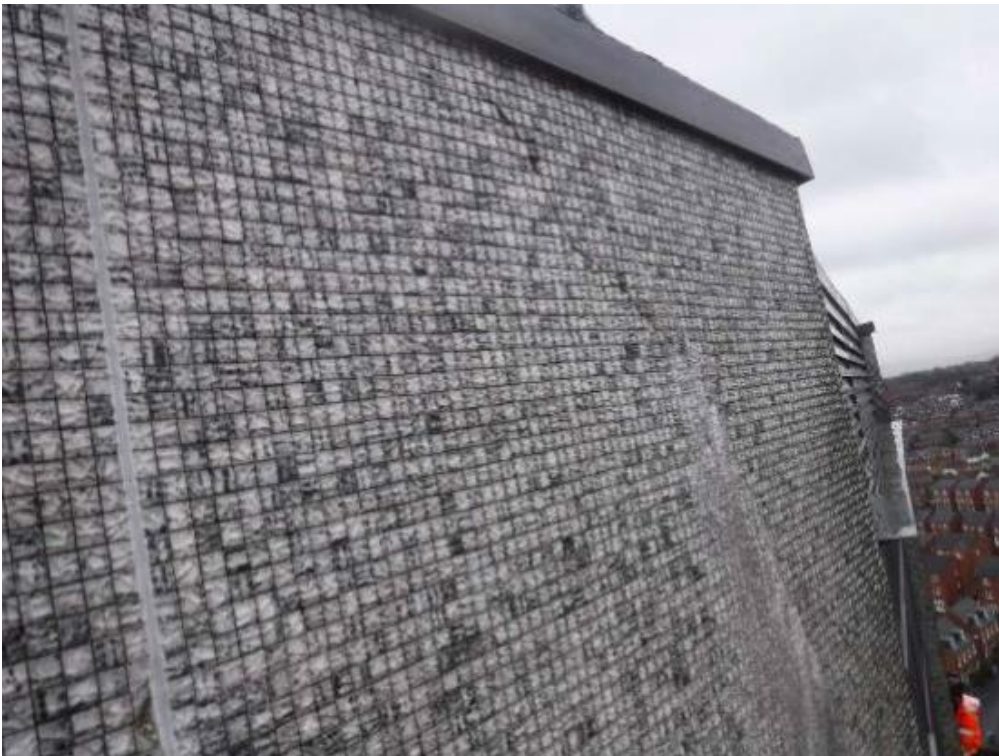
**Photo B.12: A view showing a diagonal crack with leaching deposits to the 12th storey of the south elevation**

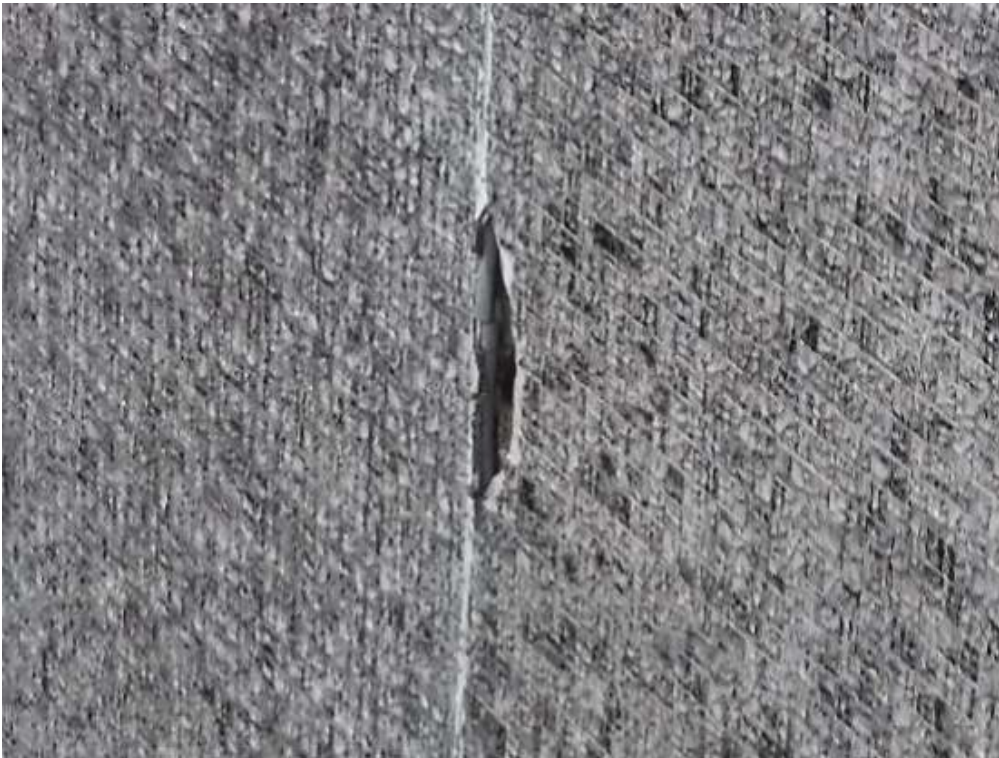
**Photo B.15: A view showing an area of spalling with exposed reinforcement at a joint in the 7th storey of the south elevation**

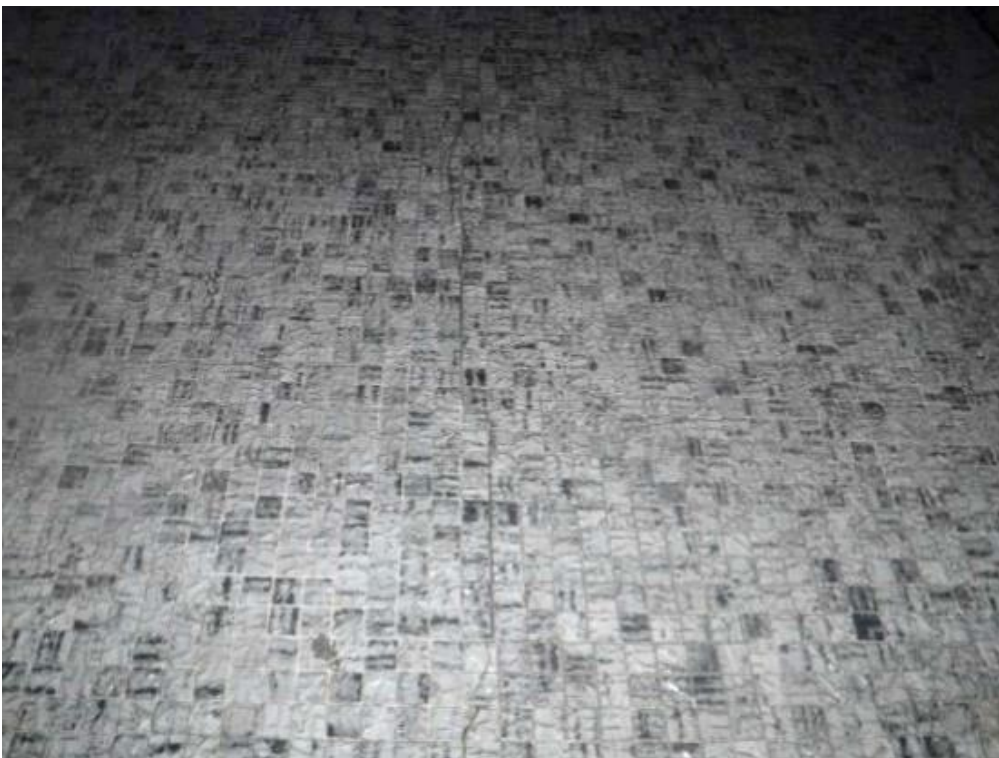
**Photo B.16: A view showing a vertical crack in the internal face of the south entrance**

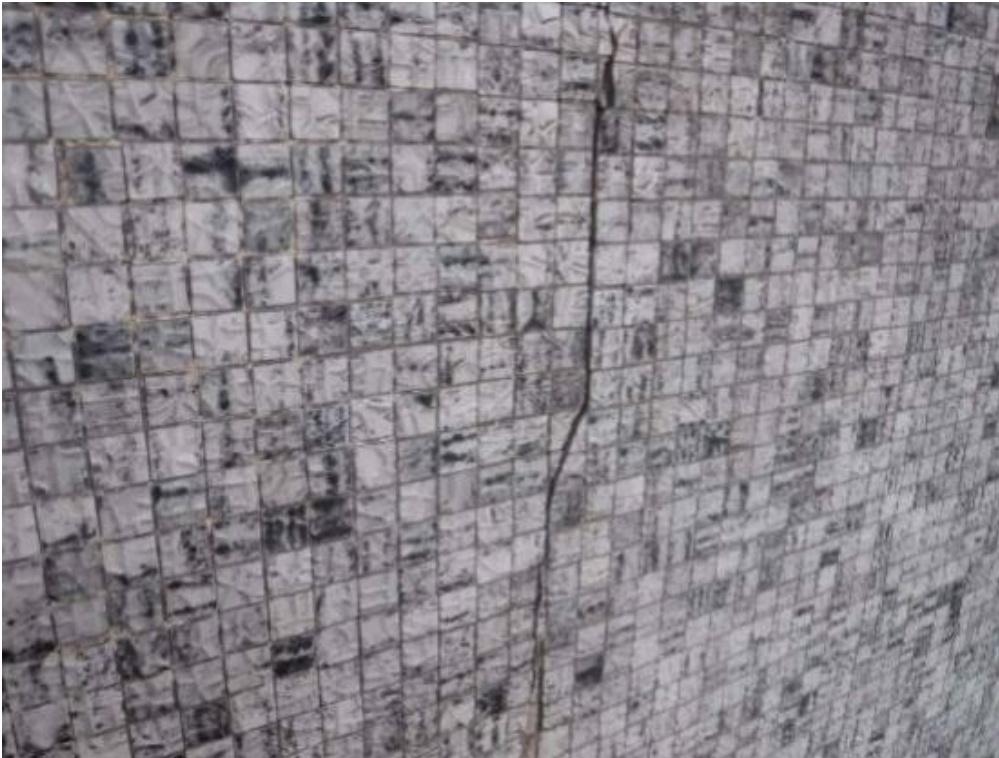
**Photo B.17: A view showing a vertical crack in the internal face of the south entrance**

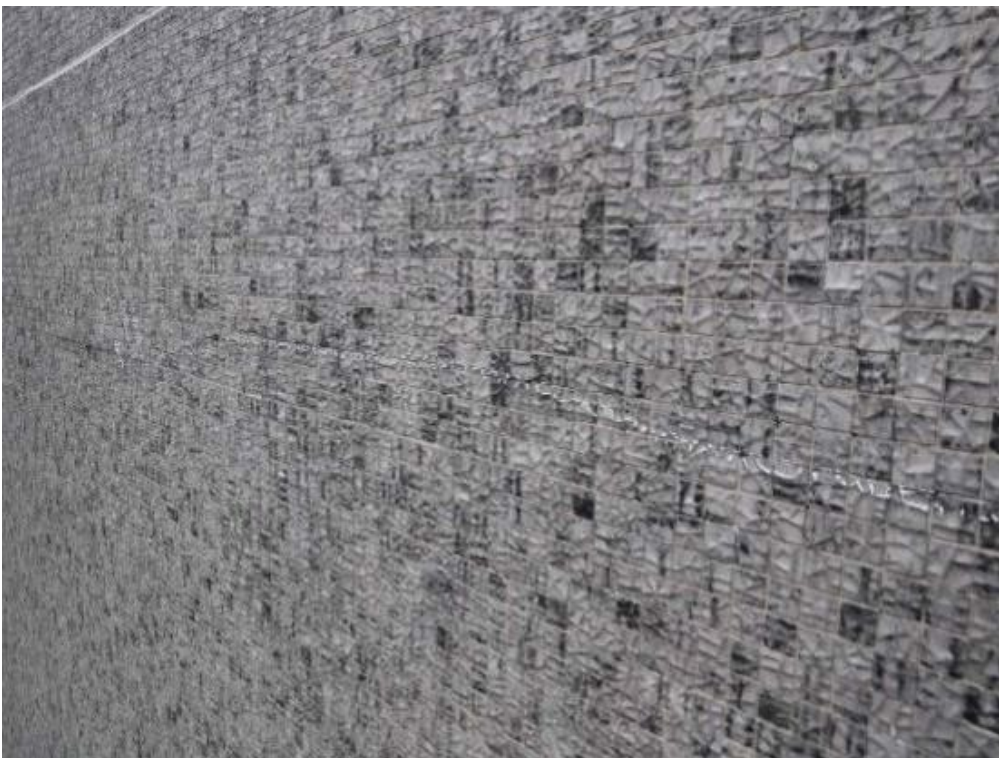
**Photo B.18: A view showing a full width horizontal crack in the 10th storey of the south elevation**

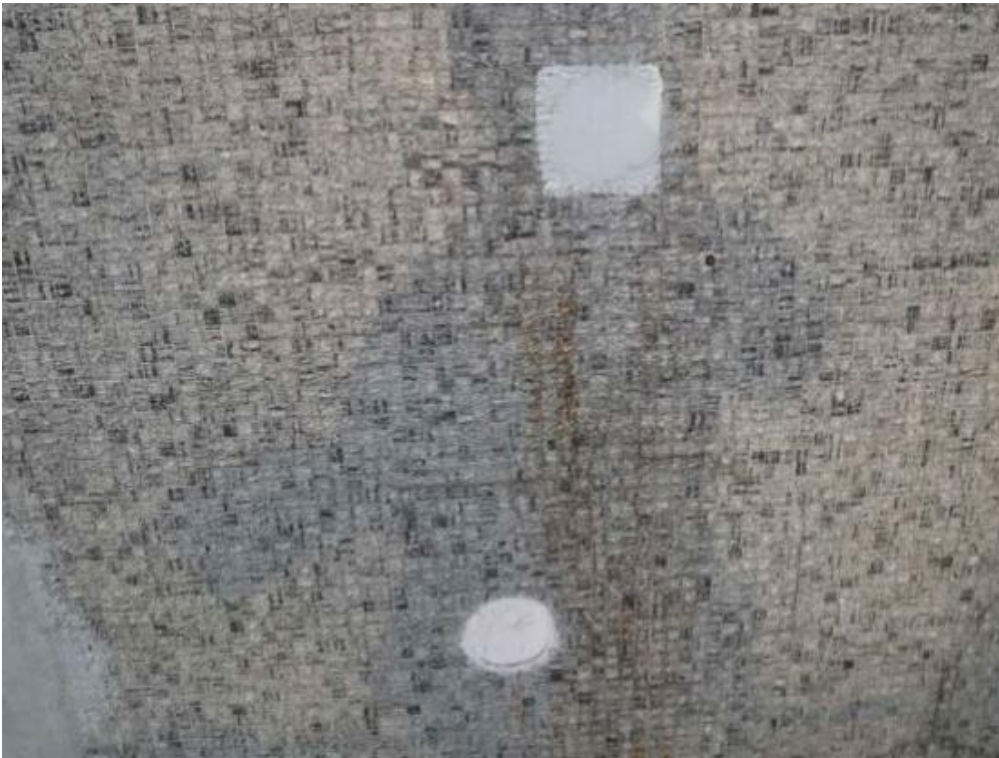
**Photo B.19: A view showing two repaired core holes in the south elevation at ground level**

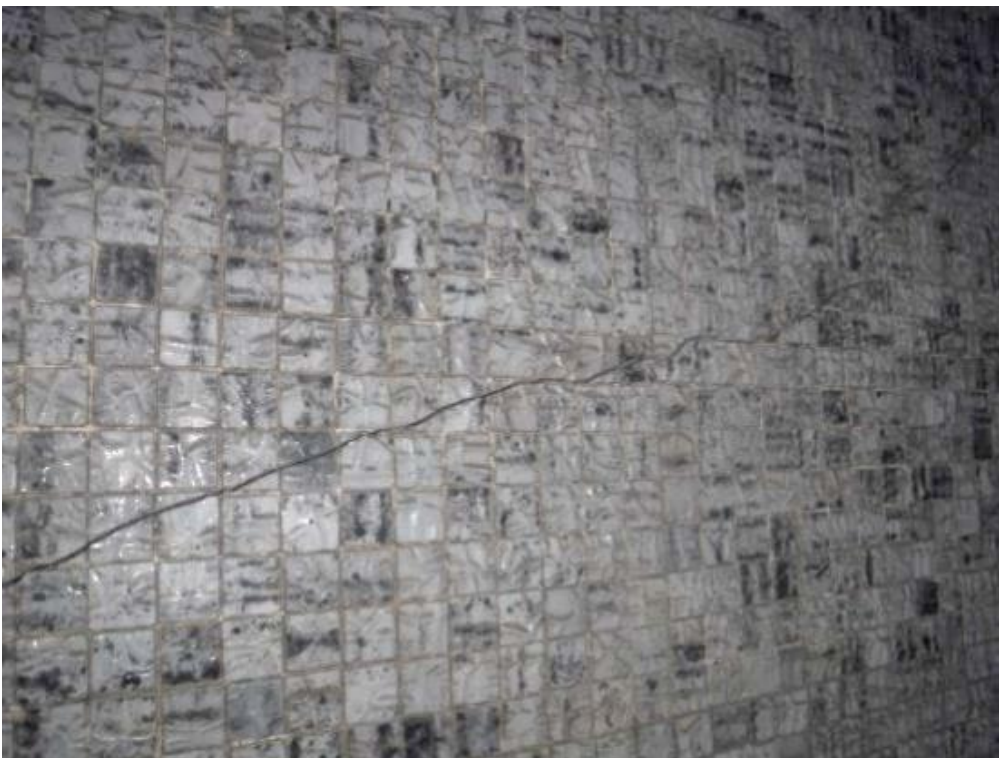
**Photo B.20: A view showing a diagonal crack in the internal face of the south entrance**

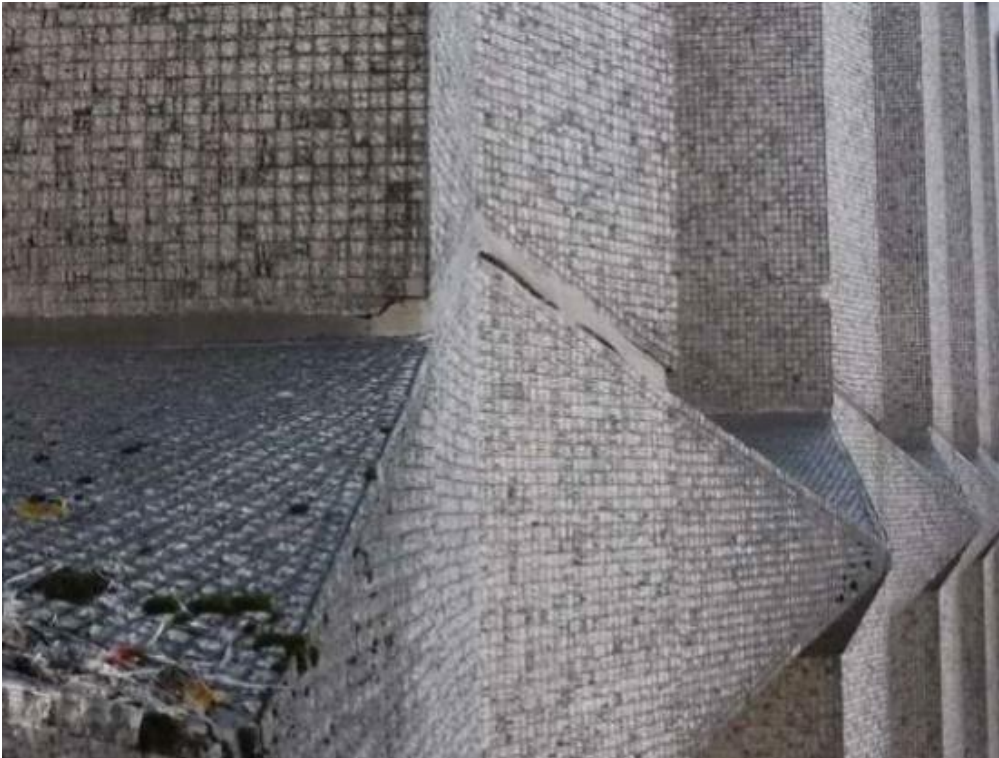
**Photo B.23: A view showing de-bonded sealant to the east elevation (row O storey 12)**

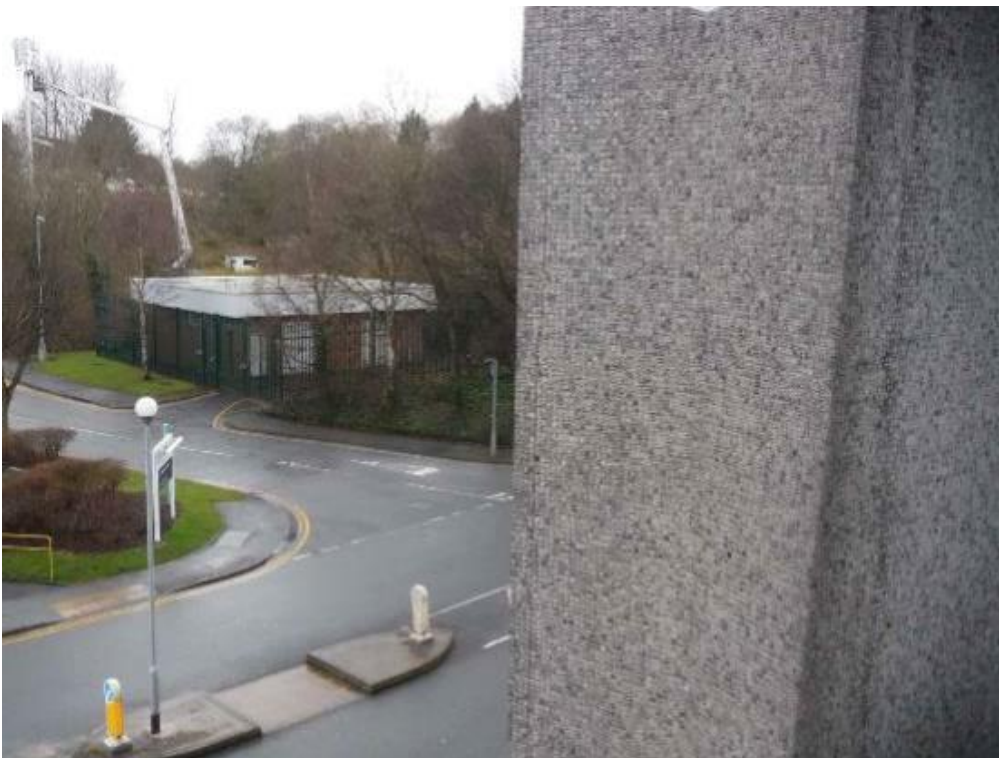
**Photo B.24: A view showing a vertical crack with hollow sounding cladding to the east elevation (row X storey 2)**

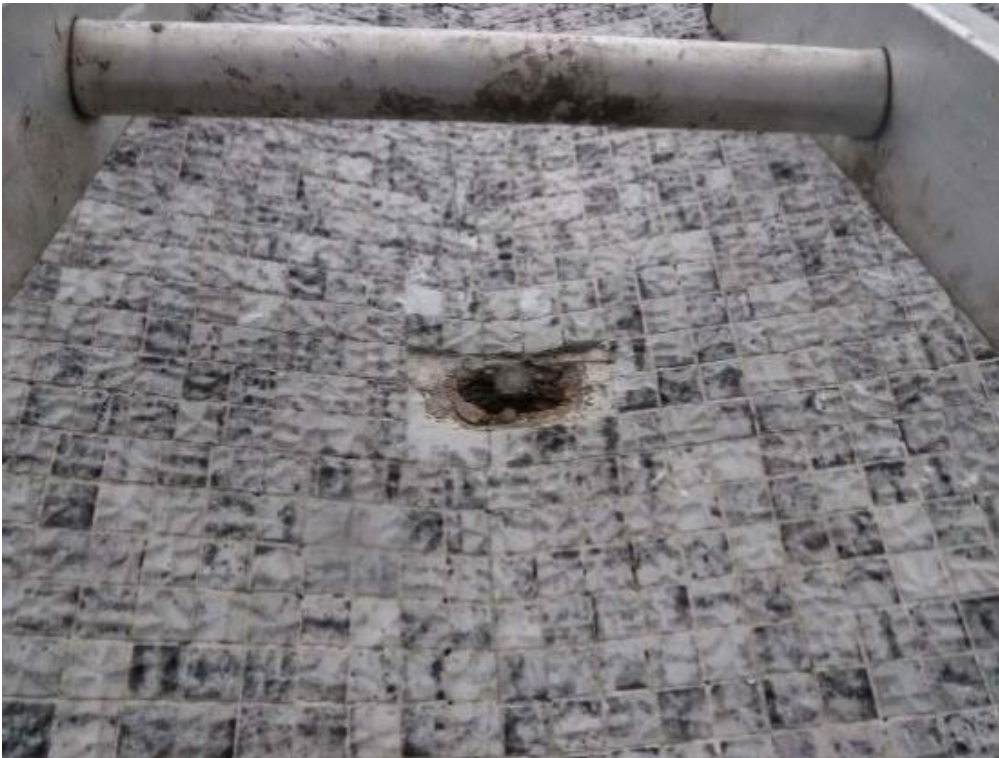
**Photo B.27: A view showing spalling with exposed reinforcement to the east elevation (row R storey 2)**

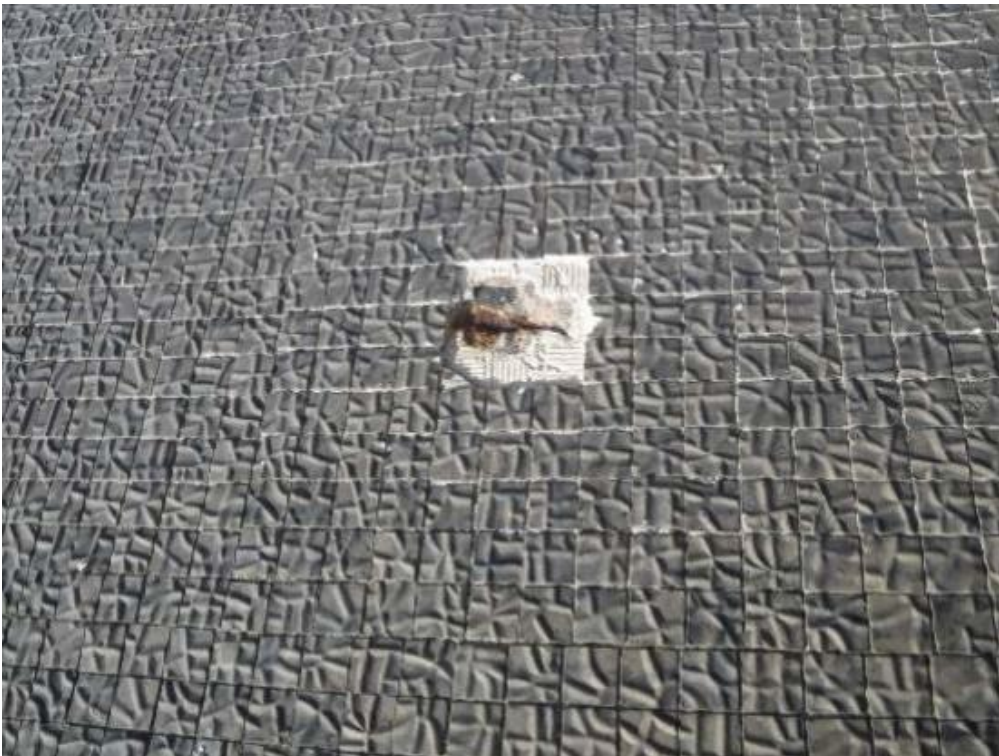
**Photo B.28: A view showing spalling with exposed reinforcement to the east elevation (row S storey 6)**

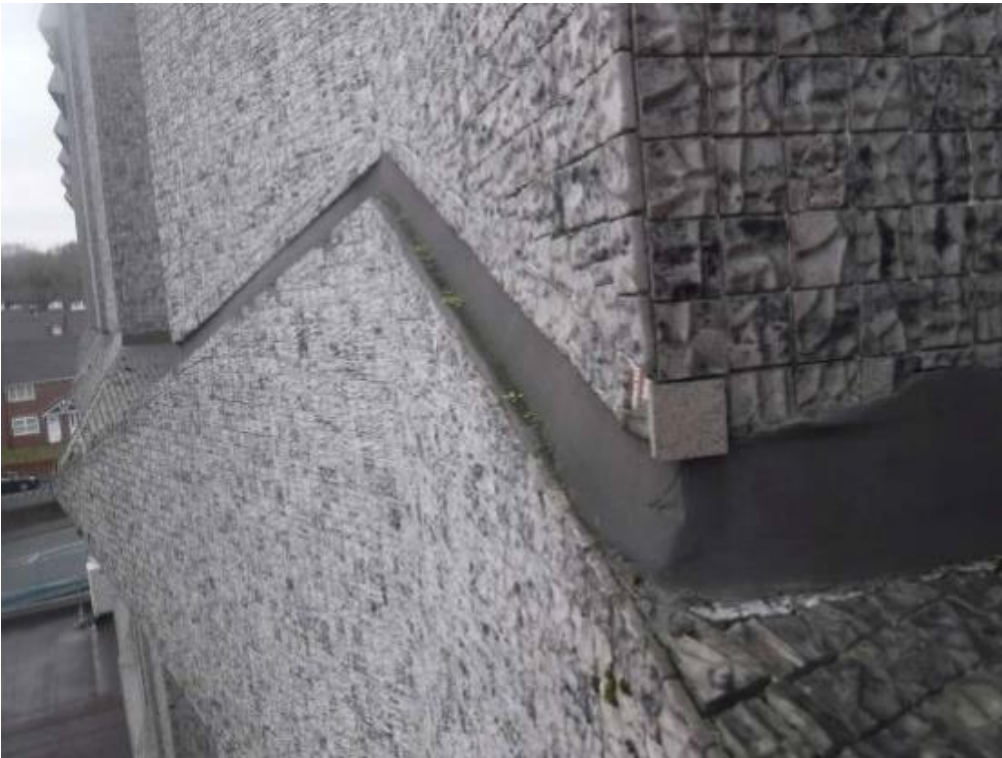
**Photo B.41: A view showing a misaligned panel to the west elevation (row BM storey 4)**

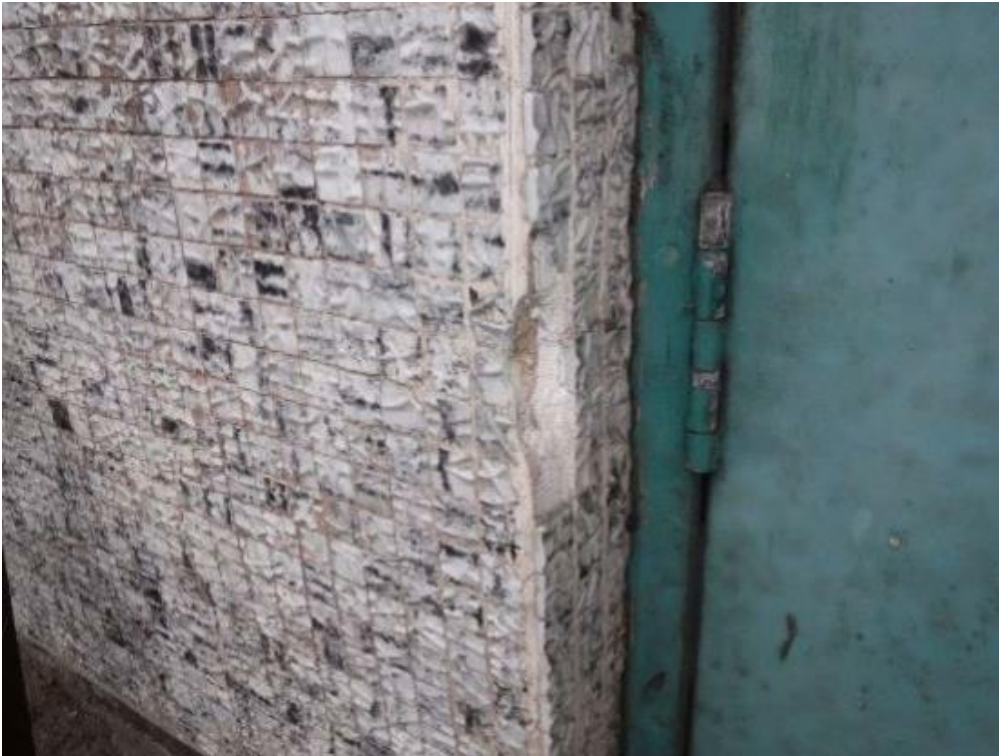
**Photo B.49: A view showing spalling to the corner of the doorway (West machine hall north elevation)**

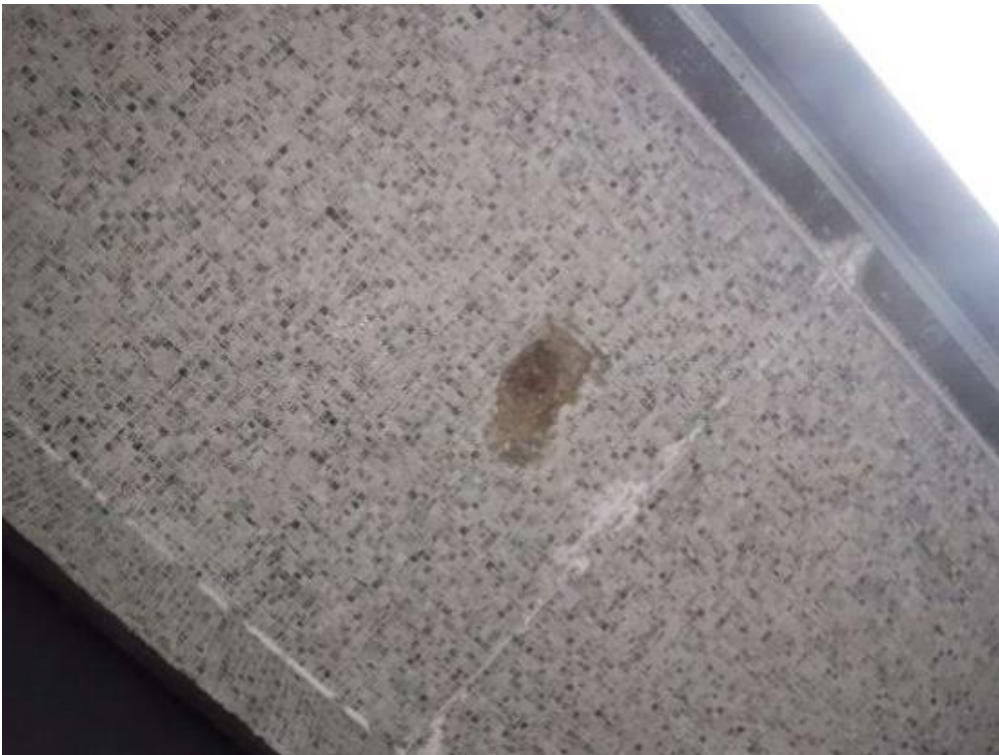
**Photo B.50: A view showing spalling to the soffit of the upper cantilever (West machine hall north elevation)**

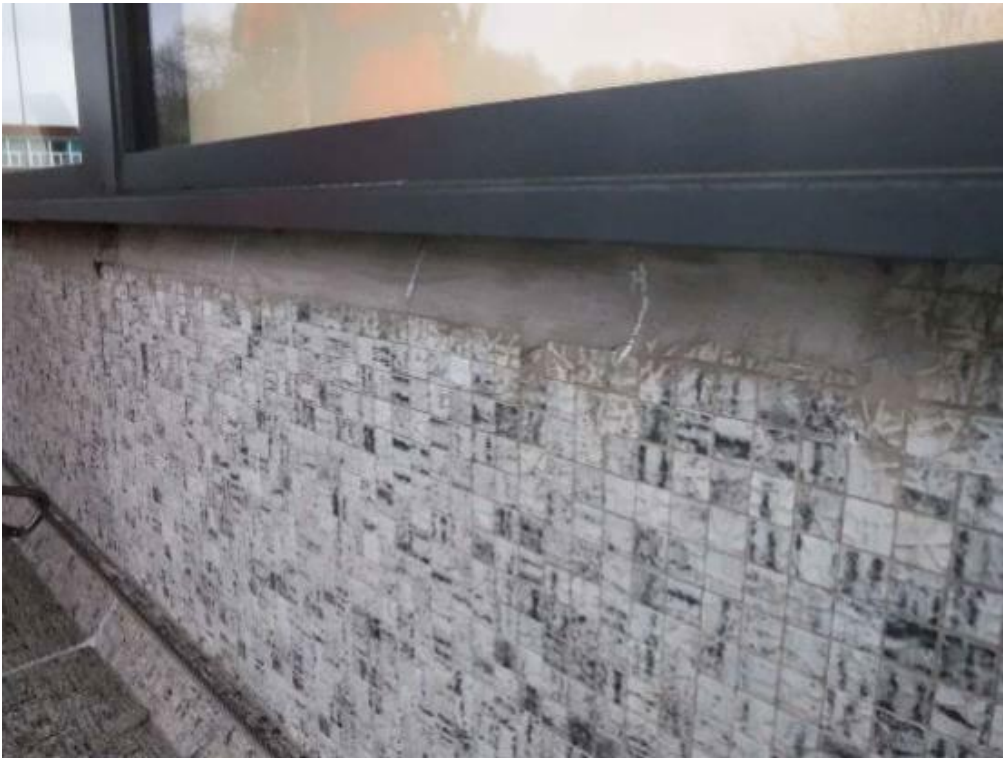
**Photo B.61: A view showing vertical cracks in a repair below the window sill (West machine hall south elevation)**

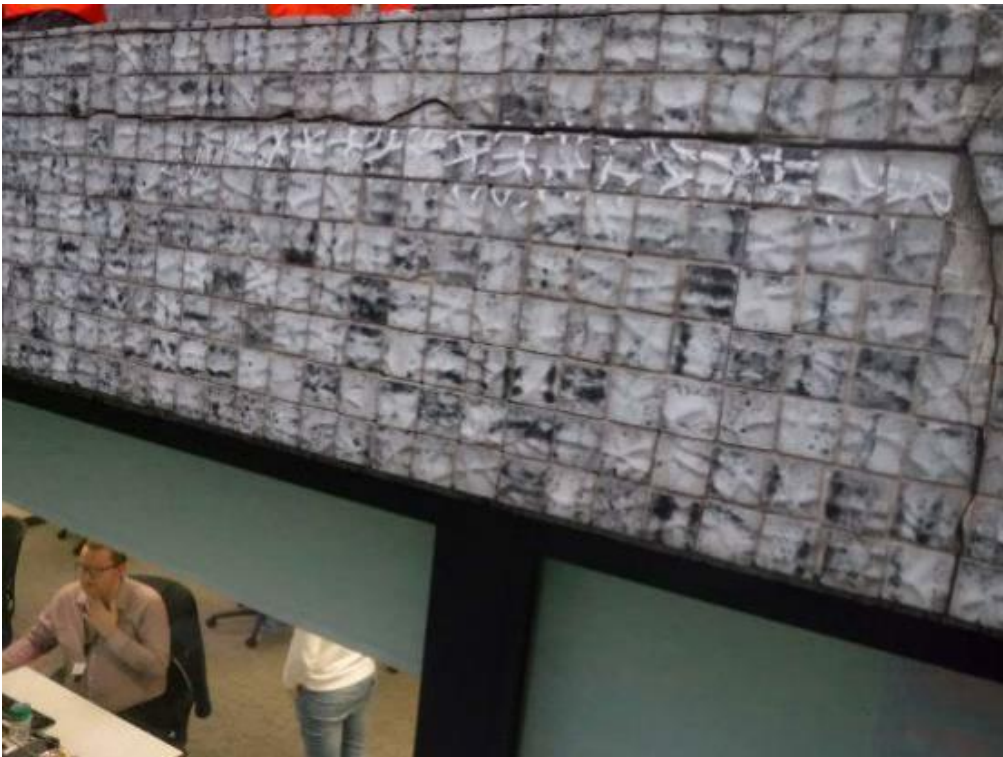
**Photo B.62: A view showing a horizontal crack in the elevation of the lower cantilever (West machine hall, south elevation)**

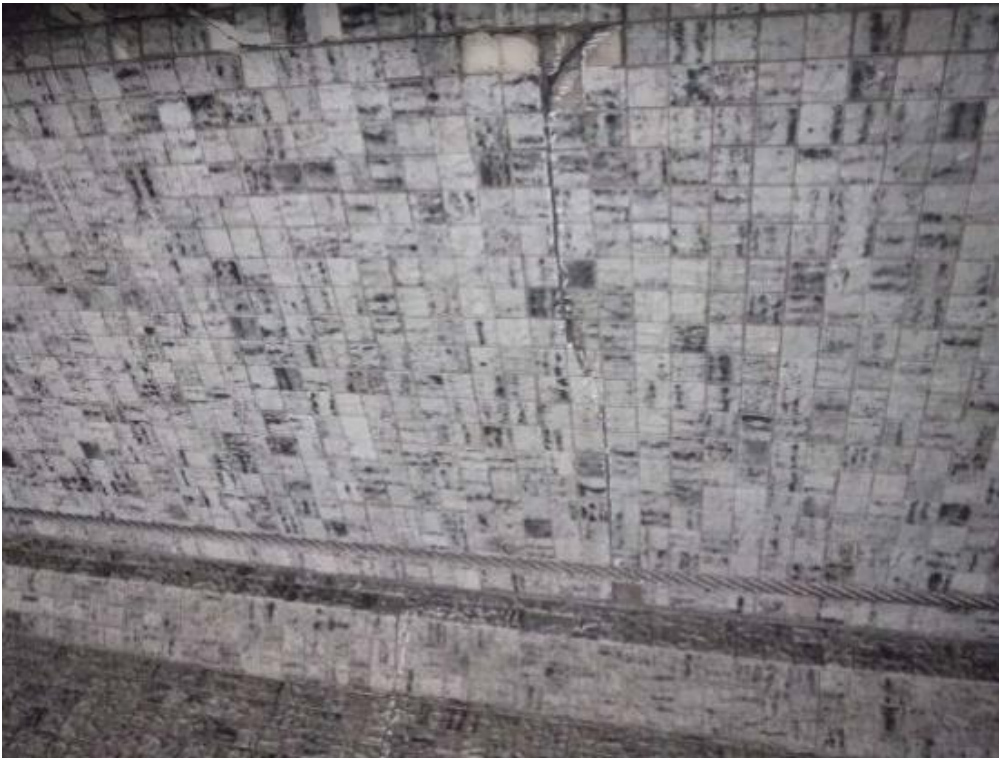
**Photo B.63: A view showing a vertical crack in the south elevation of the West machine hall**

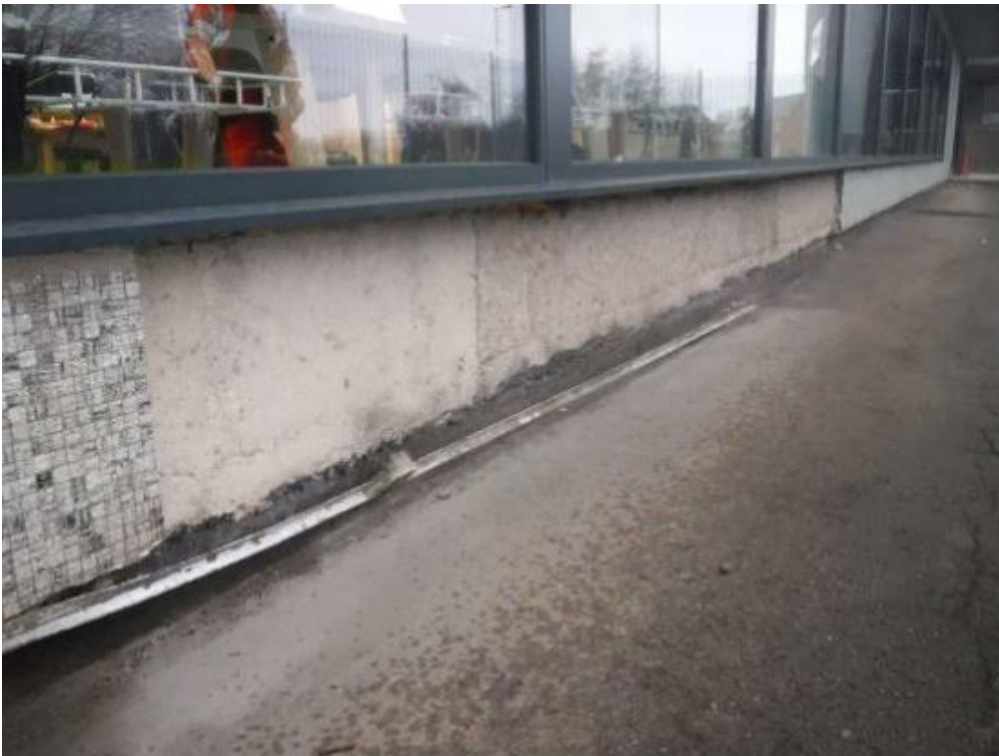
**Photo B.64: A view showing a section of missing cladding to the south elevation of the West machine hall**

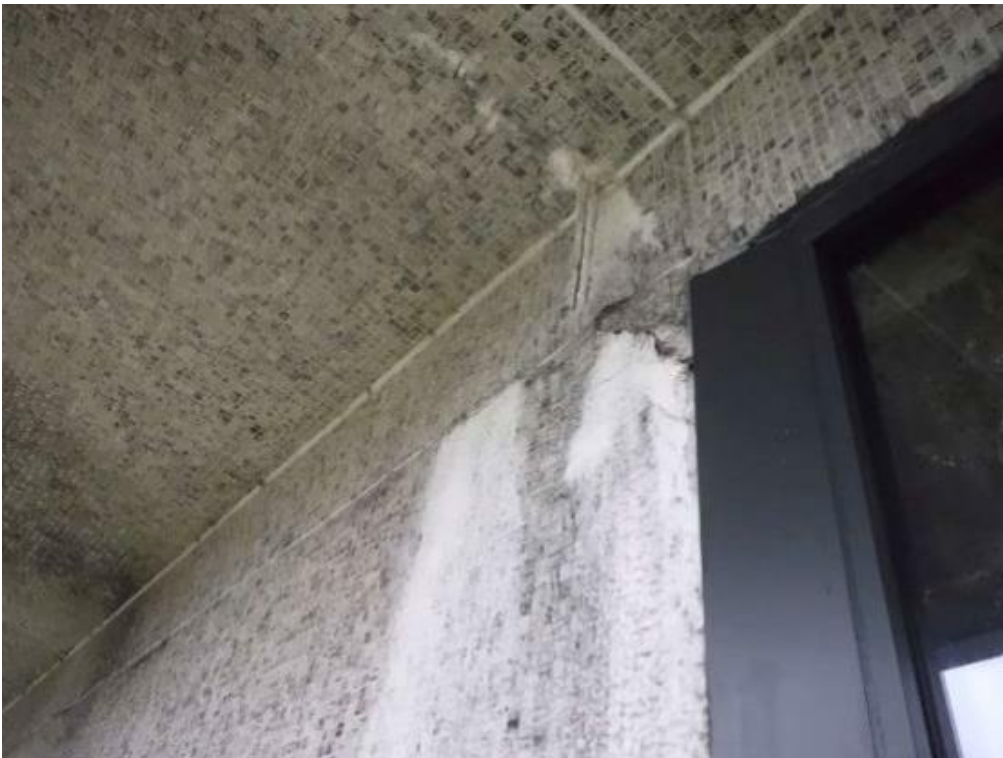
**Photo B.66: A view showing a vertical crack in the west elevation of the West Machine Hall**

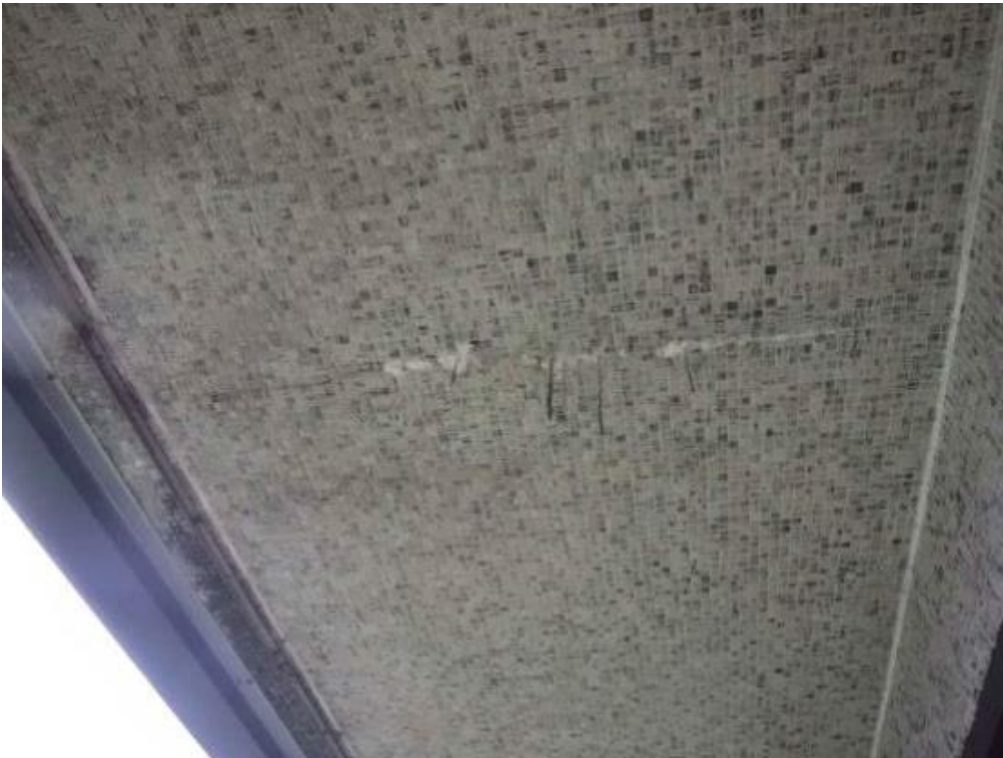
**Photo B.67: A view showing a crack in the soffit of the upper cantilever (West Machine Hall, west elevation)**

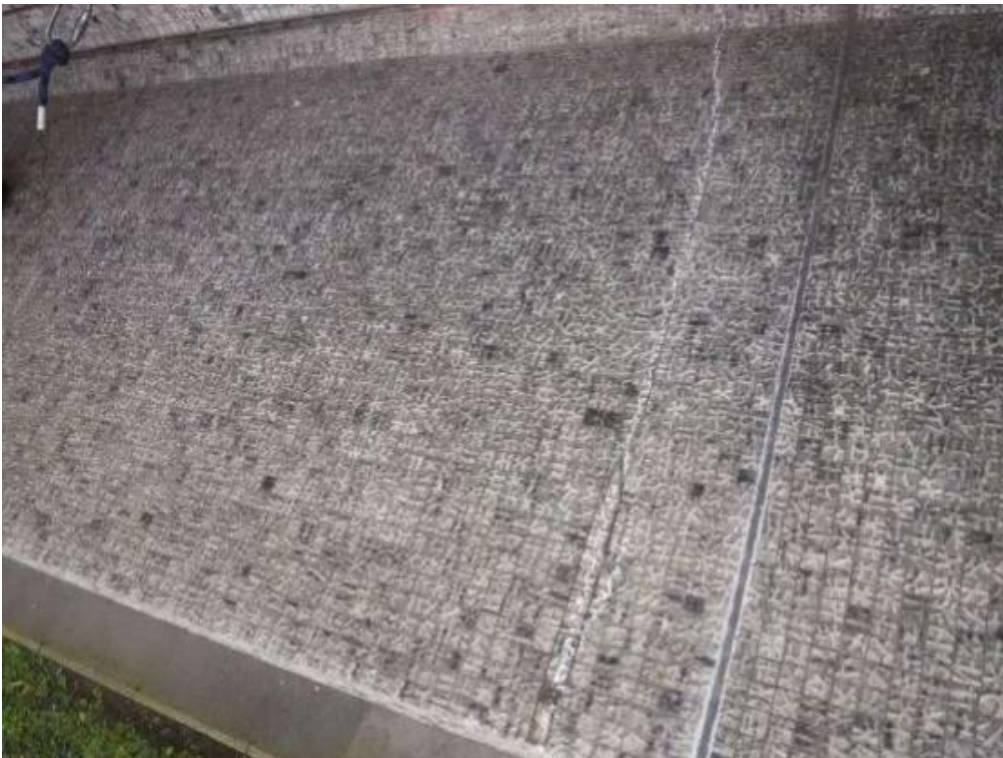
**Photo B.68: A view showing a crack in the top face of the lower cantilever (West Machine Hall)**

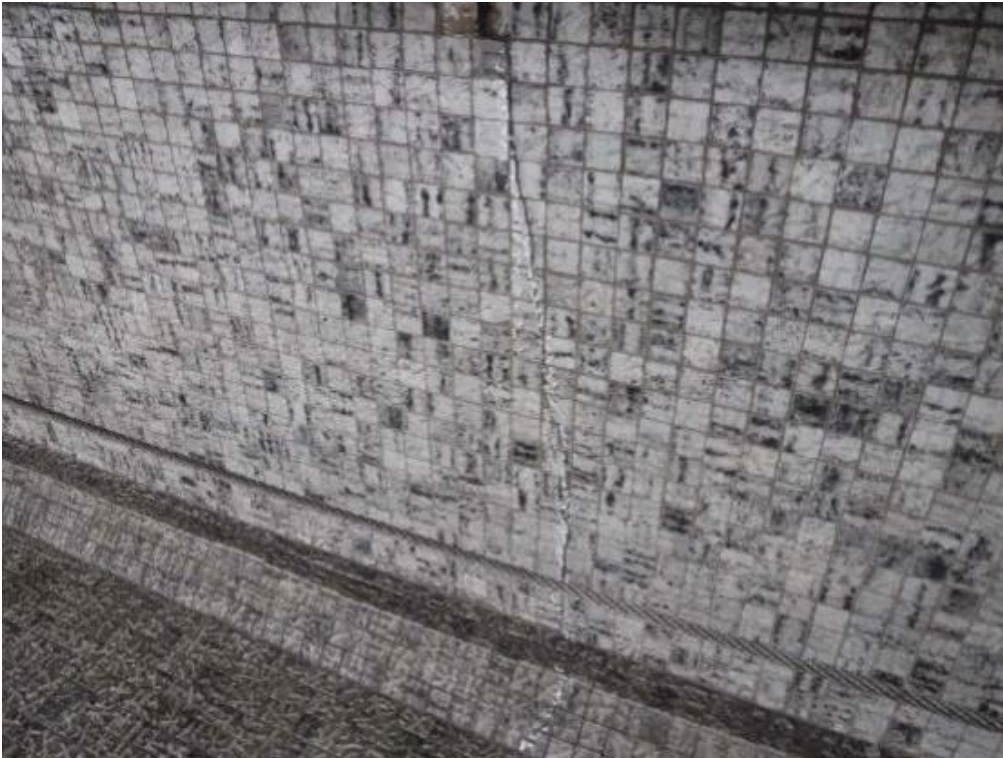
**Photo B.69: A view showing a vertical crack in the west elevation (West Machine Hall)**

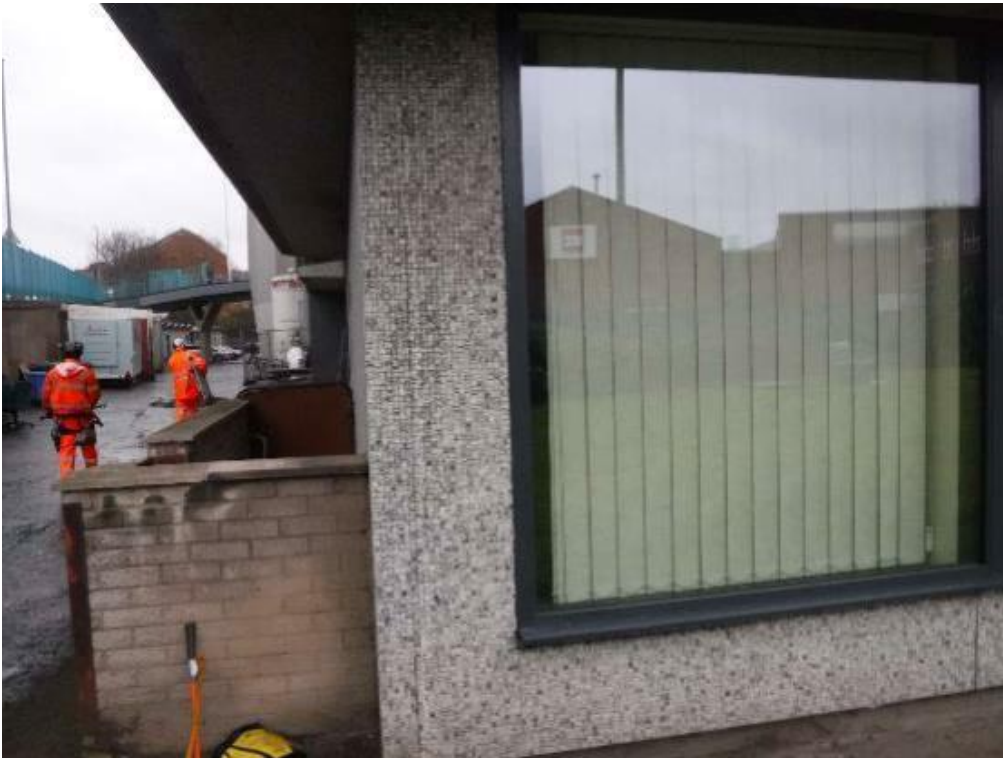
**Photo B.71: A view showing a vertical crack to the elevation (West machine hall west elevation)**

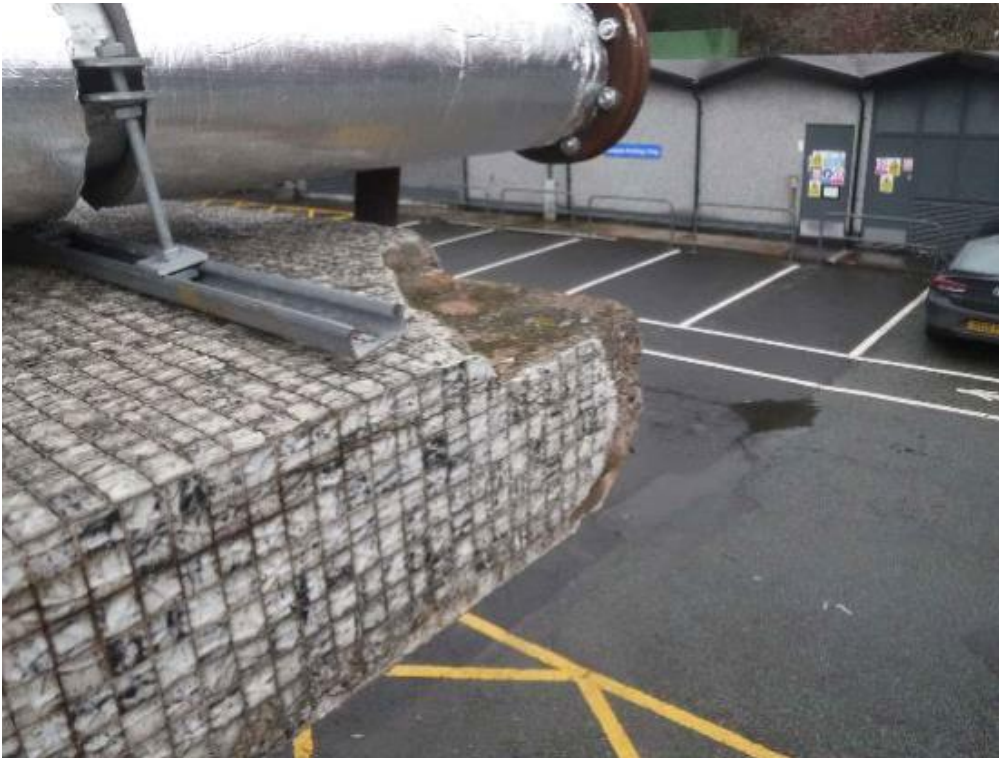
**Photo B.73: A view showing spalling to the edge of the lower cantilever (East Machine Hall, north elevation)**

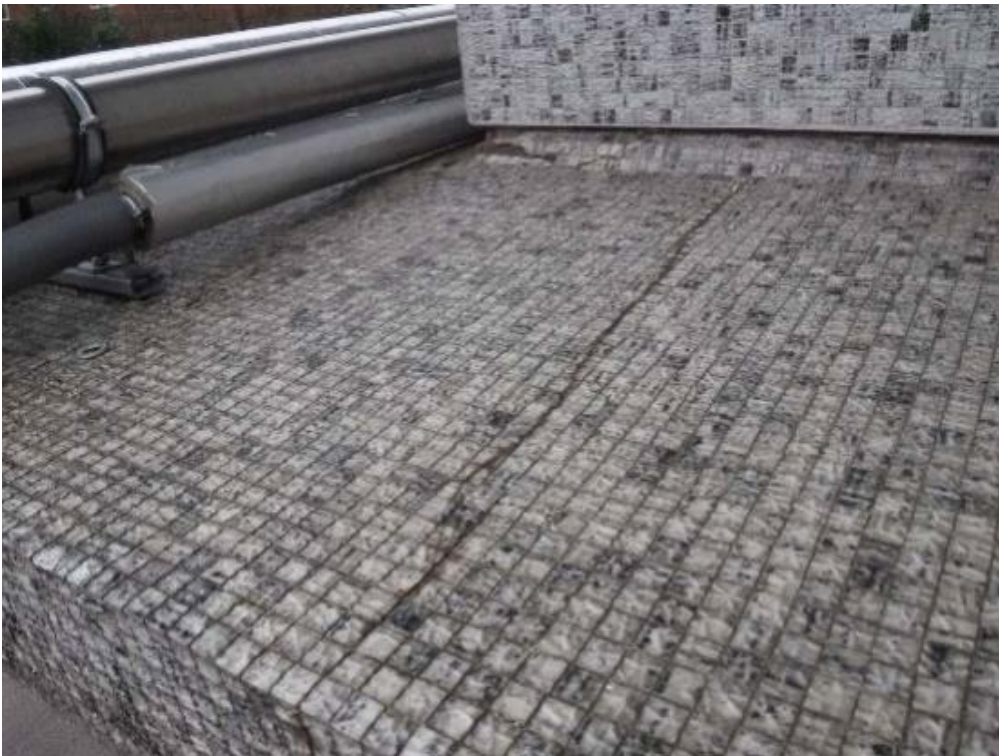
**Photo B.75: A view showing a crack in the soffit of the lower cantilever (East Machine Hall, north elevation)**
