# **Hexagon Tower**

Deterioration of Cladding  
Pre-planning Report

March 2021

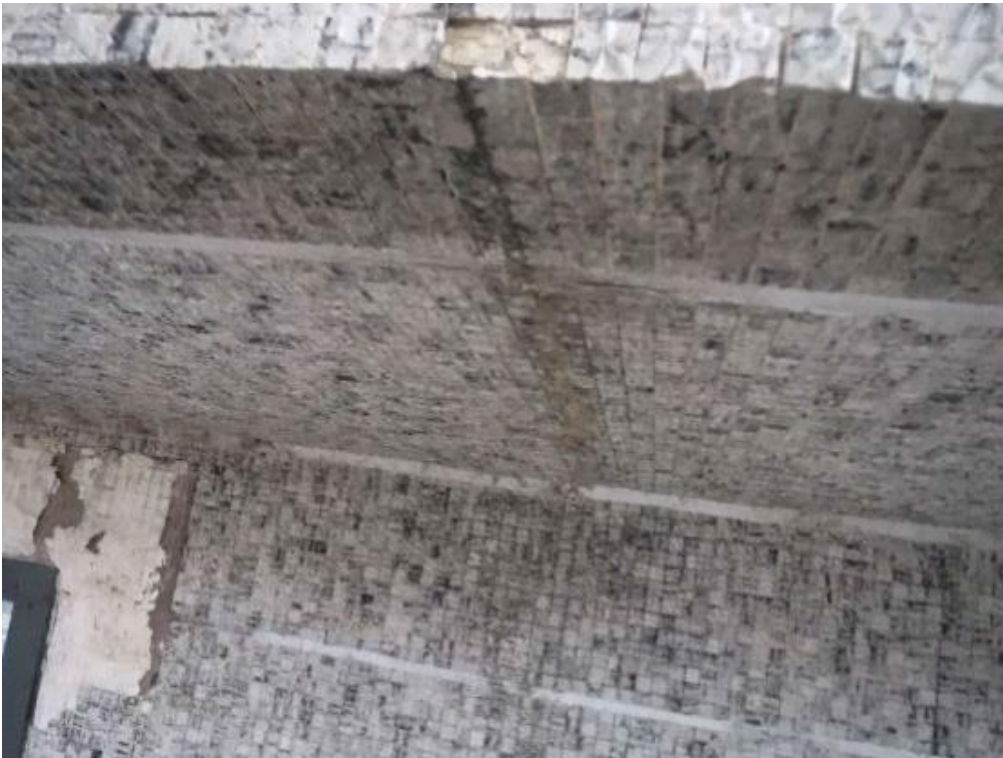
**Photo B.76: A view showing an area of spalling above a window in the north elevation of the East Machine Hall**

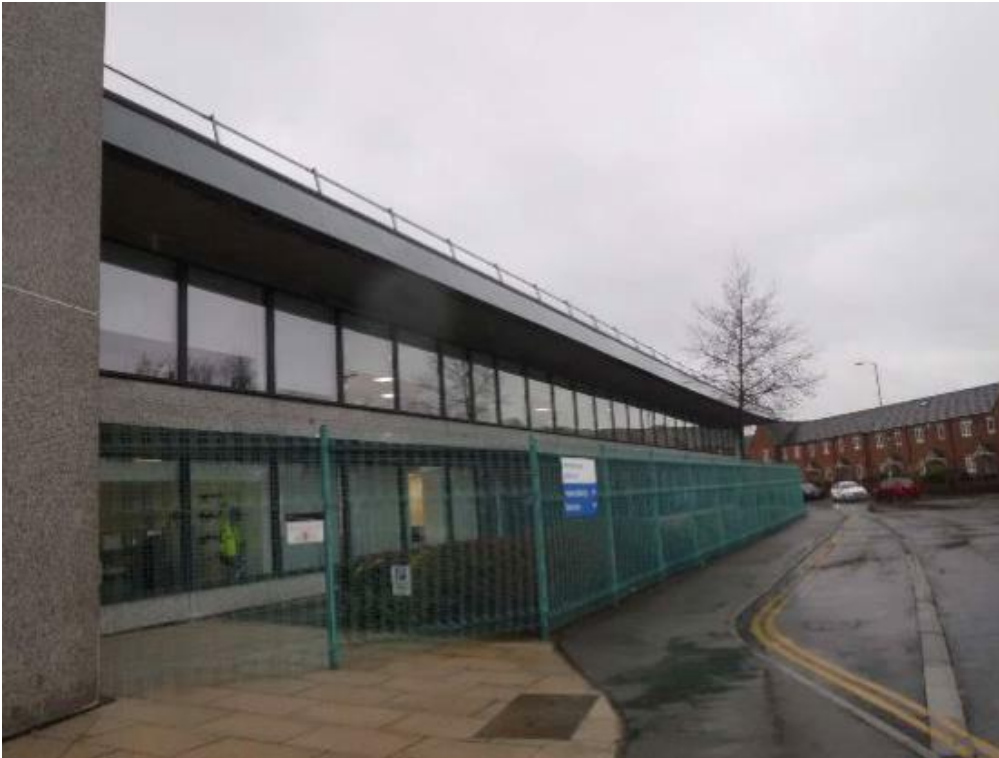
**Photo B.78: A view showing de-bonded sealant in the south elevation of the East Machine Hall**

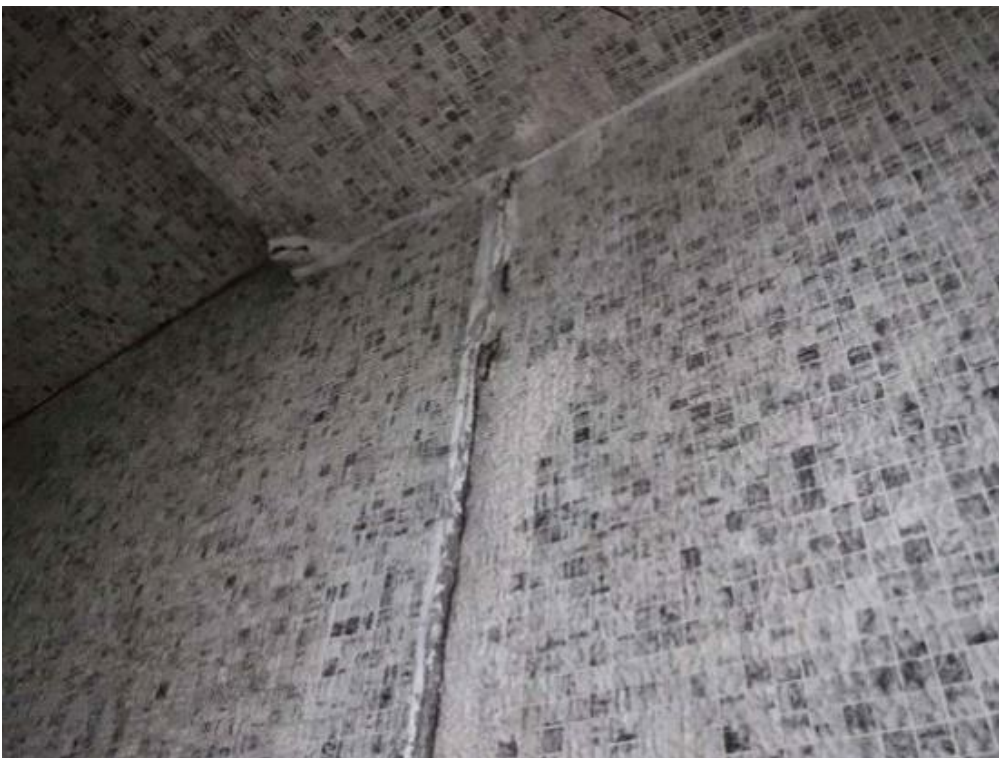
**Photo B.79: A view showing de-bonded sealant in the top of the lower cantilever (East Machine Hall, south elevation)**

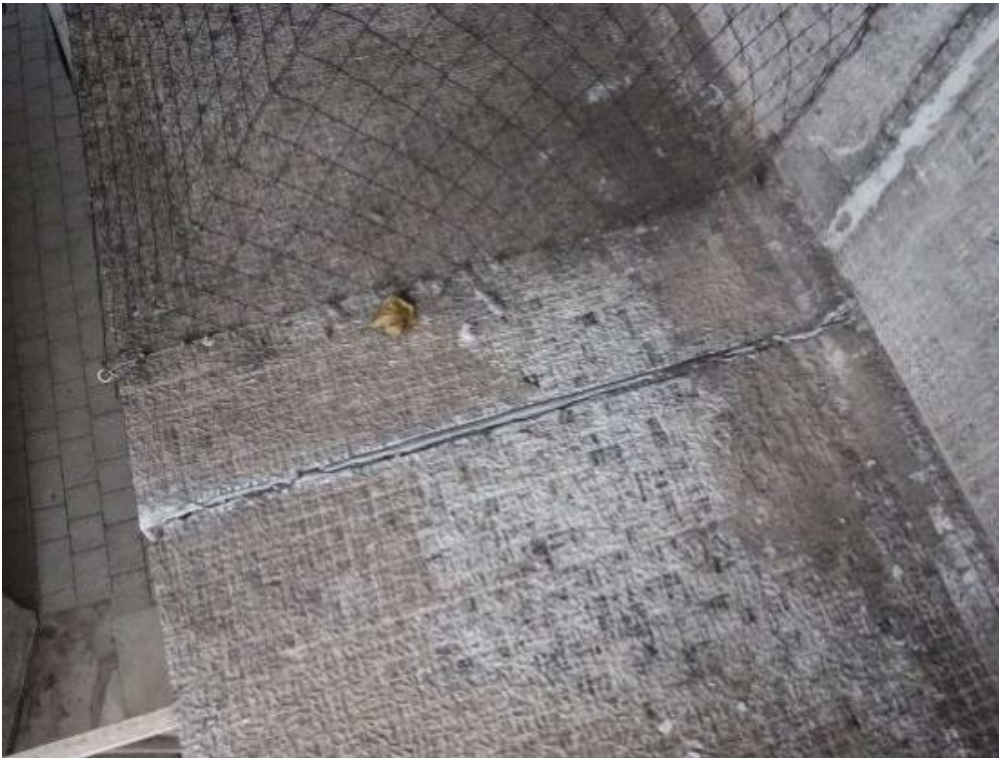
**Photo B.80: A view showing vertical and horizontal cracks in the south elevation of the East Machine Hall**

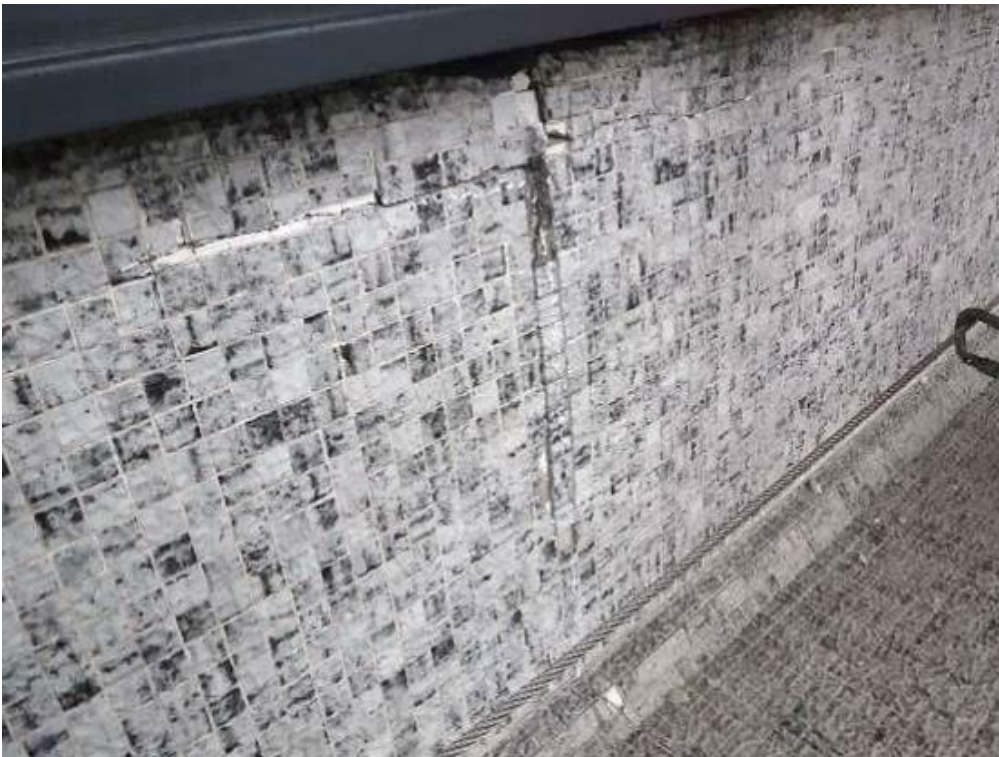
**Photo B.81: A view showing a vertical crack in the south elevation of the East Machine Hall**

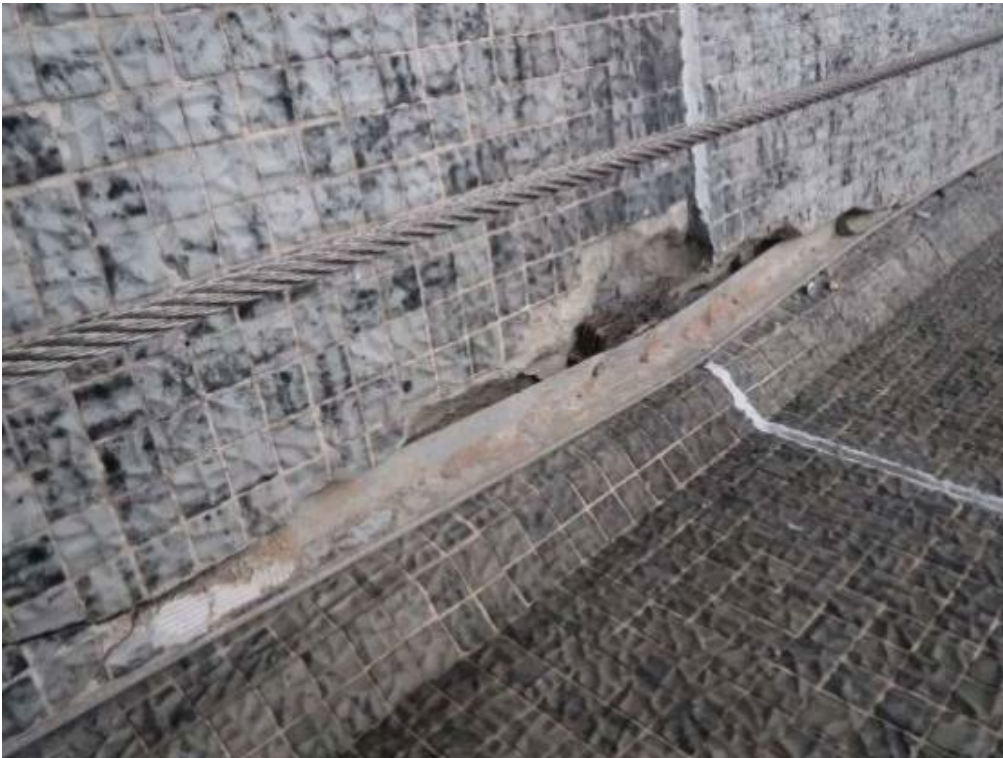
**Photo B.84: A view showing a spall to the base of the mosaic panel (East Machine Hall, south elevation)**

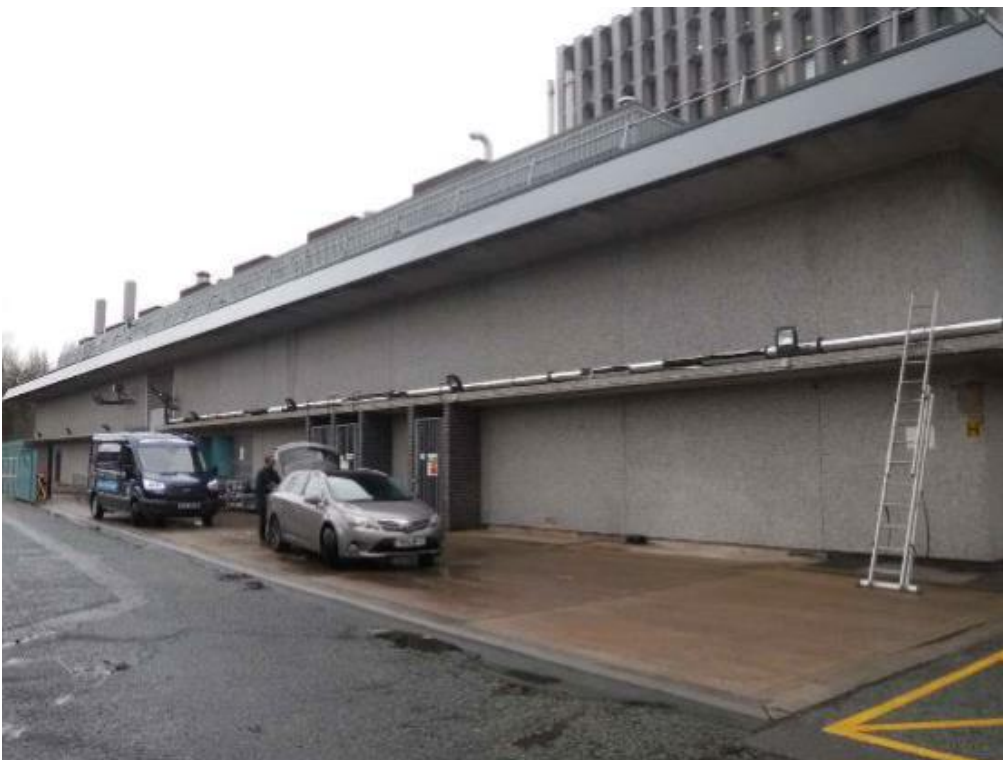
**Photo B.87: A view showing a vertical crack in the east elevation of the East Machine Hall**

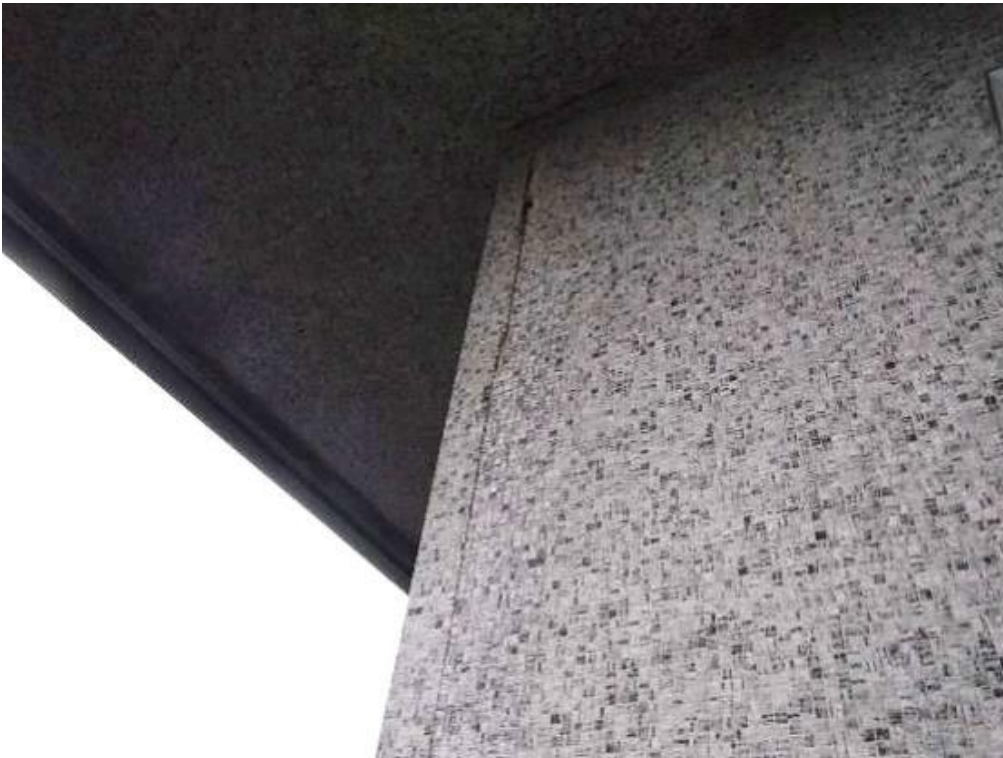
**Photo B.88: A view showing a horizontal crack in the east elevation of the lower cantilever (East Machine Hall)**

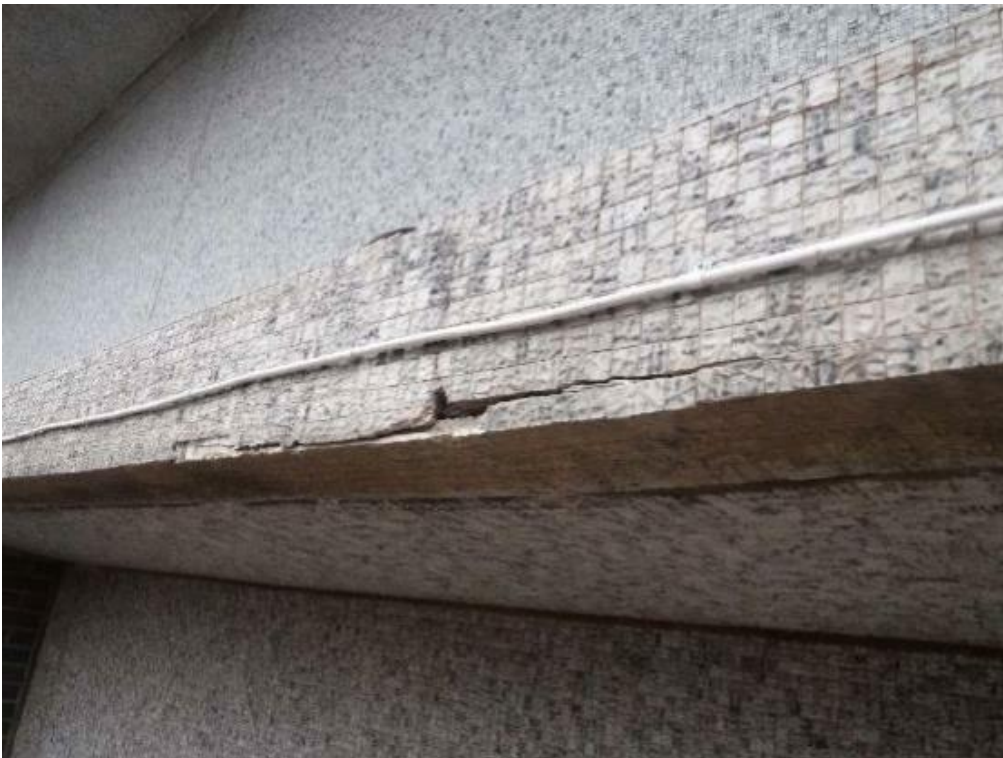
**Photo B.89: A view showing spalled cladding on the east elevation of the East Machine Hall**

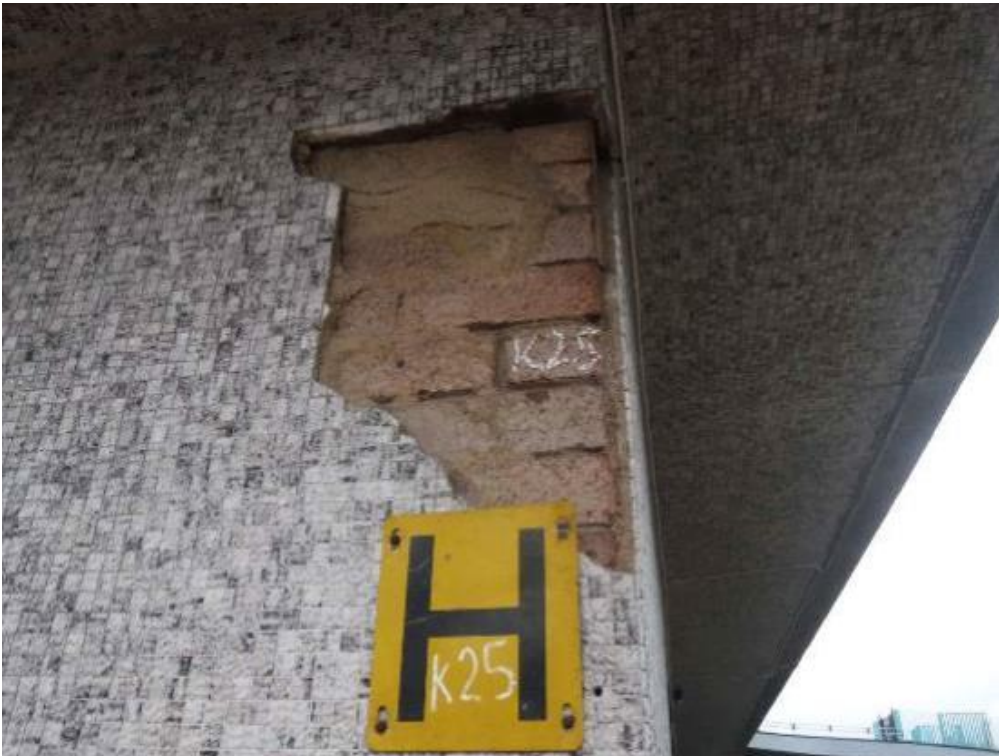
**Photo B.90: A view showing an area of spalling and a horizontal crack in the east elevation of the lower cantilever (East Machine Hall)**

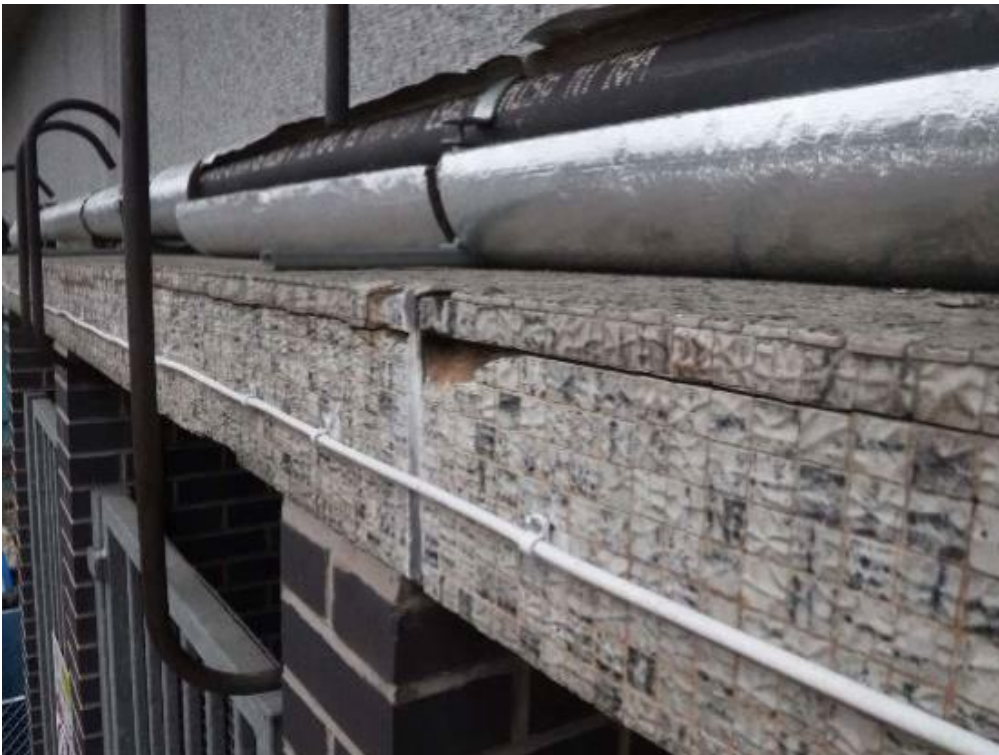
**Photo B.91: A view showing spalling to the soffit of the lower cantilever (East Machine Hall)**
