Wythenshawe Hall

PROJECT TITLE  
Wythenshawe Hall - Refurbishment Works

DRAWING TITLE  
Ground Floor - Tenant Hall / Suite Area A0/36 - Proposed Works

DRAWING NO. MCC-B01-01-DR-B-0019

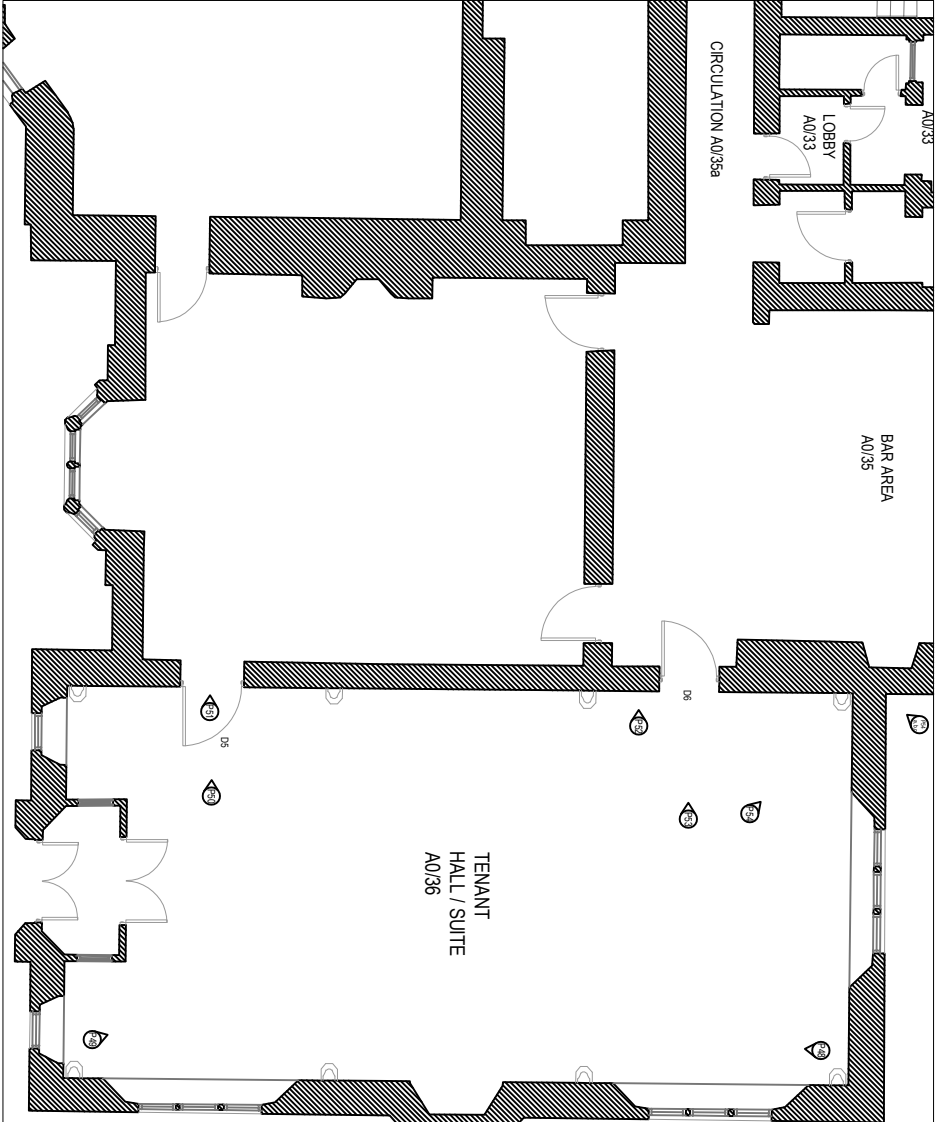
P54c - Rear Elevation gable end wall, defective brickwork joints to be repointed in a lime mortar.

Defective Mortar Joints to Exterior Wall - On the rear elevation gable end solid wall, erosion has occurred of the mortar joints due to a historic defective R.W.P. The defective rainwater goods have since been replaced but the defective mortar joints require making good. Allow for repointing 150m2 of external brickwork in lime mortar.
