## Manchester Reform Club

### External fabric project: Mortar replacement & window decoration

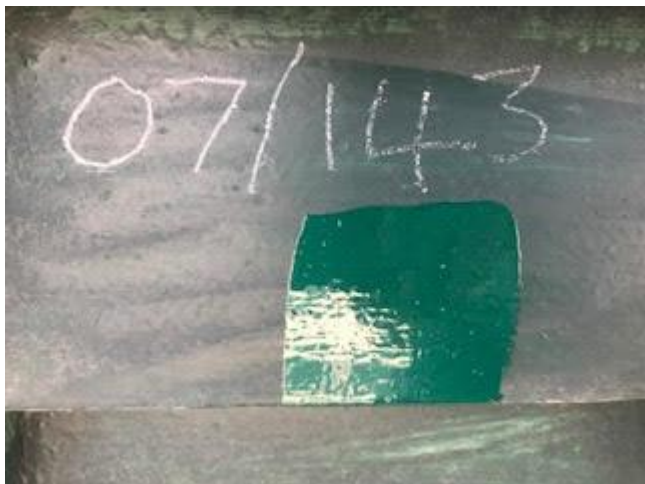
| Agreed paint sample with LPA, colour 07/143 | Finished paint to timber oriel louvers to turrets |

We are proposing to use the agreed colour scheme determined by the research provided by the report "Final APR Report Manchester Reform Club OCT19" produced by Hirst Conservation. The colour we are proposing to use is Dulux 07/143 as shown in the above sample and completed decoration to the turret louver windows. By utilizing the same colour throughout the scheme, this provides a consistent appearance to the building.

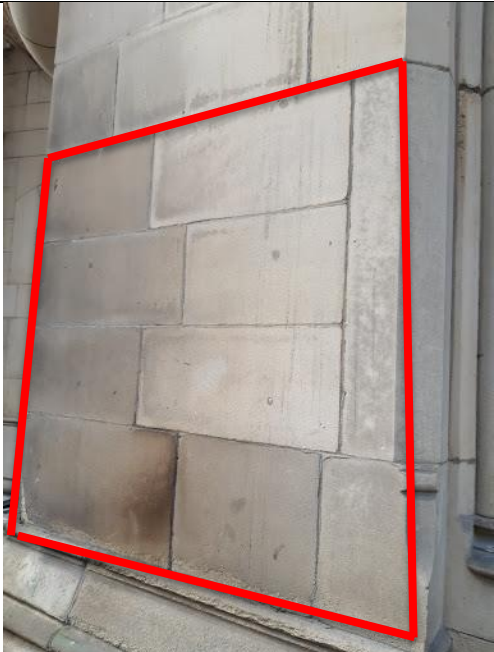
| Marked up area for mortar sample | Mortar sample location on Spring Gardens elevation (Grand Pacific level) |

We are proposing to undertake a mortar sample for Manchester City Council (MCC) to review and approve. The sample will be completed in the above area which Bruntwood will provide a full detailed photographic schedule of the stages of raking out and repointing.
