Stage 1 / 2  
Structural  
Inspection 32-34  
Laystall Street

32-34 Laystall Street,  
Manchester,

23 October 2020

1/20445/REP/001

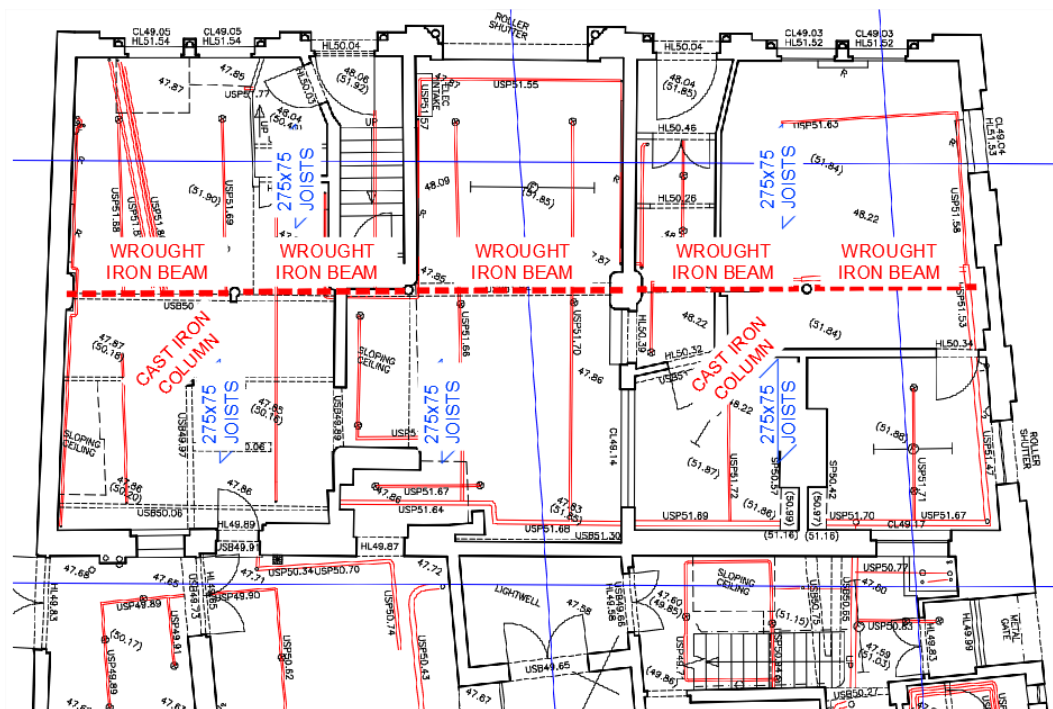
#### 4.3 FIRST FLOOR

4.3.4 Damp penetration through from the roof level is evident at the top of the mezzanine floor staircase. A large area of plaster and paintwork is damaged, and the ceiling collapsed.

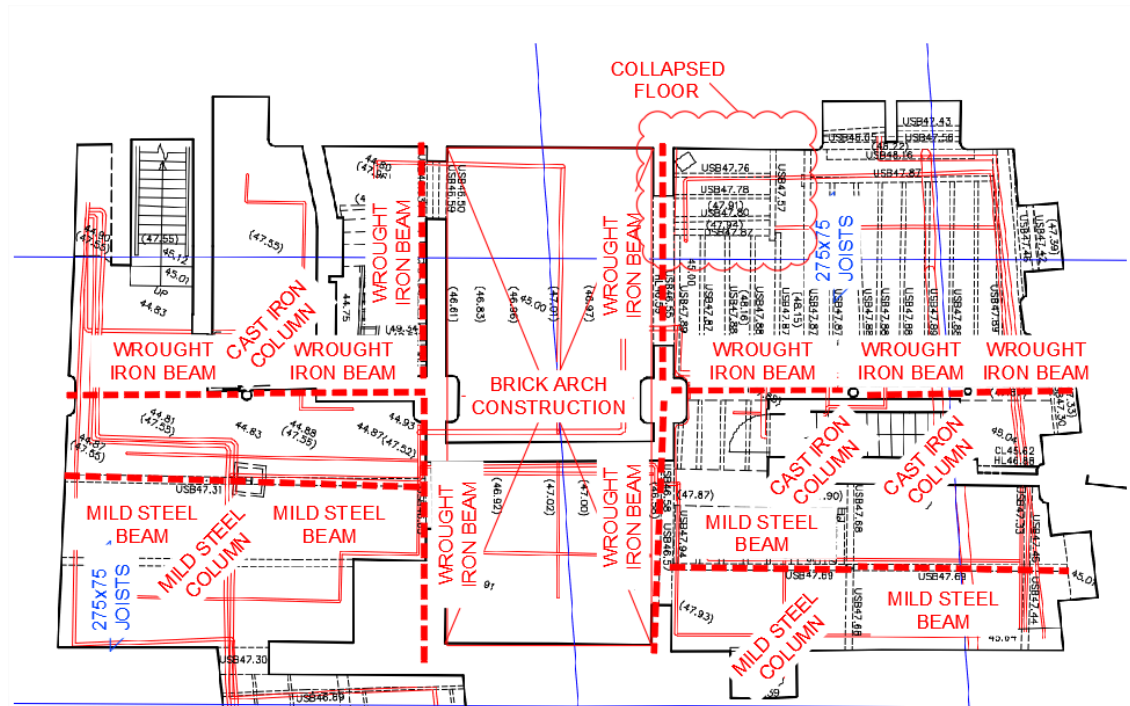
#### 4.4 GROUND

4.4.2 At ground floor the building is essentially separated down the middle by a full height loading bay, which has a floor of concrete construction over brick arches, visible in the basement. The concrete floor is set at a lower level than the general ground floor construction and nominally falls towards the rear of the building.
