## REPORT ON THE EXTERNAL WALLS

Vulcan Works  
2 Malta Street  
Manchester  
M4 7BH

Residential Management Group  
RMG House  
Essex Road  
Hoddesdon  
EN11 0DR

Contract No: SB/10349  
Dated: 16 October 2020

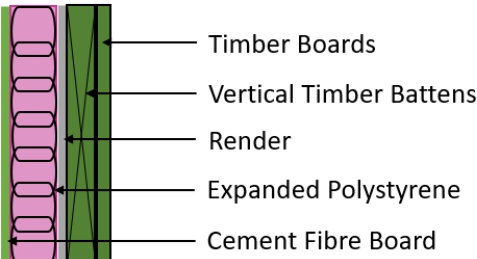
| Sample | Cavity | Horizontal Cavity Barrier | Vertical Cavity Barrier | Protection Around Openings |
|---|---|---|---|---|
| A | Yes | No | N/A at this position | No (Vent) |

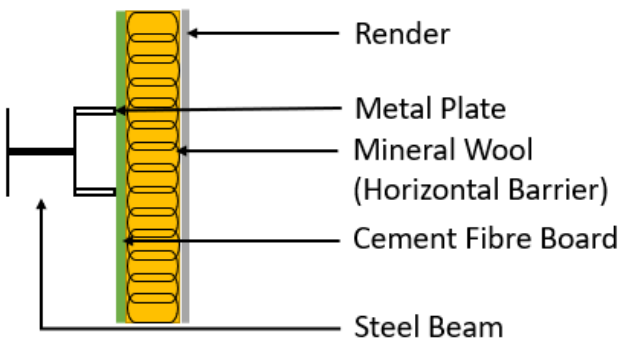
| Sample | Cavity | Horizontal Cavity Barrier | Vertical Cavity Barrier | Protection Around Openings |
|---|---|---|---|---|
| B | No | Mineral Wool | N/A at this location | N/A at this location |

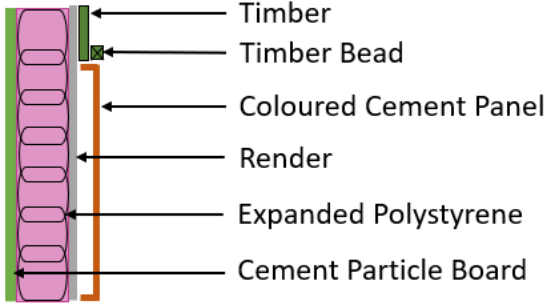
| Approx. Wall Detail | |
|---|---|
| C | C |

| Sample | Cavity | Horizontal Cavity Barrier | Vertical Cavity Barrier | Protection Around Openings |
|---|---|---|---|---|
| C | Yes | N/A at this position | N/A at this position | N/A at this position |

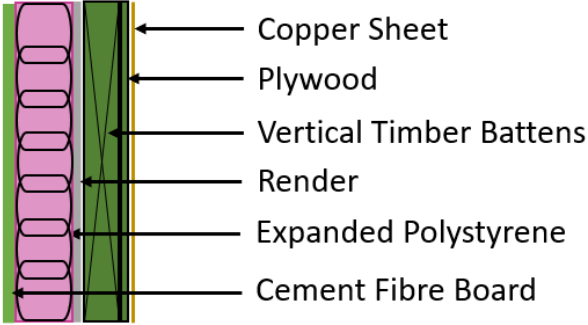
| Approx. Wall Detail | |
|---|---|
| E | E |

| Sample | Cavity | Horizontal Cavity Barrier | Vertical Cavity Barrier | Protection Around Openings |
|---|---|---|---|---|
| E | Yes | N/A at this position | N/A at this position | N/A at this position |
