CONDITION SURVEY

LECTURE THEATRES 1 + 2 -  
EDUCATION NORTH

EXISTING GF LOADED LAYOUTS

2344-ELC-ZZ-ZZ-DR-A-70001

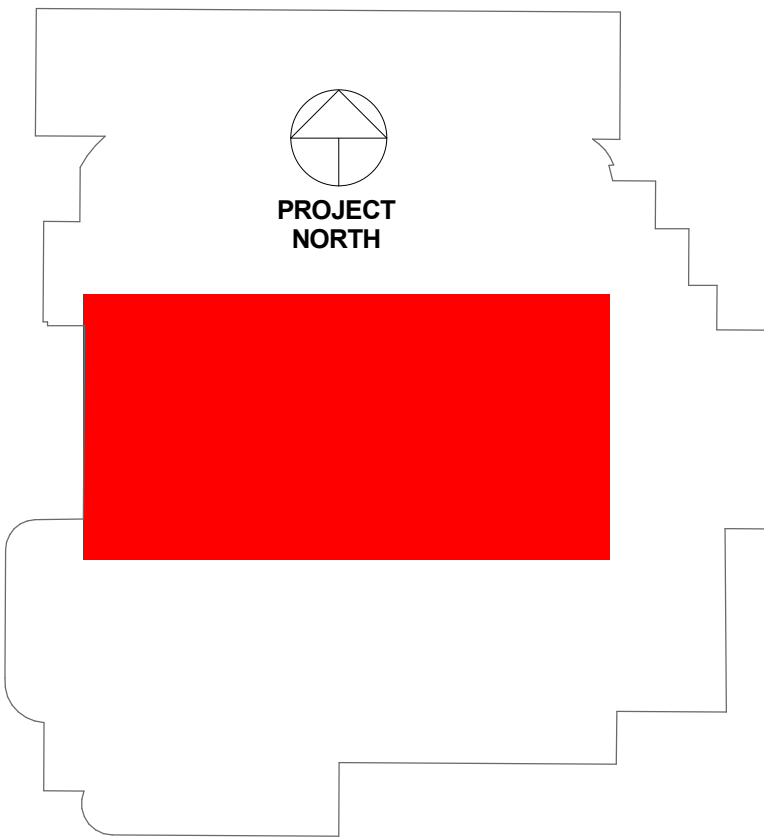
- **Walls:** Areas of patching require making good, general marks, column edges damaged, wallpaper, evidence of damp/water penetration
- **Floor:** Carpet, heavily stained

- **Skirtings:** Good condition, timber, painted/varnished
- **Seating:** Fabric stained, damaged and missing seats (retractable portion performance not checked)

- **Balustrades:** Good condition
- **Acoustic Panelling:** Poor condition, heavily stained (acoustic performance unknown)
- **Vinyl Flooring:** (Control Room), Reasonable, joints not welded

- **Worktops:** (Control Room), Poor condition, holes in laminate, chipped laminate, stained
- **Blinds:** Poor condition, broken/damaged slats
- **Projection Screens:** Good condition

- **Ceilings:** Poor condition of plasterboard ceiling in control room, other (plasterboard ceilings in good condition, raked metal plank ceiling tiles require reseating)

- **Doors:** Painted doors, generally in good condition, existing double doors not DDA compliant, smoke/intumescent seals not continuous over lock/hinges, upper level doors no smoke seals to fire doors

- **Lecturn:** Good condition

- Suspended ceiling tiles marked and stained
- Vinyl flooring stained but generally intact

- Strip out existing lecture theatre seating (retractable structure remains)
- Strip out existing FF&E
- Remove existing carpet finish to retractable structure and floors
- Remove existing acoustic boards from rear wall and separating wall to Lecture Theatre 2
- Remove existing lecturn and AV equipment
- Remove existing data point and telephone from mess room and store telephoe for re-fixing

Remove existing data/telephone outlet.  
Remove wall mounted telephone and  
store for relocating onto new partition
