| Project: | LONDON ROAD FIRE STATION |

| Drg Title: | SECOND FLOOR OBSERVATIONS<br>SHEET 2 OF 3 |

| 060270 / 10-02-02 | V01 |

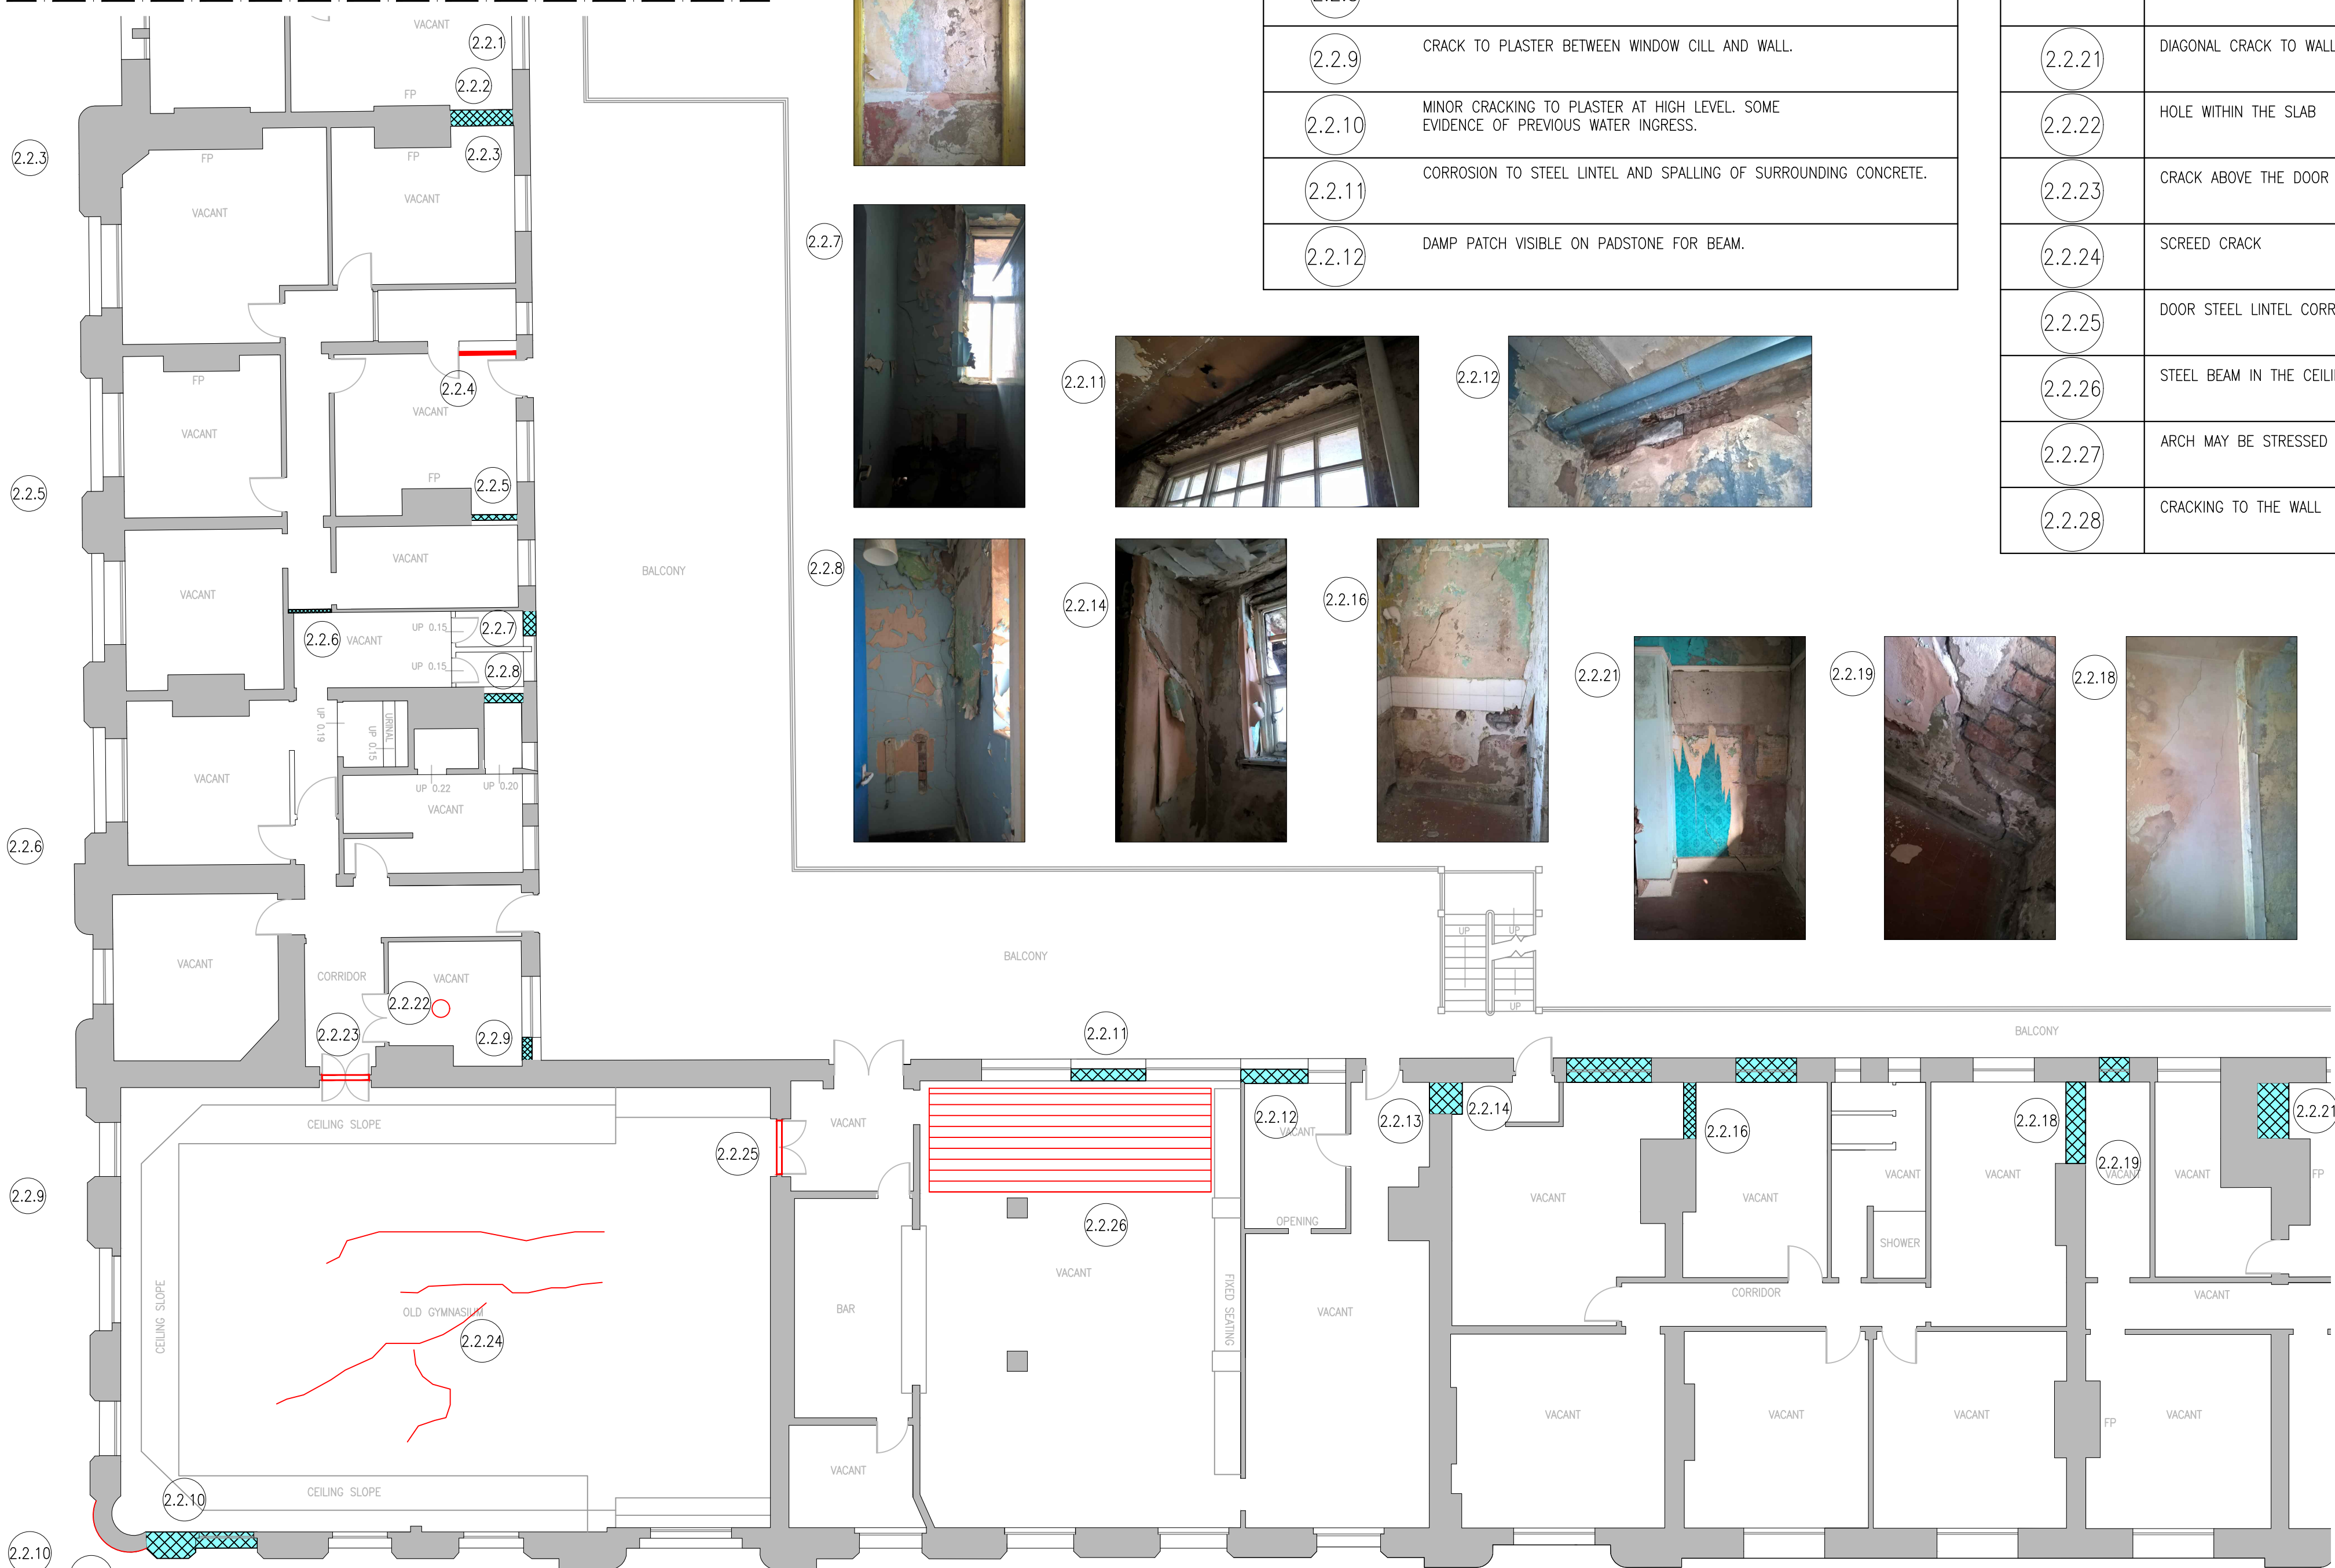
PLAN ON EXISTING SECOND FLOOR  
SCALE 1:100

| REF | OBSERVATION |
| 2.2.1 | CRACK TO PLASTER BETWEEN WINDOW CILL AND WALL. |
| 2.2.2 | DIAGONAL CRACK TO WALL EVIDENT TO BOTH SIDES. |
| 2.2.3 | DIAGONAL CRACK TO WALL EVIDENT TO BOTH SIDES. |
| 2.2.4 | DIAGONAL CRACK TO WALL EVIDENT TO BOTH SIDES. |
| 2.2.5 | DIAGONAL CRACK TO WALL EVIDENT TO BOTH SIDES. |
| 2.2.6 | STRAIGHT LINE CRACK TO PARTITION WALL |
| 2.2.7 | BRICKWORK HAS BEEN BROKEN OUT TO INSTALL TOILETS |
| 2.2.8 | DIAGONAL CRACK TO WALL EVIDENT TO BOTH SIDES. |
| 2.2.9 | CRACK TO PLASTER BETWEEN WINDOW CILL AND WALL. |
| 2.2.10 | MINOR CRACKING TO PLASTER AT HIGH LEVEL. SOME EVIDENCE OF PREVIOUS WATER INGRESS. |
| 2.2.11 | CORROSION TO STEEL LINTEL AND SPALLING OF SURROUNDING CONCRETE. |
| 2.2.12 | DAMP PATCH VISIBLE ON PADSTONE FOR BEAM. |

| REF | OBSERVATION |
|---|---|
| 2.2.13 | DIAGONAL CRACK TO WALL EVIDENT TO BOTH SIDES |
| 2.2.14 | DIAGONAL CRACK TO WALL EVIDENT TO BOTH SIDES. |
| 2.2.16 | DIAGONAL CRACK TO WALL EVIDENT TO BOTH SIDES. |
| 2.2.18 | DIAGONAL CRACK TO WALL EVIDENT TO BOTH SIDES. |
| 2.2.19 | DIAGONAL CRACK TO WALL EVIDENT TO BOTH SIDES. |
| 2.2.21 | DIAGONAL CRACK TO WALL EVIDENT TO ONE SIDE ONLY. |
| 2.2.22 | HOLE WITHIN THE SLAB |
| 2.2.23 | CRACK ABOVE THE DOOR LINTEL |
| 2.2.24 | SCREED CRACK |
| 2.2.25 | DOOR STEEL LINTEL CORRODED |
| 2.2.26 | STEEL BEAM IN THE CEILING NEEDS PAINTING |
| 2.2.27 | ARCH MAY BE STRESSED |
| 2.2.28 | CRACKING TO THE WALL |
