| Project: | LONDON ROAD FIRE STATION | | | |
| Drg Title: | THIRD FLOOR OBSERVATIONS<br>SHEET 1 OF 3 | | | |
| Drg No: | 060270 / 10-03-01 | | | Rev:<br><br>V02 |

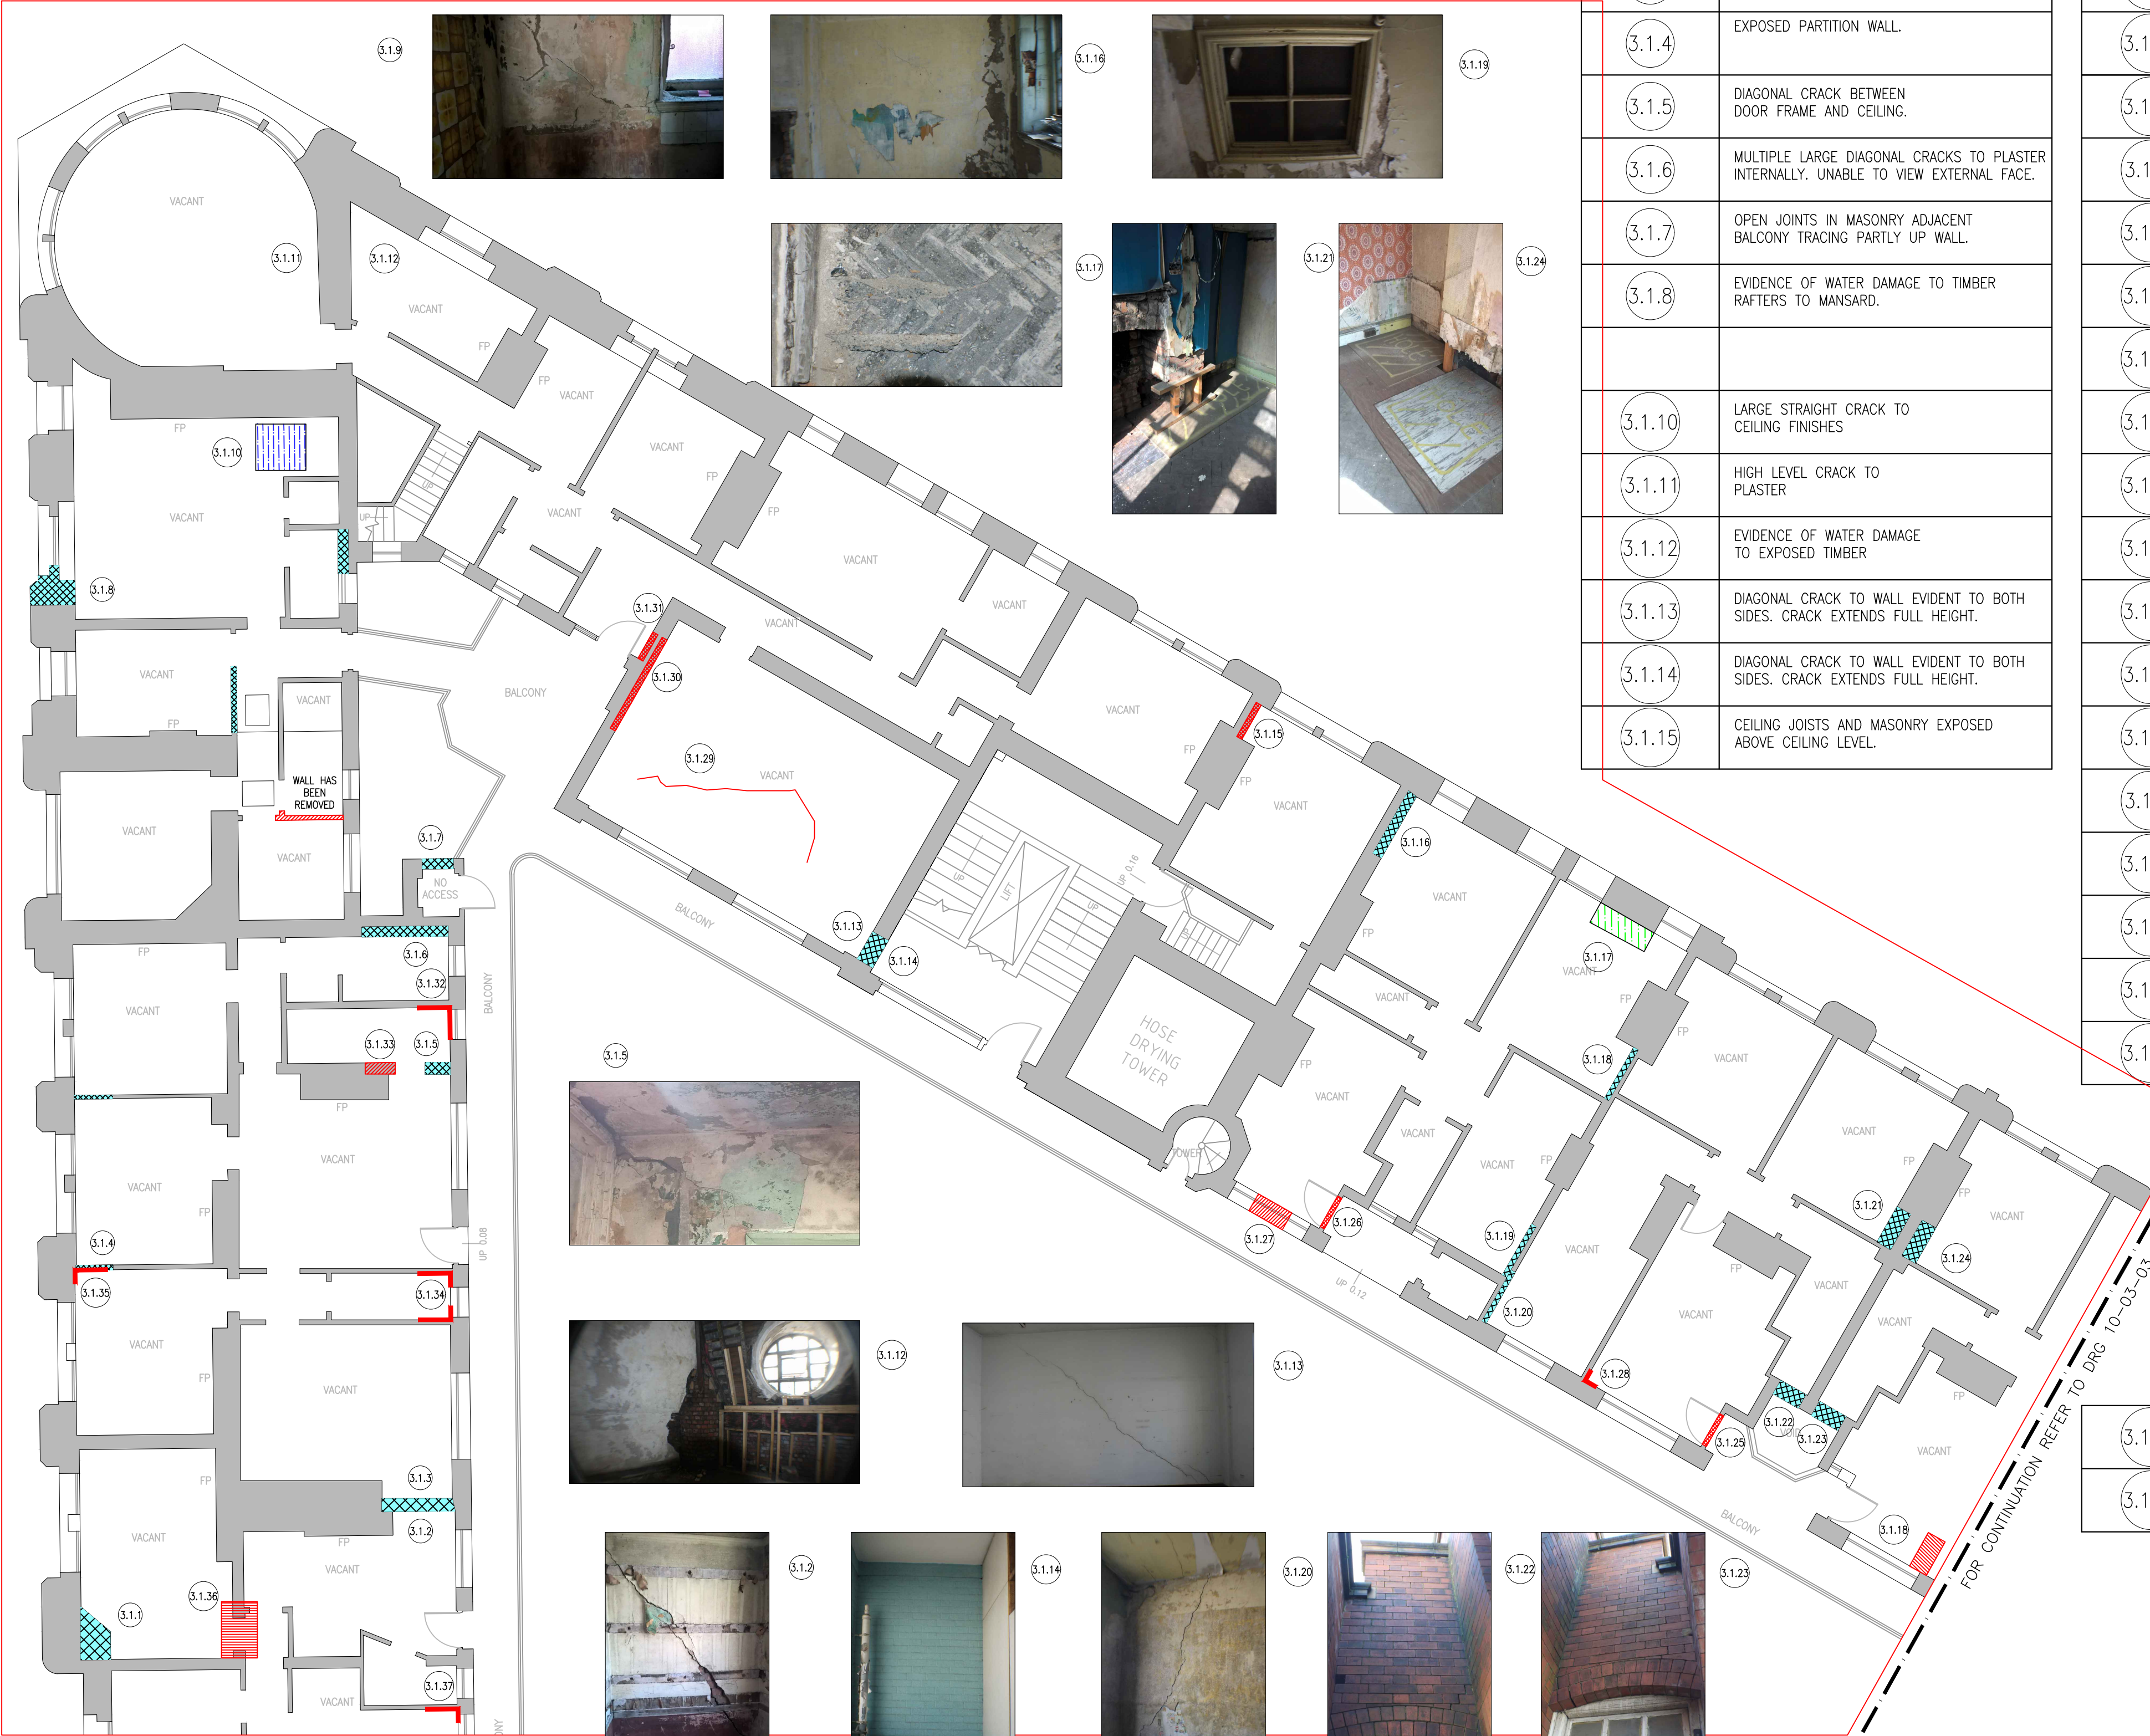
| REF | OBSERVATION |
|---|---|
| 3.1.1 | RAINWATER PIPE CUT INTO WALL. |
| 3.1.2 | DIAGONAL CRACK TO WALL EVIDENT TO BOTH SIDES. CRACK EXTENDS FULL HEIGHT. |
| 3.1.3 | DIAGONAL CRACK TO WALL EVIDENT TO BOTH SIDES. CRACK EXTENDS FULL HEIGHT. |
| 3.1.4 | EXPOSED PARTITION WALL. |
| 3.1.5 | DIAGONAL CRACK BETWEEN DOOR FRAME AND CEILING. |
| 3.1.6 | MULTIPLE LARGE DIAGONAL CRACKS TO PLASTER INTERNALLY. UNABLE TO VIEW EXTERNAL FACE. |
| 3.1.7 | OPEN JOINTS IN MASONRY ADJACENT BALCONY TRACING PARTLY UP WALL. |
| 3.1.8 | EVIDENCE OF WATER DAMAGE TO TIMBER RAFTERS TO MANSARD. |
| 3.1.10 | LARGE STRAIGHT CRACK TO CEILING FINISHES |
| 3.1.11 | HIGH LEVEL CRACK TO PLASTER |
| 3.1.12 | EVIDENCE OF WATER DAMAGE TO EXPOSED TIMBER |
| 3.1.13 | DIAGONAL CRACK TO WALL EVIDENT TO BOTH SIDES. CRACK EXTENDS FULL HEIGHT. |
| 3.1.14 | DIAGONAL CRACK TO WALL EVIDENT TO BOTH SIDES. CRACK EXTENDS FULL HEIGHT. |
| 3.1.15 | CEILING JOISTS AND MASONRY EXPOSED ABOVE CEILING LEVEL. |

| REF | OBSERVATION |
|---|---|
| 3.1.16 | MINOR DIAGONAL CRACKING TO PLASTER TO ONE SIDE ONLY. |
| 3.1.17 | CRACKING TO FLOOR SCREED. |
| 3.1.18 | EXPOSED LINTEL AND MASONRY IN GOOD CONDITION. |
| 3.1.19 | HATCH INTO ROOF SPACE. UNABLE TO ACCESS (ASBESTOS). |
| 3.1.20 | CRACK TO WALL (ONLY ONE SIDE ACCESSIBLE, ASSUME EVIDENT ON BOTH SIDES) EXISTING MONITORING POINTS 36-37. |
| 3.1.21 | EXISTING HOLES IN FLOOR. BOARDED OVER. |
| 3.1.22 | OPEN JOINTS TO MASONRY AND DROPPING TO ARCH BRICKWORK. |
| 3.1.23 | OPEN JOINTS TO MASONRY AND DROPPING TO ARCH BRICKWORK. |
| 3.1.24 | EXISTING HOLES IN FLOOR. BOARDED OVER. |
| 3.1.25 | CORROSION TO STEEL AND SPALLING OF CONCRETE LINTEL |
| 3.1.26 | CORROSION TO STEEL AND SPALLING OF CONCRETE LINTEL |
| 3.1.27 | CRACK TO PLASTER BETWEEN FLOOR AND WINDOW CILL. |
| 3.1.28 | FULL HEIGHT CRACKING AT WALL INTERSECTION |
| 3.1.29 | CRACKING TO FLOOR SCREED |
| 3.1.30 | DIAGONAL CRACKING TO THE WALL |
| 3.1.31 | CRACKING AT THE TOP OF THE WALL |
| 3.1.32 | FULL HEIGHT CRACKING AT WALL INTERSECTION |
| 3.1.33 | CRACKING AT THE TOP OF THE WALL |
| 3.1.34 | FULL HEIGHT CRACKING AT WALL INTERSECTION |
| 3.1.35 | FULL HEIGHT CRACKING AT WALL INTERSECTION |

| 3.1.36 | CRACKING TO THE WALL ABOVE THE DOOR LINTEL |
| 3.1.37 | FULL HEIGHT CRACKING AT WALL INTERSECTION |
