## Design and Access Statement

Manchester Central – Painting of gable steelwork

Prepared by Taylor Design Architects Ltd  
February 2020

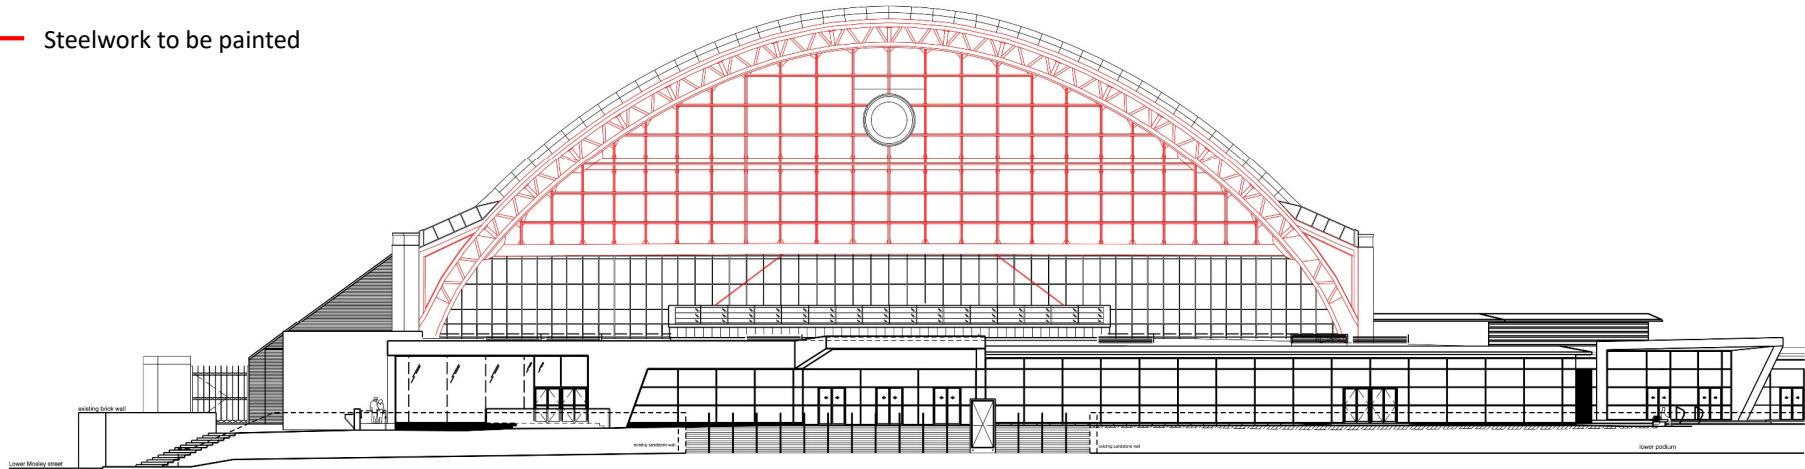
North-East Elevation

On the newer sections the condition of the existing coatings appears generally sound with only minor areas of corrosion and coating breakdown noted. The area of corrosion are isolated and mainly found along the horizontal angle sections and where coatings had been removed by mechanical damage exposing the substrate beneath.

Thanks to micro-destructive testing it has been possible to identify in the original sections a total number of 24 coats of paint, varying in thickness and generic type. The failing topcoat was found to be an alkyd type material applied over an epoxy type coating not adequately prepared and which consequently contributed to the delamination witnessed. The survey also highlighted top coat adhesion weaknesses.

The coating system on the newer sections was found to be an epoxy system, with the exception of the alkyd type top coat which, again was poorly adhered to the underlying paint layer, however the overall adhesion of the remaining epoxy system had fair to good adhesion. Were identified six layer on paint in total.

According with the report outcome, MCCC proposes to intervene by fully removing the poorly adherent top coats, power tool prepare areas of exposed substrate to an St3 standard and patch prime, followed by a full over coat.

The intent is to remove and replace the existing finish over all the surfaces, to repair, or reinstate, intermediate coats and to renew all paint in locations where corrosion of the substrate is present.

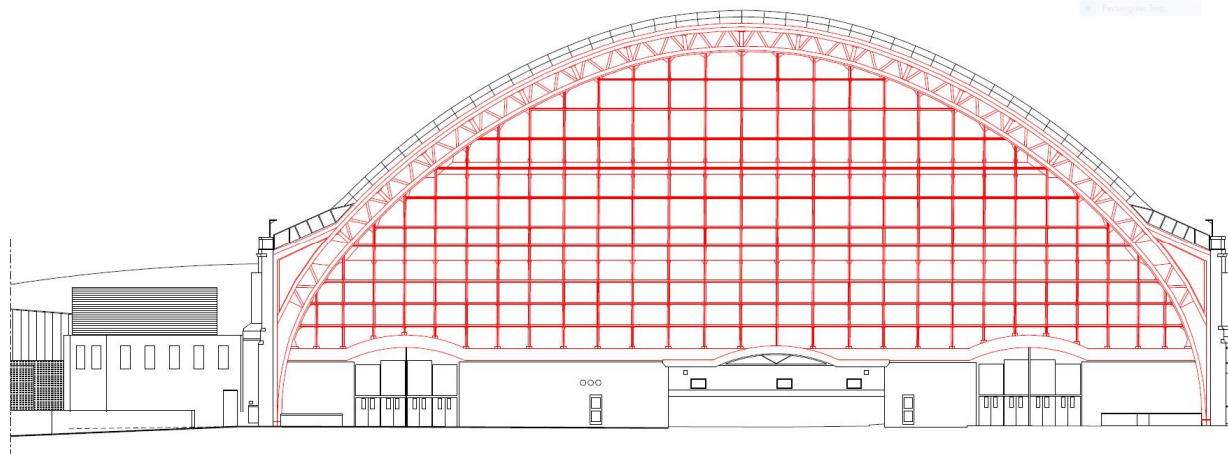
South-West Elevation

The rear gable has a similar design of the previous section with the addition of a lower level framework and ornate detail at either side of the main arch. The condition of the existing coating was found to be fair with minor areas of corrosion and coating breakdown present. There is however noticeable flaking and delamination of the grey top coat, which had also discoloured in a number of areas. Corrosion is more widespread compared with the Front Gable end.

Micro destructive testing have identified two coating system present, the first is on the newer angled bracing and it comprises seven layers of paint similar to those found on the front Gable newer sections. The system appears to be an epoxy type material with the exception of the delaminating top alkyd type coating. The adhesion of the coating system on these newer sections ranged from fair to good.

The survey also highlights that a number of the 'back to back' gaps had been filled with and this had created a moisture trap and rust staining are visible. The only real area of concern has been identified in some isolated patches where the original coating system had not been fully removed and it is possible that lead based coating may still be present. The ornate configuration also appeared to be in good condition with very little breakdown, but where there are plies between the main arch and ornate structure there is clear rust staining present.
