# Method Statement for Soft Strip Works

**79 Mosley Street  
St Peters Square  
Manchester**

Method statement for Investigative Works and Soft Strip works at No. 79 Mosley Street.

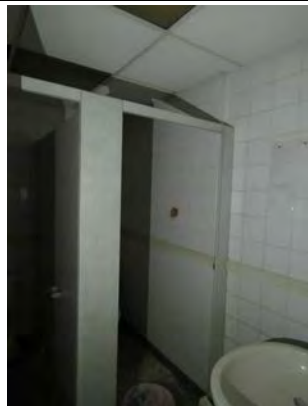
| Room number / area | Element to be removed / significance | Description | Photo |
|---|---|---|---|
| All floors | All WC fittings, of no historic significance | WC fittings including WCs, urinals, cubicles, mirrors, tiling, fixtures and fittings | |

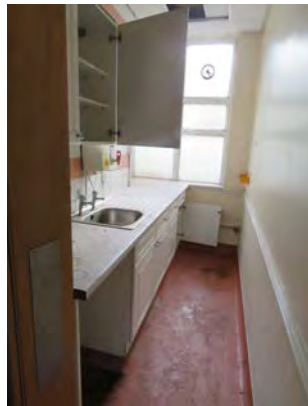
| Room number / area | Element to be removed / significance | Description | Photo |
|---|---|---|---|
| All floors | All kitchenette fittings, of no historic significance | Kitchenette fittings including worktops, taps, basins, plumbing, tiling, appliances, fixtures and fittings | |

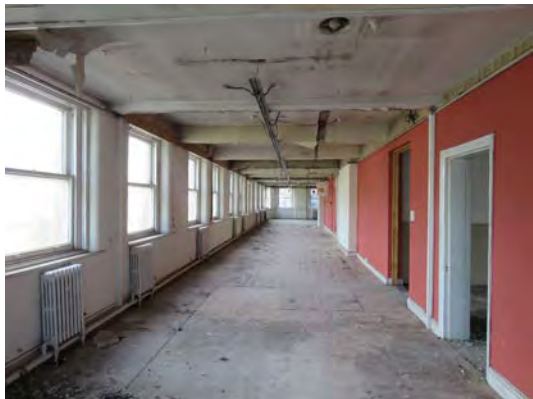
| Room number / area | Element to be removed / significance | Description | Photo |
|---|---|---|---|
| All floors | Perimeter radiators and pipework, of no historic significance | Perimeter radiators, pipework, boilers, associated fixtures and fittings | |

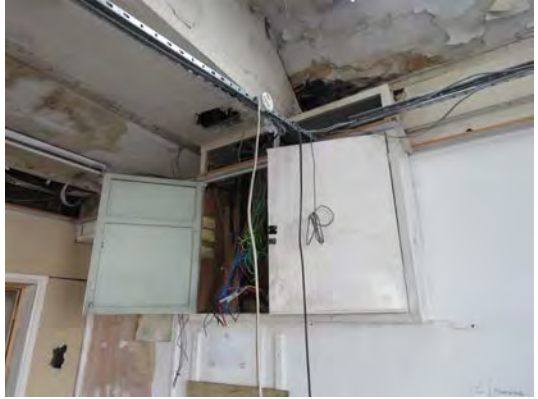
| Room number / area | Element to be removed / significance | Description | Photo |
|---|---|---|---|
| All floors | M&E installations, all of no historic significance | M&E installations generally, comprising electrical installations and wiring, telecoms, service trays and ducting. | |

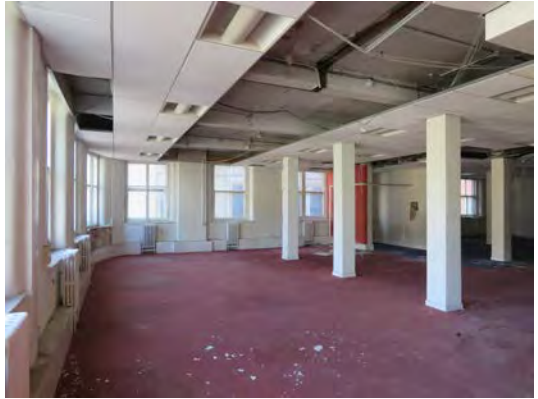
| Room number / area | Element to be removed / significance | Description | Photo |
|---|---|---|---|
| All floors | Floor coverings, of no historic significance | Floor coverings generally comprising carpets, tiles, hardboard, lino stair treads, and similar materials. | |

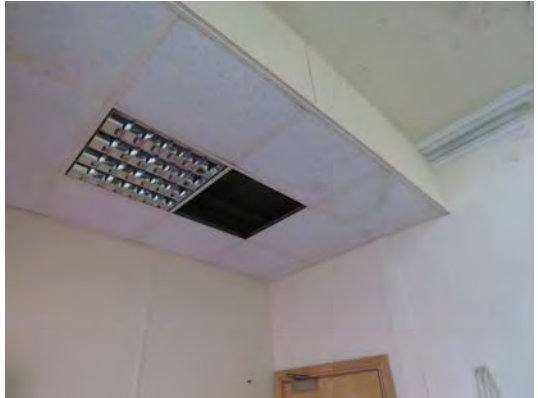
| Room number / area | Element to be removed / significance | Description | Photo |
|---|---|---|---|
| All floors | Modern suspended ceilings, of no historic significance | Modern suspended ceilings comprising aluminium channel supports, tiled insert sections, lighting, perimeter fixings and all other related fixtures. | |

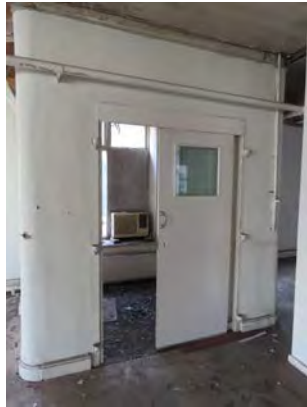
| Room number / area | Element to be removed / significance | Description | Photo |
|---|---|---|---|
| 3 <sup>rd</sup> Floor | Modern entrance door to hoist shaft, of no historic significance | Modern sliding timber door with glazed panel | |

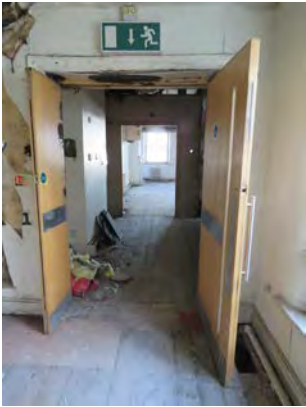
| Room number / area | Element to be removed / significance | Description | Photo |
|---|---|---|---|
| 3 <sup>rd</sup> floor | Double doors of no historic significance | Set of modern double doors at entrance to principal staircase | |

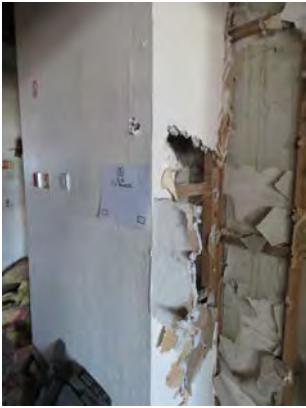
| Room number / area | Element to be removed / significance | Description | Photo |
|---|---|---|---|
| 3 <sup>rd</sup> floor | Plasterboard boxing in of no historic significance | Plasterboard boxing in to principal staircase | |

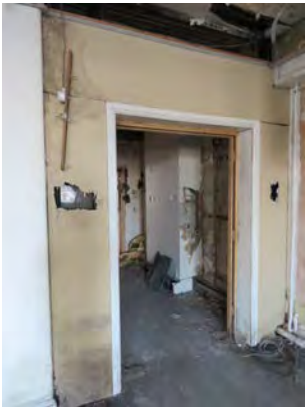
| Room number / area | Element to be removed / significance | Description | Photo |
|---|---|---|---|
| 3 <sup>rd</sup> floor | Door frame and panelling surround of no historic significance | Timber door frame and panelling surround | |

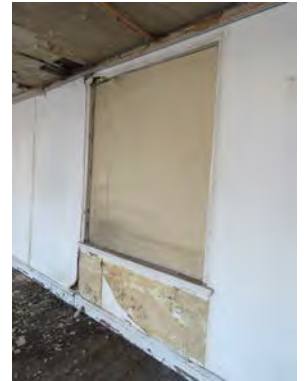
| Room number / area | Element to be removed / significance | Description | Photo |
|---|---|---|---|
| 3 <sup>rd</sup> floor | Panelling enclosure of no historic significance | Boarding / panelling to staircase enclosure.<br><b>Special note: Care required as the panel may conceal historic glass which should be protected and left in situ</b> | |

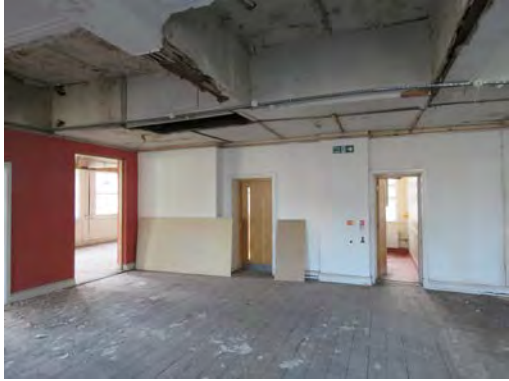
| Room number / area | Element to be removed / significance | Description | Photo |
|---|---|---|---|
| 3 <sup>rd</sup> floor | Single entrance doors of no historic significance | Two modern single entrance doors and frames to former side office and kitchenette from office floor plate | |

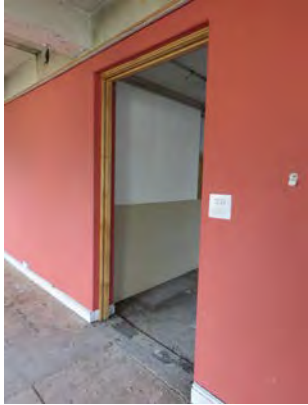
| Room number / area | Element to be removed / significance | Description | Photo |
|---|---|---|---|
| 3 <sup>rd</sup> floor | Door frame of no historic significance | Timber door frame to former set of double doors | |

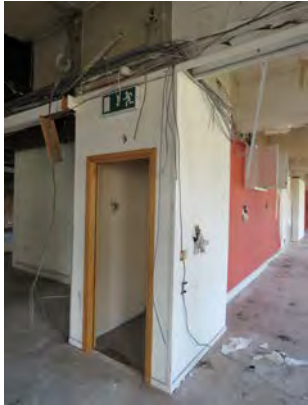
| Room number / area | Element to be removed / significance | Description | Photo |
|---|---|---|---|
| 3 <sup>rd</sup> floor | Entrance vestibule, doors and associated areas around secondary staircase of no historic significance | Entrance vestibule structure, doors to WC and shower room, WC and shower room contents and fit out including tiling, cubicles, plumbing and related items. | |

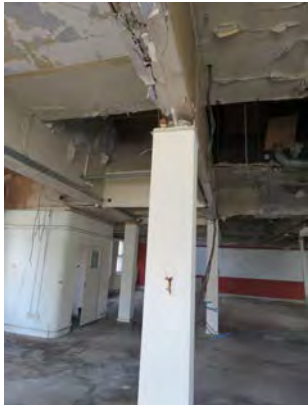
| Room number / area | Element to be removed / significance | Description | Photo |
|---|---|---|---|
| 3 <sup>rd</sup> floor | Column encasements of no historic significance | Plasterboard column encasements to rear (former warehouse) section of building. | |

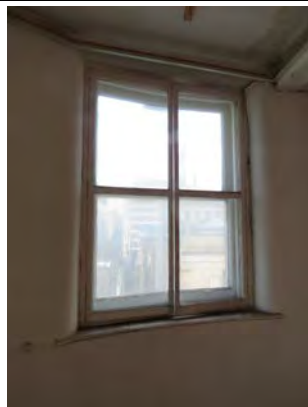
| Room number / area | Element to be removed / significance | Description | Photo |
|---|---|---|---|
| 3 <sup>rd</sup> floor | Secondary glazing, of no historic significance | Modern secondary glazing inward opening timber framed casement units to third floor | |

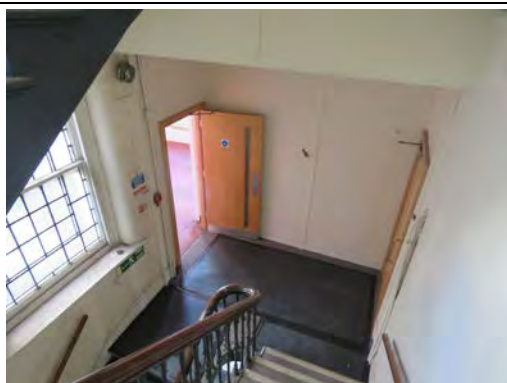
| Room number / area | Element to be removed / significance | Description | Photo |
|---|---|---|---|
| 2 <sup>nd</sup> floor | Single entrance doors, of no historic significance | Two modern single entrance doors and frames to secondary staircase from office floorplate. | |

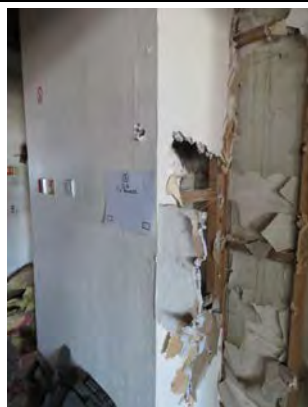
| Room number / area | Element to be removed / significance | Description | Photo |
|---|---|---|---|
| 2 <sup>nd</sup> floor | Plasterboard boxing in of no historic significance | Plasterboard boxing in to principal staircase | |

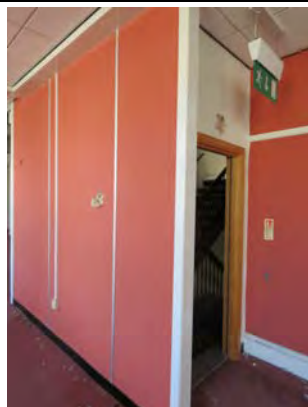
| Room number / area | Element to be removed / significance | Description | Photo |
|---|---|---|---|
| 2 <sup>nd</sup> floor | Single entrance door of no historic significance | Modern single entrance doors and frame to former side office from office floor plate | |

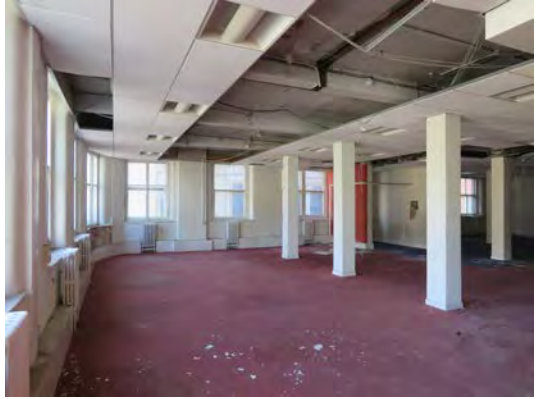
| Room number / area | Element to be removed / significance | Description | Photo |
|---|---|---|---|
| 2 <sup>nd</sup> floor | Column encasements of no historic significance | Plasterboard column encasements to front and rear (former office and former warehouse) sections of building. | |

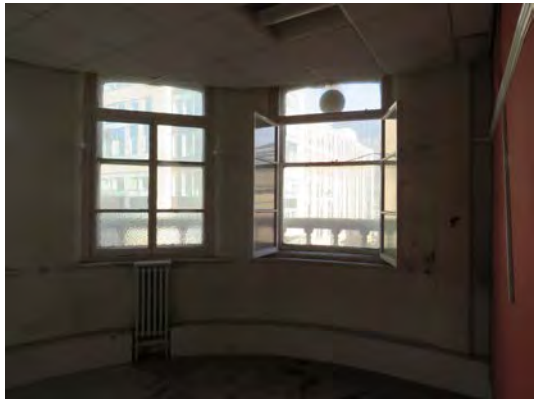
| Room number / area | Element to be removed / significance | Description | Photo |
|---|---|---|---|
| 2 <sup>nd</sup> floor | Secondary glazing, of no historic significance | Modern secondary glazing inward opening timber framed casement units to second floor | |

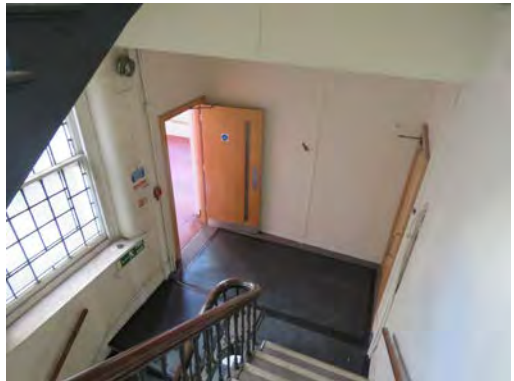
| Room number / area | Element to be removed / significance | Description | Photo |
|---|---|---|---|
| 1 <sup>st</sup> floor | Single entrance doors, of no historic significance | Two modern single entrance doors and frames to secondary staircase from office floorplate. | |

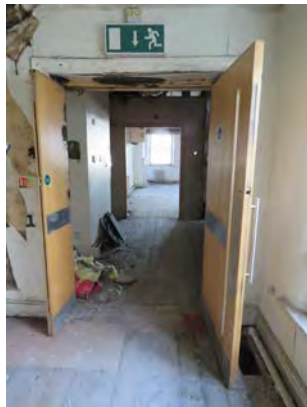
| Room number / area | Element to be removed / significance | Description | Photo |
|---|---|---|---|
| 1 <sup>st</sup> floor | Double doors of no historic significance | Set of modern double doors at entrance to principal staircase | |

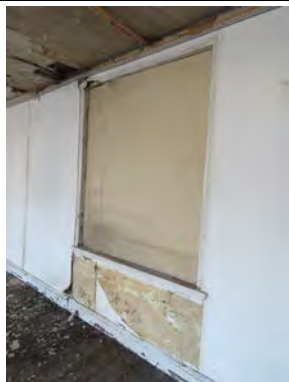
| Room number / area | Element to be removed / significance | Description | Photo |
|---|---|---|---|
| 1 <sup>st</sup> floor | Panelling enclosure of no historic significance | Boarding / panelling to staircase enclosure.<br><b>Special note: Care required as the panel may conceal historic glass which should be protected and left in situ</b> | |

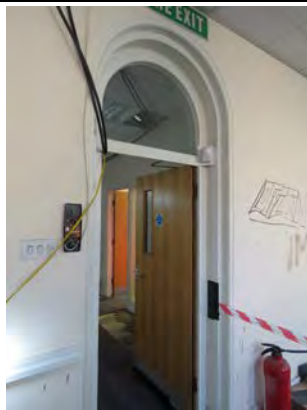
| Room number / area | Element to be removed / significance | Description | Photo |
|---|---|---|---|
| 1 <sup>st</sup> floor | Single entrance doors, of no historic significance | Modern single entrance doors and frames to first floor generally. | |

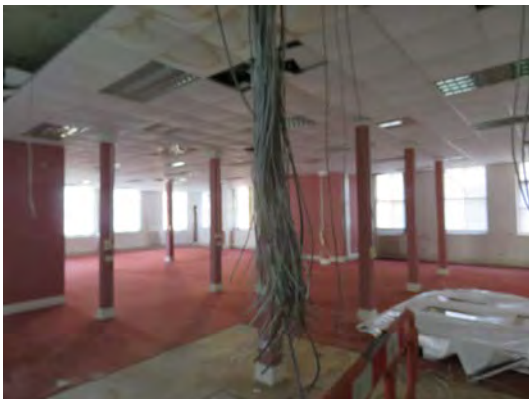
| Room number / area | Element to be removed / significance | Description | Photo |
|---|---|---|---|
| 1 <sup>st</sup> floor | Column encasements of no historic significance | Plasterboard column encasements to front and rear (former office and former warehouse) sections of building. | |

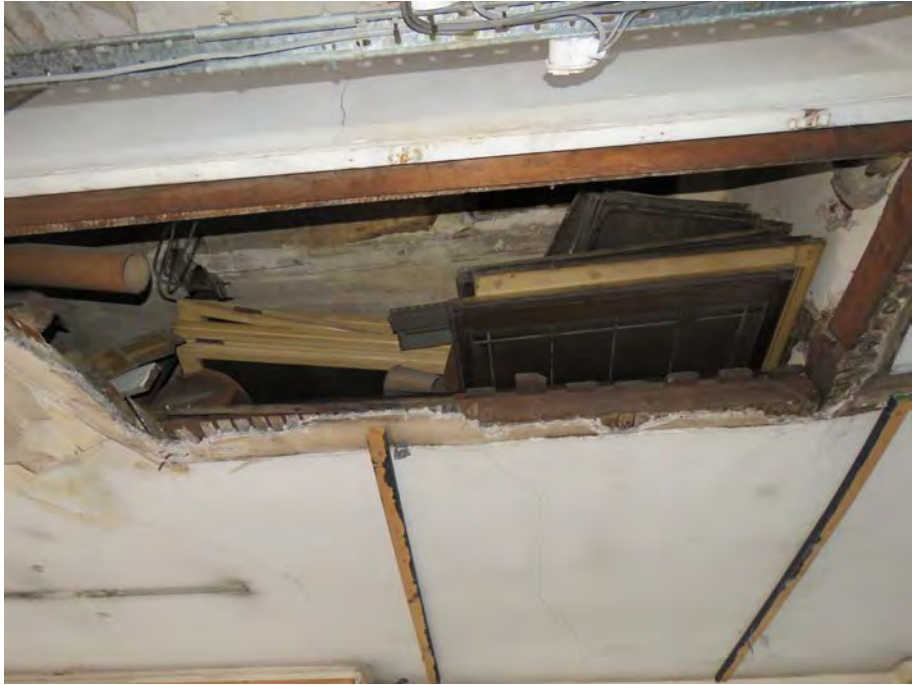
| Room number / area | Element to be <u>retained</u> / protected | Photo |
|---|---|---|
| 3 <sup>rd</sup> floor | Stored joinery items to ceiling void | |

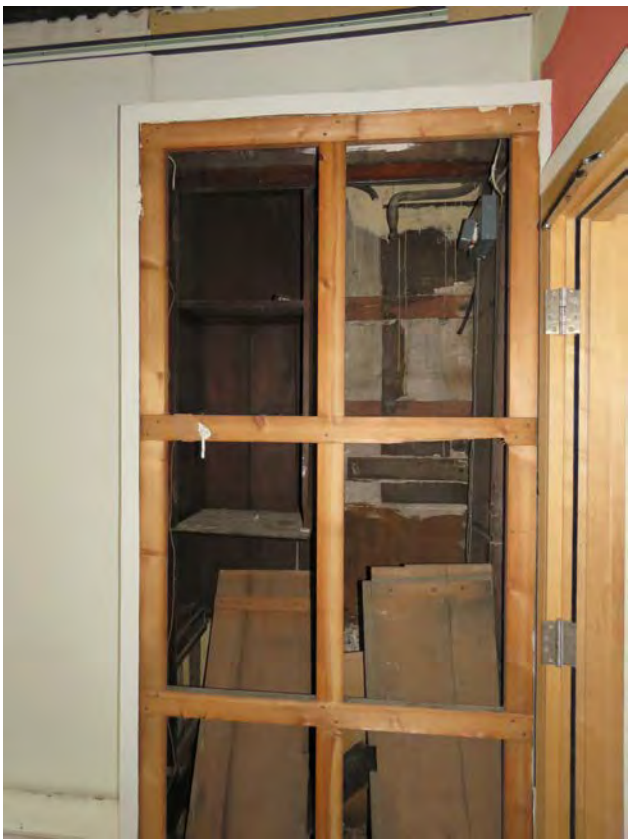
| Room number / area | Element to be <u>retained</u> / protected | Photo |
|---|---|---|
| 2 <sup>nd</sup> floor | Built-in cupboards to side office | |

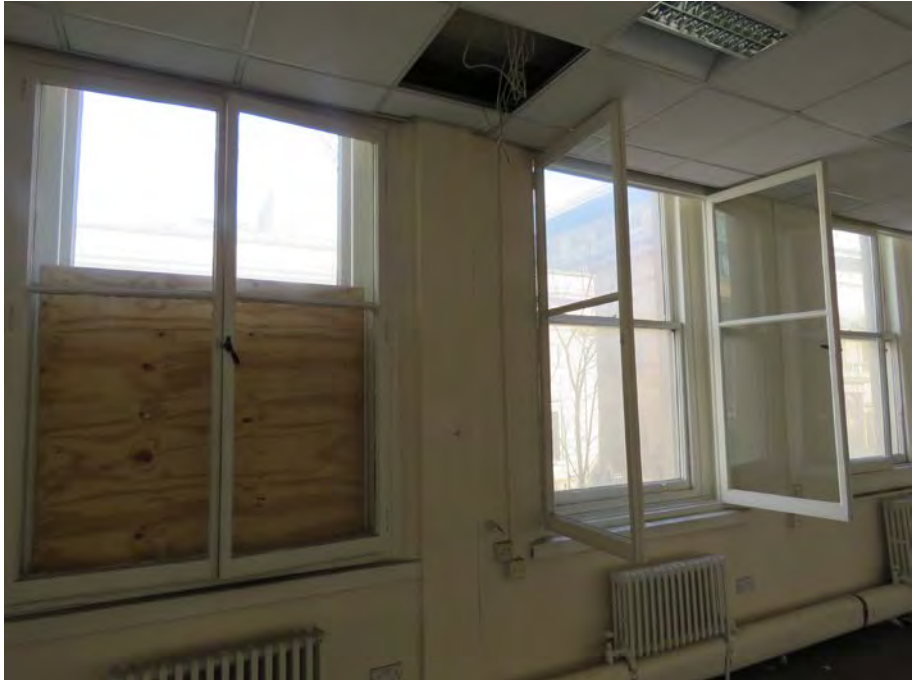
| Room number / area | Element to be retained / protected | Photo |
|---|---|---|
| 1 <sup>st</sup> floor | Alternate secondary glazing typology to parts of first floor, to be retained | |

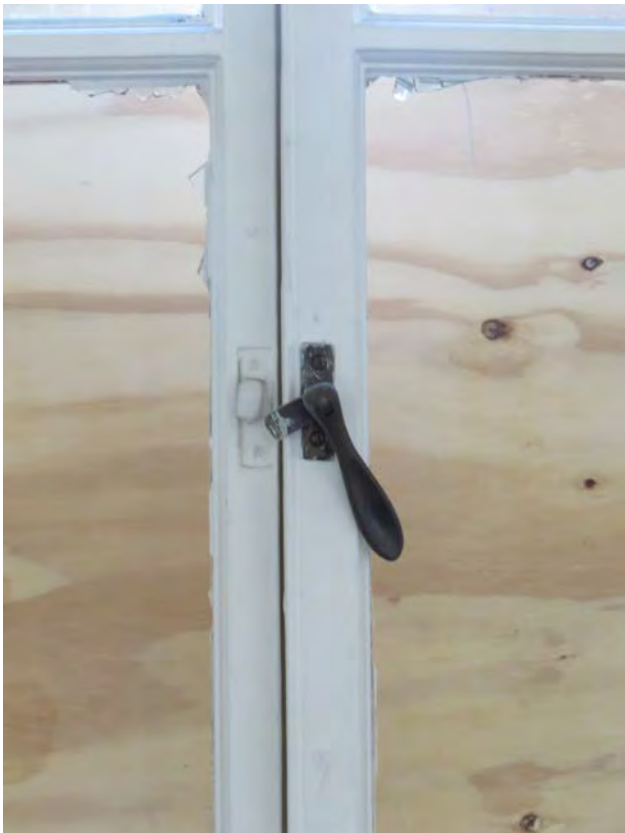
| Room number / area | Element to be retained / protected | Photo |
|---|---|---|
| 1 <sup>st</sup> floor | Alternate secondary glazing typology to parts of first floor, to be retained (detail of handle) | |

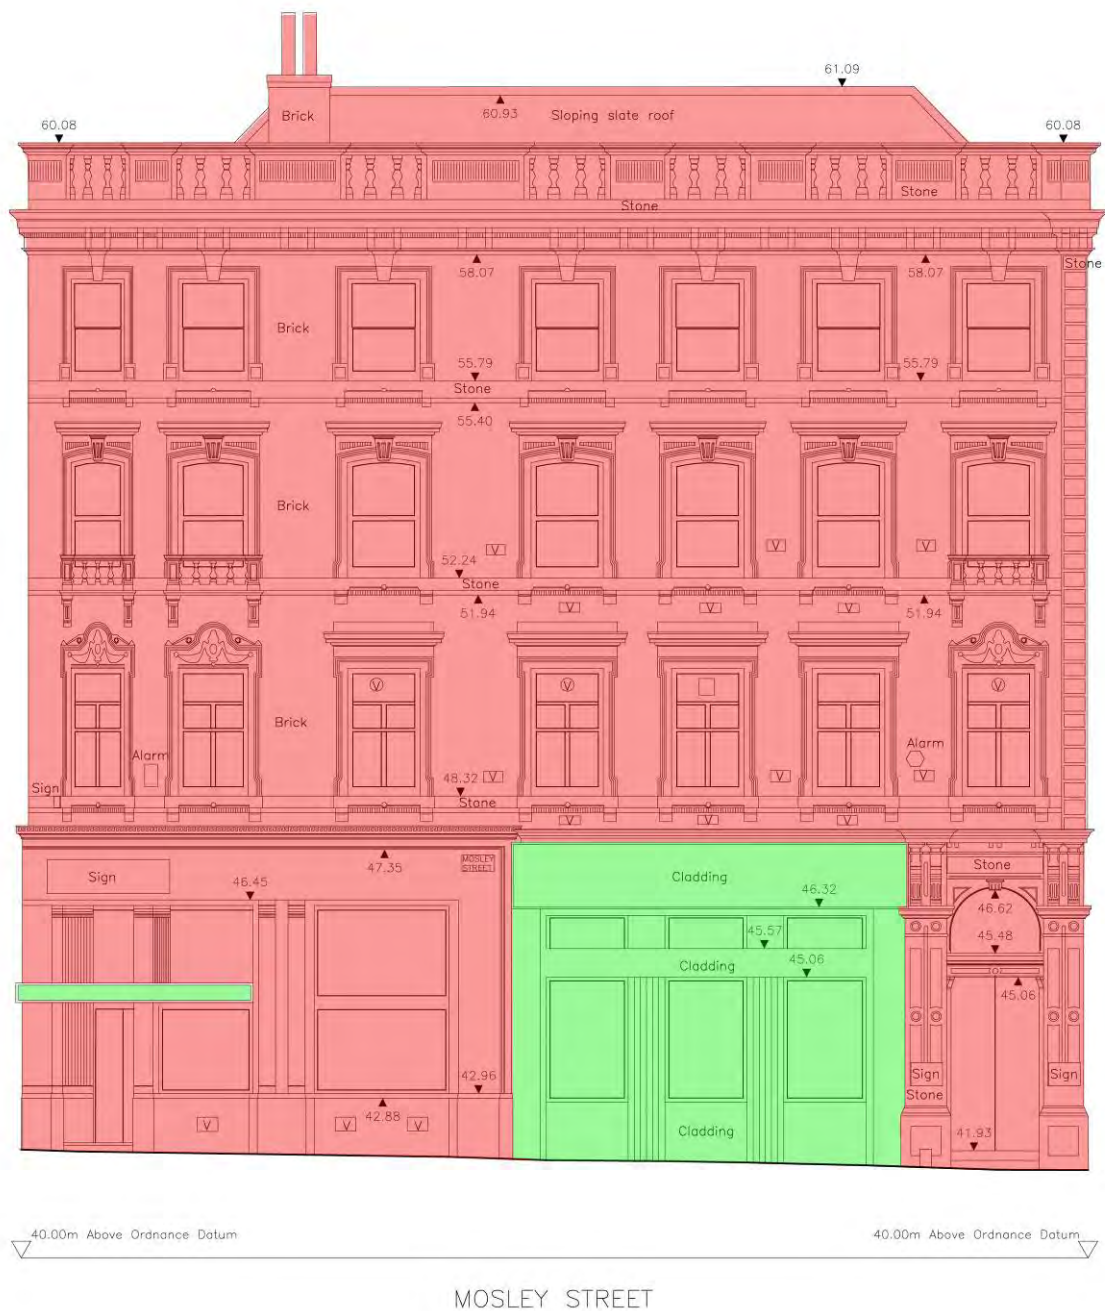
Mosley Street Elevation – Note the shopfront highlighted in green is of no significance, but following investigative works, the original shopfront structure has been discovered beneath which is of high significance.

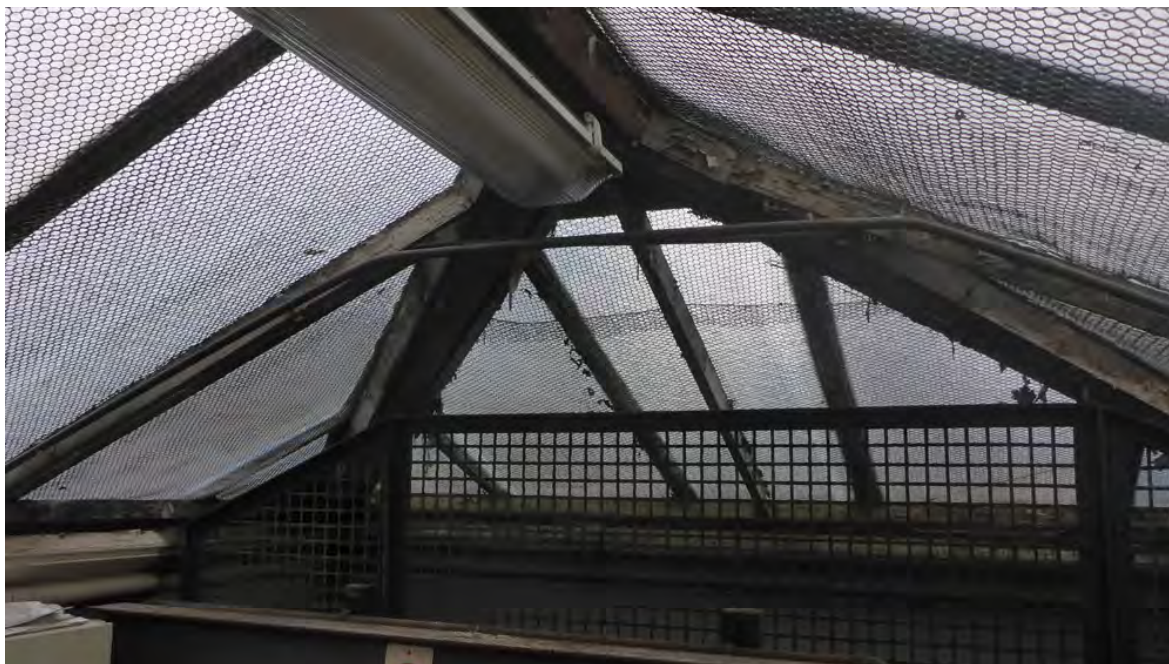
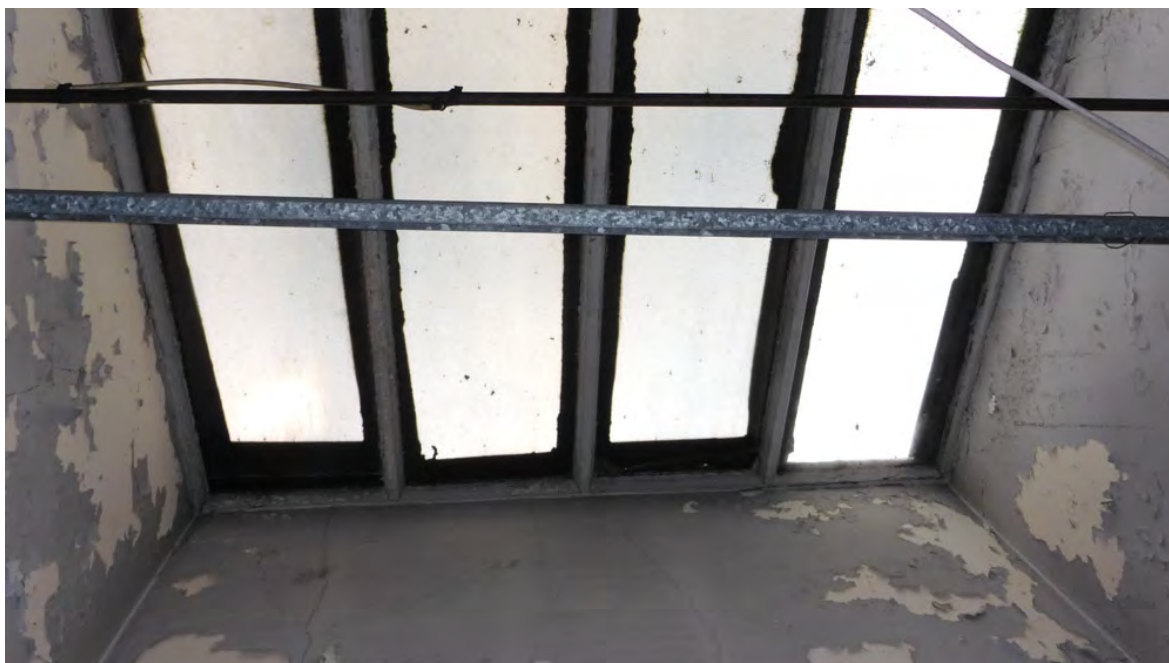
- Asbestos rope was identified as bedding to the various rooftop skylights. A sample of the material was analysed and the results returned were found to be positive for the presence of asbestos. If works are likely to disturb the material, it should be removed and disposed of as asbestos waste. (S# 32)

| <b>Floor</b> | - All | <b>Position Description</b> | - Asbestos rope bedding to the various roof top skylights |

| <b>Asbestos Type</b> | - Chrysotile (White) | <b>Product Type</b> | - Rope |

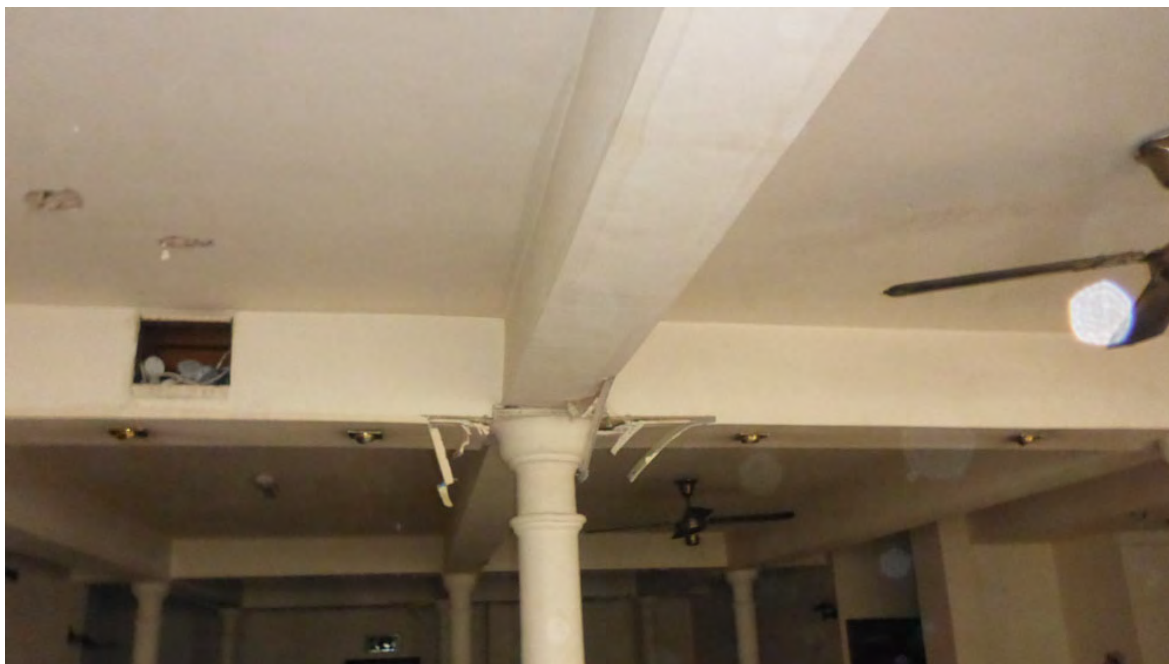
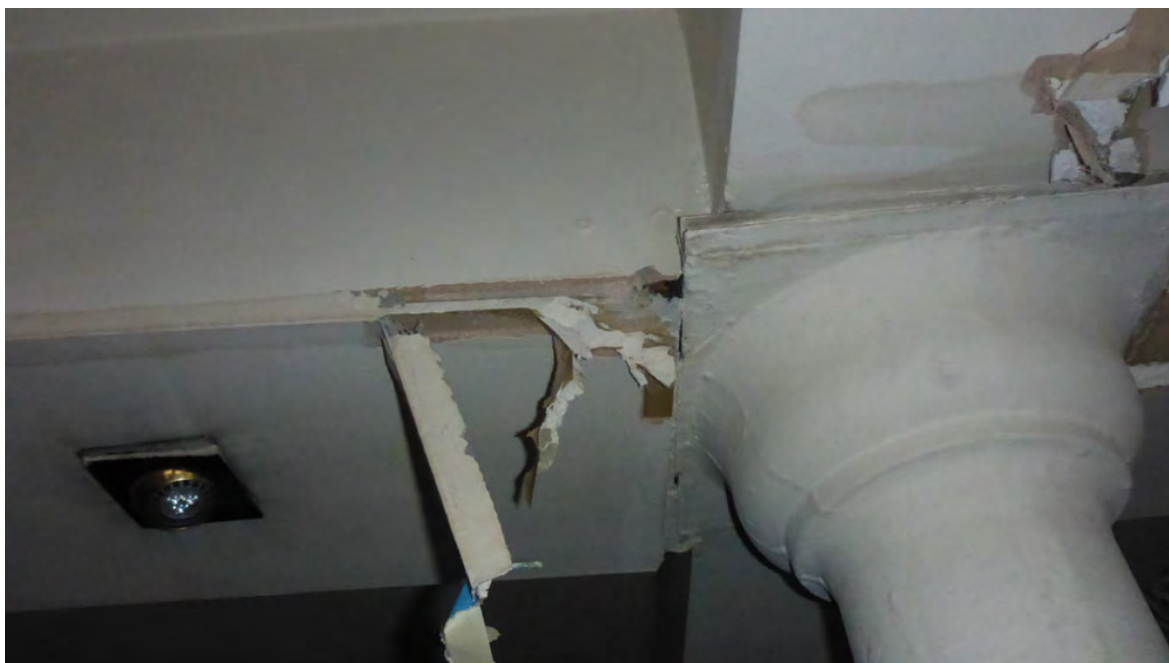
| <b>Building</b> | - Main | <b>Room</b> | - Restaurant Seating Area |
| <b>Floor</b> | - Basement | <b>Position Description</b> | - Asbestos insulation board cladding to the ceiling beams |

| <b>Asbestos Type</b> | - Amosite (Brown) & Chrysotile (White) | <b>Product Type</b> | - Insulation Board |
| <b>Comments</b> | Approximately 45 Lin m of asbestos insulation board was identified as cladding to the Restaurant Seating Area ceiling beams (please see plan for extent and location). A sample of the material was analysed and the results returned were found to be positive for the presence of asbestos. The material should be removed by a licensed asbestos removal contractor prior to any works in this area. (S# 01) | | |

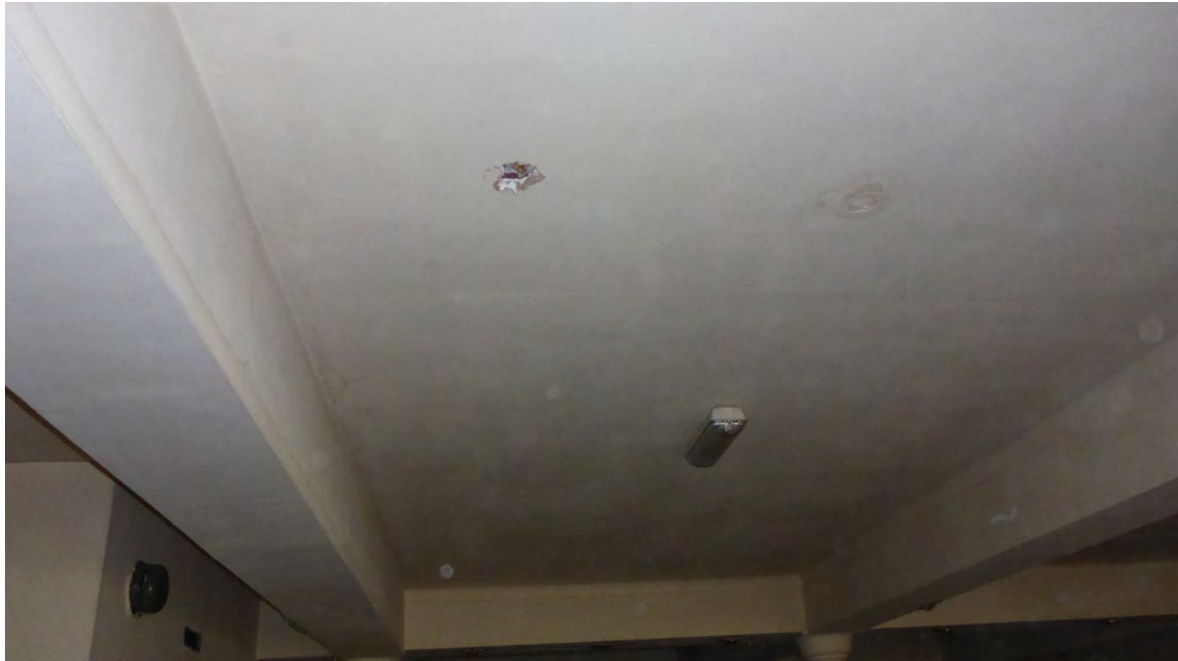
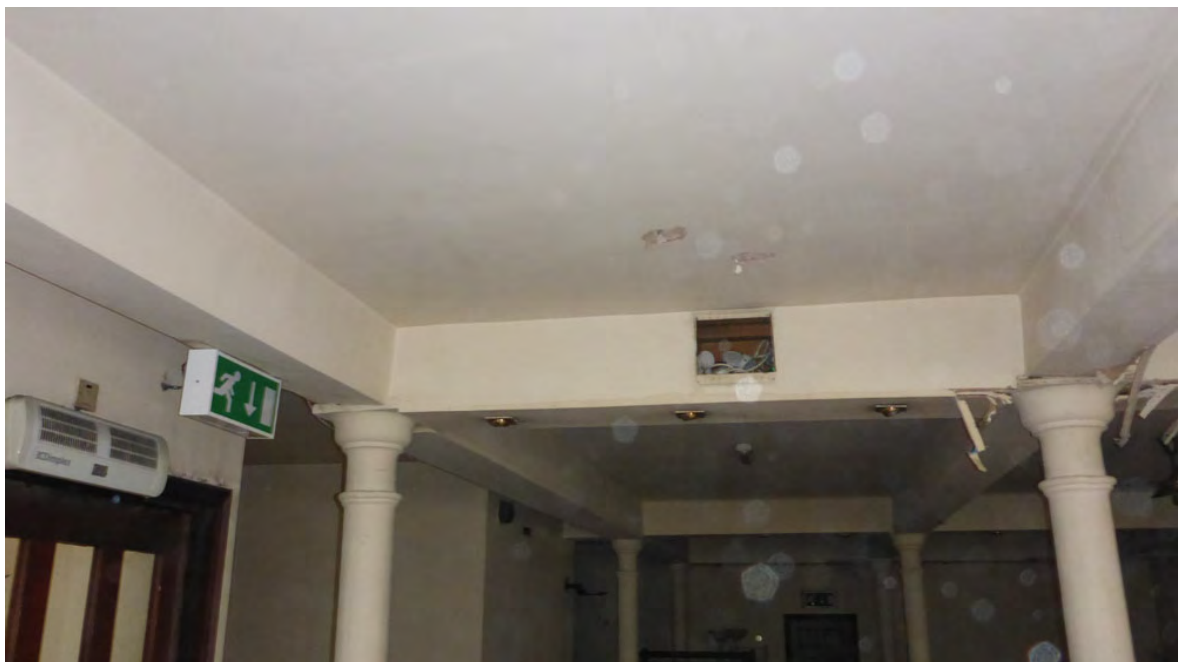
| <b>Building</b> | - Main | <b>Room</b> | - Restaurant Seating Area / Entrance |
| <b>Floor</b> | - Basement | <b>Position Description</b> | - Asbestos insulation board to the ceiling |

| <b>Asbestos Type</b> | - Chrysotile (White) | <b>Product Type</b> | - Insulation Board |
| <b>Comments</b> | <p>Approximately 20 Sq. m of asbestos insulation board was identified to the Restaurant Seating Area / Entrance ceilings, beyond existing finishes (please see plan for extent and location). A sample of the material was analysed and the results returned were found to be positive for the presence of asbestos. The material should be removed by a licensed asbestos removals contractor prior to any works in this area. (S# 02)</p> | | |

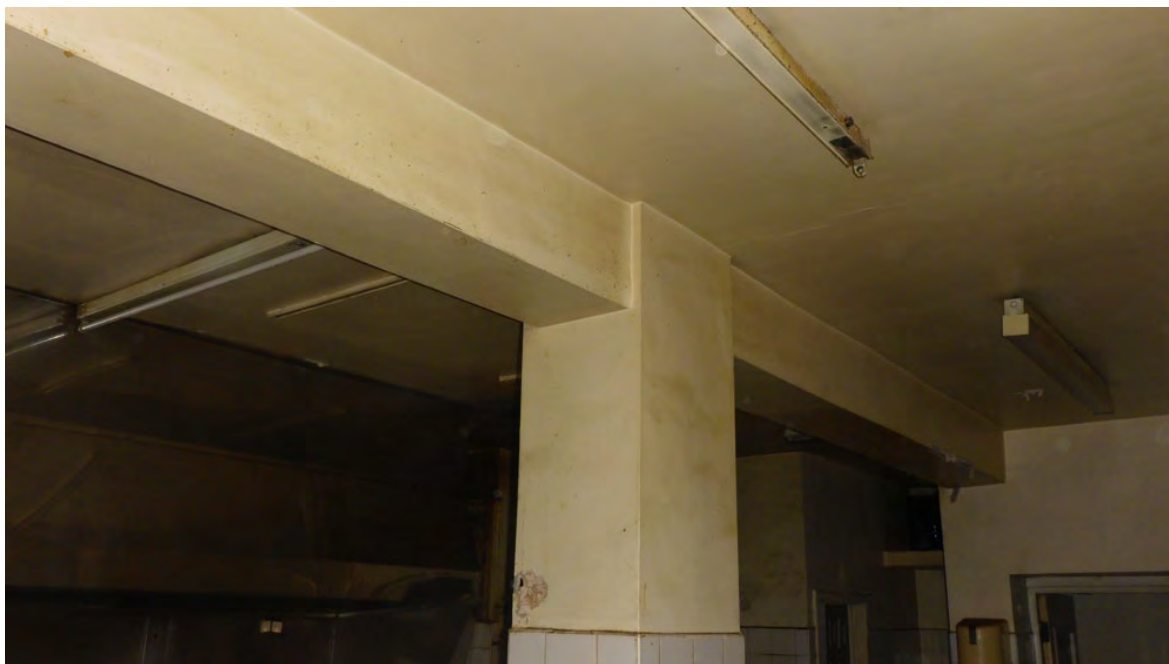
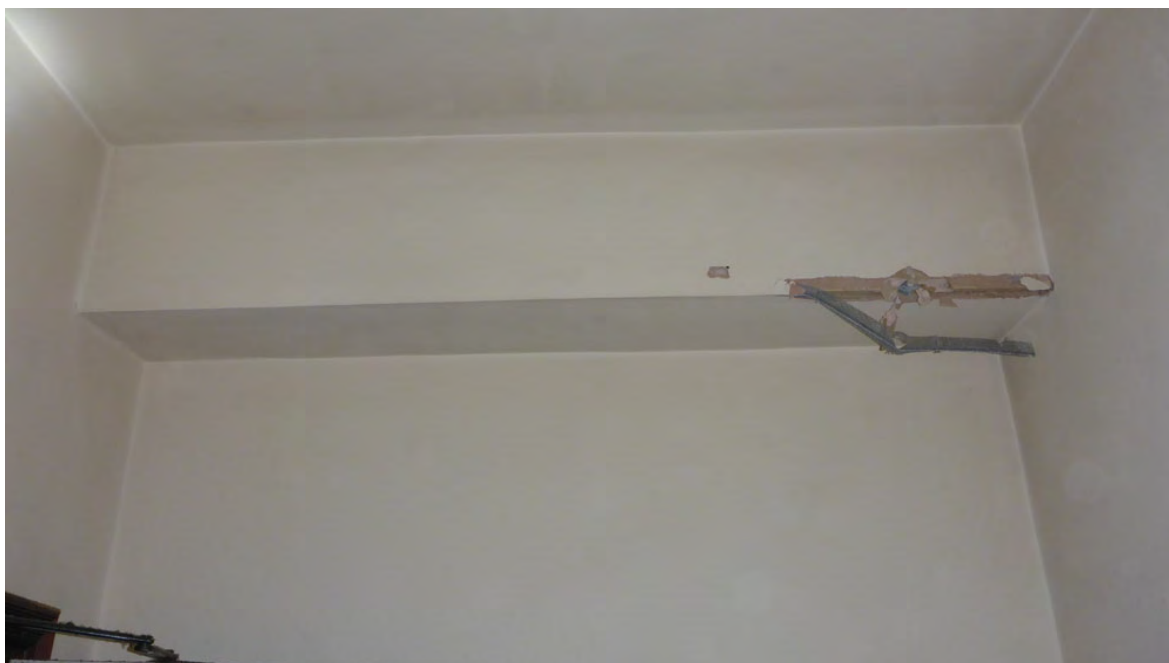
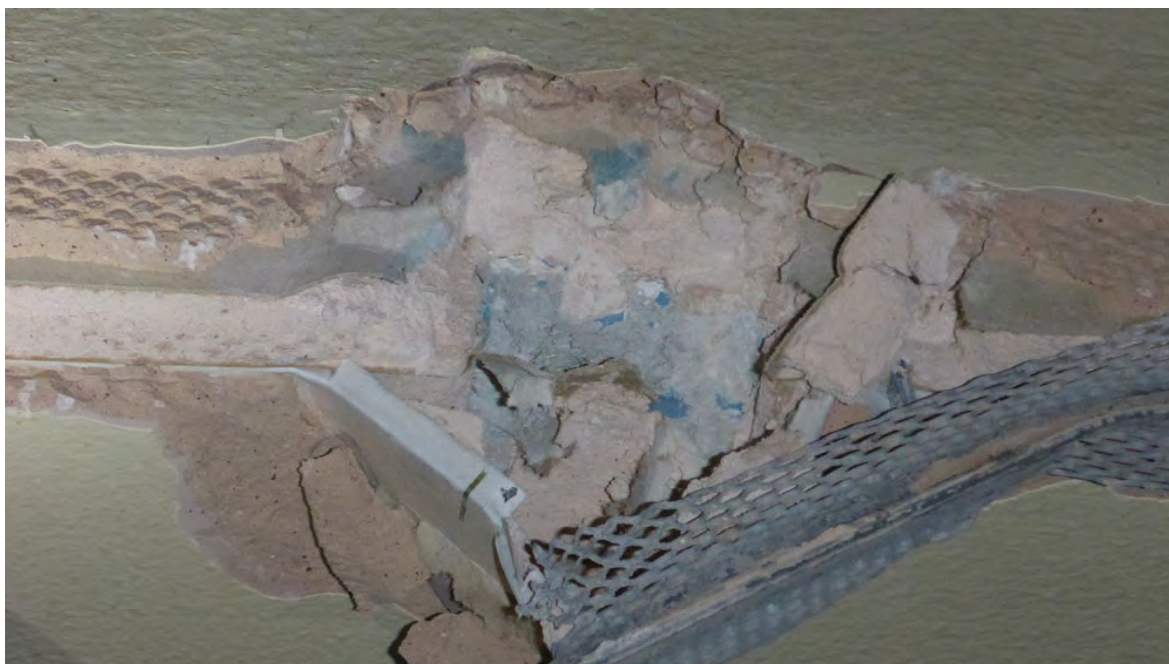
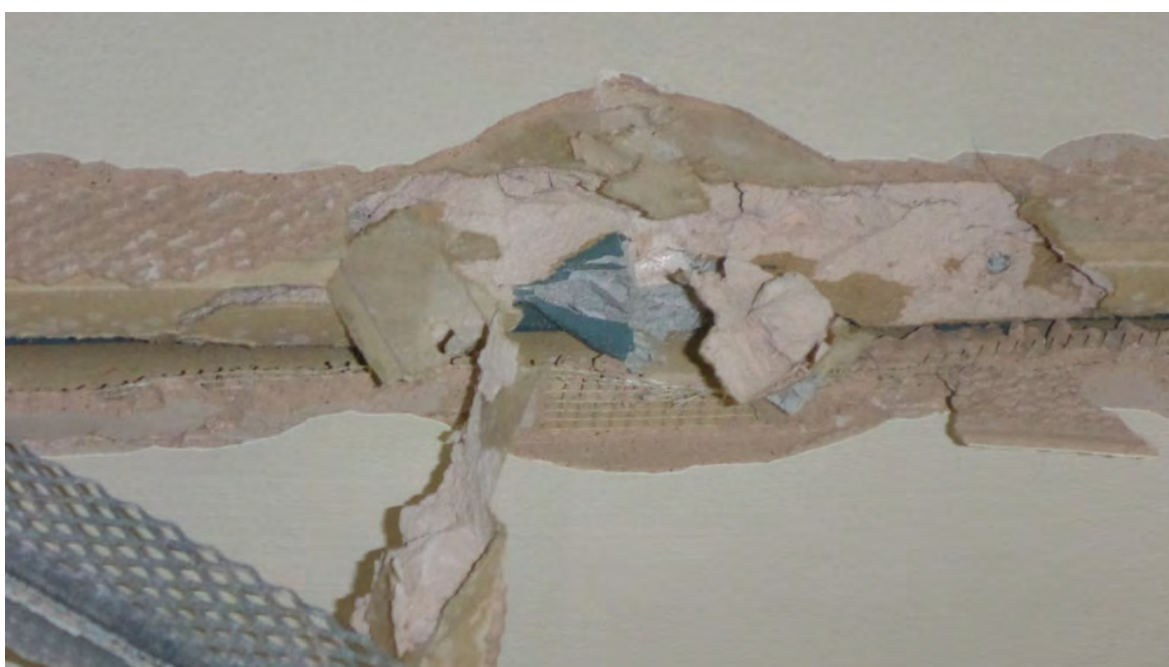
| <b>Building</b> | - Main | <b>Room</b> | - Restaurant Kitchen / Kitchen Lobby |
| <b>Floor</b> | - Basement | <b>Position Description</b> | - Asbestos insulation board cladding to the ceiling beams |

| <b>Asbestos Type</b> | - Amosite (Brown) & Chrysotile (White) | <b>Product Type</b> | - Insulation Board |
| <b>Comments</b> | Approximately 9 Lin m of asbestos insulation board was identified as cladding to the Restaurant Kitchen and Kitchen Lobby ceiling beams (please see plan for extent and location). The material is visually similar to that within the Restaurant Seating Area and is therefore presumed to be positive for the presence of asbestos. The material should be removed by a licensed asbestos removals contractor prior to any works in this area. (As S# 01) | | |

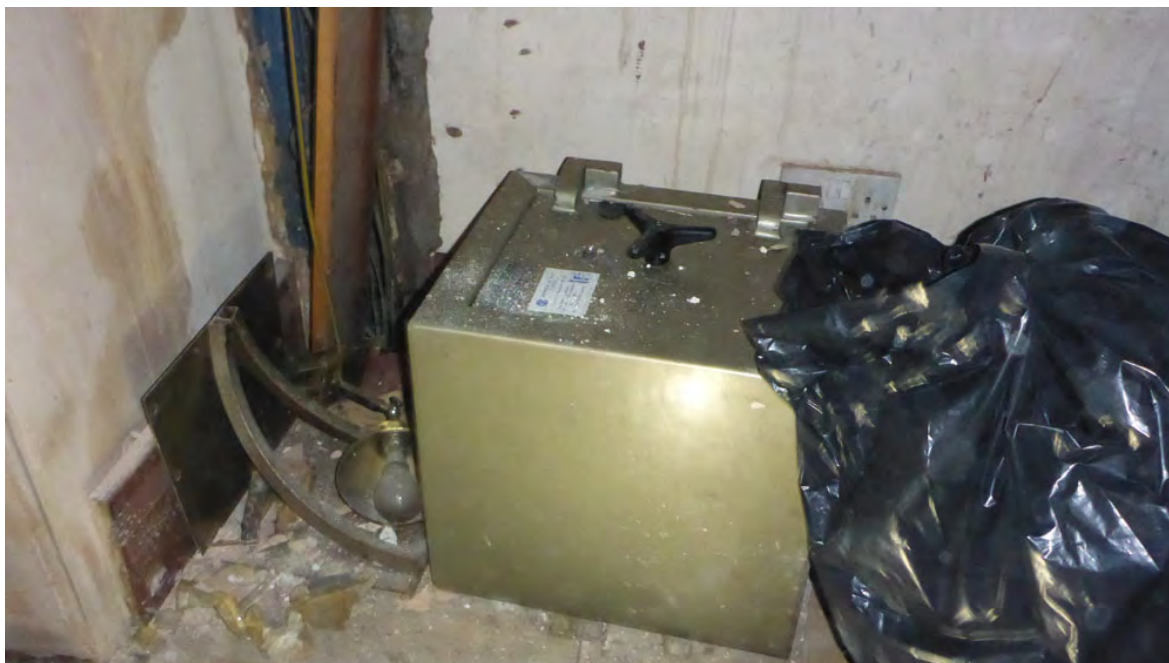
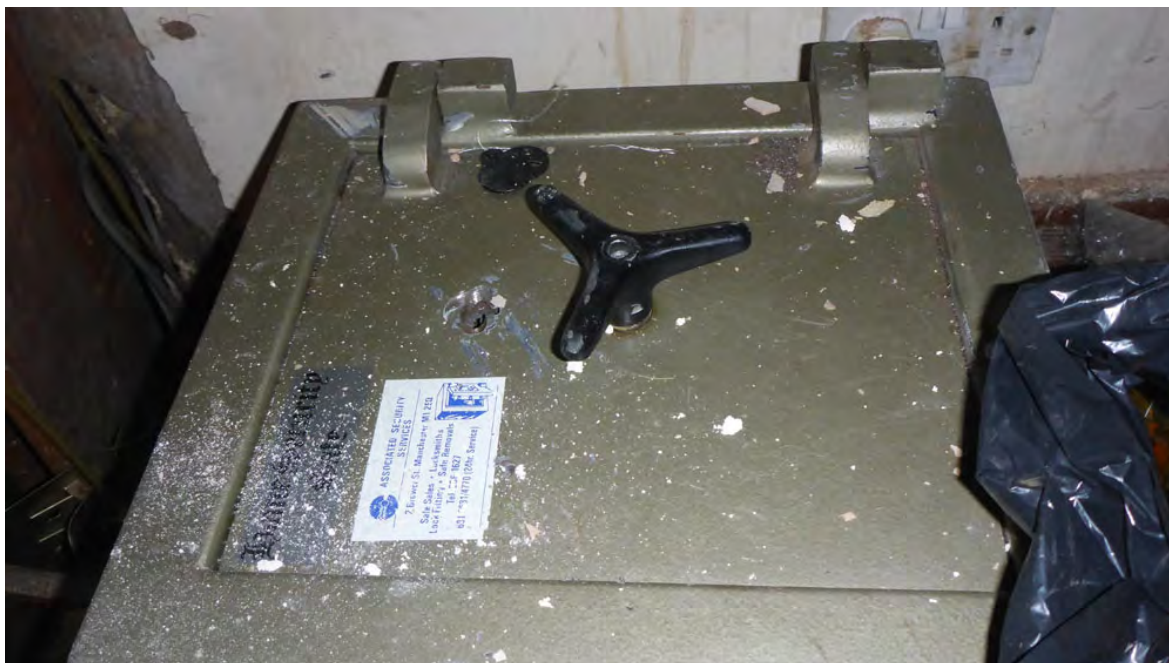
| <b>Building</b> | - Main | <b>Room</b> | - Under-stairs Store |
| <b>Floor</b> | - Basement | <b>Position Description</b> | - Concealed asbestos components presumed to the safe |

| <b>Asbestos Type</b> | - Amosite (Brown) | <b>Product Type</b> | - Mattresses & Packing |
| <b>Comments</b> | <p>1 No. redundant safe unit within the Under-stairs Store is presumed to contain concealed asbestos as fire protection. The safe should be removed whole and disposed of as asbestos waste prior to any works in this area.</p> | | |
