# Method Statement for Soft Strip Works

**79 Mosley Street  
St Peters Square  
Manchester**

Method statement for Investigative Works and Soft Strip works at No. 79 Mosley Street.

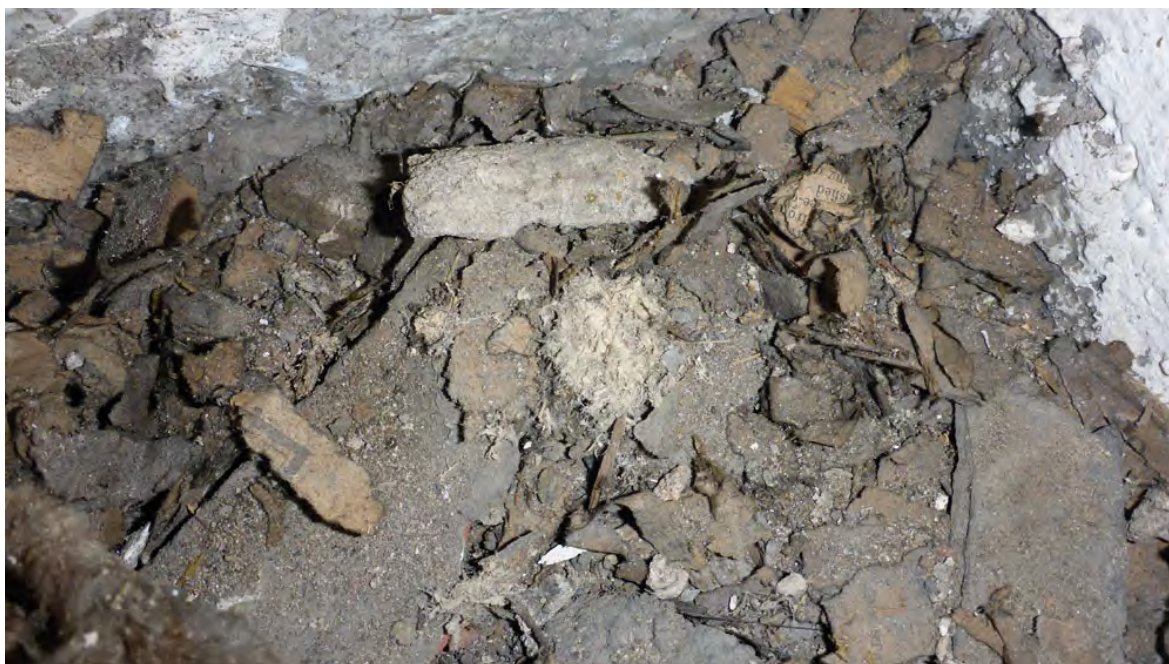
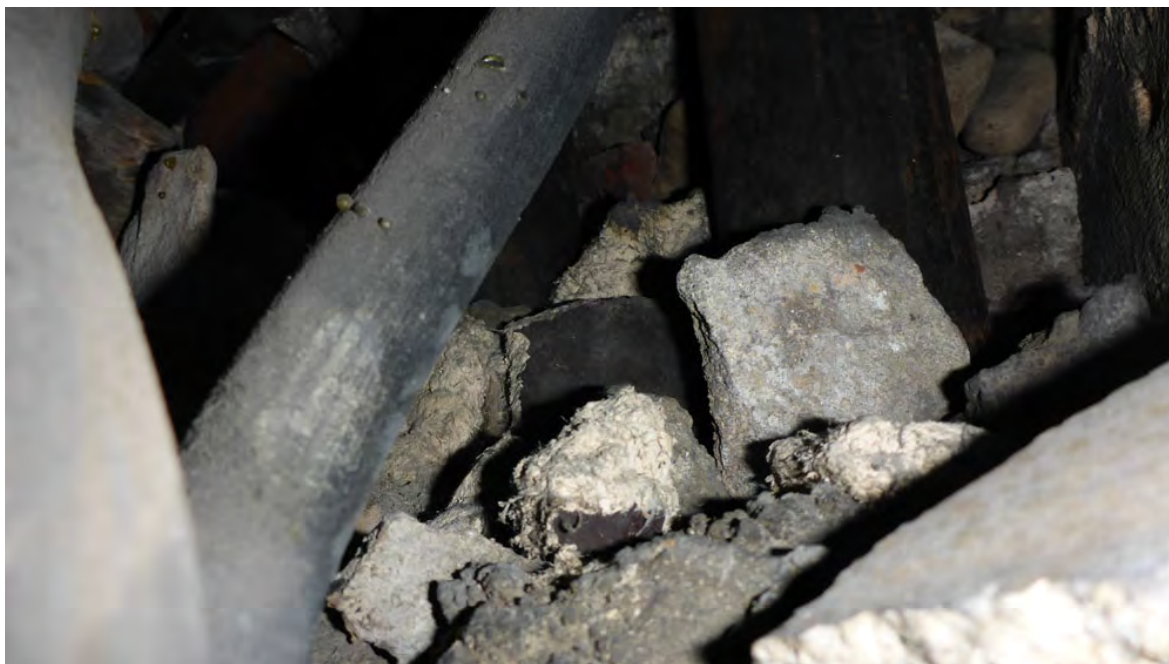
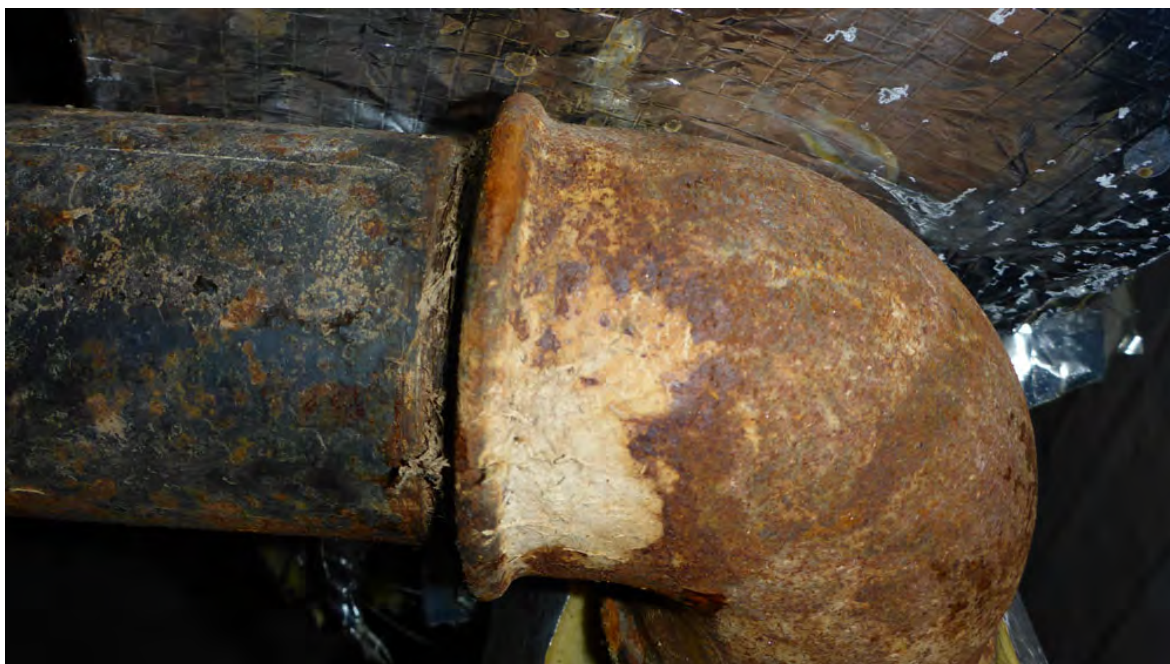
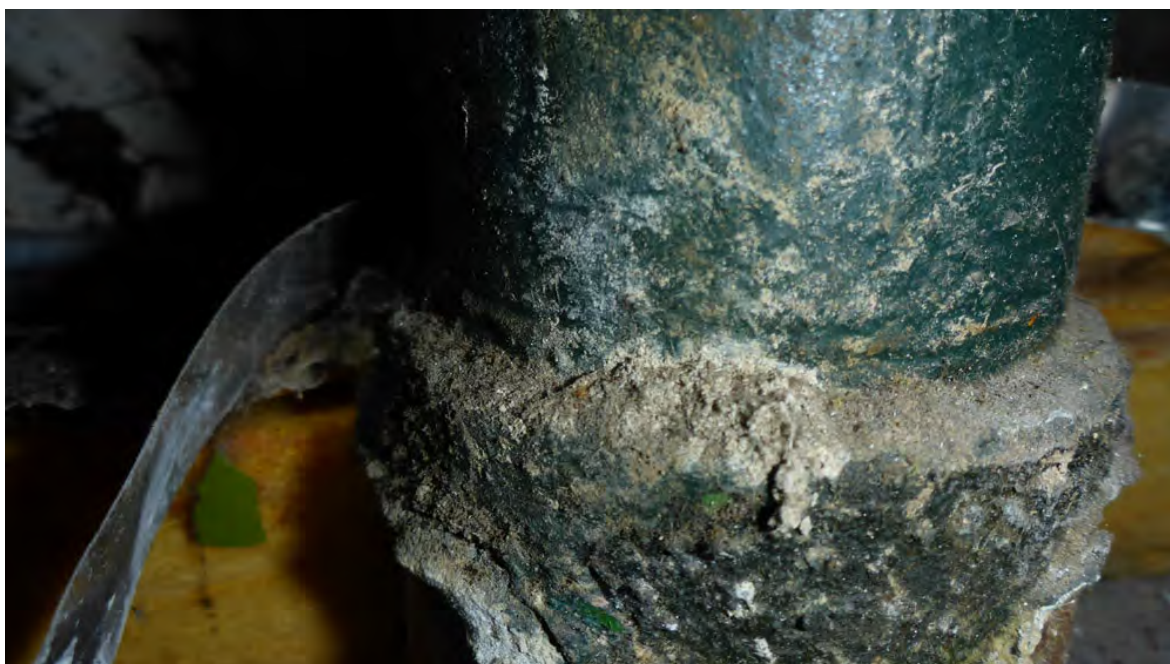
| <b>Building</b> | - Main | <b>Room</b> | - Lift / Safe Room Lobby & Plant Room |
| <b>Floor</b> | - Basement | <b>Position Description</b> | - Asbestos thermal insulation debris and residues to surfaces, walls, wall penetrations, pipework and brackets |

| <b>Asbestos Type</b> | - Crocidolite (Blue), Amosite (Brown) & Chrysotile (White) | <b>Product Type</b> | - Thermal Insulation |
| <b>Comments</b> | Asbestos thermal insulation debris and residues were identified to surfaces, walls, wall penetrations, pipework and brackets (approximately 170 Lin M total pipework) at high and low levels throughout the Lift Lobby / Safe Room Lobby and Plant Room (also above the Safe Room). A number of samples were analysed and the results returned were all found to be positive for the presence of asbestos. Access to the area should be restricted until such time as a full environmental clean can be undertaken by a licensed asbestos removals contractor. (S# 07, 08, 09, 10, 11, 12 & 13) | | |

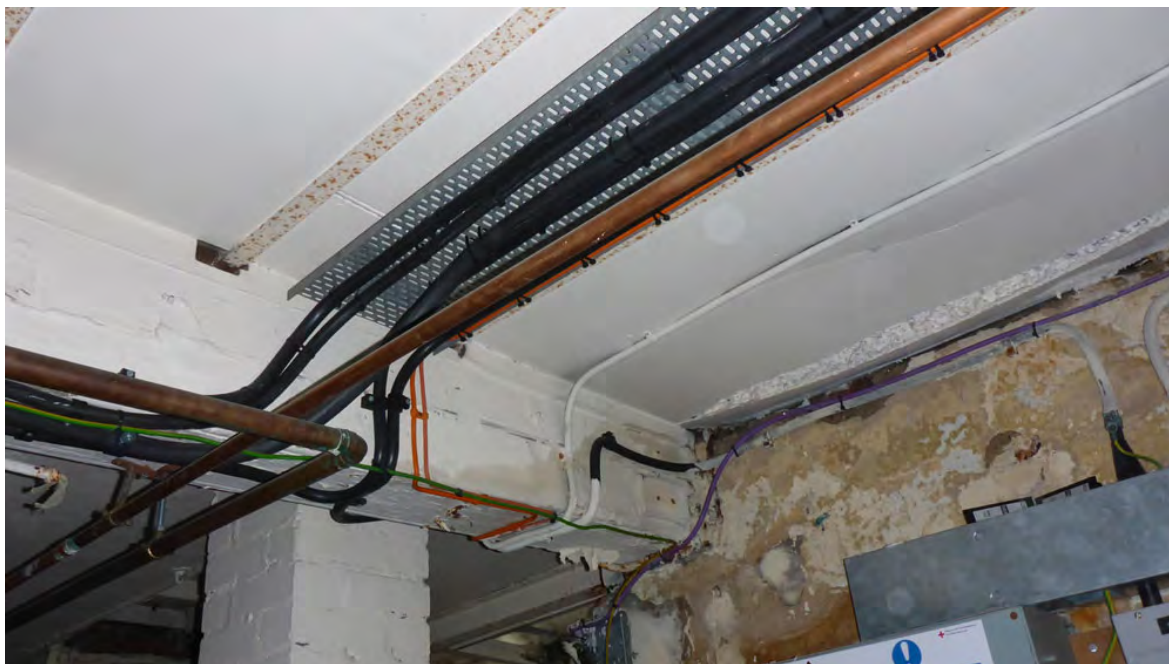
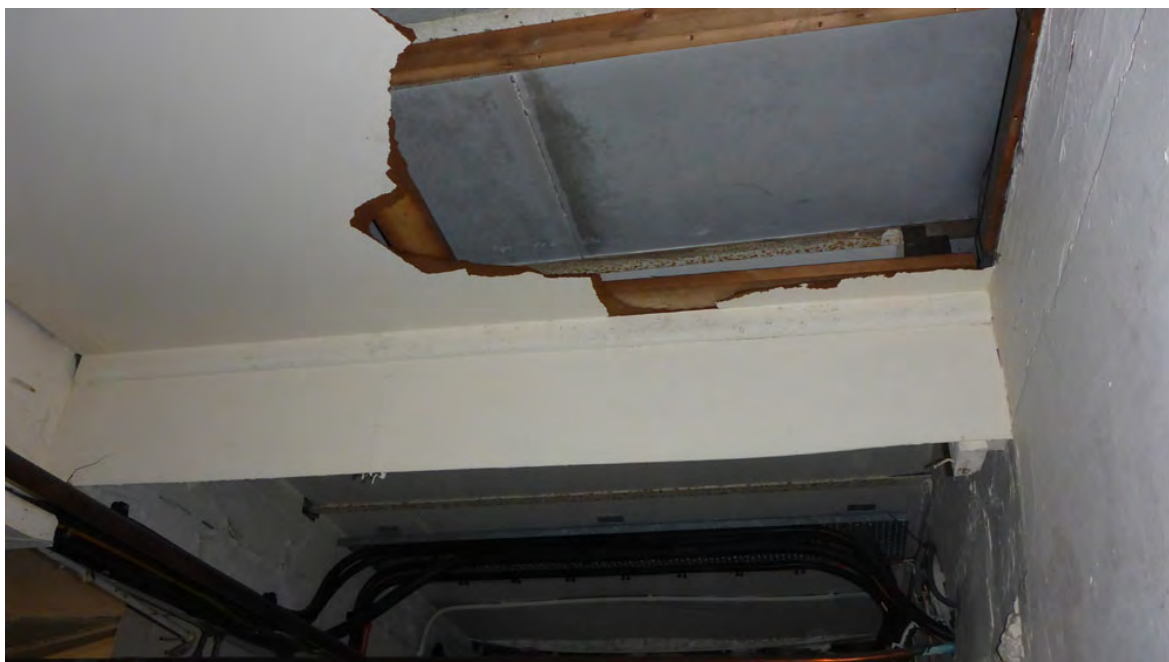
| <b>Building</b> | - Main | <b>Room</b> | - File Store, Server Room |
| <b>Floor</b> | - Basement | <b>Position Description</b> | - Asbestos cement board to part of the ceilings |

| <b>Asbestos Type</b> | - Chrysotile (White) | <b>Product Type</b> | - Cement Board |
| <b>Comments</b> | <p>Approximately 10 Sq. m of asbestos cement board was identified to a section of the File Store ceiling at the Mosley Street side of the room, passing through into the Server Room (please see plan for location and extent). A sample of the material was analysed and the results returned were found to be positive for the presence of asbestos. The material should be removed and disposed of as asbestos waste prior to any works in this area. (S# 17)</p> | | |

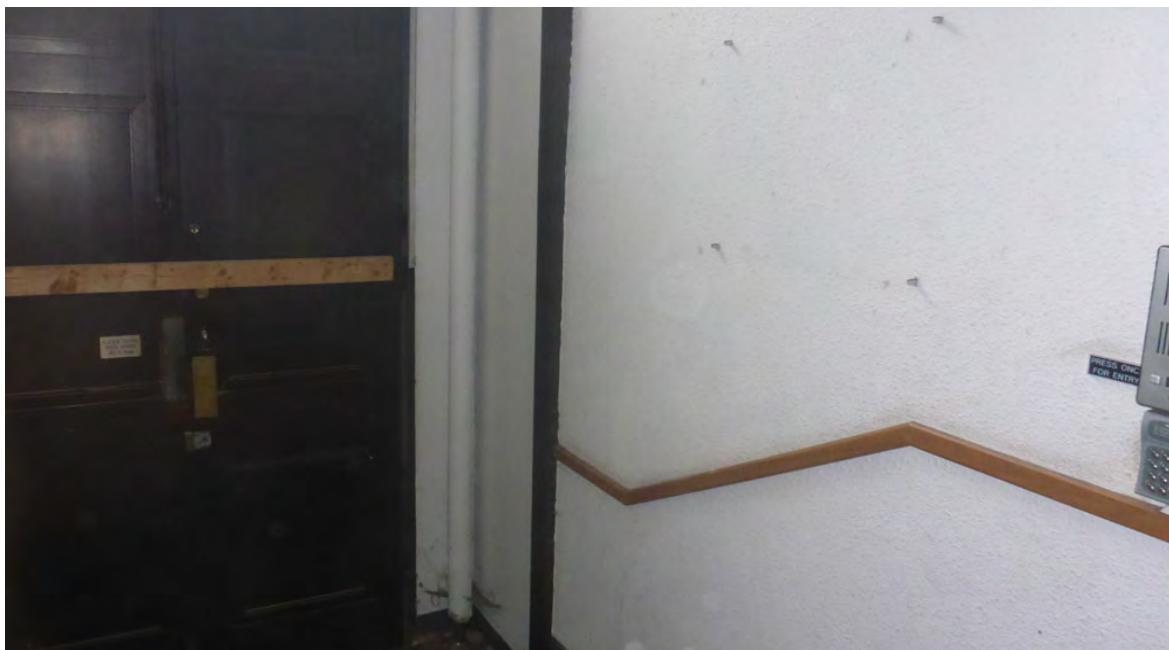
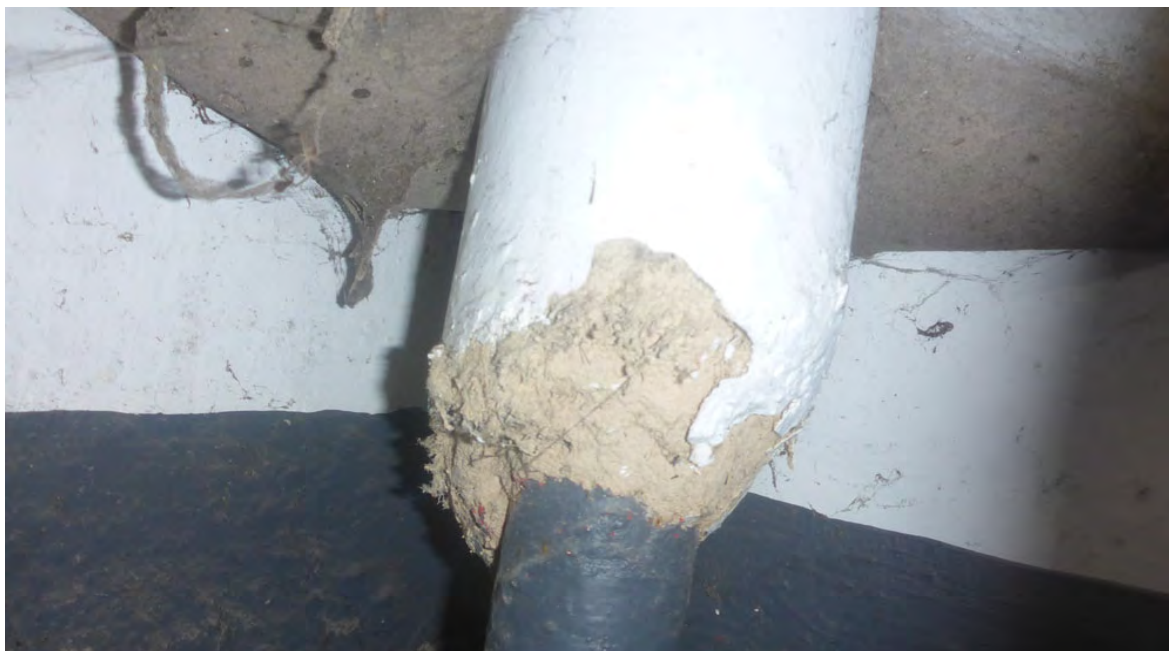
| <b>Building</b> | - Main | <b>Room</b> | - Mosley Street Side Entrance Lobby |
| <b>Floor</b> | - Ground | <b>Position Description</b> | - Asbestos thermal insulation to 1 No. vertical pipe beside the door |

| <b>Asbestos Type</b> | - Crocidolite (Blue) & Chrysotile (White) | <b>Product Type</b> | - Thermal Insulation |
| <b>Comments</b> | <p>Approximately 4 Lin m of asbestos thermal insulation was identified to 1 No. vertical pipe in the front corner of the Mosley Street Side Entrance Lobby. The material is visually similar to that within the Lift Lobby and is therefore presumed to be positive for the presence of asbestos. The material should be removed by a licensed asbestos removals contractor prior to any works in this area. (As S# 21)</p> | | |

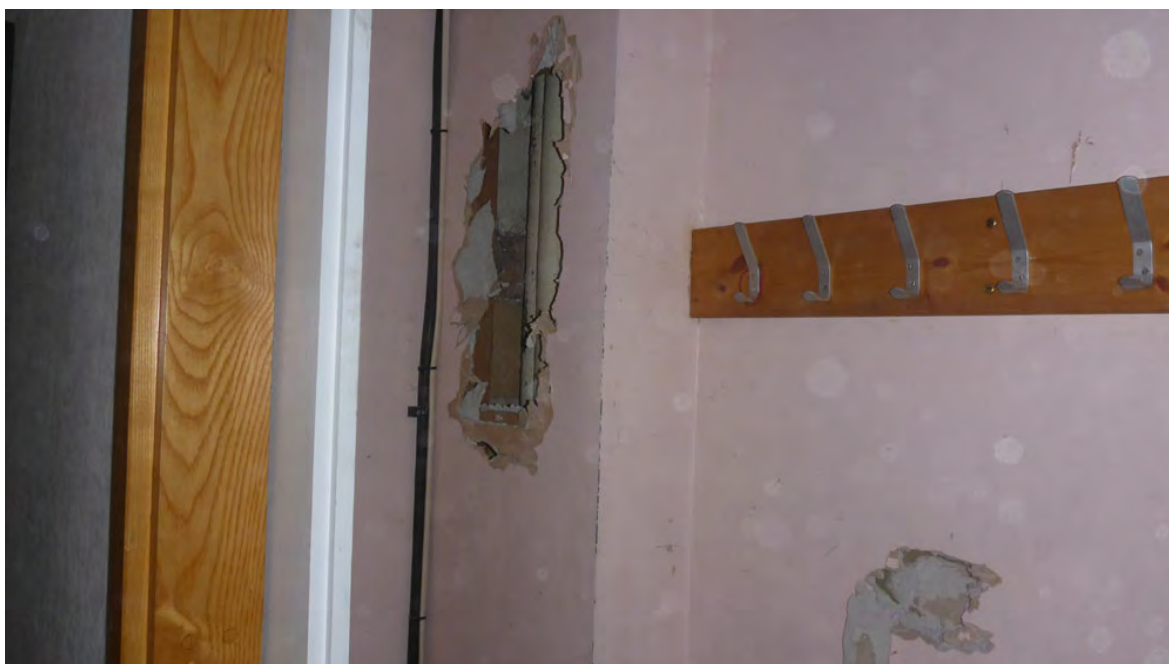
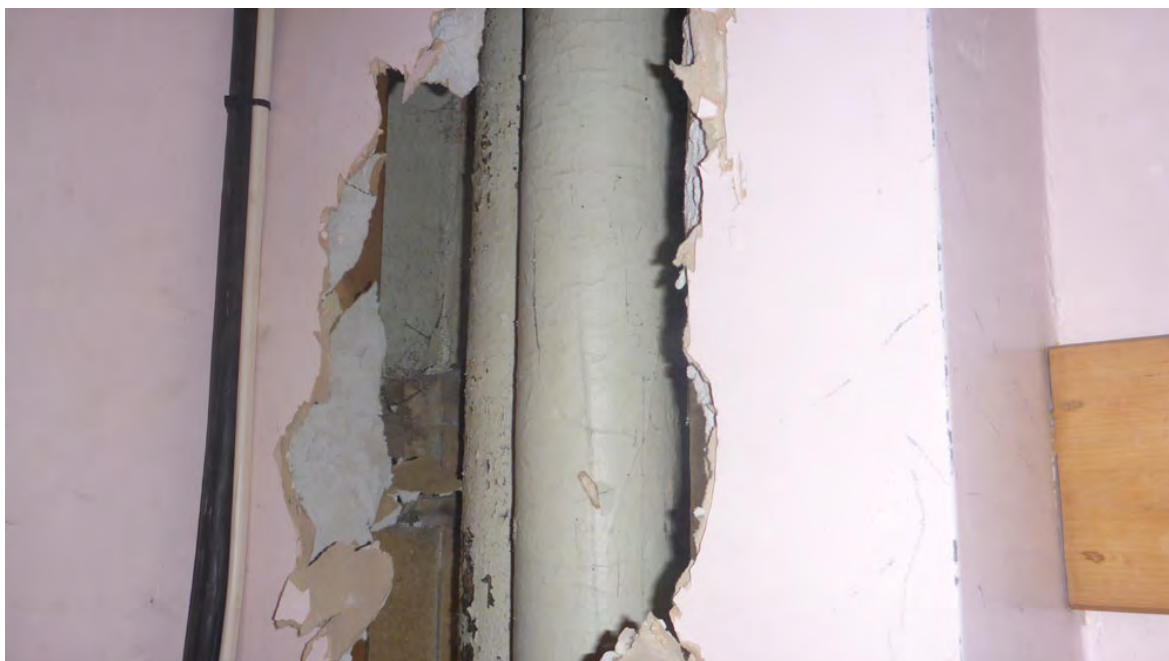
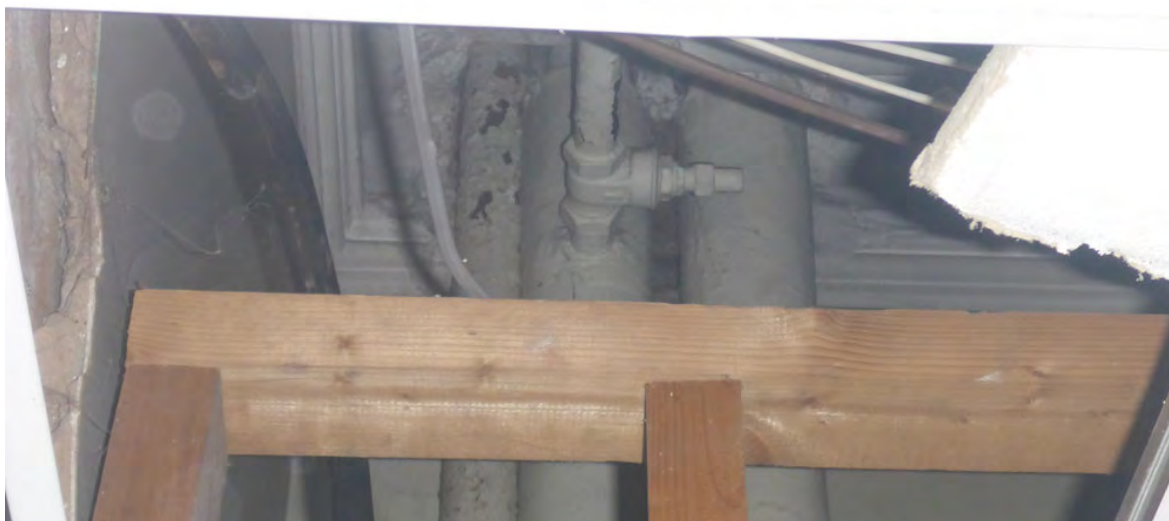
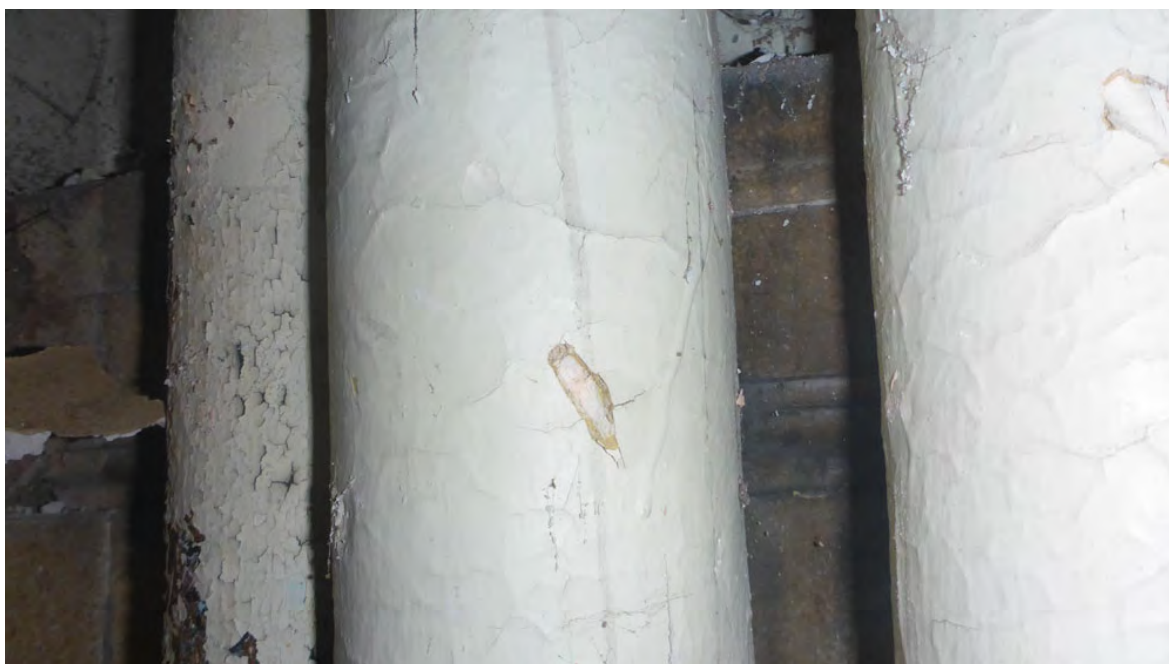
| <b>Building</b> | - Main | <b>Room</b> | - Lightwell Lobby Store |
| <b>Floor</b> | - Ground | <b>Position Description</b> | - Asbestos thermal insulation to 2 No. vertical pipes within the boxwork and above the Store |

| <b>Asbestos Type</b> | - Crocidolite (Blue) & Chrysotile (White) | <b>Product Type</b> | - Thermal Insulation |
| <b>Comments</b> | Approximately 4 Lin m (each) of asbestos thermal insulation was identified to 2 No. vertical pipes to the Lightwell Lobby Store box-work. The material is visually similar to that within the Lift Lobby and is therefore presumed to be positive for the presence of asbestos. The material should be removed by a licensed asbestos removals contractor prior to any works in this area. (As S# 21) | | |

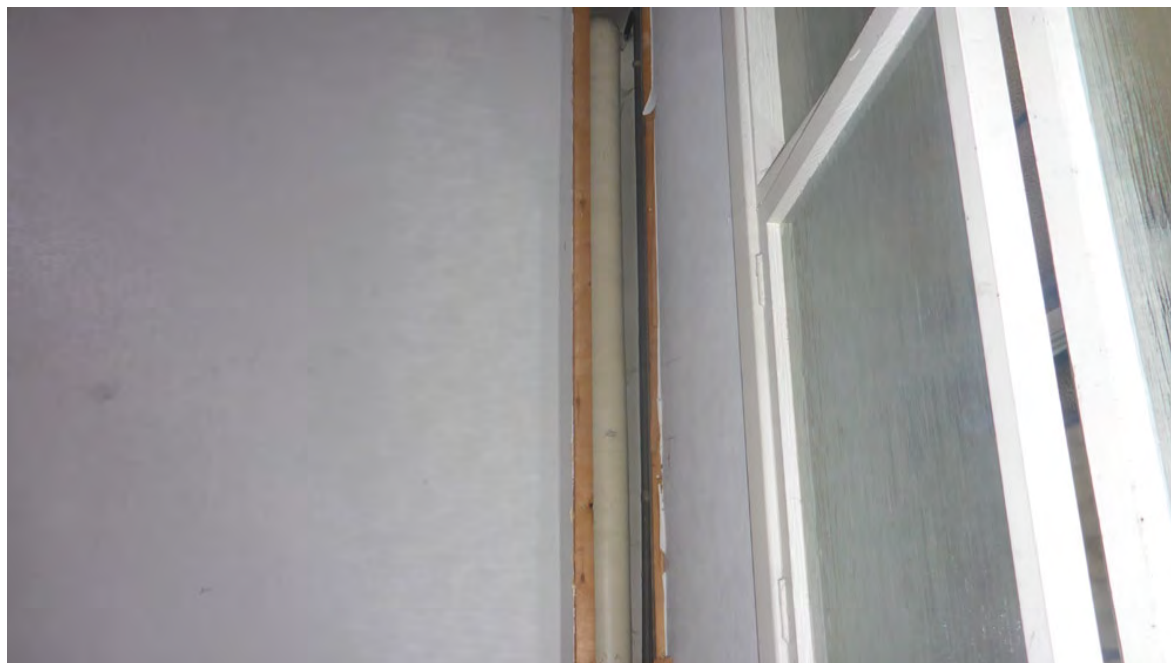
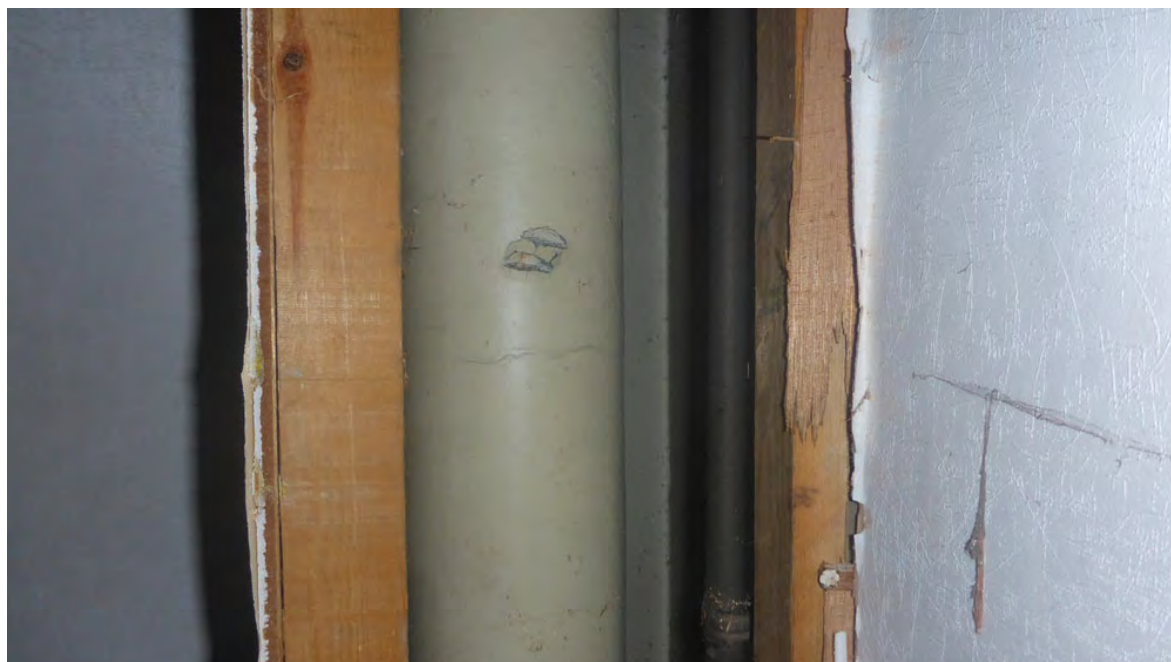
| <b>Building</b> | - Main | <b>Room</b> | - Lift Stairwell |
| <b>Floor</b> | - Ground | <b>Position Description</b> | - Asbestos thermal insulation to 1 No. vertical pipe within the half-landing boxwork |

| <b>Asbestos Type</b> | - Crocidolite (Blue) & Chrysotile (White) | <b>Product Type</b> | - Thermal Insulation |
| <b>Comments</b> | Approximately 3 Lin m of asbestos thermal insulation was identified to 1 No. vertical pipe within box-work on the half-landing of the Lift Stairwell. The material is visually similar to that within the Lift Lobby and is therefore presumed to be positive for the presence of asbestos. The material should be removed by a licensed asbestos removals contractor prior to any works in this area. (As S# 21) | | |

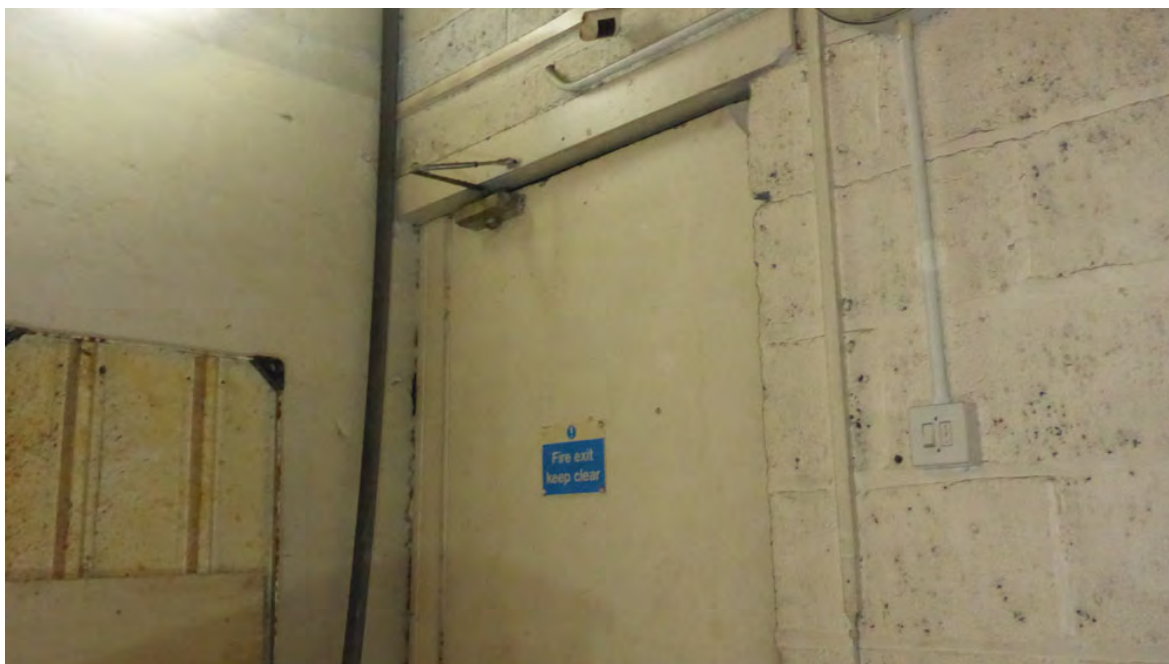
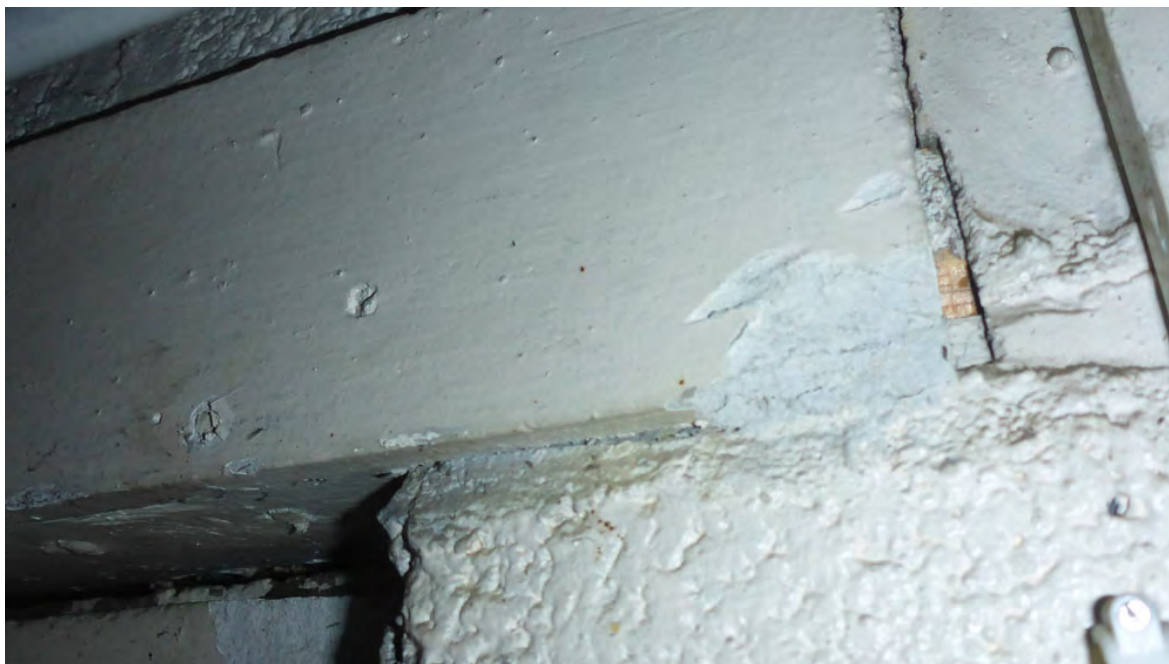
| <b>Building</b> | - Main | <b>Room</b> | - Fire Escape |
| <b>Floor</b> | - Ground | <b>Position Description</b> | - An asbestos insulation board lining to the door, door head and associated debris to the floor |

| <b>Asbestos Type</b> | - Amosite (Brown) & Chrysotile (White) | <b>Product Type</b> | - Insulation Board |
| <b>Comments</b> | Approximately 2 Sq. m of asbestos insulation board with associated debris to the floor was identified to the Ground Floor Fire Escape door, door head and Landing, accessed via the Rear Fire Exit. A sample of the material was analysed and the results returned were found to be positive for the presence of asbestos. The material should be removed by a licensed asbestos removals contractor prior to any works in this area. (S# 04) | | |

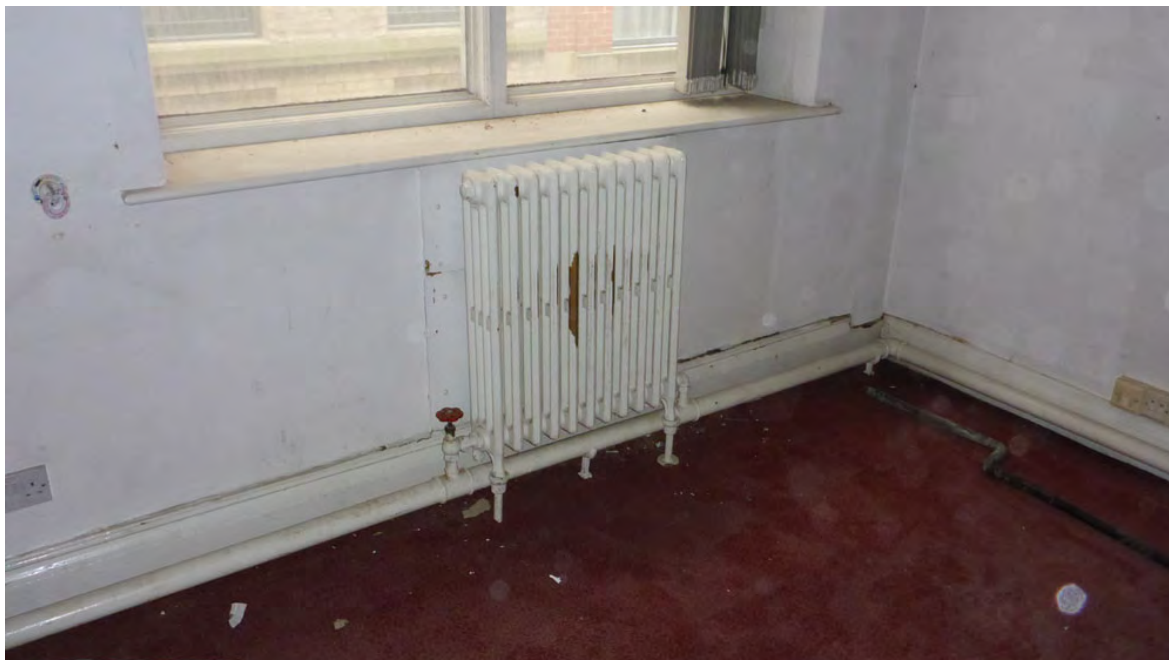
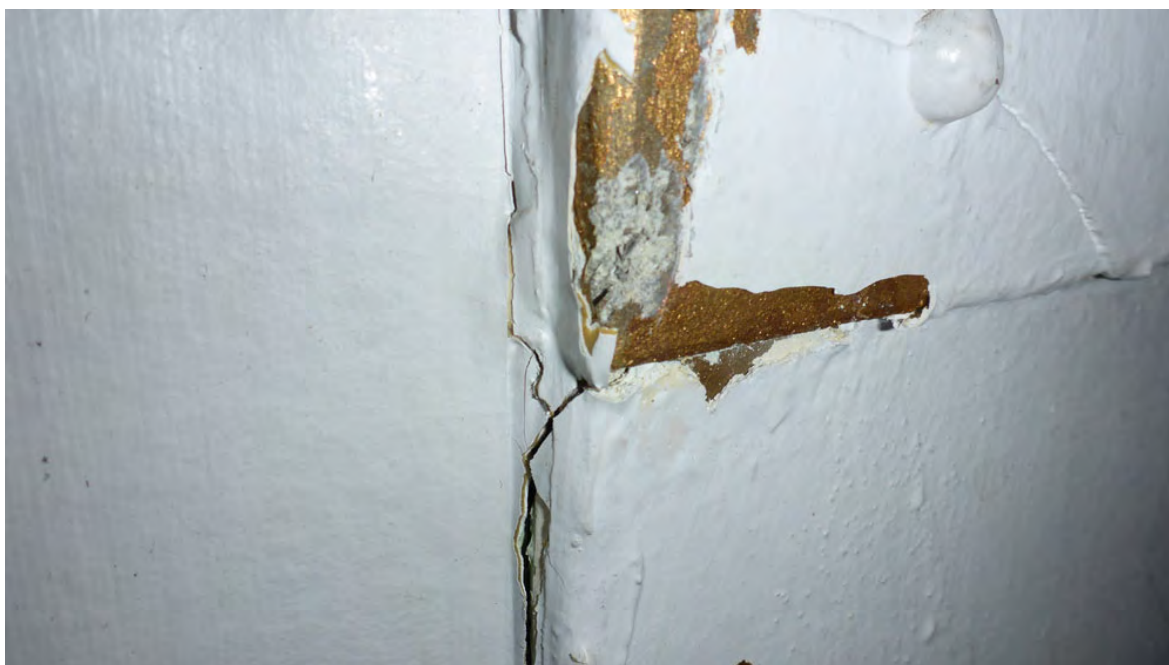
| <b>Building</b> | - Main | <b>Room</b> | - Open Plan Office |
| <b>Floor</b> | - First | <b>Position Description</b> | - An asbestos cement board panel behind the end radiator |

| <b>Asbestos Type</b> | - Chrysotile (White) | <b>Product Type</b> | - Cement Board |
| <b>Comments</b> | Approximately 1 Sq. m of asbestos cement board was identified as a panel behind the end Open Plan Office radiator. The material was visually similar to that of the Basement Safe Room vent cover and is therefore presumed to be positive for the presence of asbestos. The material should be removed and disposed of as asbestos waste prior to any works in this area. (As S# 05) | | |

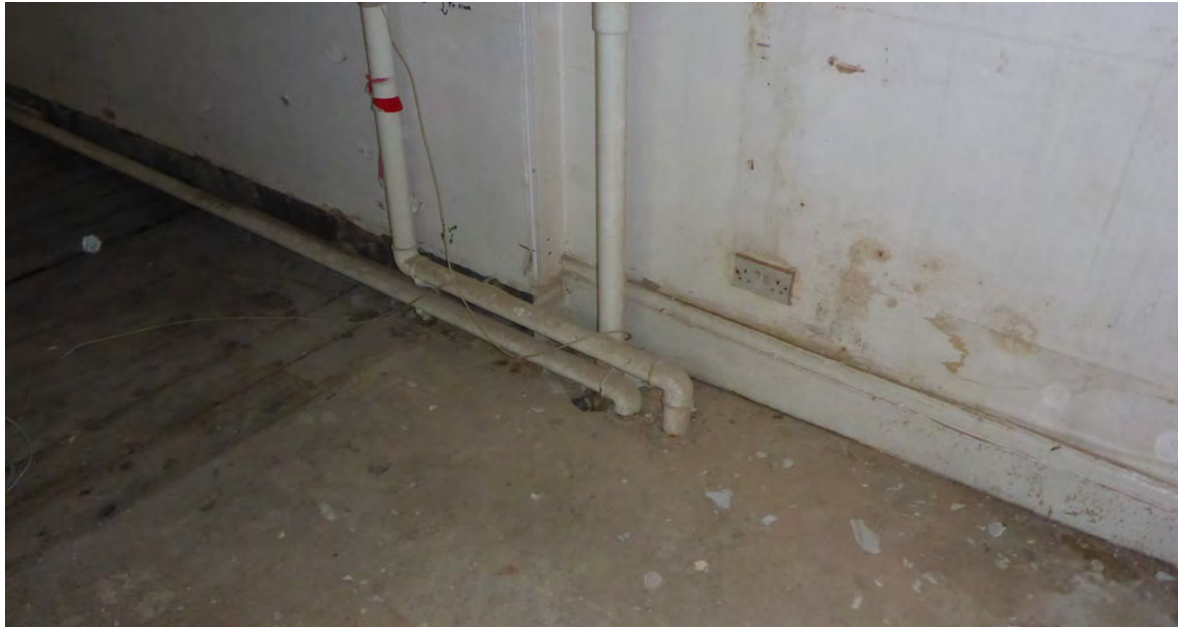
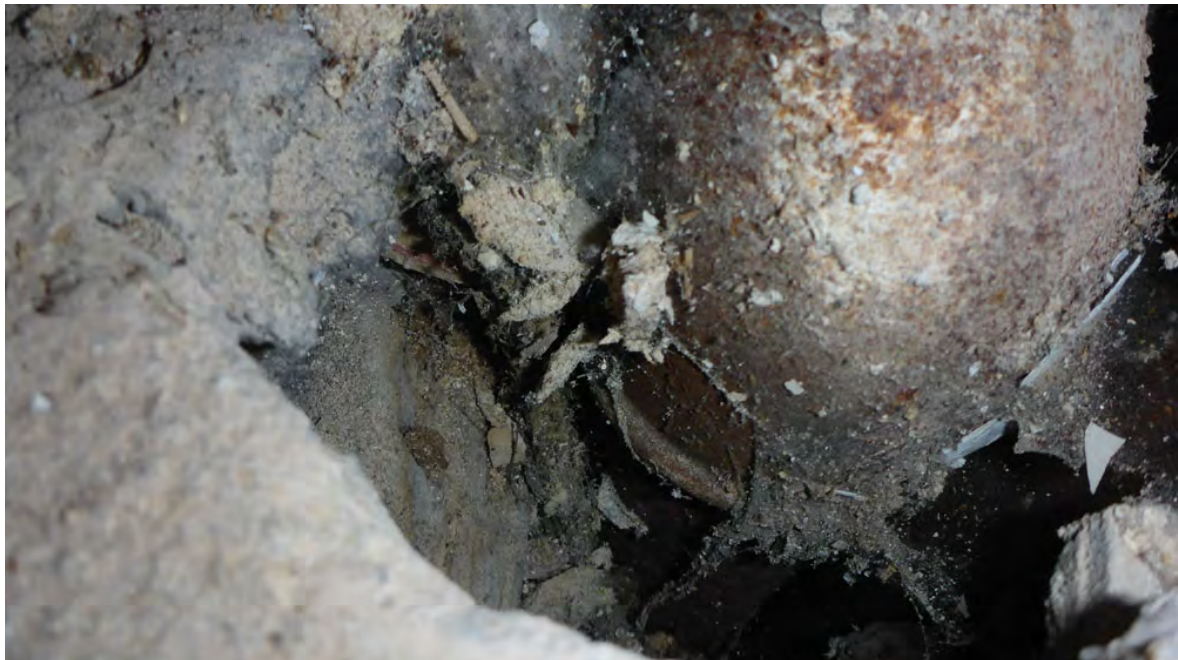
| <b>Building</b> | - Main | <b>Room</b> | - Lightwell Lobby |
| <b>Floor</b> | - First | <b>Position Description</b> | - Asbestos thermal insulation debris / residues within the floor void where pipework passes through |

| <b>Asbestos Type</b> | - Crocidolite (Blue) & Chrysotile (White) | <b>Product Type</b> | - Thermal Insulation |
| <b>Comments</b> | Asbestos thermal insulation debris / residues were identified within the Lightwell Lobby floor, seen to pass up from the lagged pipework below. The material is visually similar to that within the Ground Floor Lift Lobby and is therefore presumed to be positive for the presence of asbestos. The material should be removed by a licensed asbestos removals contractor prior to any works in this area. (As S# 21) | | |

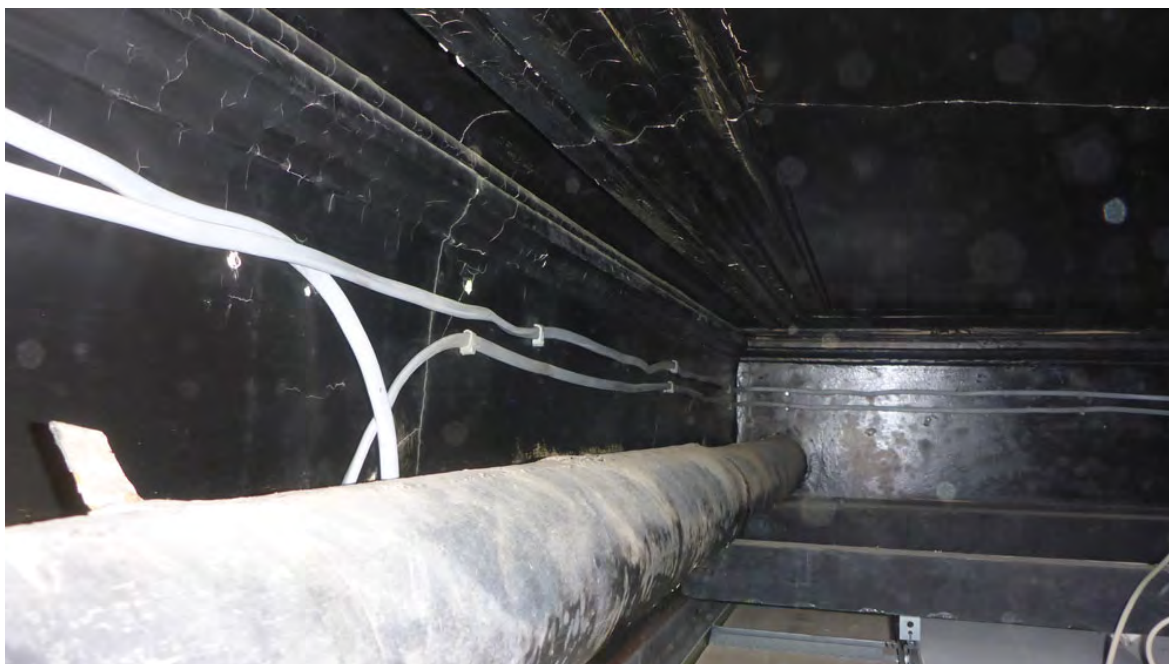
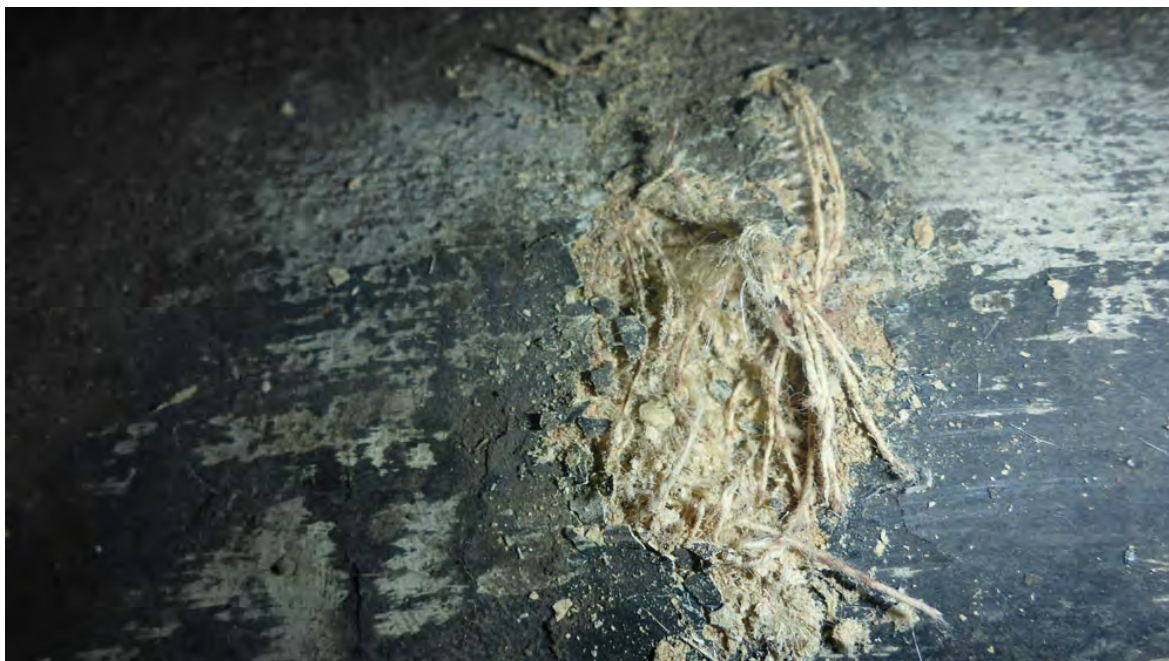
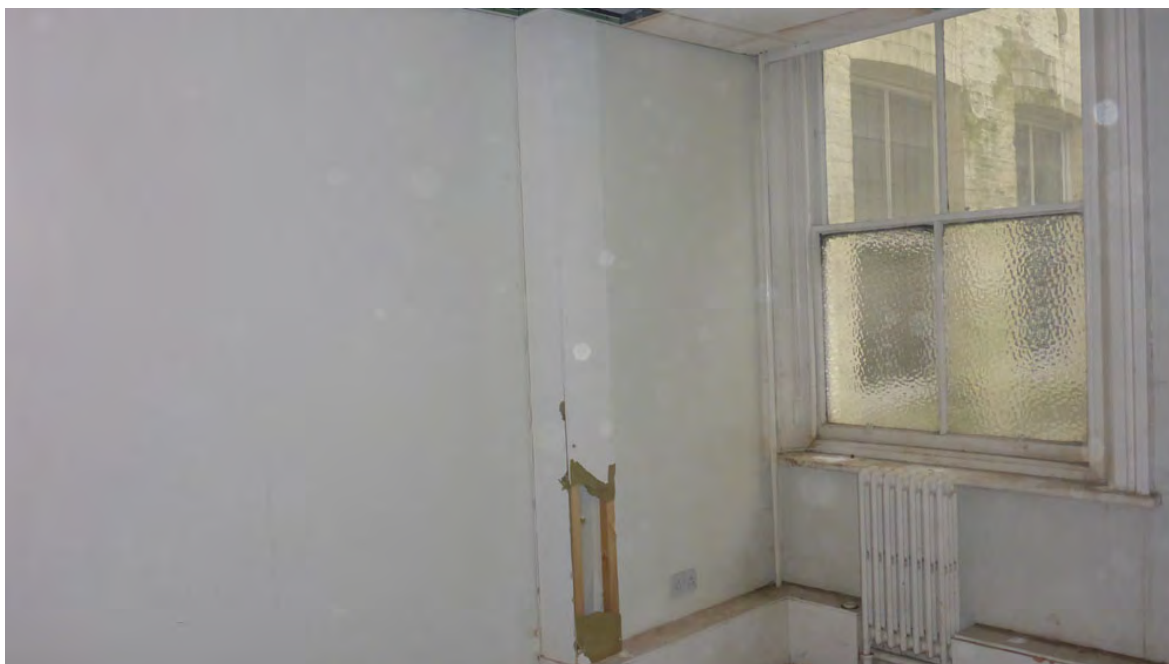
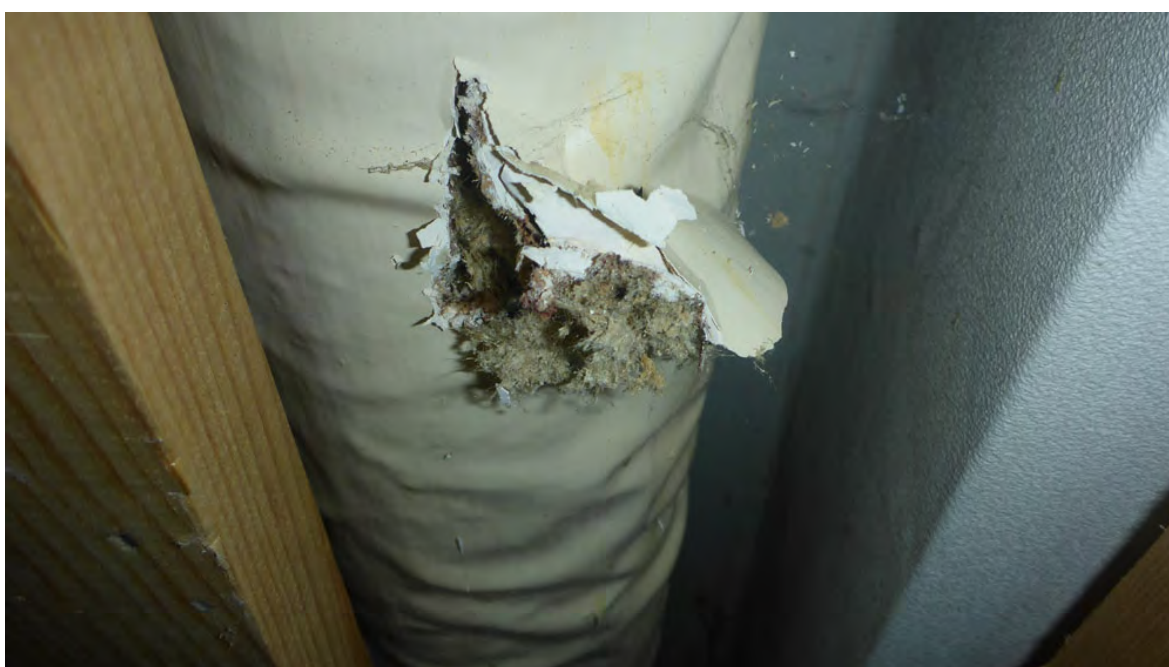
| <b>Building</b> | - Main | <b>Room</b> | - Central Kitchen |
| <b>Floor</b> | - Second | <b>Position Description</b> | - Asbestos thermal insulation to 1 No. pipe within the Ceiling Void & 1 No. vertical pipe within the left hand box-work |

| <b>Asbestos Type</b> | - Amosite (Brown) & Chrysotile (White) | <b>Product Type</b> | - Thermal Insulation |
| <b>Comments</b> | <p>Approximately 3 Lin m of asbestos thermal insulation was identified to 1 No. horizontal pipe within the Central Kitchen ceiling void, running parallel to the door, with a further 3 Lin m identified to 1 No. vertical pipe within box-work to the left hand wall. A sample of the material was analysed and the results returned were found to be positive for the presence of asbestos. The material should be removed by a licensed asbestos removals contractor prior to any works in this area. (S# 30)</p> | | |

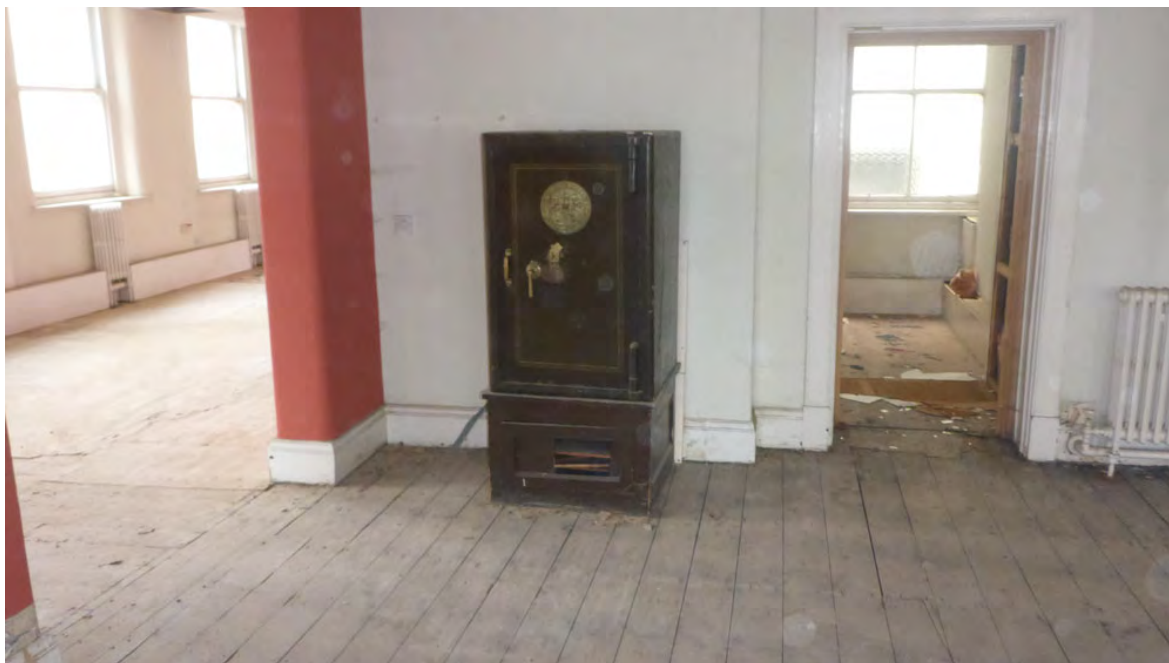
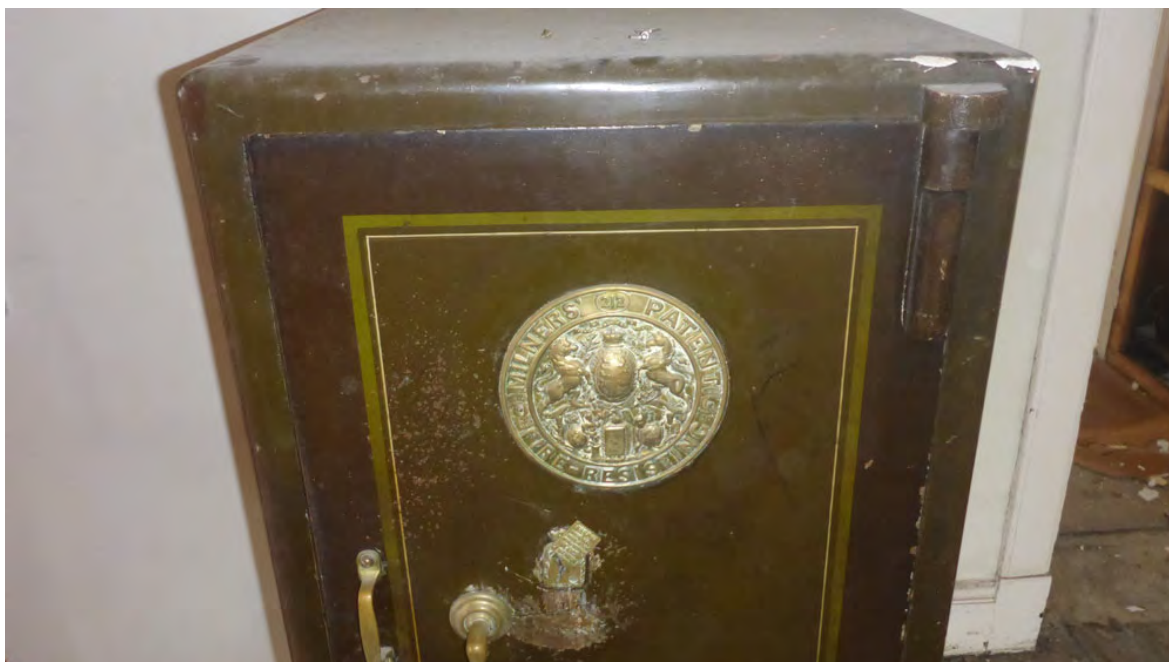
| <b>Building</b> | - Main | <b>Room</b> | - Mosley Street Large Office |
| <b>Floor</b> | - Second | <b>Position Description</b> | - Concealed asbestos componentst presumed to the safe |

| <b>Asbestos Type</b> | - Amosite (Brown) | <b>Product Type</b> | - Mattresses & Packing |
| <b>Comments</b> | 1 No. redundant safe to the Mosley Street Large Office is presumed to contain concealed asbestos components for fire protection. The safe should be removed whole and disposed of as asbestos waste prior to any works in this area. | | |
