# Method Statement for Soft Strip Works

**79 Mosley Street  
St Peters Square  
Manchester**

Method statement for Investigative Works and Soft Strip works at No. 79 Mosley Street.

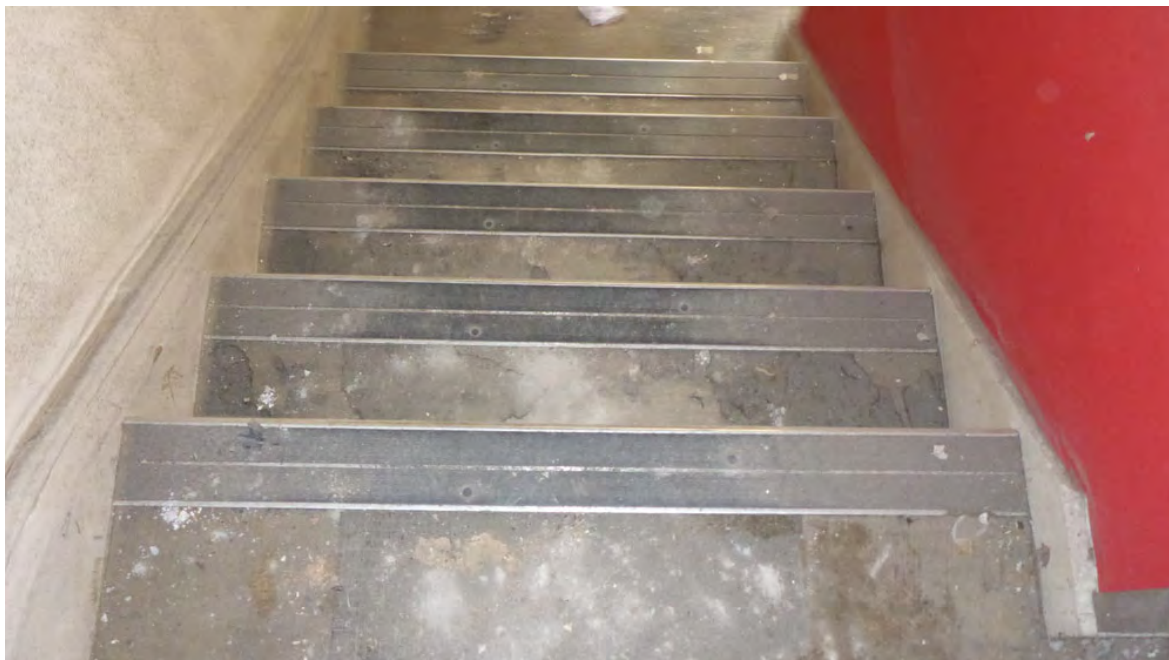
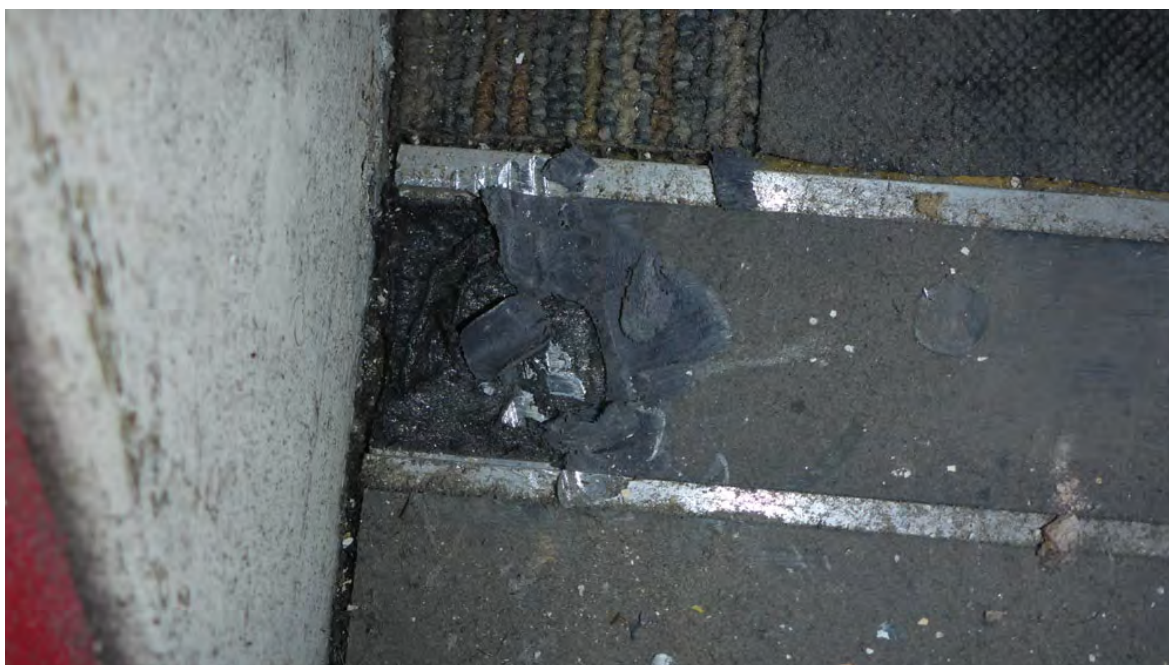
| <b>Building</b> | - Main | <b>Room</b> | - Throughout |
| <b>Floor</b> | - Throughout | <b>Position Description</b> | - Non-asbestos stair nosings throughout |

| <b>Asbestos Type</b> | - No Asbestos Detected | <b>Product Type</b> | - Stair Nosing |
| <b>Comments</b> | Non-asbestos stair nosings were identified to stairs throughout the building. A sample of the material was analysed and the results returned were found to be negative for the presence of asbestos. No further action is required for this material, it is mentioned for identification purposes only. (S# 33) | | |

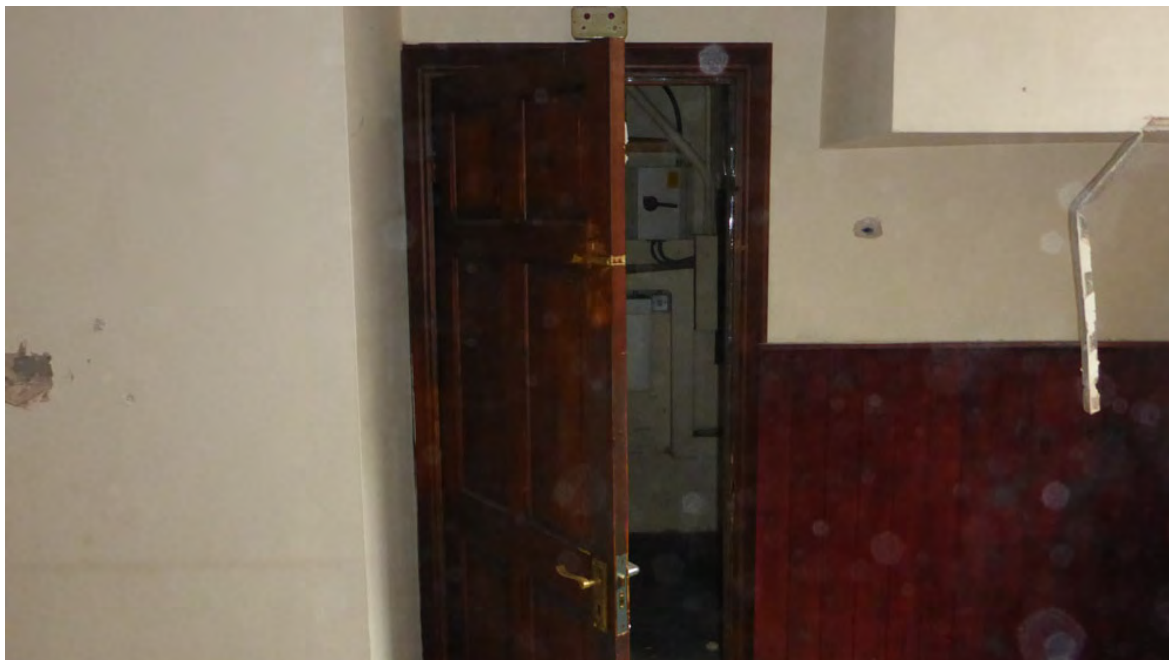
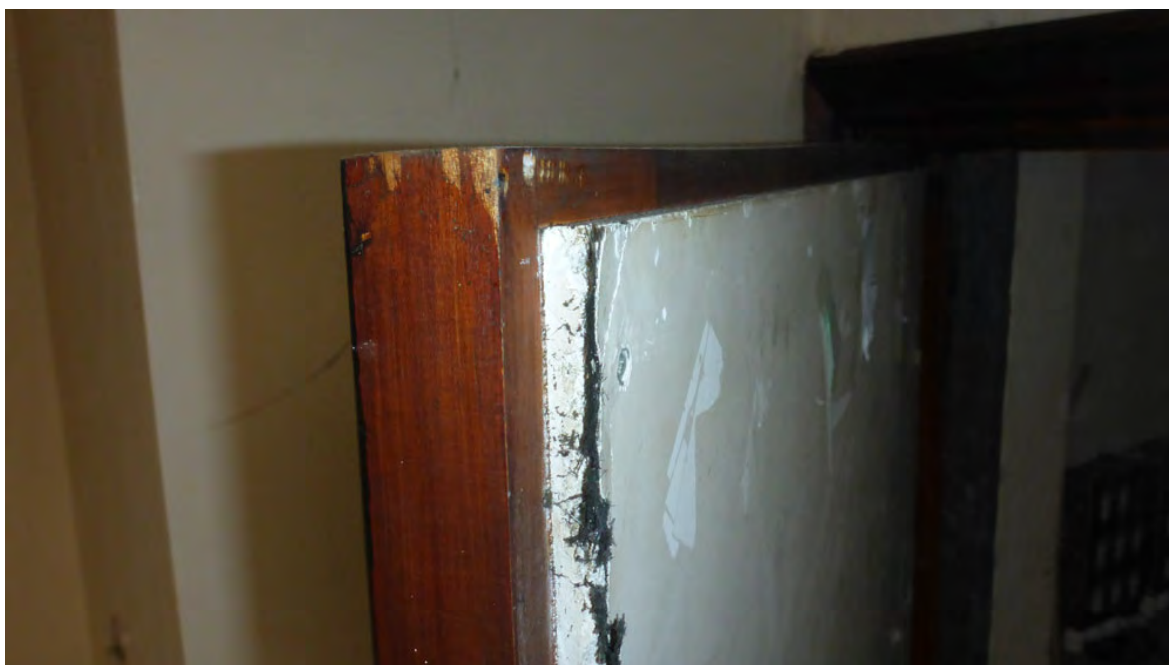
| <b>Building</b> | - Main | <b>Room</b> | - Restaurant Electrics Room |
| <b>Floor</b> | - Basement | <b>Position Description</b> | - A non-asbestos insulation board lining to the door |

| <b>Asbestos Type</b> | - No Asbestos Detected | <b>Product Type</b> | - Insulation Board |
| <b>Comments</b> | Non-asbestos insulation board was identified as a lining to the Restaurant Electrics room door. A sample of the material was analysed and the results returned were found to be negative for the presence of asbestos. No further action is required for this material, it is mentioned for identification purposes only. (S# 03) | | |

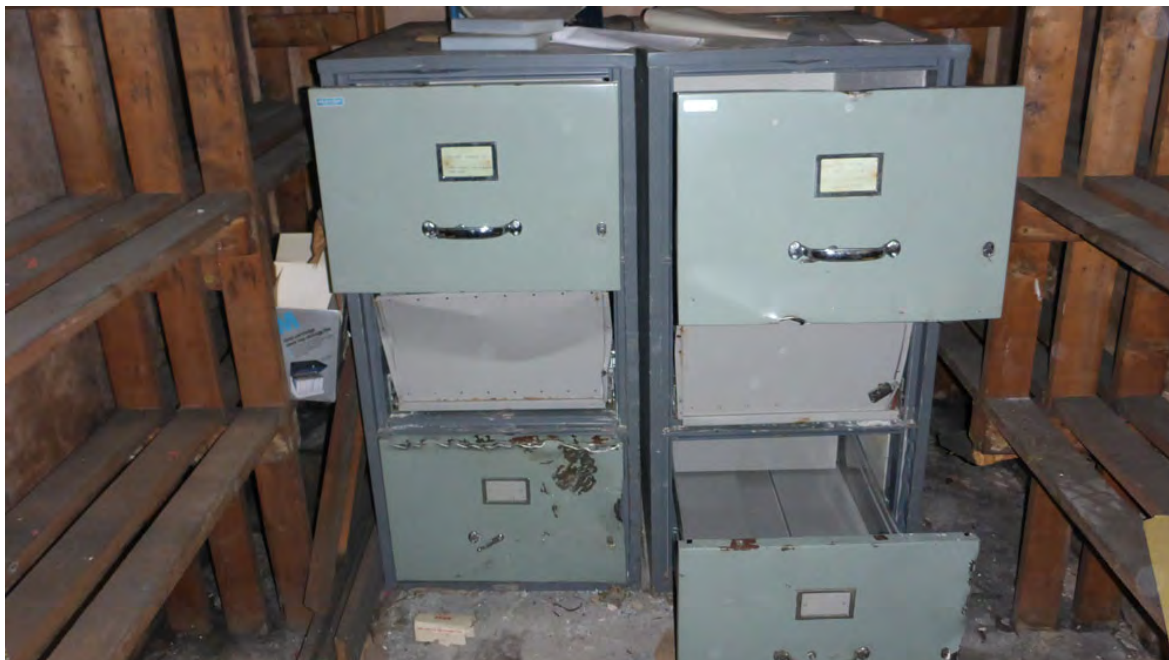
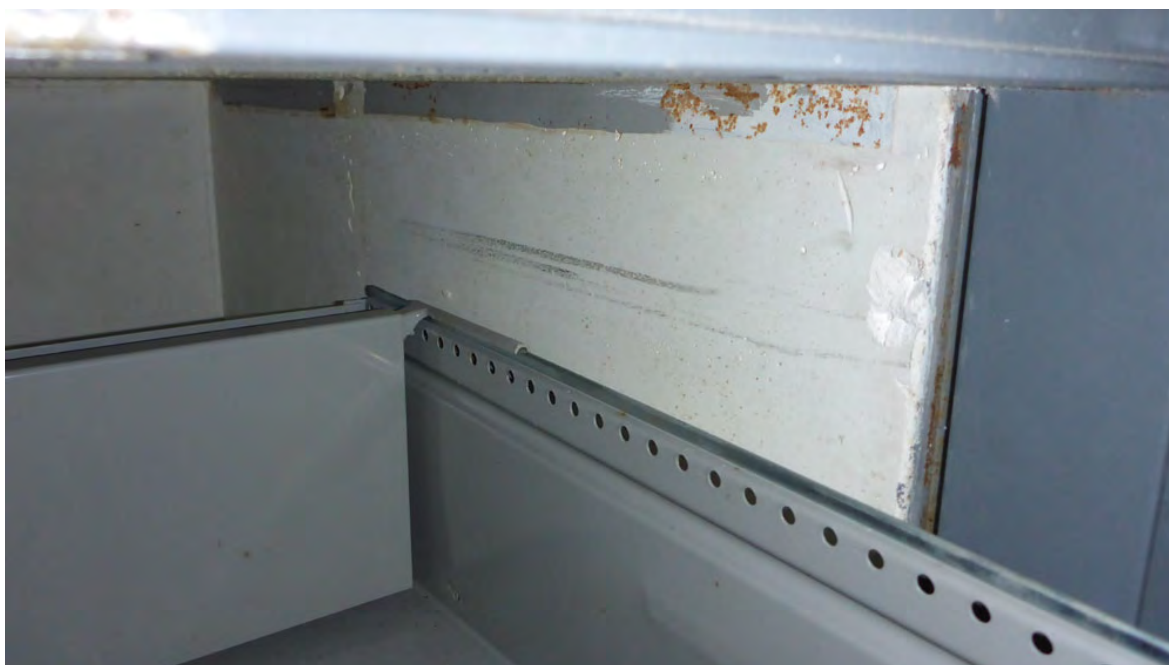
| <b>Floor</b> | - Basement | <b>Position Description</b> | - A non-asbestos insulation board internal lining to 2 No. filing cabinets |

| <b>Comments</b> | Non-asbestos insulation board was identified as an internal lining to 2 No. Safe Room filing cabinets. A sample of the material was analysed and the results returned were found to be negative for the presence of asbestos. No further action is required for this material, it is mentioned for identification purposes only. (S# 06) | | |

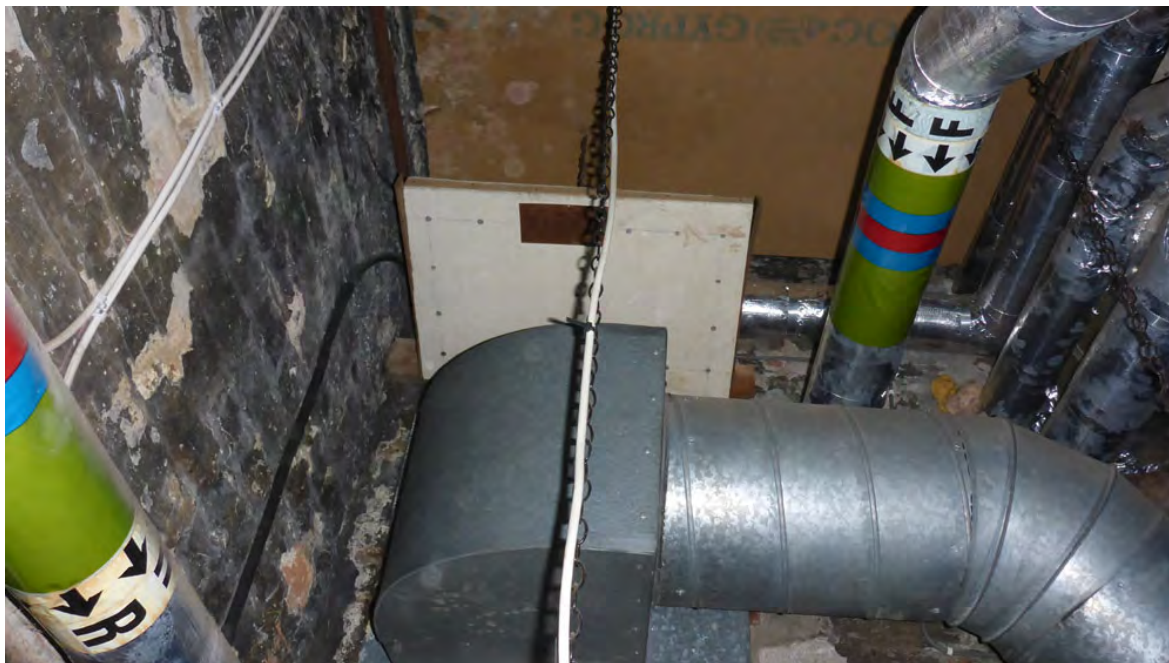
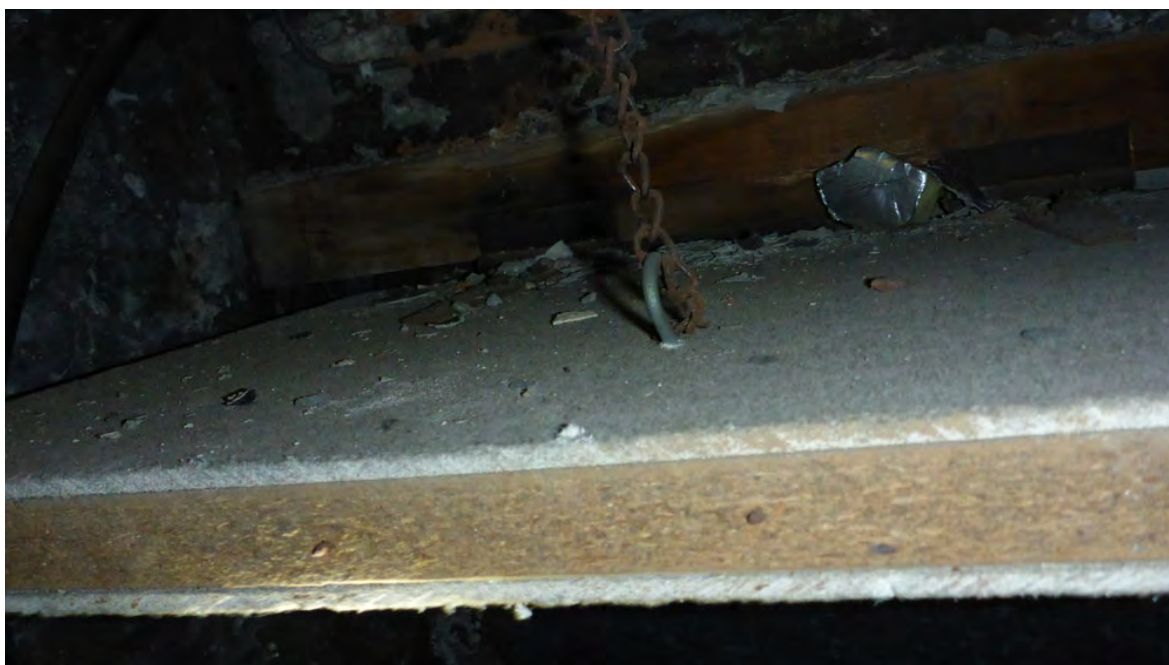
| <b>Floor</b> | - Basement | <b>Position Description</b> | - A non-asbestos insulation board lining to the high level shelf above the door |

| <b>Comments</b> | Non-asbestos insulation board was identified as a lining to a high level Plant Room shelf, above the door. A sample of the material was analysed and the results returned were found to be negative for the presence of asbestos. No further action is required for this material, it is mentioned for identification purposes only. (S# 15) | | |

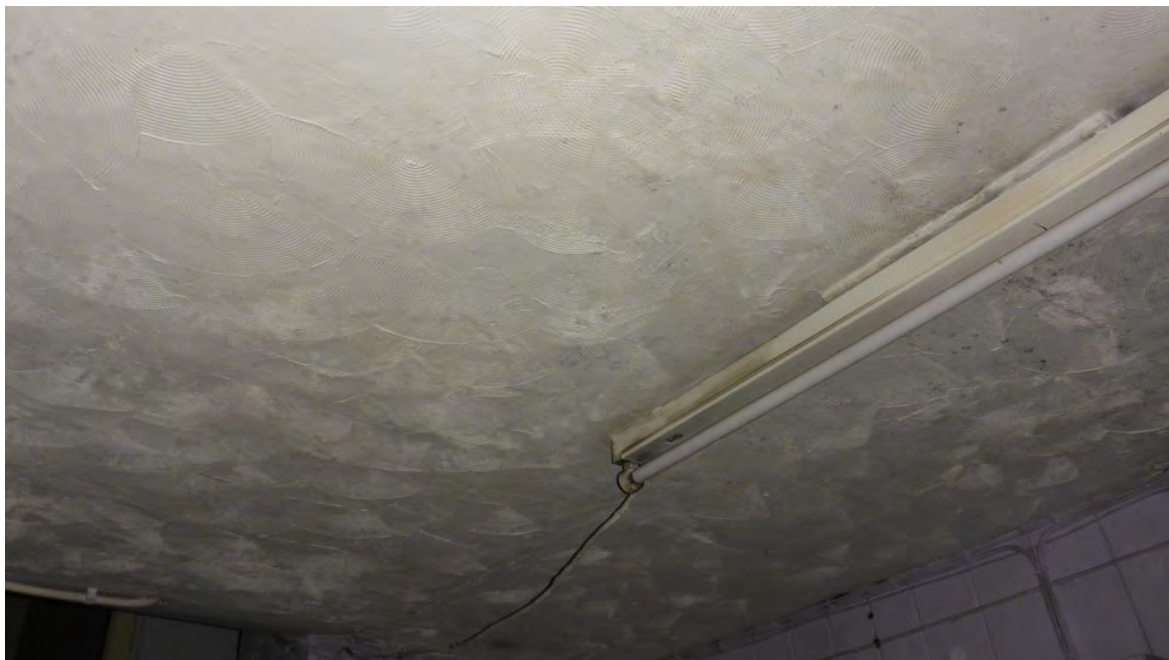
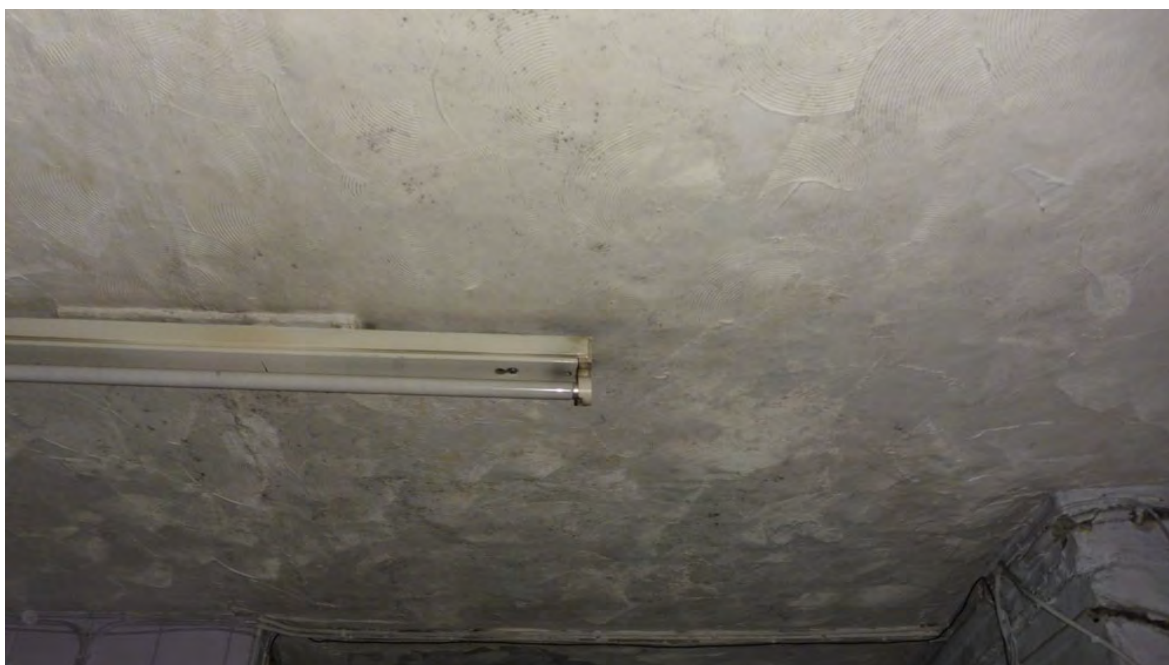
| <b>Floor</b> | - Basement | <b>Position Description</b> | - A non-asbestos textured coating to the ceiling |

| <b>Comments</b> | Non-asbestos textured coatings were identified to the ceiling of the basement Toilet and Toilet Lobby. No further action is required for this material, it is mentioned for identification purposes only. (S# 01; Certificate No. 1811350) | | |

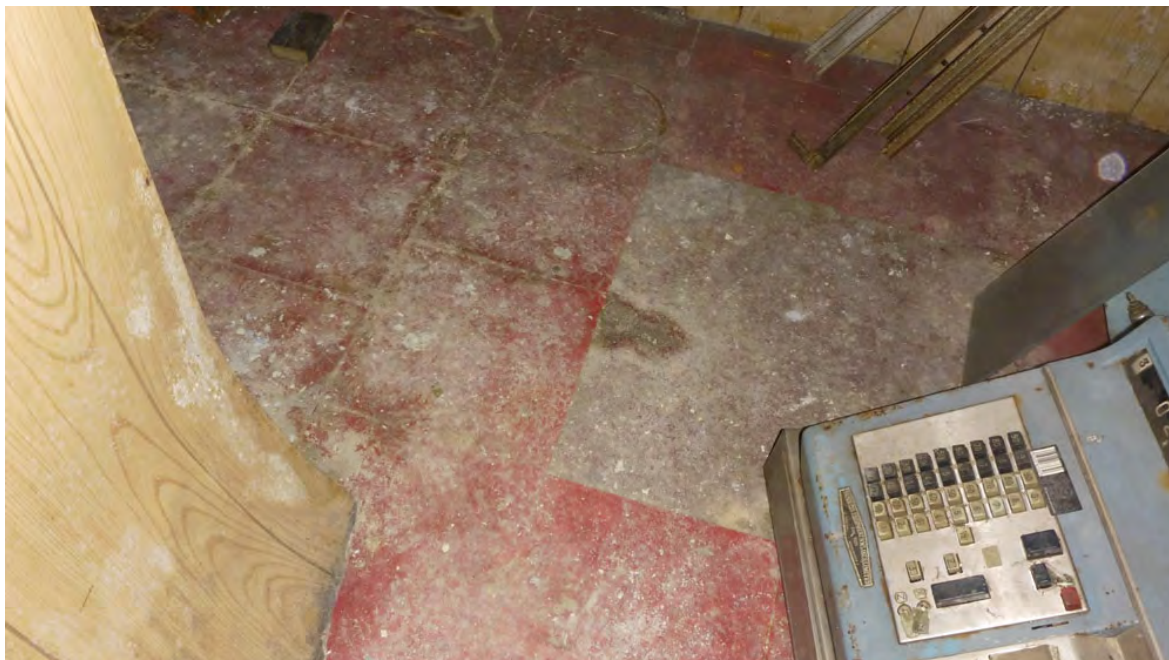
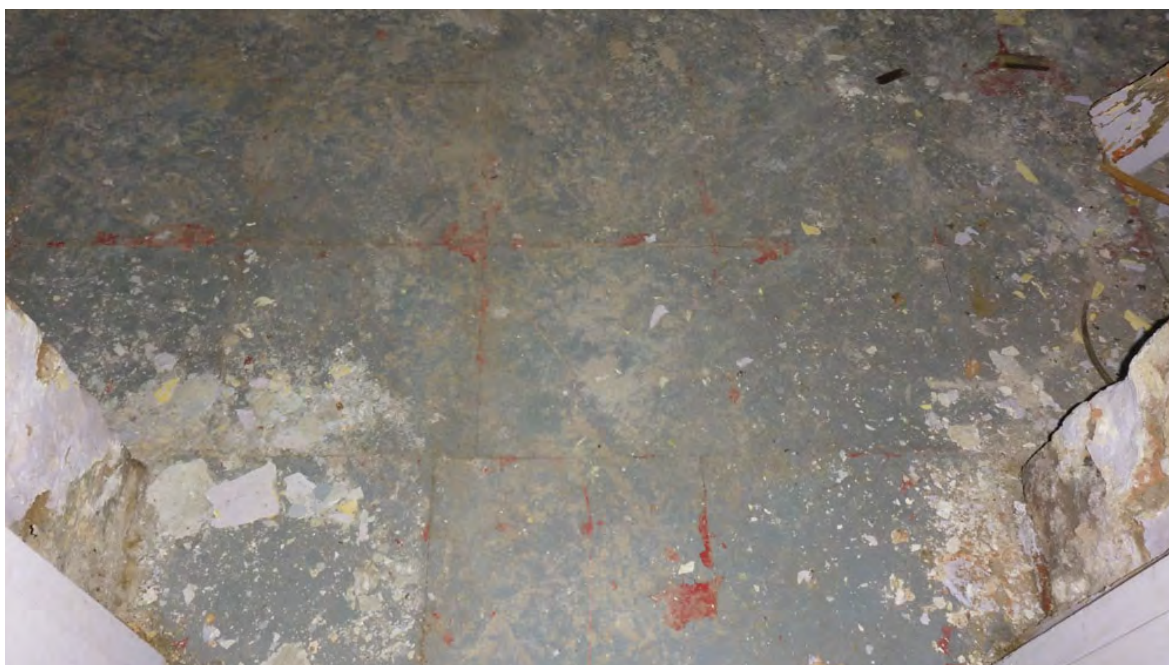
| <b>Floor</b> | - Basement | <b>Position Description</b> | - A non-asbestos red floor tiles throughout |

| <b>Comments</b> | Non-asbestos red floor tiles were identified within the basement Toilet, Toilet Lobby and Wash Room. No further action is required for this material, it is mentioned for identification purposes only. (S# 02; Certificate No. 1811350) | | |

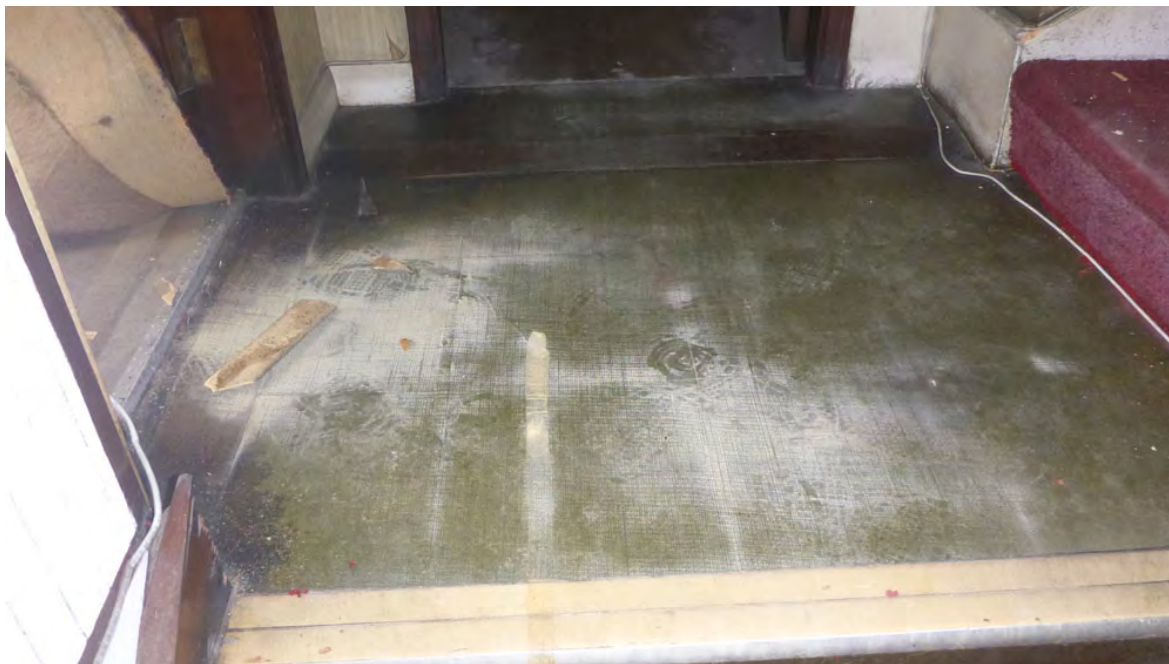
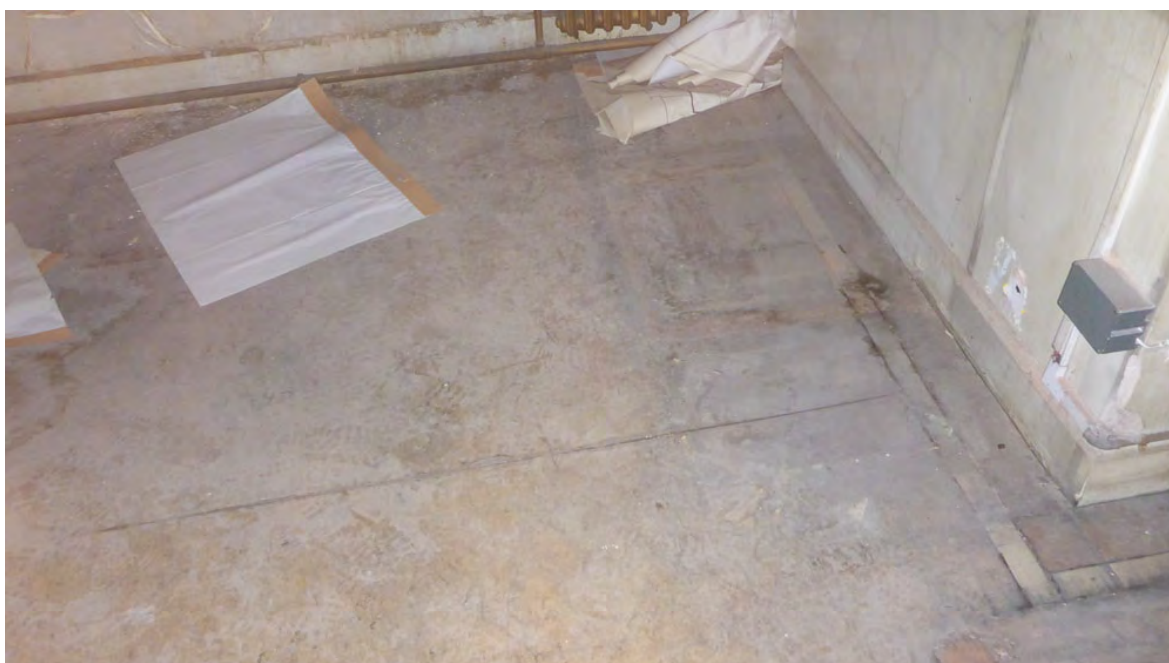
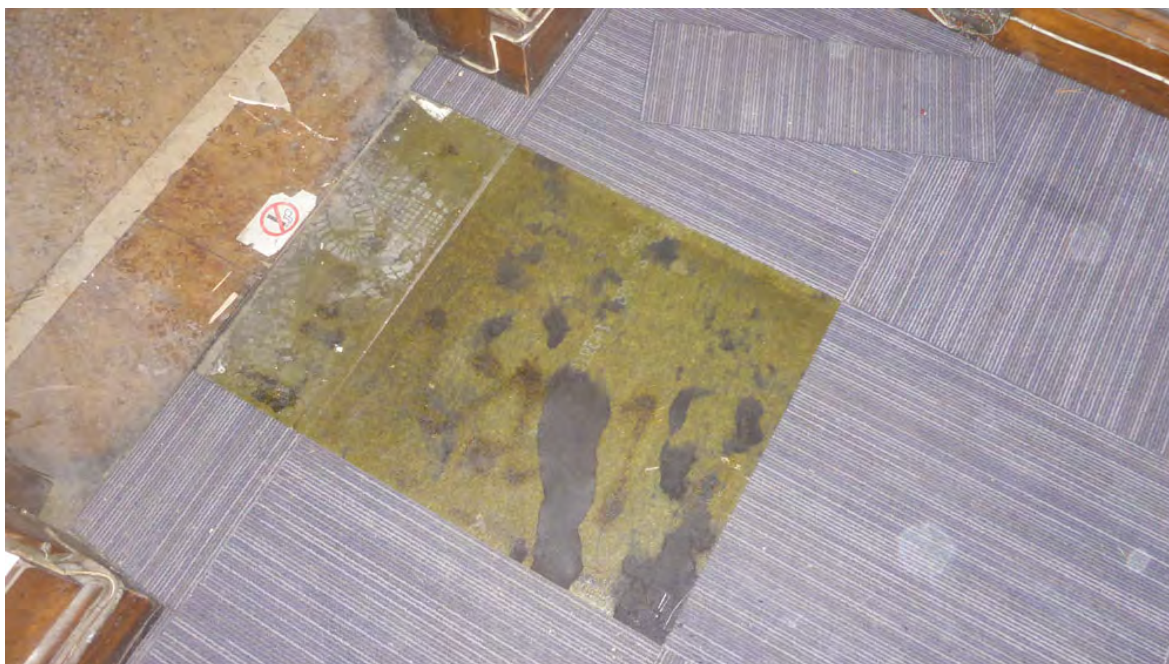
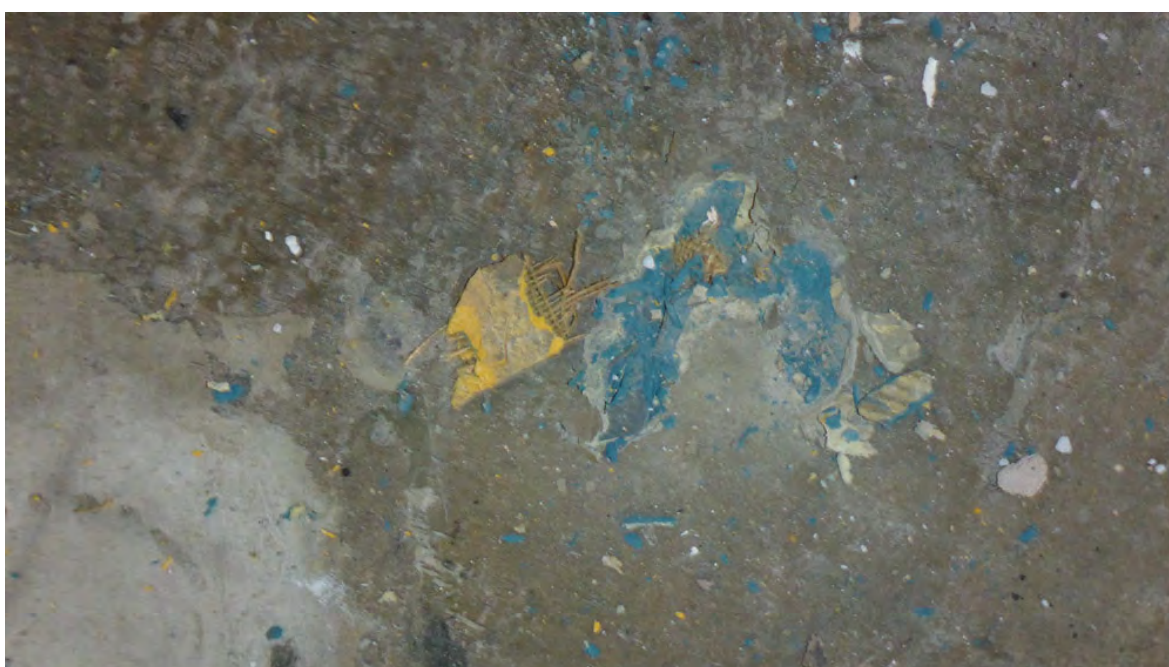
| <b>Floor</b> | - Ground | <b>Position Description</b> | - Non-asbestos green, brown, yellow and blue vinyl / floor tiles |

| <b>Comments</b> | <p>Green, brown, yellow and blue vinyl / floor tiles were identified as primary floor coverings and beneath existing floor coverings to a number of areas throughout the Ground Floor. Samples of the materials were analysed and the results returned were all found to be negative for the presence of asbestos. No further action is required for this material, it is mentioned for identification purposes only. (S# 18, 19, 23, 24)</p> | | |

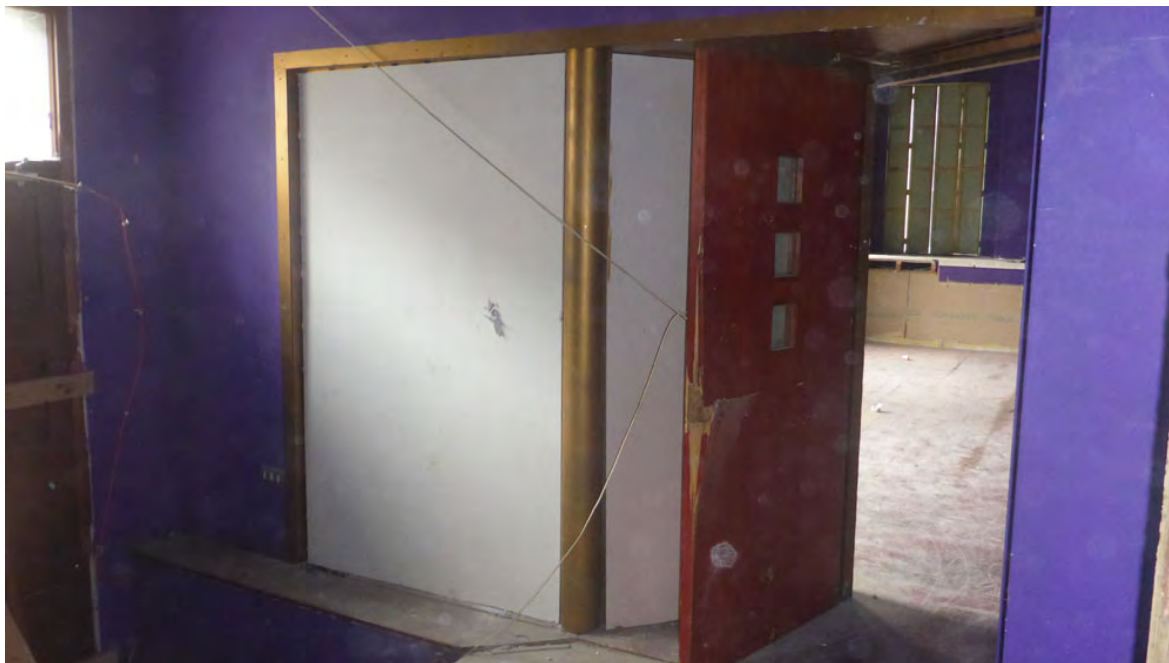
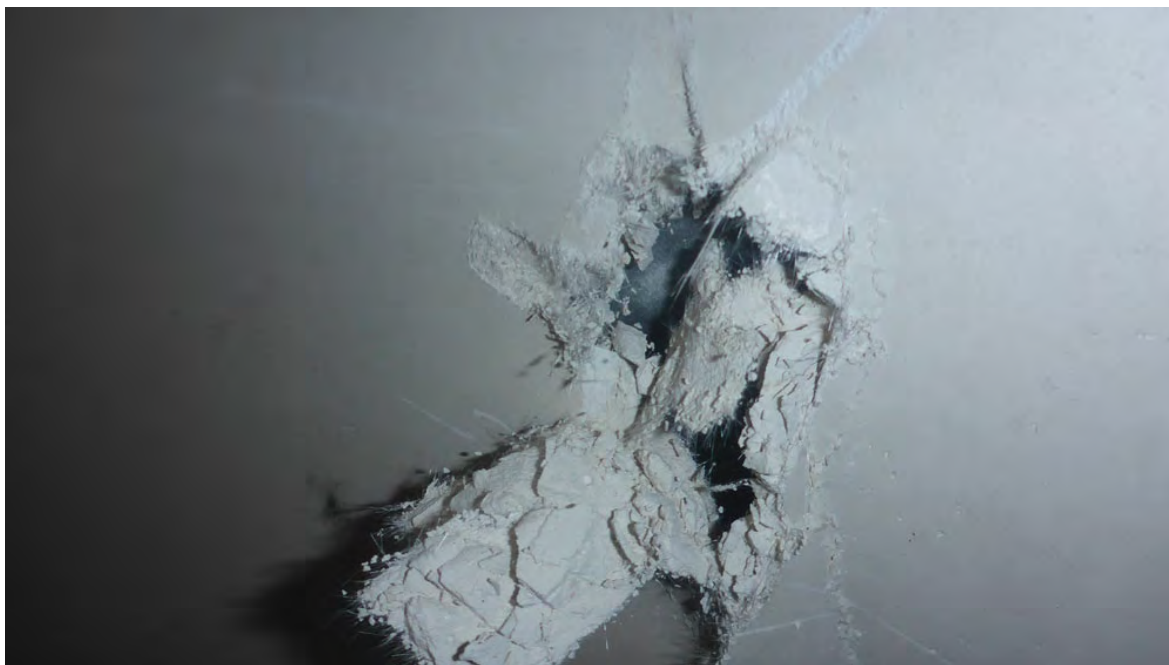
| <b>Floor</b> | - Ground | <b>Position Description</b> | - Non-asbestos insulation board to the stairs left hand side partition |

| <b>Comments</b> | <p>Non-asbestos insulation board was identified as a partition wall to the left of the Princess Street Entrance stairs. A sample of the material was analysed and the results returned were found to be negative for the presence of asbestos. No further action is required for this material, it is mentioned for identification purposes only. (S# 20)</p> |

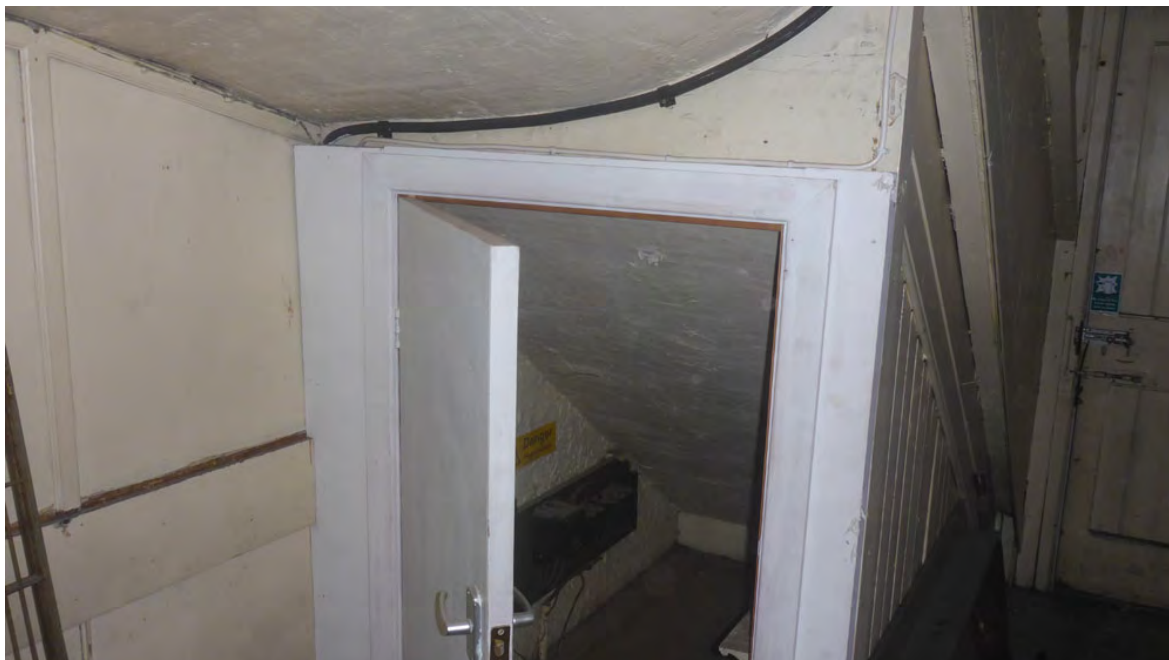
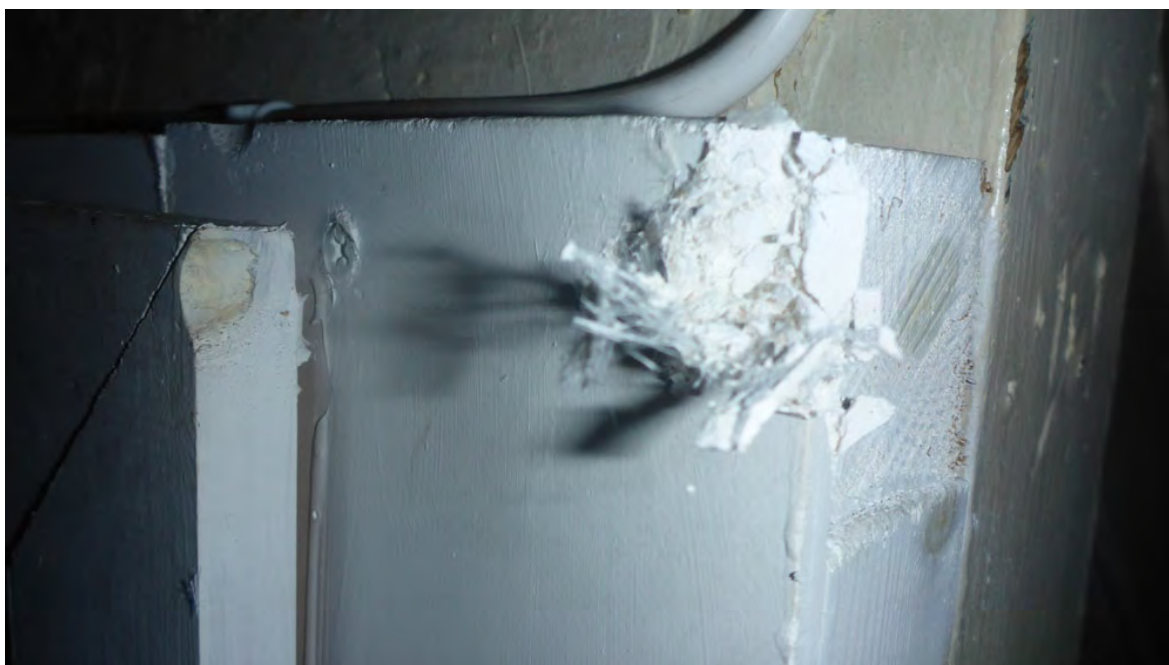
| <b>Floor</b> | - Ground | <b>Position Description</b> | - Non-asbestos insulation board to the door surround |

| <b>Comments</b> | <p>Non-asbestos insulation board was identified as a door surround to the Rear Fire Exit Store. The material is visually similar to Princess Street Entrance partition and is therefore presumed to be negative for the presence of asbestos. No further action is required for this material, it is mentioned for identification purposes only. (As S# 20)</p> |

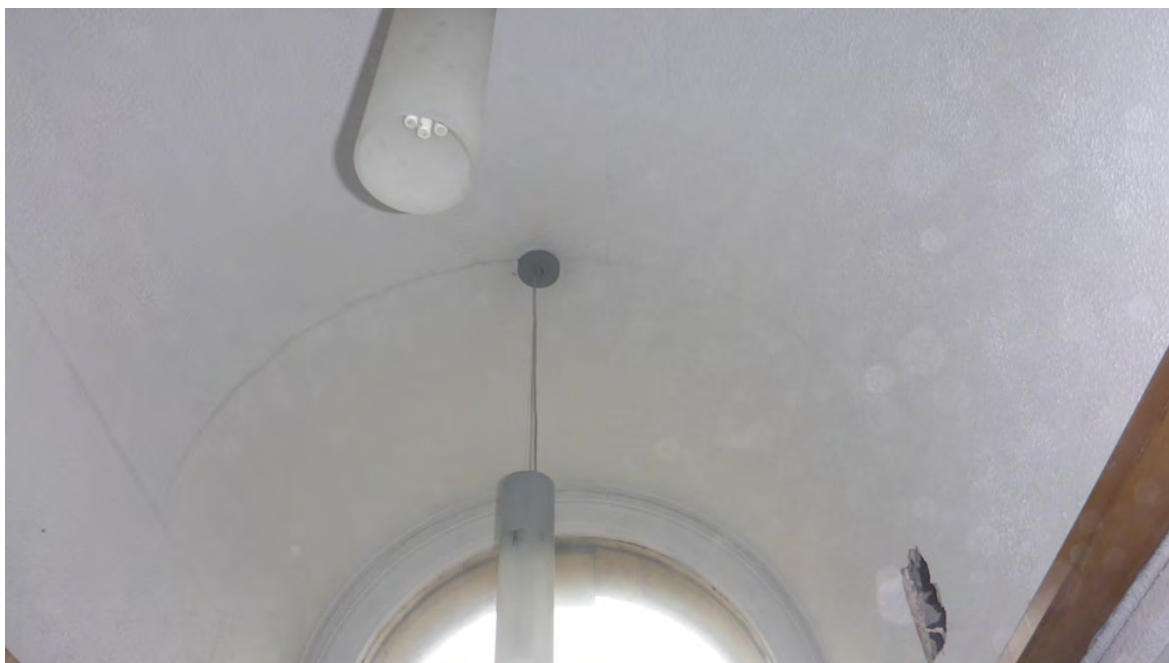
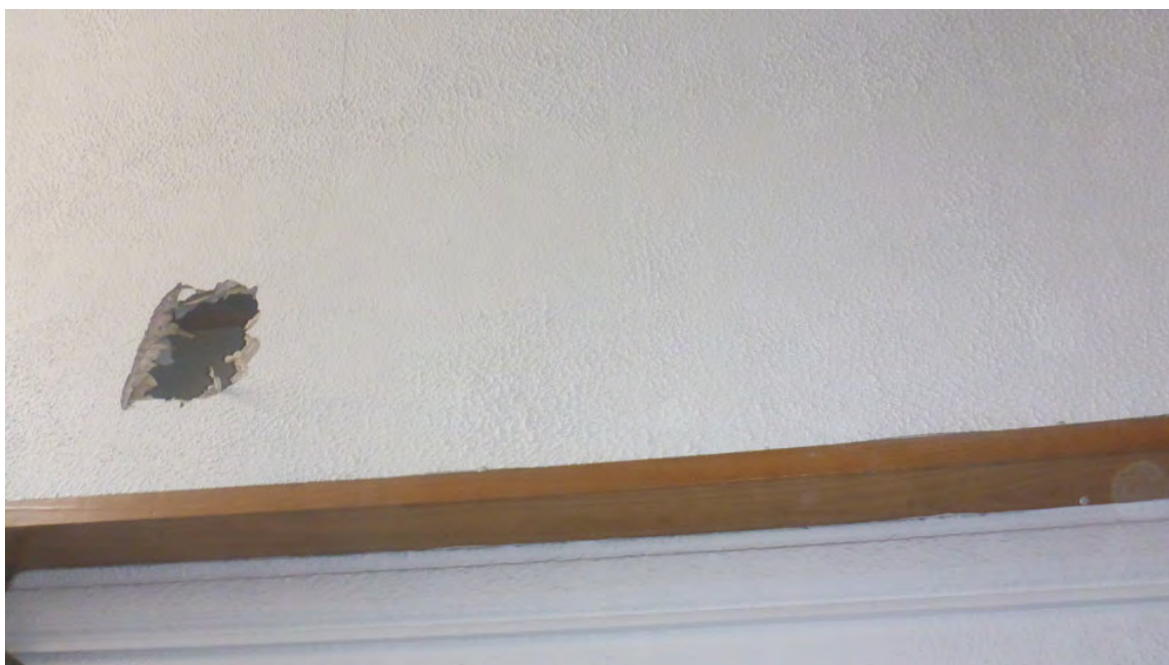
| <b>Floor</b> | - Ground | <b>Position Description</b> | - Non-asbestos textured coating to the ceiling |

| <b>Comments</b> | Non-asbestos textured coating was identified to the Mosley Street Side Entrance Lobby ceiling. A sample of the material was analysed and the results returned were found to be negative for the presence of asbestos. No further action is required for this material, it is mentioned for identification purposes only. (S# 22) | | |

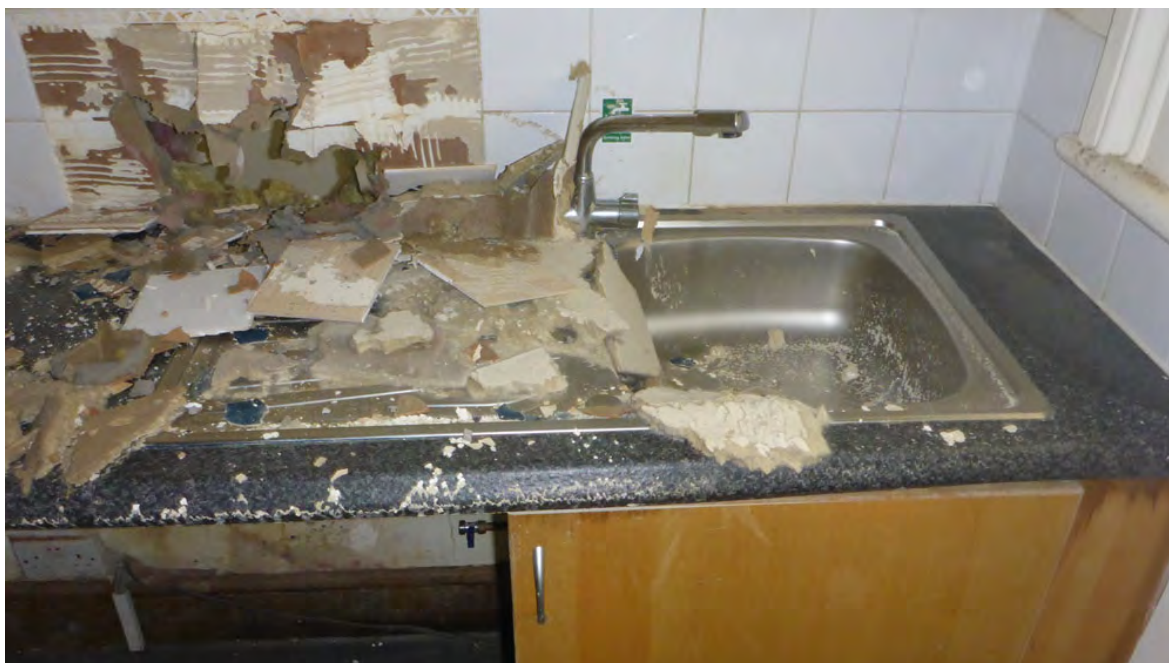
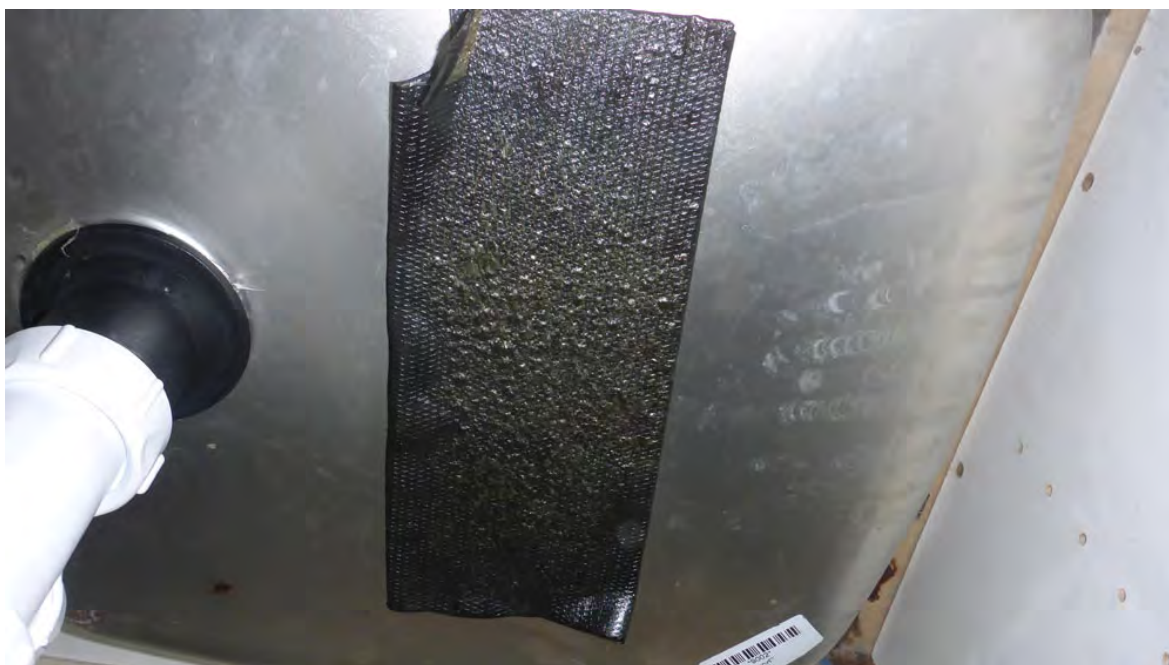
| <b>Floor</b> | - Ground | <b>Position Description</b> | - A non-asbestos sink pad to the sink unit |

| <b>Comments</b> | A non-asbestos sink pad was identified to the Central Kitchen sink unit. The material is known to be negative for the presence of asbestos, however it is commonly mistaken for an ACM. No further action is required for this material, it is mentioned for identification purposes only. | | |

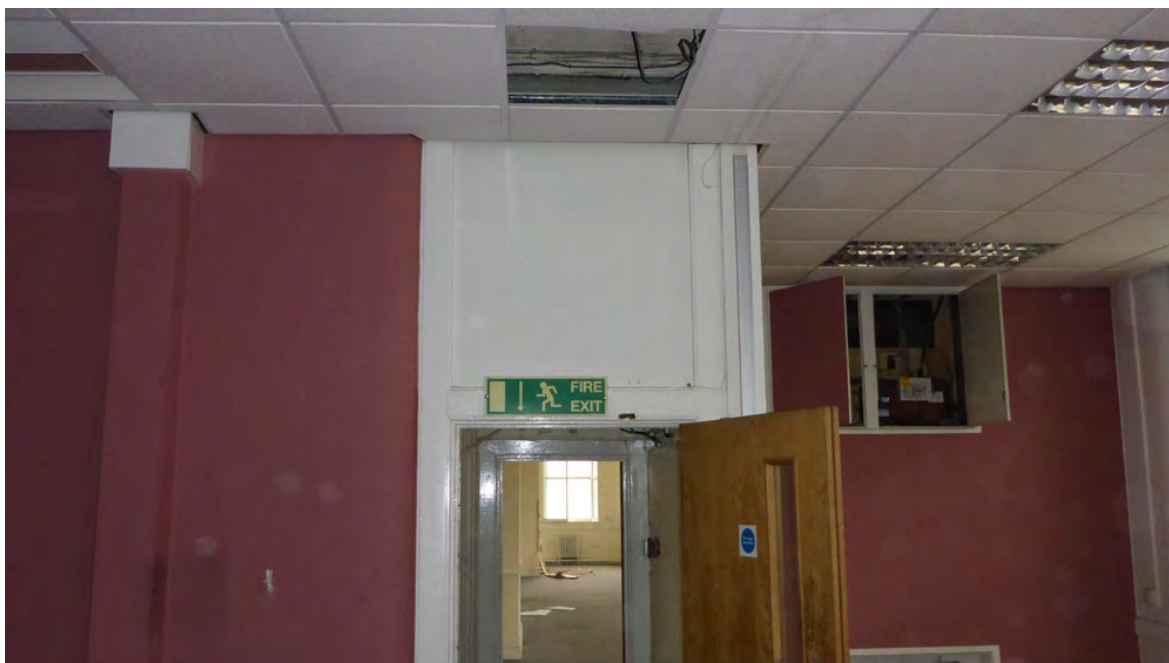
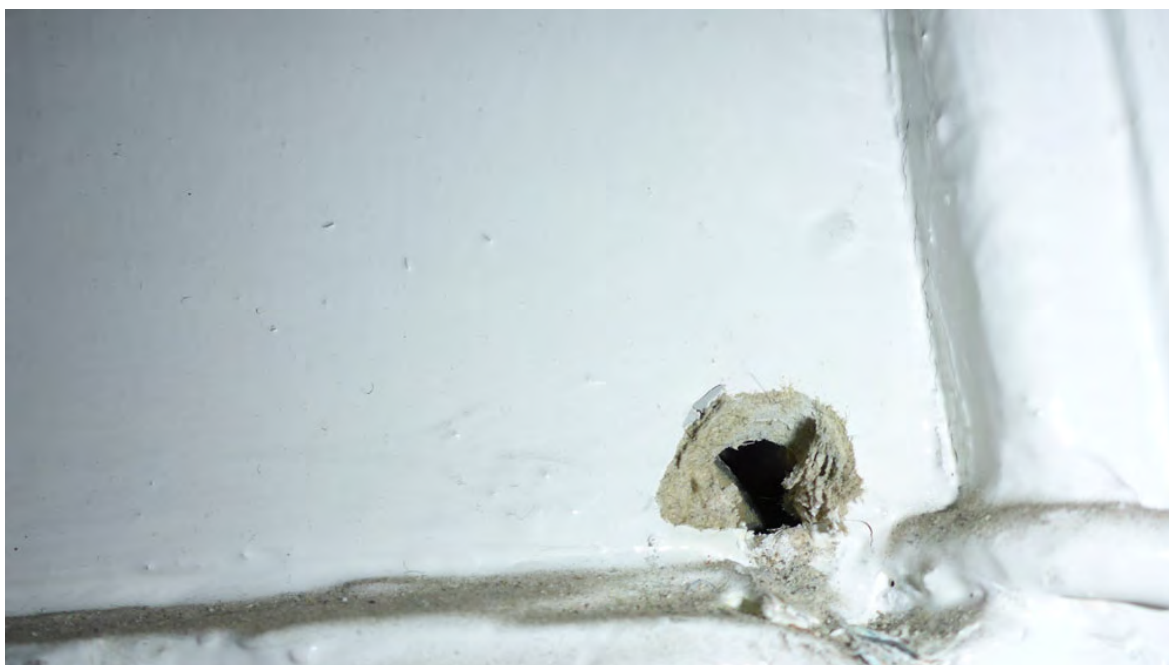
| <b>Floor</b> | - First | <b>Position Description</b> | - A non-asbestos cement board door head |

| <b>Comments</b> | Non-asbestos cement board was identified as a door head to the Open Plan Office / Main Staircase door. A sample of the material was analysed and the results returned were found to be negative for the presence of asbestos. No further action is required for this material, it is mentioned for identification purposes only. (S# 25) | | |
