# Method Statement for Soft Strip Works

**79 Mosley Street  
St Peters Square  
Manchester**

Method statement for Investigative Works and Soft Strip works at No. 79 Mosley Street.

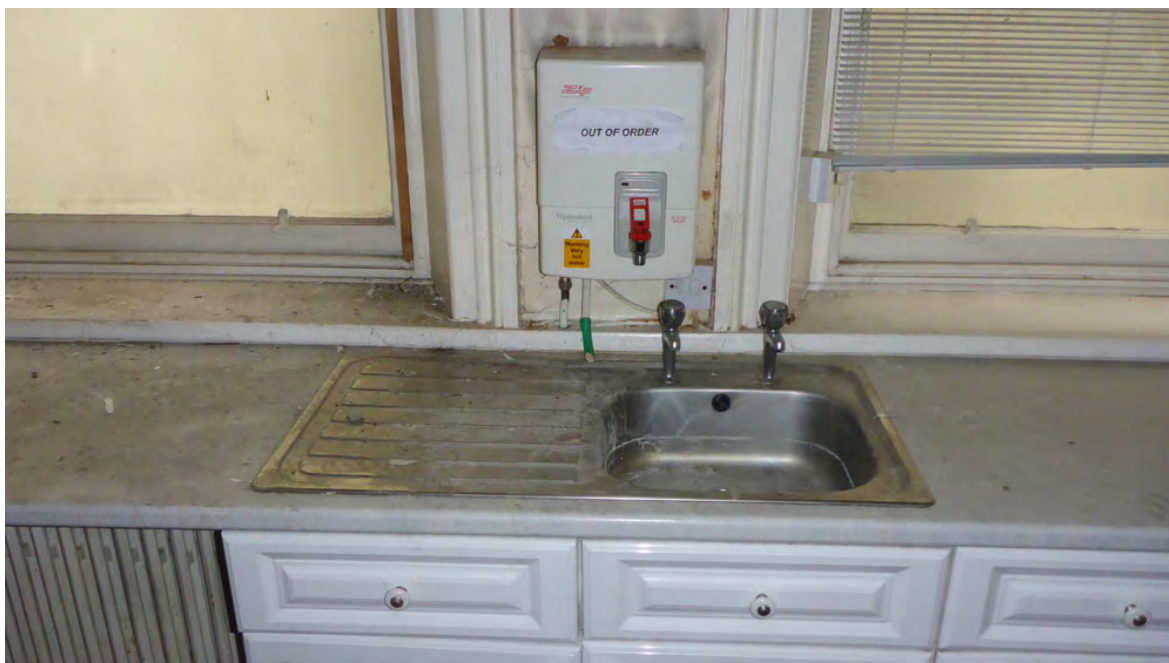
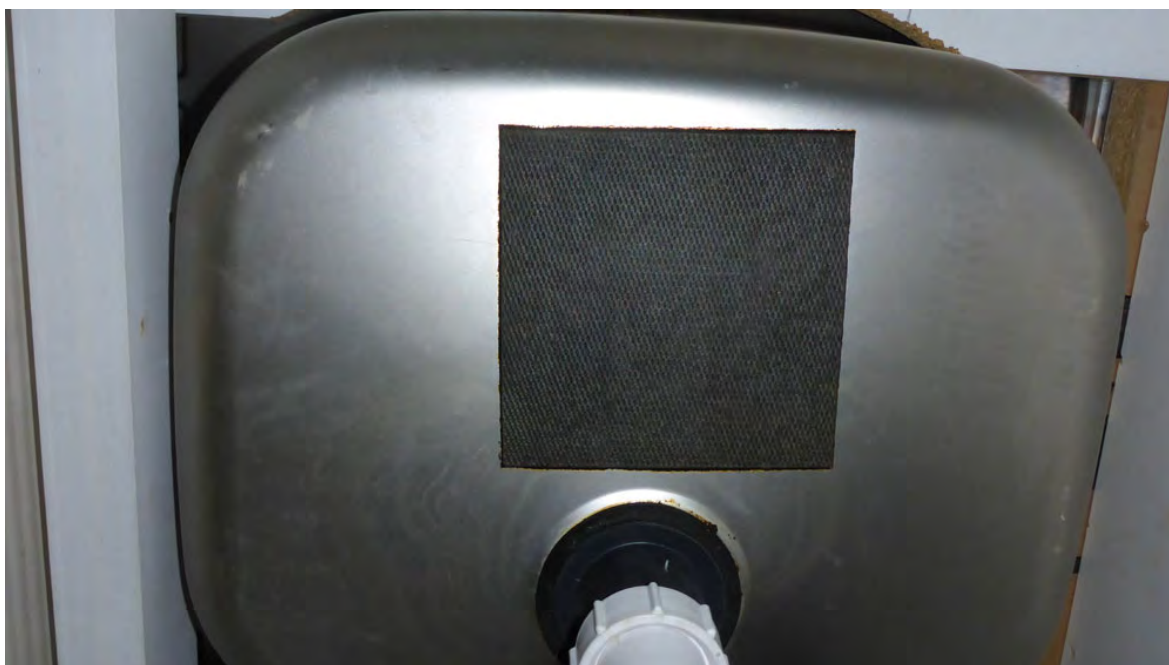
| <b>Floor</b> | - First | <b>Position Description</b> | - A non-asbestos sink pad to the sink unit |

| <b>Comments</b> | A non-asbestos sink pad was identified to the Central Kitchen sink unit. A sample of the material was analysed and the results returned were found to be negative for the presence of asbestos. No further action is required for this material, it is mentioned for identification purposes only. (S# 26) | | |

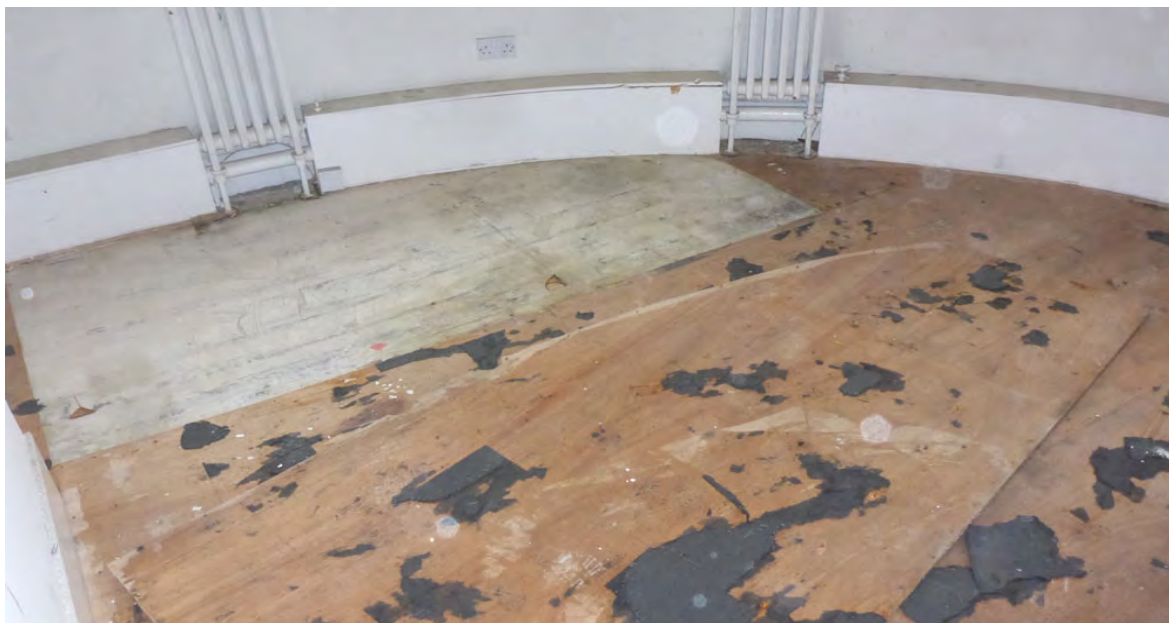
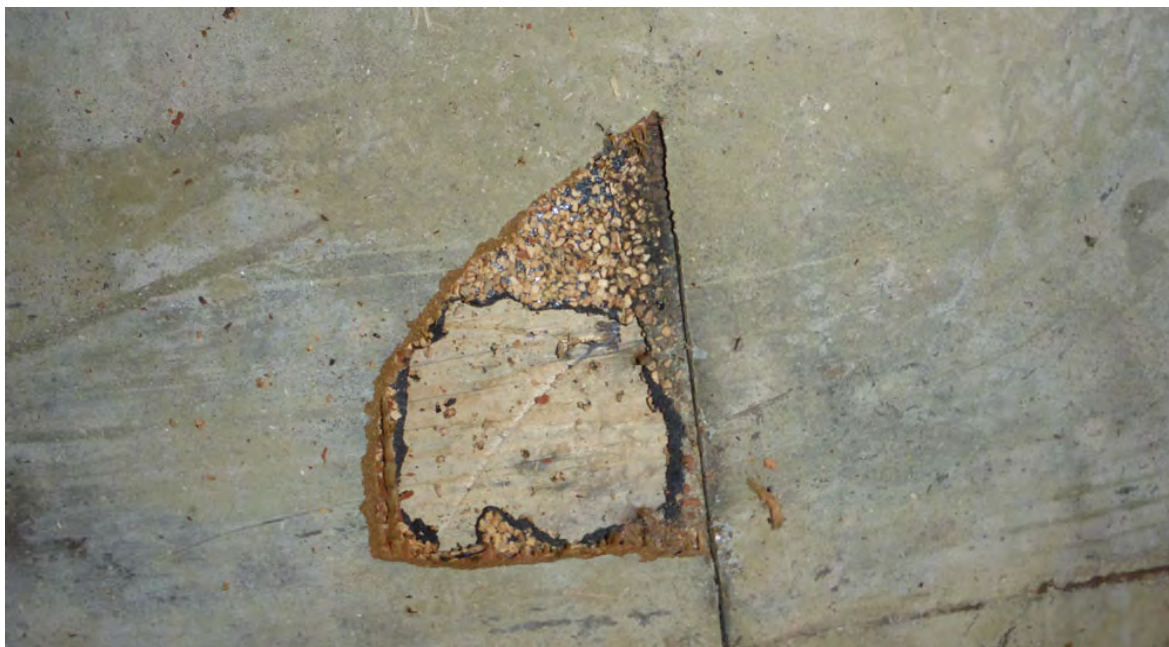
| <b>Floor</b> | - Second | <b>Position Description</b> | - Non-asbestos vinyl to the floor beneath the wooden floor, with a non-asbestos bitumen underlining |

| <b>Comments</b> | A non-asbestos vinyl and bitumen underlining was identified to the Mosley / Princess Street Corner Office, beneath the wooden floor. This is typical of numerous floor areas throughout the building. Samples of the materials were analysed and the results returned were found to be negative for the presence of asbestos. No further action is required for this material, it is mentioned for identification purposes only. (S# 28, 29) | | |

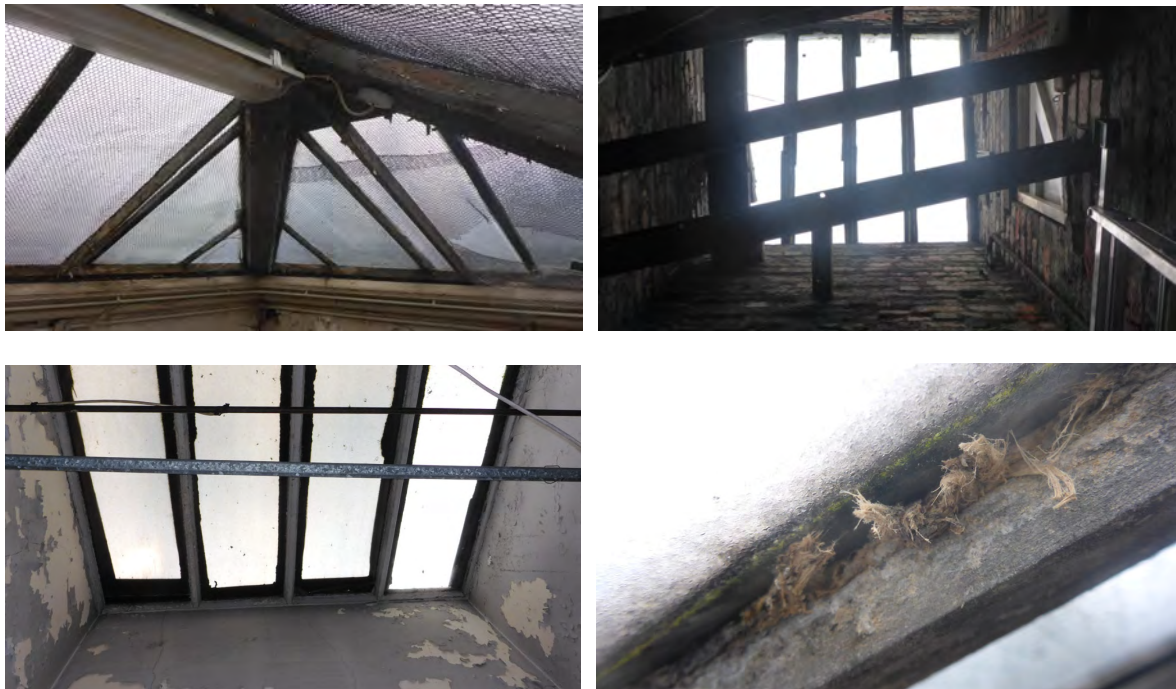
## Area 01: External – Roof - Asbestos rope bedding to various skylights

Asbestos rope bedding to the various roof top skylights

Upon completion of the asbestos removal, temporary reinstatement of a weather tight covering should be carried out. This should include but not be limited to temporary boarding of the skylights and the installation of a waterproof felt or other suitable barrier.

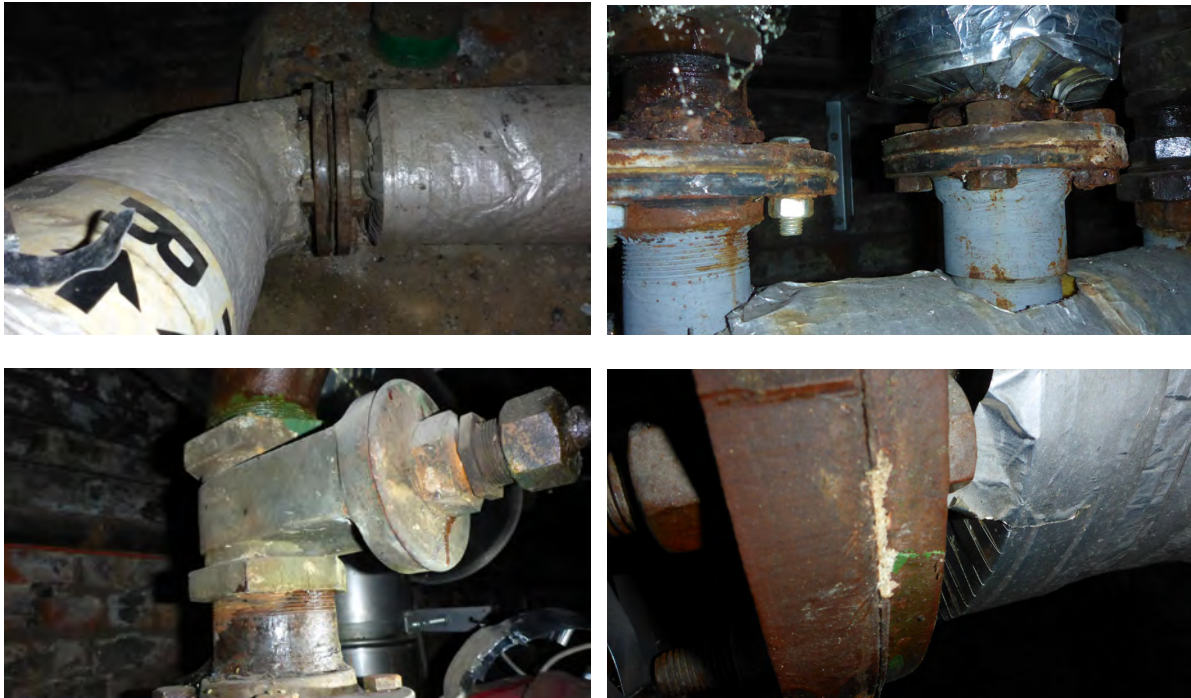
## Area 02: All Floors – Throughout – Compressed asbestos fibre gaskets

Compressed asbestos fibre gaskets to pipe-work flange joints throughout the building

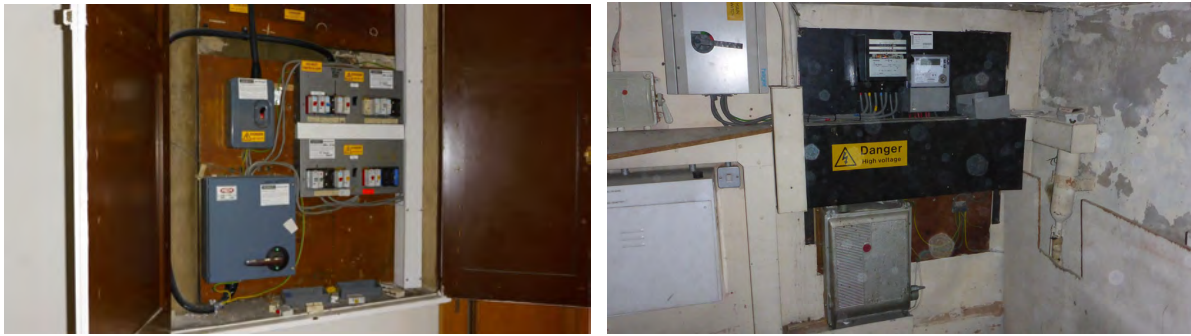
### Area 03: All Floors – Throughout – Old electrics

Internal asbestos components to old electrics throughout the building

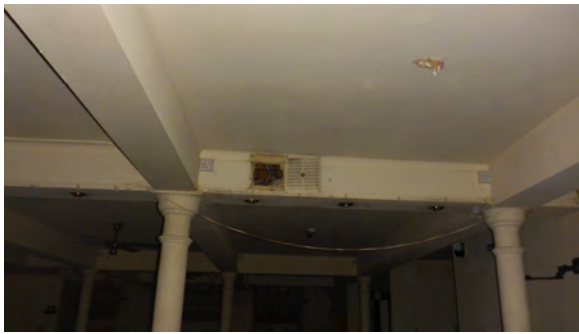
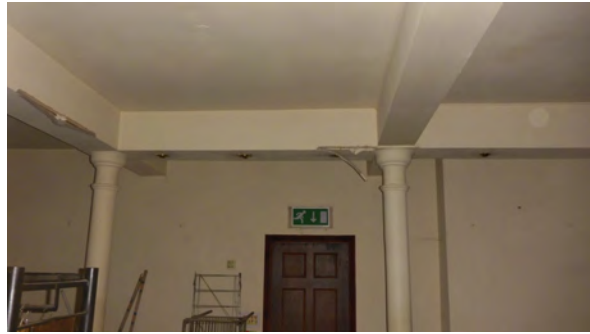
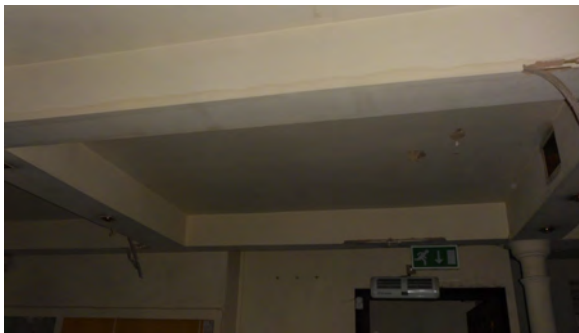
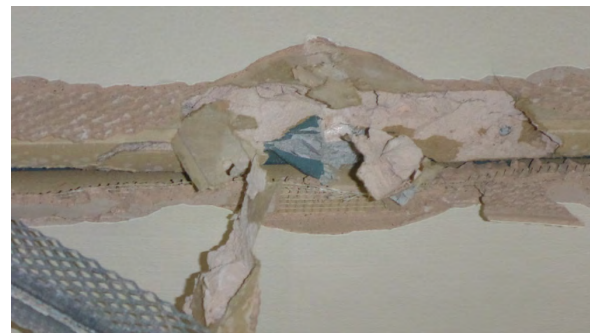
#### **Area 04: Basement – Restaurant – Asbestos insulation board to the ceiling & beams**

Asbestos insulation board cladding to the structural beams and part of the ceiling

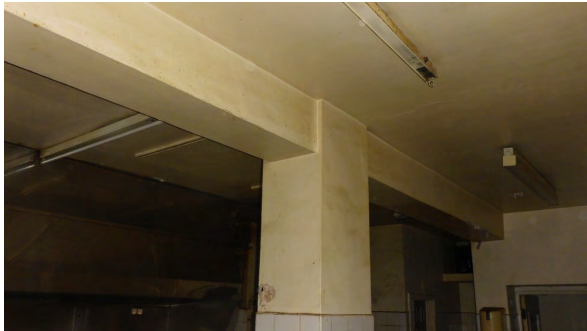
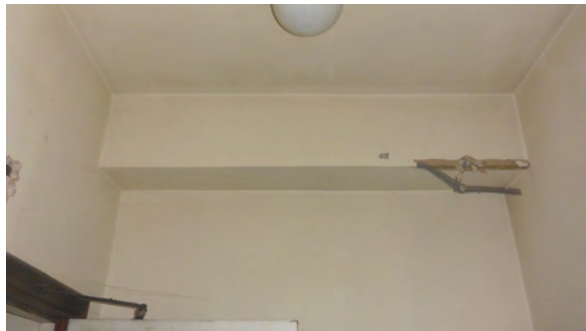
## **Area 05: Basement – Restaurant Kitchen & Lobby – Asbestos insulation board to the beams**

Asbestos insulation board cladding to the structural beams

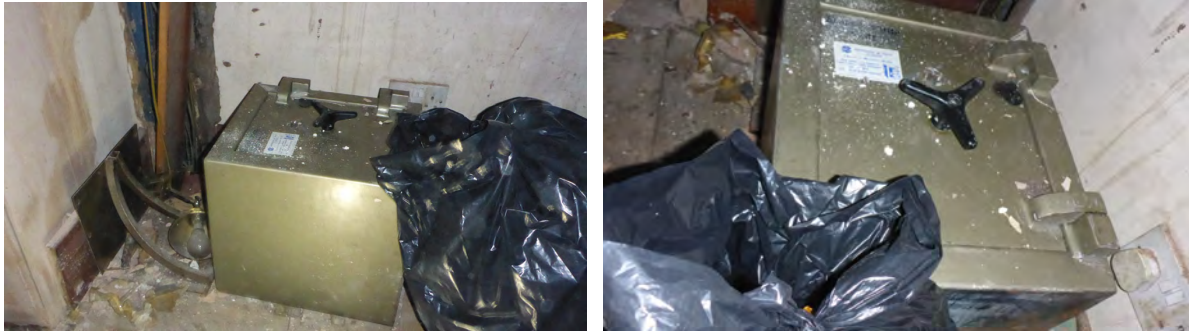
**Area 06: Basement – Beneath Stairs – Presumed internal asbestos to the safe unit**

The safe unit is presumed to contain internal asbestos components

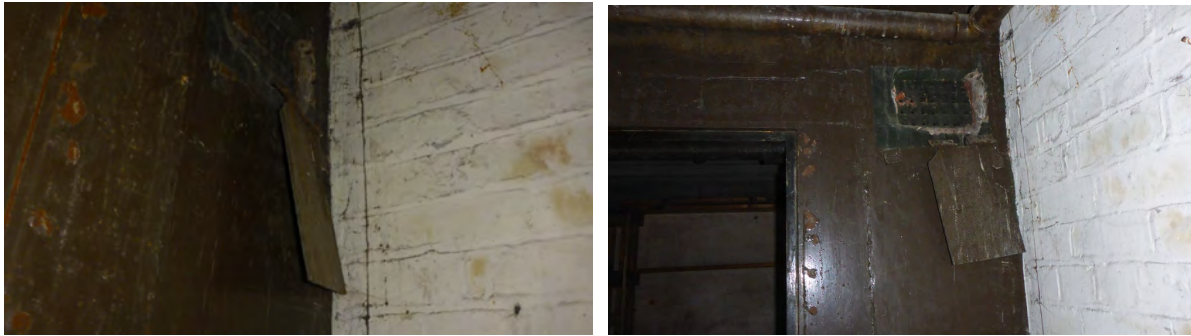
**Area 07: Basement – Safe Room Lobby – Asbestos cement board to the Safe Room air vent**

Small asbestos cement board panel to the Safe Room air vent

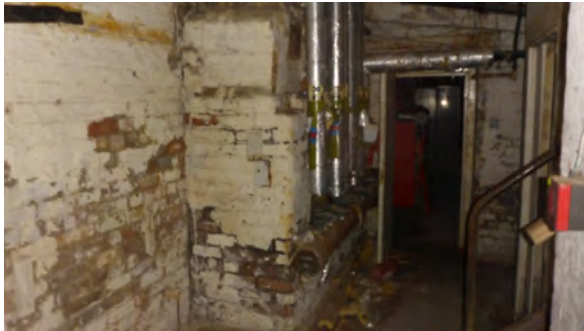
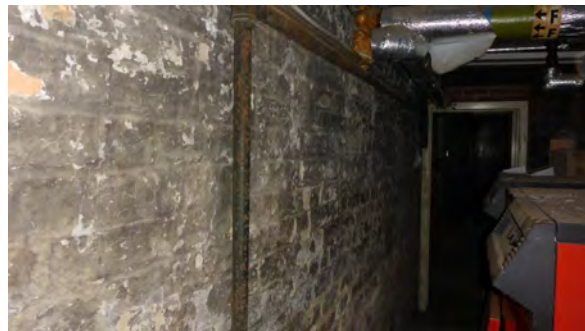
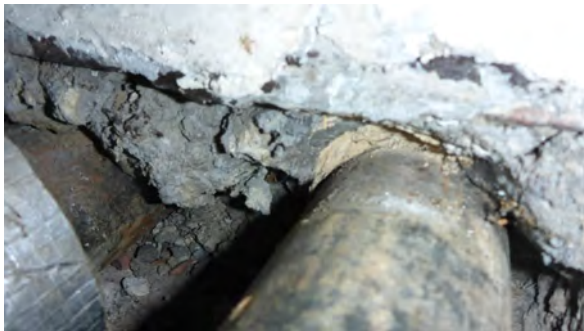
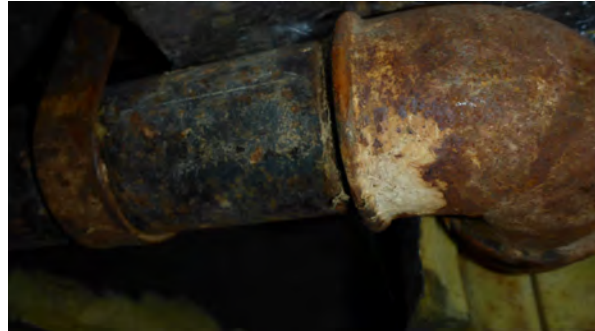
**Area 08: Basement – Lift / Safe Room Lobby & Plant Room – Asbestos thermal insulation debris and residues throughout**

Asbestos thermal insulation debris and residues to pipe-work, plant, ceilings, walls, penetration points, floors and surfaces throughout

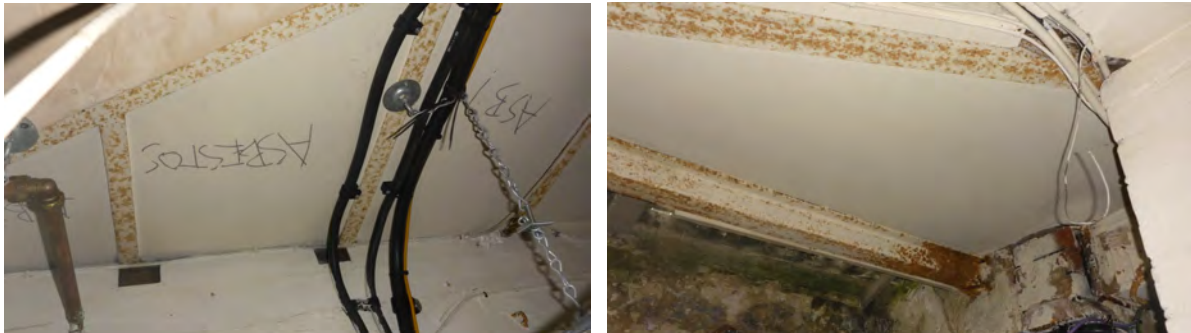
**Area 010: Basement – File Store & Server Room – Asbestos cement boarding to the ceilings**

Asbestos cement boarding to part of the ceilings

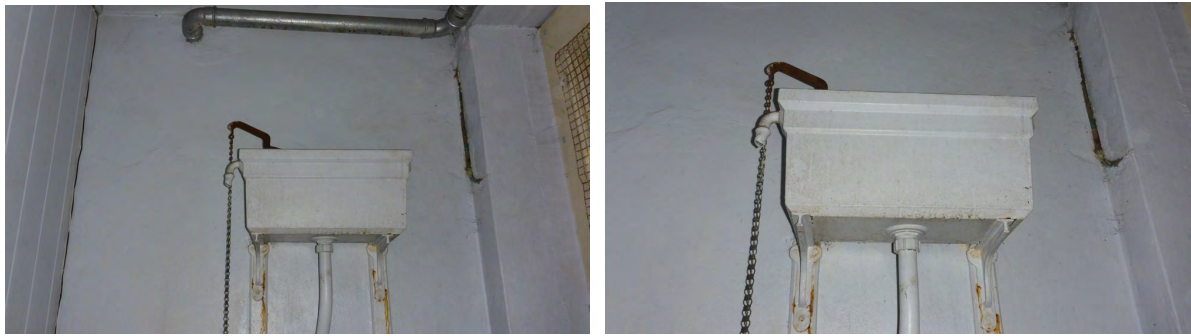
**Area 012: Basement – Toilet – An asbestos reinforced composite toilet cistern**

An asbestos reinforced composite (ARC) toilet cistern to the wall of the Toilet

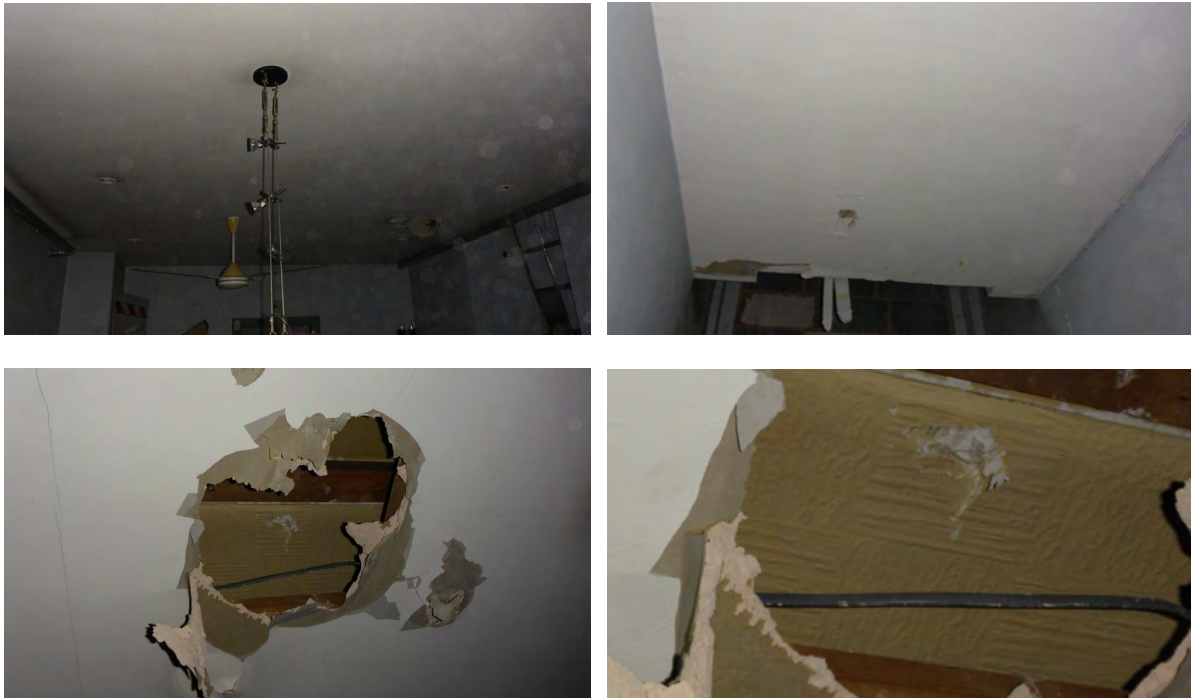
### **Area 013: Basement – Former Salon – Asbestos cement boarding to the ceiling**

Asbestos cement boarding to the original ceiling, beyond plasterboard

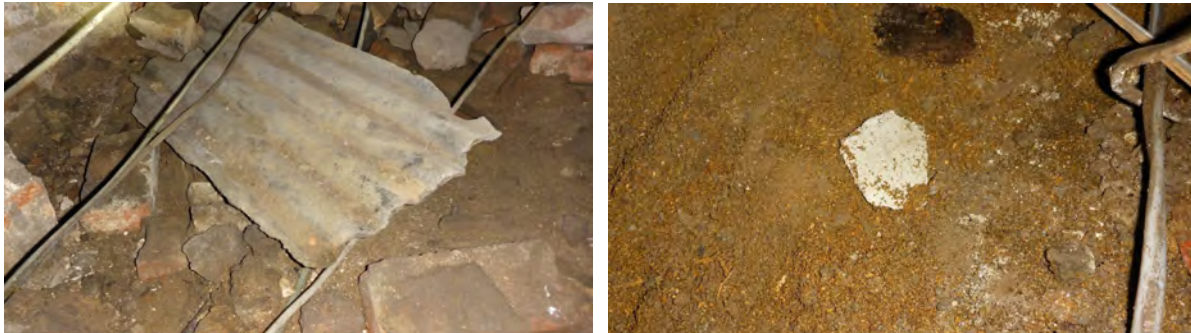
**Area 014: Basement – Undercroft Below Restaurant Kitchen – Minor asbestos cement & insulation board debris**

Minor asbestos cement and insulation board debris to the floor of the Undercroft

The works appear to be typical of the removal of minor loose asbestos insulation board and cement debris from a soil floor. The works will involve the removal of general building waste and rubble, prior to a fine cleaning of the soil surface, removing all remaining waste materials along with the asbestos cement and insulation board debris.

Upon completion of these works, a temporary hard board covering should be fixed over all opening made through the wooden floors.

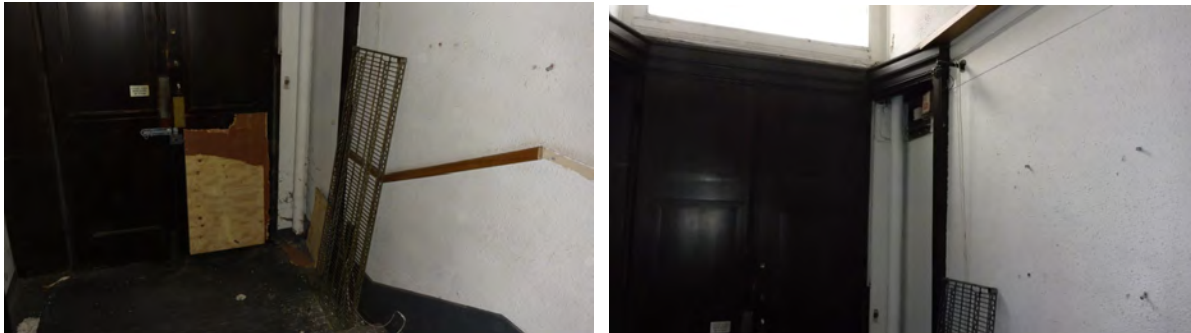
## **Area 15: Ground Floor – Mosley Street Entrance – Asbestos thermal insulation to vertical pipe-work**

Asbestos thermal insulation to the vertical pipe beside the door

In order to allow the formation of an enclosure, the contract must carefully, under controlled conditions, remove a section of the arched plasterboard ceiling around the pipe. High level access equipment may be required.

The works will involve the removal of redundant asbestos insulated pipe-work using a “wrap & cut” technique, including all associated brackets and hangers etc. Following removal of the pipe-work, all surfaces throughout the enclosure should be environmentally cleaned, removing all loose debris and residues.

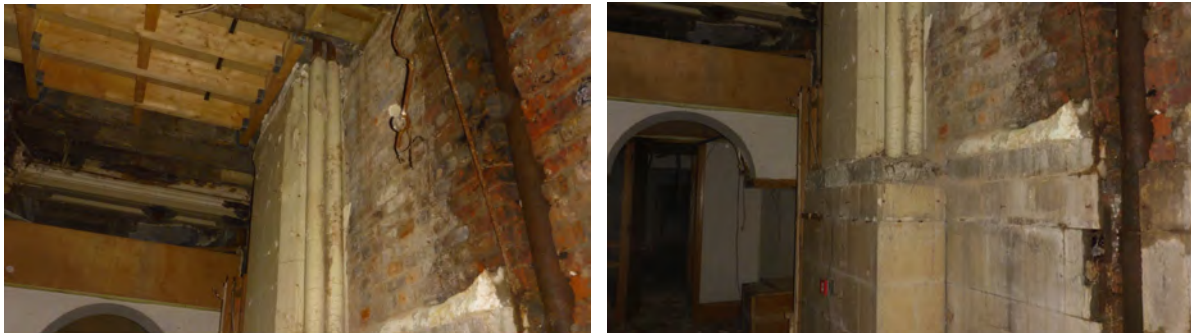
## **Area 16: Ground Floor – Lift Lobby – Asbestos thermal insulation to vertical pipe-work**

Asbestos thermal insulation to 2 vertical pipes beside the chimney, adjacent to the Lifts

The works will involve the removal of the low level stone / brick work to expose the pipes. Following this, the redundant asbestos insulated pipe-work should be removed using a “wrap & cut” technique, including all associated brackets and hangers etc. Following removal of the pipe-work, all surfaces throughout the enclosure should be environmentally cleaned, removing all loose debris and residues.

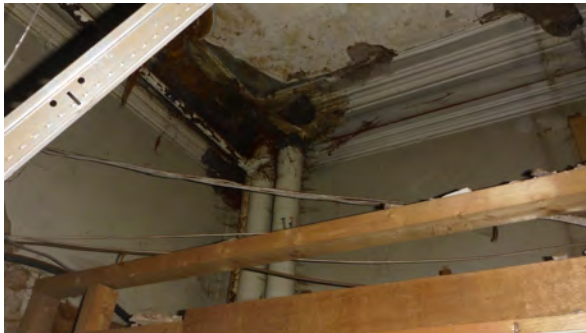
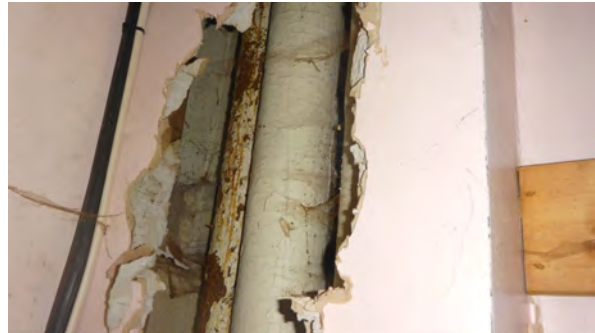
## **Area 17: Ground Floor – Lightwell Lobby / Store – Asbestos thermal insulation to pipe-work**

Asbestos thermal insulation to 2 vertical pipes within the box-work and above the Lightwell Lobby Store

It was noted that the floors in the vicinity of the Lightwell Lobby and Store were suffering from the effects of dry-rot. As such, the contractor should allow for the professional assessment of the building structure in this area and should employ any such control measures deemed necessary prior to commencing with the works.

The works will involve the removal of redundant asbestos insulated pipe-work using a “wrap & cut” technique, including all associated brackets and hangers etc. Following removal of the pipe-work, all surfaces throughout the enclosure should be environmentally cleaned, removing all loose debris and residues.

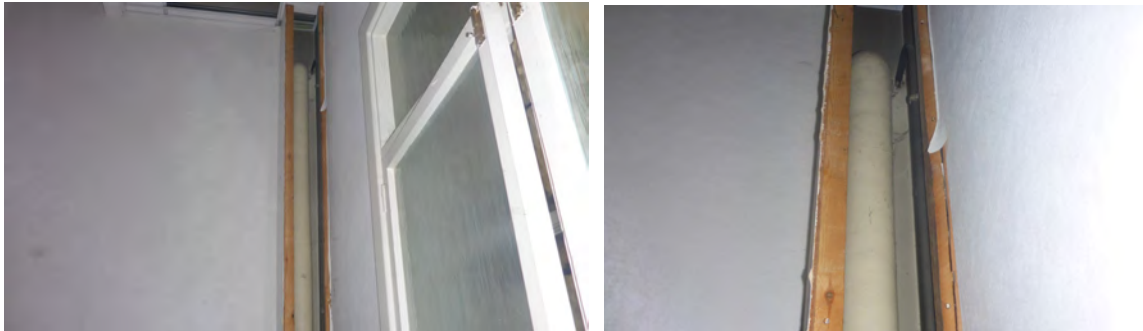
## **Area 18: Ground Floor – Lift Stairwell Half-landing – Asbestos thermal insulation to pipe-work**

Asbestos thermal insulation to pipe-work within the Half-landing box-work between the ground and first floor

The works will involve the removal of redundant asbestos insulated pipe-work using a “wrap & cut” technique, including all associated brackets and hangers etc. Following removal of the pipe-work, all surfaces throughout the enclosure should be environmentally cleaned, removing all loose debris and residues.

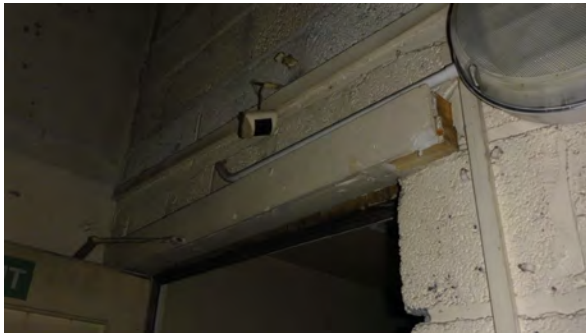
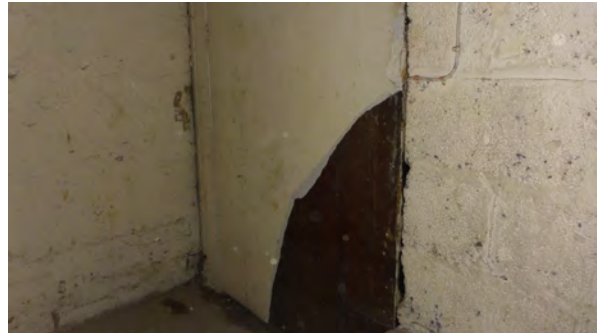
**Area 19: Ground Floor – Rear Fire Escape – Asbestos insulation board door head, door lining and associated debris**

Asbestos insulation board lining to the fire exit door and door-head, with associated debris to the floor

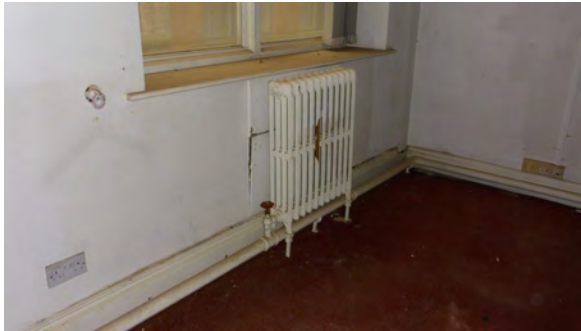
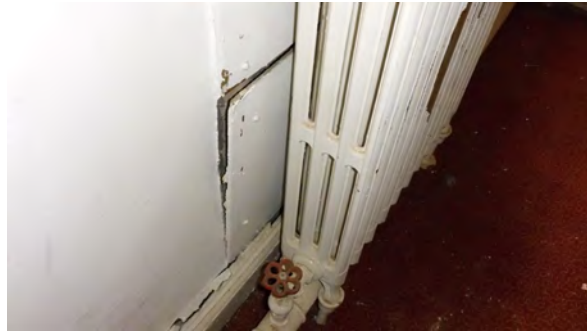
**Area 020: First Floor – Open Plan Office – Asbestos cement boarding behind the radiator**

Asbestos cement boarding to the wall behind the radiator

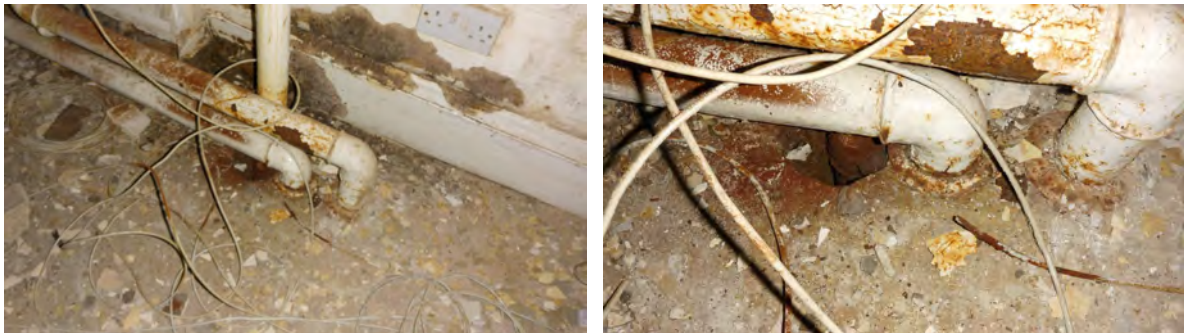
## **Area 21: First Floor – Lightwell Lobby – Asbestos thermal insulation debris in the floor void**

Minor asbestos thermal insulation debris around pipe-work within the floor void

The works will involve the removal of redundant low level pipe-work and asbestos insulation debris within the floor void, passing through to the Lightwell Lobby below. It is envisioned that these works will run concurrently with the removal of asbestos insulated pipe-work within this location on the floor below. Following removal of the pipe-work and debris, all surfaces throughout the enclosure should be environmentally cleaned, removing all loose debris and residues.

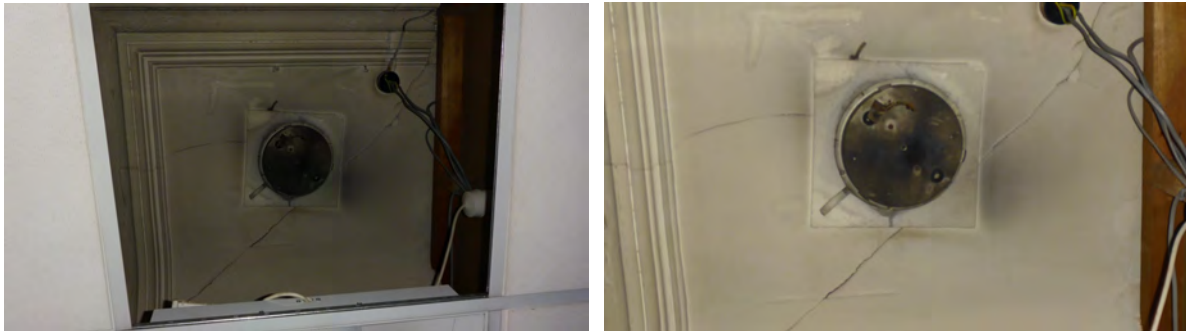
## **Area 22: First Floor – Lift Stairwell Half-landing – Asbestos insulation board panel to the ceiling**

Asbestos insulation board panel to the original Half-landing ceiling between the first and second floor

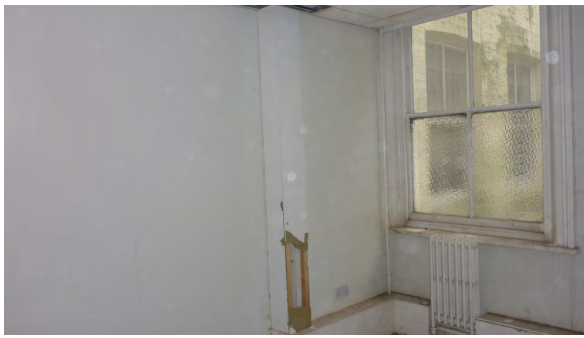
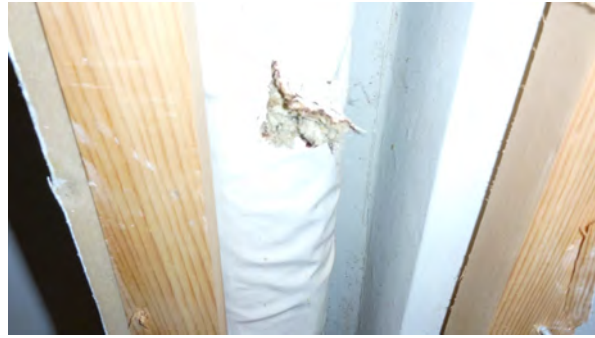
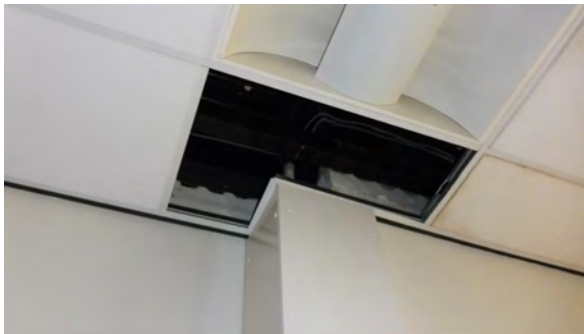
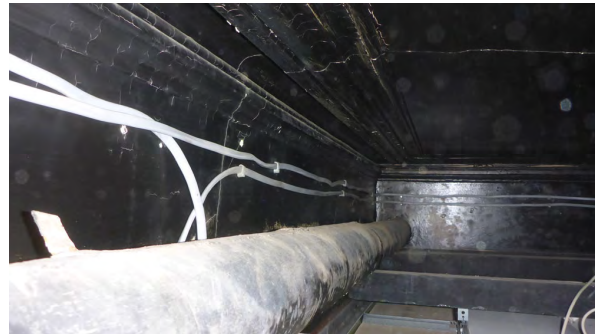
### **Area 23: Second Floor – Central Kitchen – Asbestos thermal insulation to pipe-work**

Asbestos thermal insulation to pipe-work within the Ceiling Void and vertical box-work

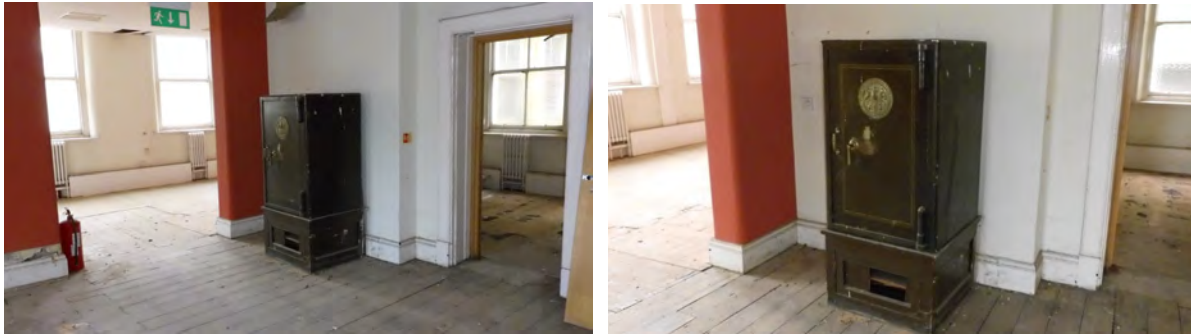
#### **Area 024: Second Floor – Mosley Street Office – Presumed asbestos to the old safe**

Presumed concealed internal asbestos to the old safe unit

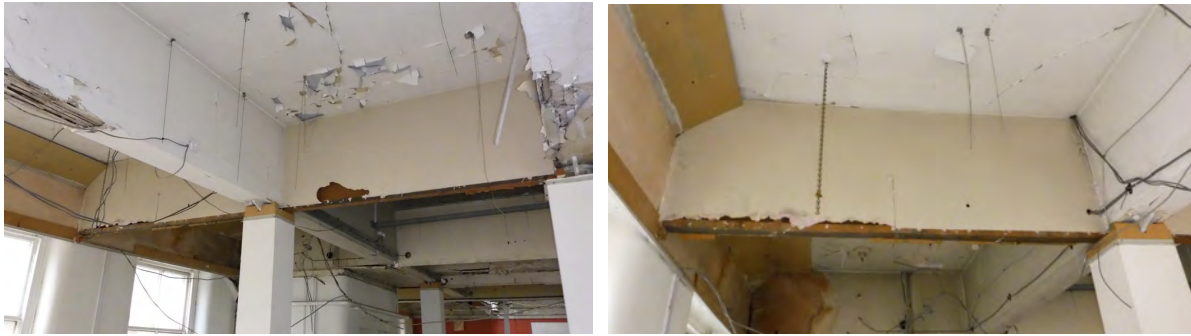
## **Area 25: Second Floor – Open Plan Office – Asbestos insulation board firebreak**

Asbestos insulation board firebreak at high level between the Main Staircase and Back George Street
